SHUTTLE HYPERVELOCITY IMPACT DATABASE

IAC-11.A6.3.7

62nd International
Astronautical Congress
Cape Town, South Africa
3 – 7 October 2011

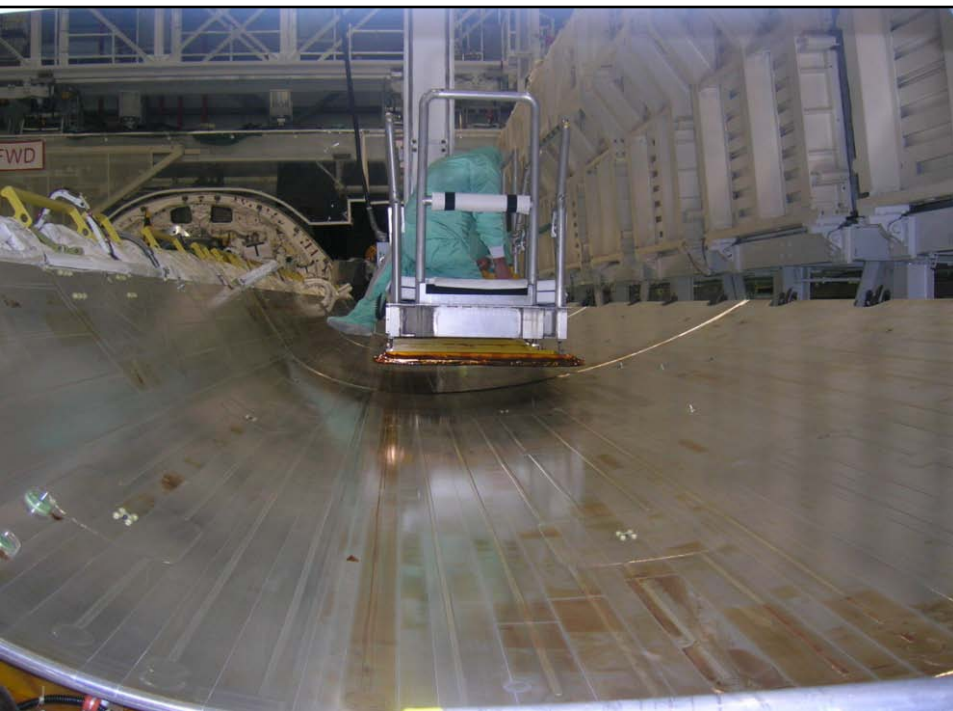
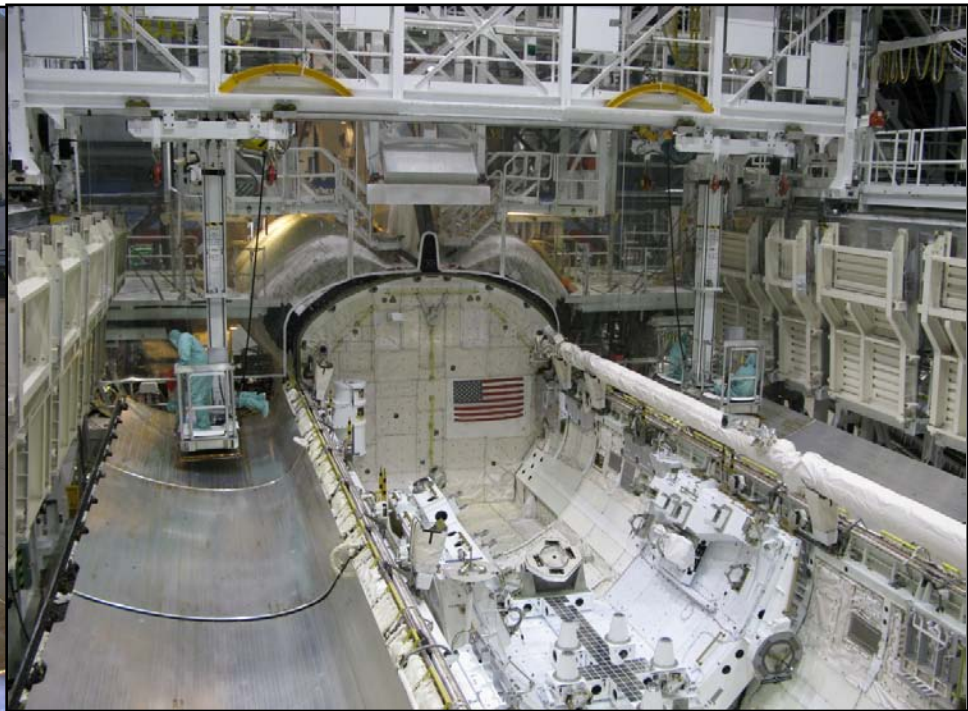
- ❑ Radiator dent & ding inspections were performed after each mission using a bridge crane and 2 platforms.
- ❑ Required contamination suits

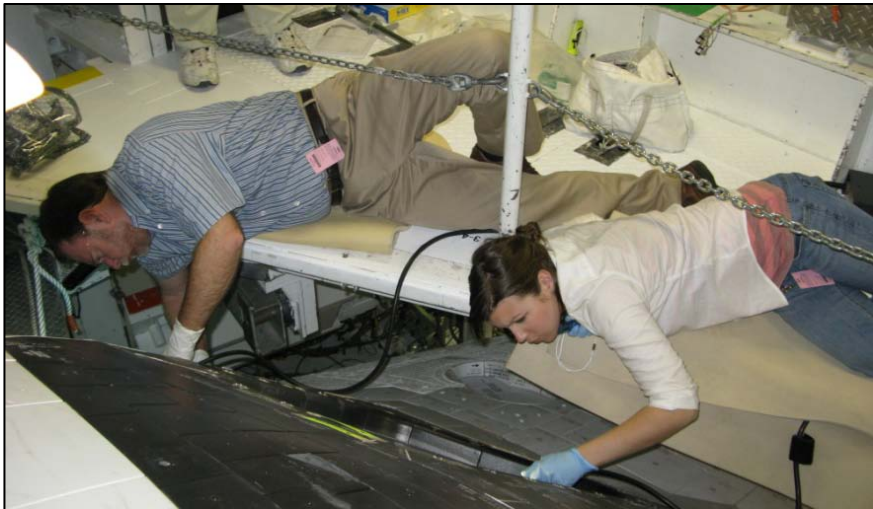
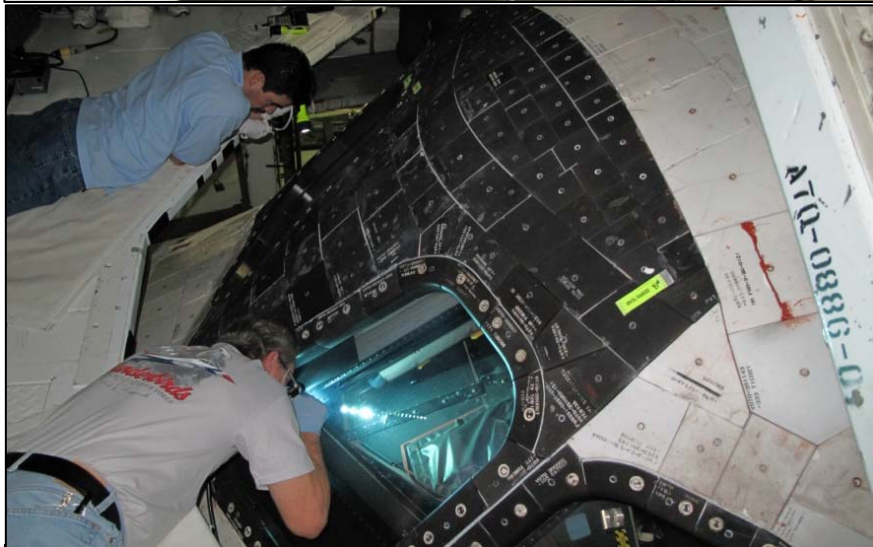
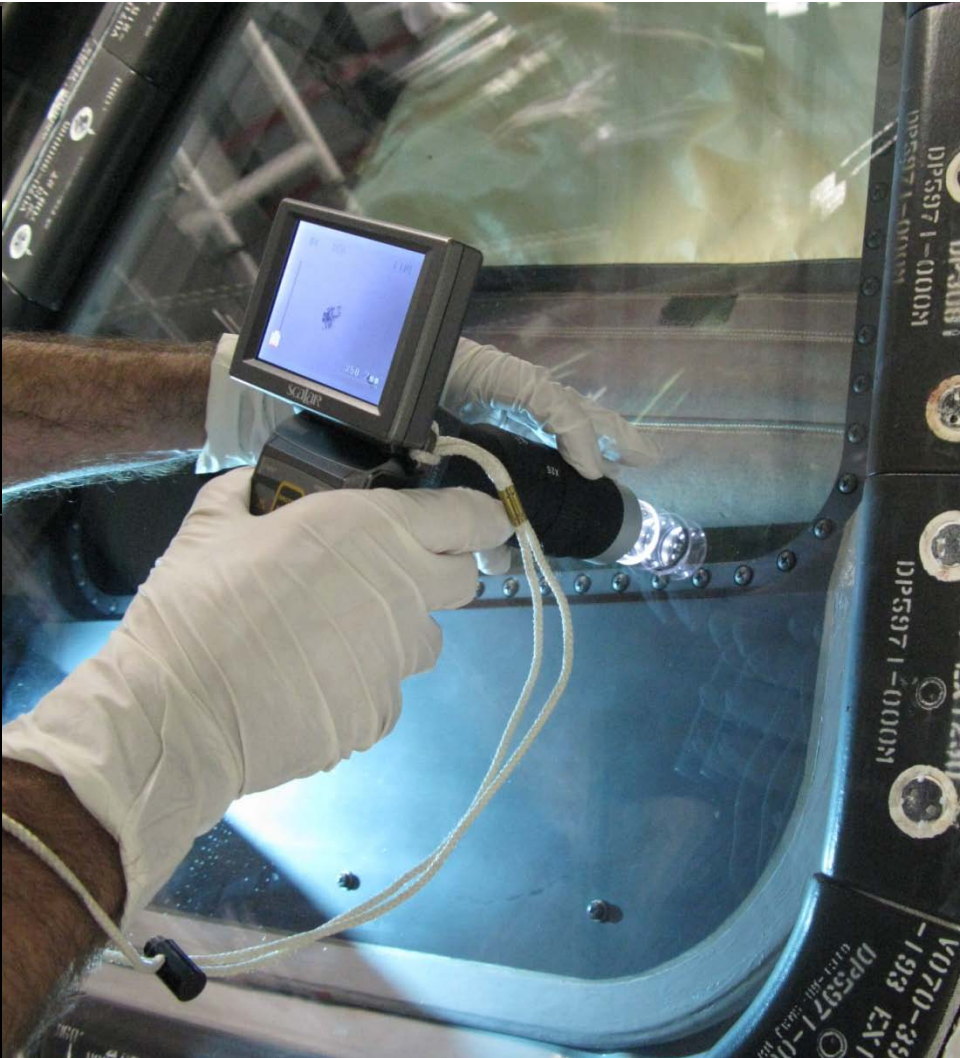
- ❑ Inspection access by platform. Awkward reaches necessary for complete inspection.

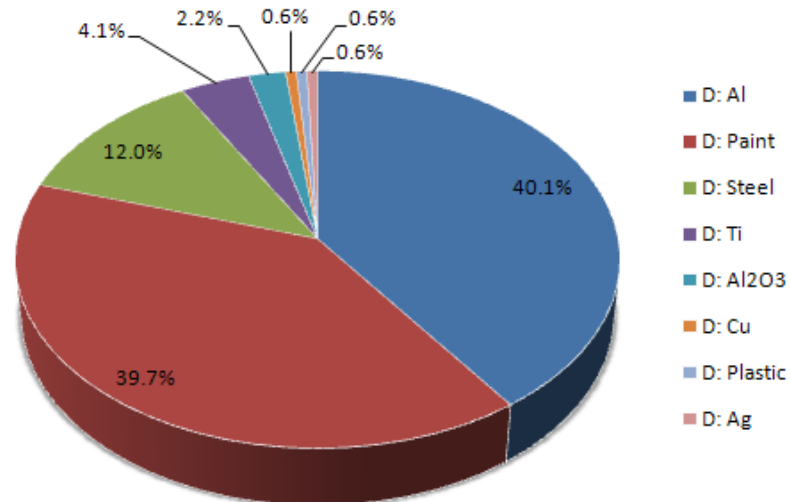
Orbital Debris Sources: Windows

D: Al	127
D: Paint	126
D: Steel	38
D: Ti	13
D: Al2O3	7
D: Cu	2
D: Plastic	2
D: Ag	2
D: Na/K	0
D: binders	0
D: waste	0
D: NiCd	0
D: PCboard	0
Total	317

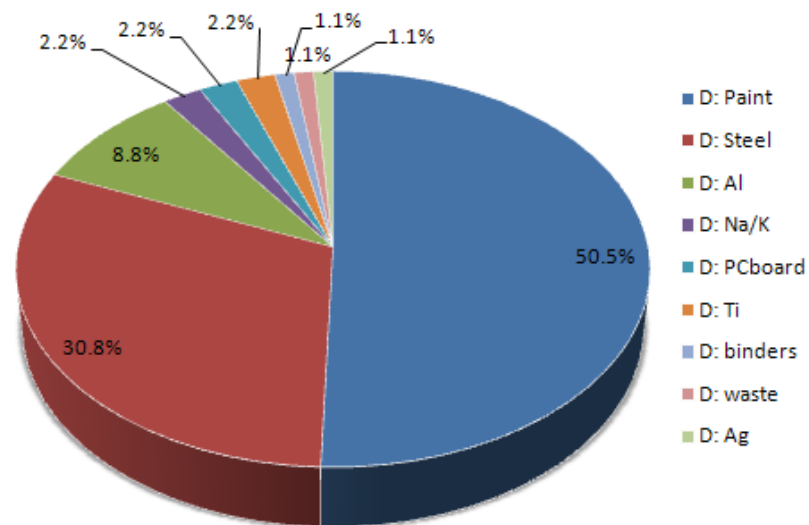
Orbital Debris Sources: Radiators

D: Paint	46
D: Steel	28
D: Al	8
D: Na/K	2
D: PCboard	2
D: Ti	2
D: binders	1
D: waste	1
D: Ag	1
D: Al2O3	0
D: Cu	0
D: NiCd	0
D: Plastic	0
Total	91
