Geoscience Laser Altimetry System (GLAS) Loop Heat Pipe Anomaly and On Orbit Testing

The Geoscience Laser Altimetry System (GLAS) is the sole instrument on the ICESat Satellite. On day 230 of 2003, the GLAS Component Loop Heat Pipe (CLHP) entered a slow circulation mode that resulted in the main electronics box reaching its hot safing temperature, after which the entire instrument was turned off. The CLHP had a propylene working fluid and was actively temperature controlled via a heater on the compensation chamber. The slow circulation mode happened right after a planned propulsive yaw maneuver with the spacecraft. It took several days to recover the CLHP and ensure that it was still operational. The recovery occurred after the entire instrument was cooled to survival temperatures and the CLHP compensation chamber cycled on a survival heater. There are several theories as to why this slow circulation mode exhibited itself, including: accumulation of Non-Condensable Gas (NCG), the secondary wick being under designed or improperly implemented, or an expanded (post-launch) leak across the primary wick. Each of these is discussed in turn, and the secondary wick performance is identifi

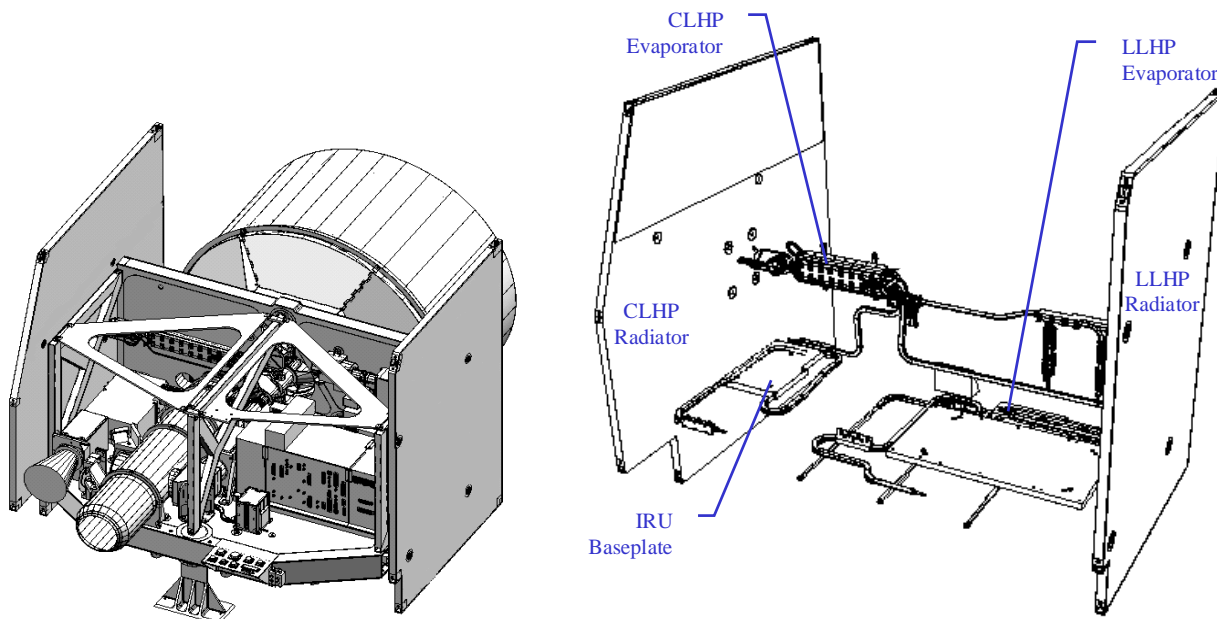
The thermal control system of GLAS required tight, stable temperature control under significantly varying sink temperatures, low heater power, and significant capacity to handle the instrument power of 110 W on the Laser side (with 45 kg of thermal mass) and 143 W on the component side (60 kg of thermal mass). To accomplish this, the thermal system had two independently controlled propylene Loop Heat Pipe (LHP) systems both fed by a network of ammonia Constant Conductance Heat Pipes (CCHPs). The Laser side had a Loop Heat Pipe (LHP) hereafter referred to as a Laser LHP or LLHP. The electronics side LHP was called the Component Loop Heat Pipe (CLHP) of which most of this paper refers. The electronics and Lasers were thermally isolated from the deck via titanium flexures to minimize gradients on the optical bench. The actively controlled LHP systems had heaters on their compensation chambers that were electronically controlled to maintain the temperature of GLAS's Laser and Electronics systems (also effectively controlling the bench temperature). By mechanically connecting the liquid return line to the vapor line near the evaporator body, the required heater power was very low for the precise thermal control (about 4-5 W per LHP). Fig 1 shows a simple schematic of the system.

Figure 1. GLAS Instrument Mechanical Model (Left), Heat Pipe Network and LHPs (Right)
