Moisture-Induced TBC Spallation on Turbine Blade Samples

James L. Smialek

NASA Glenn Research Center

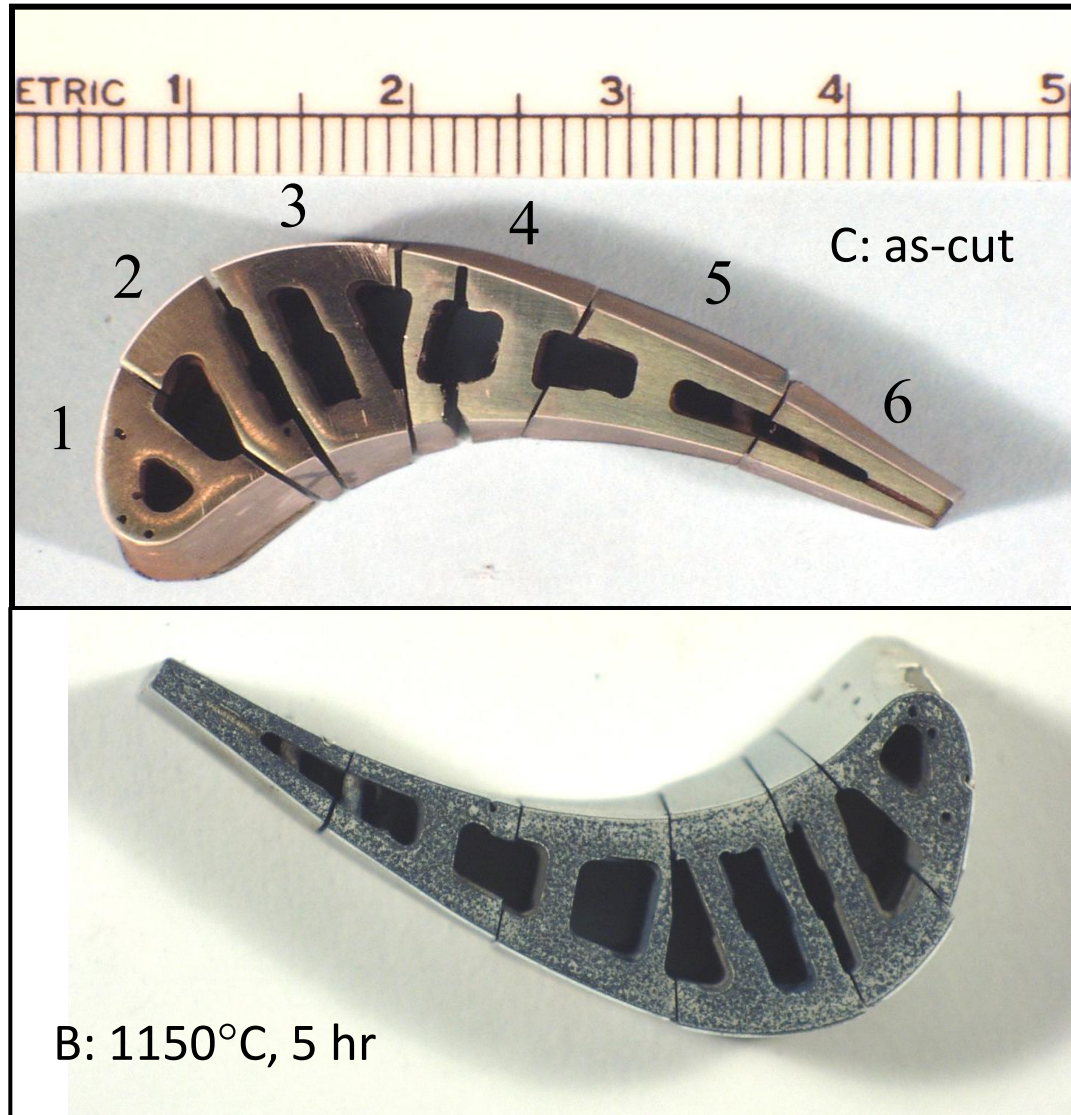
Figure 2

Figure 2. Sliced TBC coated turbine blade chord and six test sections for water drop experiments. Section C as-cut and sanded and Section B after oxidation at 1150°C for 5 hr.

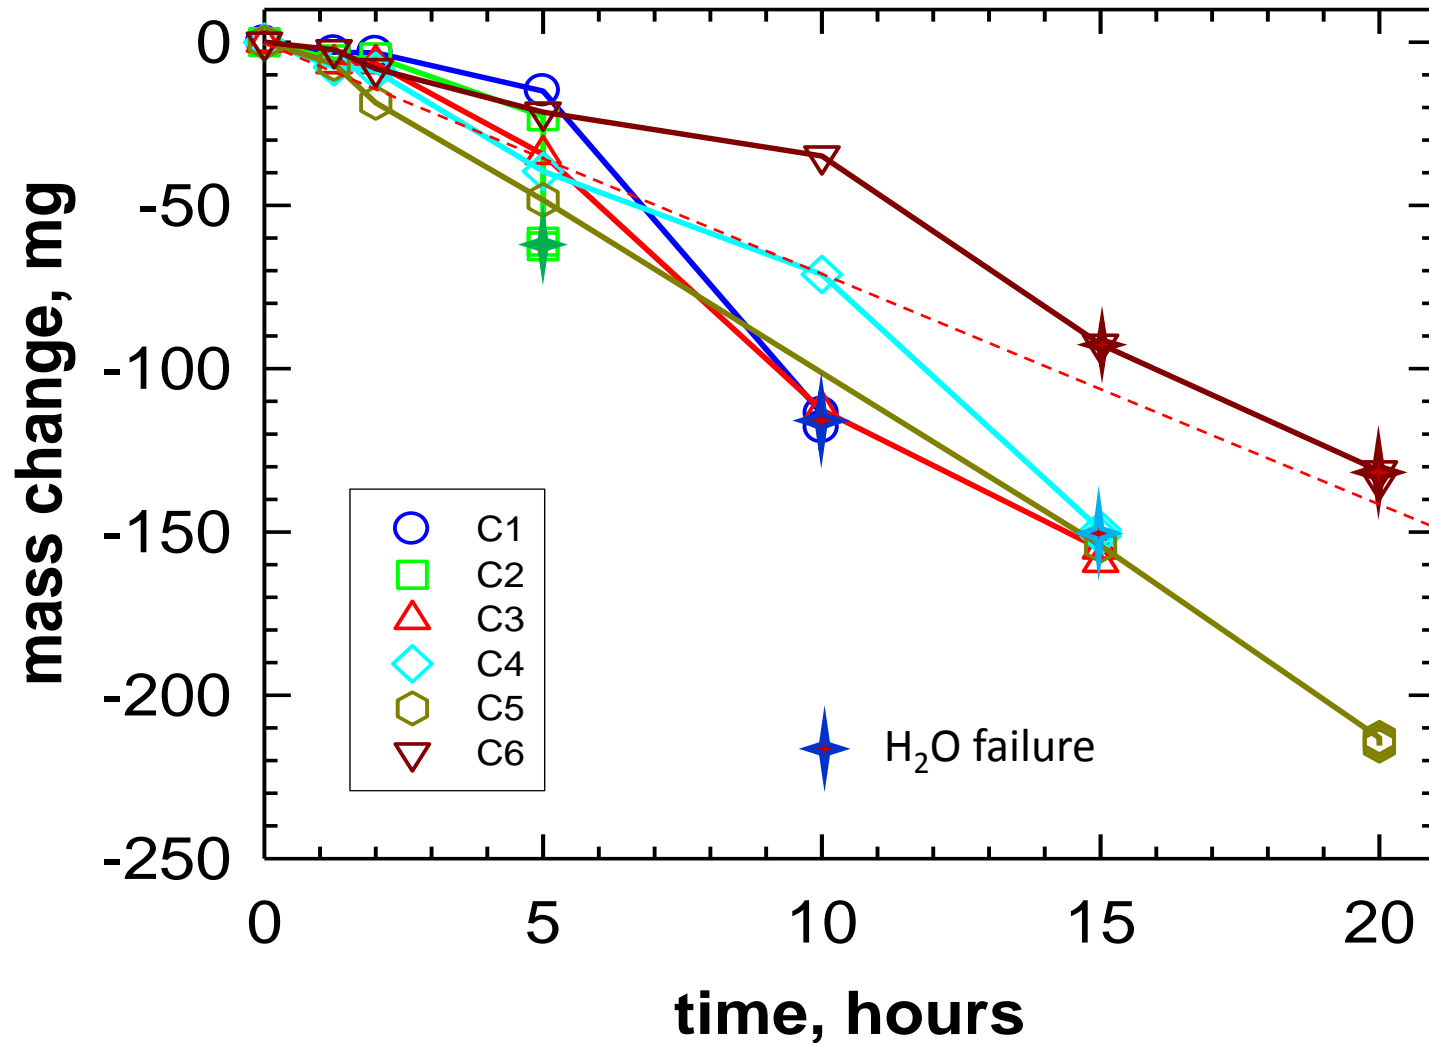
Figure 7

The weight change response for testing chord C at 1200°C is shown in [figure 7](#). Now the oxidation of the base metal produced nearly 50 mg weight loss after just 5-10 hr oxidation, or at an average rate of ~7 mg/hr. These large losses obscured any additional abrupt drops in weight associated with visual observation of coating failure. Moisture induced TBC failures are noted for samples C1, C2, C4, and C6 occurring at 5, 10, 15, and 20 hr total test time. A summary of the survival/failure history is presented in [figure 8](#). Here it can be seen that sample C1 spalled exclusively by water failure at just 5 hr. Sample C2 spalled partially by cooldown, then by moisture testing, both at 10 hr. Samples C3-C6 exhibited partial failure on cooldown from 10-20

Figure 7. Mass losses for 1200°C intermittent oxidation of Section C samples. Water drop spallation failures indicated by star symbol. Dashed line indicates approximate loss rate for uncoated superalloy cut edges.
