DRAFT: FEDSM2005-77052

A CFD ANALYSIS OF EASTERLY WIND FLOW IMPACTING THE VEHICLE ASSEMBLY BUILDING

ABSTRACT

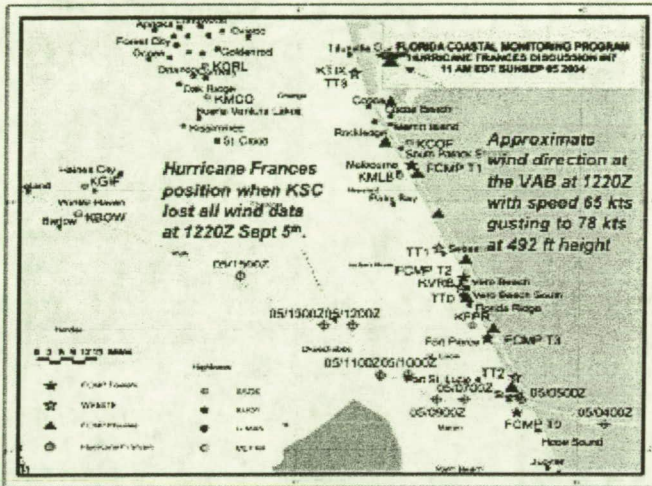
Figure 2. Approach, landfall, and departure track of Frances

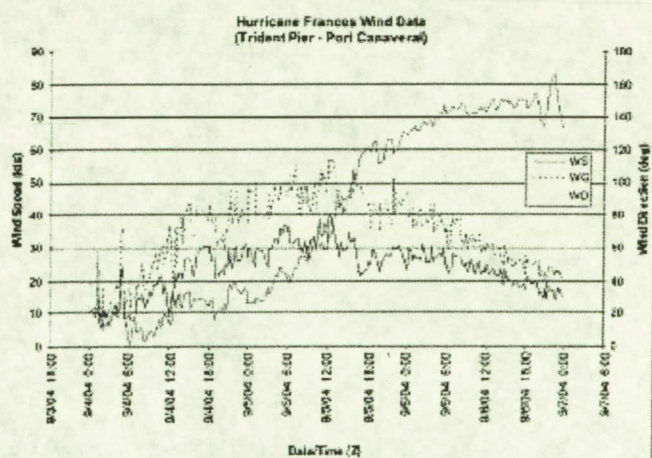
Figure 3. Hurricane Frances wind data from Trident Pier at Port Canaveral

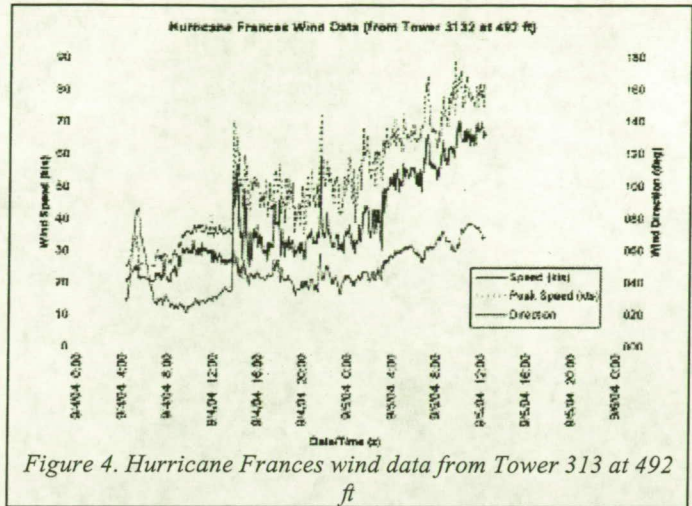
Between 0930Z and 1200Z on September 5, the maximum sustained wind at the 492-ft level was about 70 kt, with a peak gust of 89 kt (see Figure D-4). The direction was between 062° and 077° and was rapidly veering (turning clockwise with time). At the 295-ft level, the maximum sustained wind was about 61 kt from a general direction of 64° to 78° , with a maximum gust of 78

Figure 4. Hurricane Frances wind data from Tower 313 at 492 ft

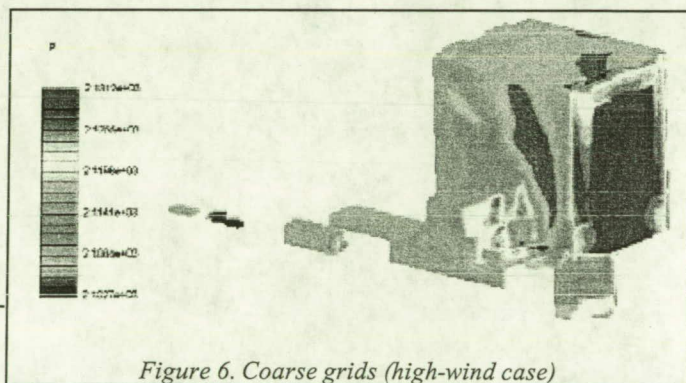
Figure 6. Coarse grids (high-wind case)

Figures 6 through 12 graphically show the CFD pressure distributions on the VAB for various wind intensities from the east. Figures 9 and 10 show the results when the wind is biased $\pm 10^\circ$ about the East face. The predicted streamlines in Figure 13 indicate strong vortices in the region between the low and high bays of the VAB. This indication is consistent with the fact that the most damage was confined to the south face. In addition, photographs taken after Hurricane Frances indicate that the panels in this region were peeled off the wall in two directions (i.e., either toward the upper left corner of the south face or toward the upper right corner). This two-directional flow phenomenon (Figure 14) is also predicted by the velocity vectors of the computational simulation (Figure 15), indicating a strong recirculation zone near the region where the panels were stripped off the surface. The CFD analysis also predicted flow separation around the top of the building, which again is consistent with the actual damage seen on the roof (Figure 16). The north side of the building only suffered minimal damage, as shown in Figure 17.

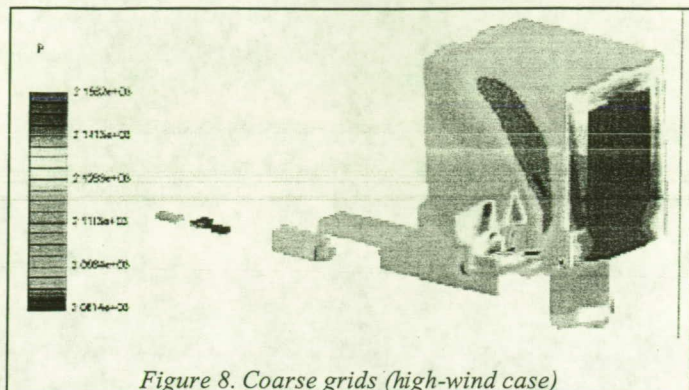
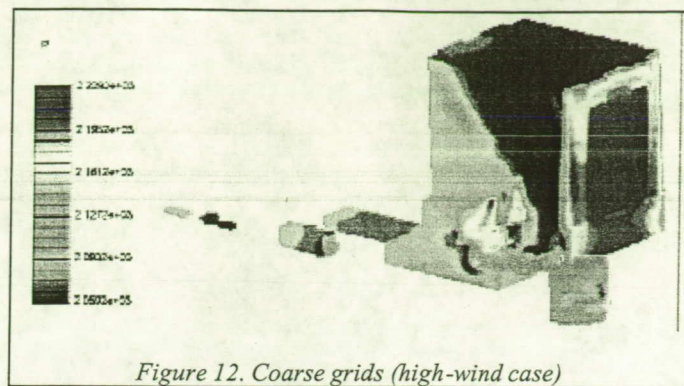
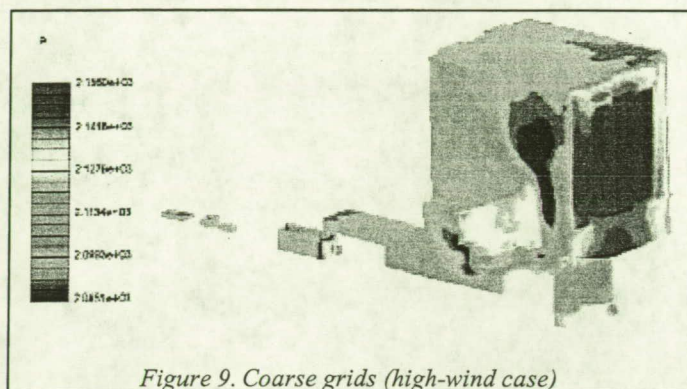
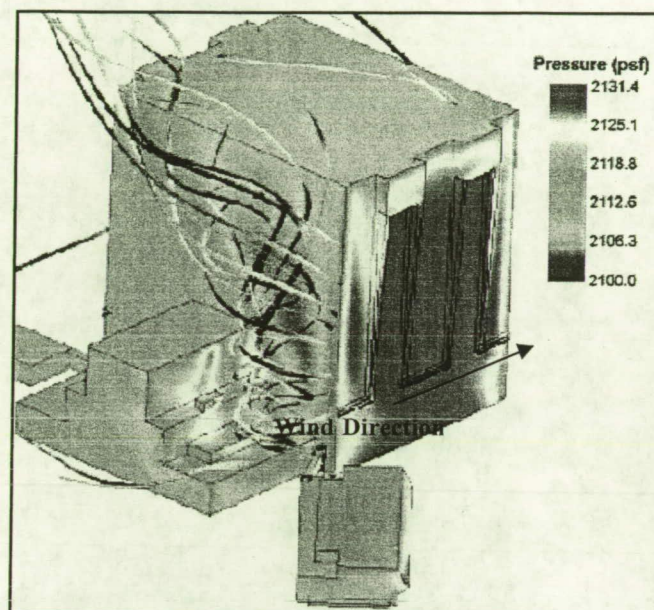
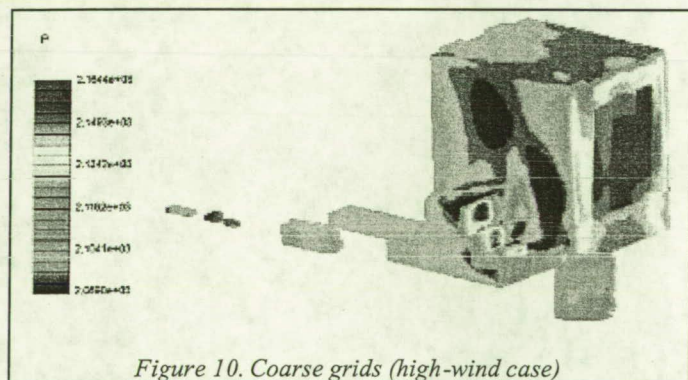
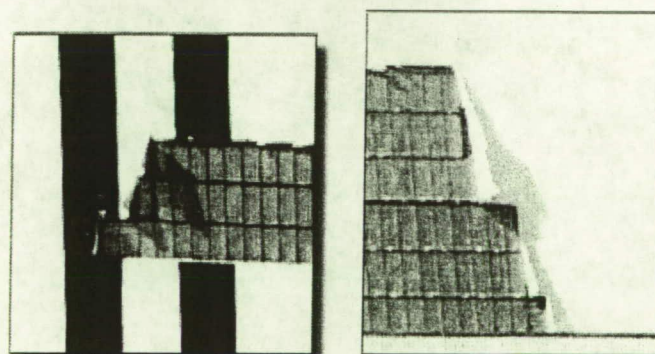
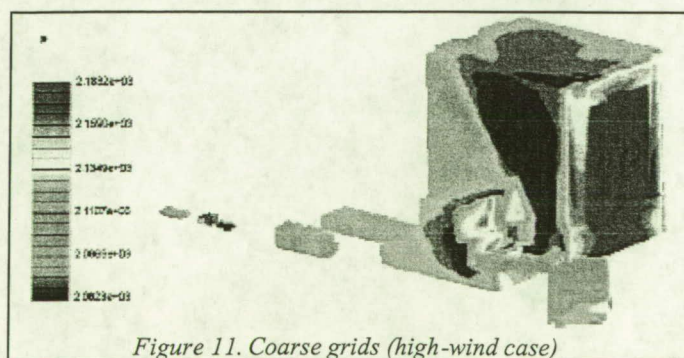
This analysis shows the potential damage area on the south face is sensitive not only to wind speed, but to relatively small changes in direction. The table shows four simulation that were made for a Category 3 hurricane: a wind directly impacting the east face, plus three of the same speed that were biased $\pm 10^\circ$ off the east face. The maximum pressure difference is encountered when the wind direction is 10° south of the building's east-west axis. This direction nicely corresponds to the period of the storm when the wind was at its maximum.
