# Photogrammetry Measurements During a Tanking Test on the Space Shuttle External Tank, ET-137

## ABSTRACT

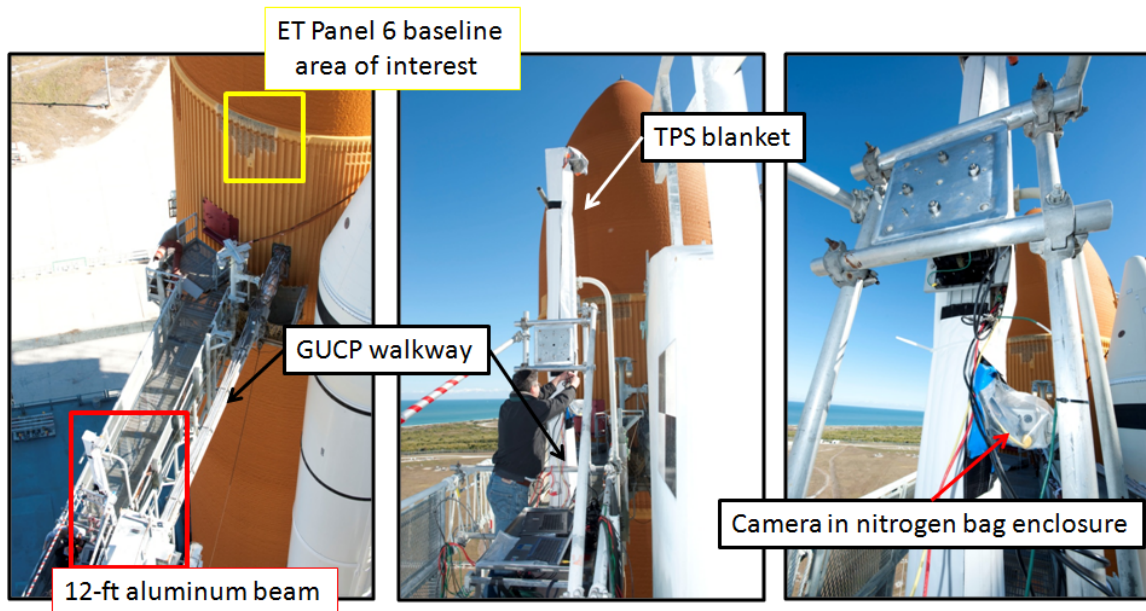
**Fig. 3** Details and camera setup for ET Panel 6

The Panel 6 camera pair was mounted on the railing of the GUCP walkway located on the 215-ft level of the fixed service structure (FSS) and aimed at ET Panel 6, focusing on the region near the LO2 flange. This particular region was chosen because it allowed technician and engineer access to both the cameras and the ET via the GUCP walkway, and also because Panel 6 was structurally similar to Panel 2 in terms of geometry, including similar skin thickness and doubler regions. A pair of Vision Research Phantom v10.1 4 megapixel (MP) cameras was attached onto a 13 foot long, vertically mounted 6-in- by 6-in- extruded aluminum beam at a base separation of approximately 7 feet. They were enclosed in nitrogen gas purged bags to meet the safety requirements and mitigate the risk for a spark, fire or explosion during the test. The aluminum beam was covered in a thermal protection blanket to minimize thermal expansion due to temperature change throughout the day. The thermal expansion of the beam was a major concern for the integrity of the calibration of the cameras. This issue will be discussed further in the *Calibration Procedures* section. Figure 3 shows the Panel 6 test setup.

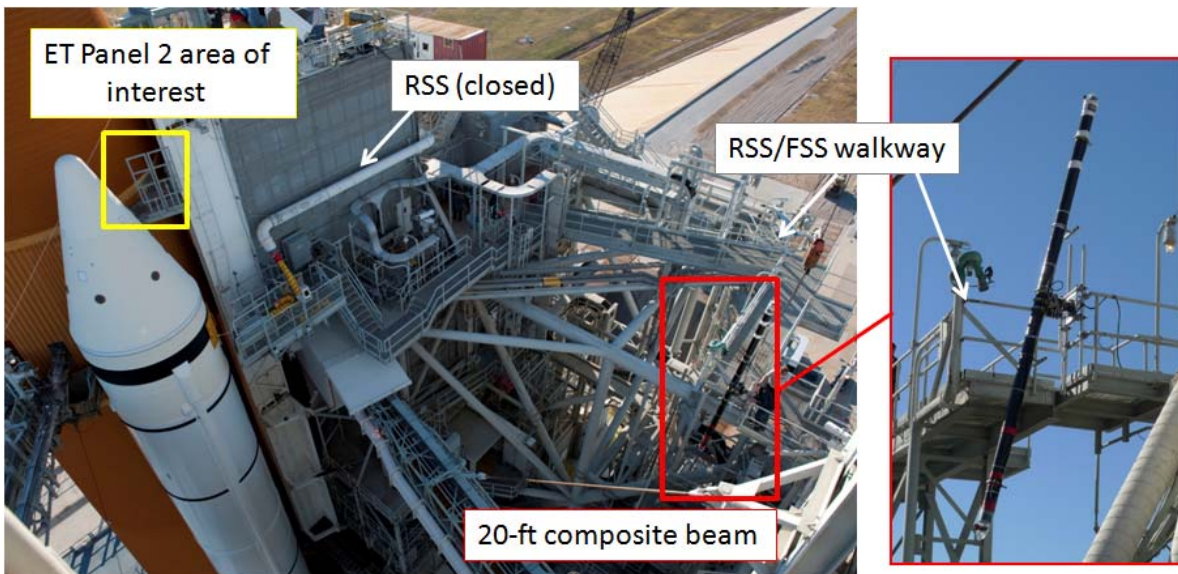
**Fig. 4** Details and camera setup for ET Panel 2

A second camera pair was constrained to be used on the repaired region on ET Panel 2. The first option was to use the removable service structure (RSS) for the mounting of the camera pair because the RSS was very close to the Panel 2 region while also having ample room to setup and operate the camera equipment. However, the tanking test required that the RSS be in the open position in order to accurately simulate the launch countdown, which made it impractical to use. With the removable service structure rotated into the open position and therefore unusable, the closest available mounting location was the walkway which connected the FSS to the RSS. This walkway was located approximately 60 feet away from the ET. The 60-ft distance constrained the camera base separation to be between 20 ft and 30 ft. As such, Baumer 5MP cameras were mounted on a custom 20-ft long, 6-in diameter woven composite hollow beam. A composite beam was chosen for the beam as alternative aluminum or steel beams were rejected because of their large weight and possible large expansion properties under changing weather conditions. As with the Panel 6 cameras, the Panel 2 cameras were enclosed in nitrogen purged gas bags. Figure 4 shows the setup for ET Panel 2.

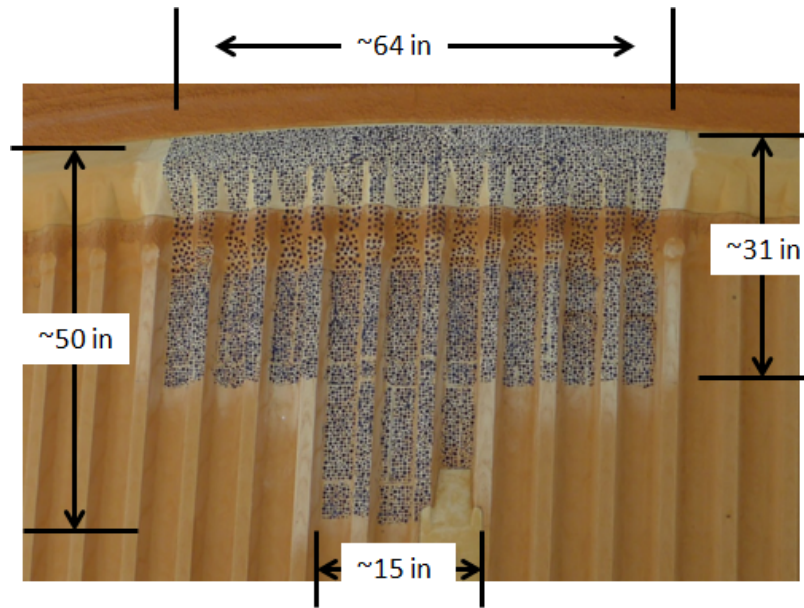
**Fig. 6** Speckle pattern on ET Panel 6

A dot speckle pattern was stenciled on the ET Panel 2 and Panel 6 locations by orbiter technicians with approved black epoxy marker paint. The dots were nominal 3/8-in diameter, and they were painted between stringers 5 and 14 on Panel 6 and over the repaired region for Panel 2. For Panel 6, the pattern extended from just above the LO2 flange, down onto the intertank structure, and approximated a T shape. For Panel 2, the pattern resembled a square painted over the repaired area shown in Figure 2. Figure 6 shows a close up view of the application of the dot speckle pattern on Panel 6.

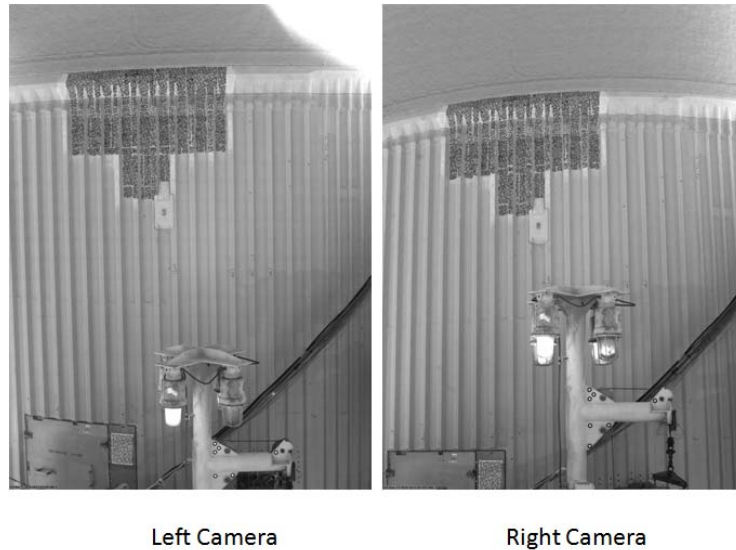
**Fig. 8** Panel 6 stereo camera view

All results were examined post-tanking test. When examining the results post-test, it was noted that Panel 6 data were of much higher fidelity than Panel 2 results and will therefore be used as the example for the data analysis. Figure 8 shows sample images captured from the left and right camera of Panel 6. The calibrated region is much larger than the patterned region based on the original goal of measuring a significant portion of the length of the intertank. However, the patterned region was significantly reduced due to flight safety concerns.

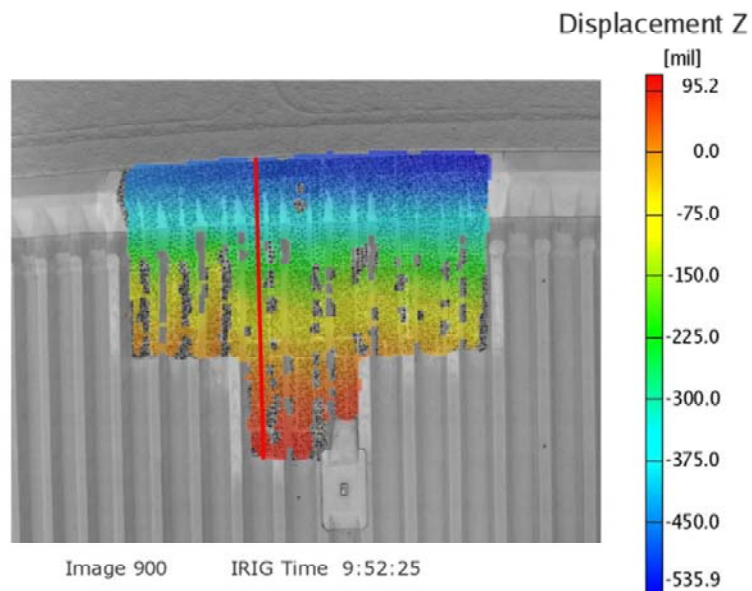
**Fig. 13** An extracted section line for the valley between stringers 8 and 9

Spatial trends in the data were next extracted using the section line function. A section line represented the data as a function of position for a discrete time, rather than plotting as a function of time. The section line in Figure 13 (shown in red) extended vertically between the top and bottom of the speckle region in a valley between stringers 8 and 9.
