## **Boiling eXperiment Facility (BXF)**

# **Fluid Toxicity Technical Interchange Meeting (TIM) with the Payload Safety Review Panel (PSRP)**

June 14, 2012

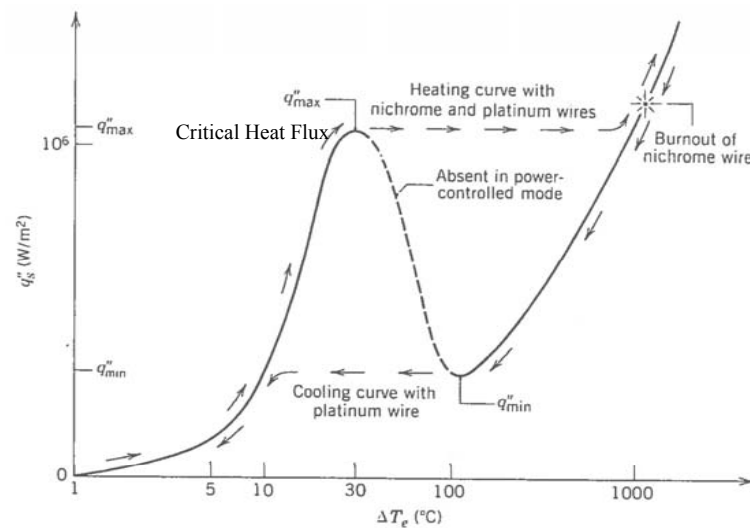
Figure 10.3 Nukiyama's boiling curve for saturated water.

- Heater Operating Conditions
  - 60 W @ 24 VDC, 1/8" DIA x 6" LG, 1/4" No Heat Zone
  - Heat Flux  $\approx 4 \text{ W/cm}^2$
  - $\sim 0.04 \text{ L/min}$ . flow over each heater at time of anomaly
- Fluid manufacturer 3M recommends heat flux of no more than 6-10 W/cm<sup>2</sup>
  - If exceed, “boiling is no longer stable, a vapor blanket forms on the wire, and the wire temperature skyrockets.”
  - This is called exceeding the “critical heat flux,” and it leads to burnout of heating element.

Typical boiling curve with onset to “burnout point” or “boiling crisis”

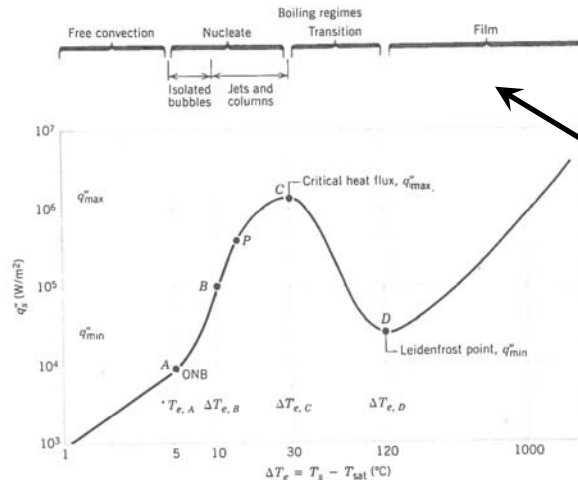
Figure 10.4 Typical boiling curve for water at one atmosphere: surface heat flux  $q''_s$  as a function of excess temperature,  $\Delta T \equiv T_s - T_{sat}$ .

- Heater manufacturer Watlow examined discoloration and damage of heaters
  - “All signs of failures appear to be from exposure to high temperature.”
  - Heater #1: “Melting of sheath (insulation breakdown due to high temperature causing an arc...)”
  - Heater #2: “Discoloration and oxidation with a shorted internal winding due to high temperature.”
  - Possible causes: “Watt density too high” and “Material flow issues - low flow, no flow, or pattern of flow not taking heat away.”
  - Recommendation: “Suggest you monitor the heater temperature and use a high-limit controller to shut the heater down to avoid overtemperature.”

Typical boiling curve with critical heat flux and boiling types

Film boiling completely blankets surface, insulating it and allowing only radiative loss of heat.
