Stress Analysis and Testing at the Marshall Space Flight Center to Study Cause and Corrective Action of Space Shuttle External Tank Stringer Failures

Robert J. Wingate*

NASA Marshall Space Flight Center, Huntsville, AL

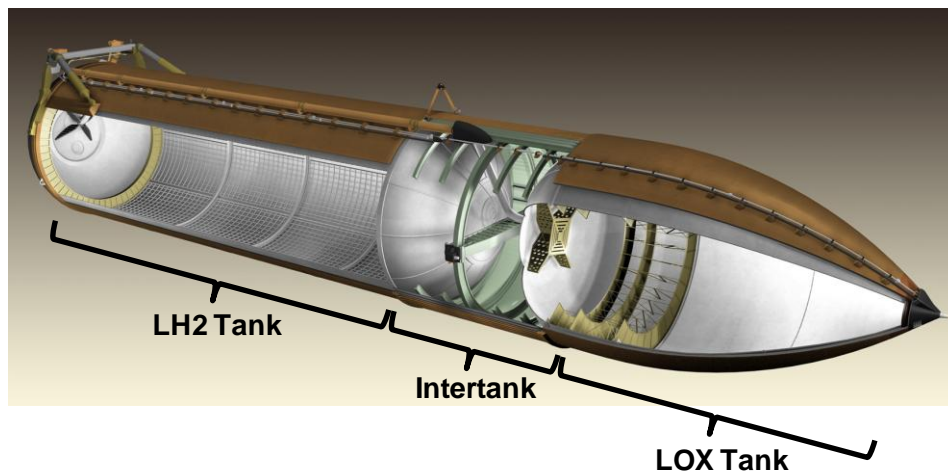
Removal of the damaged foam revealed that an underlying aluminum hat-section stringer had cracked approximately 9 inches along each side, just inboard of the fasteners that attached the stringer “feet” to the intertank forward flange chord (Figure 2). The crack in the foam was solely a result of the stringer failure. An adjacent stringer was also found to be similarly cracked on each side for about 3 inches along its forward end, although the SOFI directly over it had appeared undamaged.

Figure 2. Stringer cracks discovered after STS-133 launch scrub. ET-137 stringer S7-2 shown. (Bottom left inset: stringer S7-2 after removal from ET-137 and foam residue cleaned off.)

The two stringers were repaired in-situ at the launch pad by removing several inches of the forward end of each damaged stringer and splicing on an equivalent length taken from new stringers. Aluminum sheet stock doublers formed into a shape resembling the letter 'Z' were overlaid and fastened on the splice location to mechanically tie each portion of new stringer to the remaining portion of original stringer. The SOFI was then manually re-applied, allowed to cure, and trimmed to meet flight requirements. The remnants of the two stringers containing the cracks were shipped first to the MAF and later to the MSFC for forensic engineering.

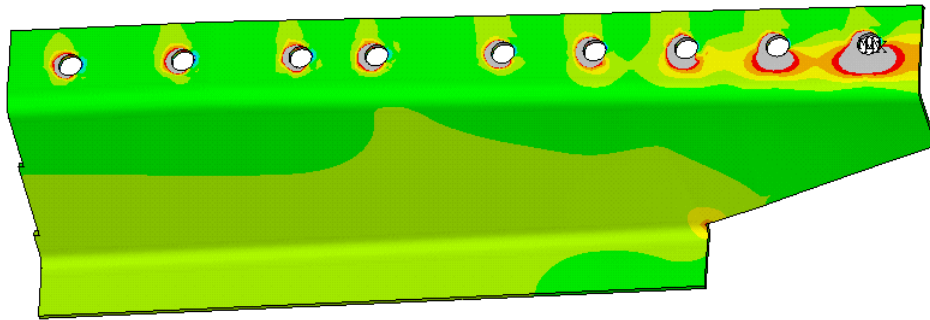
Initially, only the nominal skin/stringer, as-designed configurations were modeled. Results were obtained for stringer displacement, chord rotation, internal forces in the sidewall of the stringer, and stresses in the feet of the stringer (Figure 12). The results indicated that:

- Local peak stresses in the region of the first three fasteners (where the fractography indicated that the failures had initiated) occurred during the temperature profiles corresponding to the LOX liquid level reaching the ring frame to which the intertank forward chord was attached;
- The different skin configurations under the stringers had an effect, with the stringers closest to the thrust panels (where doubler skins were used and where the first observed stringer failure occurred) seeing higher peak local stresses at the forward fasteners due to transient thermal conditions. (Recall that fractography indicated that the failures initiated in the region near the second fastener from the chord.)
- Local peak stresses in the region of fastener locations 4 through 9 resulted from steady state thermal conditions combined with ascent flight loads.[‡]

Figure 12. Example FE result of stringer foot 1st principal stress on the bottom of the foot at the 3700 sec thermal transient.
