Stringer Bending Test Helps Diagnose and Prevent Cracks in the Space Shuttle's External Tank

Joseph B. Saxon¹, Gregory R. Swanson², William P. Ondocsin³, and Robert J. Wingate⁴
NASA Marshall Space Flight Center, Huntsville, AL

*Extended Abstract of Proposed Paper for the 53rd AIAA/ASME/ASCE/AHS/ASC Structures, Structural Dynamics, and Materials Conference,
April 23-26, 2012, Honolulu, Hawaii*

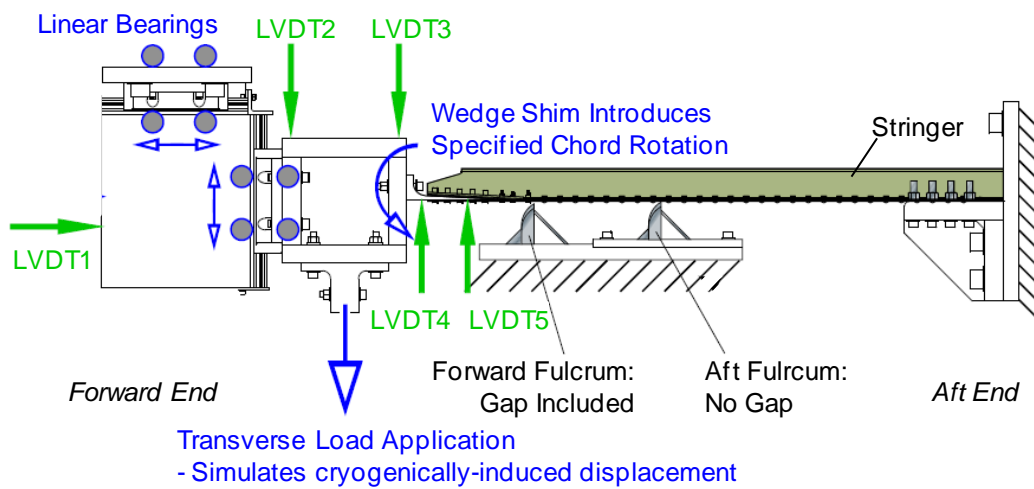
Figure 4. MSFC single stringer bending test configuration.

On December 31, 2011, MSFC tested its first flight-like stringer. There were two defining characteristics of this bending test: (1) the stringer was from a suspect heat lot, and (2) it marked the first use of the double-fulcrum configuration shown in Figure 4. The double-fulcrum was intended to drive more load into the forward fasteners than achieved in the pathfinder tests. The test reached an estimated nominal deflection without incident, but with a small and slow increase in load, the stringer failed suddenly with a fracture pattern that perfectly matched that seen on ET-137. This was a watershed moment since no previous testing at MSFC or MAF had clearly replicated the failures seen on ET-137.
