STS-133/ET-137 Tanking Test Photogrammetry Assessment

Stanley T. Oliver¹

NASA Marshall Space Flight Center, Huntsville, AL

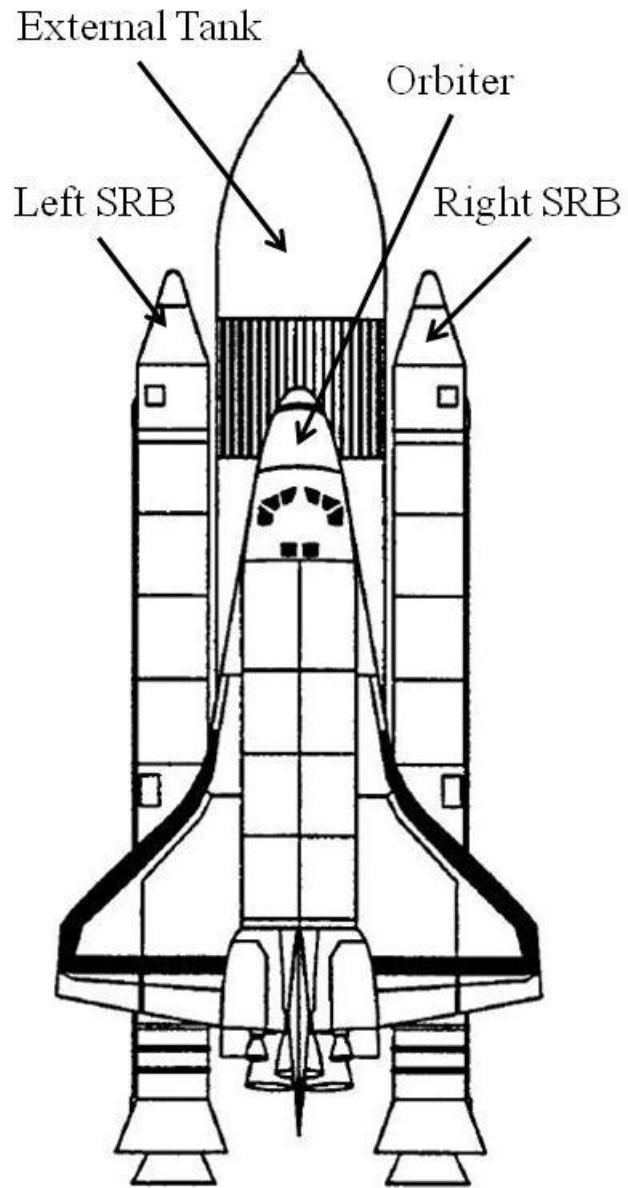
Figure 1. The Space Shuttle flight vehicle.

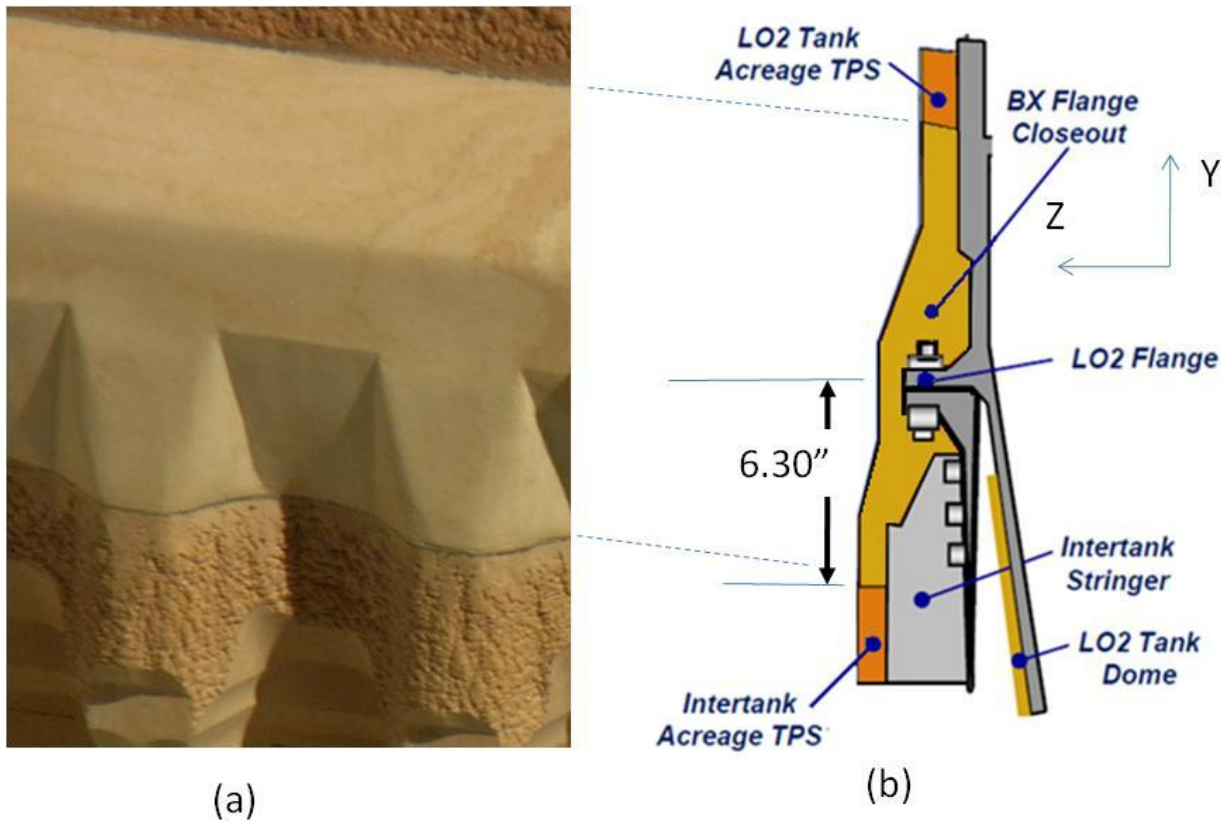
Figure 8. (a) TPS close-out photograph and (b) cross section schematic.

The LO2 flange was obscured by the TPS, which made it difficult to locate the Y-coordinate of the flange beneath the speckled region. However, design drawings of the LO2 flange TPS close-out indicate that the mating surface between the LO2 and IT flange is 6.30 inches above the intersection of the IT acreage and LO2 flange close-out TPS applications⁴. This intersection is clearly visible in a photograph of the flange TPS close-out shown in Fig. 8(a). The lighter colored TPS in the center of the photograph is the LO2 flange TPS close-out, while the darker colored TPS covers the LO2 tank and IT acreage. Within ARAMIS, the intersection was also clearly visible and could be used to interrogate its Y-coordinate. The Y-coordinate of the Intertank to LO2 flange was determined to be 44.1 inches in the coordinate system shown in Fig. 7. Figure 8(b) shows a cross sectional schematic of the LO2 flange region, showing the LO2 and IT metallic components and the TPS coverage. Dotted lines between Fig.8(a) and Fig. 8(b) link the TPS intersections shown in the photograph and schematic. Also identified is the 6.30 inch dimension between the LO2 and IT flange interface and LO2 flange close-out TPS application.

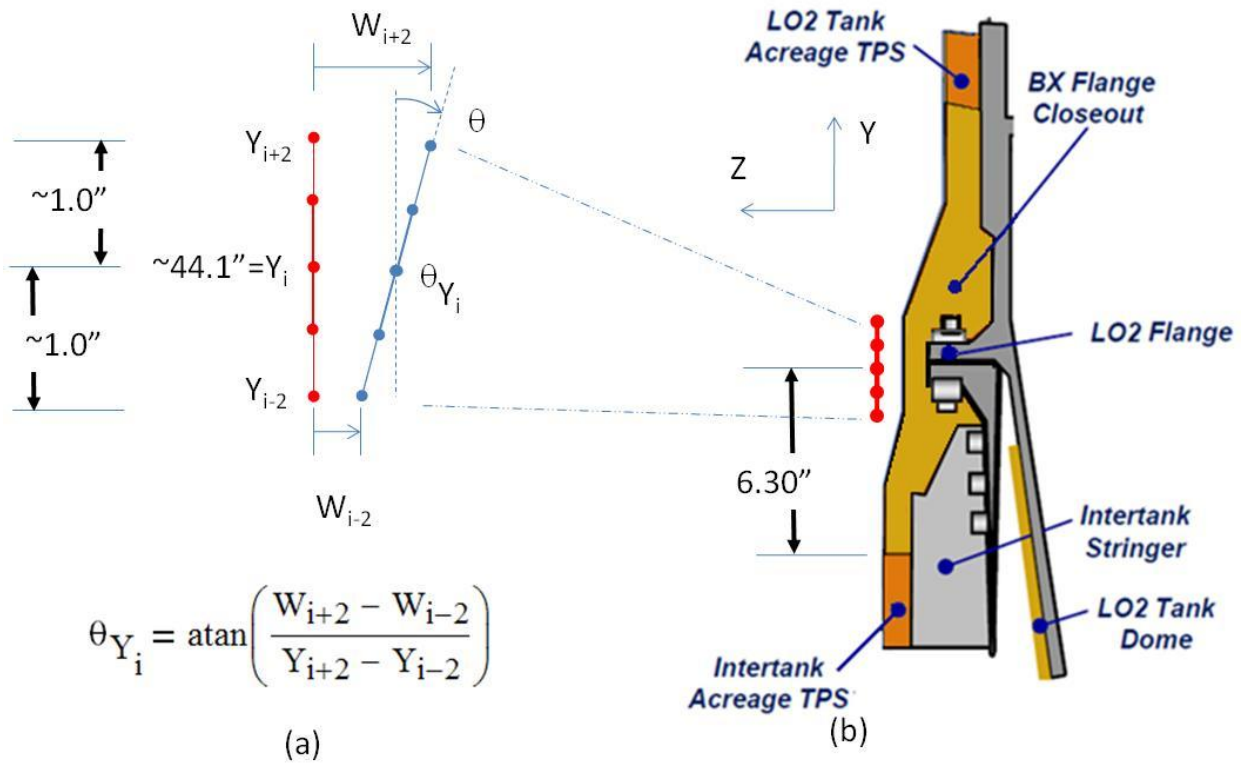
Figure 9. (a) Rotation computation for LO2 flange and (b) cross section schematic with corresponding region of interest highlighted.

The LO2 flange rotation computation methodology used an inverse trigonometric relationship, relating the rotation (θ) to the change in out-of-plane displacements (W) and Y-coordinates (Y). This approach inherently accounts for rigid body motion since it considers changes in position. Figure 9(a) shows the methodology for calculating the rotation at the data point closest to the LO2 flange, Y_i . Rotation is based on the Y-coordinates and corresponding out-of-plane displacement (W) of two data points, one above and one below the flange, skipping the two data points nearest to Y_i . Ignoring the $(i+1)$ and $(i-1)$ data points tended to smooth the rotation data. Figure 9(b) shows a cross section schematic depicting the LO2 flange region and the approximate range of the photogrammetry data used in the calculation of the rotation.

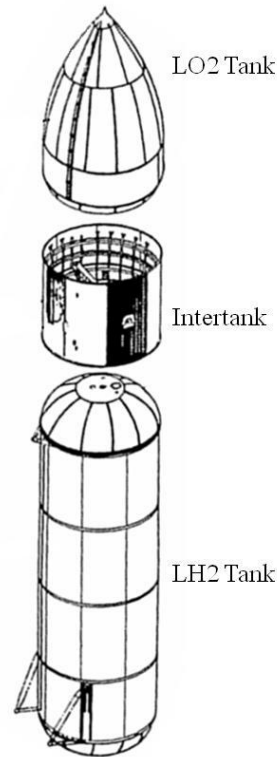
Figure 2. Expanded view of the External Tank's primary structural components.

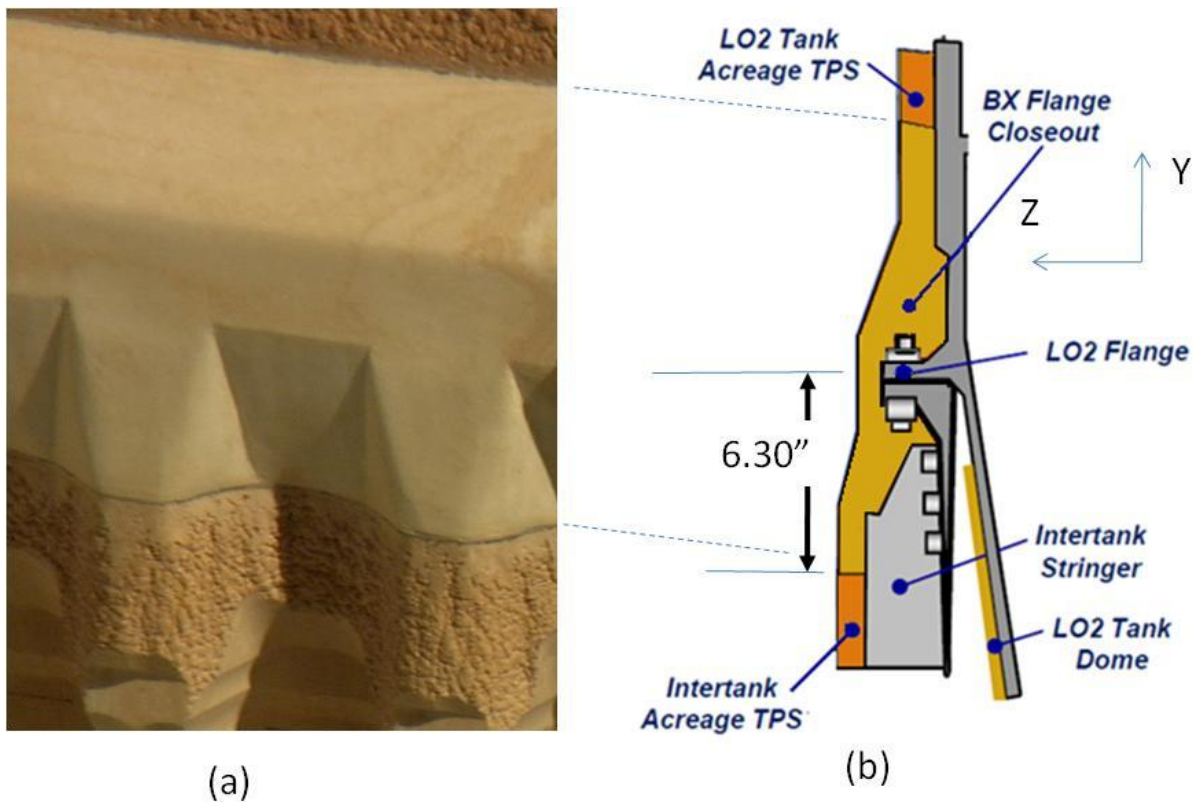
Figure 8. (a) TPS close-out photograph and (b) cross section schematic.

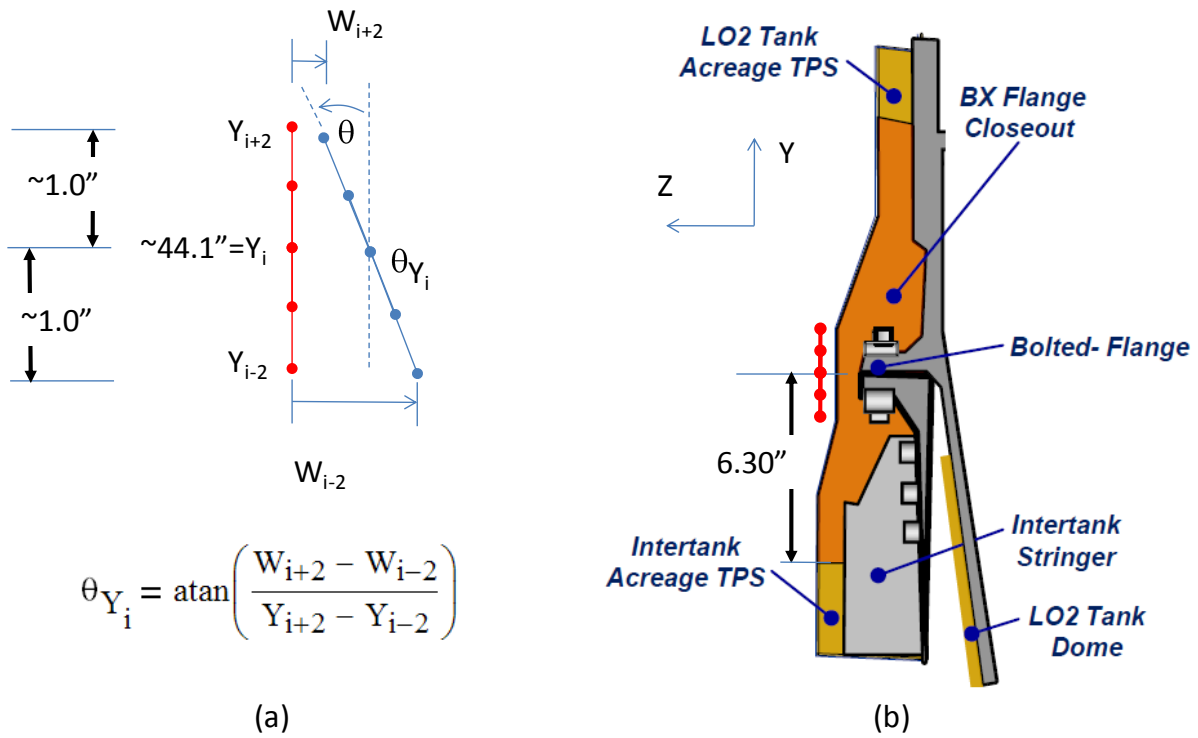
Figure 9. (a) Rotation computation methodology for LO2 flange and (b) cross section schematic with corresponding approximate location of data points of interest from photogrammetry data lines.
