# **STS-133 Space Shuttle External Tank Intertank Stringer Crack Investigation Stress Analysis**

*53<sup>rd</sup> AIAA/ASME/ASCE/AHS/ASC Structures, Structural Dynamics and Materials Conference  
April 23-26, 2012  
Honolulu, Hawaii*

# STS-133 Space Shuttle External Tank Intertank Stringer Crack Investigation Stress Analysis

**The structural failure of five hat-section stringers on the intertank of the Space Shuttle STS-133 External Tank prompted an investigation into the cause and the implementation of a repair. A detailed stress analysis of the failed hardware was performed by the Marshall Space Flight Center to help understand both the cause of the cracking and the effectiveness of the repair. The analysis showed how the stringers behaved as the External Tank is filled with cryogenic propellants. Assembly conditions that were considered potential contributors to the cause of the failure, due to induced assembly stress, were evaluated. The repair that was installed and flown was analyzed and shown to be effective in reducing the stress level in the stringer which contributed to the confidence in its performance. Results from the analysis were shown to be comparable with tankin

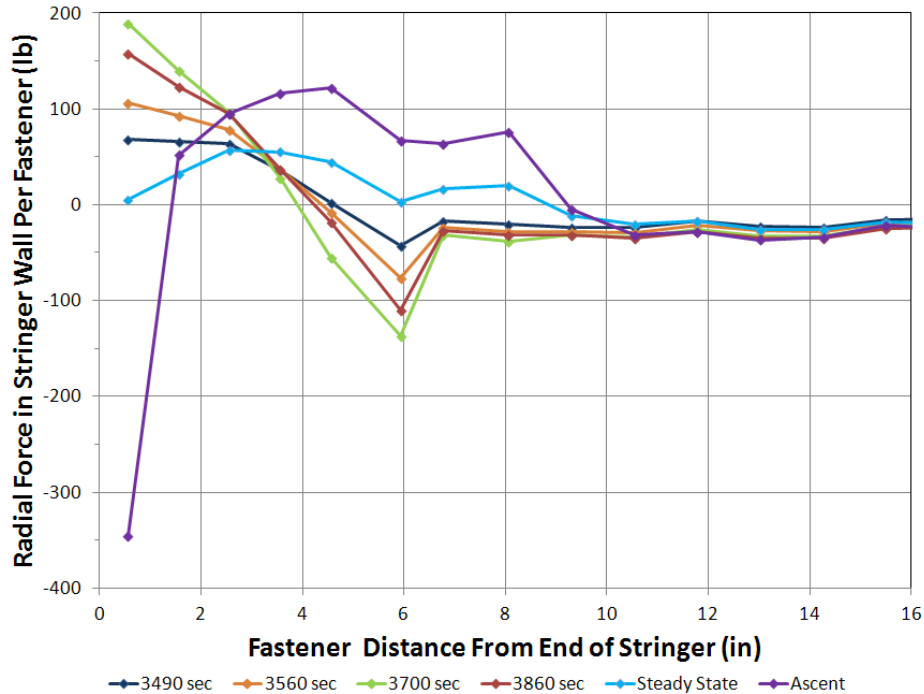
Figure 7. Stringer sidewall force during chill-down transient.

The chill-down loading was seen to introduce a radial inward pull force at the first four stringer fastener locations, which was reacted by a radial outward push force over the next few aft fastener locations. The loading is somewhat reversed in the ascent loading case. A compressive radial outward force is exerted on the tip of the stringer and a tensile inward pull force is exerted over the next seven fasteners.

The pull force exerted through the forward fasteners causes significant bending to develop in the sheet metal of the stringer feet as illustrated in Figure 8.

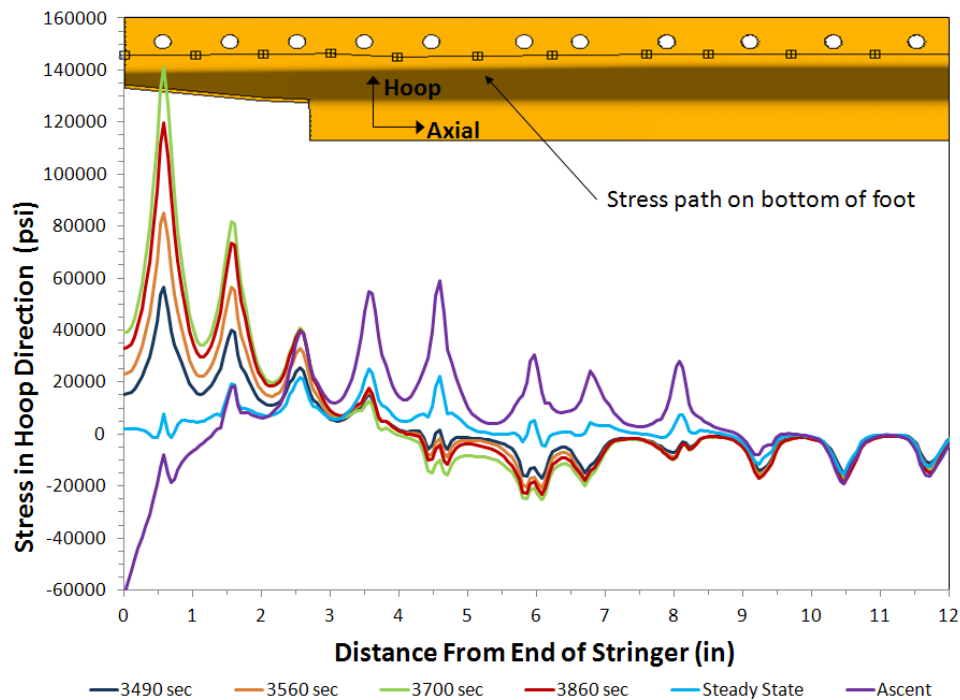
**Figure 10.** Stringer stress along path on bottom side of foot.

The stress in the foot of the stringer was further monitored in the analysis by plotting the stress along a path on the bottom of the stringer foot just inboard of the fastener hole. Figure 10 plots the stringer stress along this path for

The chill-down transient time that produces the peak stringer force and stress is 3700 seconds, which corresponds to when the LOX level covers the LOX tank y-ring. After that time the intertank itself cools down, which causes the chord and skin to shrink in radially, thereby reducing the stringer bending severity.

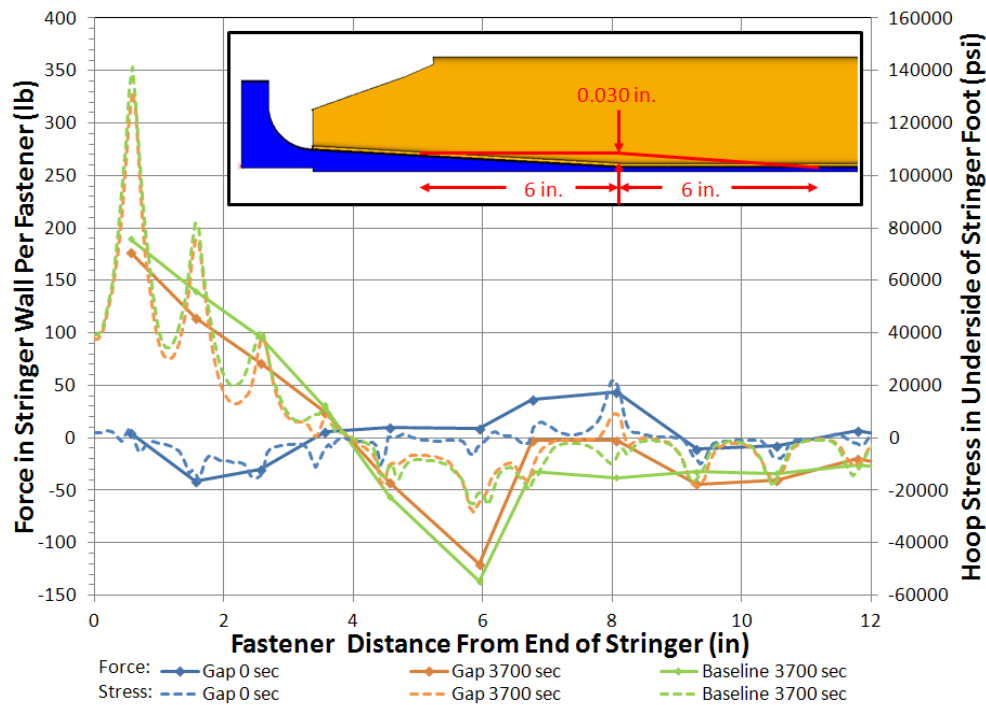
Figure 13. Gap at stringer foot bend results.

One condition of interest was the allowance of up to a 0.030 inch gap to exist between the stringer feet and the underlying structure. Gaps larger than 0.030 inch were to be filled with a shim. The stress analysis examined two possible gap conditions and how they affected the loads and stress in the stringer. The first condition represented a 0.030 inch gap at the bend in the feet approximately eight inches from the stringer forward end. The gap linearly tapered down to a closed state six inches on either side of this point. The second condition represented a 0.030 inch gap at the very forward end of the stringer that tapered down to a closed state at the bend in the feet. Figure 13 and Figure 14 show the sidewall radial force and stringer foot path hoop stress for these two gap conditions. Each plot shows the results with just the gap closed at room temperature and the results at 3700 seconds, along with the baseline case at 3700 seconds.

The radial force and stress in the feet is higher at the location of the gap than other areas for the installed room temperature condition. The gap at the bend in the feet produces slightly higher loads and stress than the gap at the end of the stringer. The gap at the bend in the feet does not affect the loads and stress at 3700 seconds. The gap at the end adds to the stress and loads for the 3700 second case at the first three fasteners, but the peak values are only slightly increased.

These results indicate that an allowed gap of 0.030 inch not at the end of the stringer is benign. If the gap exists at the end of the stringer, the gap adds to the severity of the peak stress state but not substantially.

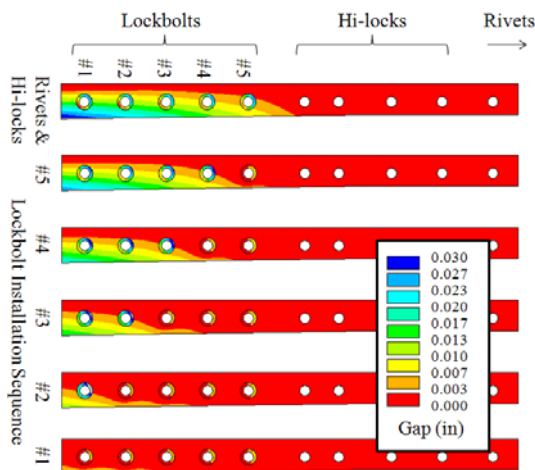
Figure 16. “Toe forward” gap under stringer foot during lockbolt installation sequence.

Another assembly condition that was examined was what was referred to as a “toe forward” condition. This condition is characterized by the outboard edge of the forward ends of the stringer feet being out-of-plane and more radially inward than other regions of the bottom of the feet (Figure 15). This condition was considered one of the more severe conditions relative to the stringer crack issue, since installation of the stringer to the intertank would force the feet at the ends of the stringer to bend in a manner that would introduce local bending in the feet in the same location and direction as experienced during chill-down.

The “toe forward” assembly condition was evaluated by considering a scenario where all of the rivets and hi-locks (fasteners used to attach the majority of the stringer to the skin) were installed, and then the five lockbolts (five forward most fasteners used to attach the stringer to the skin) were installed one at a time (modeled as two at a time since the model used one-half symmetry) from aft to forward. The toe of the stringer foot was set to be 0.050 inch forward of the heel of the feet based on measurement of an existing non-installed stringer. Figure 16 shows how the gap under the foot was closed as each fastener was installed. Figure 17 shows the

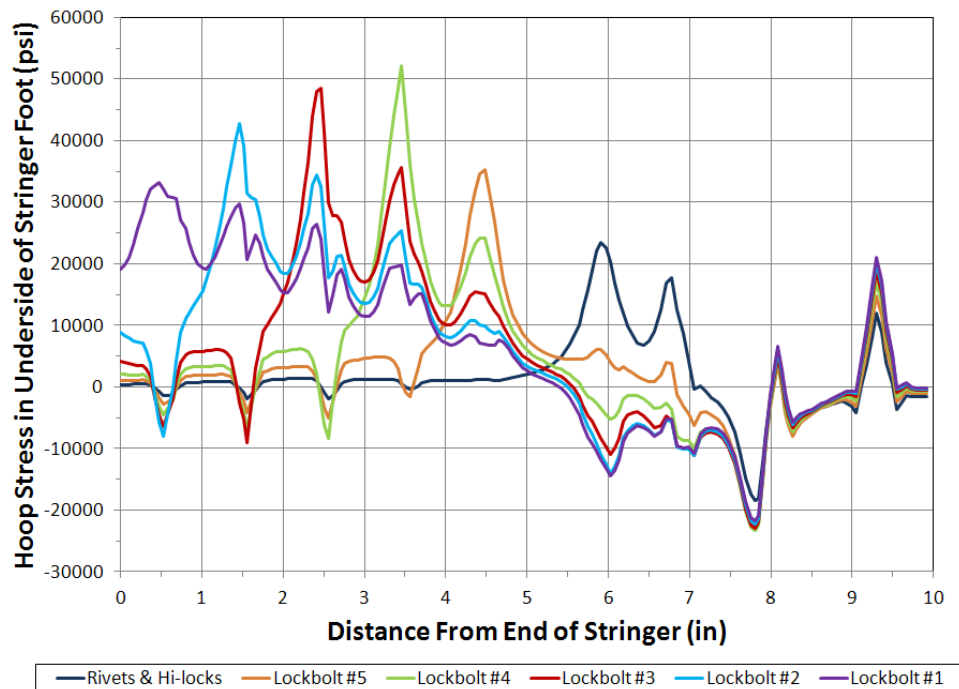
Figure 17. “Toe forward” gap results.

stress along the path on the underside of the foot after installation of each lockbolt. The stress levels associated with this assembly condition are more than twice as high as the two gap conditions considered above, indicating that this type of condition would negatively affect the strength capability during chill-down.

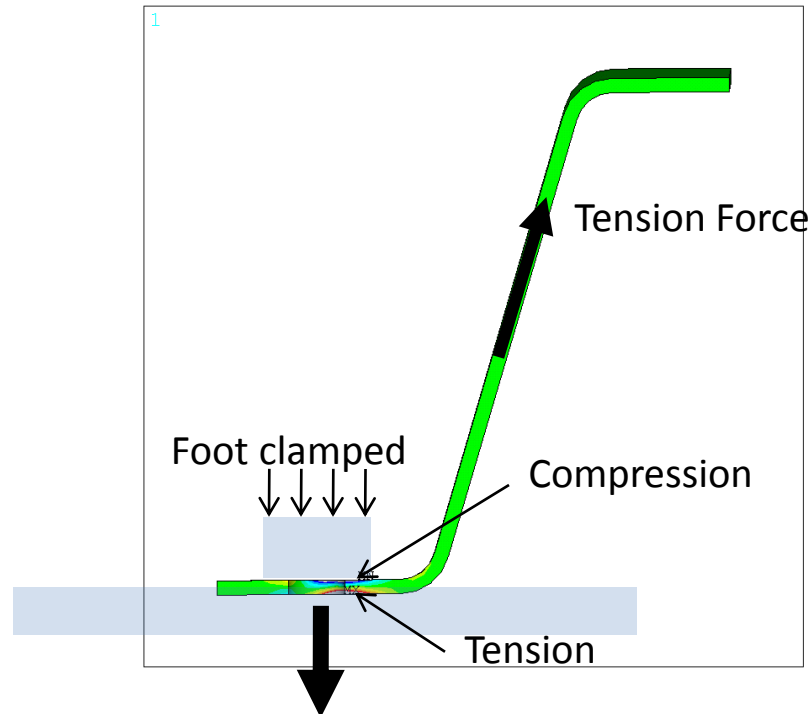
- Thermal shrinkage of the LOX tank Y-Ring and intertank chord forces the forward end of the stringer to bend radially inward.
- The inward radial load is introduced through the fasteners into the foot of the stringer.
- Large bending stresses develop in the stringer foot around the inside of the fastener head.
  - Peak elastic stress are above the material yield strength. In reality local yielding occurs around the fasteners.

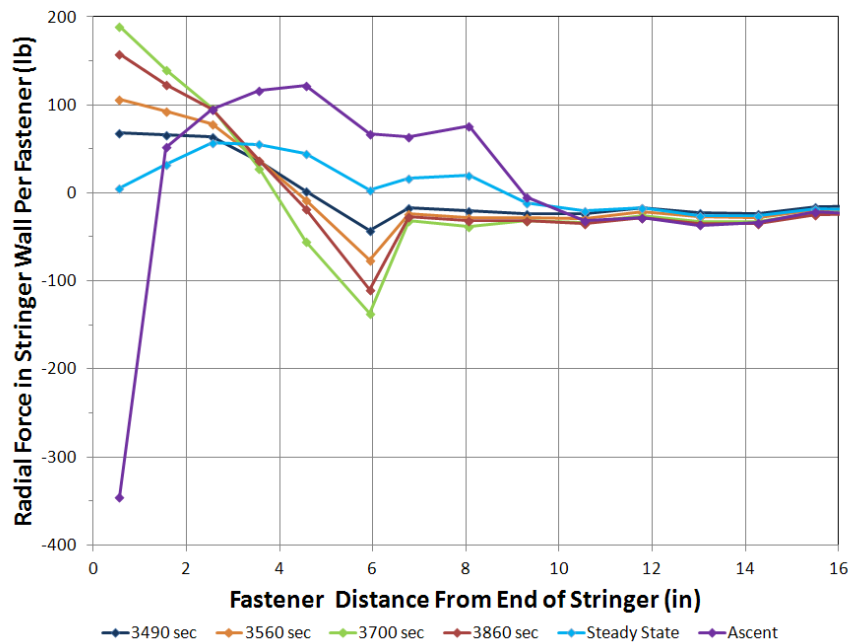
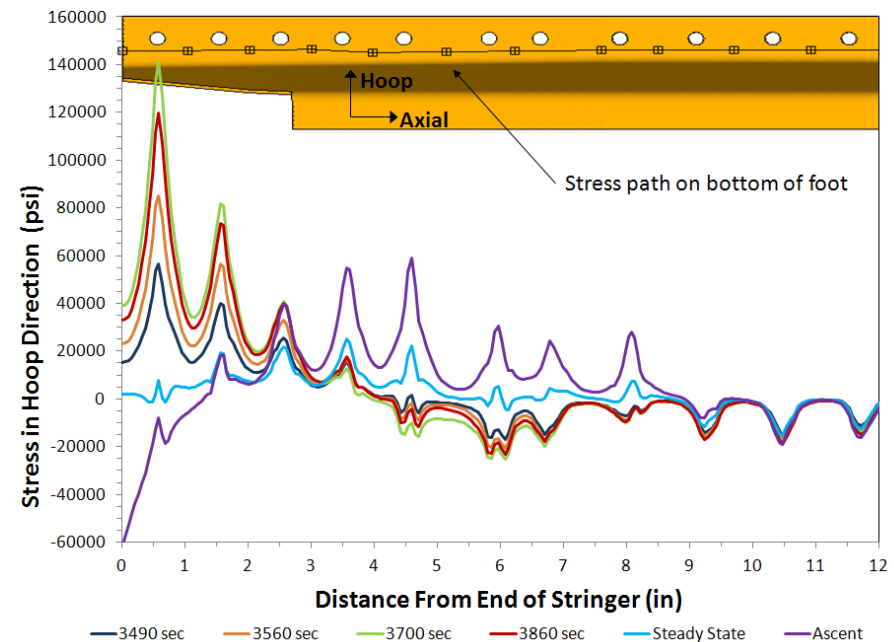
- The behavior of the stringer along the axial direction was monitored by examining the force in the sidewall and the stress on the underside of the foot at various times.
- As the LOX tank y-ring shrinks an inward radial tensile load is applied to the first four fasteners which is reacted by a compressive load over the next few fasteners.
- During ascent the tip experiences a compressive load.
- High stress levels localized at each fastener location.

- Worst case loading occurs at 3700 seconds (after start of tank fill process)
- STS-133 crack occurred at 3599 seconds

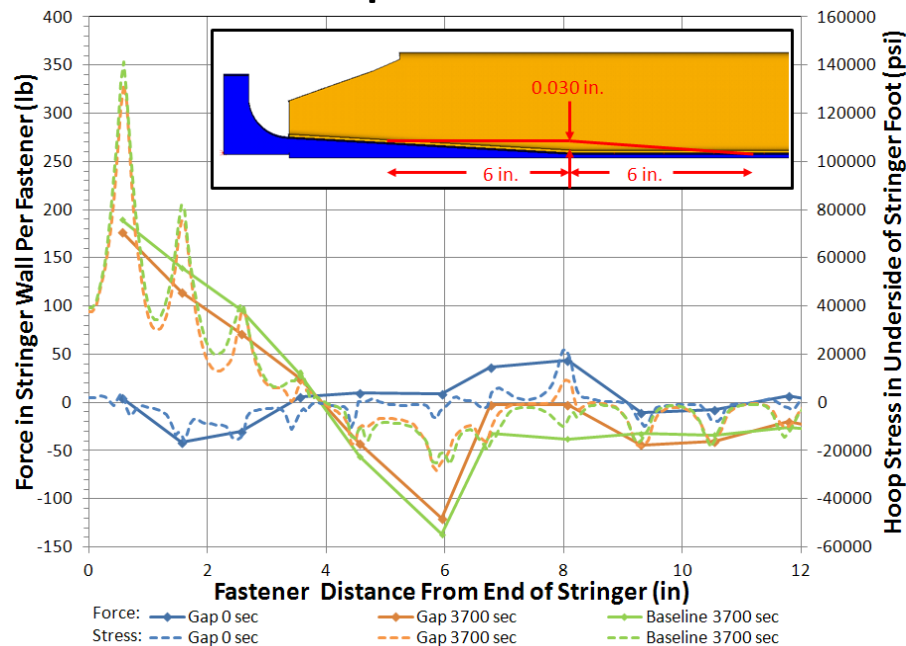
## Gap at Bend

Assembly stress is benign

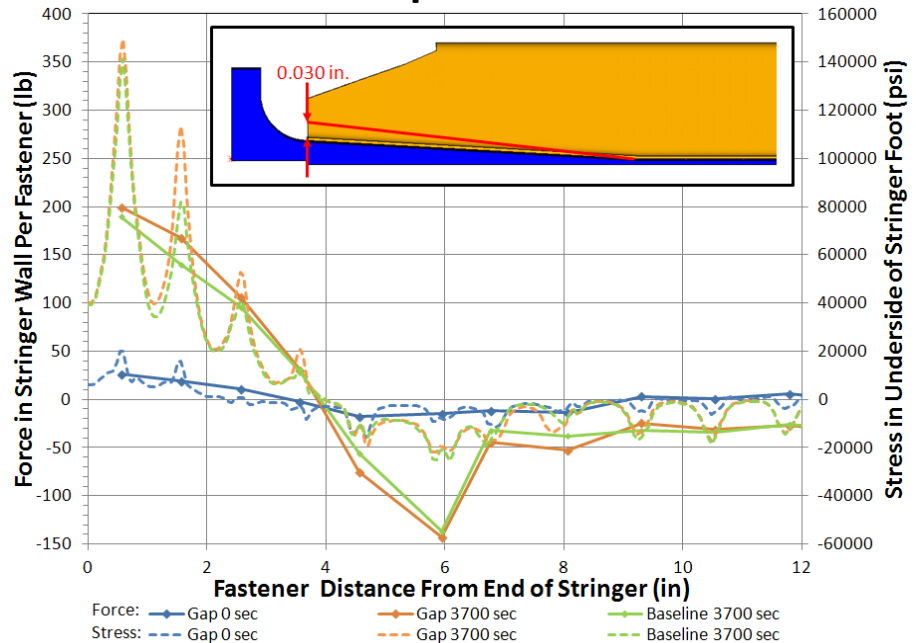
## Gap at End

Assembly stress is small

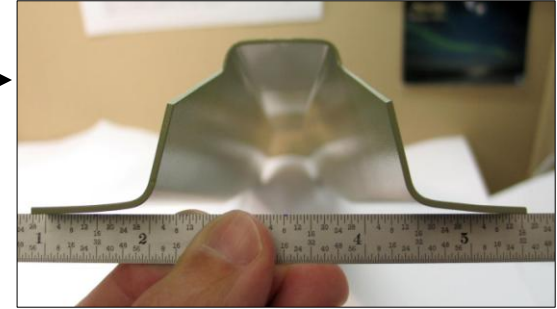
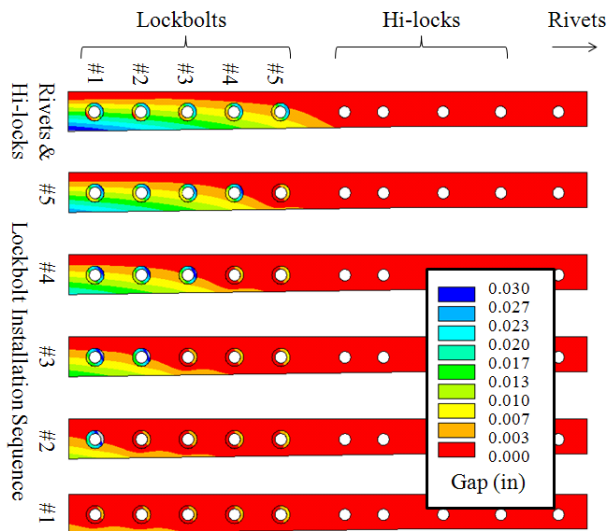
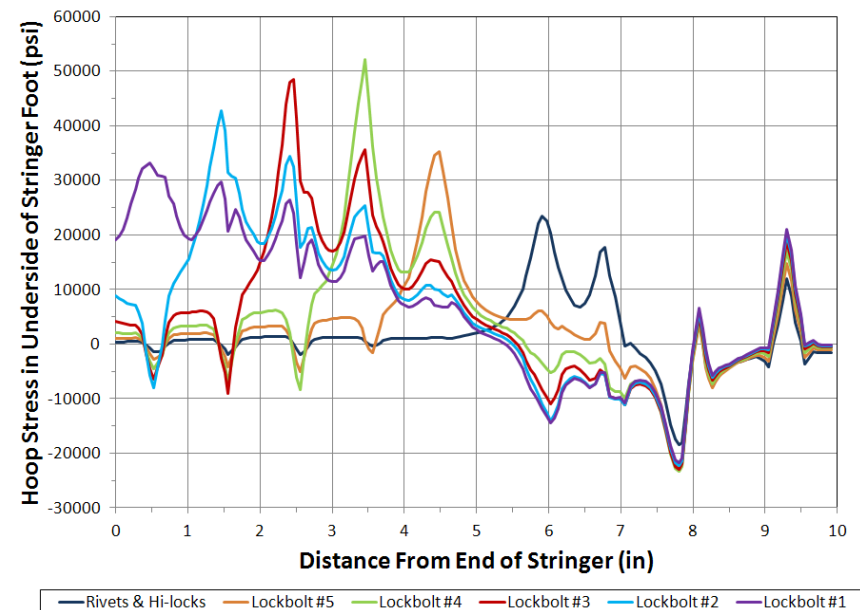
## “Toe Forward”

- Based on observed condition. →
- Toe of foot is radially inward relative to the heel.
- Preload applied one Lockbolt at a time.

Gap Under Foot

Assembly stress is significant and it adds directly to bending stress experienced during the chill-down transient.

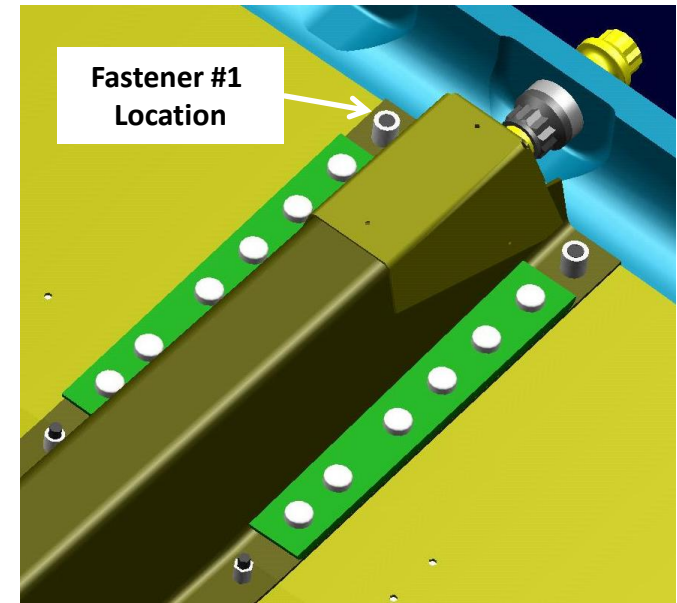
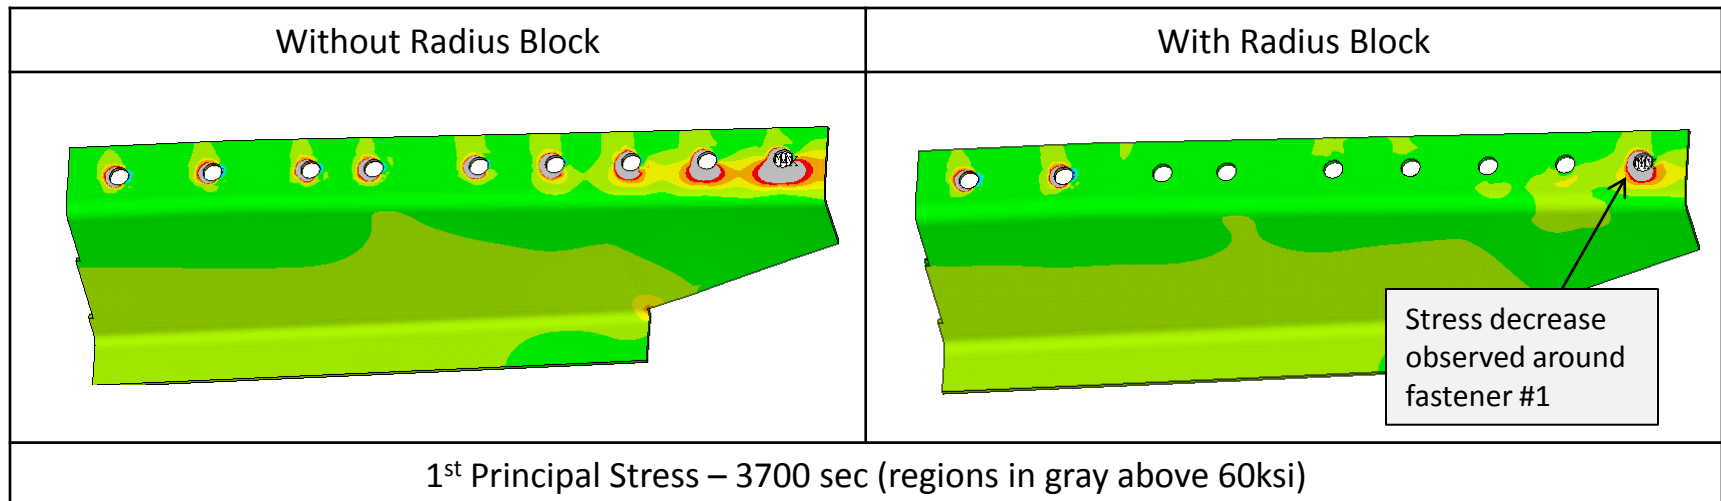
## Radius Block Repair

- The radius block was added to the model and the results were compared to the baseline.
- The stringer foot bending directly under the radius block was greatly eliminated.
- The bending stress at the highest stressed region around the fastener #1 location was also significantly reduced.

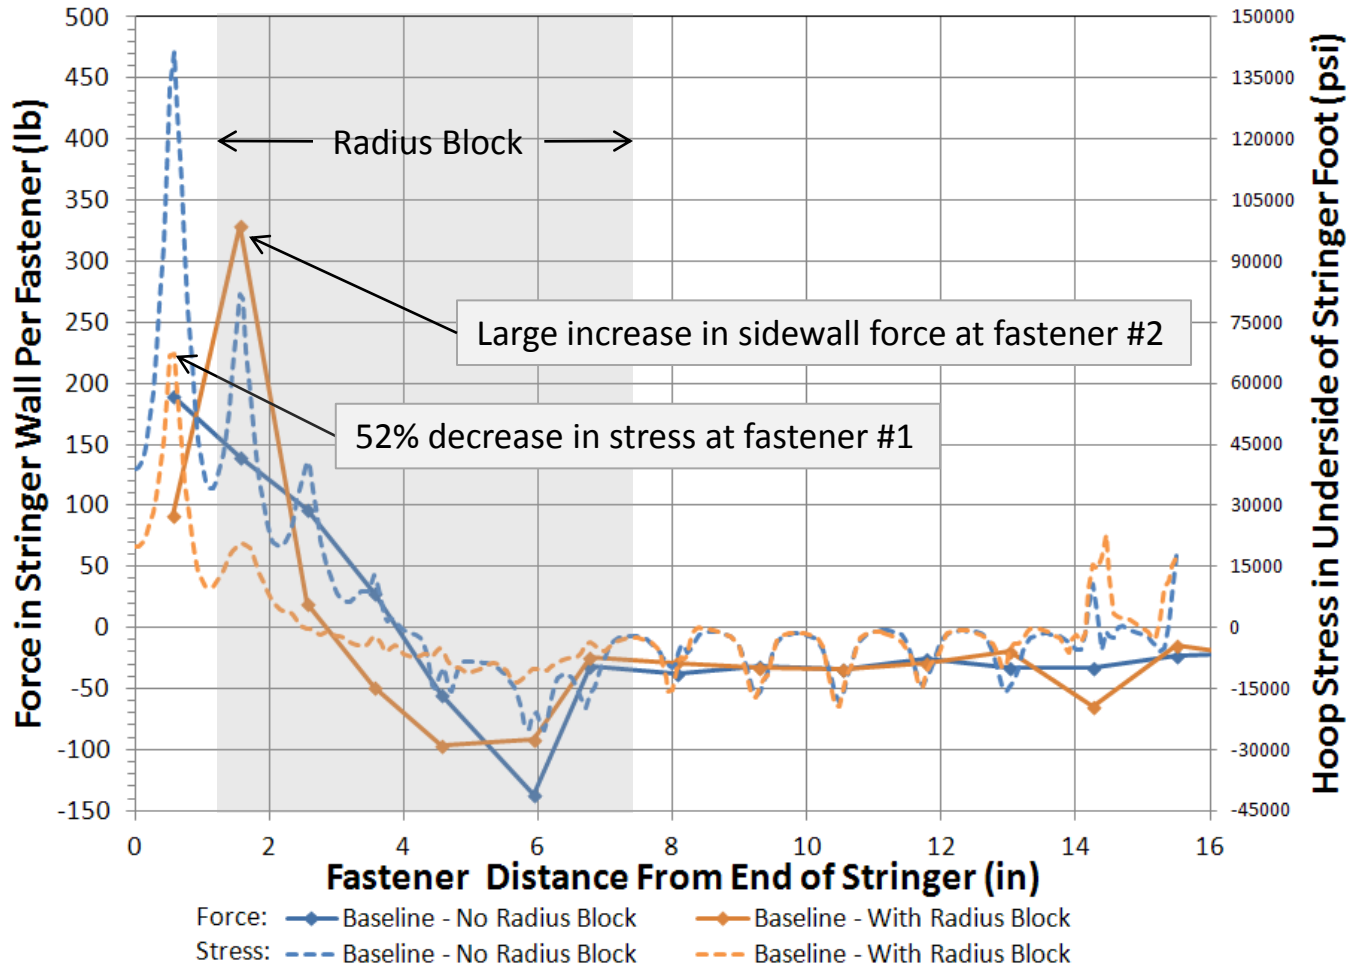
- Load into the stringer is concentrated at the #2 fastener location.
- Bending stress in the foot is significantly reduced .

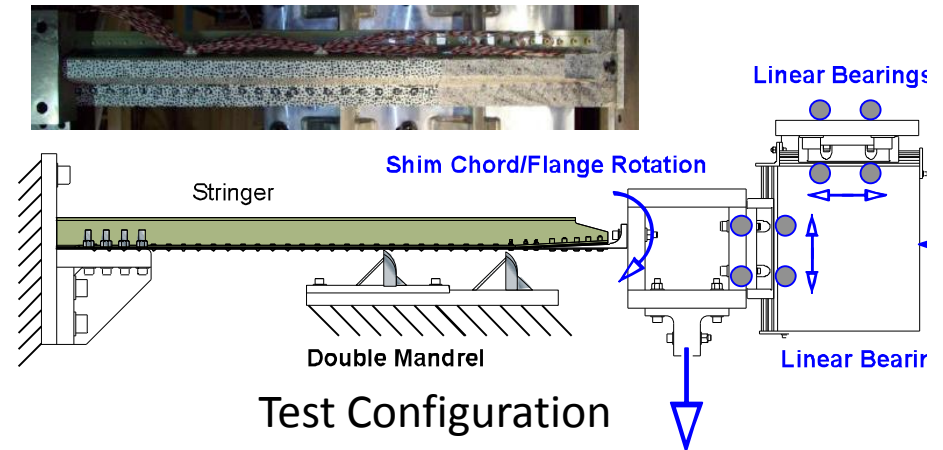
## Test Comparison

- Relative analytical stress/strain compared to relative strength observed in sub-component testing.
- Comparison is favorable except for test results with two skin doublers.
