**Title: Assessment of Damage Containment Features of a Full-Scale PRSEUS  
Fuselage Panel through Test and Teardown**

## ABSTRACT

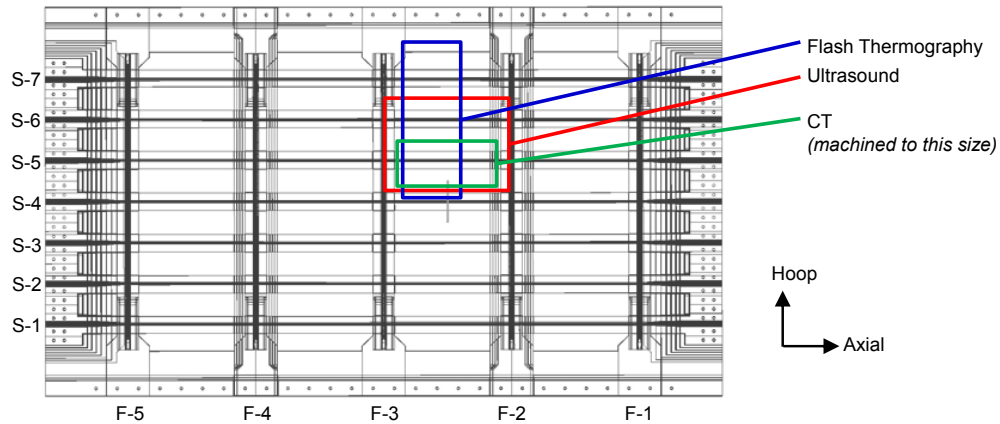
Figure 3. Areas inspected with each NDI method

Pulse-echo ultrasonic, flash thermography, and x-radiography computed tomography (CT) scans were taken after catastrophic fracture in the vicinity of the notch tip B (only half the panel was available for posttest inspection). The regions scanned are shown in Figure 3 for each method used. Visual inspection was performed throughout the interior and exterior surface of the panel. Details of the three advanced NDI methods used are described as follows:

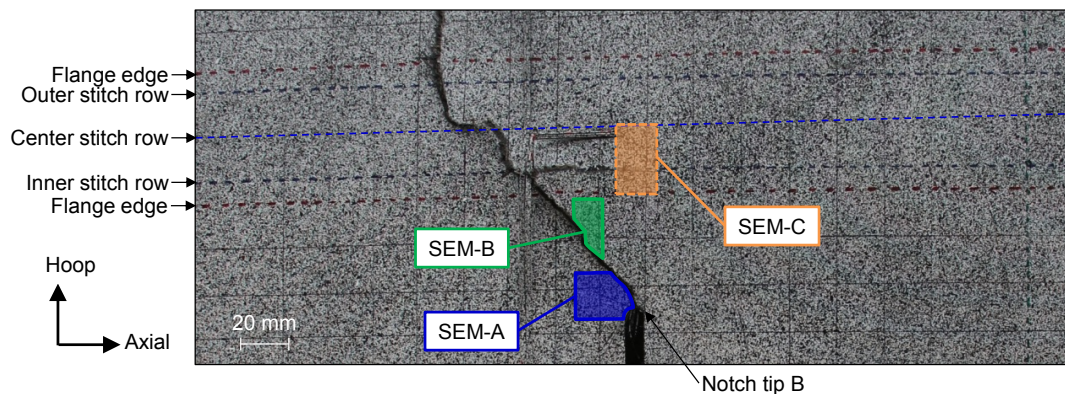
Figure 4. Locations of posttest inspections.

The region of the panel directly ahead of notch tip B, which was machined out of the panel for CT inspection was examined visually in a teardown evaluation to determine the extent and location of damage. Failure in each ply was assessed qualitatively using visual inspection aided by low magnification light microscopy for the purpose of future comparisons with progressive failure analyses. Additionally, selected segments cut from this region, as shown highlighted in Figure 4, were examined using a scanning electron microscope (SEM) to determine the failure mechanisms active.

Three key areas were examined in the fractography study: 1) the damage formation region at the notch tip, denoted SEM-A, 2) the delaminated surface ahead of the notch tip, denoted SEM-B, and 3) the disbonded surface on the stringer flange of the skin/stringer interface including the stitch failure of the first stringer ahead of the notch, denoted SEM-C. All SEM specimens were less than 40 mm in length and width to fit within the SEM chamber.

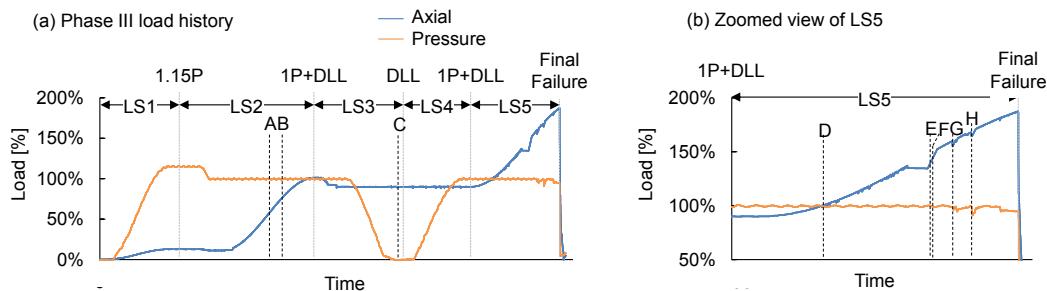
Figure 5. Phase III load history with key damage progression observations letter A-H.

The five-step loading sequence load history, applied in Phase III, is shown in Figure 5. Also shown in Figure 5 are key damage progression observation points, denoted with capital letters A-H. Note that during the final load step, the hydraulic pump of the loading fixture briefly shut down, resulting in a short duration of constant axial load, which upon resumption was followed by a brief higher axial loading rate, as shown in Figure 5(b) just before label 'E'.

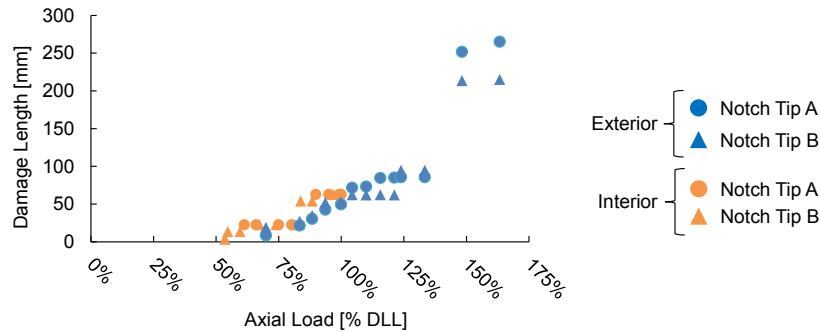
Exterior damage lengths were measured for load up to 160% DLL (point G in Figure 5) where damage propagated beyond the two-bay region. Interior damage lengths were measured up to the point where damage reached the adjacent stringers, S-3 and S-5 (point E in Figure 5). The exterior and interior crack length measurements are shown in Figure 8. The interior crack length was consistently slightly greater than the exterior crack length. The results clearly indicate a nearly constant crack growth rate up to 148% DLL. At that load level, a large damage extension is seen which corresponds to the instantaneous damage growth event where damage progressed along the stitch row.

Figure 8. Crack progression up to point G in Figure 5 showing constant crack growth rate during LS-2 and LS-5.

At 160% DLL damage progressed outside of the two-bay region and the camera's field of view, thus no further damage length measurement was possible.

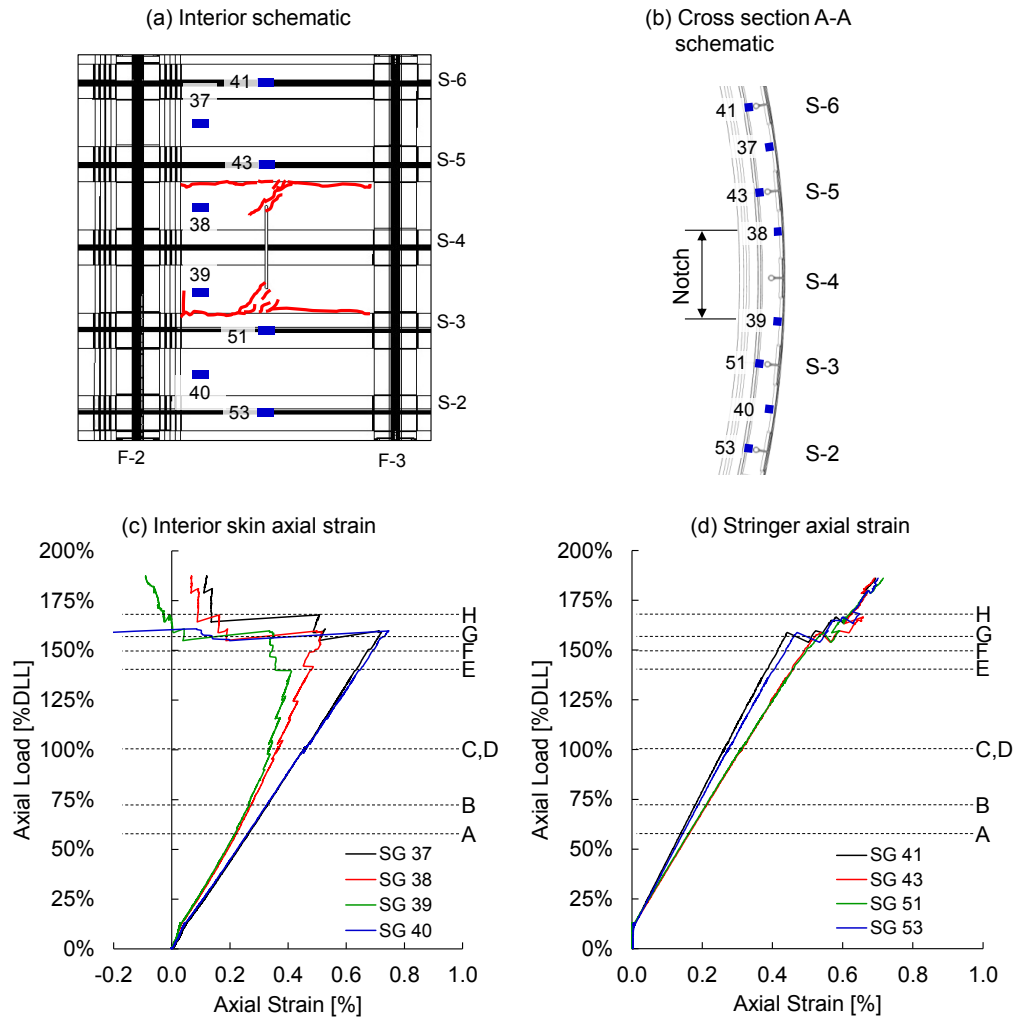
Damage progression was evident through strain records, which showed several strain redistributions occurred before fracture load was reached. The axial strains recorded by selected strain gages are shown in Figure 9 for monotonic axial loading in LS-1, LS-2, and LS-5. The locations of the strain gages are shown in the schematics of Figure 9(a) and Figure 9(b). Figure 9(a) also shows the state-of-damage ahead of the notch tip at the load of 140% DLL (point E in Figure 5). The correlation between strain redistributions and key visual observations of damage progression (i.e. points A through H shown in Figure 5), is shown by overlaying points A through H on the strain plots in Figure 9.

In LS-2, strain gages mounted in the two-bay region indicated damage progression, while those mounted outside the two-bay region indicated no affect from damage progression as seen in Figure 9(c) from 60% to 100% DLL. That is, while damage propagated through the two-bay skin, damage remained contained within the two-bay region.

During LS-5, significant strain redistribution was observed at 160% DLL, when damage progressed beyond the two-bay region. The four strain gages on the interior skin near the mid-bay, SG 37, SG 38, SG 39, and SG 40, shown in Figure 9(c), showed a sudden reduction in the local strain, indicating failure of the skin.

Note that SG 37 and SG 40 are equidistant from the panel edges and measure almost the same strains. This behavior indicates that the load introduction was uniform through a load of 160% DLL. Strain gages SG 38 and SG 39, which were located in the same bays as the notch tips, exhibited several discontinuities throughout loading from 100% to 160% DLL, corresponding again to the intermittent nature of damage accumulation. The massive damage accumulation observed in the skin at 160% - 165% DLL, as shown post-failure in Figure 10, nearly completely unloaded the skin in these four bays. The strains in the stringers S-6, S-5, S-3, and S-2 (recorded by SG 41, SG 43, SG 51, and SG 53, respectively) are nearly identical, as show in Figure 9(d), and show a sudden increase in strain at 160% DLL.

Figure 9. Strain results during monotonic axial of LS-1, LS-2, and LS-5.

That is, the stitched stringers bridged the failed skin (despite the local skin/stringer disbonding), and carried most of the load up to fracture. The results also show the symmetry of the strain distribution as manifested by the strain records of stringers S-2 and S-6 (SG 53 and SG 41, respectively) and stringers S-3 and S-5 (SG 51 and SG 43, respectively) throughout the failure process.
