NASA  
Engineering Directorate  
Materials Science Division  
Kennedy Space Center, Florida

KSC-MSL-2009-0297

SUBJECT: Failure Analysis of Main Flame Deflector Nelson Studs

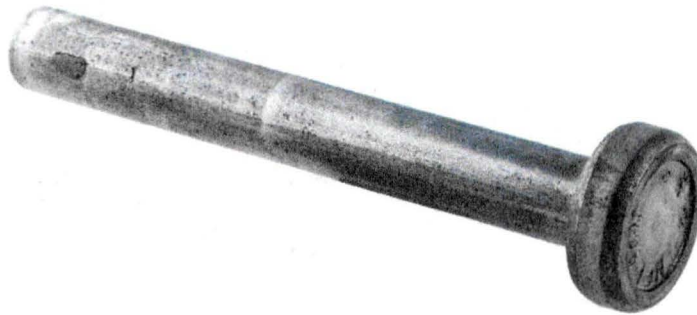
- 3.1. The damaged and the unused flame deflector Nelson studs were photographed, as received (Figures 2 and 3). Both orange-red and black corrosion product were observed on the damaged studs, along with remnants of refractory material from the flame deflector and orange paint used to mark the studs. The studs were preferentially damaged on the side of the stud that was facing the solid rocket motor blast when they were installed (Figure 2, arrows).

Figure 3. Unused Nelson stud, as received. Scale is two inches.

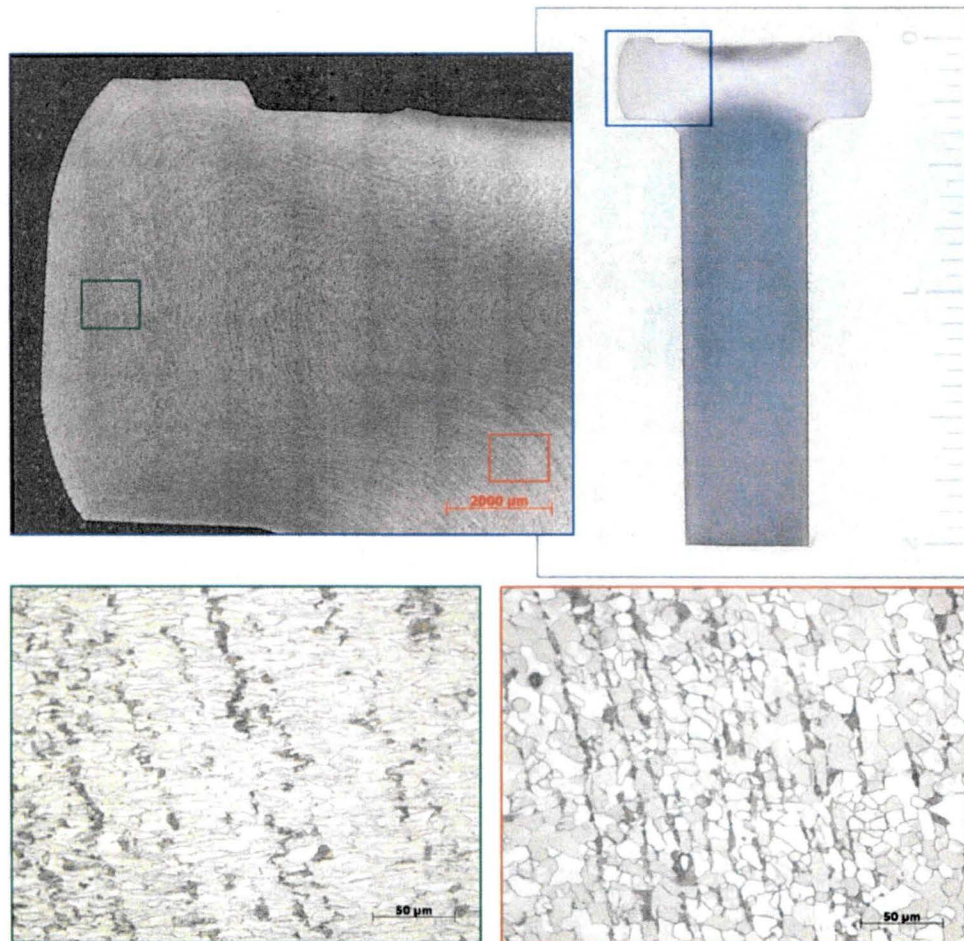
- 3.4. The unused stud was cross-sectioned, mounted, and prepared for metallographic examination. Flow lines were observed in the head of the stud, which is the typical macrostructure of a forged head (Figure 6, upper row). Cold worked grains were observed in the head of the stud, which is typical for forged microstructures (Figure 6, bottom left). The body of the stud consisted of predominantly ferrite grains with minor amounts of elongated pearlite (Figure 6, bottom right), which is typical for rolled plain carbon steel.

Figure 6. Micrographs of the unused stud cross section, showing the macrostructure (top row) and the microstructure (bottom row). The microstructure of the stud consisted of ferrite grains (light) with minor amounts of pearlite (dark). The head of the stud displayed cold worked grains (bottom left) as compared to the body of the stud (bottom right). Original magnifications: 1.5X (top right), 10X (top left), 300X (bottom row)
