LOGISTICAL AND ANALYTICAL APPROACH TO A FAILURE ABOARD THE INTERNATIONAL SPACE STATION

Steve McDanel, M. Clara Wright, Victoria Salazar, David Lubas, Bryan Tucker
National Aeronautics and Space Administration (NASA)
Kennedy Space Center, Florida

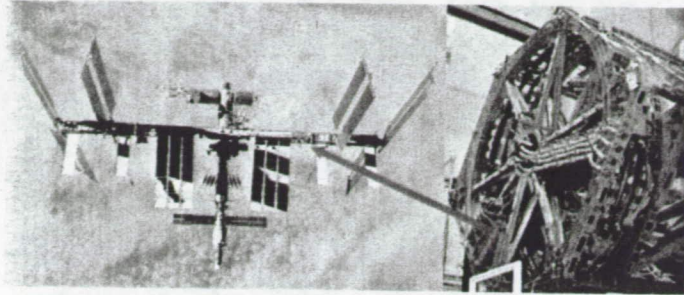
Figure 3
Starboard SARJ location aboard ISS.

As expansive and robust as the ISS and its scientific capabilities are, its analytical and forensic resources are limited. In order to investigate the failure of a system or component aboard the station, determine its failure mode, propose a repair, and ensure that a similar failure does not occur in the future, the logistical considerations are immense. Involved space-based failures must be investigated back on Earth, and ISS crew members must work in unison with Mission Control to coordinate any investigation. Such was the case when an anomaly was discovered with one of the mechanisms that auto-track the solar arrays with the Sun, specifically the starboard SARJ. The SARJ is essentially a 10 ft/3.05m diameter ring with two associated drive lock assemblies (DLAs) and 12 associated trundle bearing assemblies (TBAs) which travel along the SARJ, Figure 3. Gold plated 440C rollers inside the TBAs make rolling contact with the nitrided 15-5 PH stainless steel races of the SARJ; the gold plating helped serve as lubrication between the TBAs and SARJ bearing surfaces. In 2007, NASA engineers noticed an increased power draw when the starboard SARJ was operated. Likewise, higher than nominal vibration of the starboard SARJ was detected, potentially a result of excessive friction. Further analysis revealed a correlation between the vibrations and electrical demands. The starboard SARJ would need to be inspected in order to ascertain the cause of the anomalies.
