**Space Shuttle Stiffener Ring foam failure analysis, a non-conventional approach.**

## Solid Rocket Booster Stiffener Ring Foam Failure

Philip M. Howard  
July 9, 2007

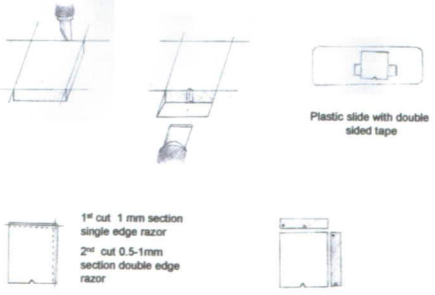
## Sectioning of Foam

1<sup>st</sup> cut 1 mm section  
single edge razor  
2<sup>nd</sup> cut 0.5-1mm  
section double edge  
razor

Plastic slide with double  
sided tape

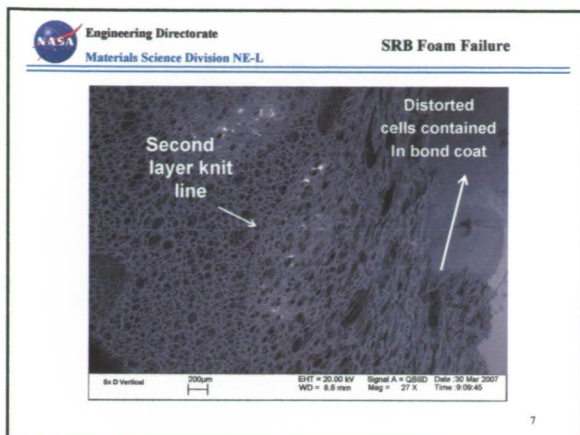
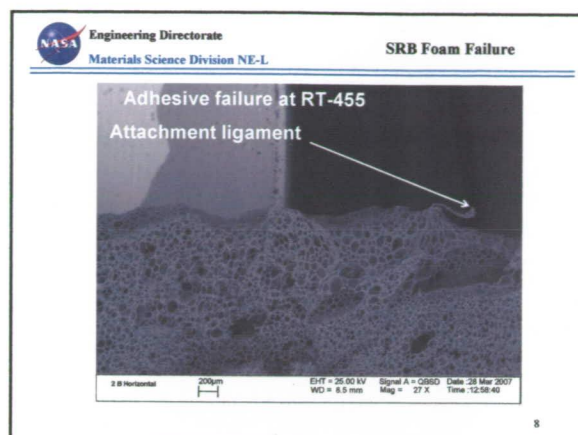
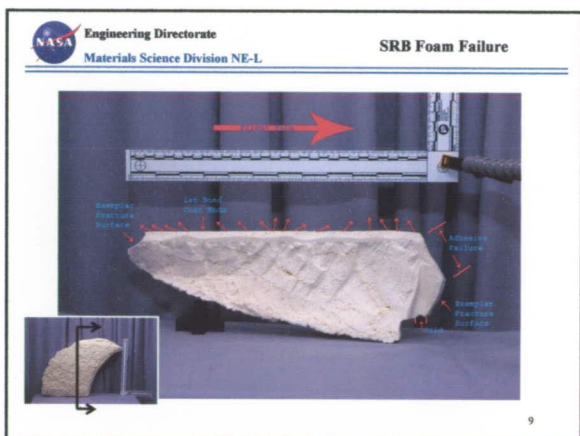
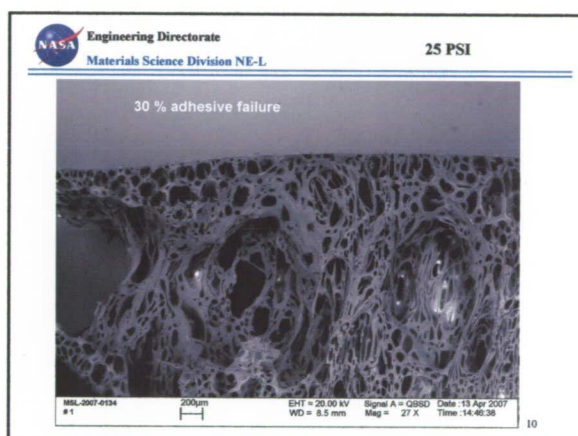
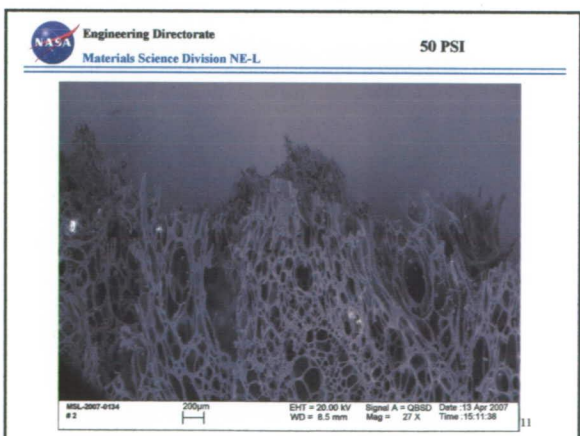
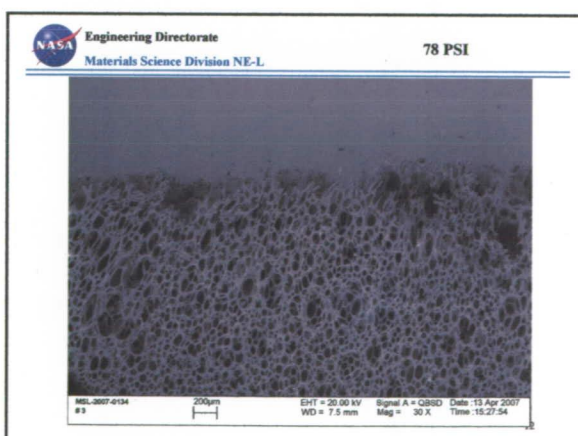
The foam bond coat displayed two modes of failure:

- > Cohesive failure was observed next to the SRB substrate due to severely deformed foam cells in the bond coat
- > Adhesive failure was observed at the RT-455 Epoxy interface.
- > 78 % surface of the foam application failed

The observed morphology of the fracture surfaces indicates that the bond coat was not fully cured before other forces were applied, e.g. the expansion forces of the second coat distorted the bonding cells.

- > Inadequate cure time of the bond coat
- > Substrate temperature
