# Testing and Analysis Validation of a Metallic Repair Applied to a PRSEUS Tension Panel

**A design and analysis of a repair concept applicable to a stiffened composite panel based on the Pultruded Rod Stitched Efficient Unitized Structure was recently completed. The damage scenario considered was a midbay-to-midbay saw-cut with a severed stiffener, flange and skin. Advanced modeling techniques such as mesh-independent definition of compliant fasteners and elastic-plastic material properties for metal parts were utilized in the finite element analysis supporting the design effort. A bolted metallic repair was selected so that it could be easily applied in the operational environment. The present work describes results obtained from a tension panel test conducted to validate both the repair concept and finite element analysis techniques used in the design effort. The test proved that the proposed repair concept is capable of sustaining load levels that are higher than those resulting from the current working stress allowables. This conclusion enables upward revision of the stress allowables that had been kept at an overly-conservative level due to concerns associated with repairabi

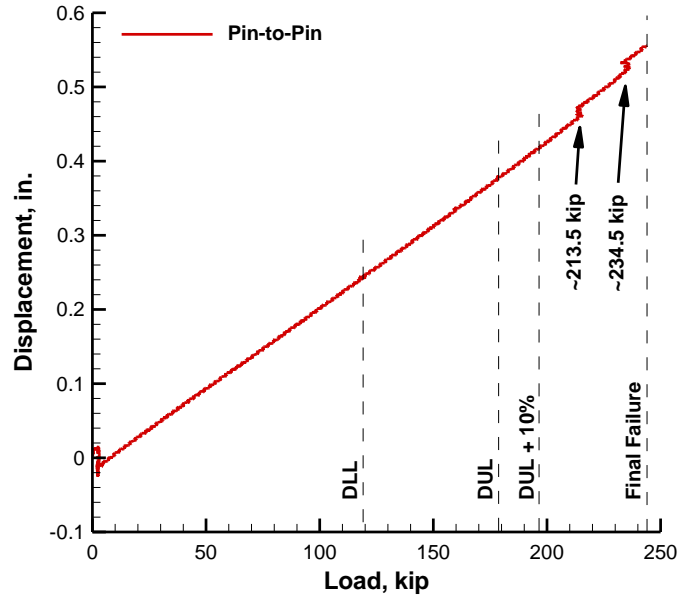
Figure 10. Pin-to-pin displacement versus loading.

The final failure was preceded by two noticeable load reductions, as illustrated in Figure 10, occurring around 213.5 kip and 234.5 kip. More detailed examination of the two load reductions in Figure 10 (not shown for brevity) revealed that each were comprised of two separate but closely spaced events. A summary of the loads and locations of these events is shown in Table 2.

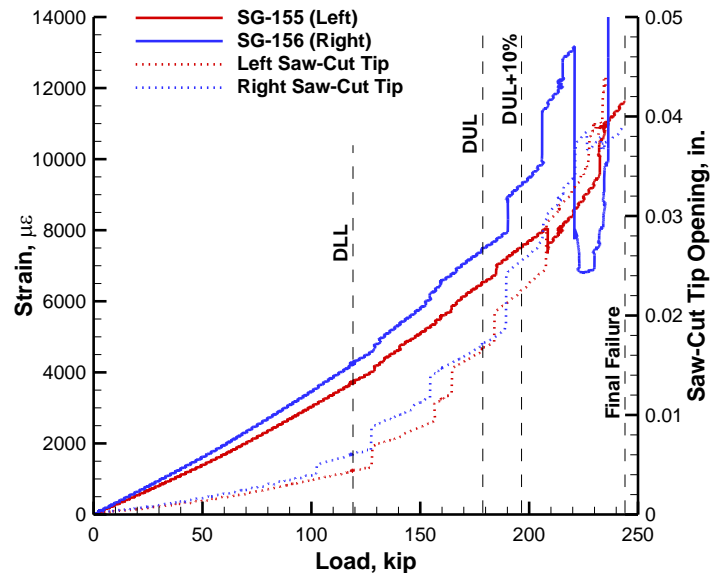
The first identifiable local failure was initiated in the region of the right-hand-side saw-cut tip (when looking at the panel from its stiffened side) at a load of 102.5 kip or 86.1% of DLL and is shown in Figure 11. The tip of the saw-cut is highlighted with a yellow dashed line in Figure 11 and the speckling visible inside the saw-cut area is on the smooth side doubler. The surface fiber splitting is not easily visible in Figure 11, however, the extent of the splitting was 0.15 in. and was determined based on displacement contours from the high-resolution VIC-3D acquisition. Both left- and right-hand-side saw-cut tip openings and surface splitting lengths were traced using the high-resolution VIC-3D acquisition throughout the entire loading sequence. For brevity, only the surface openings are presented in Figure 12 along with strain readings from the two closest strain gages, SG-155 and -156, located one inch to the side of the left- and right-hand side saw-cut tips, respectively. It is seen in Figure 12 that the initial saw-cut tip event at 102.5 kip was so minor that it did not result in a noticeable strain reading disruption in the two aforementioned strain gages. It is therefore concluded that this local event did not significantly affect the behavior of the panel away from the saw-cut for load less than DLL.

Figure 12. Saw-cut tip openings and strains in its vicinity.

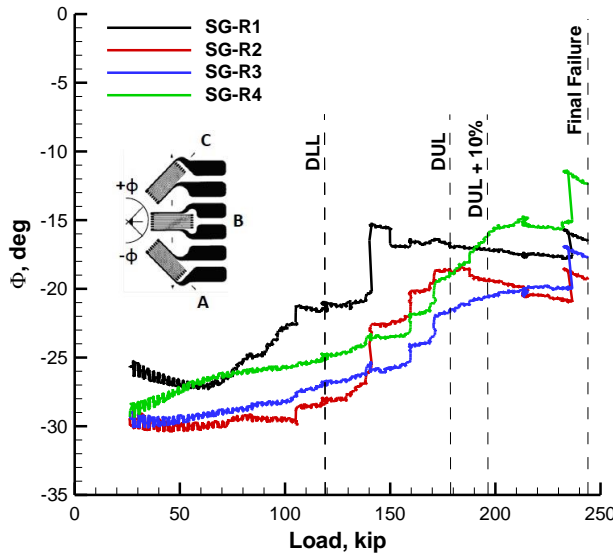
The only other minor event at load less than DLL was identified based on the strain gage data from the rosettes affixed to the severed stringer under the repair angles. Specifically, a slight discontinuity was first noticed in the strain principal direction shown in Figure 13 at 106.0 kip in rosettes SG-R1 and -R2. Note that these two rosettes are affixed to the tapered section of the stringer, where the pultruded rod has only a partial overwrap, a configuration that can potentially be prone to delamination. It is therefore concluded that a minor delamination in the tapered section between the pultruded rod and the partial overwrap might have occurred at this instance. Note that the event is so minor that the maximum principal strain values shown in Figure 14 are virtually unaffected.

**Figure 13. Principal strain direction from severed stringer strain gage rosettes.**

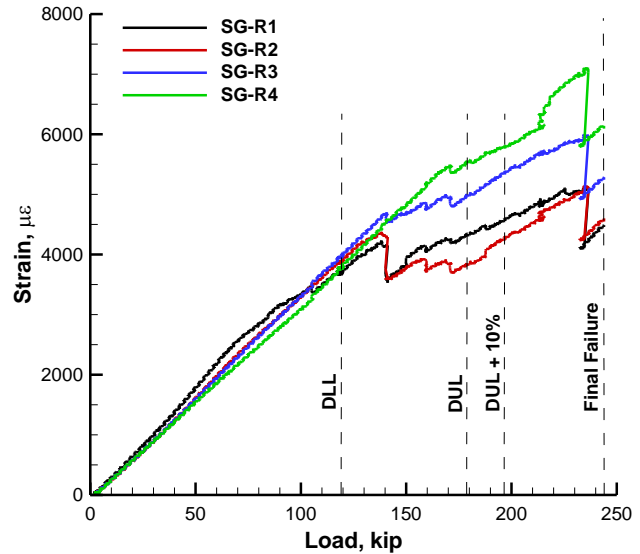
**Figure 14. Maximum principal strain from severed stringer strain gage rosettes.**

As the load was increased above the DLL, additional damage developed in the panel. Based on previously introduced principal direction and maximum principal strain plots (Figure 13 and Figure 14, respectively) it is likely that the suspected delamination of the pultruded rod in the severed stringer progressed in an abrupt fashion around 141.3 kip load. This event was more pronounced when compared to the previously noted event of similar nature at 106.0 kip, as evidenced not only by a more substantial principal direction change in Figure 13 but also by a strain level reduction in Figure 14. Note though, that the behavior was still limited to SG-R1 and -R2 affixed within the tapered section of the severed stringer. Several less pronounced events occurred between 141.3 kip and DUL. While these discontinuities in principal strain direction and magnitude were considerably smaller, their significance stems from the fact that they involved a larger span of the severed stringer. This conclusion is based on discontinuities identified also for rosettes SG-R3 and -R4 affixed beyond the tapered section of the stringer.

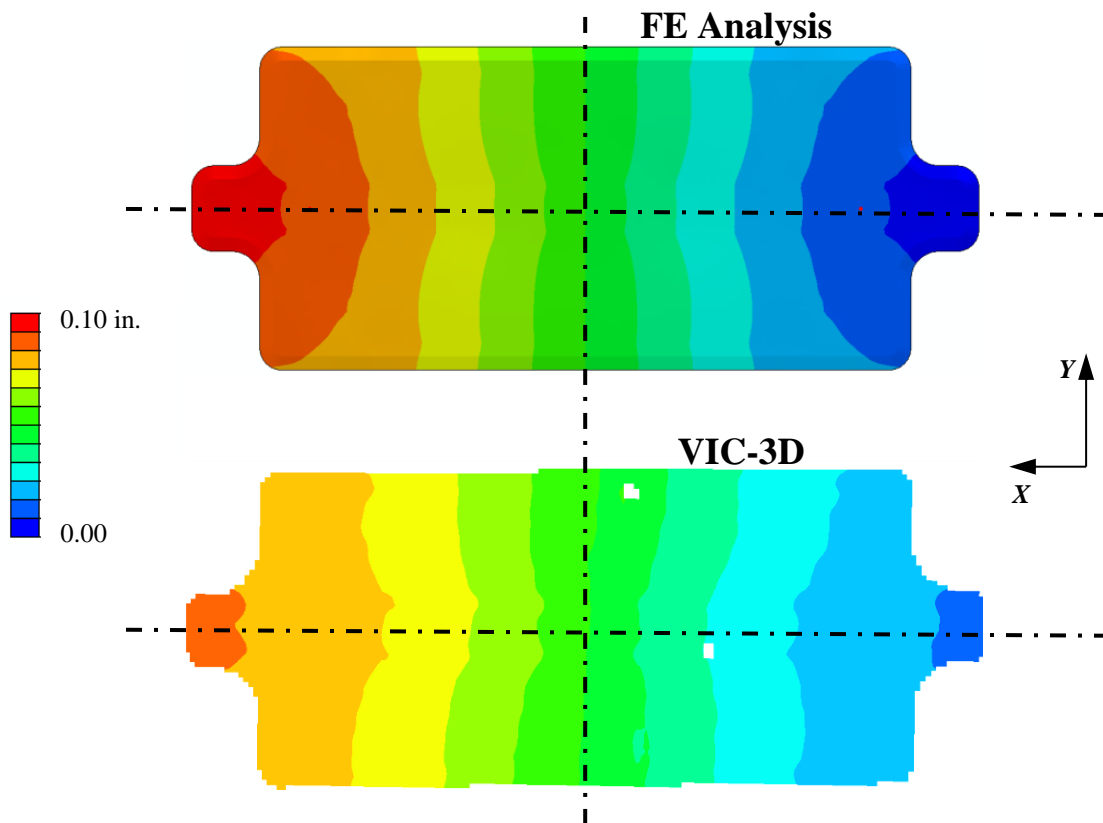
First, full field experimental displacement fields were compared with the FE analysis results to verify that the overall behavior of the test panel resembled that obtained from the predictions. Due to the smoothness of the unstiffened side of the panel, global VIC-3D system produced larger and less fragmented acquisition on this side of the panel. The extensional displacement field for the smooth-side doubler is shown in Figure 23 and compared with the FE prediction. For brevity, only the results for DUL of 178.7 kip are presented. Overall, a good agreement is demonstrated by similar displacement patterns and comparable displacement magnitudes. Nevertheless, the test data shows some distortions to the displacement field symmetry and generally displays a smaller extension of the doubler.

**Figure 23. In-plane extensional displacement of the smooth side doubler at the DUL of 178.7 kip.**

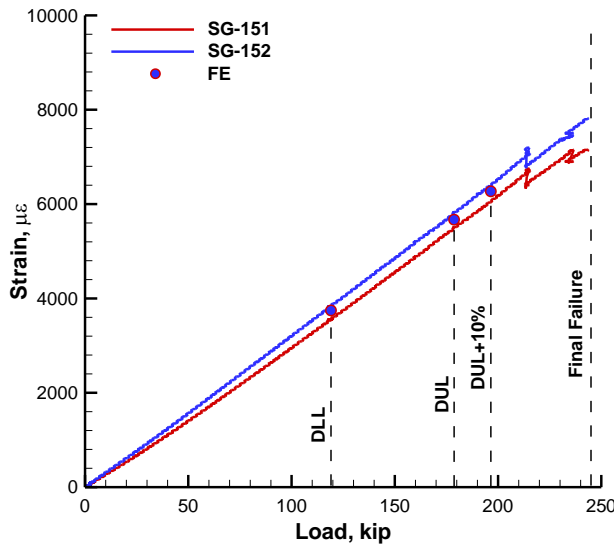
The FE analysis results compare very favorably with the test strain levels in the flanges of the two outside stringers, as shown in Figure 24. While the test data shows slight non-symmetry, the FE analysis results are enveloped by the test results from the two symmetrically placed sensors. Test strain levels in the webs of the two outside stringers, presented in Figure 25, show almost identical values for both sides of the panel and also compare very well with the FE analysis results, where the latter show a slight tendency to overestimate the actual strain levels. This tendency may be introduced by a simplified FE modeling of the stringers<sup>10,11</sup> where the pultruded rod and overwrap are modeled together as beam elements and, therefore, the rod overwrap is not explicitly modeled.

**Figure 24. Mid-span strain vs. load at the flanges of the outside stringers.**

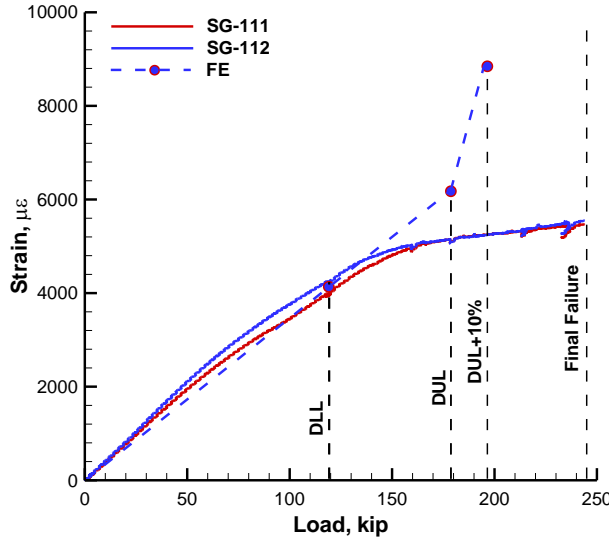
The strain level comparison at the flange section of the stiffened side repair, presented in Figure 26, shows a good comparison only up to the load of approximately 140 kip, which is greater than DLL but less than DUL. Even though the comparison for load less than 140 kip is considered good, a slight departure from the linear characteristic is noted in the test results, but absent in the FE analysis results. For load levels greater than approximately 140 kip the test strain values tend to asymptote and reach only approximately 5,500  $\mu\epsilon$  level at the failure load. The FE analysis results for loads greater than 140 kip, however, first show a linear strain characteristic up to approximately the DUL of 178.7 kip, followed by a softening characteristic due to the yielding stress being exceeded and the plastic response regime being introduced in the mid-span repair section.<sup>11</sup> To assist in analysis of this discrepancy the strains acquired in the web sections of the repair angles are presented in Figure 27, where a less-pronounced but similar softening response for the load greater than DUL can also be noticed and is accurately captured by the FE analysis.<sup>11</sup> Since the locations corresponding to the results in Figure 26 and Figure 27 are only approximately 1.175 in. apart, the difference in strain characteristics may appear surprising at first. Since the flange section of the stiffened side repair is bolted to the panel but its web section is not bolted to the panel, the discrepancy between the measured and predicted strains can be assumed to be related to the manner in which the load is transferred from the damaged center stringer of the panel into the repair assembly. However, strains on the smooth side of the panel must be considered to develop a more complete picture of the test versus analysis comparison.

Figure 26. Mid-span strain vs. load at the flange section of the repair.
