## ***So Close Yet So Far: The Jammed Airlock Hatch of STS-80***

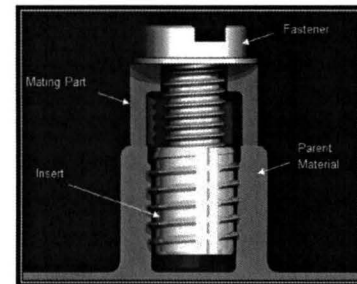
Engineers also concluded that improper thread inserts were used with the screws, which allowed them to loosen over time and eventually back out of the clutch assembly; non-locking thread inserts were used when design specifications called for locking thread inserts to be used. Additionally, appropriate torque values were not included in the engineering drawings of the assembly.

Figure 5: View of thread insert.  
Source: Google Images

A detailed maintenance investigation was completed for the faulty actuator. Results determined that the screws were removed and re-installed five times without replacing the proper thread inserts. Investigations performed on the rest of the fleet identified another 12 actuators with improper inserts (some with one locking and one non-locking insert), all of which contained loose screws. As a result, all orbiters were re-fitted with the proper thread inserts and engineering drawings were updated to include torque specifications.
