International Space Station (ISS) Soyuz Vehicle Descent Module Evaluation of Thermal Protection System (TPS) Penetration Characteristics

Hypervelocity Impact Technology Group

February 2013

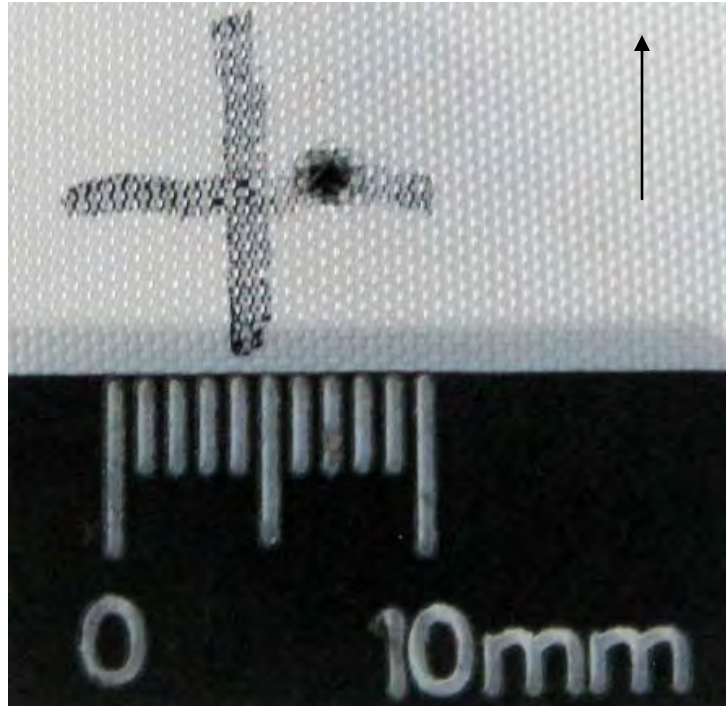
HITF12283 / Test #1 (continued)

Test Number / HITF Number	Target Type	Projectile Material	Actual Projectile Diameter (mm)	Actual Projectile Mass (g)	Actual Impact Velocity (km/s)	Impact Angle (deg)	Damage Results (mm)
1 HITF12283	Type 1 Average thin	Steel 440C	0.89	0.00281	6.86	30	<p>NP 504 Substrate = Pass / Pressure Shell = Pass Beta cloth entry damage = 1.0 x 1.2 perforation MLI exit damage = perforations present on back side of MLI blanket within a 9.6 x 8.8 area with the largest being 7.5 x 5.6 NP 504 entry damage = impacts present within 11.7 x 9.5 area with exposed severed ply's present within 6.4 x 4.1 area, no perforation present (light tight) NP 504 exit damage = 13.4 x 12.7 bump present on back side that has a maximum height of 0.2, there is a 0.3 x 0.1 detached spall area on top of bump, no perforation present (light tight) FG 7725 damage = no damage present Rear wall damage = none present</p>
2 HITF12284	Type 1 Average thin	Steel 440C	1.00	0.00400	7.16	45	<p>NP 504 Substrate = Pass / Pressure Shell = Pass Beta cloth entry damage = 1.7 x 1.3 perforation MLI exit damage = 17.5 x 9.7 perforation NP 504 entry damage = impacts present within 16.5 x 14.4 area with exposed severed ply's present within 6.3 x 7.2 area, no perforation present (light tight) NP 504 exit damage = 14.9 x 12.6 bump present on back side that has a maximum height of 0.3, there is a 1.9 x 1.0 detached spall area on top of bump, no perforation present (light tight) FG 7725 damage = 3.3 x 2.4 area with few severed fibers present on back side of 1st layer, no perforation Rear wall damage = none present</p>

Figure 12 Close-up View of Damage to Front of MLI (scale in 1mm increments / black arrow indicates flight path of projectile)

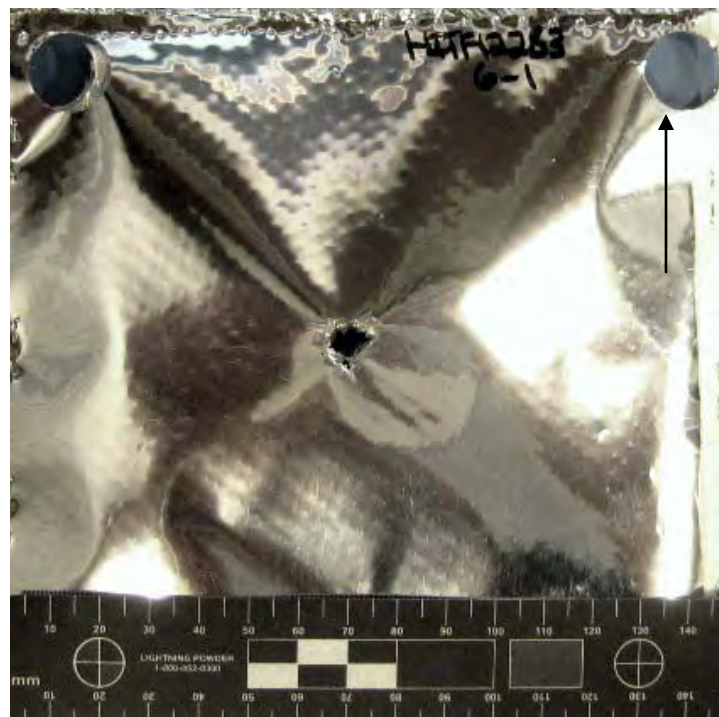
Figure 13 Overall View of Damage to Back Side of MLI (scale in 5mm increments / black arrow indicates flight path of projectile)

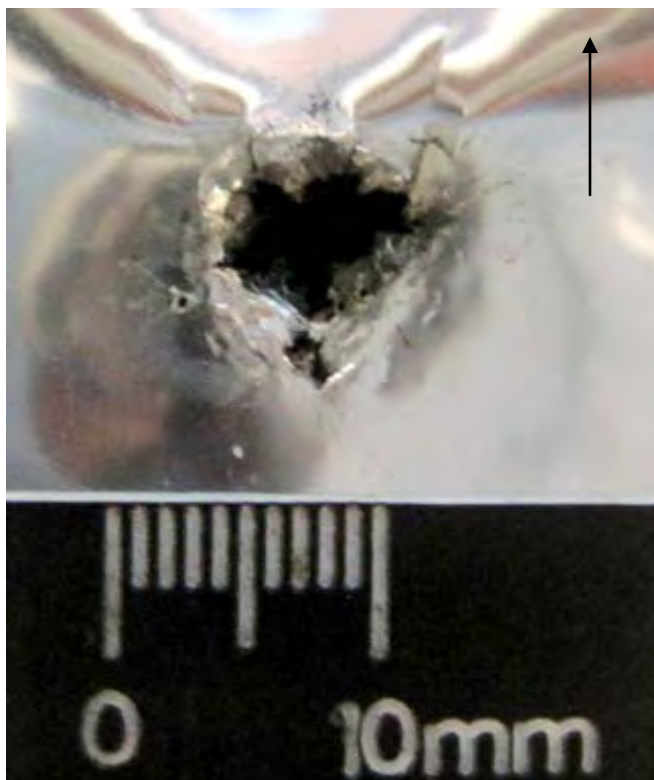
HITF12283 / Test #1 (continued)

Figure 14 Close-up View of Damage to Back Side of MLI (scale in 1mm increments / black arrow indicates flight path of projectile)

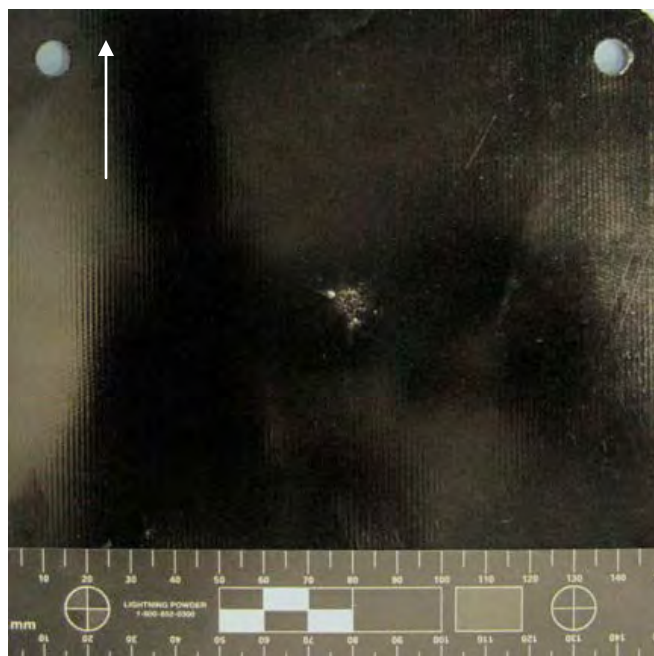
Figure 15 Overall View of Damage to Front of NP 504 Substrate (scale in 5mm increments / white arrow indicates flight path of projectile)

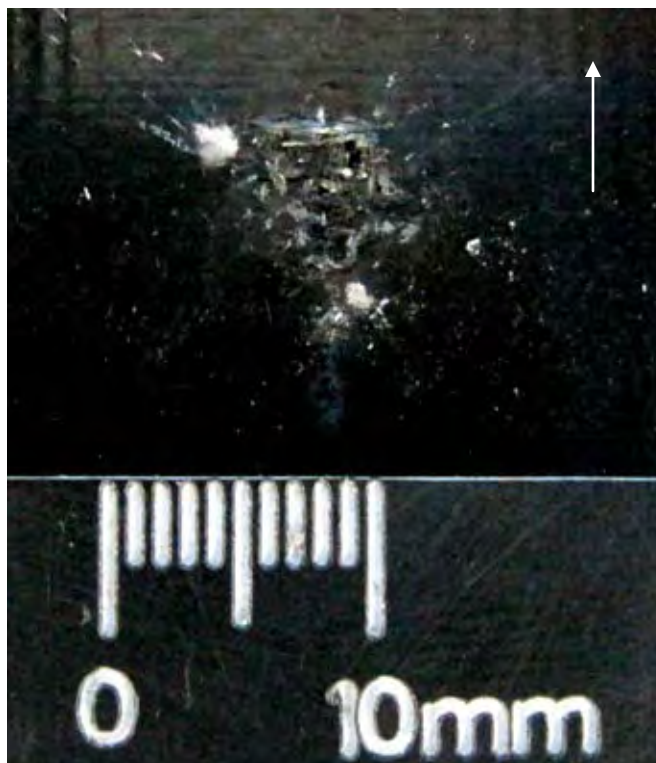
HITF12283 / Test #1 (continued)

Figure 16 Close-up View of Damage to Front of NP 504 Substrate (scale in 1mm increments / white arrow indicates flight path of projectile)

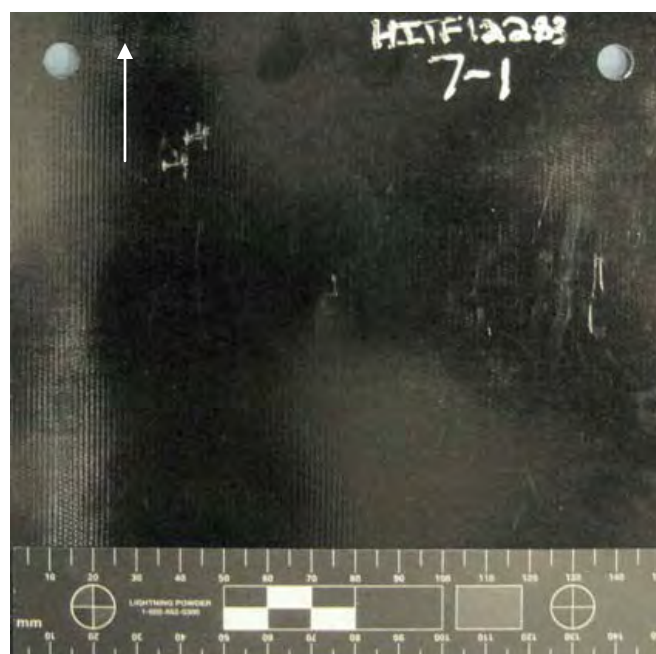
Figure 17 Overall View of Damage to Back Side of NP 504 Substrate (scale in 5mm increments / white arrow indicates flight path of projectile)

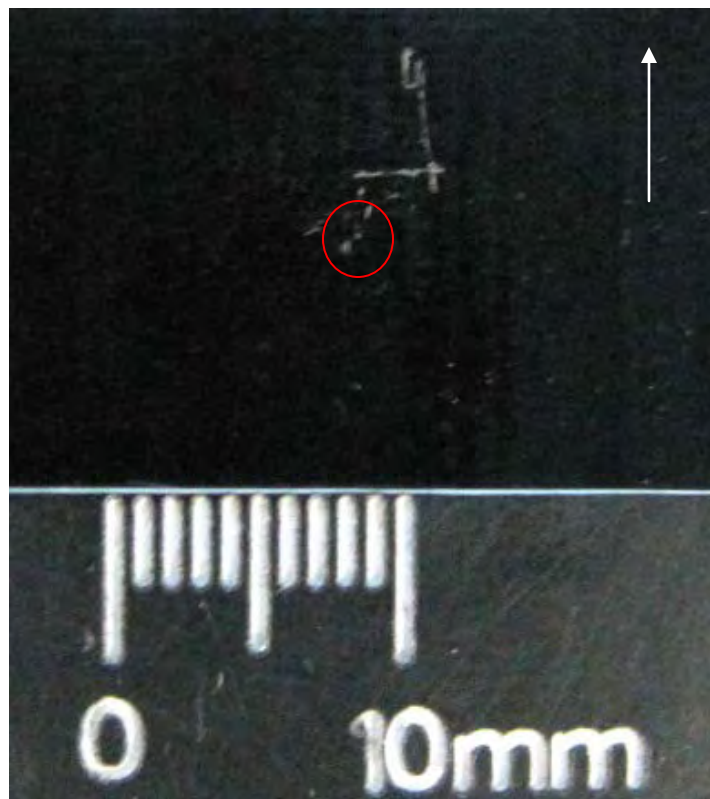
HITF12283 / Test #1 (continued)

Figure 18 Close-up View of Damage to Back Side of NP 504 Substrate (scale in 1mm increments / white arrow indicates flight path of projectile)

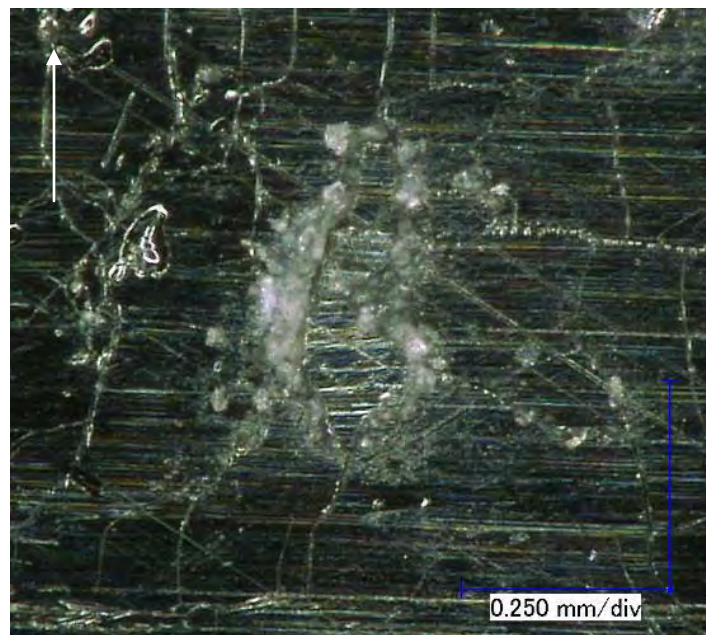
Figure 19 Close-up View of Most Significant Damage to Back Side of NP 504 Substrate (white arrow indicates flight path of projectile / damage within red circle in Figure 18)

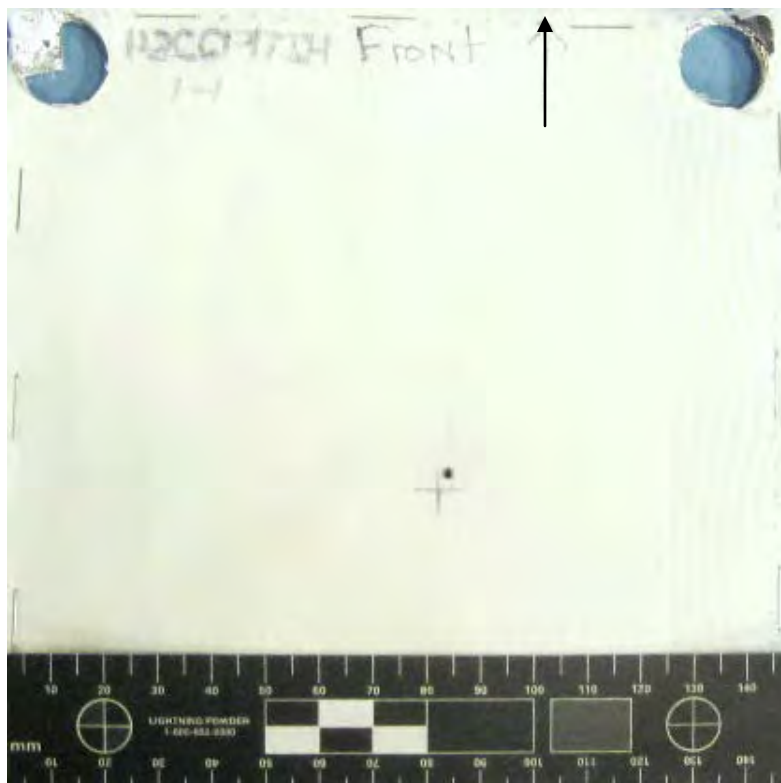
Figure 24 Overall View of Damage to Front of MLI (scale in 5mm increments / black arrow indicates flight path of projectile)

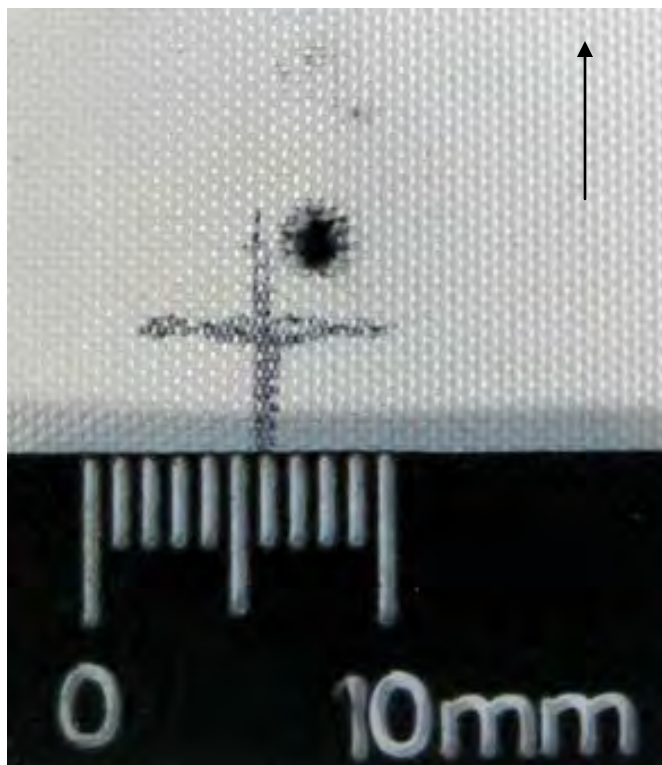
HITF12284 / Test #2 (continued)

Figure 25 Close-up View of Damage to Front of MLI (scale in 1mm increments / black arrow indicates flight path of projectile)

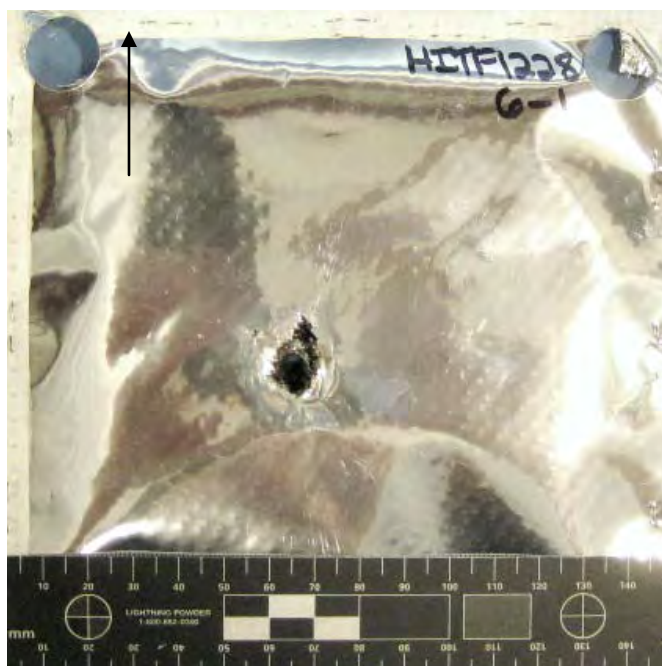
Figure 26 Overall View of Damage to Back Side of MLI (scale in 5mm increments / black arrow indicates flight path of projectile)

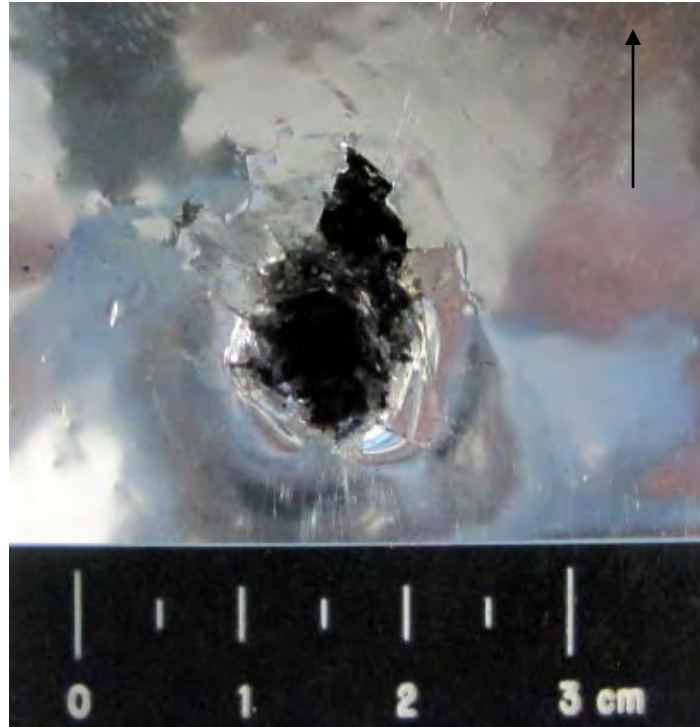
HITF12284 / Test #2 (continued)

Figure 27 Close-up View of Damage to Back Side of MLI (scale in 5mm increments / black arrow indicates flight path of projectile)

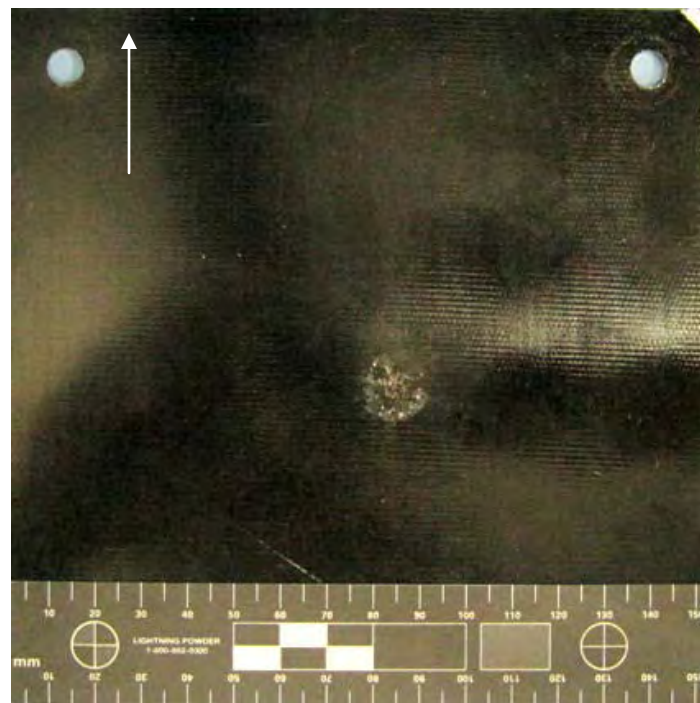
Figure 28 Overall View of Damage to Front of NP 504 Substrate (scale in 5mm increments / white arrow indicates flight path of projectile)

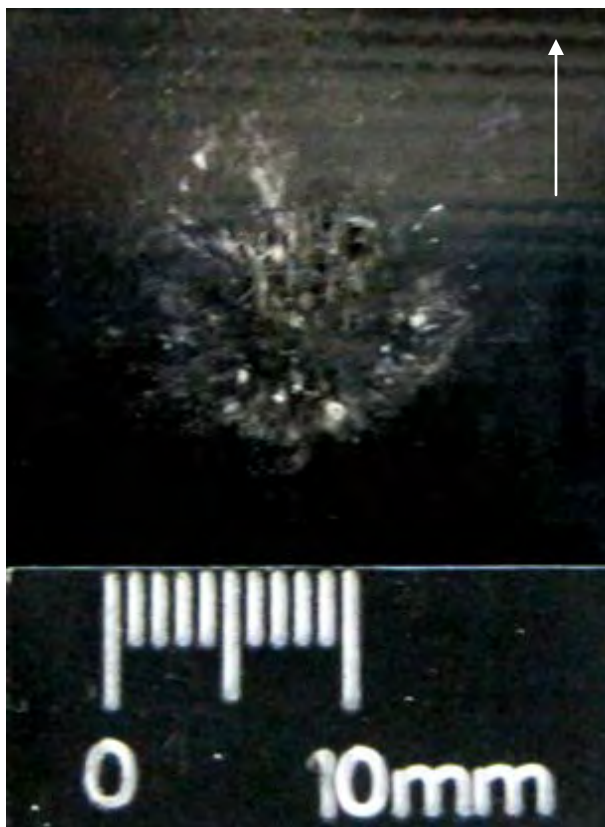
HITF12284 / Test #2 (continued)

Figure 29 Close-up View of Damage to Front of NP 504 Substrate (scale in 1mm increments / white arrow indicates flight path of projectile)

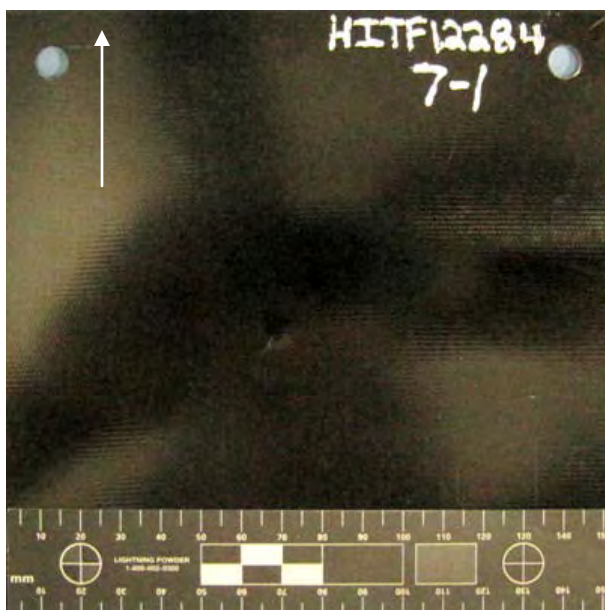
Figure 30 Overall View of Damage to Back Side of NP 504 Substrate (scale in 5mm increments / white arrow indicates flight path of projectile)

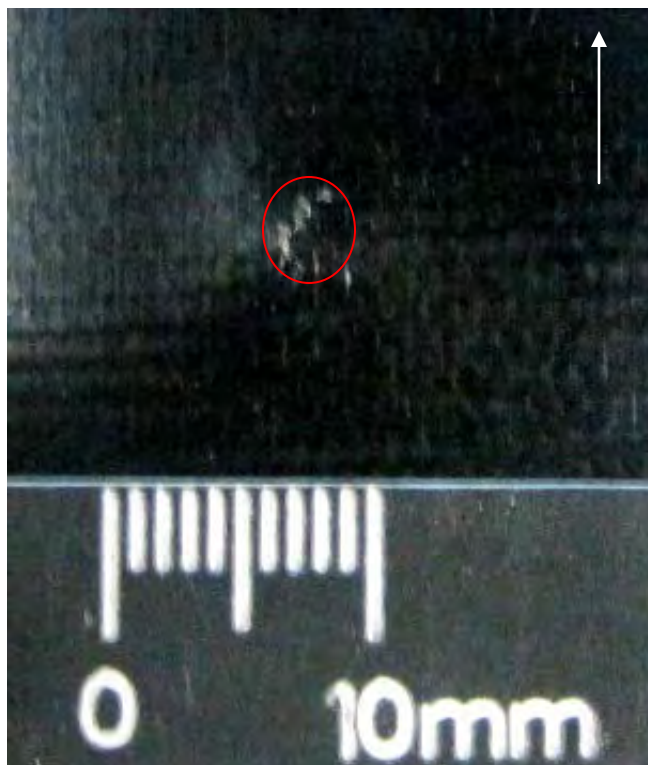
HITF12284 / Test #2 (continued)

Figure 31 Close-up View of Damage to Back Side of NP 504 Substrate (scale in 1mm increments / white arrow indicates flight path of projectile)

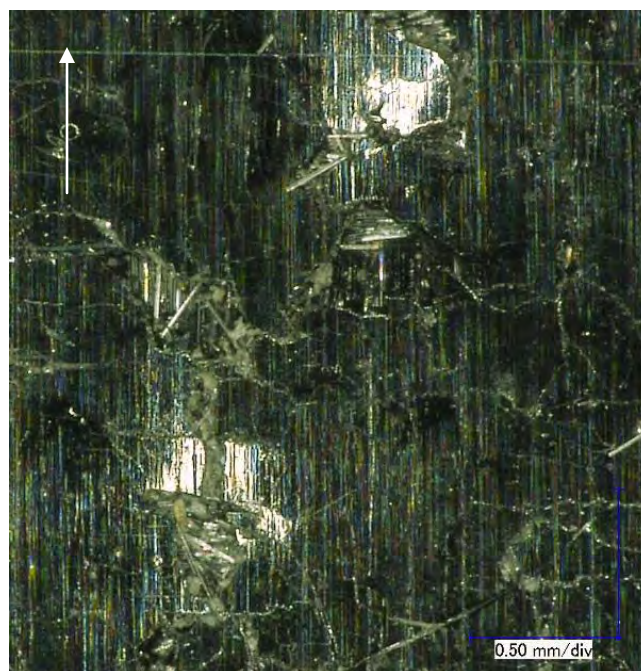
Figure 32 Close-up View of Most Significant Damage to Back Side of NP 504 Substrate (white arrow indicates flight path of projectile / damage within red circle in Figure 31)

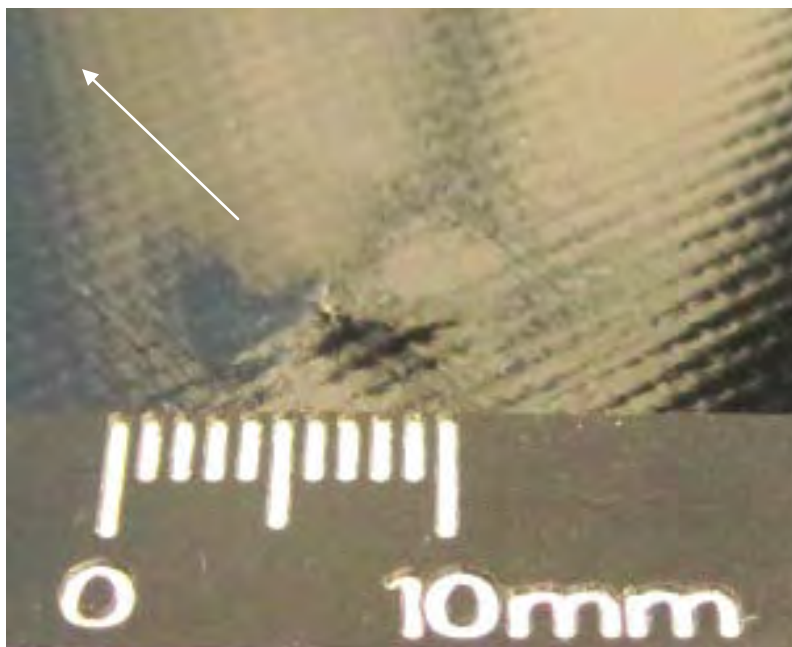
HITF12284 / Test #2 (continued)

Figure 33 Close-up Oblique Side View of Damage to Back Side of NP 504 Substrate (scale in 1mm increments / white arrow indicates flight path of projectile)

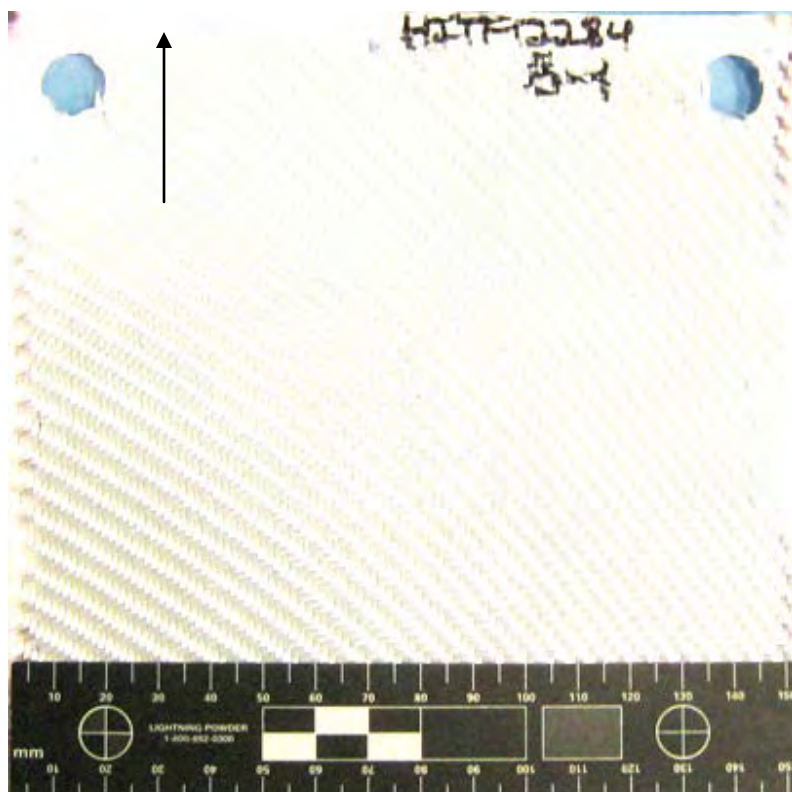
Figure 34 Overall View of Damage to Back Side of 1st Fiberglass Layer (scale in 5mm increments / black arrow indicates flight path of projectile)

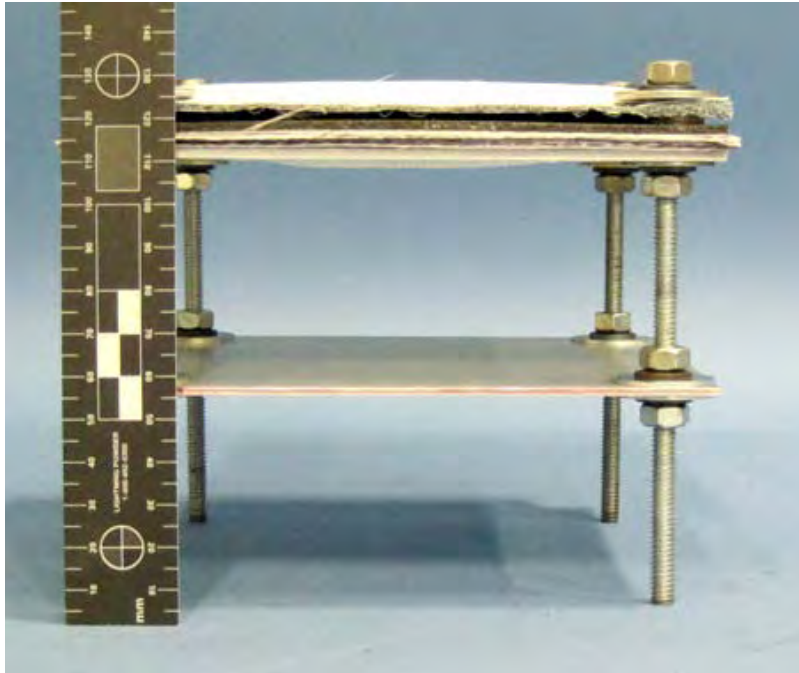
**Figure 38** Overall Side View of Sample (scale in 5mm increments)

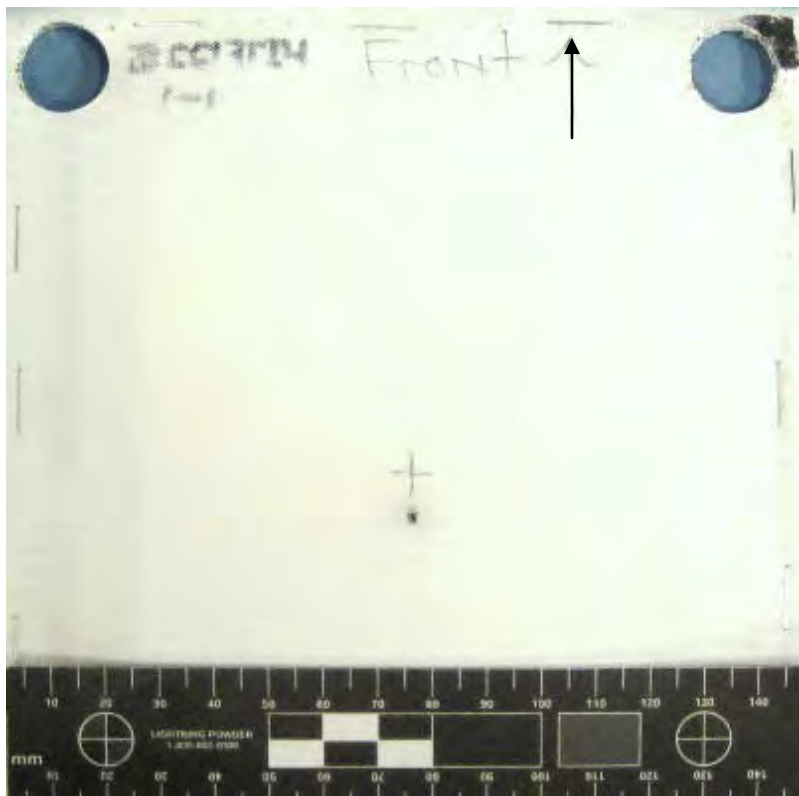
**Figure 39** Overall View of Damage to Front of MLI (scale in 5mm increments / black arrow indicates flight path of projectile)

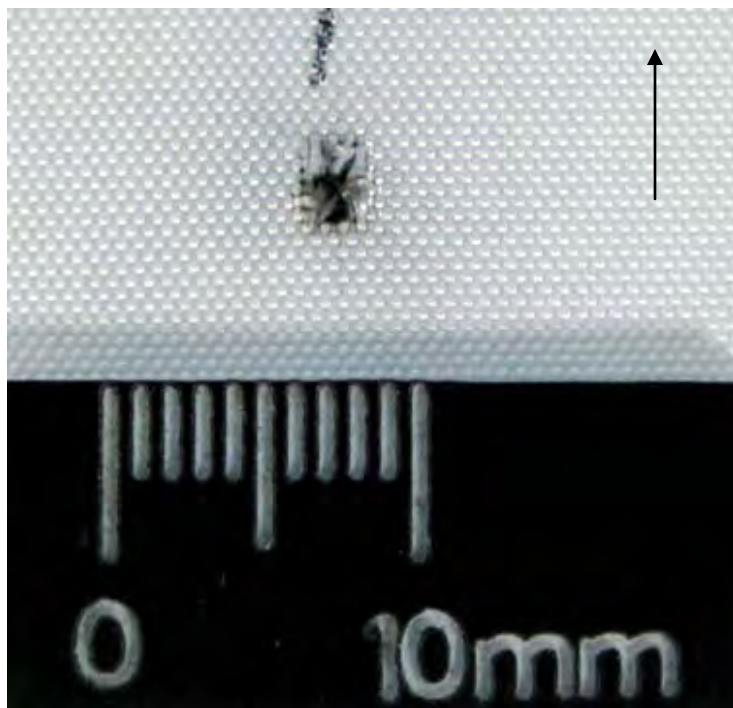
Figure 40 Close-up View of Damage to Front of MLI (scale in 1mm increments / black arrow indicates flight path of projectile)

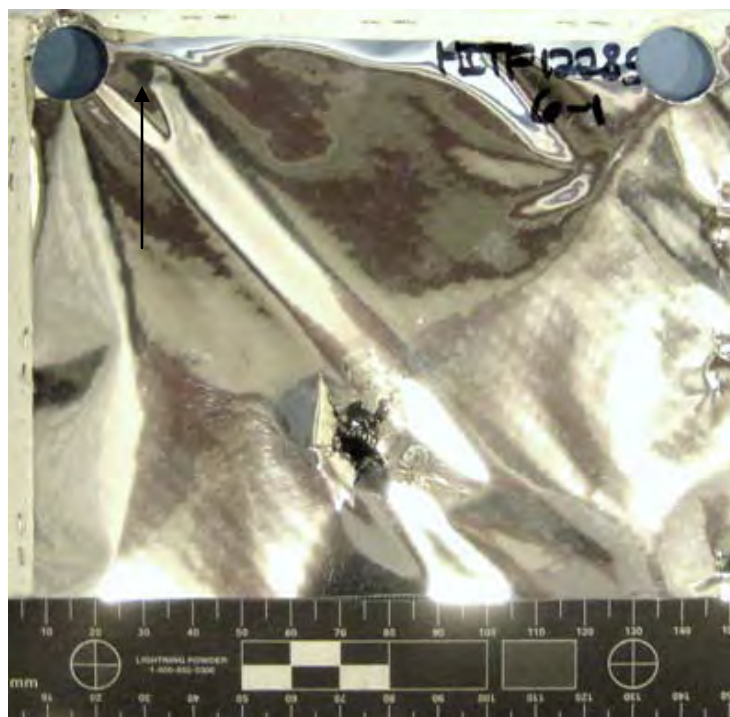
Figure 41 Overall View of Damage to Back Side of MLI (scale in 5mm increments / black arrow indicates flight path of projectile)

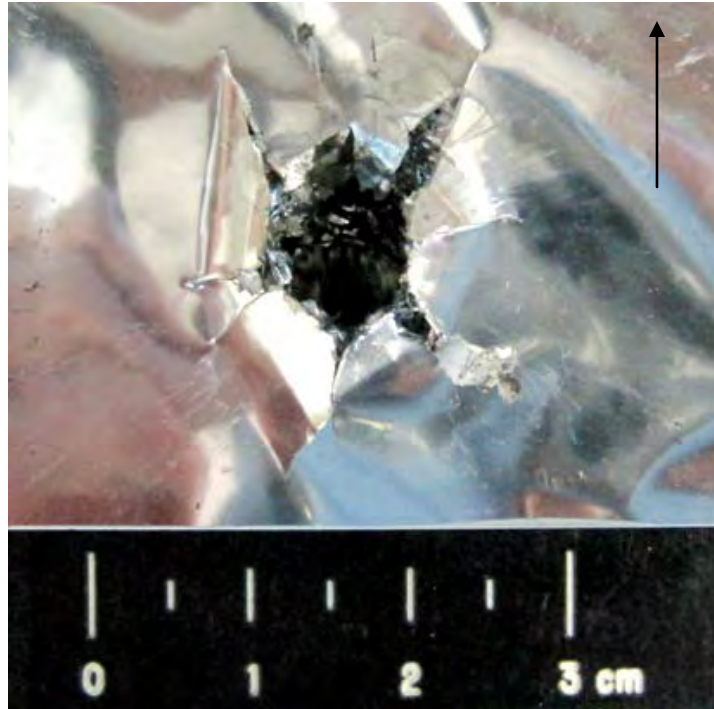
Figure 42 Close-up View of Damage to Back Side of MLI (scale in 5mm increments / black arrow indicates flight path of projectile)

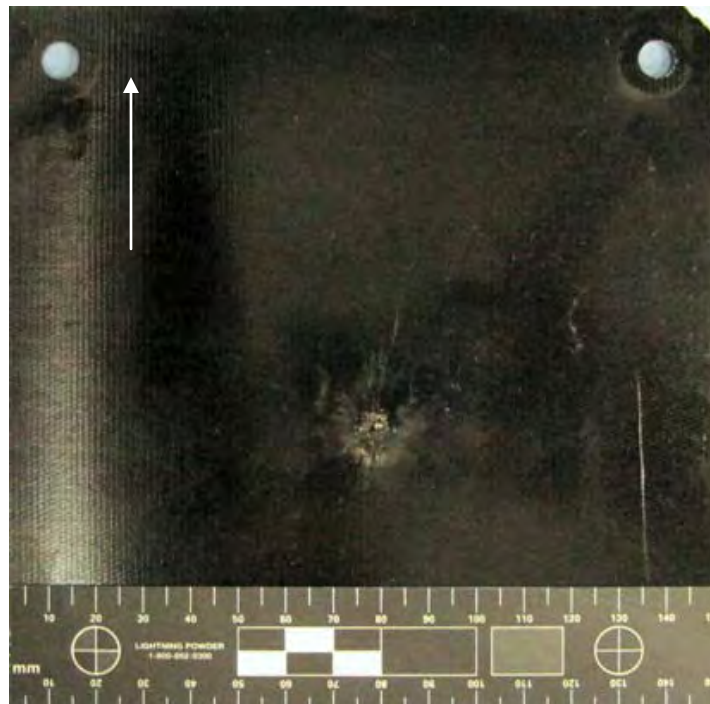
Figure 43 Overall View of Damage to Front of NP 504 Substrate (scale in 5mm increments / white arrow indicates flight path of projectile)

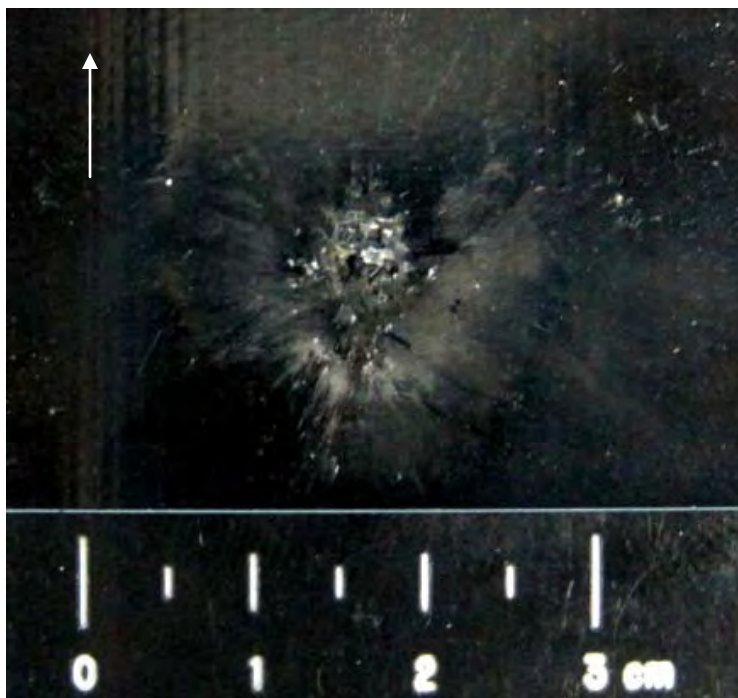
Figure 44 Close-up View of Damage to Front of NP 504 Substrate (scale in 5mm increments / white arrow indicates flight path of projectile)

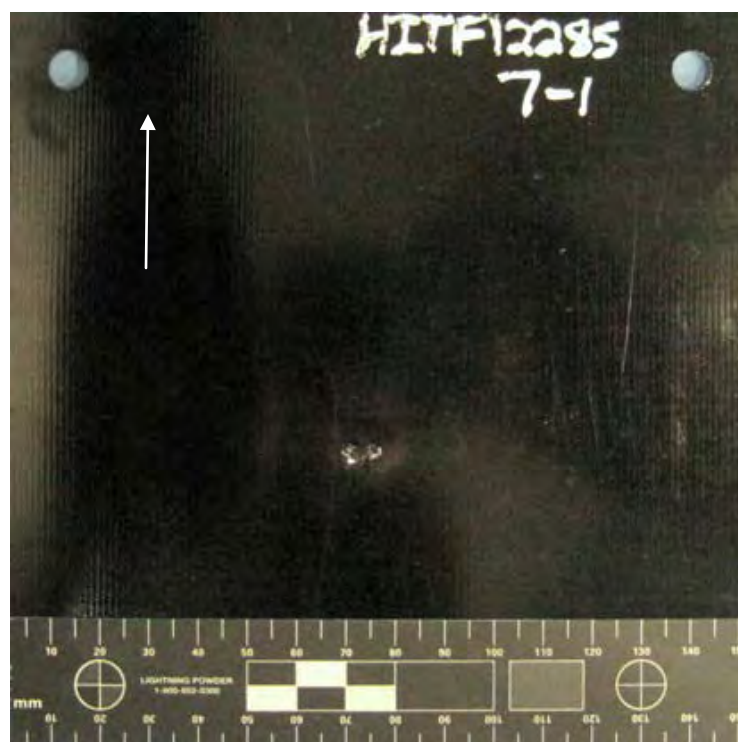
Figure 45 Overall View of Damage to Back Side of NP 504 Substrate (scale in 5mm increments / white arrow indicates flight path of projectile)

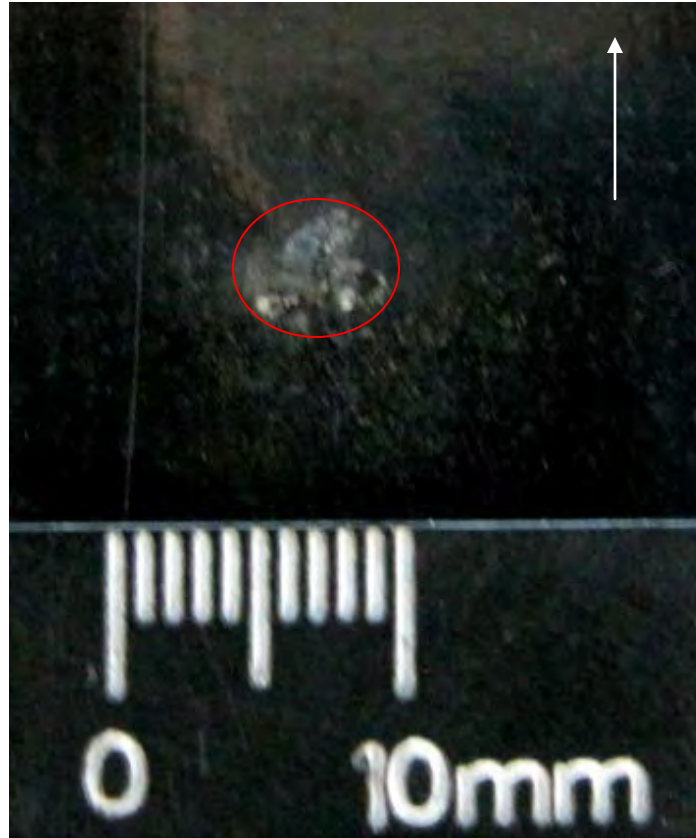
Figure 46 Close-up View of Damage to Back Side of NP 504 Substrate (scale in 1mm increments / white arrow indicates flight path of projectile)

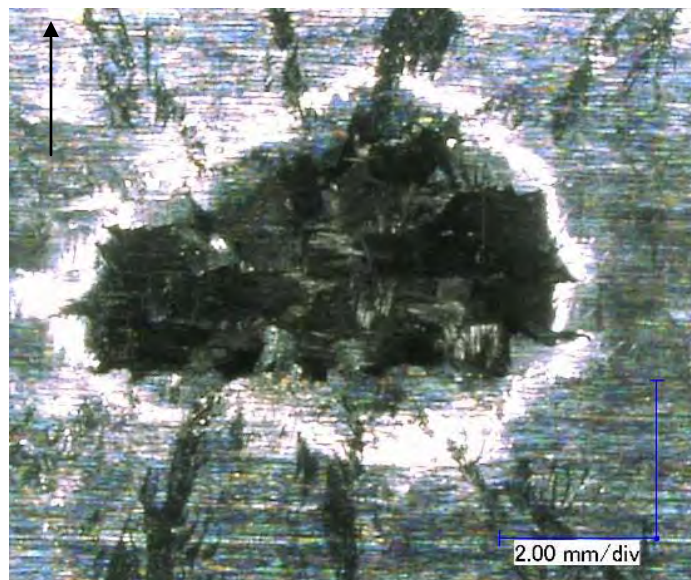
Figure 47 Close-up View of Most Significant Damage to Back Side of NP 504 Substrate (black arrow indicates flight path of projectile / damage within red circle in Figure 46)

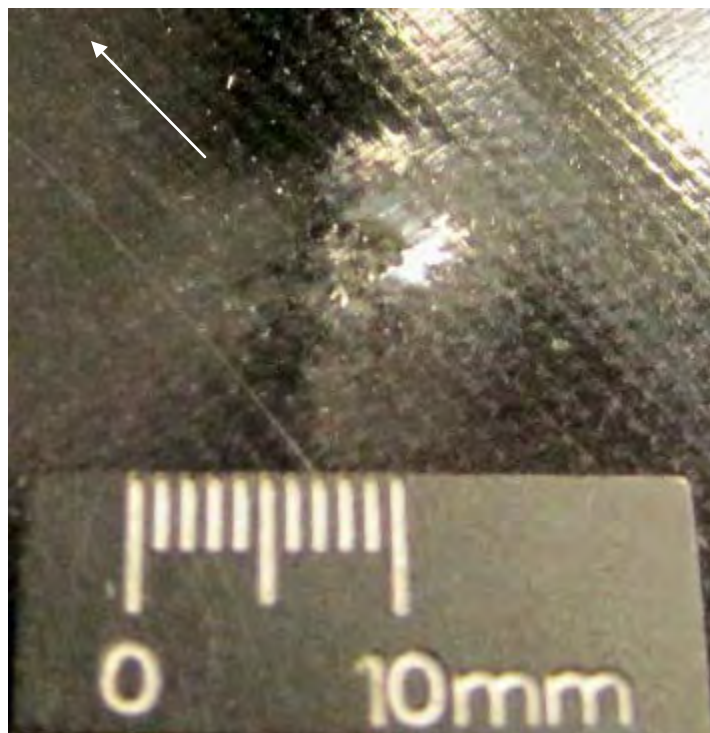
Figure 48 Close-up Oblique Side View of Damage to Back Side of NP 504 Substrate (scale in 1mm increments / white arrow indicates flight path of projectile)

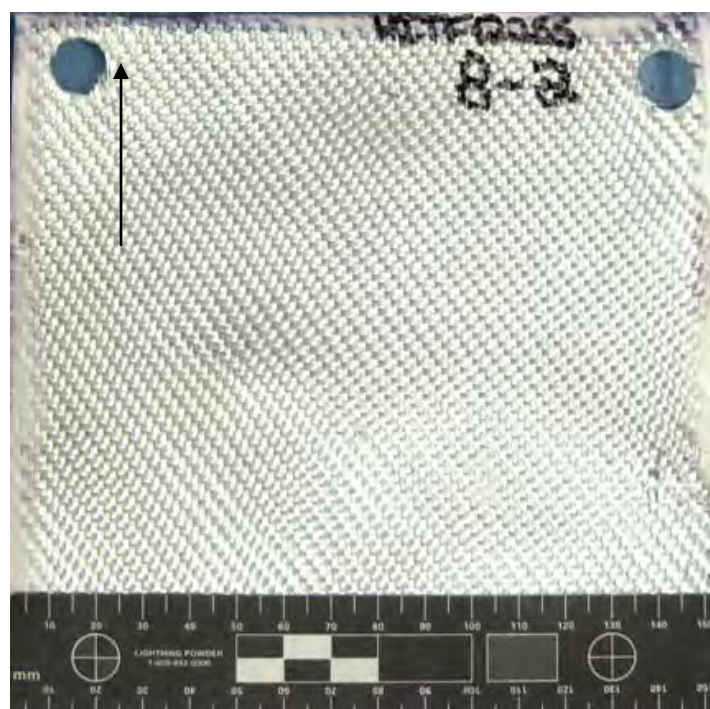
Figure 49 Overall View of Damage to Back Side of 2nd Fiberglass Layer (scale in 5mm increments / black arrow indicates flight path of projectile)

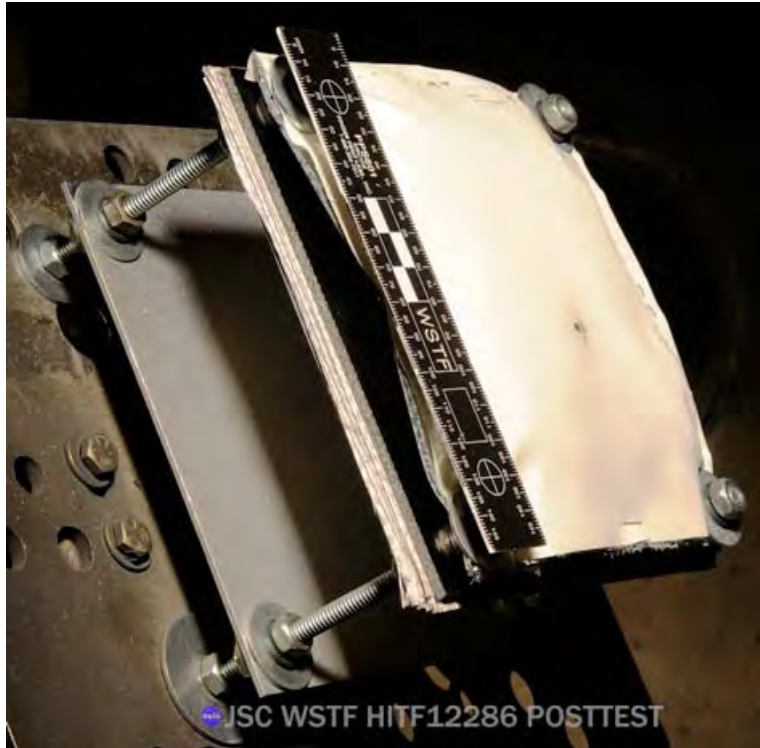
Figure 51 Overall View of Sample in the Target Tank (post-test)

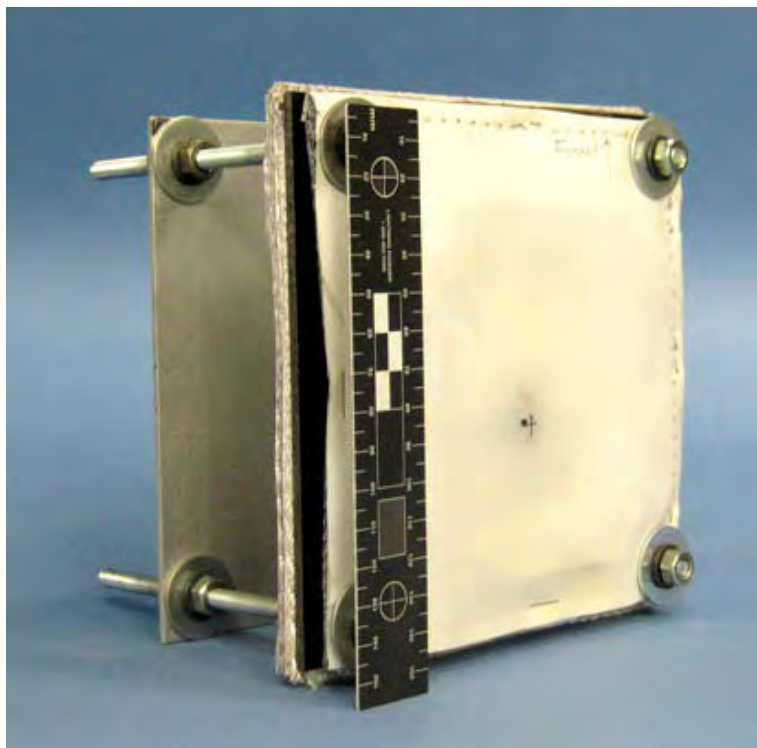
Figure 52 Overall Front Oblique View of Sample (scale in 5mm increments)

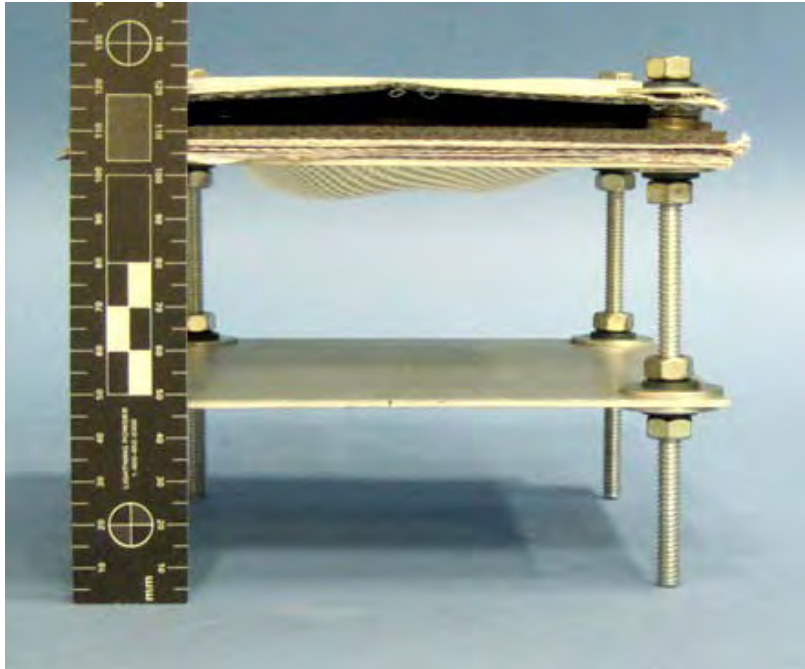
Figure 53 Overall Side View of Sample (scale in 5mm increments)

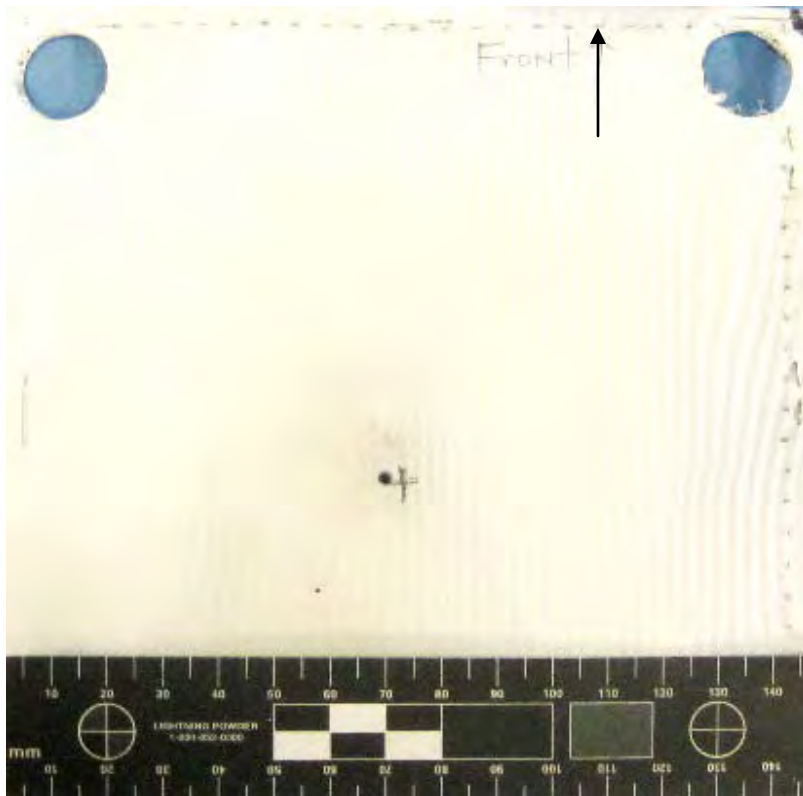
Figure 54 Overall View of Damage to Front of MLI (scale in 5mm increments / black arrow indicates flight path of projectile)

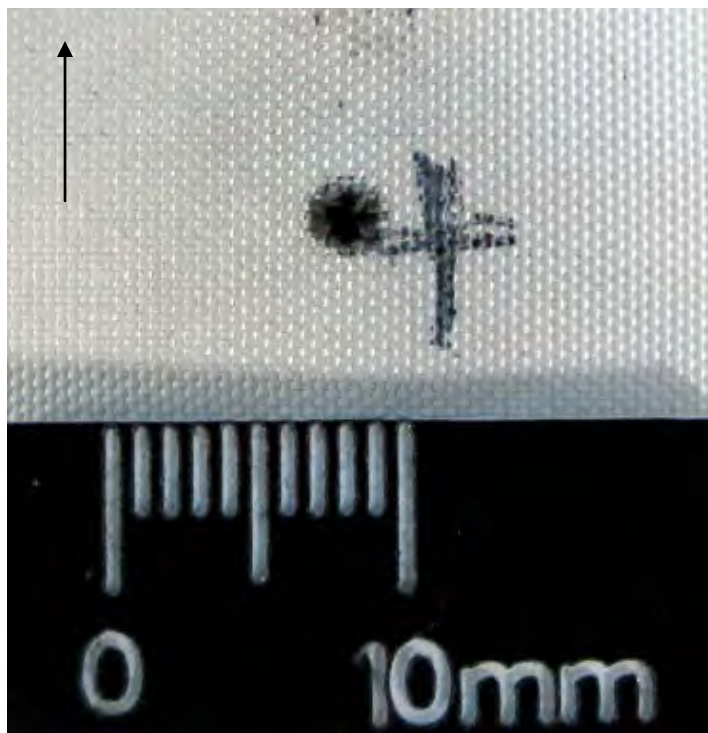
Figure 55 Close-up View of Damage to Front of MLI (scale in 1mm increments / black arrow indicates flight path of projectile)

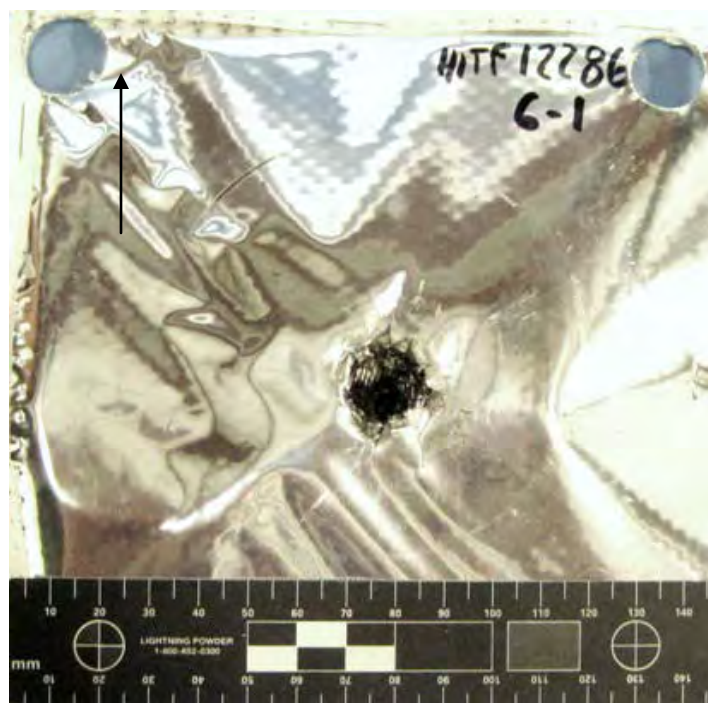
Figure 56 Overall View of Damage to Back Side of MLI (scale in 5mm increments / black arrow indicates flight path of projectile)

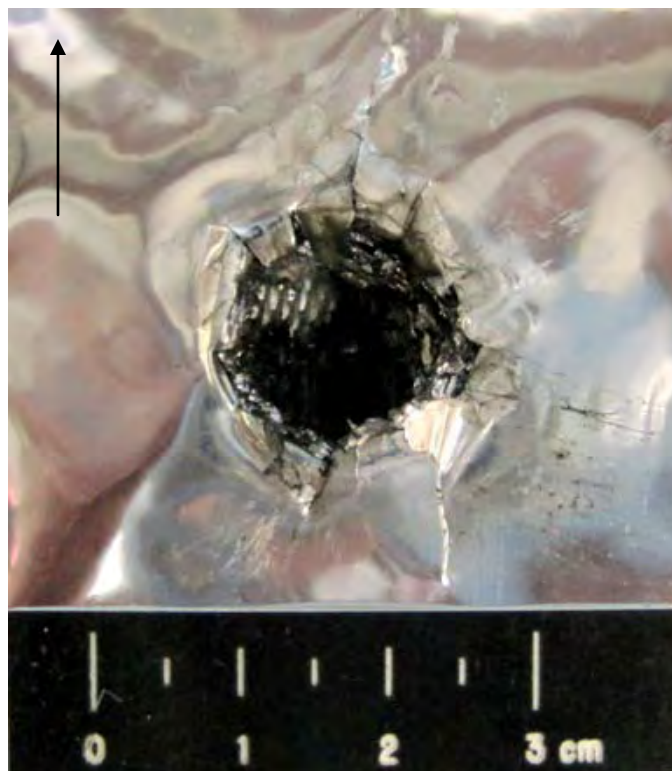
Figure 57 Close-up View of Damage to Back Side of MLI (scale in 5mm increments / black arrow indicates flight path of projectile)

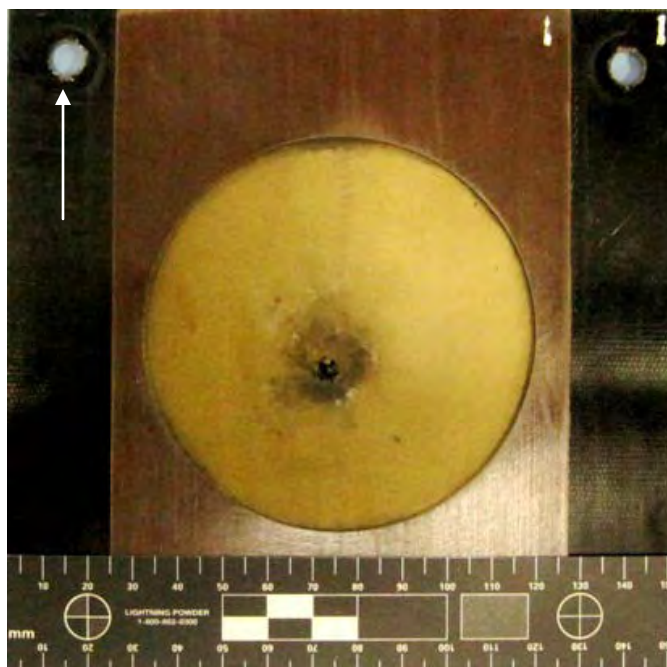
Figure 58 Overall View of Damage to Front of TORLON 5030 (scale in 5mm increments / white arrow indicates flight path of projectile)

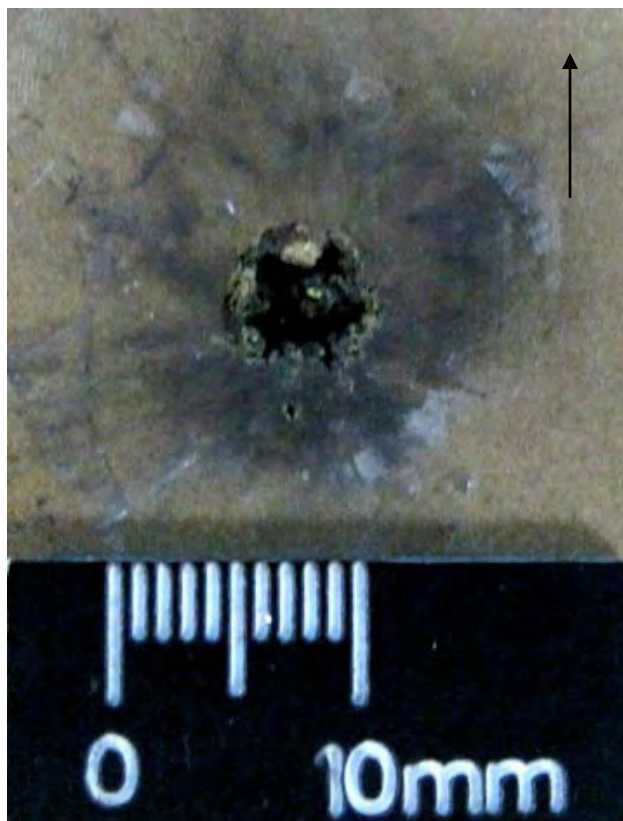
Figure 59 Close-up View of Damage to Front of TORLON 5030 (scale in 1mm increments / black arrow indicates flight path of projectile)

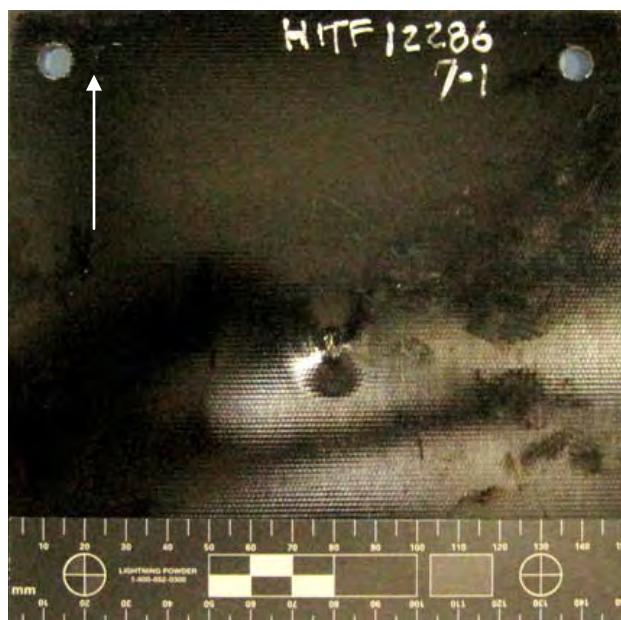
Figure 60 Overall View of Damage to Back Side of NP 504 Substrate (scale in 5mm increments / white arrow indicates flight path of projectile)
