International Space Station (ISS) Soyuz Vehicle Descent Module Evaluation of Thermal Protection System (TPS) Penetration Characteristics

Hypervelocity Impact Technology Group

February 2013

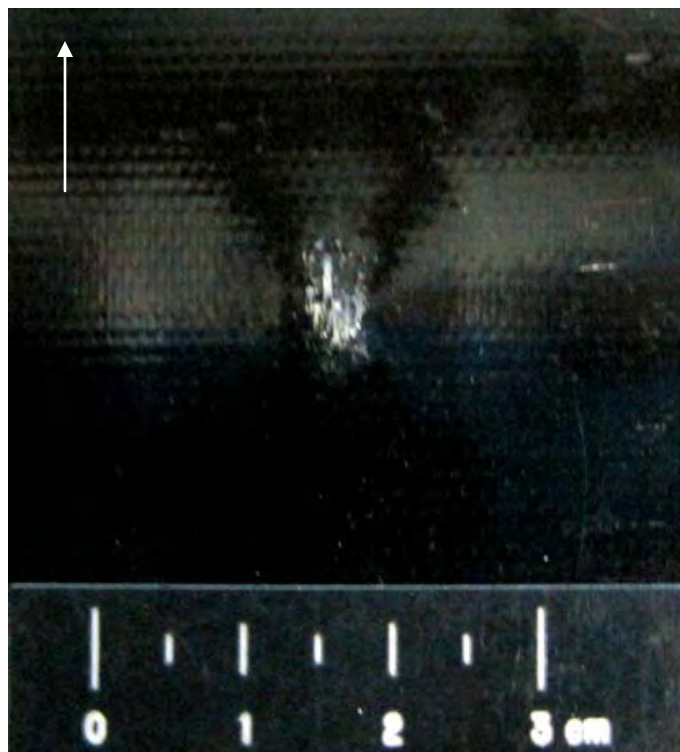
Figure 61 Close-up View of Damage to Back Side of NP 504 Substrate (scale in 5mm increments / white arrow indicates flight path of projectile)

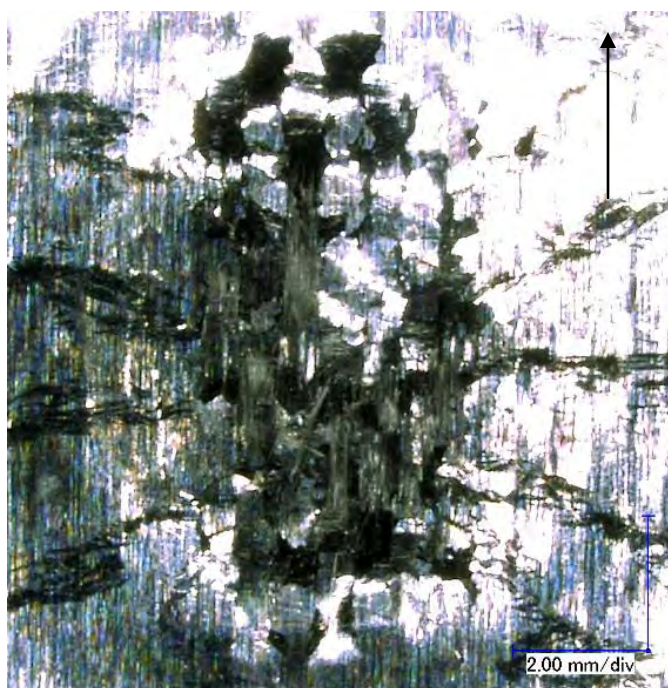
Figure 62 Close-up View of Most Significant Damage to Back Side of NP 504 Substrate (black arrow indicates flight path of projectile / damage within red circle in Figure 61)

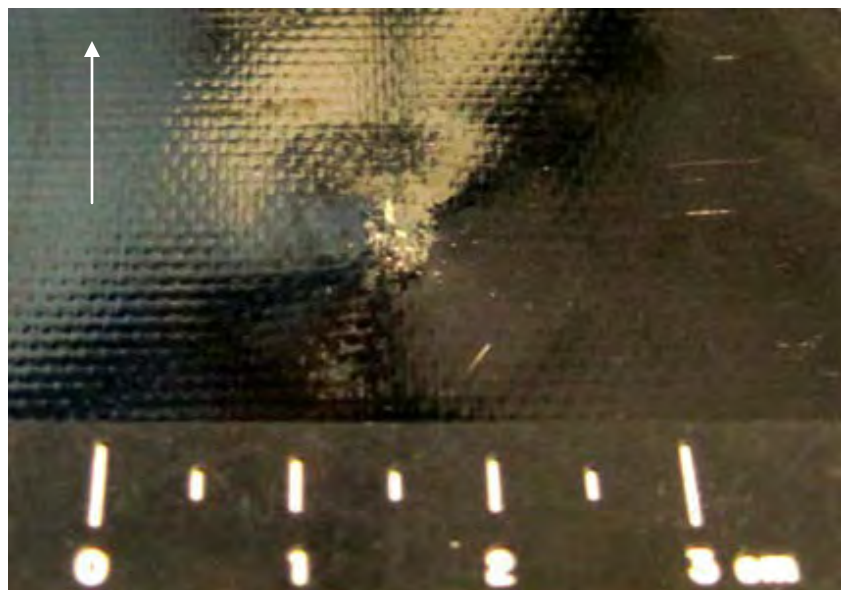
Figure 63 Close-up Oblique Side View of Damage to Back Side of NP 504 Substrate (scale in 1mm increments / white arrow indicates flight path of projectile)

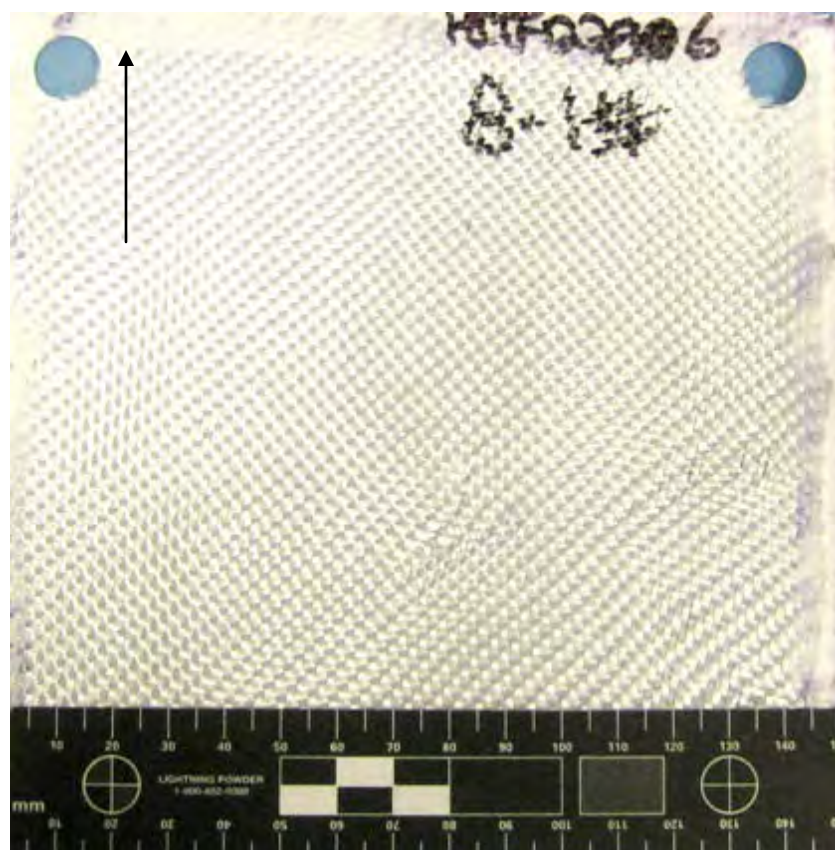
Figure 64 Overall View of Damage to Back Side of 1st Fiberglass Layer (scale in 5mm increments / black arrow indicates flight path of projectile)

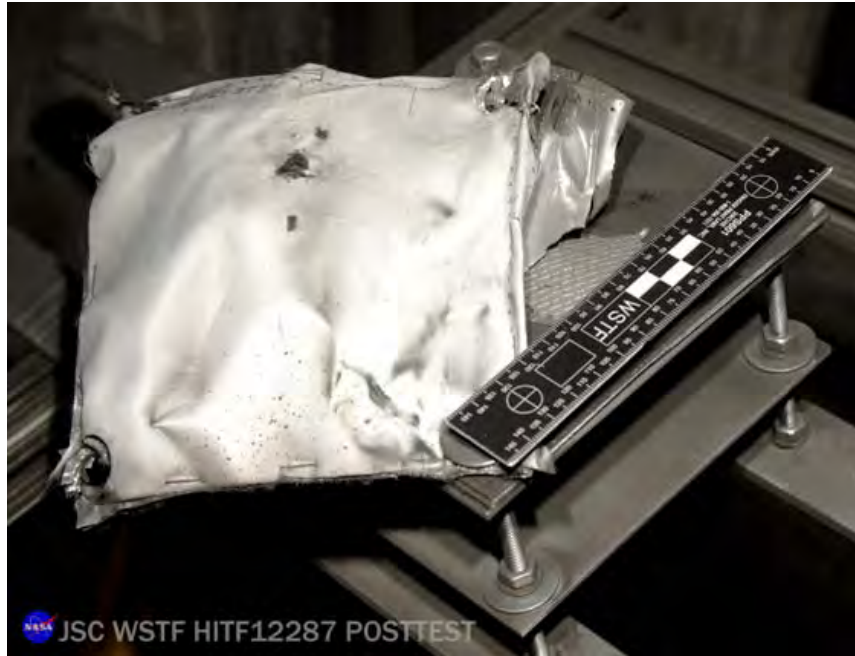
Figure 66 Overall View of Sample in the Target Tank (post-test)

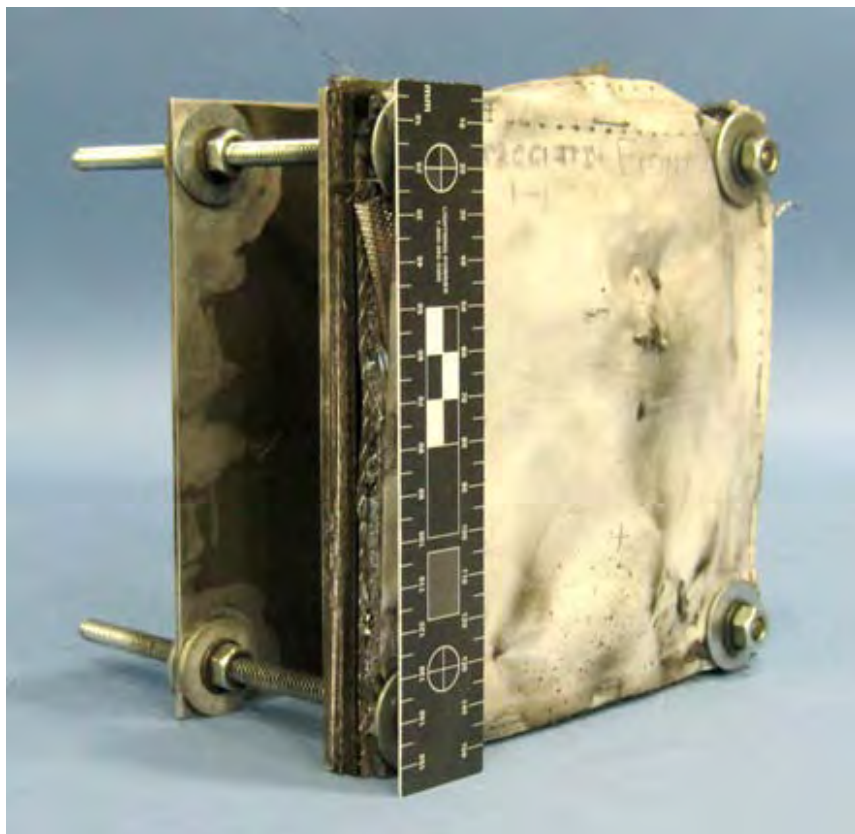
Figure 67 Overall Front Oblique View of Sample (scale in 5mm increments)

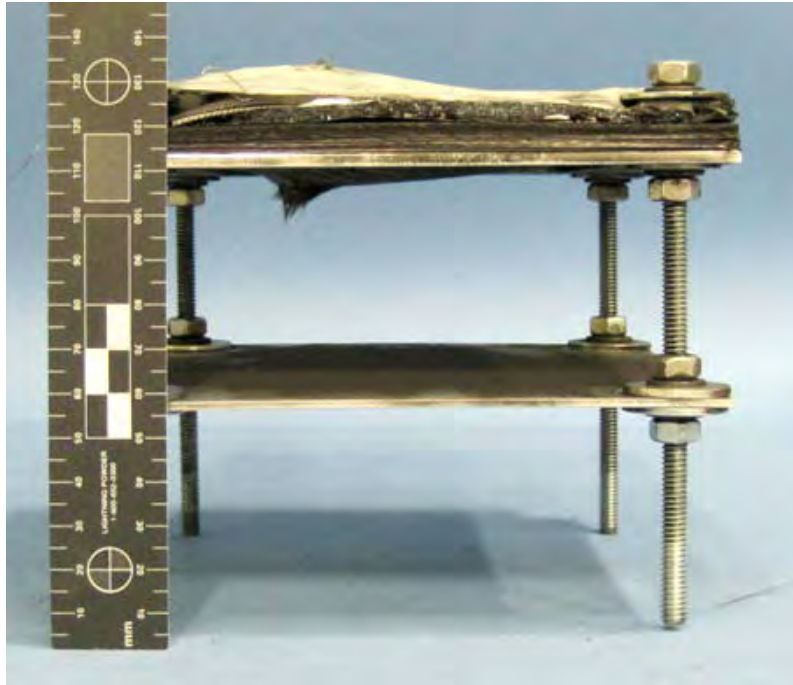
Figure 68 Overall Side View of Sample (scale in 5mm increments)

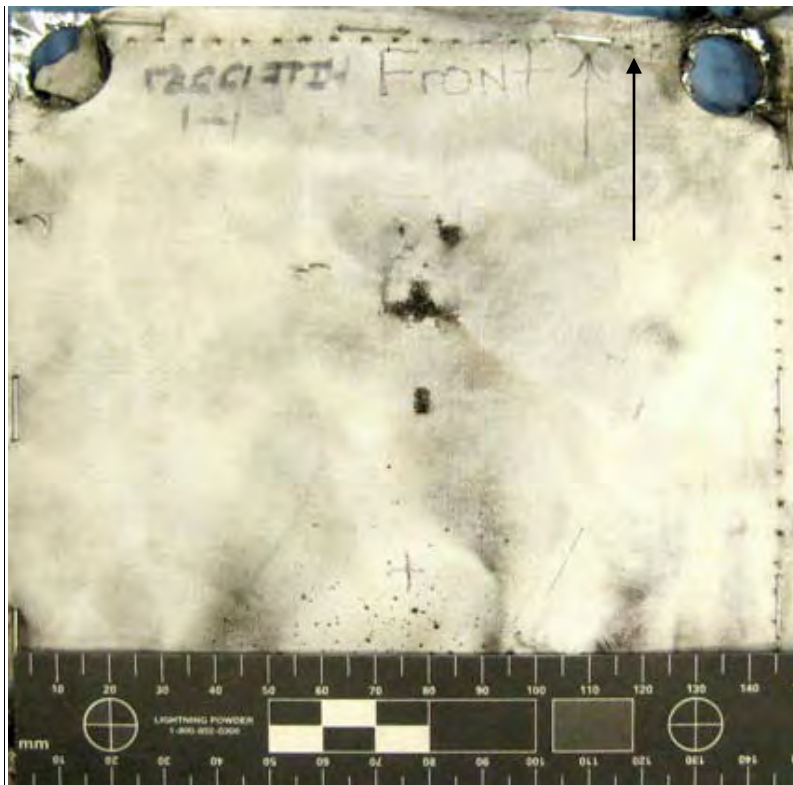
Figure 69 Overall View of Damage to Front of MLI (black arrow indicates flight path of projectile / scale in 5mm increments)

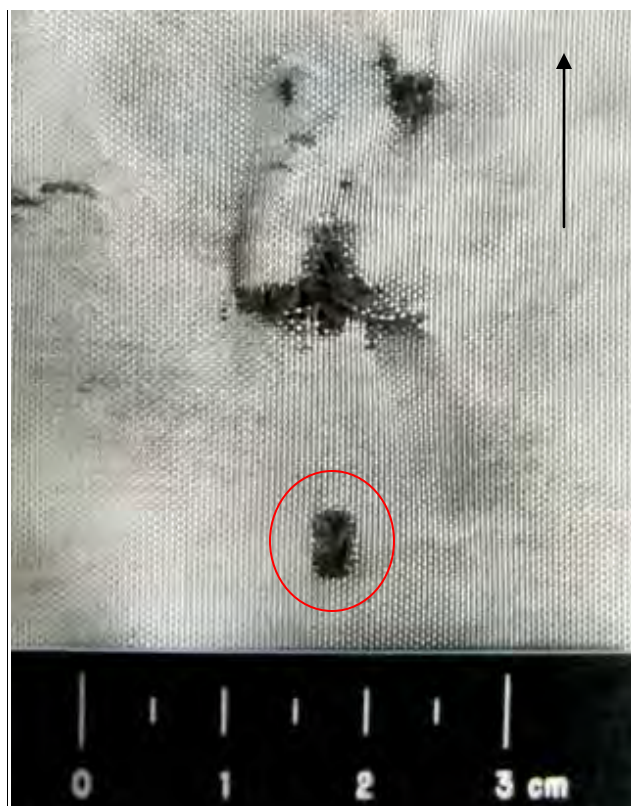
Figure 70 Close-up View of Damage to Front of MLI (scale in 5mm increments / black arrow indicates flight path of projectile / projectile impacted within red circle)

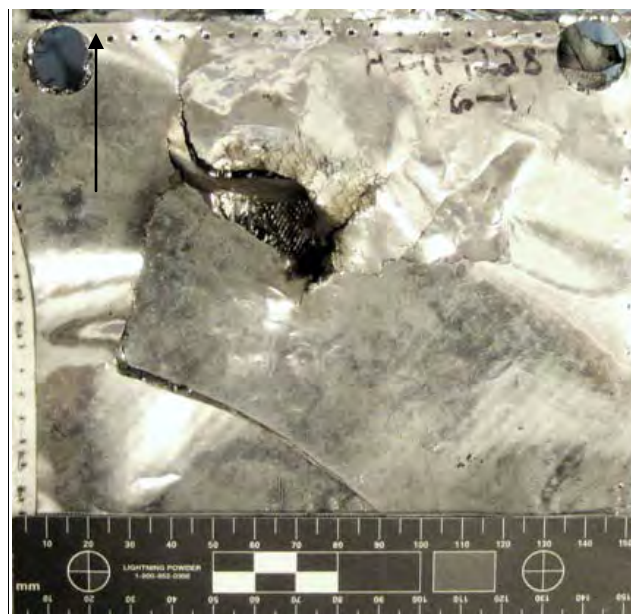
Figure 71 Overall View of Damage to Back Side of MLI (scale in 5mm increments / black arrow indicates flight path of projectile)

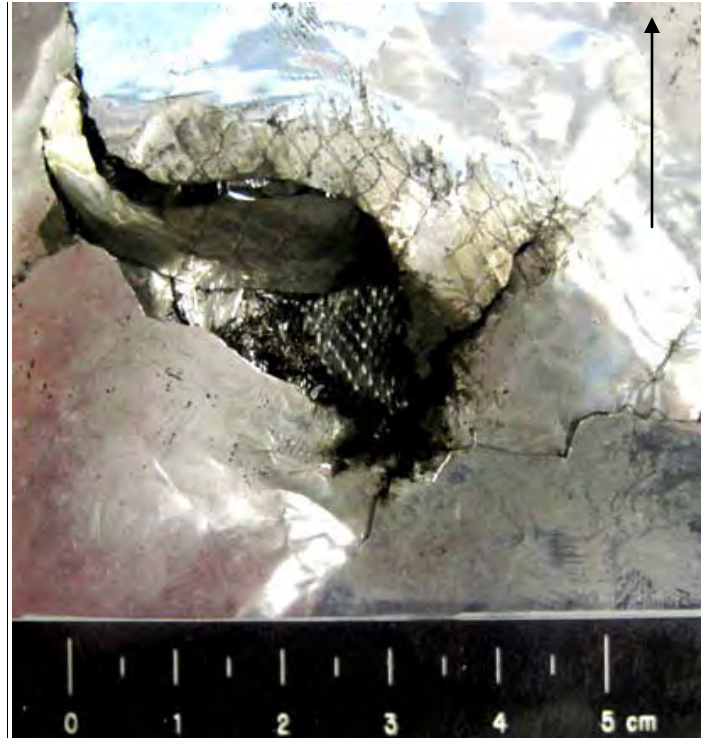
Figure 72 Close-up View of Damage to Back Side of MLI (scale in 5mm increments / black arrow indicates flight path of projectile)

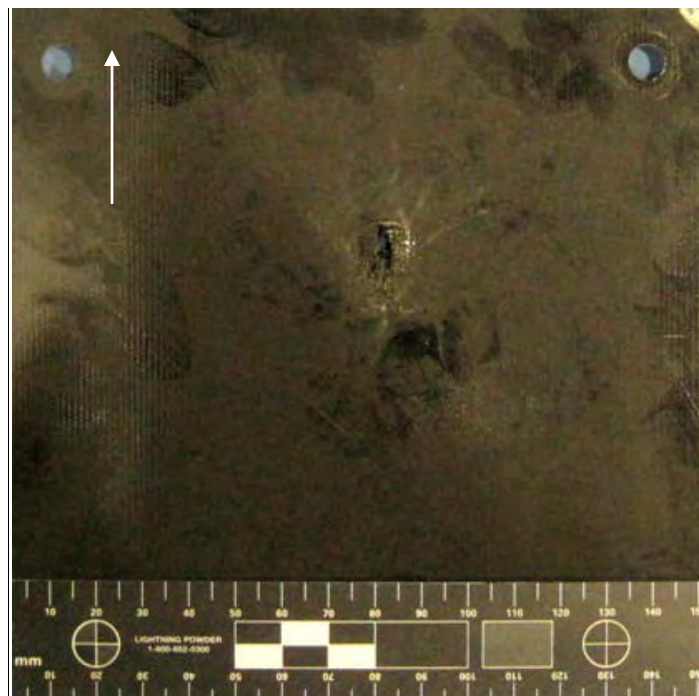
Figure 73 Overall View of Damage to Front of NP 504 Substrate (scale in 5mm increments / white arrow indicates flight path of projectile)

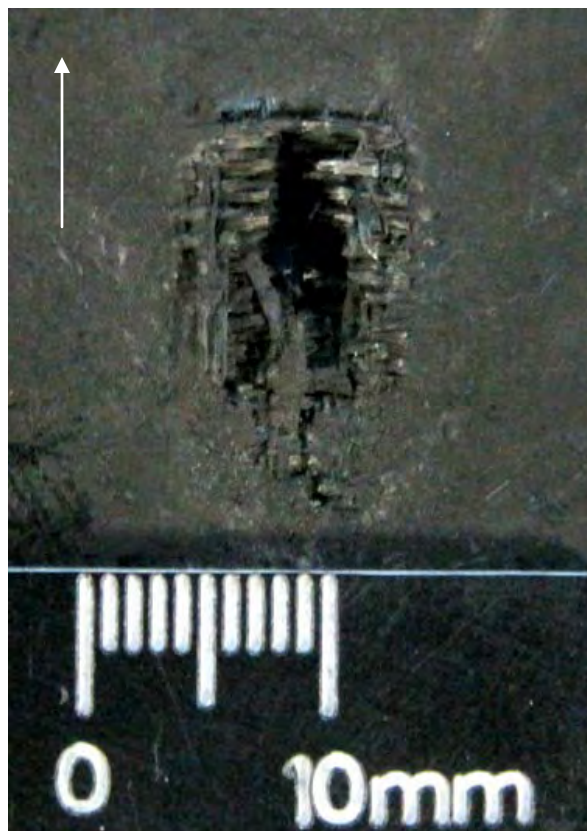
Figure 74 Close-up View of Damage to Front of NP 504 Substrate (scale in 1mm increments / white arrow indicates flight path of projectile)

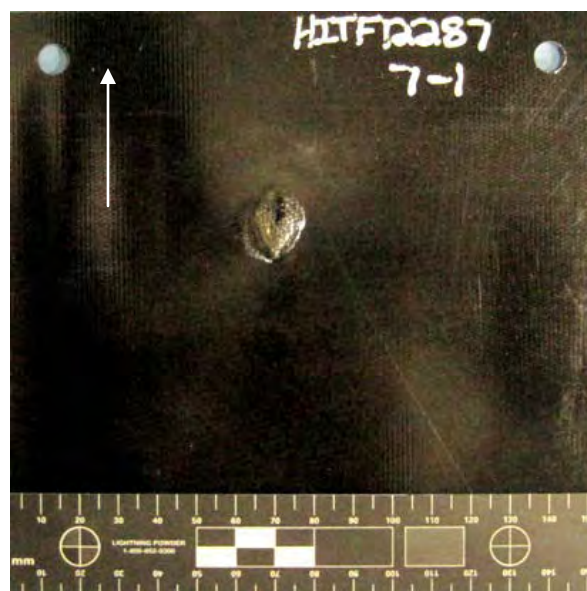
Figure 75 Overall View of Damage to Back Side of NP 504 Substrate (scale in 5mm increments / white arrow indicates flight path of projectile)

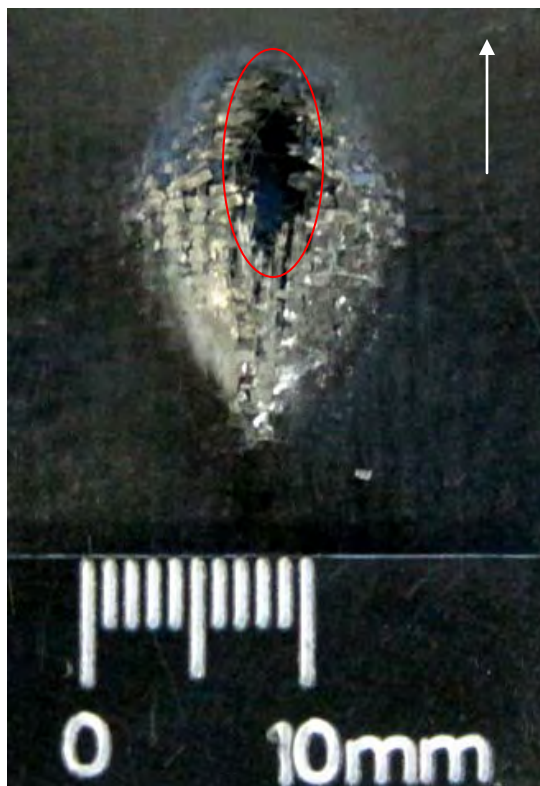
Figure 76 Close-up View of Damage to Back Side of NP 504 Substrate (scale in 1mm increments / white arrow indicates flight path of projectile)

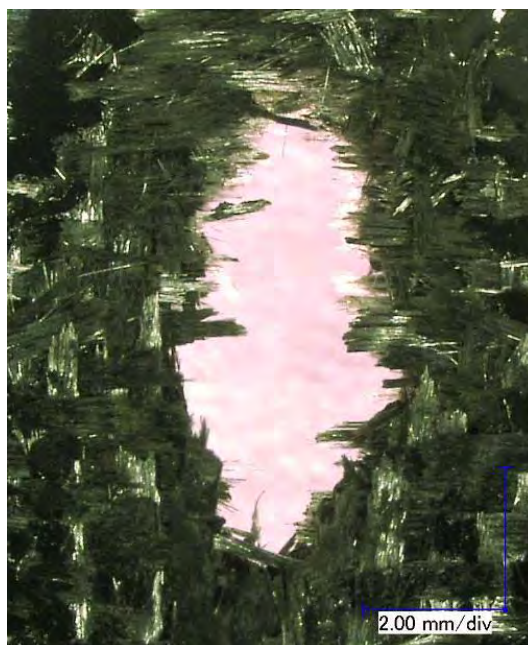
Figure 77 Close-up View of Most Significant Damage to Back Side of NP 504 Substrate (black arrow indicates flight path of projectile / damage within red circle in Figure 76)

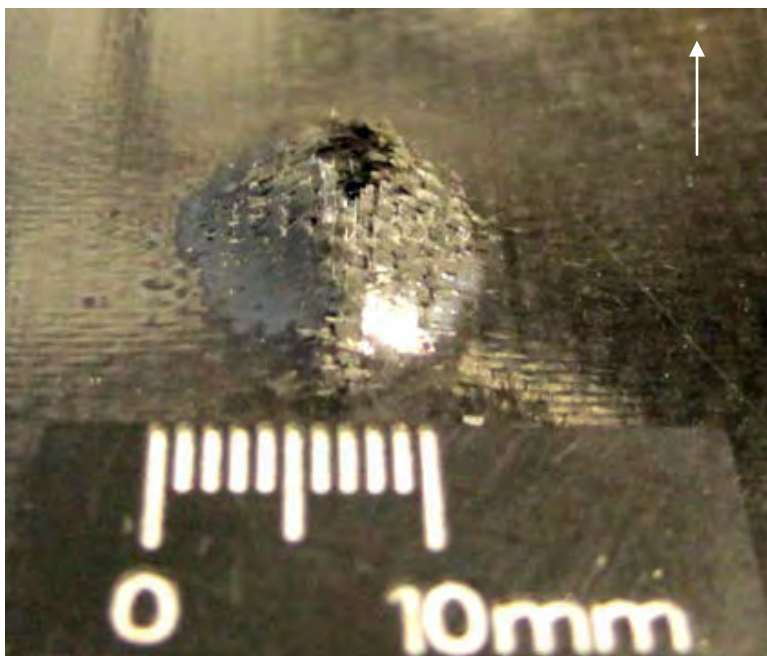
Figure 78 Close-up Oblique Side View of Damage to Back Side of NP 504 Substrate (scale in 1mm increments / white arrow indicates flight path of projectile)

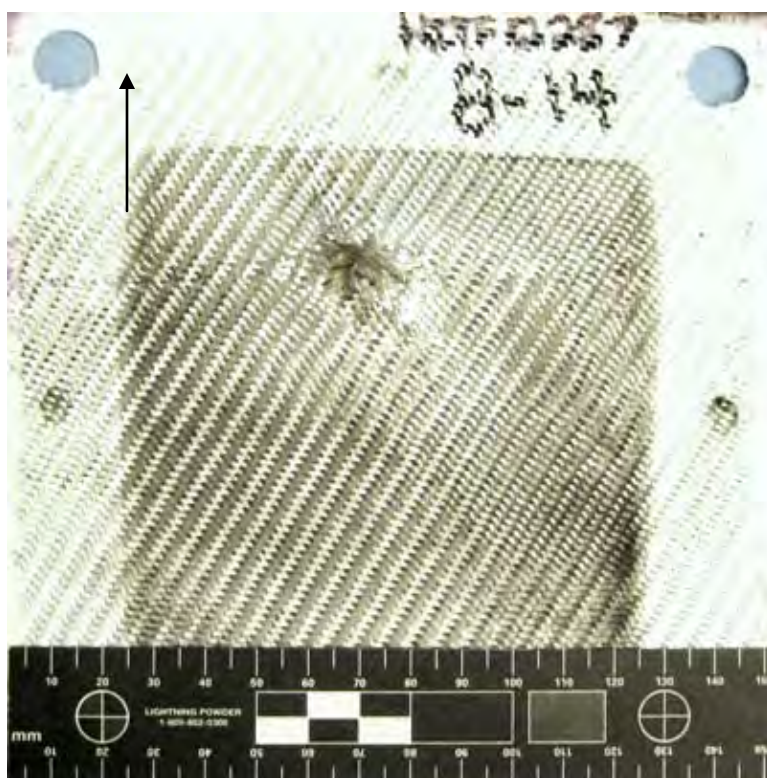
Figure 79 Overall View of Damage to Back Side of Last Fiberglass Layer (scale in 5mm increments / black arrow indicates flight path of projectile)

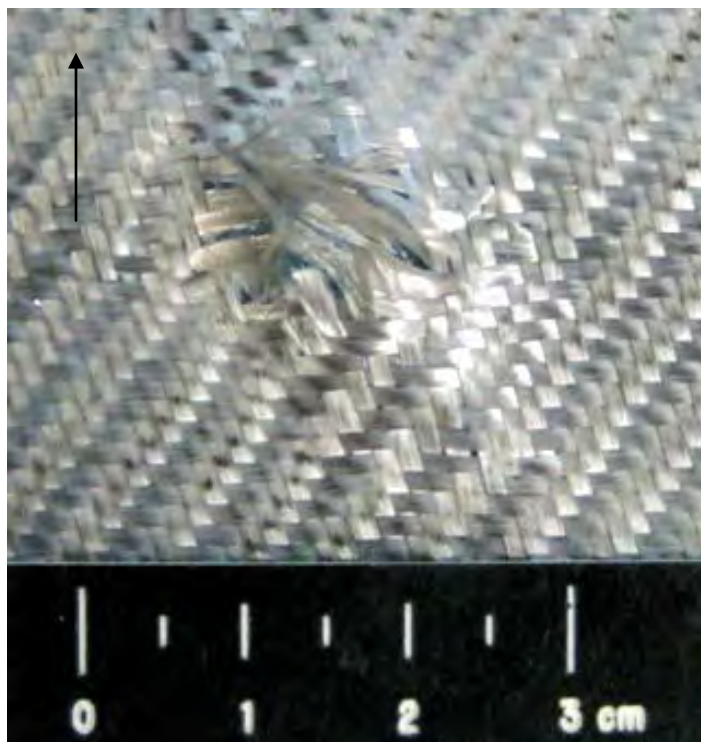
Figure 80 Close-up View of Damage to Back Side of Last Fiberglass Layer (scale in 5mm increments / black arrow indicates flight path of projectile)

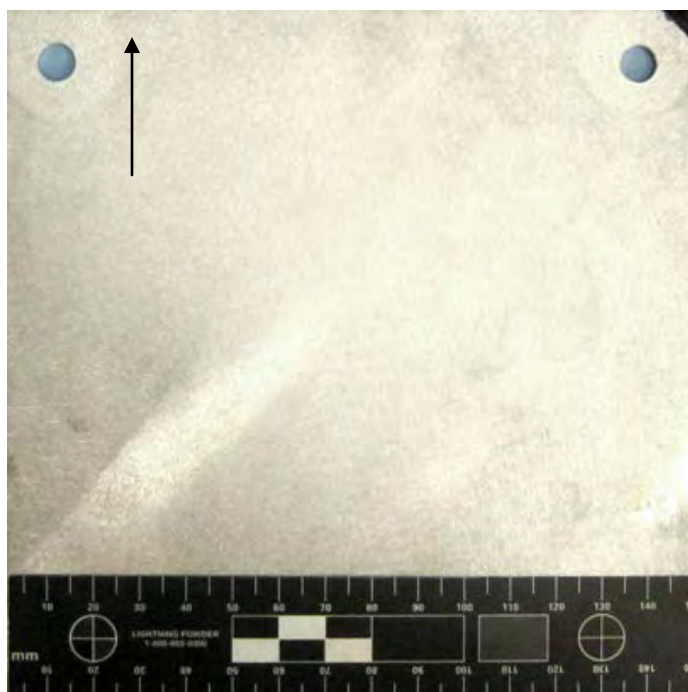
Figure 81 Overall View of Damage to Front of Rear Wall (scale in 5mm increments / black arrow indicates flight path of projectile)

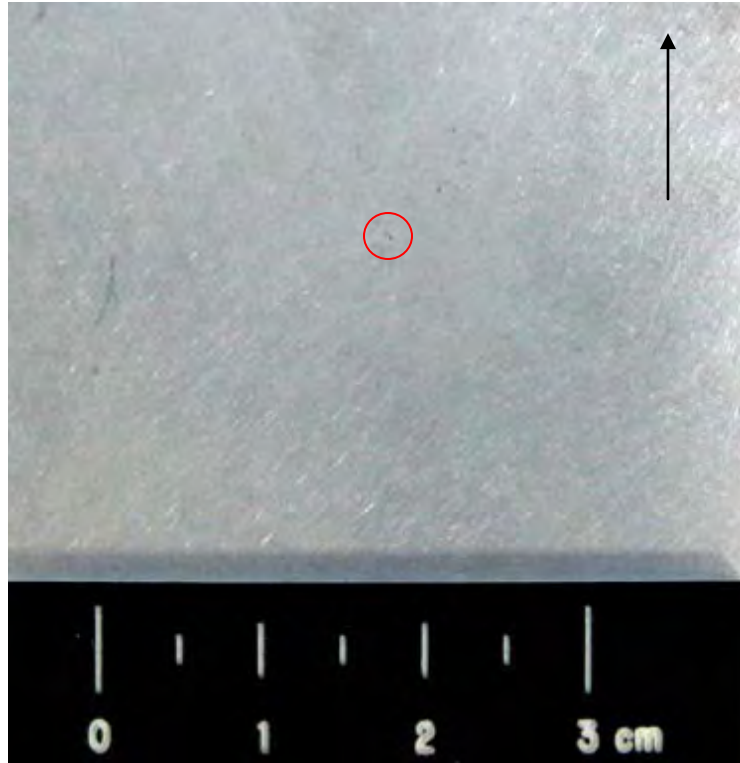
Figure 82 Close-up View of Damage to Front of Rear Wall (scale in 5mm increments / black arrow indicates flight path of projectile)

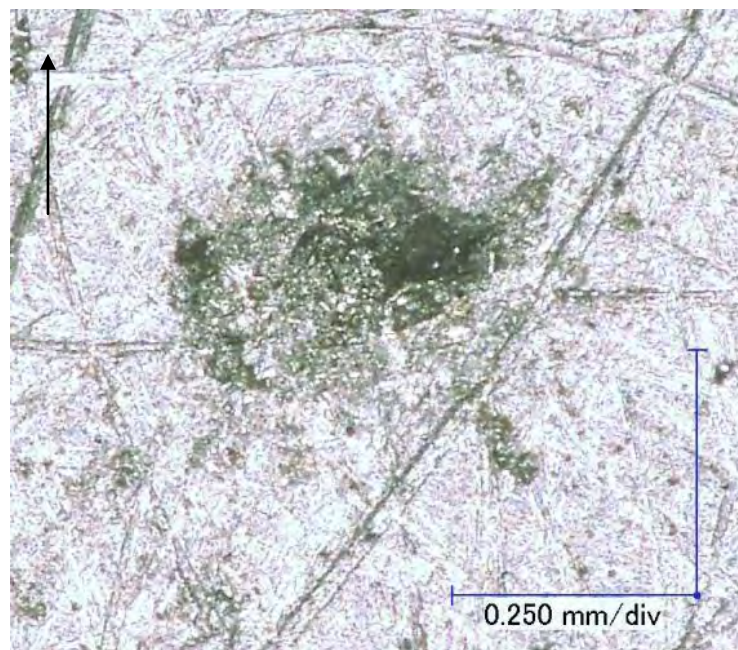
Figure 83 Close-up View of Most Significant Damage to Front of Rear Wall (black arrow indicates flight path of projectile / damage within red circle in Figure 82)

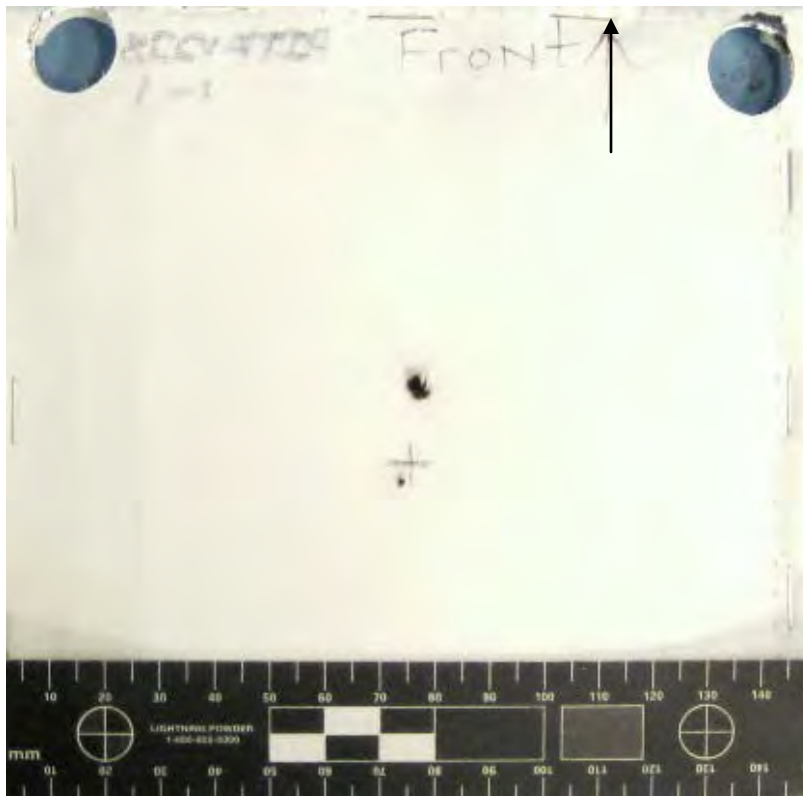
Figure 88 Overall View of Damage to Front of MLI (scale in 5mm increments / black arrow indicates flight path of projectile)

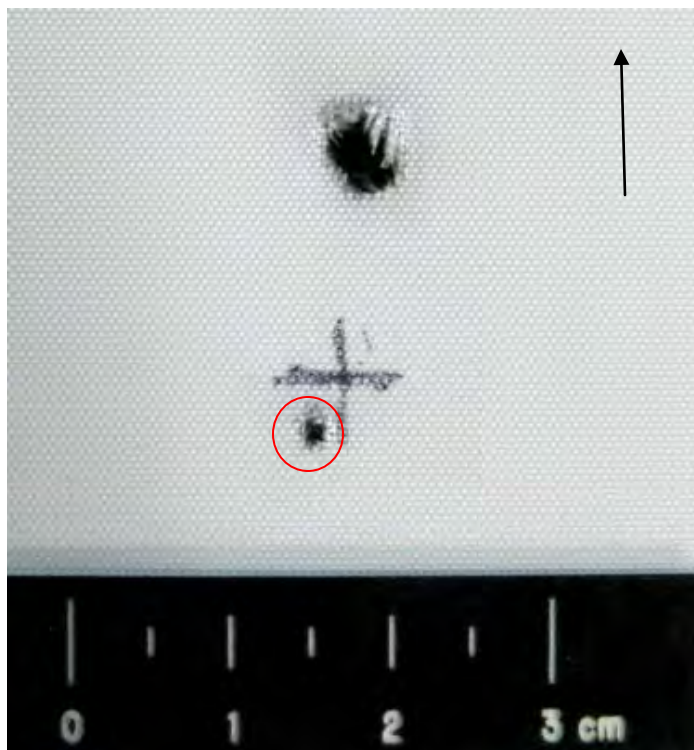
Figure 89 Close-up View of Damage to Front of MLI (scale in 5mm increments / black arrow indicates flight path of projectile / projectile impacted within red circle)

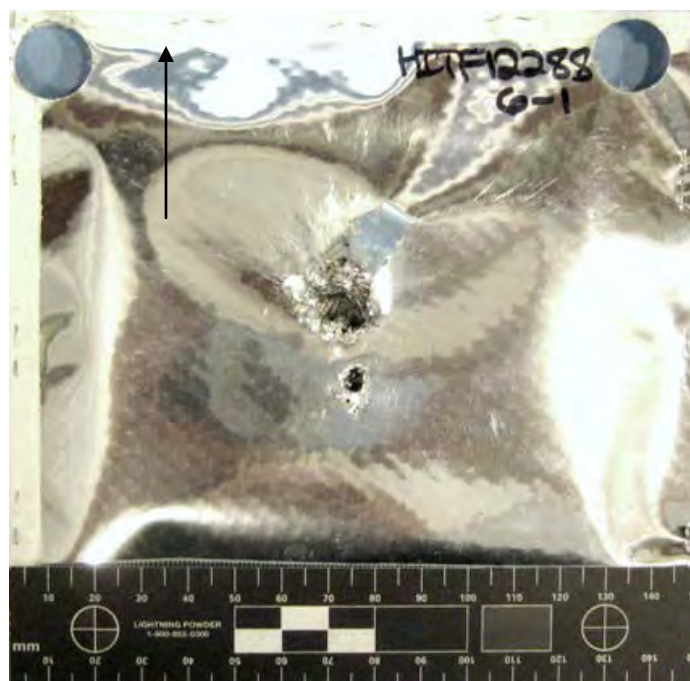
Figure 90 Overall View of Damage to Back Side of MLI (scale in 5mm increments / black arrow indicates flight path of projectile)

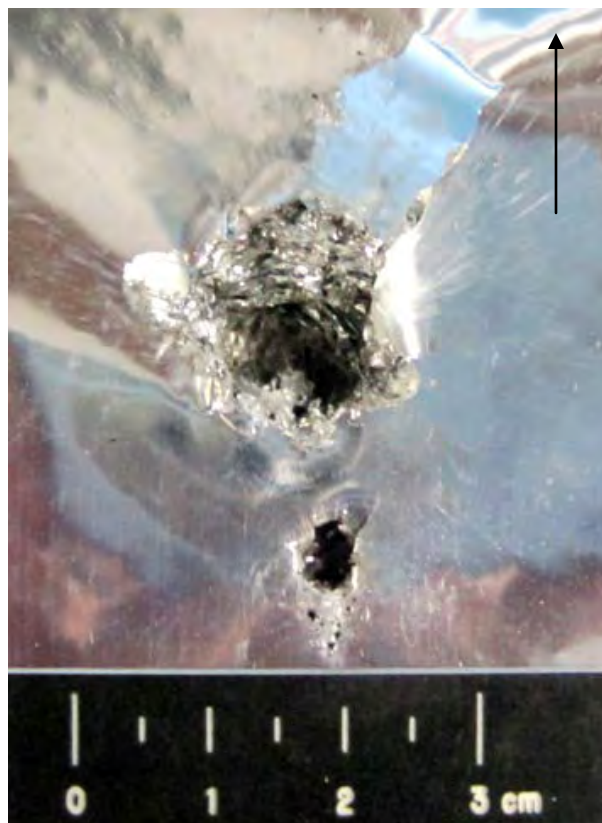
Figure 91 Close-up View of Damage to Back Side of MLI (scale in 5mm increments / black arrow indicates flight path of projectile)

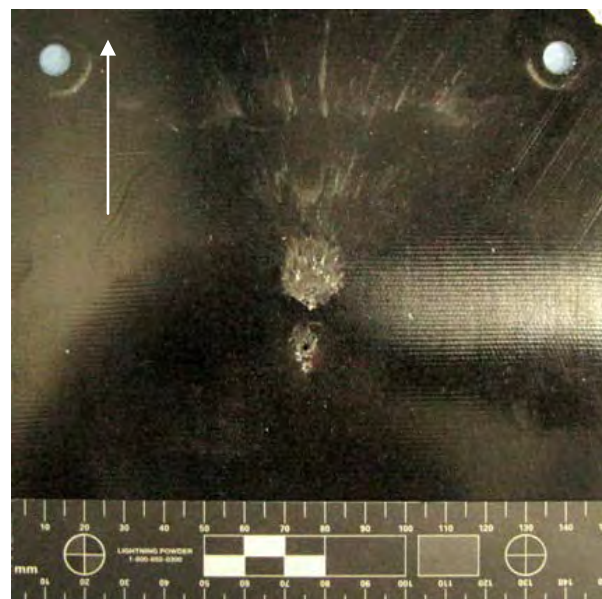
Figure 92 Overall View of Damage to Front of NP 504 Substrate (scale in 5mm increments / white arrow indicates flight path of projectile)

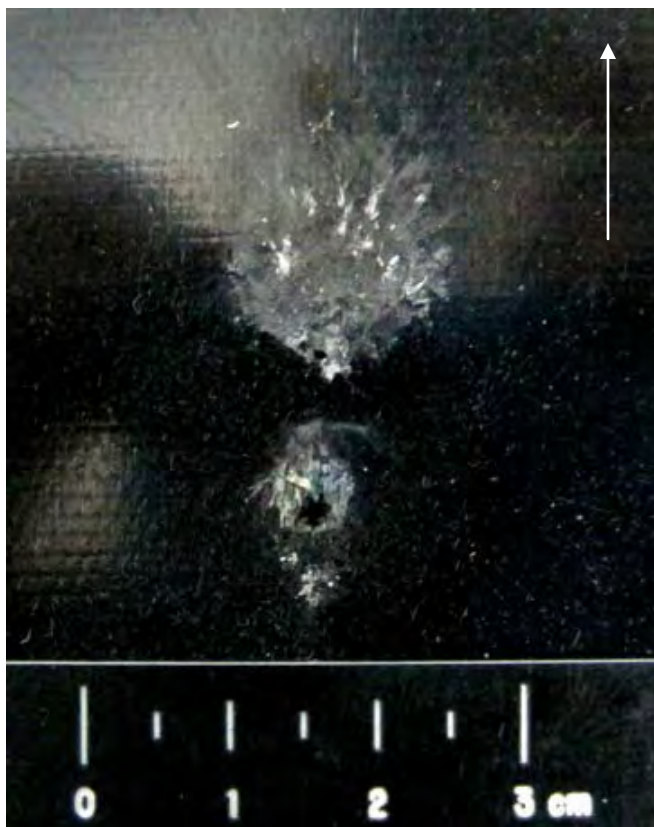
Figure 93 Close-up View of Damage to Front of NP 504 Substrate (scale in 5mm increments / white arrow indicates flight path of projectile)

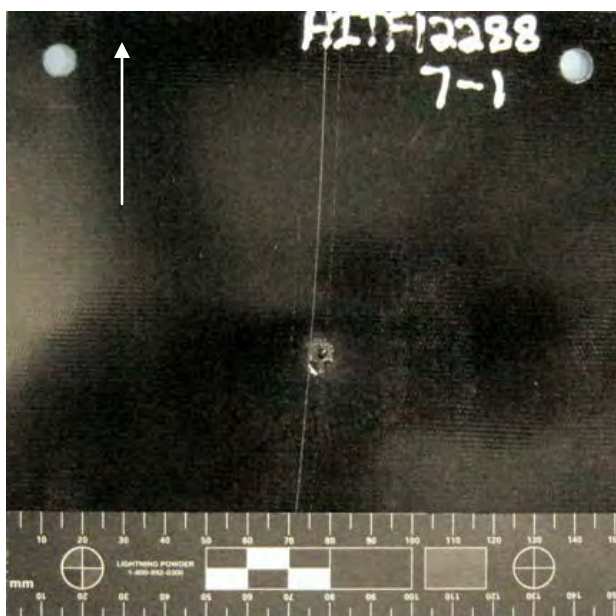
Figure 94 Overall View of Damage to Back Side of NP 504 Substrate (scale in 5mm increments / white arrow indicates flight path of projectile)

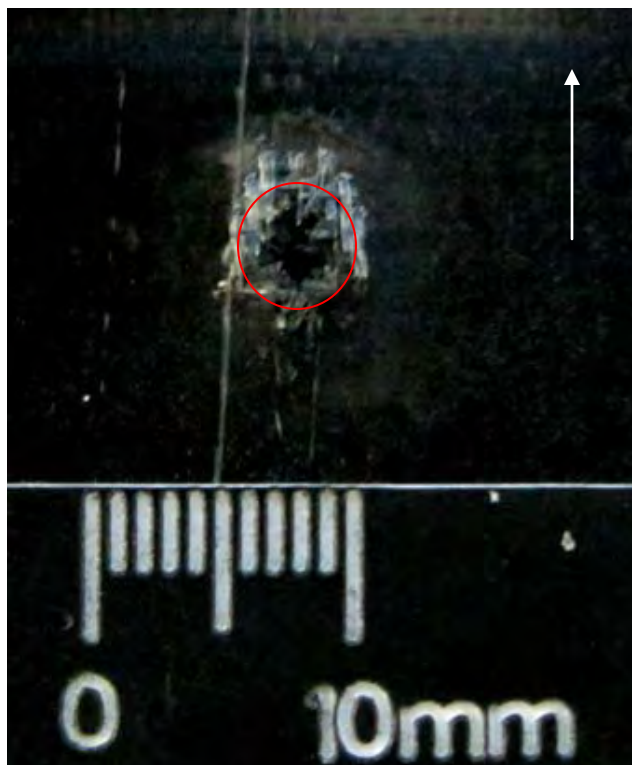
Figure 95 Close-up View of Damage to Back Side of NP 504 Substrate (scale in 1mm increments / white arrow indicates flight path of projectile)

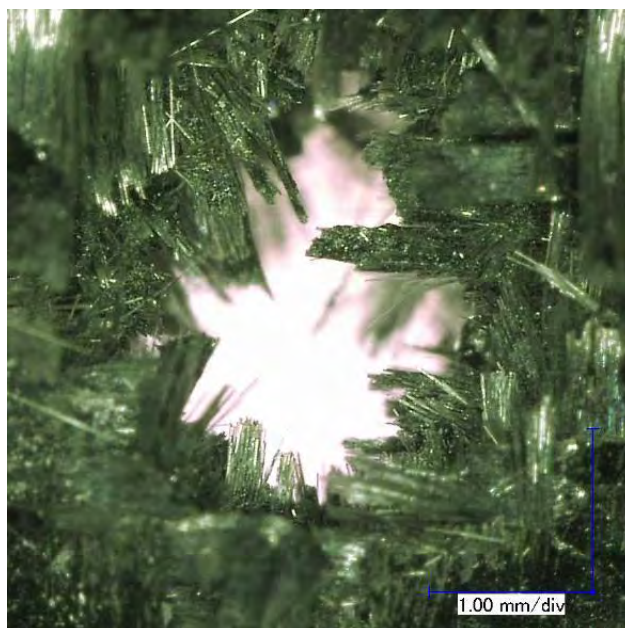
Figure 96 Close-up View of Most Significant Damage to Back Side of NP 504 Substrate (black arrow indicates flight path of projectile / damage within red circle in Figure 95)

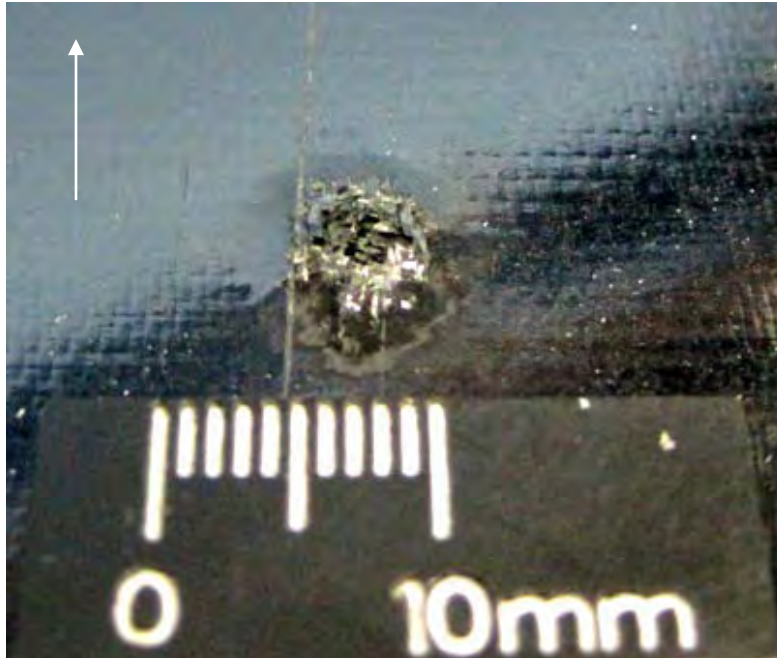
Figure 97 Close-up Oblique Side View of Damage to Back Side of NP 504 Substrate (scale in 1mm increments / white arrow indicates flight path of projectile)

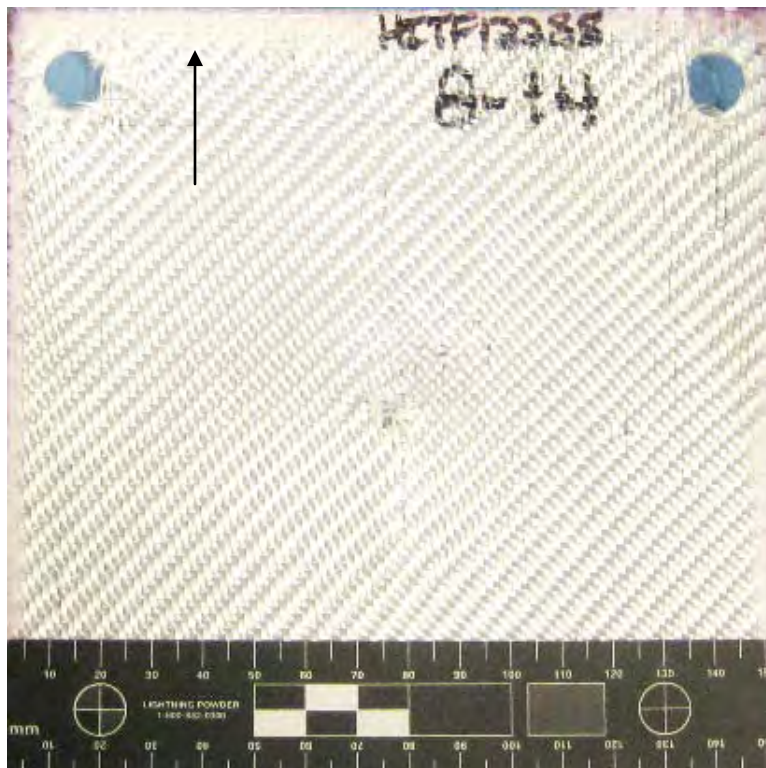
Figure 98 Overall View of Damage to Back Side of Last Fiberglass Layer (scale in 5mm increments / black arrow indicates flight path of projectile)

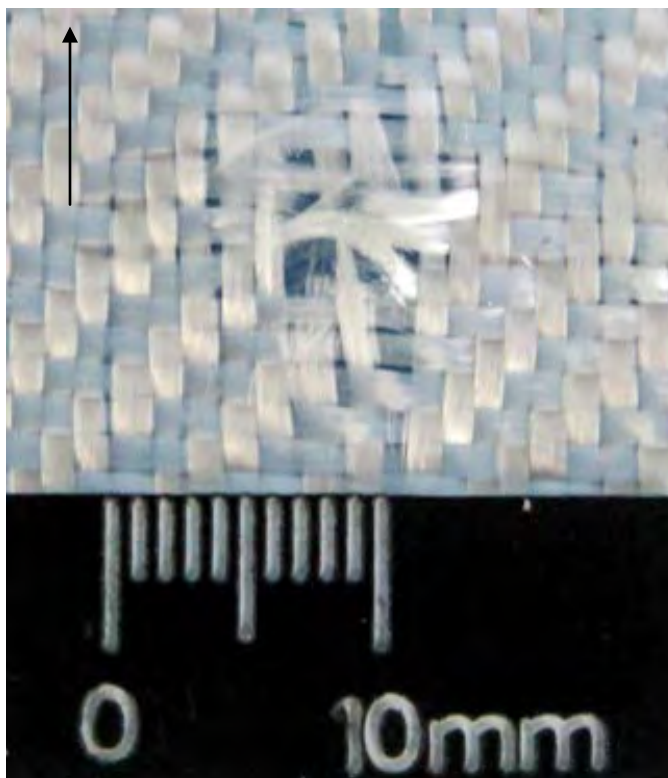
Figure 99 Overall View of Damage to Back Side of Last Fiberglass Layer (scale in 1mm increments / black arrow indicates flight path of projectile)

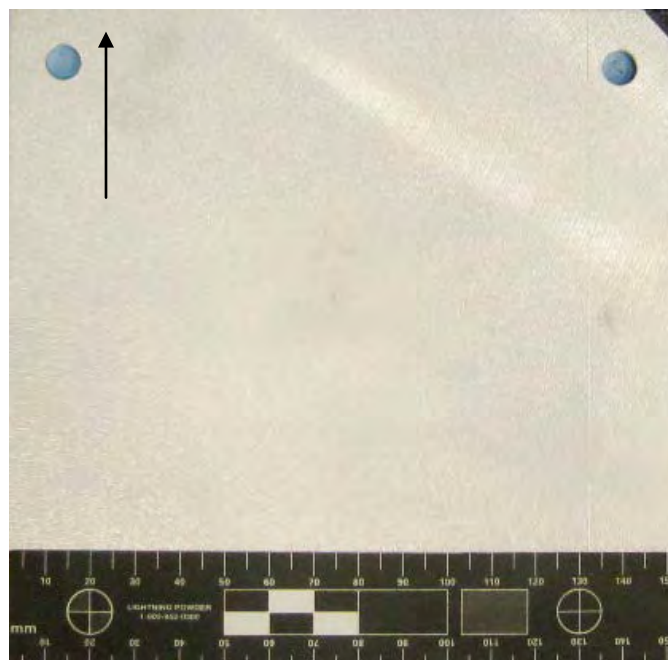
Figure 100 Overall View of Damage to Front of Rear Wall (scale in 5mm increments / black arrow indicates flight path of projectile)

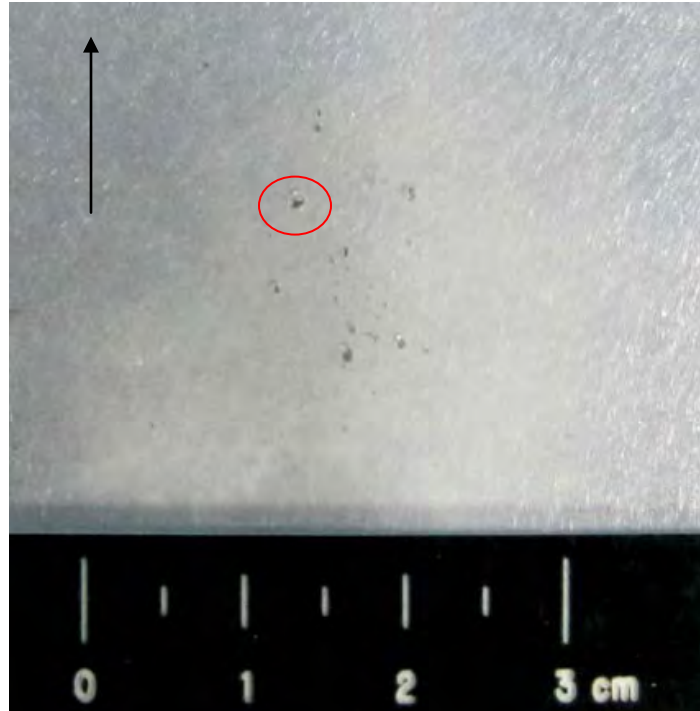
Figure 101 Close-up View of Damage to Front of Rear Wall (scale in 5mm increments / black arrow indicates flight path of projectile)

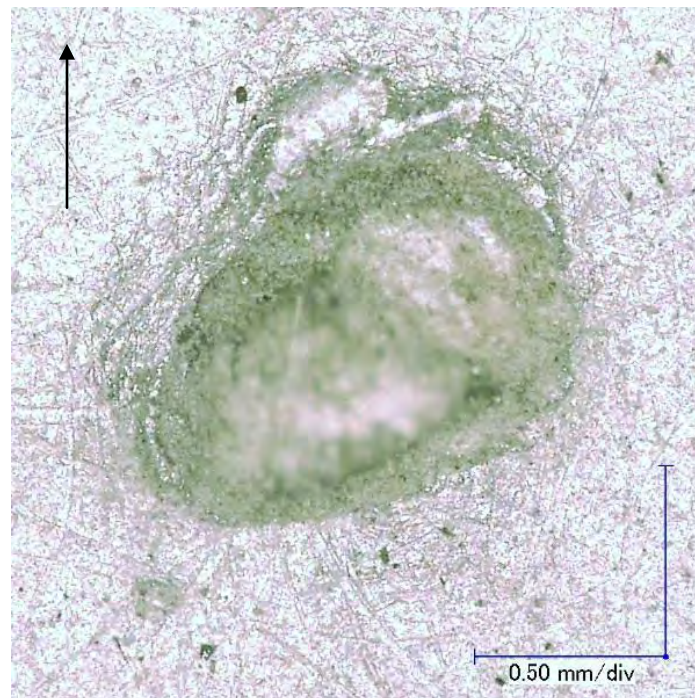
Figure 102 Close-up View of Most Significant Damage to Front of Rear Wall (black arrow indicates flight path of projectile / damage within red circle in Figure 101)

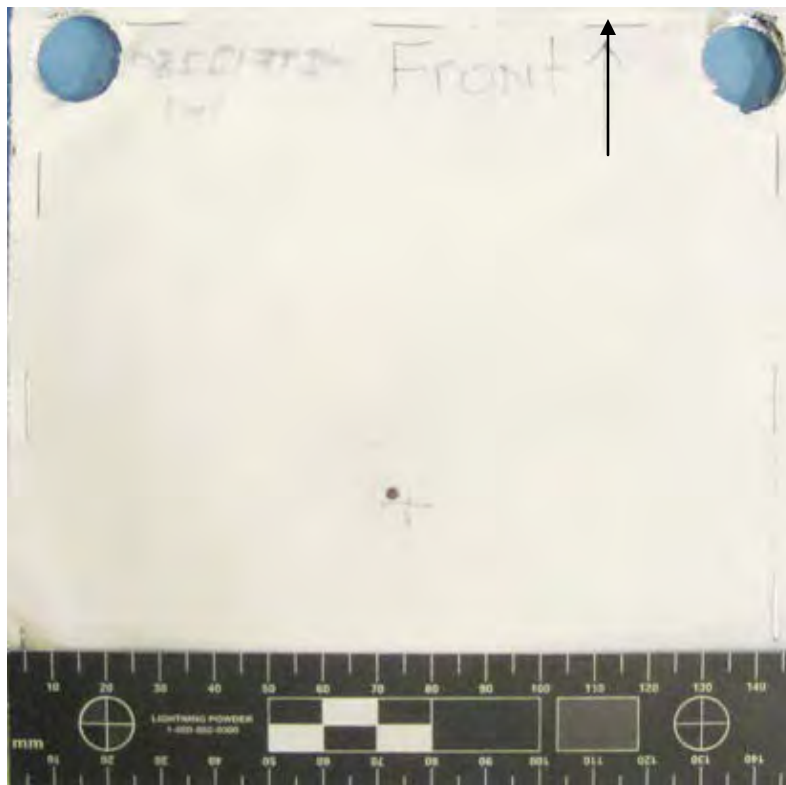
Figure 107 Overall View of Damage to Front of MLI (scale in 5mm increments / black arrow indicates flight path of projectile)

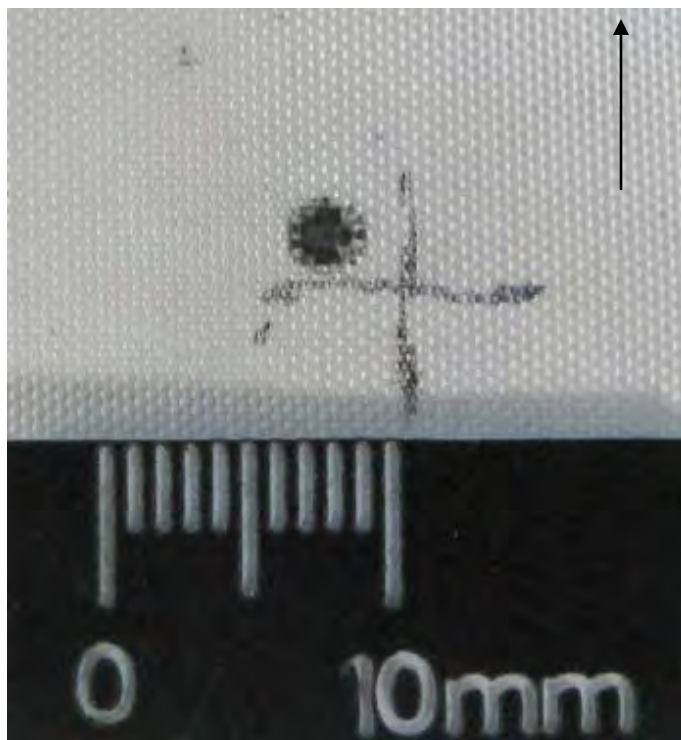
Figure 108 Close-up View of Damage to Front of MLI (scale in 1mm increments / black arrow indicates flight path of projectile)

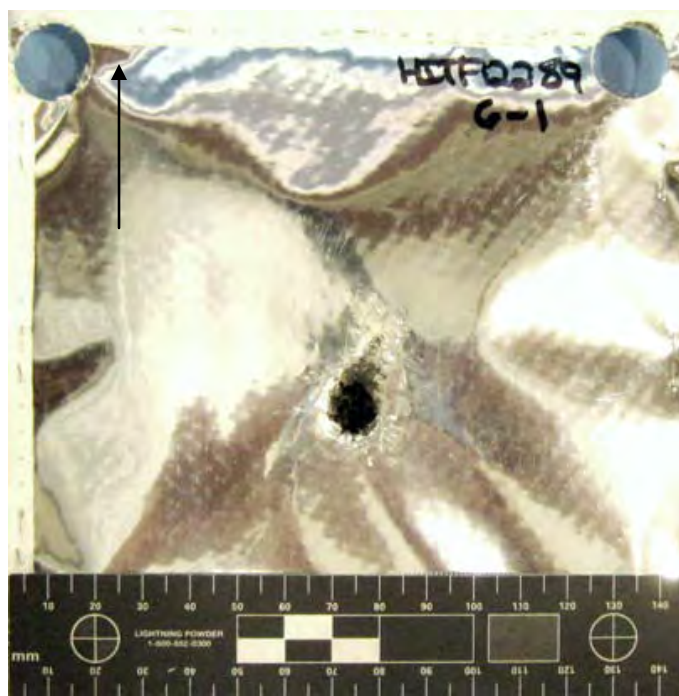
Figure 109 Overall View of Damage to Back Side of MLI (scale in 5mm increments / black arrow indicates flight path of projectile)

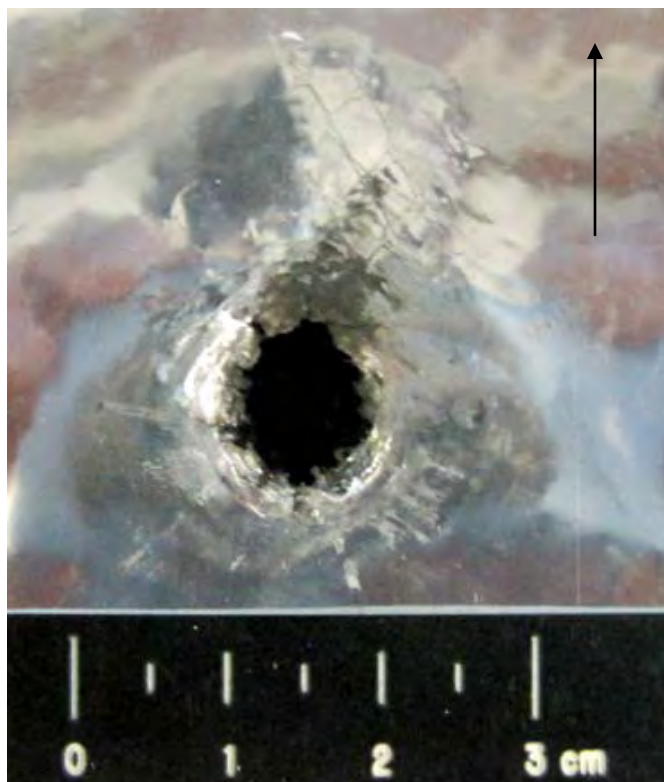
Figure 110 Close-up View of Damage to Back Side of MLI (scale in 5mm increments / black arrow indicates flight path of projectile)

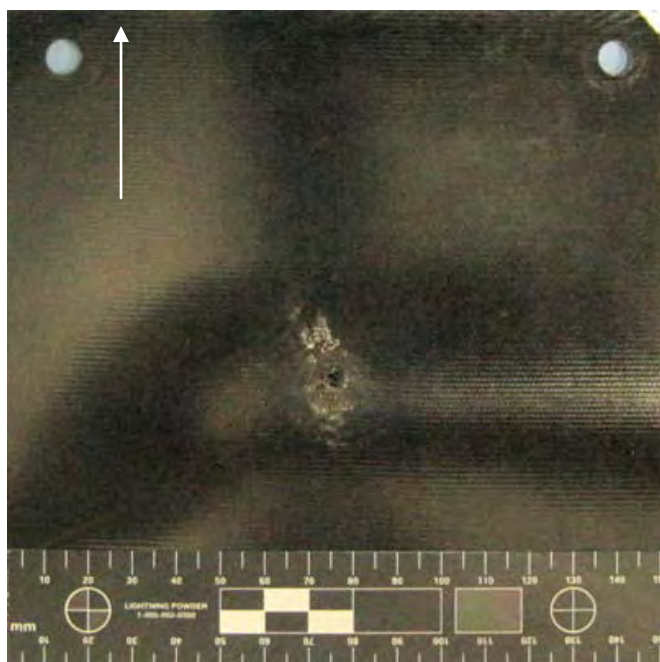
Figure 111 Overall View of Damage to Front of NP 504 Substrate (scale in 5mm increments / white arrow indicates flight path of projectile)
