International Space Station (ISS) Soyuz Vehicle Descent Module Evaluation of Thermal Protection System (TPS) Penetration Characteristics

Hypervelocity Impact Technology Group

February 2013

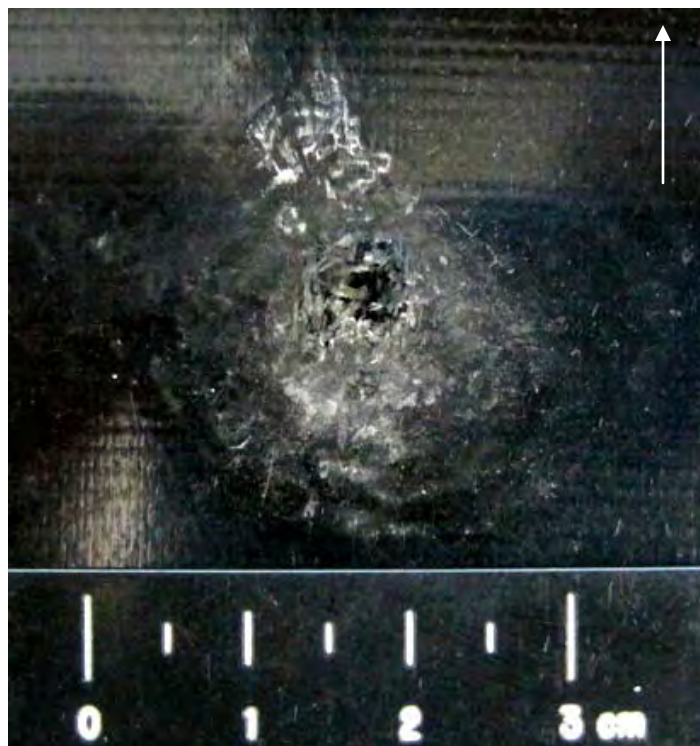
Figure 112 Close-up View of Damage to Front of NP 504 Substrate (scale in 5mm increments / white arrow indicates flight path of projectile)

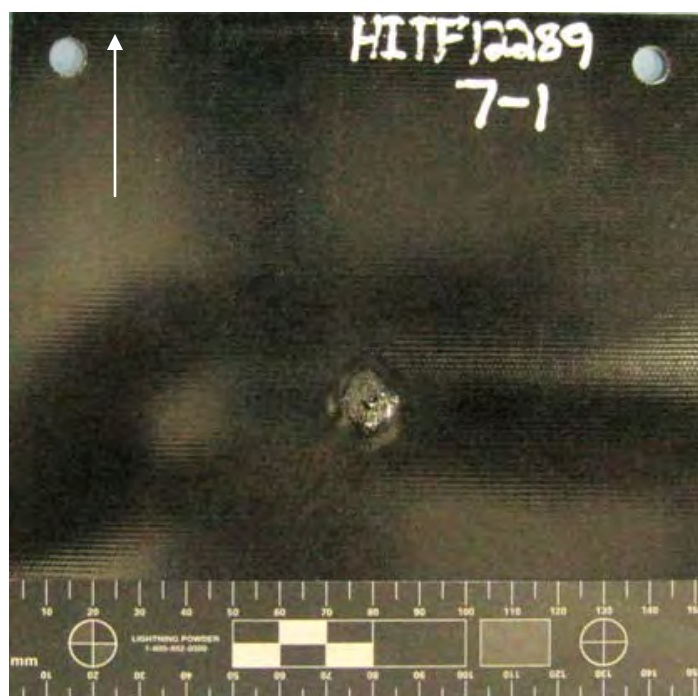
Figure 113 Overall View of Damage to Back Side of NP 504 Substrate (scale in 5mm increments / white arrow indicates flight path of projectile)

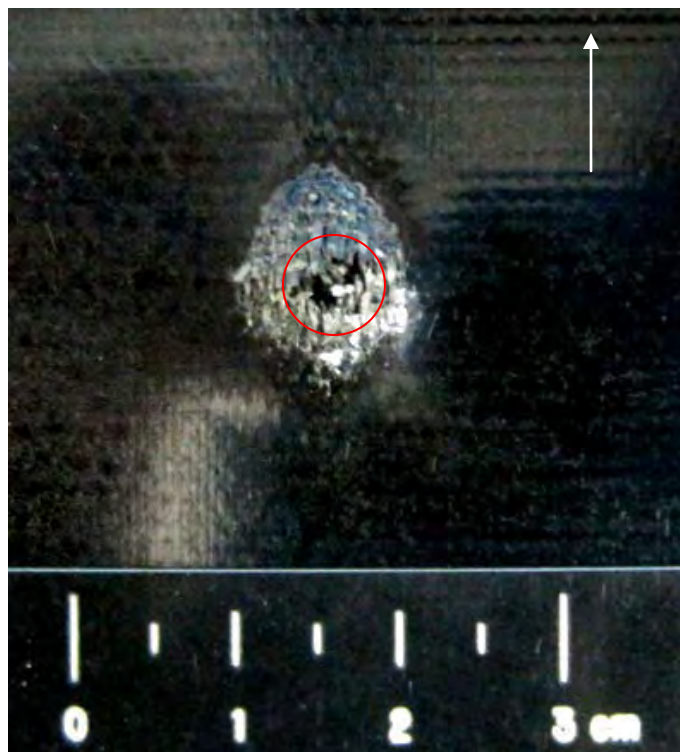
Figure 114 Close-up View of Damage to Back Side of NP 504 Substrate (scale in 5mm increments / white arrow indicates flight path of projectile)

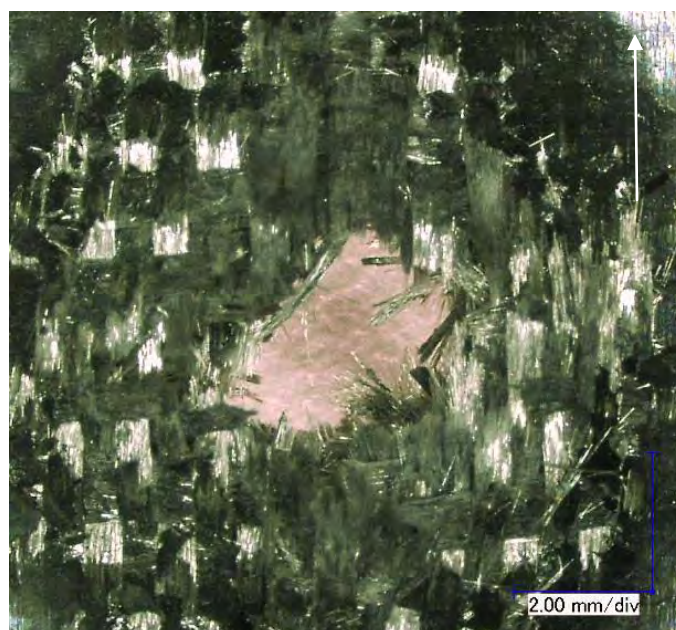
Figure 115 Close-up View of Most Significant Damage to Back Side of NP 504 Substrate (white arrow indicates flight path of projectile / damage within red circle in Figure 114)

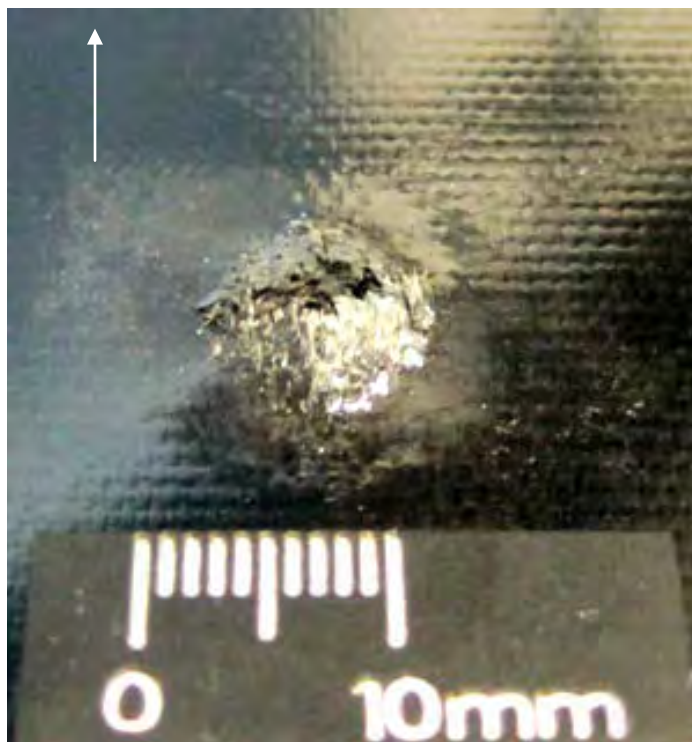
Figure 116 Close-up Oblique Side View of Damage to Back Side of NP 504 Substrate (scale in 1mm increments / white arrow indicates flight path of projectile)

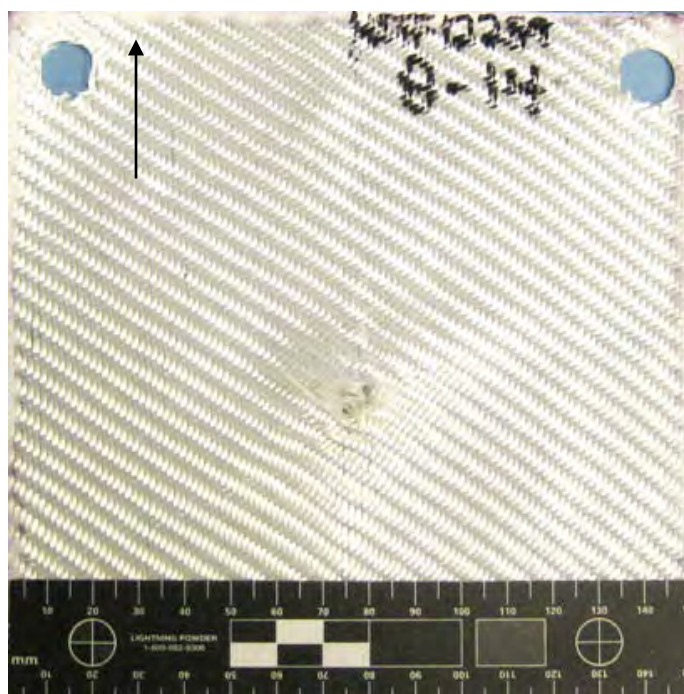
Figure 117 Overall View of Damage to Back Side of Last Fiberglass Layer (scale in 5mm increments / black arrow indicates flight path of projectile)

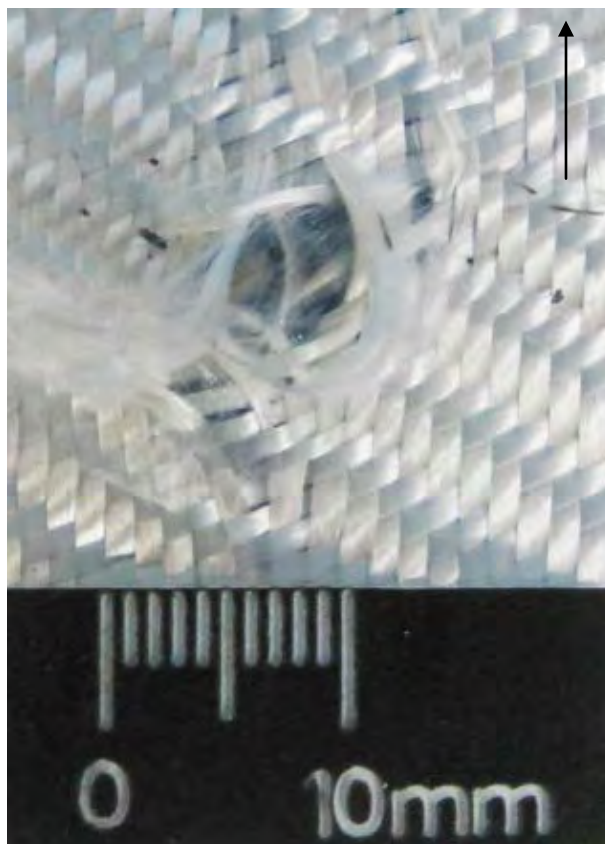
Figure 118 Overall View of Damage to Back Side of Last Fiberglass Layer (scale in 1mm increments / black arrow indicates flight path of projectile)

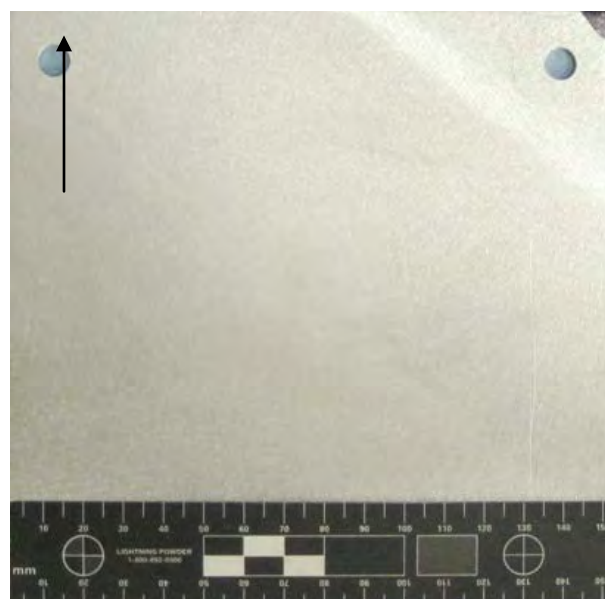
Figure 119 Overall View of Damage to Front of Rear Wall (scale in 5mm increments / black arrow indicates flight path of projectile)

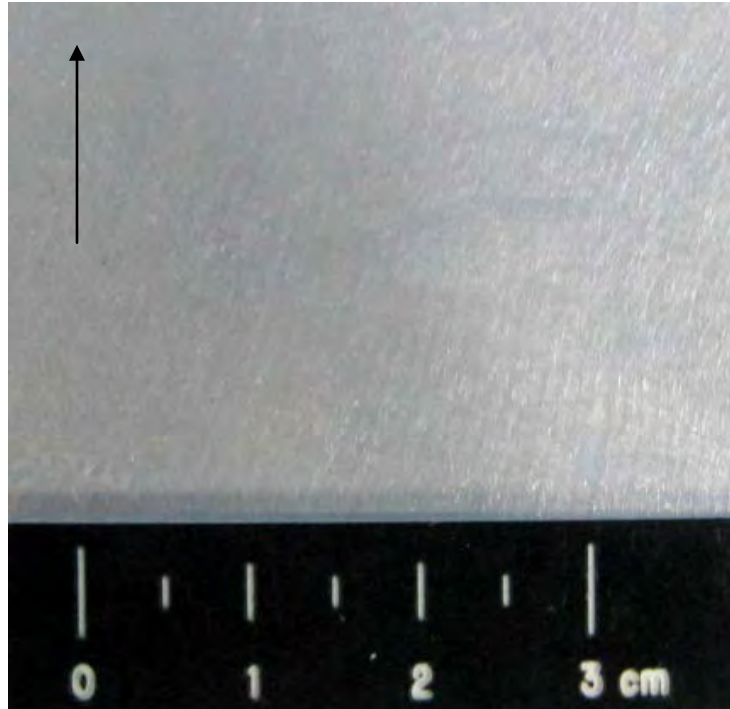
Figure 120 Close-up View of Damage to Front of Rear Wall (scale in 5mm increments / black arrow indicates flight path of projectile)

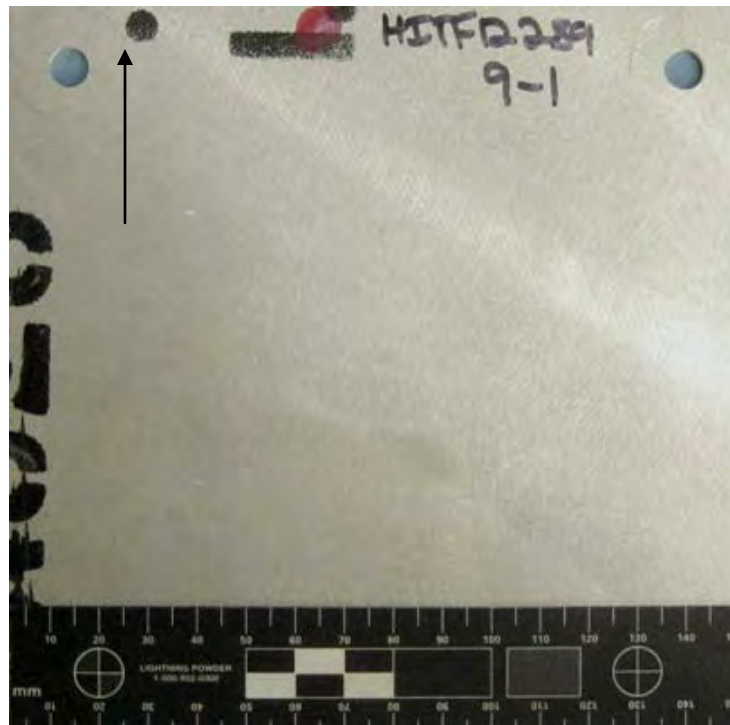
Figure 121 Overall View of Damage to Front of Rear Wall (scale in 5mm increments / black arrow indicates flight path of projectile)

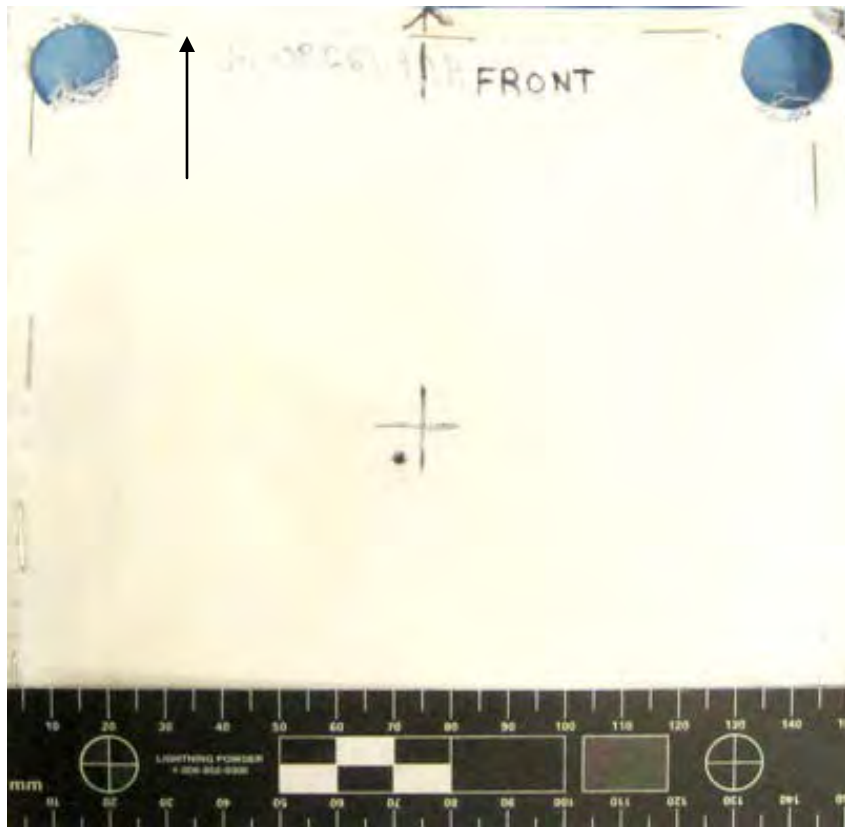
**Figure 125** Overall View of Damage to Front of MLI (scale in 5mm increments / black arrow indicates flight path of projectile)

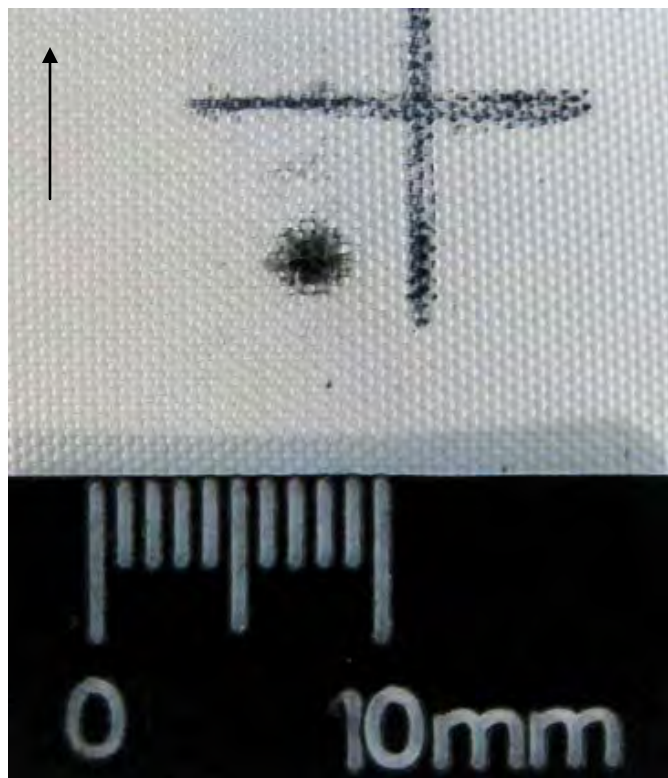
Figure 126 Close-up View of Damage to Front of MLI (scale in 1mm increments / black arrow indicates flight path of projectile)

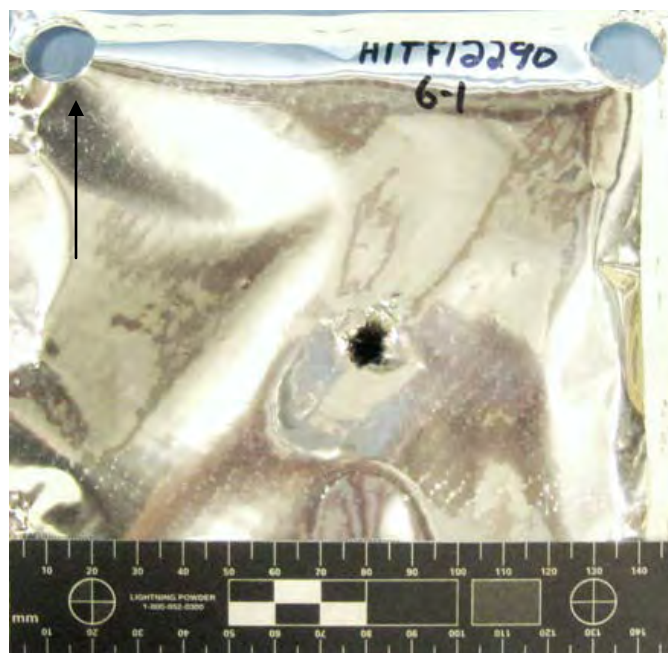
Figure 127 Overall View of Damage to Back Side of MLI (scale in 5mm increments / black arrow indicates flight path of projectile)

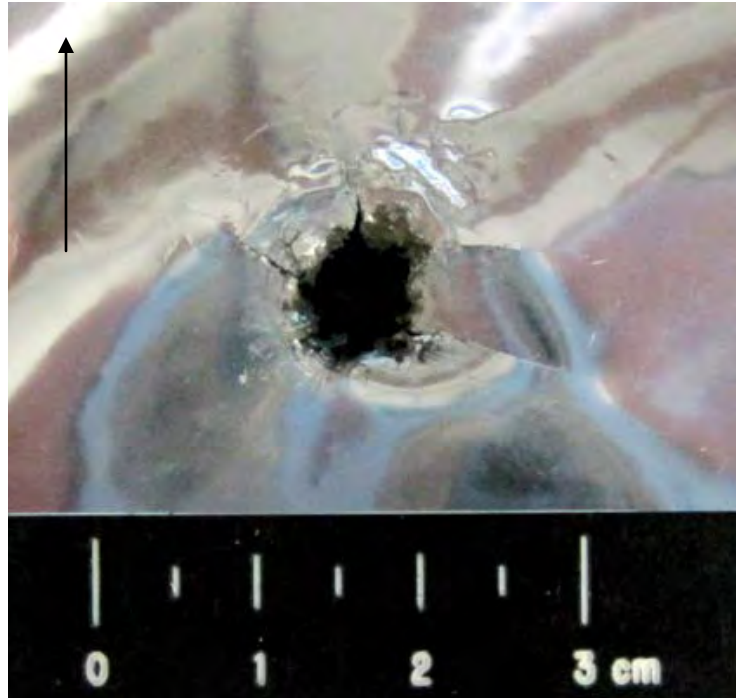
Figure 128 Close-up View of Damage to Back Side of MLI (scale in 5mm increments / black arrow indicates flight path of projectile)

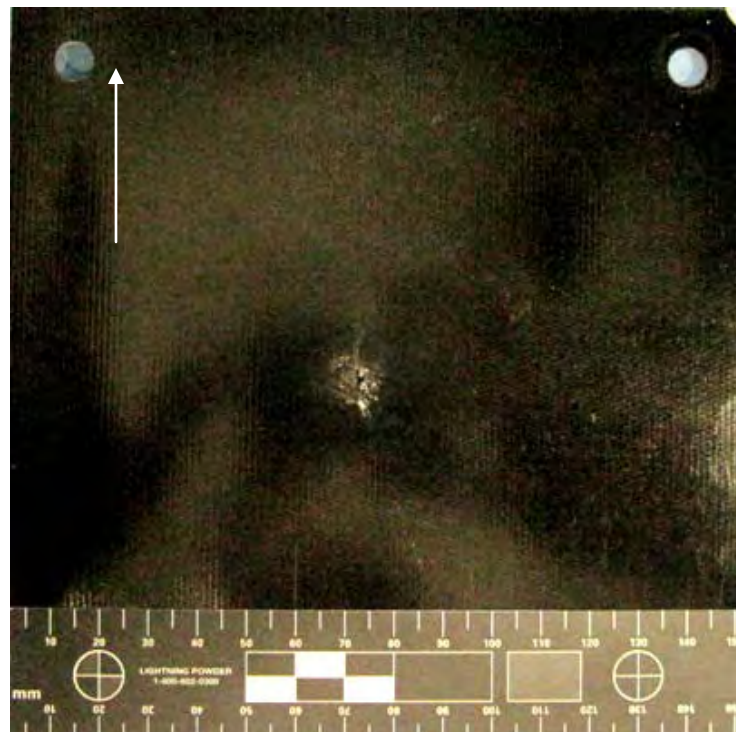
Figure 129 Overall View of Damage to Front of NP 504 Substrate (scale in 5mm increments / white arrow indicates flight path of projectile)

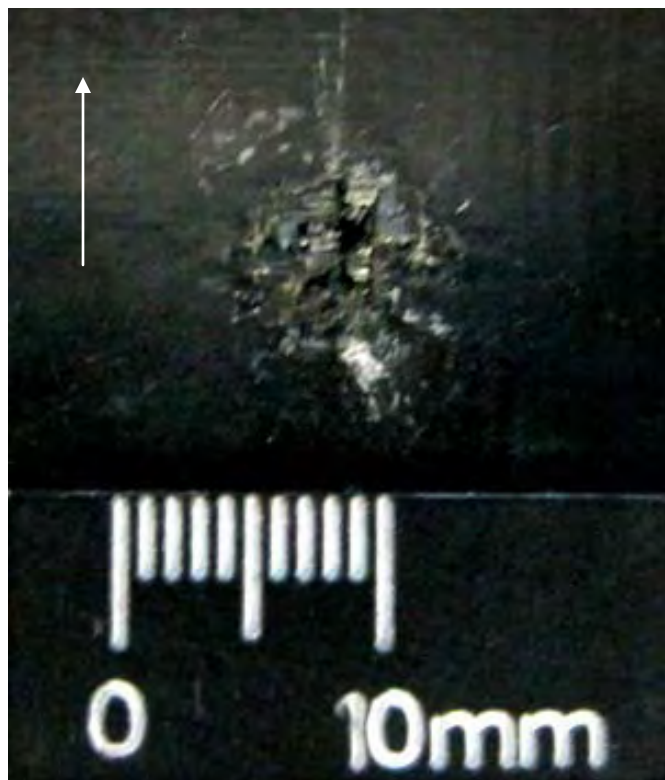
Figure 130 Close-up View of Damage to Front of NP 504 Substrate (scale in 1mm increments / white arrow indicates flight path of projectile)

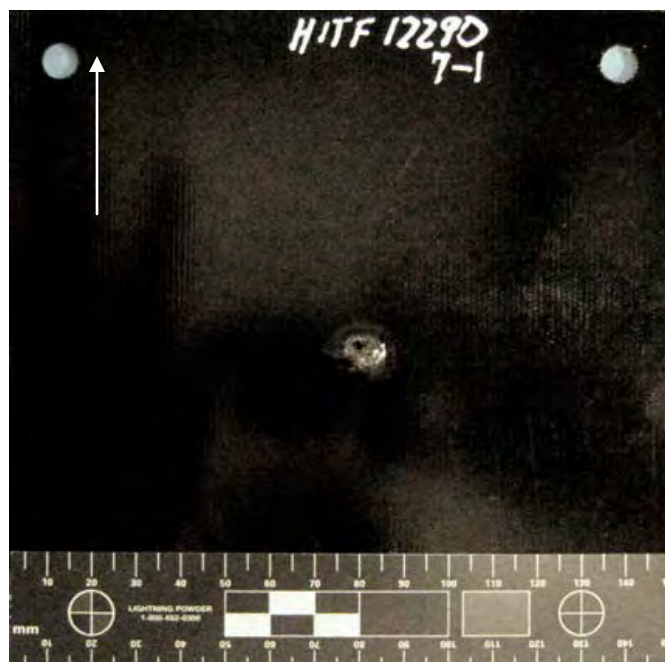
Figure 131 Overall View of Damage to Back Side of NP 504 Substrate (scale in 5mm increments / white arrow indicates flight path of projectile)

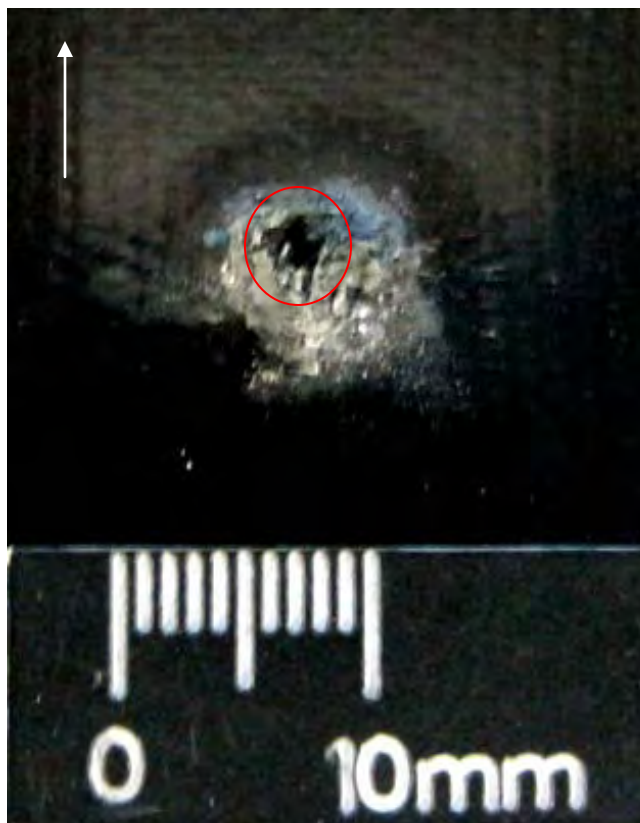
Figure 132 Close-up View of Damage to Back Side of NP 504 Substrate (scale in 1mm increments / white arrow indicates flight path of projectile)

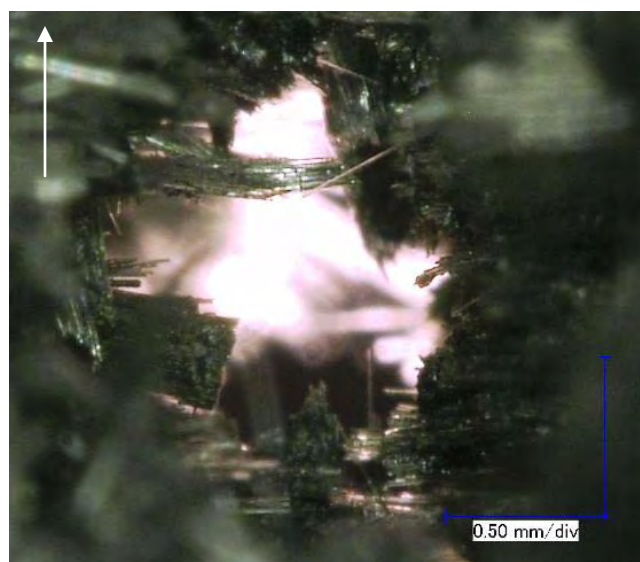
Figure 133 Close-up View of Most Significant Damage to Back Side of NP 504 Substrate (white arrow indicates flight path of projectile / damage within red circle in Figure 132)

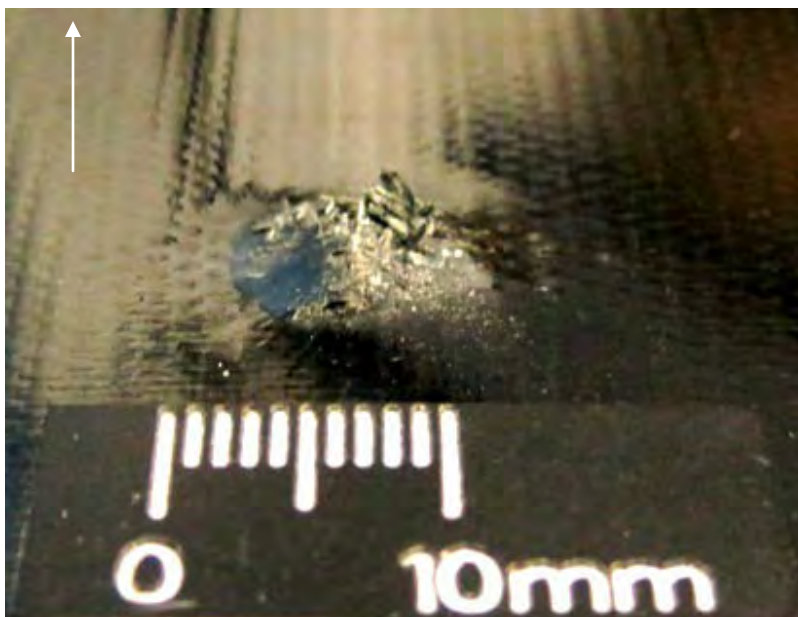
Figure 134 Close-up Oblique Side View of Damage to Back Side of NP 504 Substrate (scale in 1mm increments / white arrow indicates flight path of projectile)

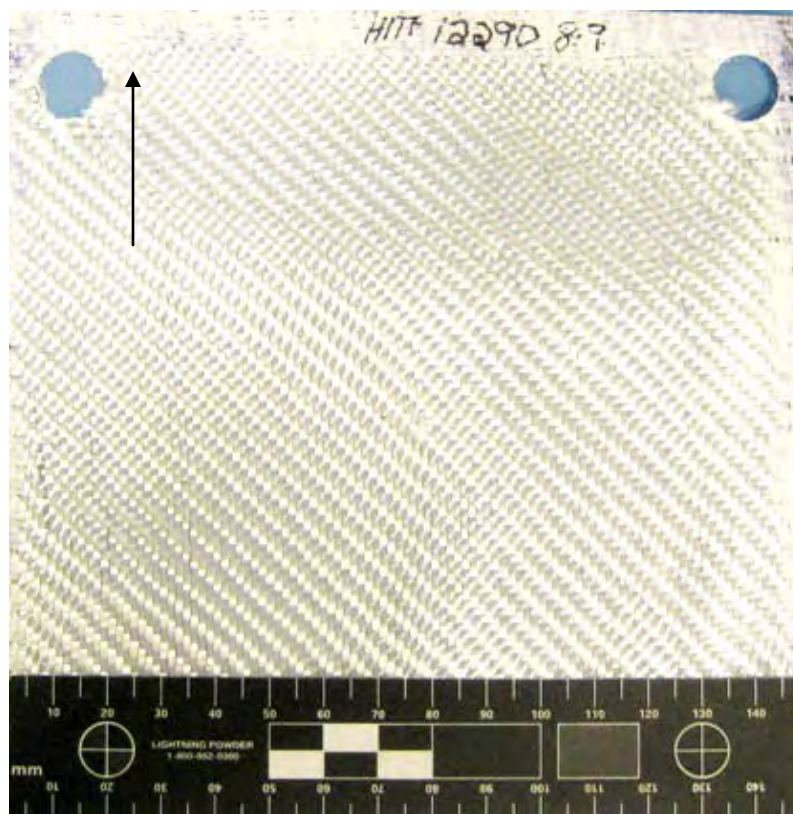
Figure 135 Overall View of Damage to Back Side of 7th Fiberglass Layer (scale in 5mm increments / black arrow indicates flight path of projectile)

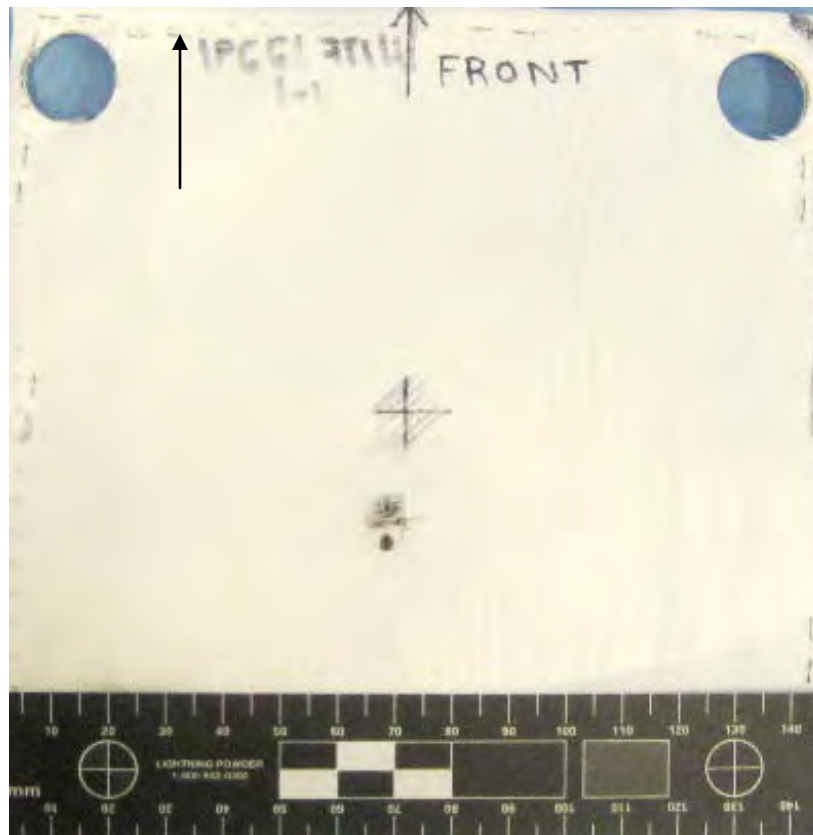
Figure 140 Overall View of Damage to Front of MLI (scale in 5mm increments / black arrow indicates flight path of projectile)

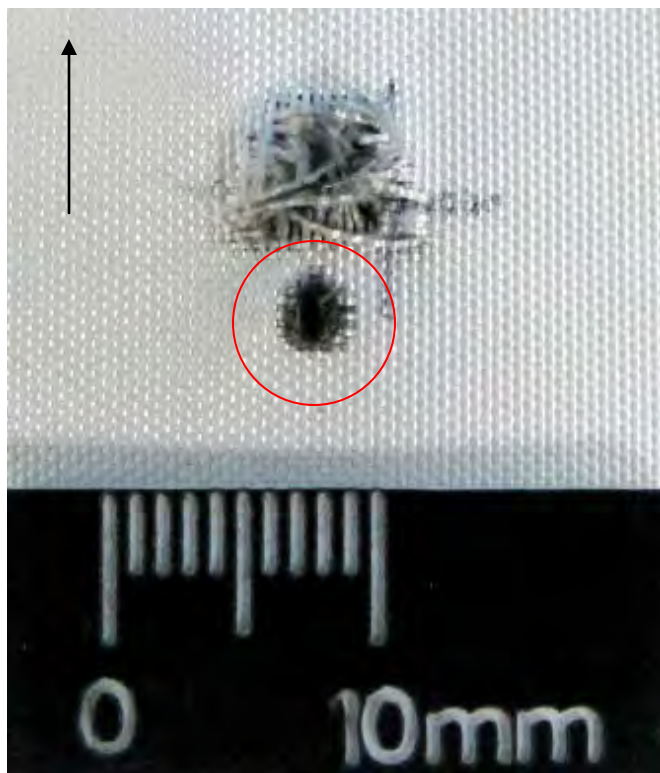
Figure 141 Close-up View of Damage to Front of MLI (scale in 1mm increments / black arrow indicates flight path of projectile / projectile impacted within red circle)

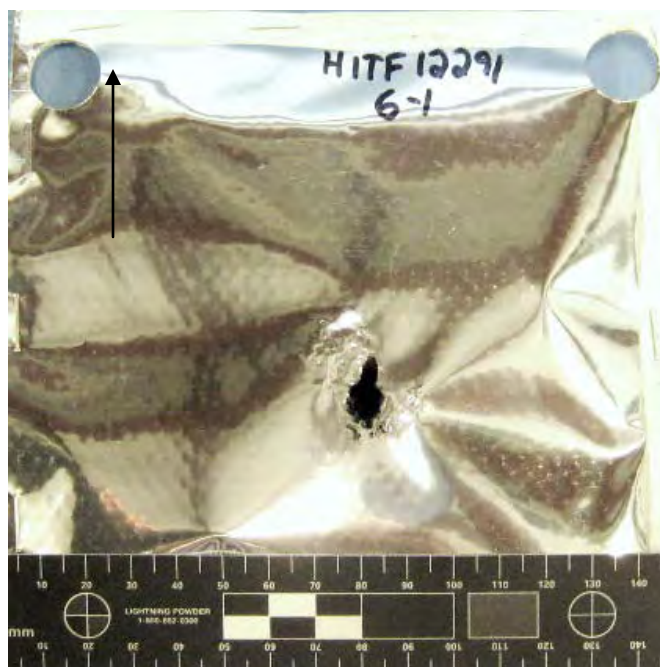
Figure 142 Overall View of Damage to Back Side of MLI (scale in 5mm increments / black arrow indicates flight path of projectile)

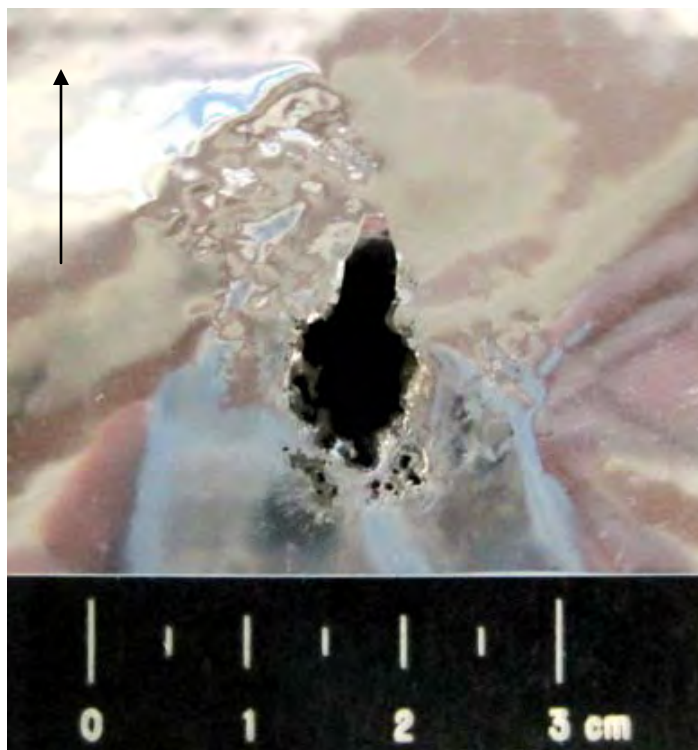
Figure 143 Close-up View of Damage to Back Side of MLI (scale in 5mm increments / black arrow indicates flight path of projectile)

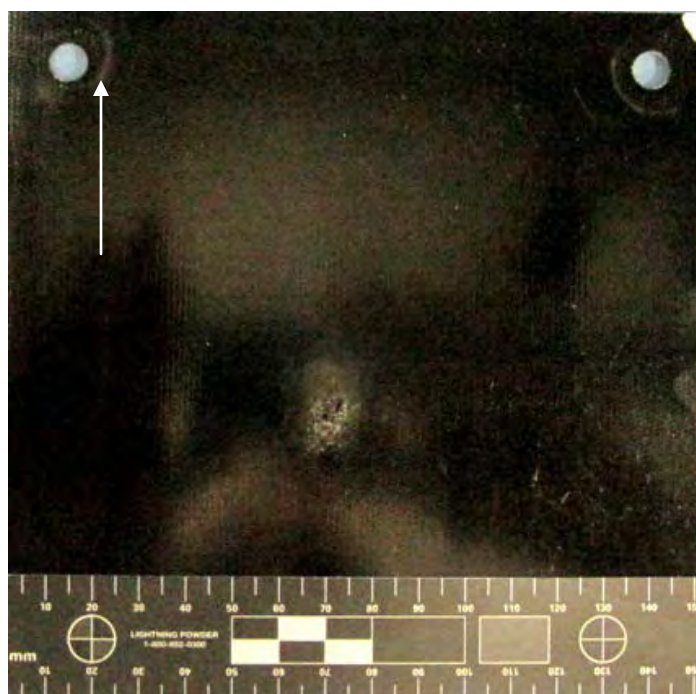
Figure 144 Overall View of Damage to Front of NP 504 Substrate (scale in 5mm increments / white arrow indicates flight path of projectile)

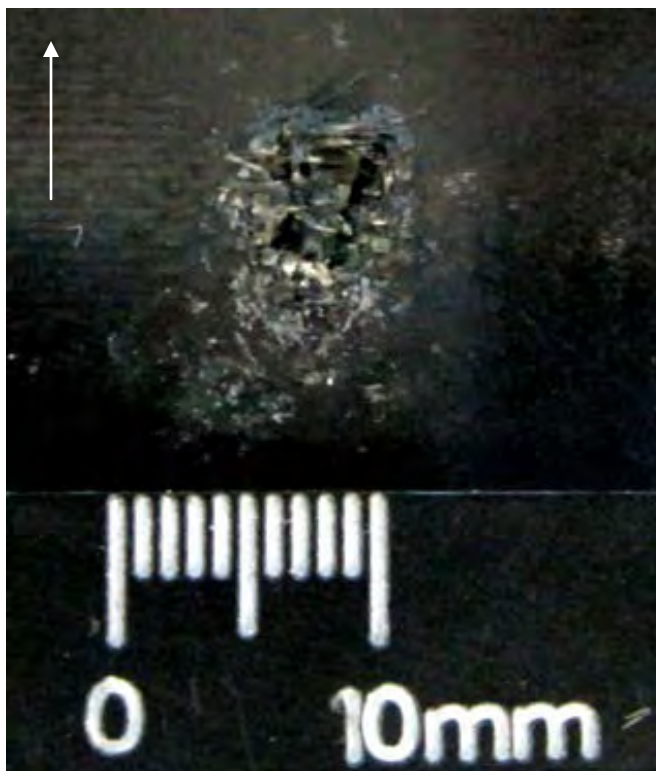
Figure 145 Close-up View of Damage to Front of NP 504 Substrate (scale in 1mm increments / white arrow indicates flight path of projectile)

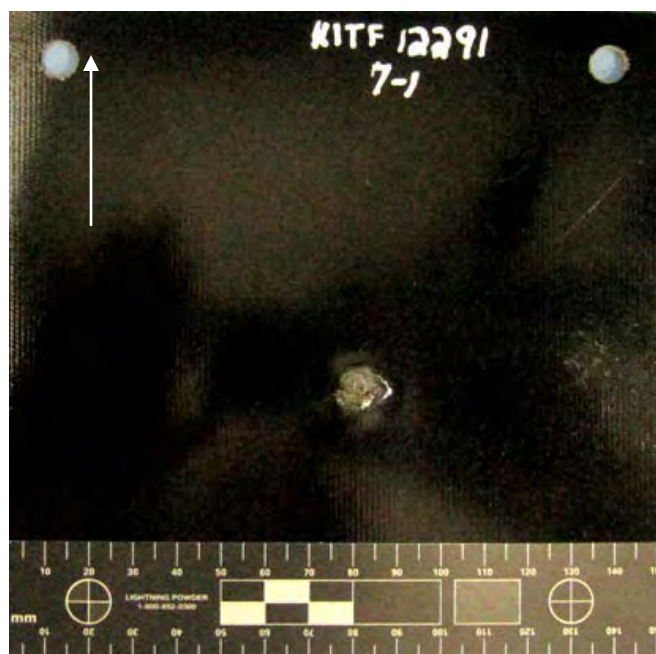
Figure 146 Overall View of Damage to Back Side of NP 504 Substrate (scale in 5mm increments / white arrow indicates flight path of projectile)

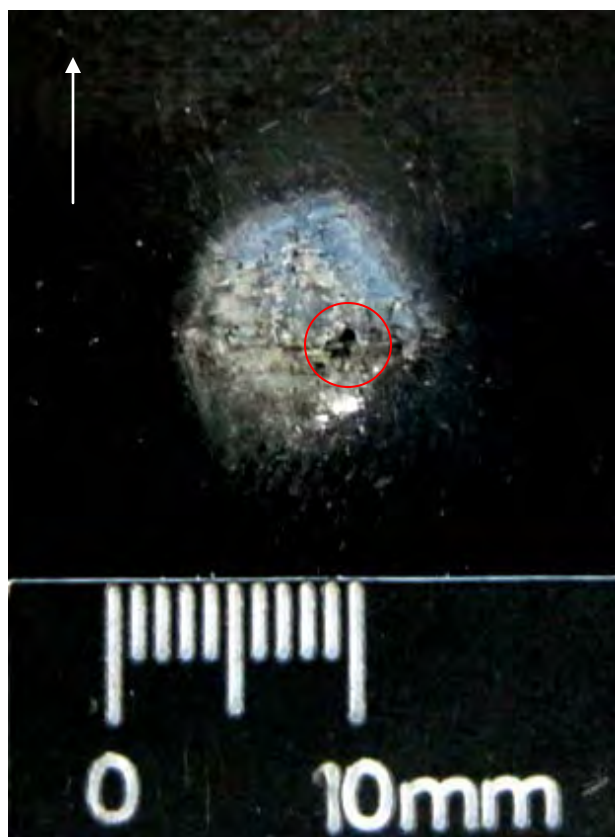
Figure 147 Close-up View of Damage to Back Side of NP 504 Substrate (scale in 1mm increments / white arrow indicates flight path of projectile)

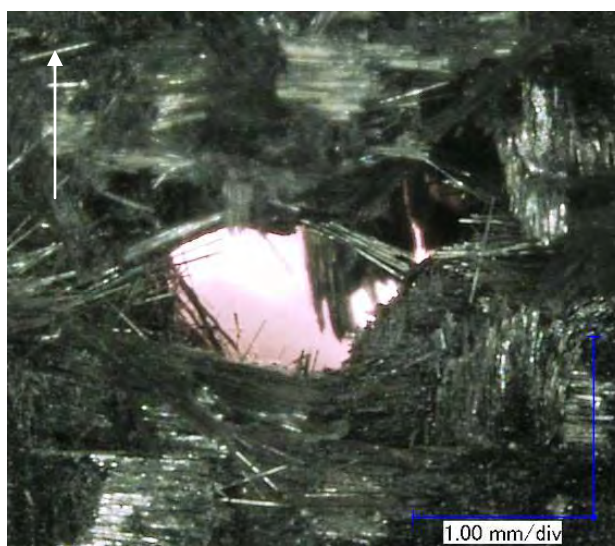
Figure 148 Close-up View of Most Significant Damage to Back Side of NP 504 Substrate (black arrow indicates flight path of projectile / damage within red circle in Figure 155)

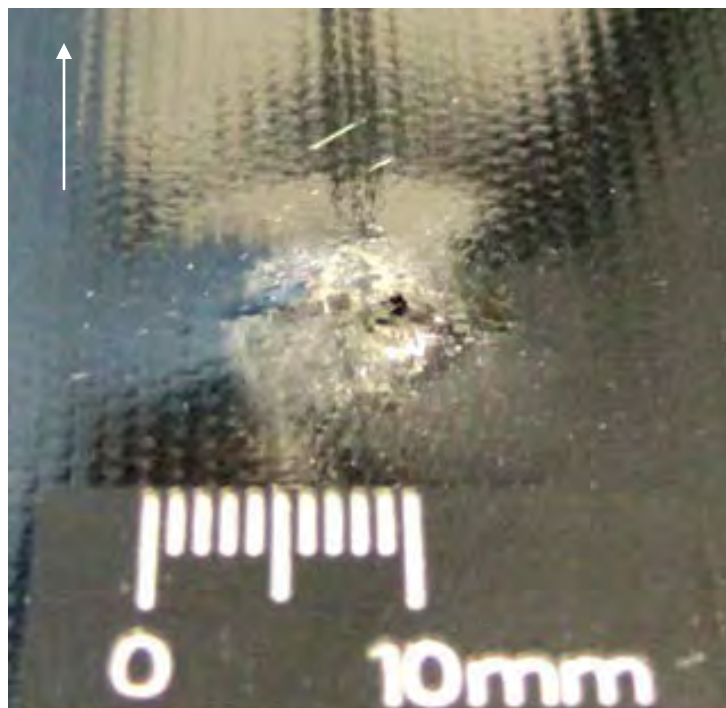
Figure 149 Close-up Oblique Side View of Damage to Back Side of NP 504 Substrate (scale in 1mm increments / white arrow indicates flight path of projectile)

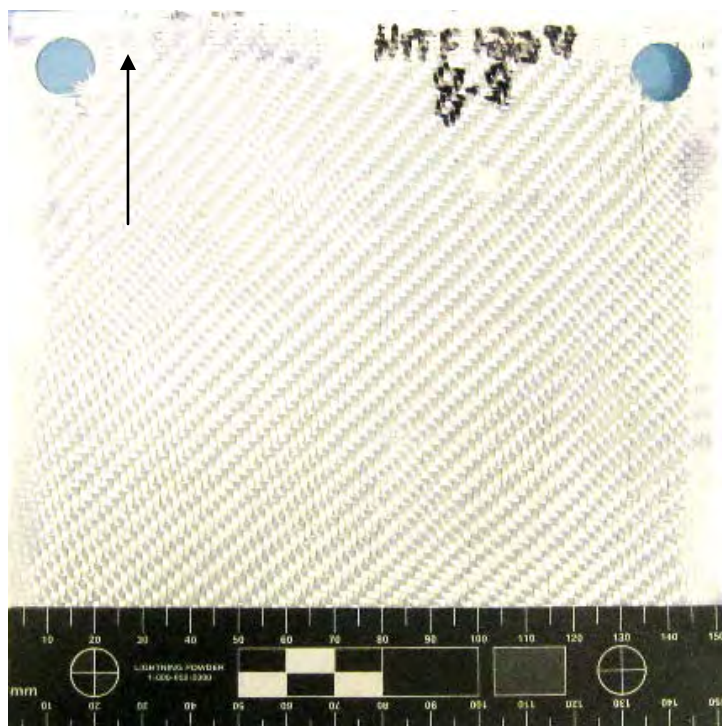
Figure 150 Overall View of Damage to Back Side of 8th Fiberglass Layer (scale in 5mm increments / black arrow indicates flight path of projectile)

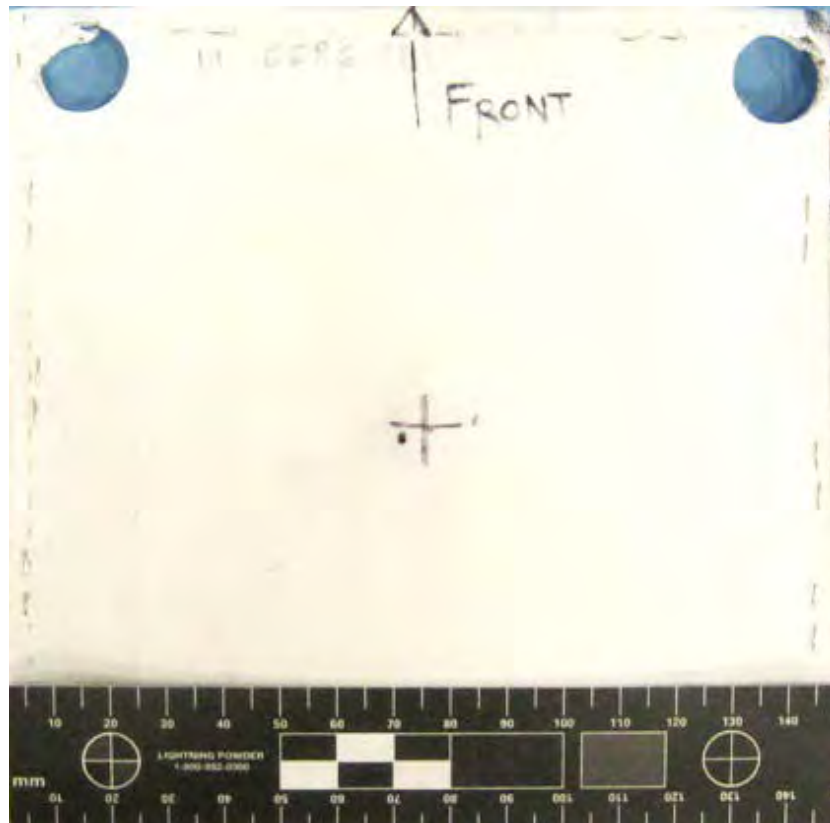
Figure 155 Overall View of Damage to Front of MLI (scale in 5mm increments / black arrow indicates flight path of projectile)

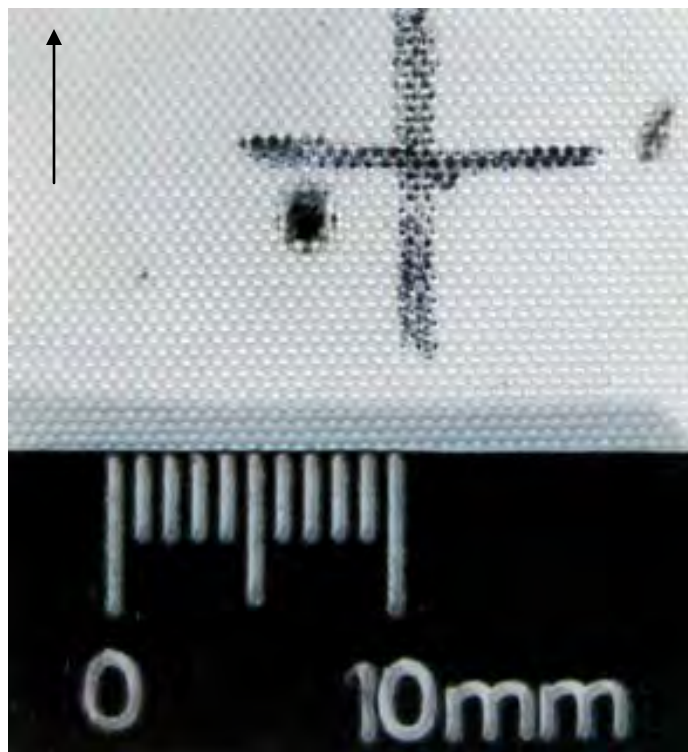
Figure 156 Close-up View of Damage to Front of MLI (scale in 1mm increments / black arrow indicates flight path of projectile)

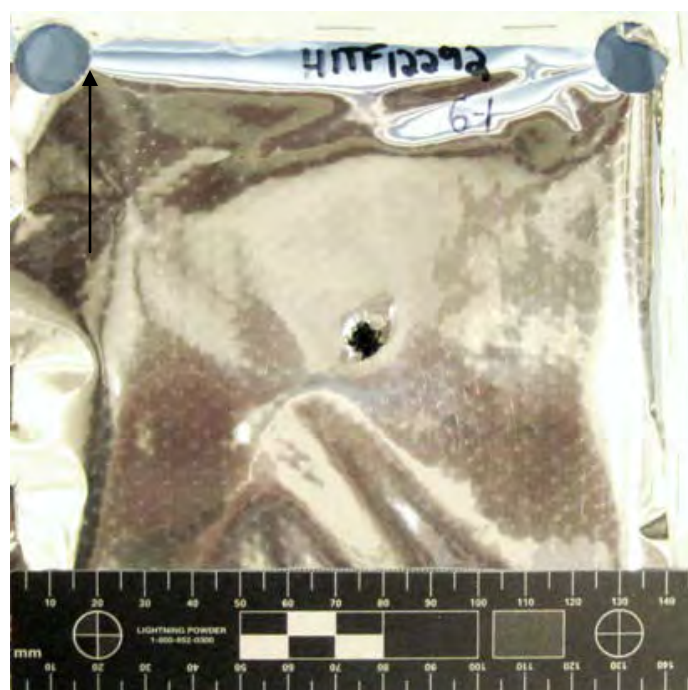
Figure 157 Overall View of Damage to Back Side of MLI (scale in 5mm increments / black arrow indicates flight path of projectile)

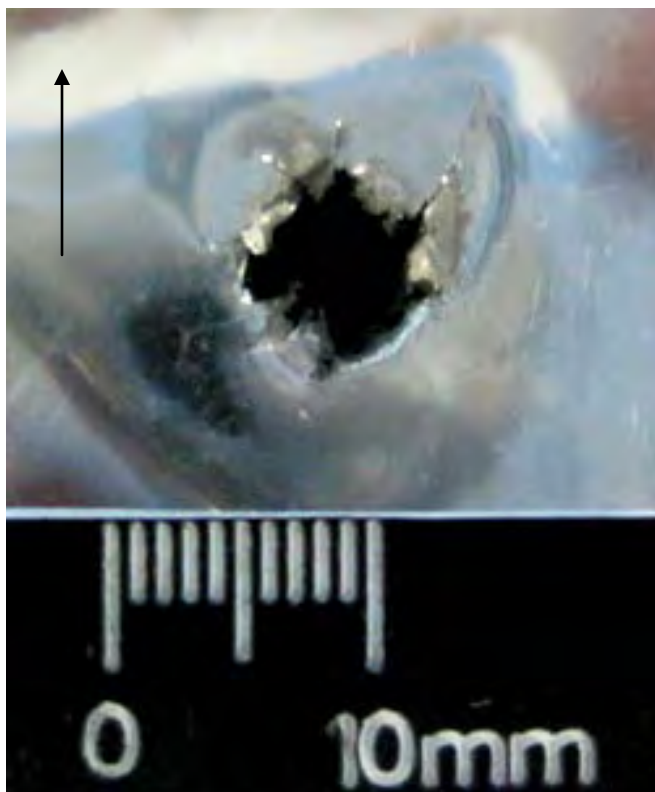
Figure 158 Close-up View of Damage to Back Side of MLI (scale in 1mm increments / black arrow indicates flight path of projectile)

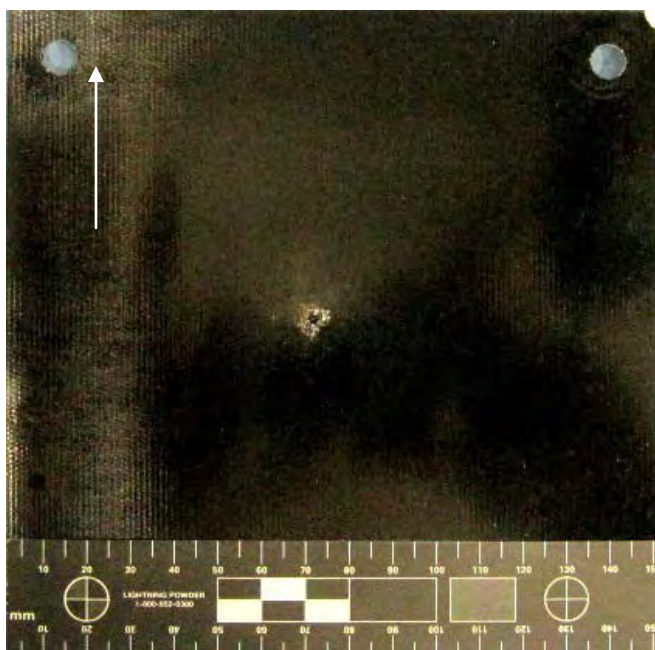
Figure 159 Overall View of Damage to Front of NP 504 Substrate (scale in 5mm increments / white arrow indicates flight path of projectile)

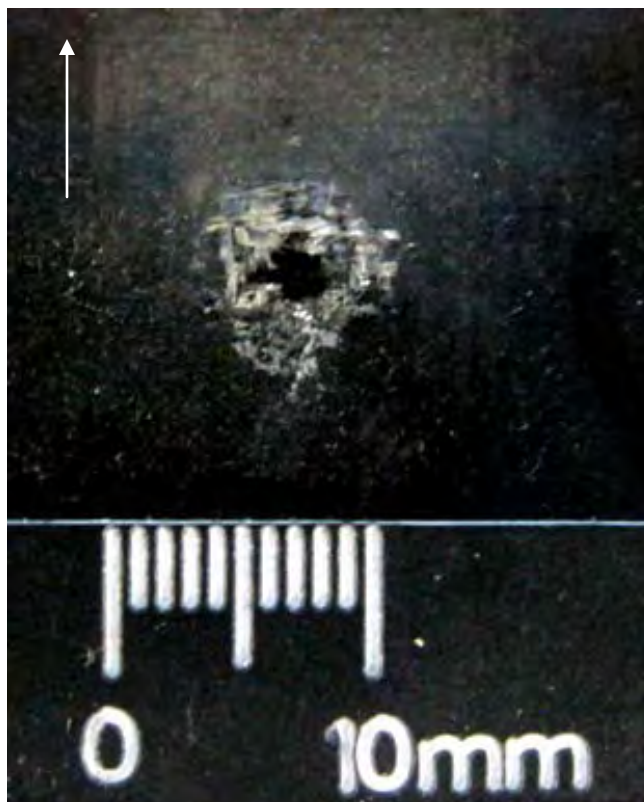
Figure 160 Close-up View of Damage to Front of NP 504 Substrate (scale in 1mm increments / white arrow indicates flight path of projectile)

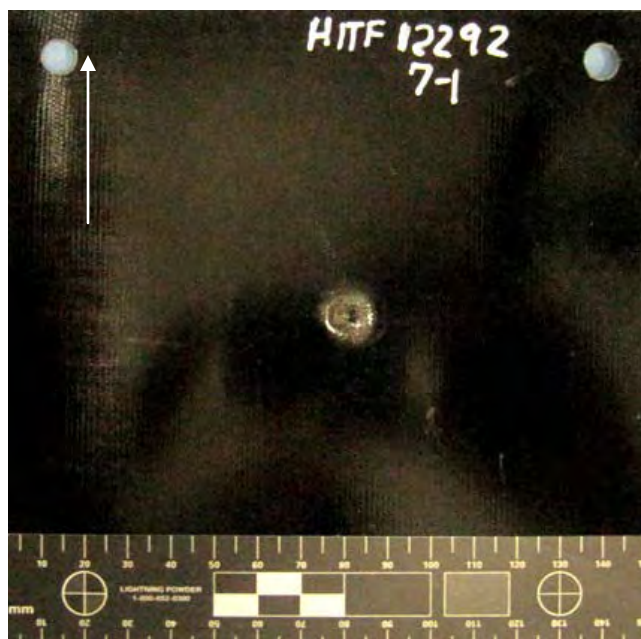
Figure 161 Overall View of Damage to Back Side of NP 504 Substrate (scale in 5mm increments / white arrow indicates flight path of projectile)

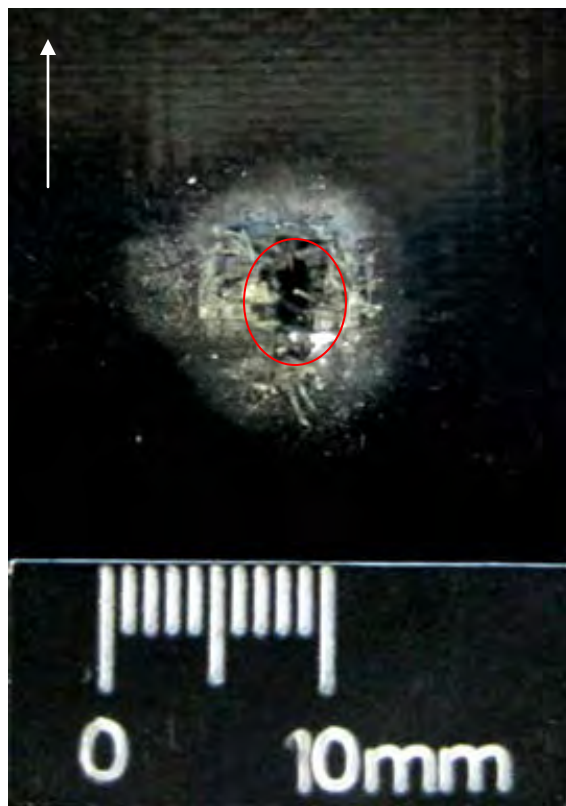
Figure 162 Close-up View of Damage to Back Side of NP 504 Substrate (scale in 1mm increments / white arrow indicates flight path of projectile)

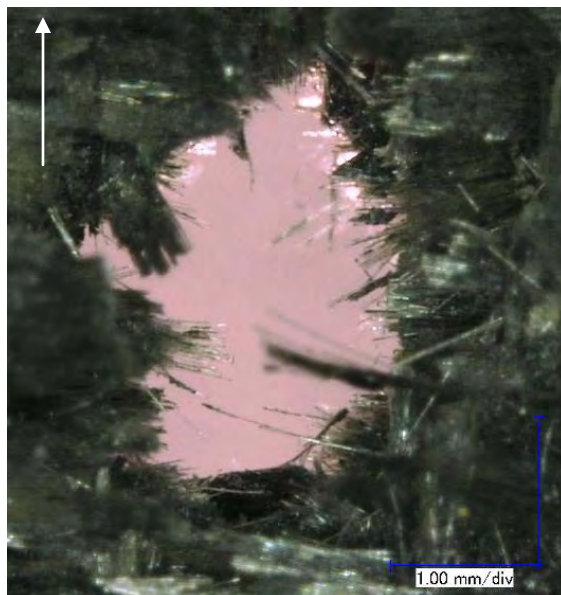
Figure 163 Close-up View of Most Significant Damage to Back Side of NP 504 Substrate (white arrow indicates flight path of projectile / damage within red circle in Figure 162)

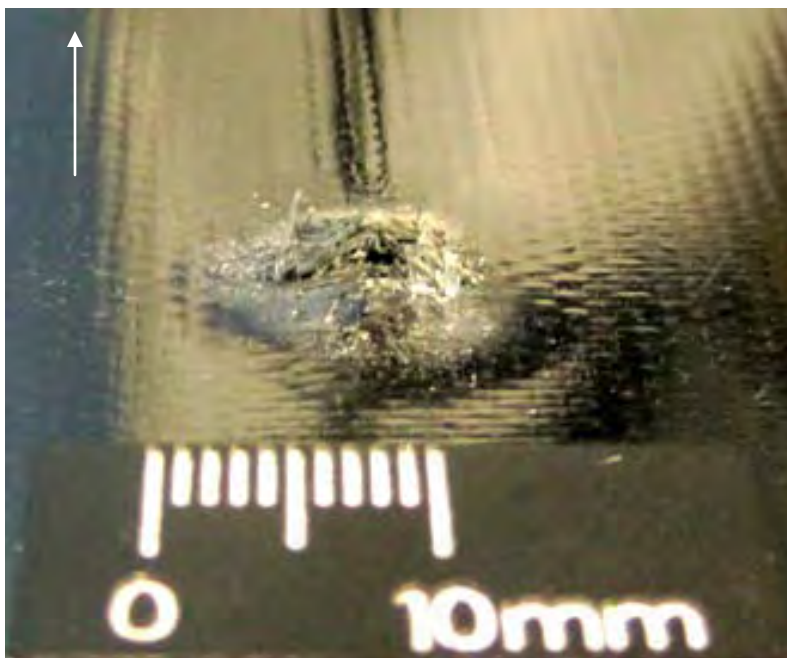
Figure 164 Close-up Oblique Side View of Damage to Back Side of NP 504 Substrate (scale in 1mm increments / white arrow indicates flight path of projectile)

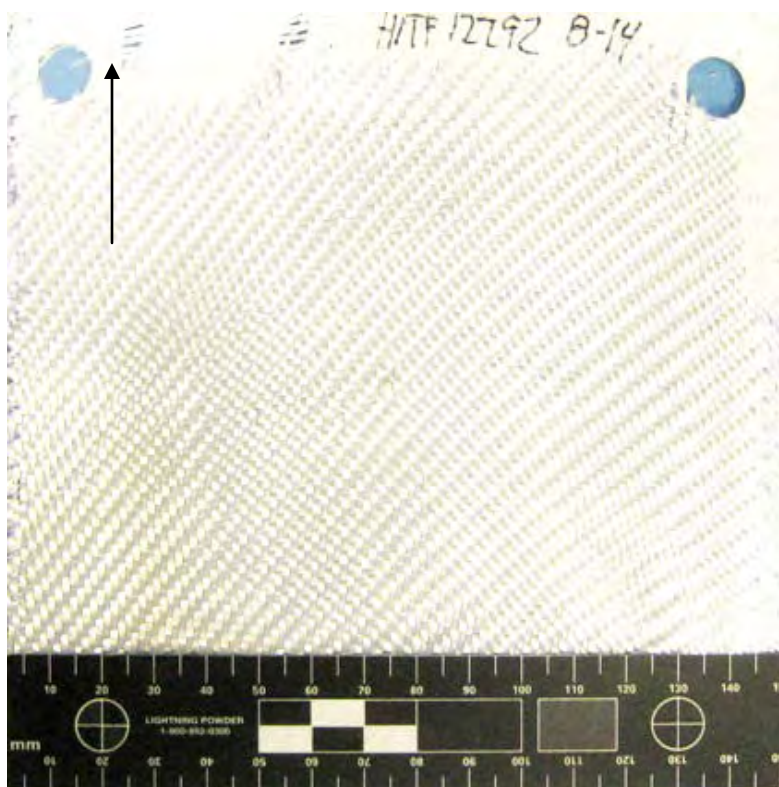
Figure 165 Overall View of Damage to Back Side of Last Fiberglass Layer (scale in 5mm increments / black arrow indicates flight path of projectile)
