International Space Station (ISS) Soyuz Vehicle Descent Module Evaluation of Thermal Protection System (TPS) Penetration Characteristics

Hypervelocity Impact Technology Group

February 2013

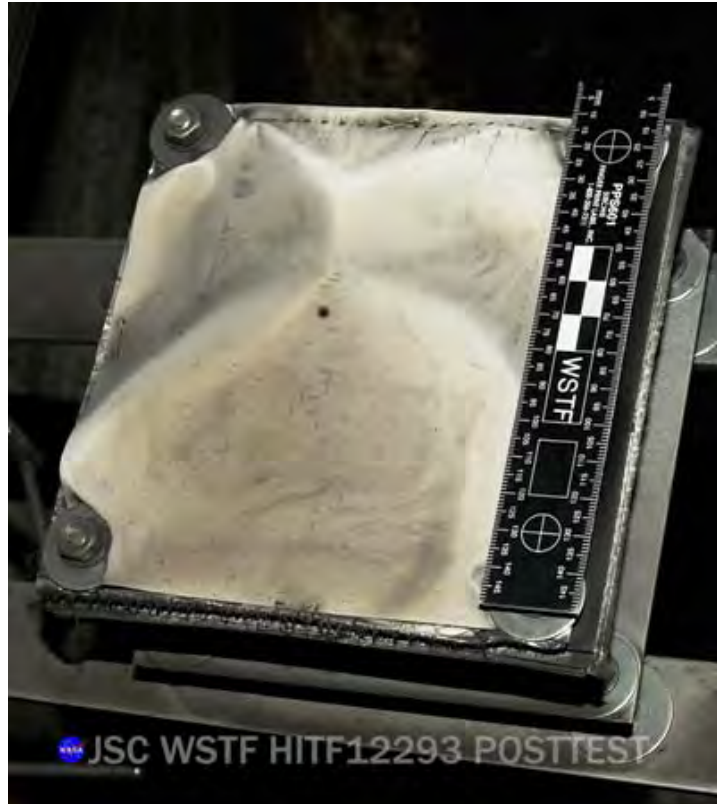
Figure 167 Overall View of Sample in the Target Tank (post-test)

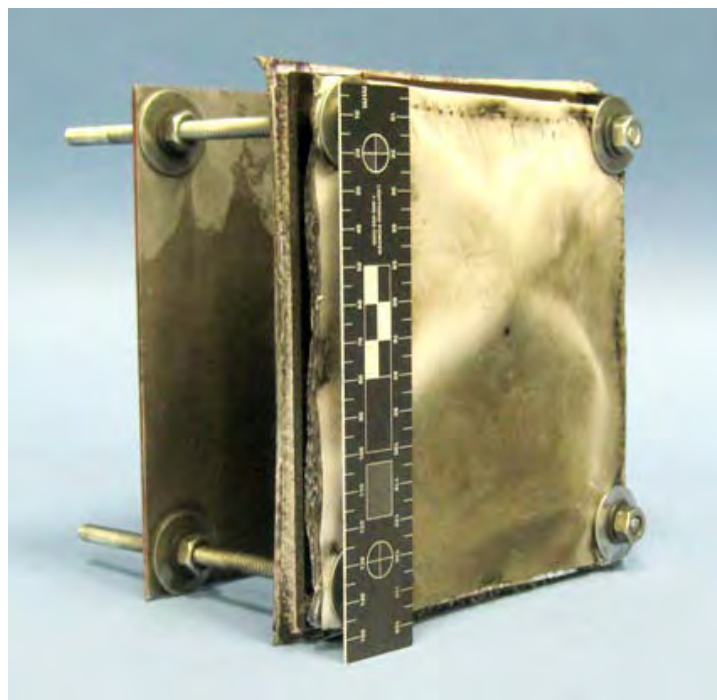
Figure 168 Overall Front Oblique View of Sample (scale in 5mm increments)

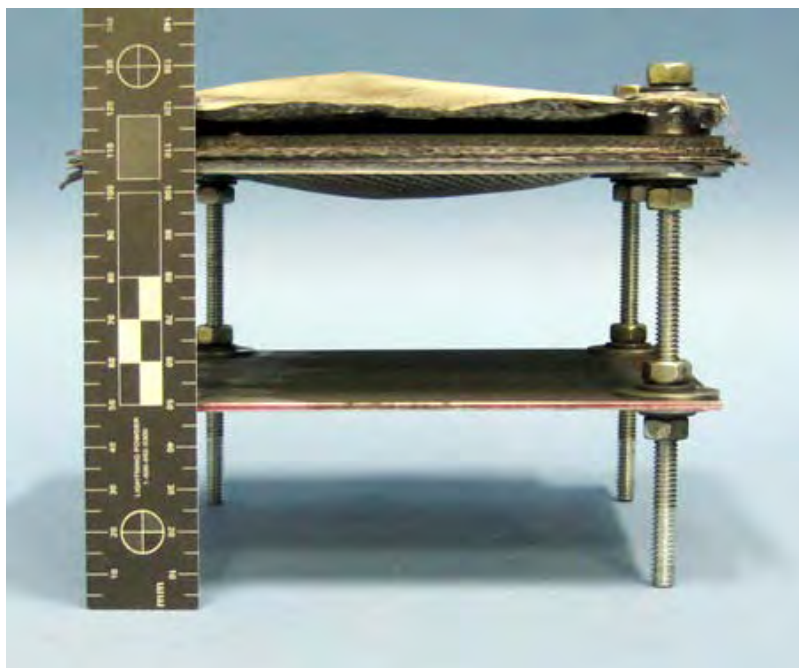
Figure 169 Overall Side View of Sample (scale in 5mm increments)

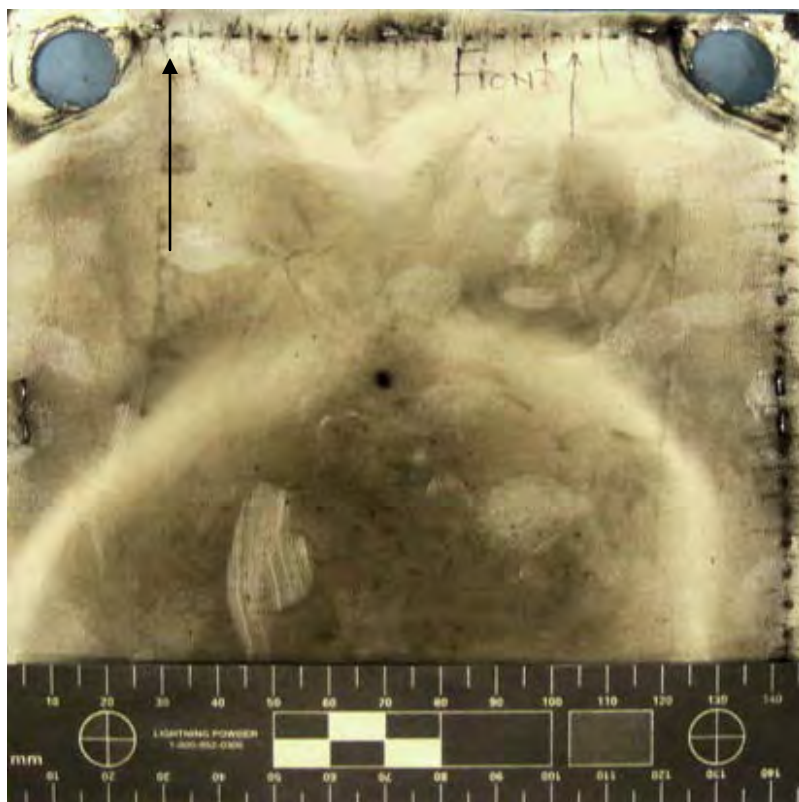
Figure 170 Overall View of Damage to Front of MLI (scale in 5mm increments / black arrow indicates flight path of projectile)

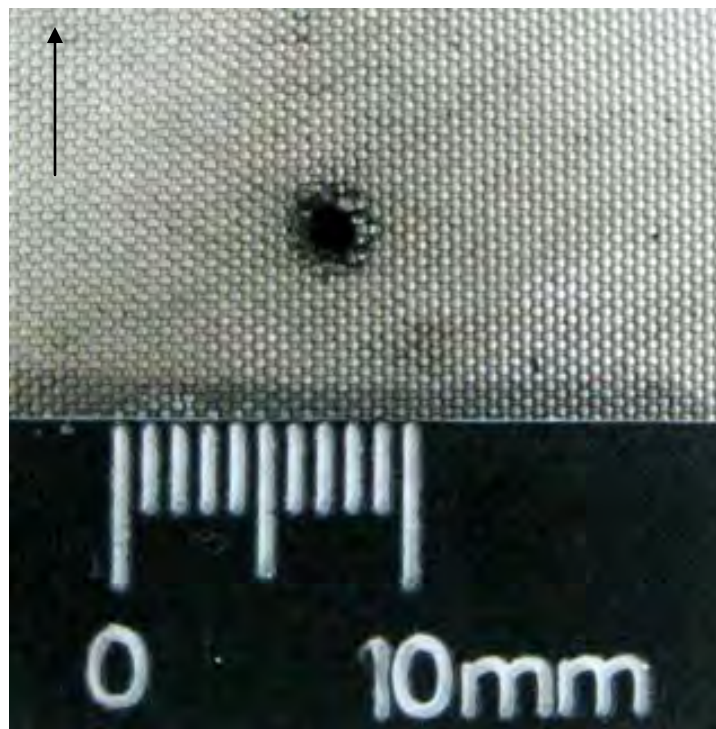
Figure 171 Close-up View of Damage to Front of MLI (scale in 1mm increments / black arrow indicates flight path of projectile / projectile impacted within red circle)

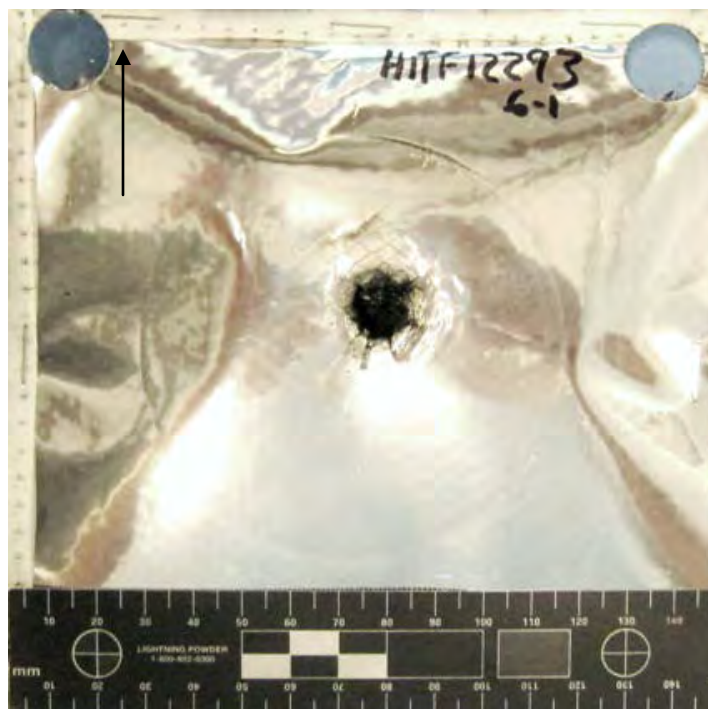
Figure 172 Overall View of Damage to Back Side of MLI (scale in 5mm increments / black arrow indicates flight path of projectile)

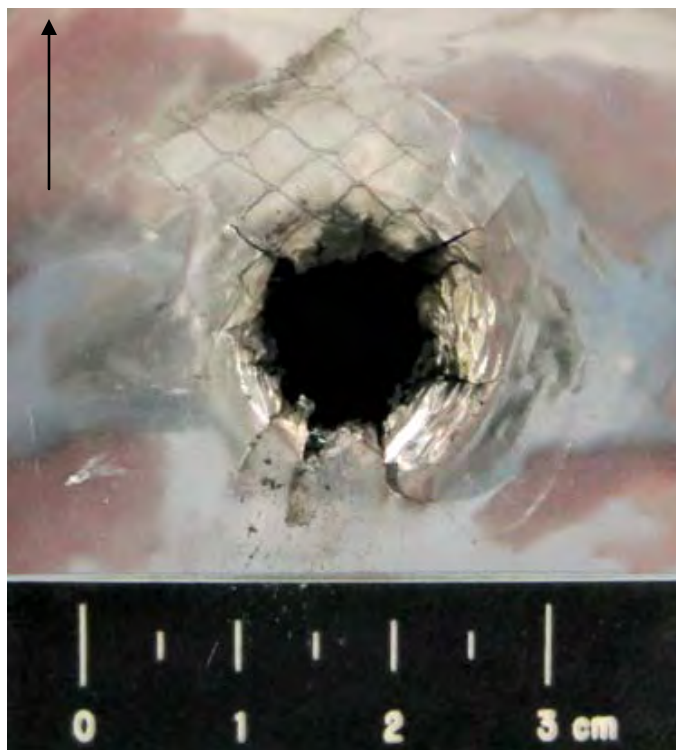
Figure 173 Close-up View of Damage to Back Side of MLI (scale in 5mm increments / black arrow indicates flight path of projectile)

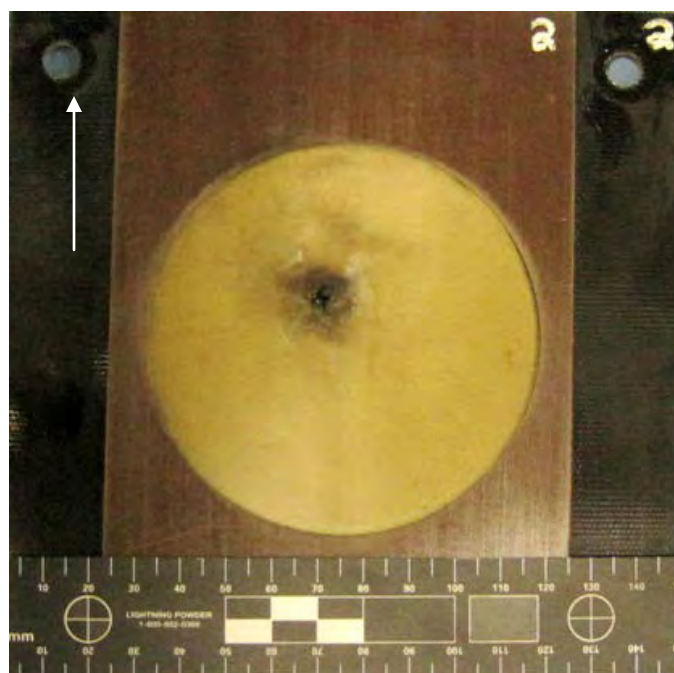
Figure 174 Overall View of Damage to Front of TORLON 5030 (scale in 5mm increments / white arrow indicates flight path of projectile)

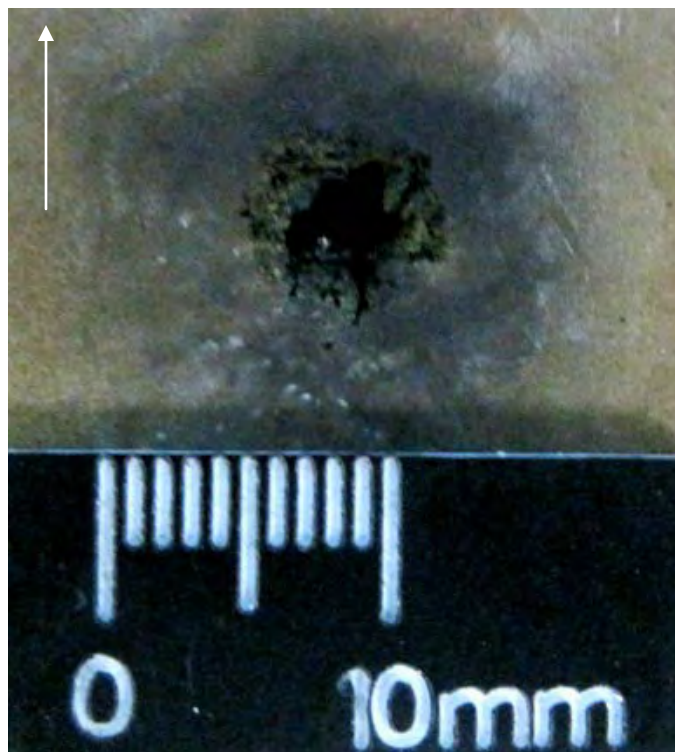
Figure 175 Close-up View of Damage to Front of TORLON 5030 (scale in 1mm increments / white arrow indicates flight path of projectile)

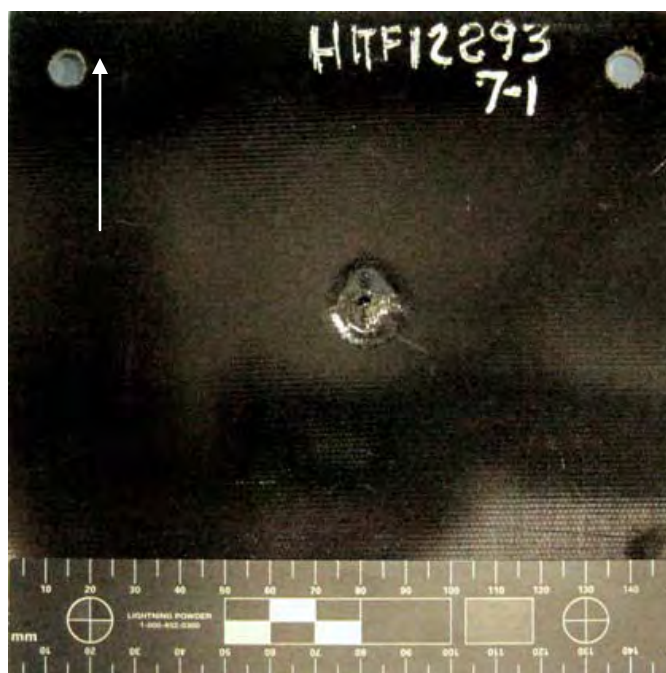
Figure 176 Overall View of Damage to Back Side of NP 504 Substrate (scale in 5mm increments / white arrow indicates flight path of projectile)

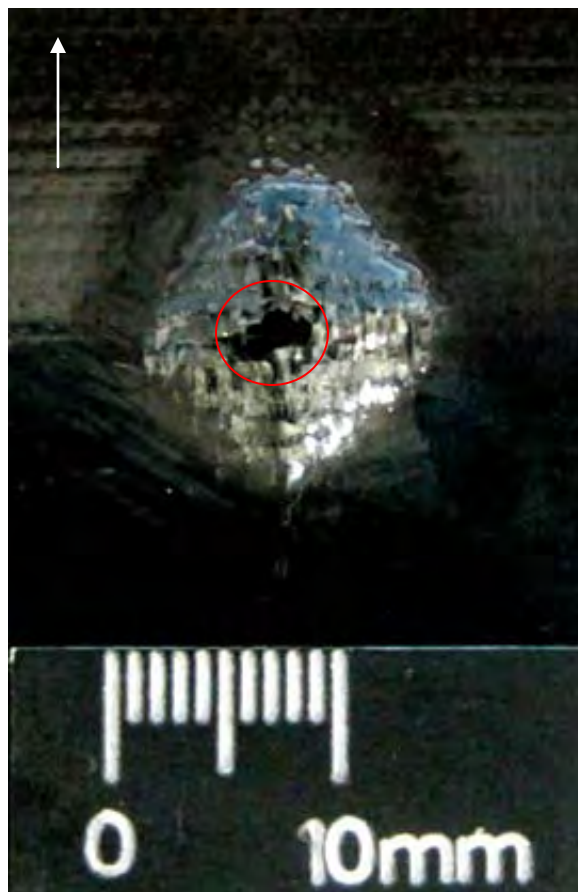
Figure 177 Close-up View of Damage to Back Side of NP 504 Substrate (scale in 1mm increments / white arrow indicates flight path of projectile)

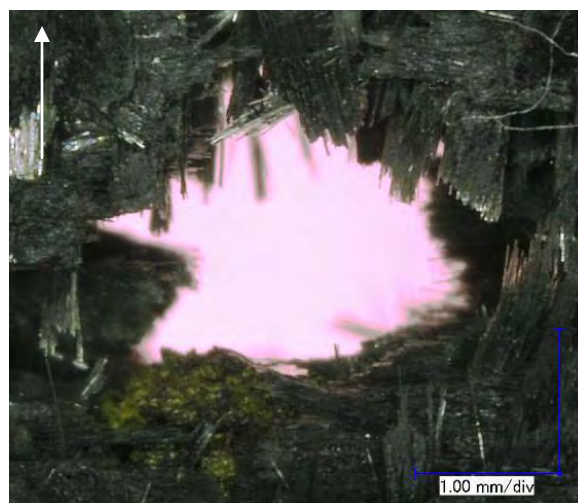
Figure 178 Close-up View of Most Significant Damage to Back Side of NP 504 Substrate (white arrow indicates flight path of projectile / damage within red circle in Figure 187)

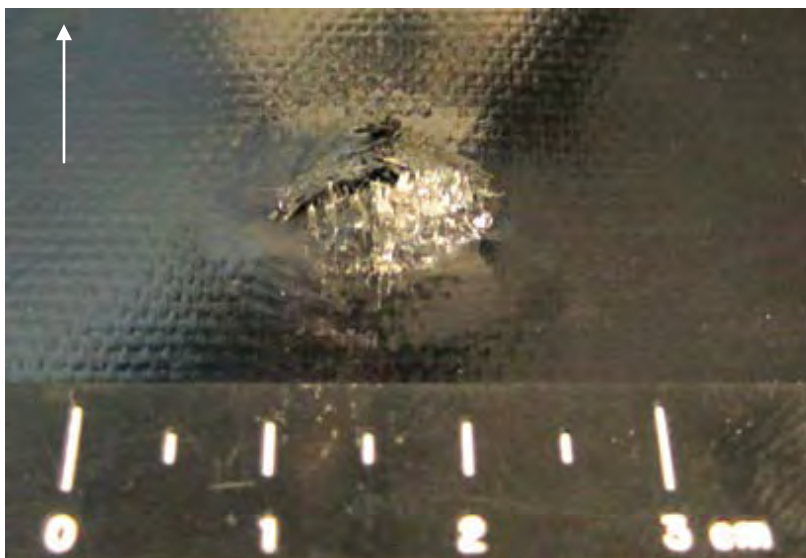
Figure 179 Close-up Oblique Side View of Damage to Back Side of NP 504 Substrate (scale in 5mm increments / white arrow indicates flight path of projectile)

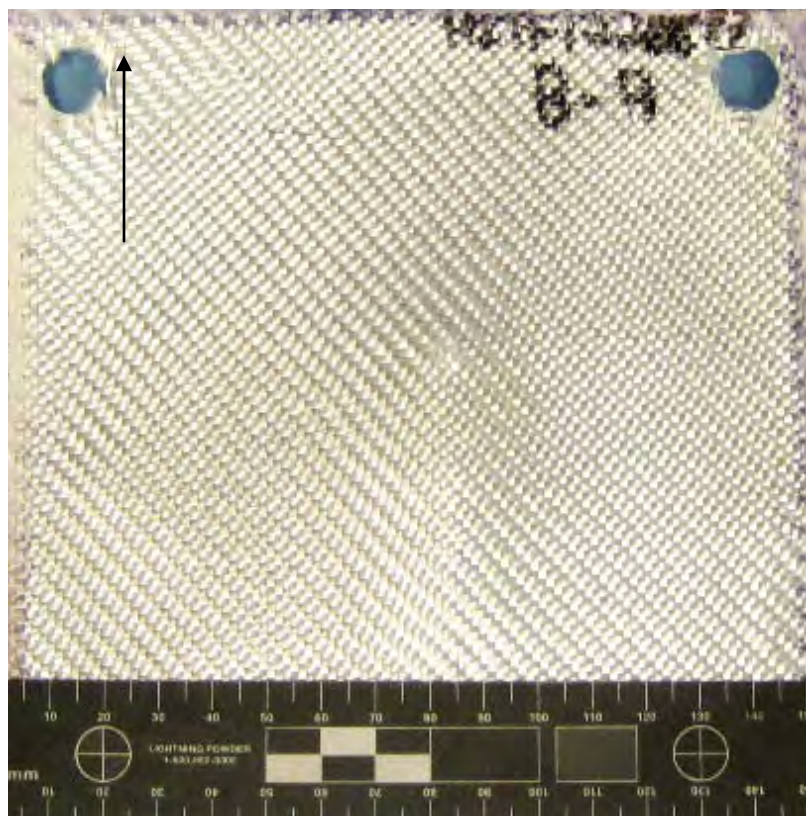
Figure 180 Overall View of Damage to Back Side of 1st Fiberglass Layer (scale in 5mm increments / black arrow indicates flight path of projectile)

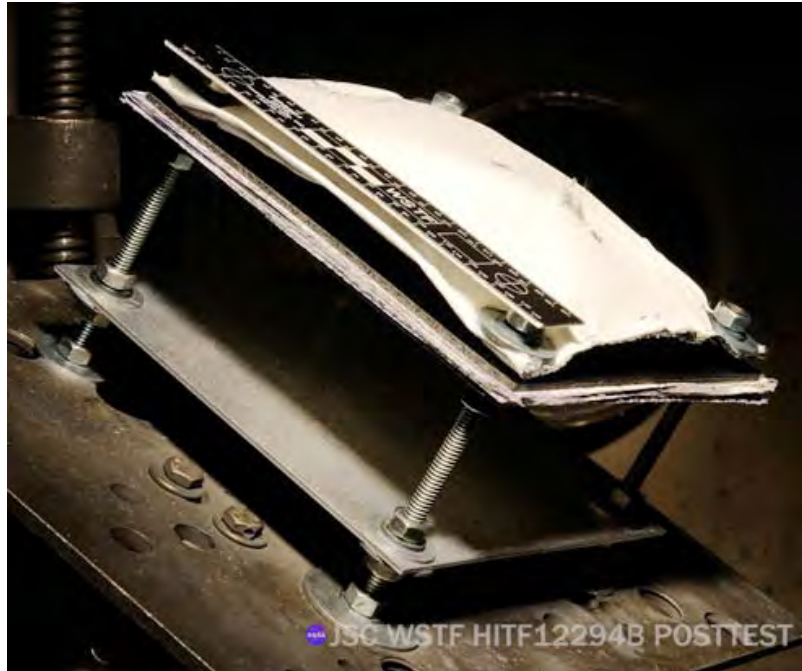
Figure 182 Overall View of Sample in the Target Tank (post-test)

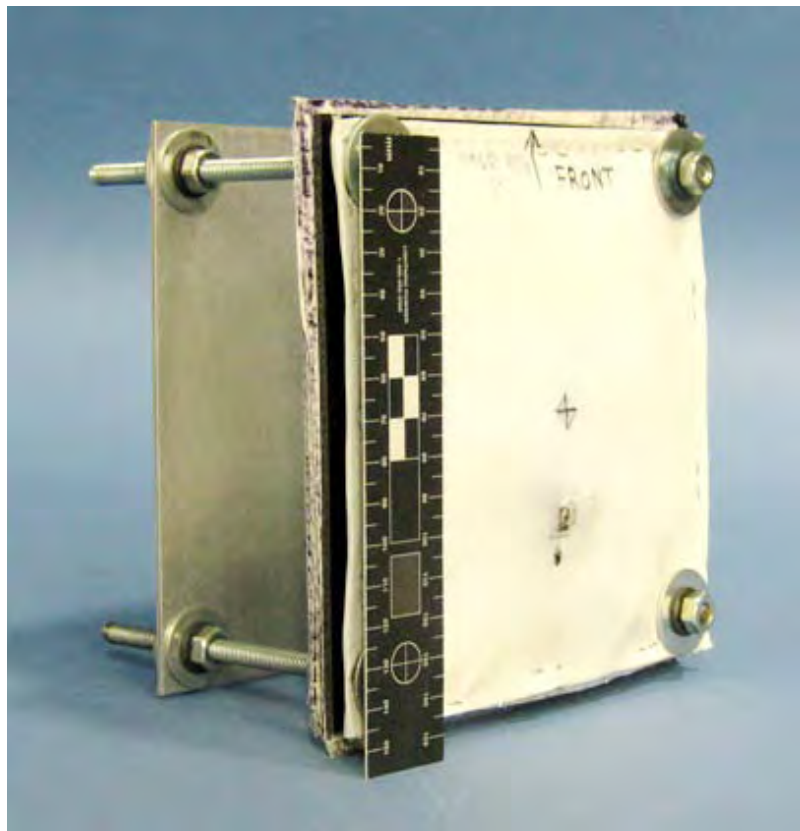
Figure 183 Overall Front Oblique View of Sample (scale in 5mm increments)

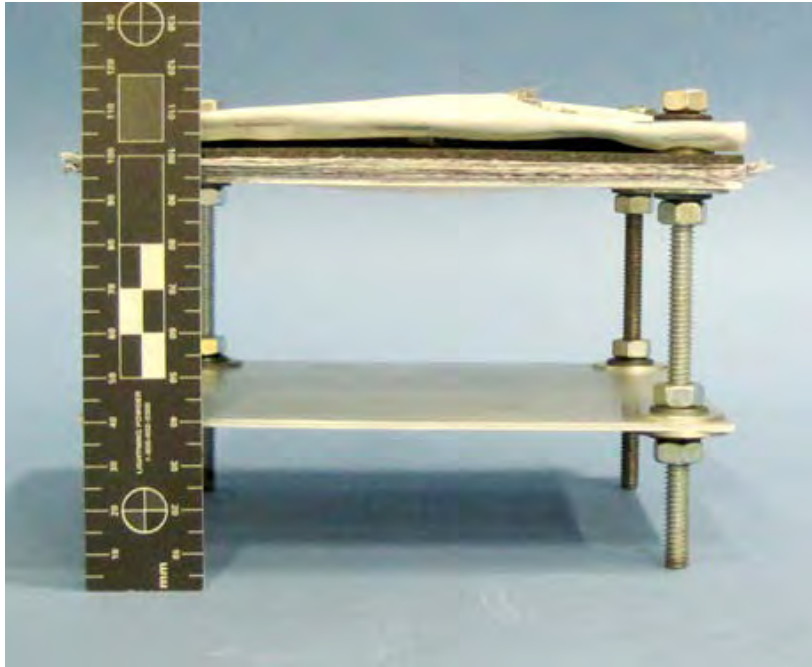
Figure 184 Overall Side View of Sample (scale in 5mm increments)

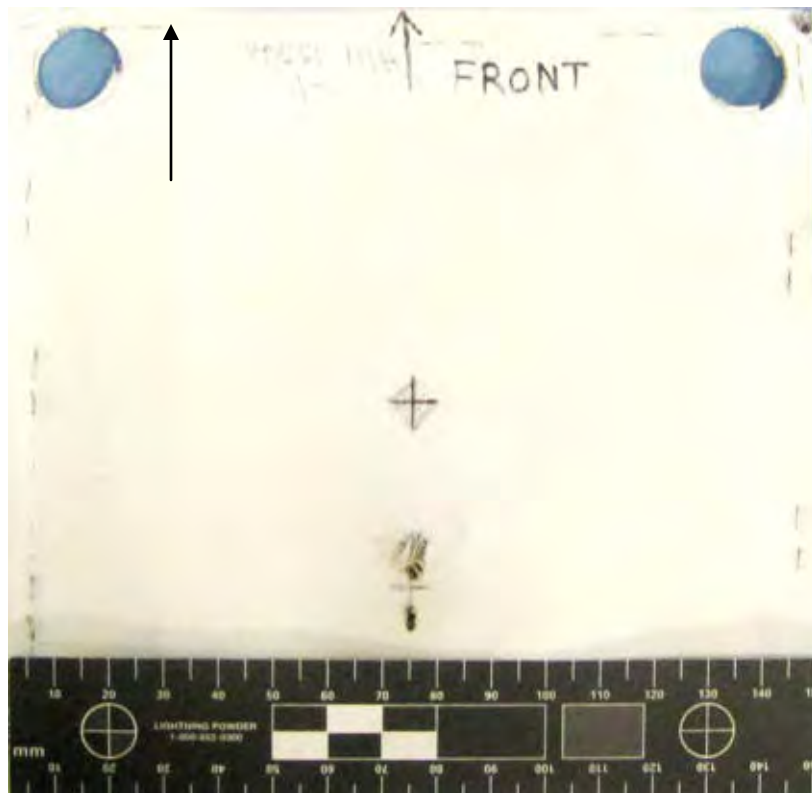
Figure 185 Overall View of Damage to Front of MLI (scale in 5mm increments / black arrow indicates flight path of projectile)

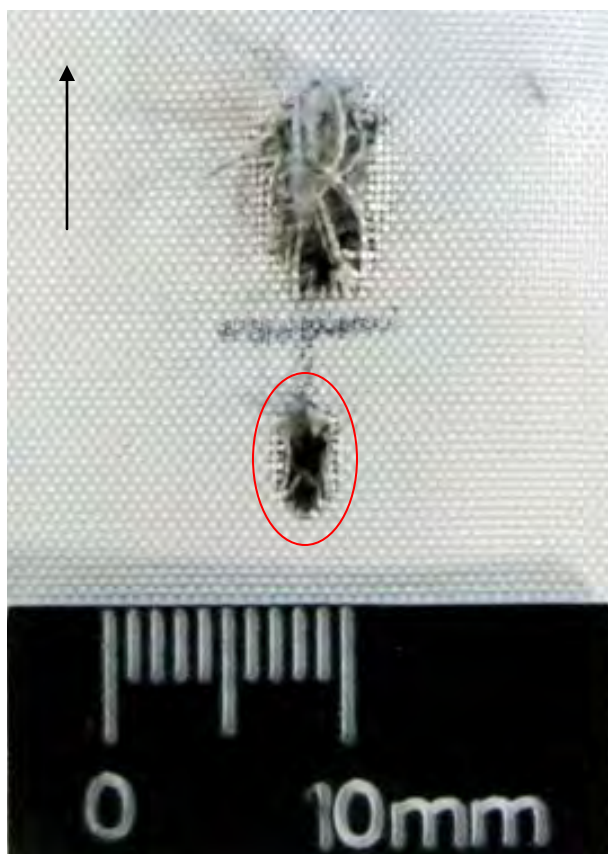
Figure 186 Close-up View of Damage to Front of MLI (scale in 1mm increments / black arrow indicates flight path of projectile / projectile impacted within red circle)

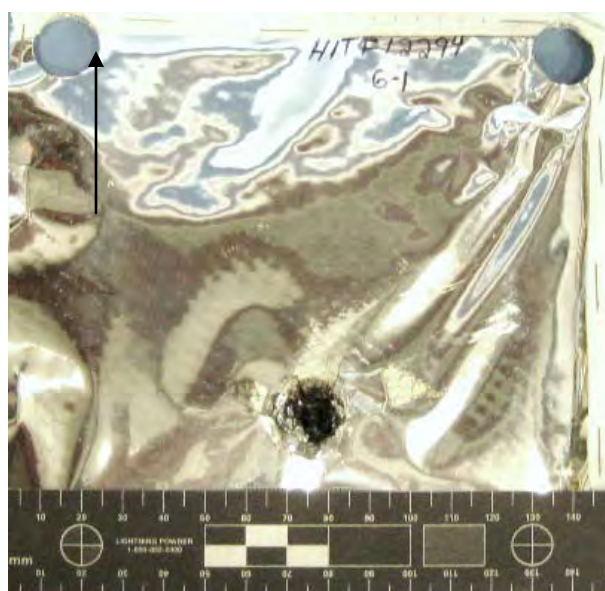
Figure 187 Overall View of Damage to Back Side of MLI (scale in 5mm increments / black arrow indicates flight path of projectile)

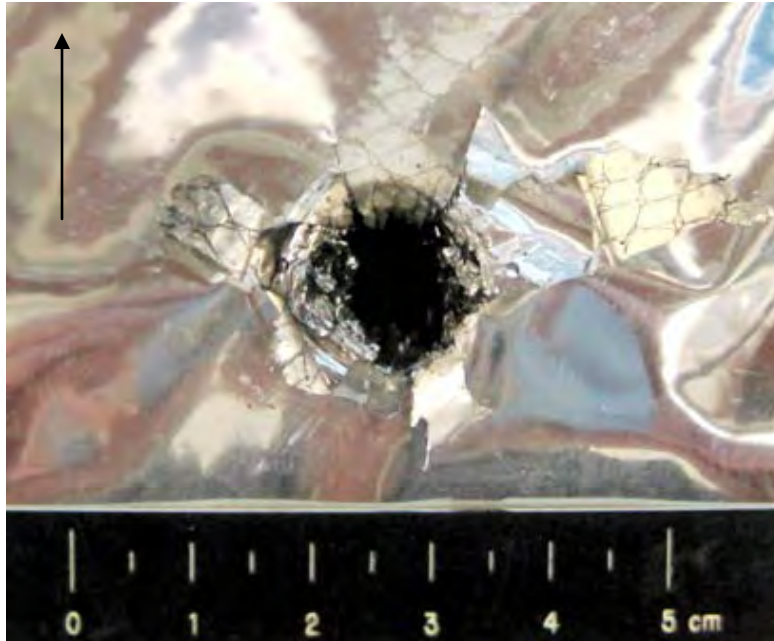
Figure 188 Close-up View of Damage to Back Side of MLI (scale in 5mm increments / black arrow indicates flight path of projectile)

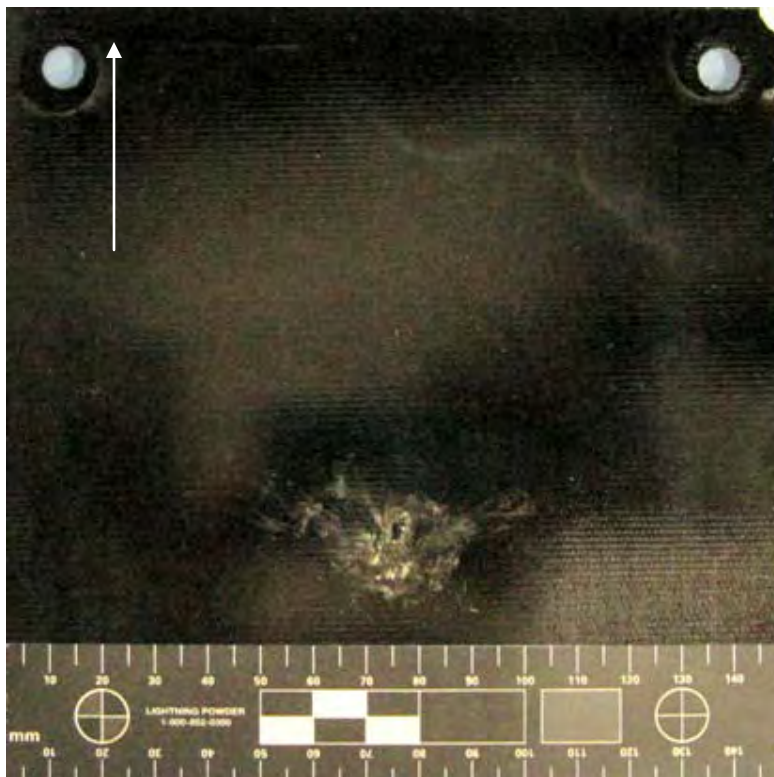
Figure 189 Overall View of Damage to Front of NP 504 Substrate (scale in 5mm increments / white arrow indicates flight path of projectile)

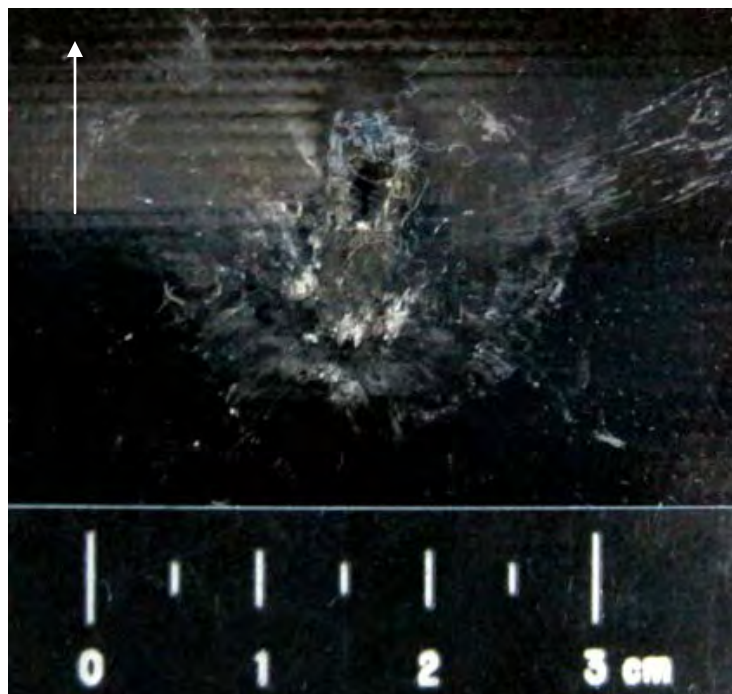
Figure 190 Close-up View of Damage to Front of NP 504 Substrate (scale in 5mm increments / white arrow indicates flight path of projectile)

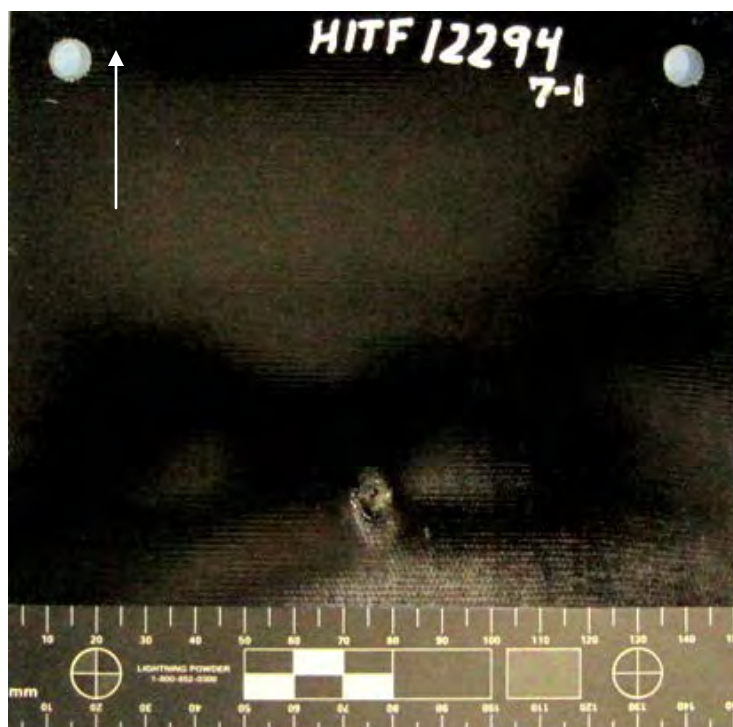
Figure 191 Overall View of Damage to Back Side of NP 504 Substrate (scale in 5mm increments / white arrow indicates flight path of projectile)

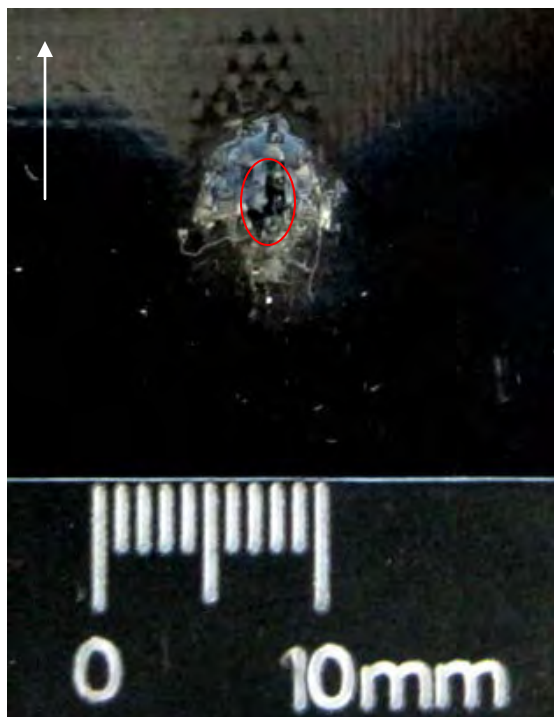
Figure 192 Close-up View of Damage to Back Side of NP 504 Substrate (scale in 1mm increments / white arrow indicates flight path of projectile)

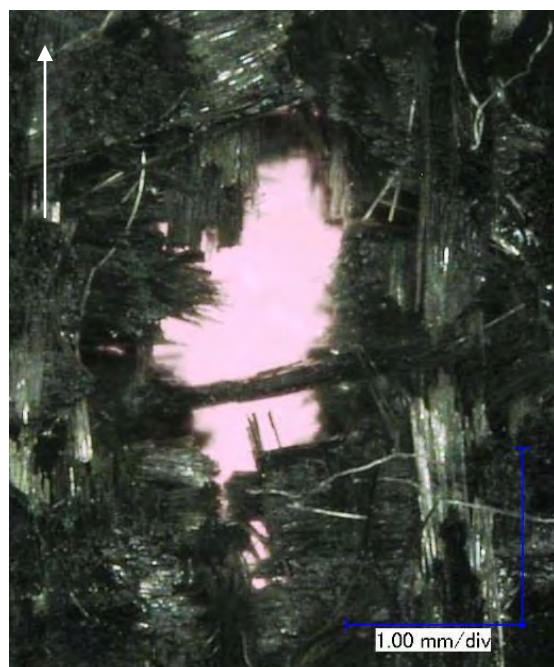
Figure 193 Close-up View of Most Significant Damage to Back Side of NP 504 Substrate (white arrow indicates flight path of projectile / damage within red circle in Figure 192)

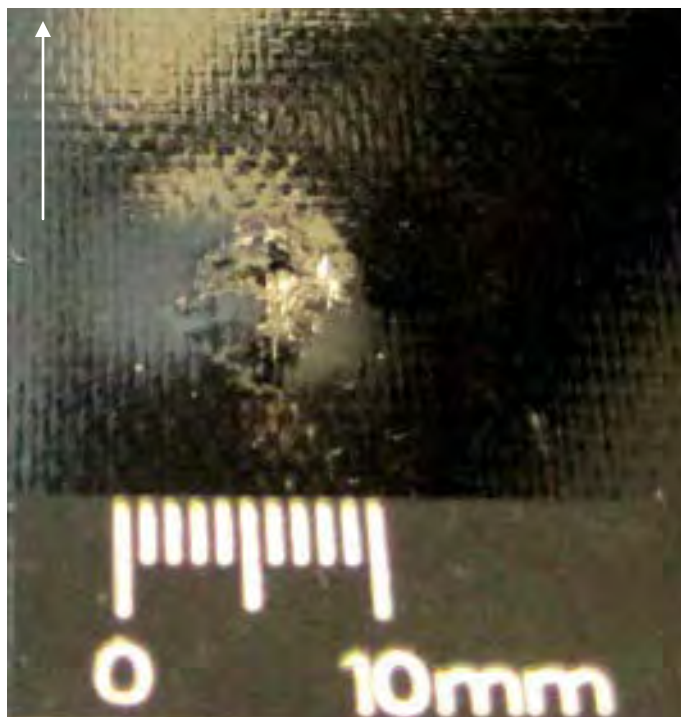
Figure 194 Close-up Oblique Side View of Damage to Back Side of NP 504 Substrate (scale in 1mm increments / white arrow indicates flight path of projectile)

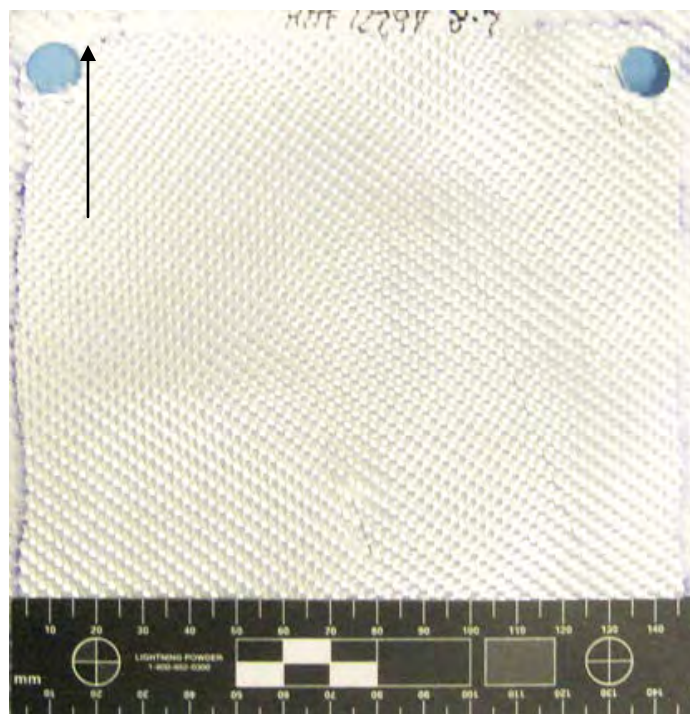
Figure 195 Overall View of Damage to Back Side of 7th Fiberglass Layer (scale in 5mm increments / black arrow indicates flight path of projectile)

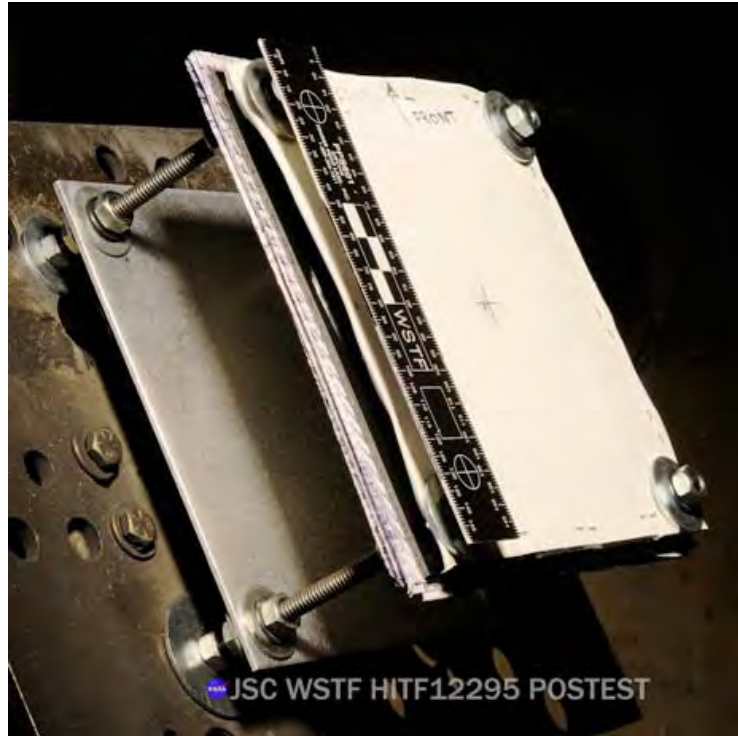
Figure 197 Overall View of Sample in the Target Tank (post-test)

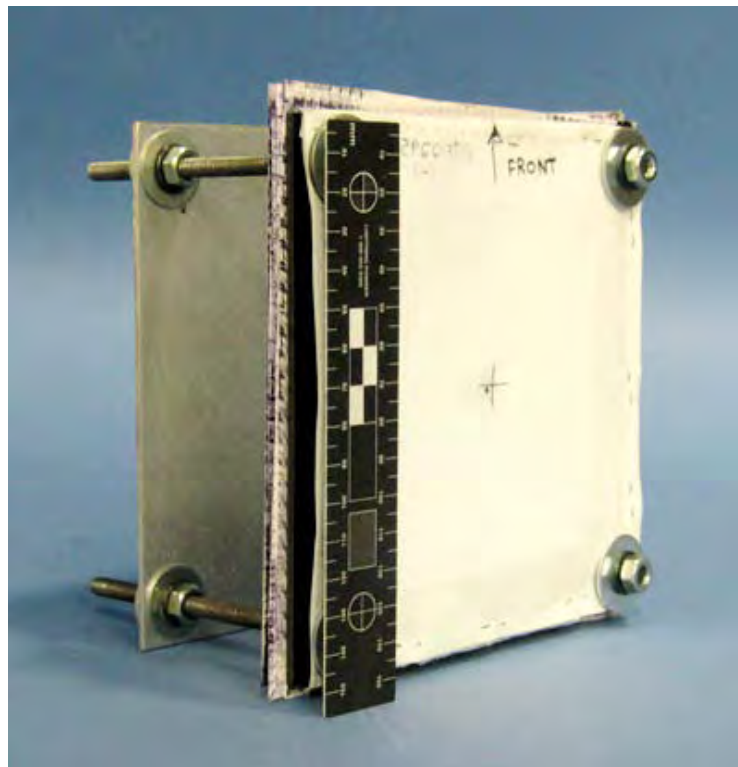
Figure 198 Overall Front Oblique View of Sample (scale in 5mm increments)

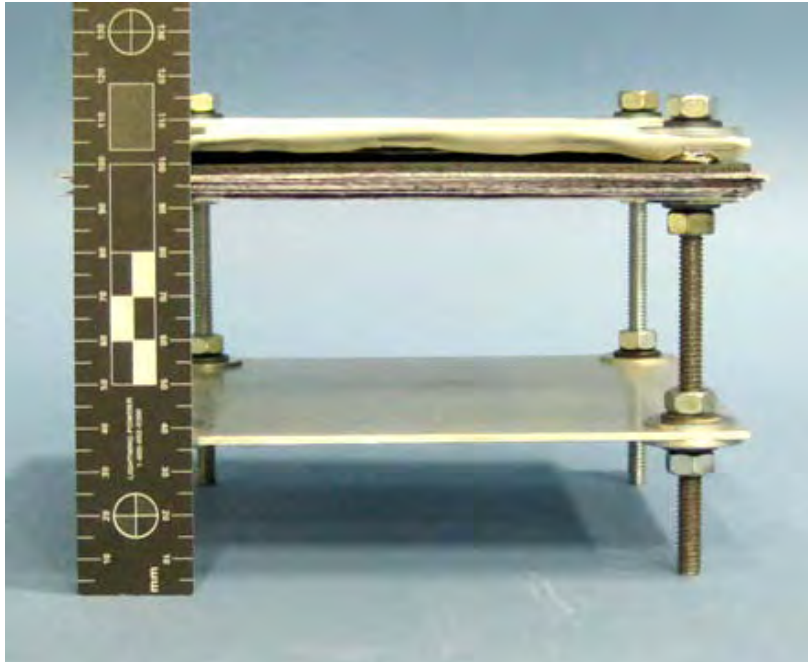
Figure 199 Overall Side View of Sample (scale in 5mm increments)

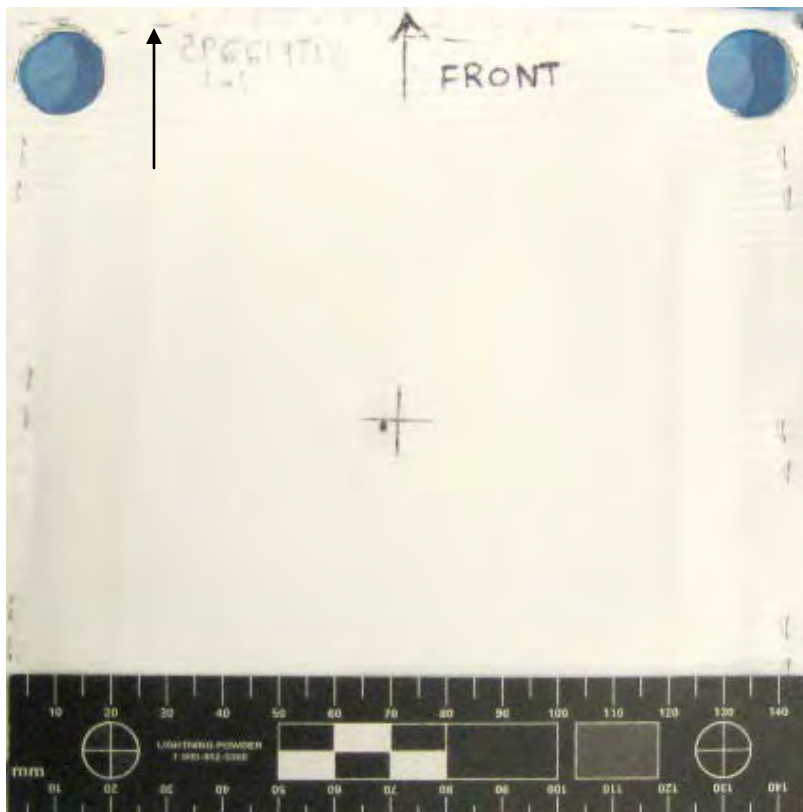
Figure 200 Overall View of Damage to Front of MLI (scale in 5mm increments / black arrow indicates flight path of projectile)

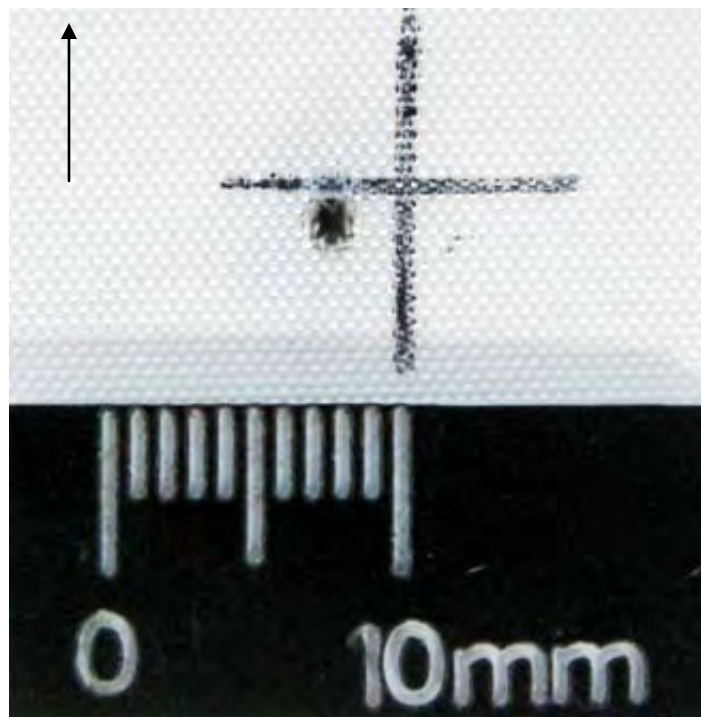
Figure 201 Close-up View of Damage to Front of MLI (scale in 1mm increments / black arrow indicates flight path of projectile)

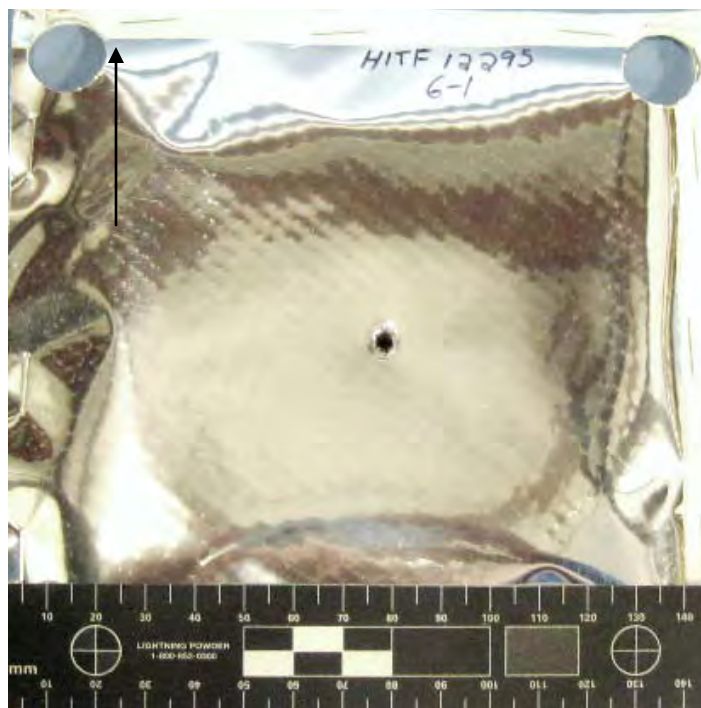
Figure 202 Overall View of Damage to Back Side of MLI (scale in 5mm increments / black arrow indicates flight path of projectile)

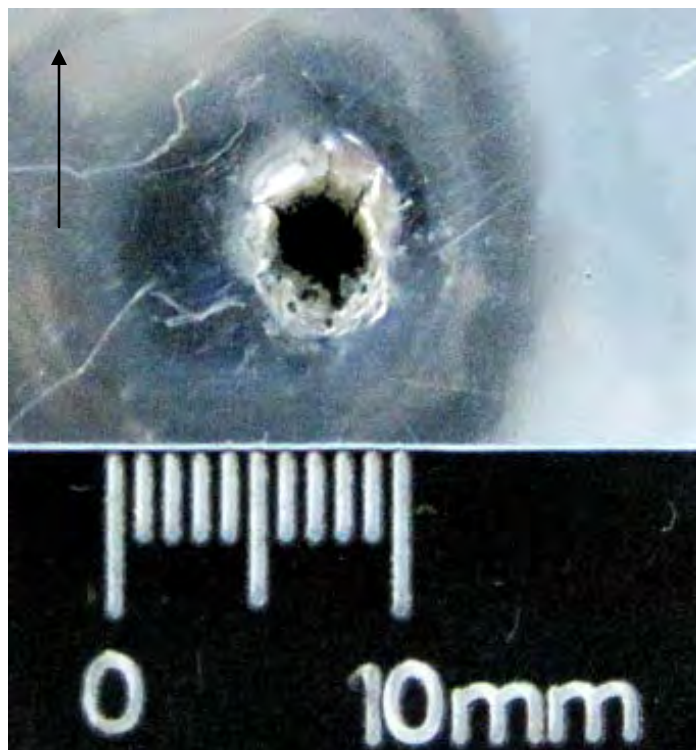
Figure 203 Close-up View of Damage to Back Side of MLI (scale in 1mm increments / black arrow indicates flight path of projectile)

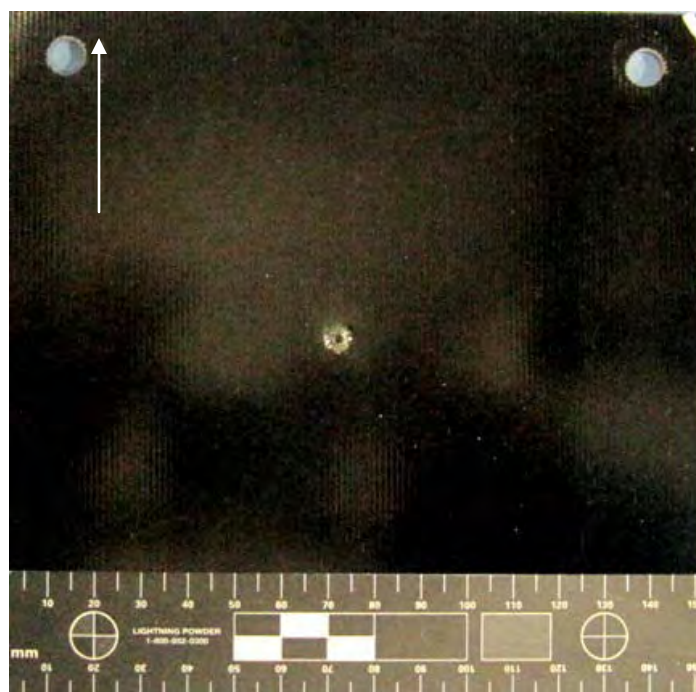
Figure 204 Overall View of Damage to Front of NP 504 Substrate (scale in 5mm increments / white arrow indicates flight path of projectile)

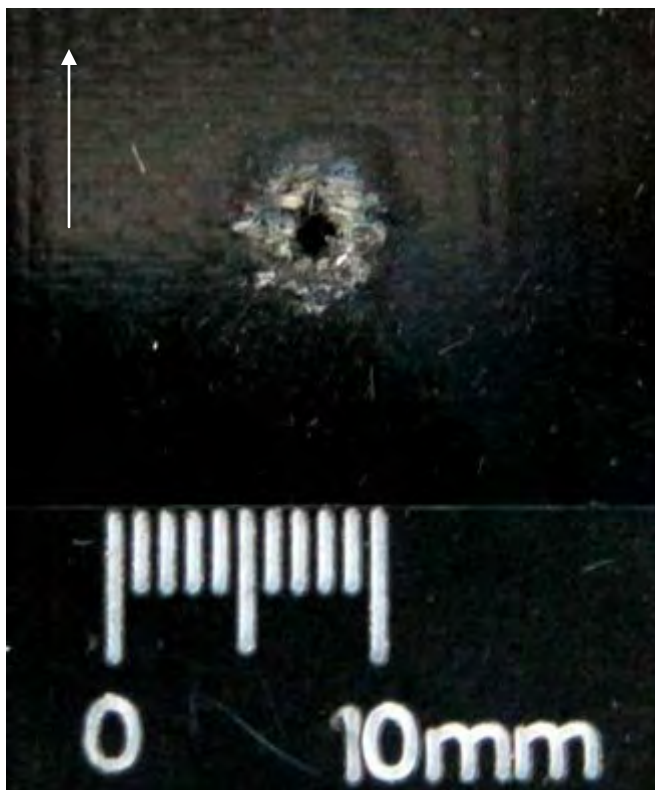
Figure 205 Close-up View of Damage to Front of NP 504 Substrate (scale in 1mm increments / white arrow indicates flight path of projectile)

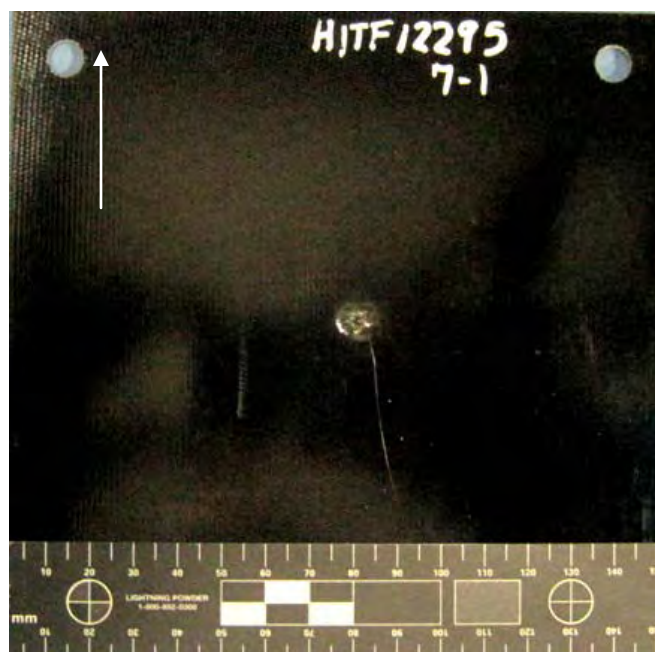
Figure 206 Overall View of Damage to Back Side of NP 504 Substrate (scale in 5mm increments / white arrow indicates flight path of projectile)

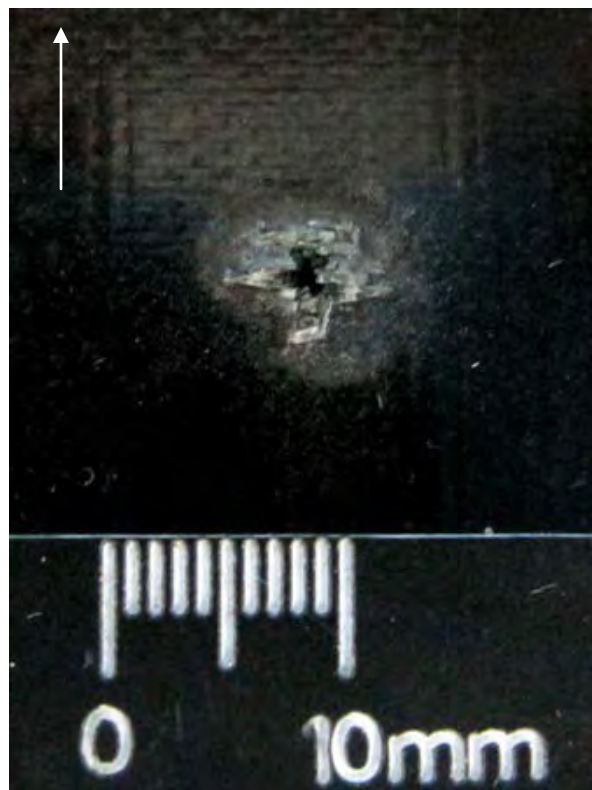
Figure 207 Close-up View of Damage to Back Side of NP 504 Substrate (scale in 1mm increments / white arrow indicates flight path of projectile)

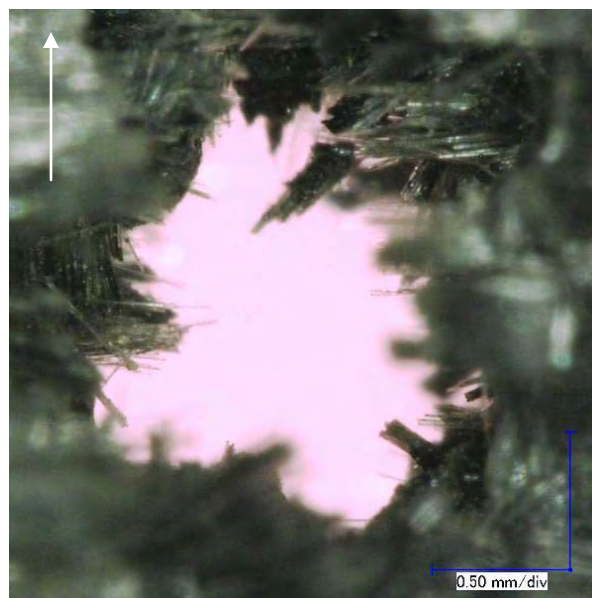
Figure 208 Close-up View of Most Significant Damage to Back Side of NP 504 Substrate (white arrow indicates flight path of projectile / damage within red circle in Figure 207)

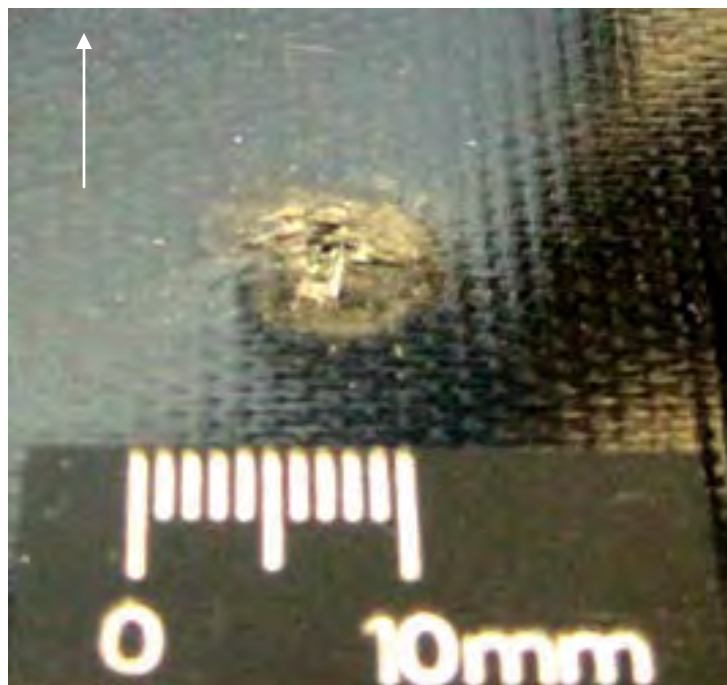
Figure 209 Close-up Oblique Side View of Damage to Back Side of NP 504 Substrate (scale in 1mm increments / white arrow indicates flight path of projectile)

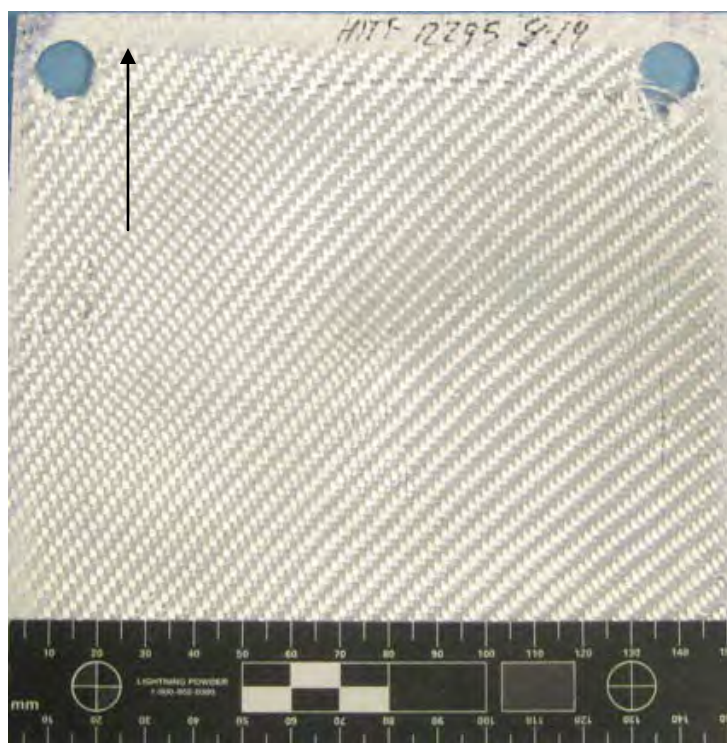
Figure 210 Overall View of Damage to Back Side of Last Fiberglass Layer (scale in 5mm increments / black arrow indicates flight path of projectile)
