International Space Station (ISS) Soyuz Vehicle Descent Module Evaluation of Thermal Protection System (TPS) Penetration Characteristics

Hypervelocity Impact Technology Group

February 2013

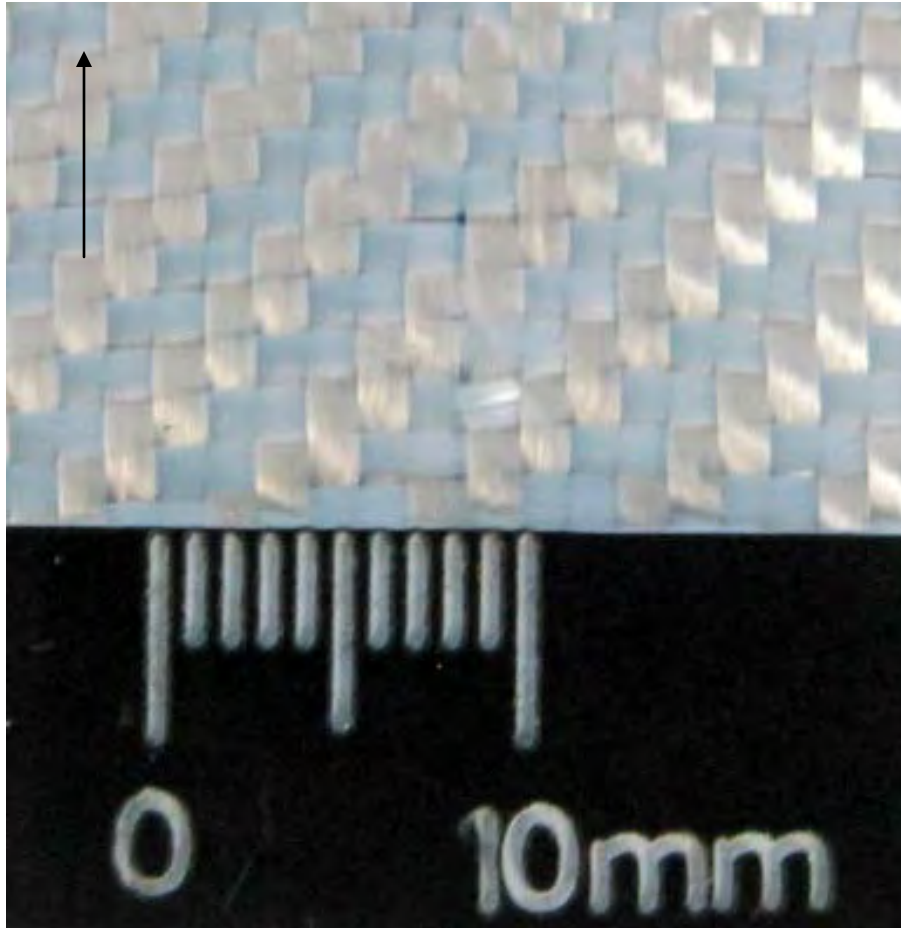
Figure 211 Close-up View of Damage to Back Side of Last Fiberglass Layer (scale in 1mm increments / black arrow indicates flight path of projectile)

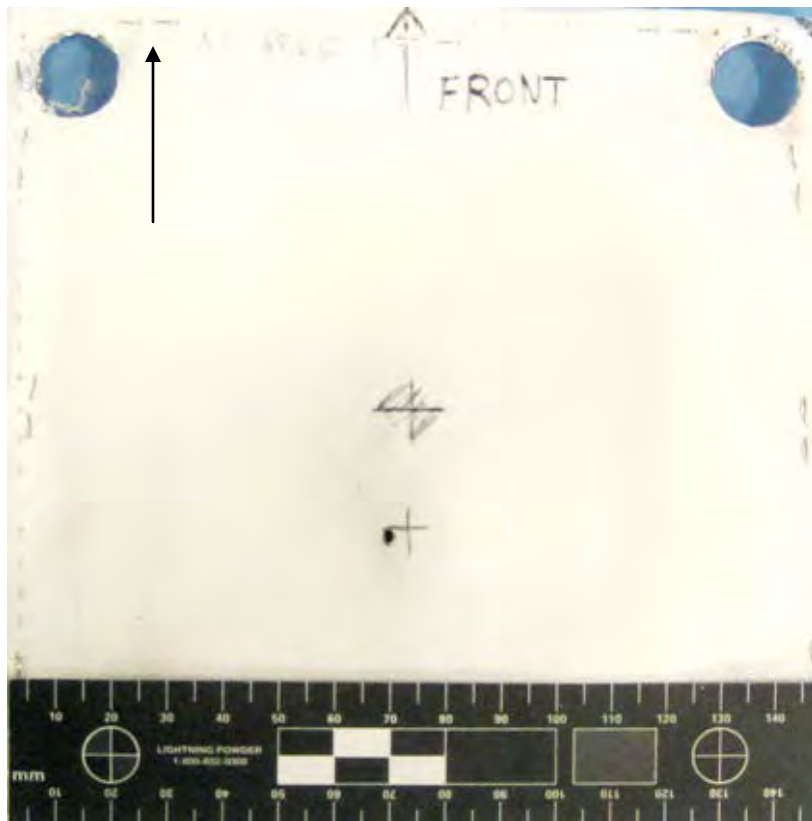
Figure 215 Overall View of Damage to Front of MLI (black arrow indicates flight path of projectile / scale in 5mm increments)

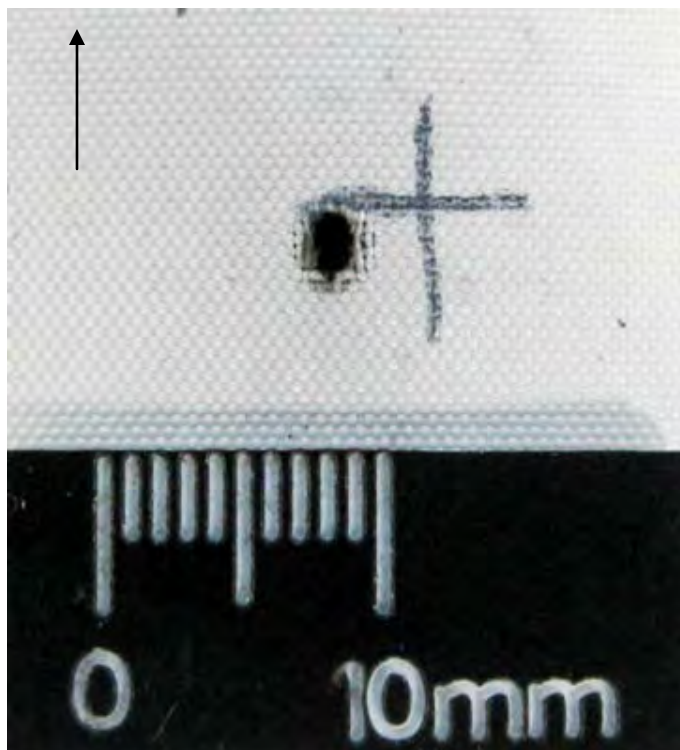
Figure 216 Close-up View of Damage to Front of MLI (scale in 1mm increments / black arrow indicates flight path of projectile)

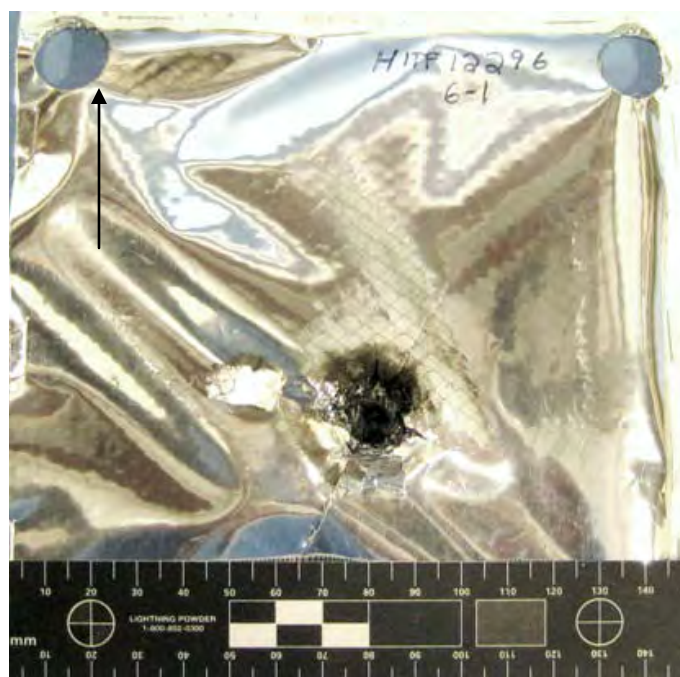
Figure 217 Overall View of Damage to Back Side of MLI (scale in 5mm increments / black arrow indicates flight path of projectile)

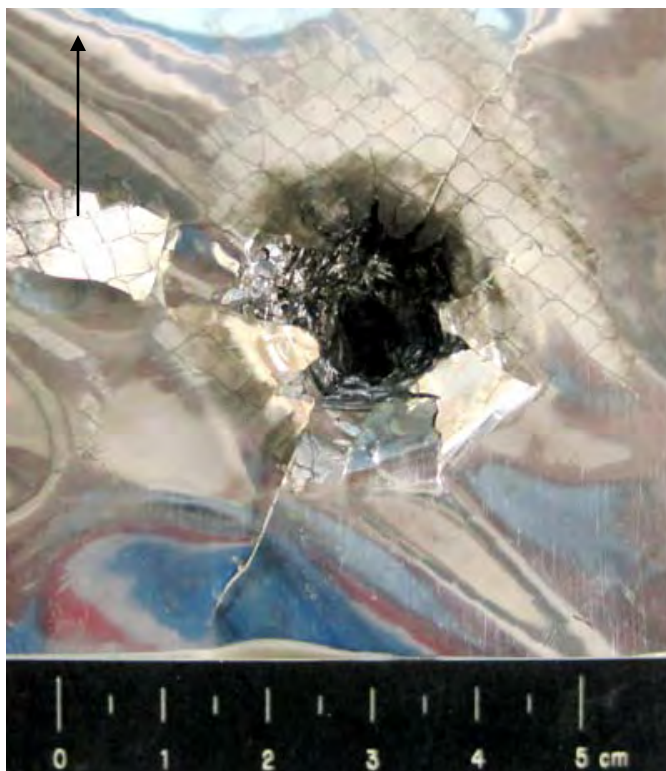
Figure 218 Close-up View of Damage to Back Side of MLI (scale in 5mm increments / black arrow indicates flight path of projectile)

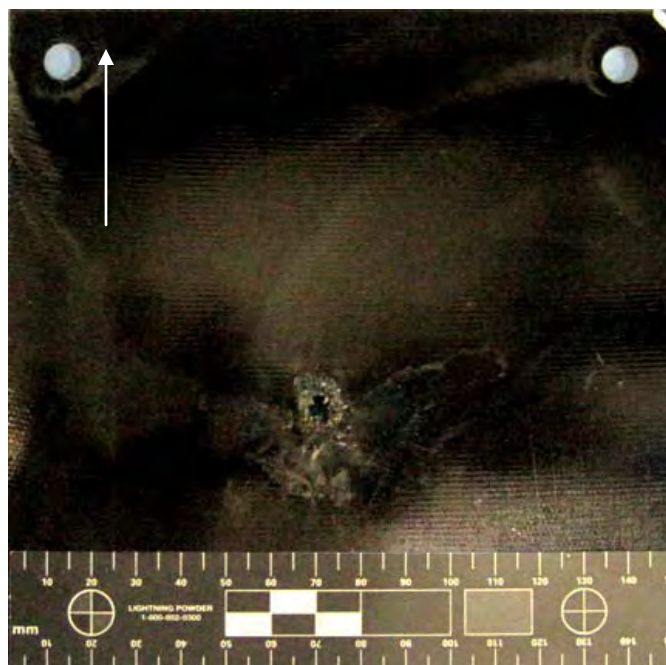
Figure 219 Overall View of Damage to Front of NP 504 Substrate (scale in 5mm increments / white arrow indicates flight path of projectile)

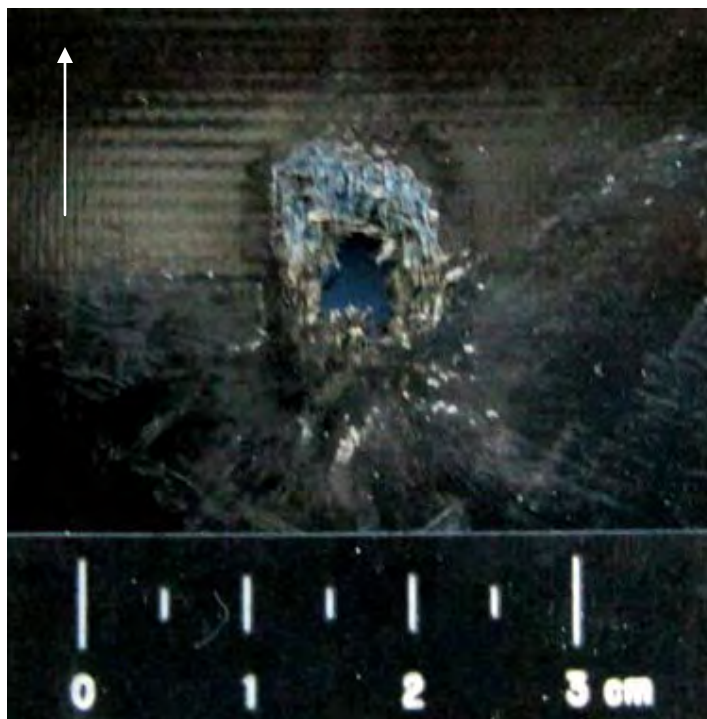
Figure 220 Close-up View of Damage to Front of NP 504 Substrate (scale in 5mm increments / white arrow indicates flight path of projectile)

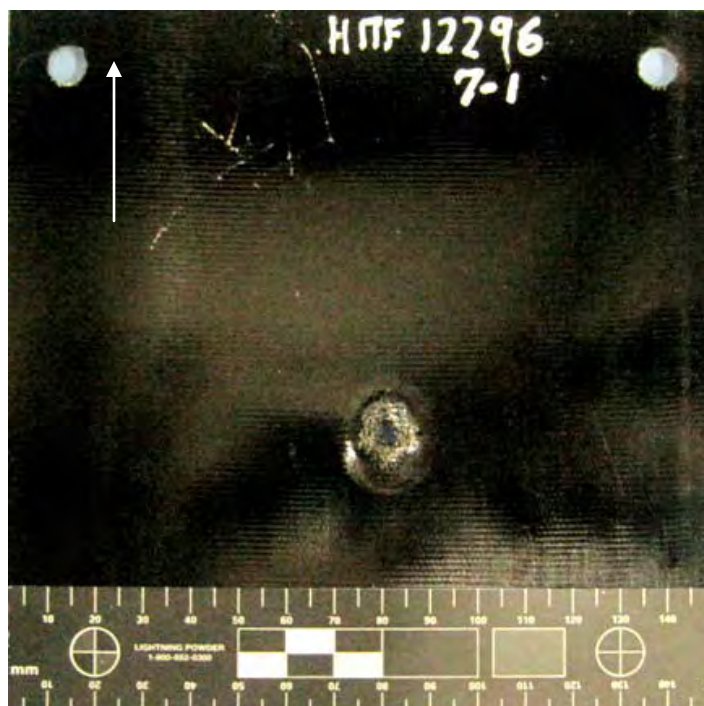
Figure 221 Overall View of Damage to Back Side of NP 504 Substrate (scale in 5mm increments / white arrow indicates flight path of projectile)

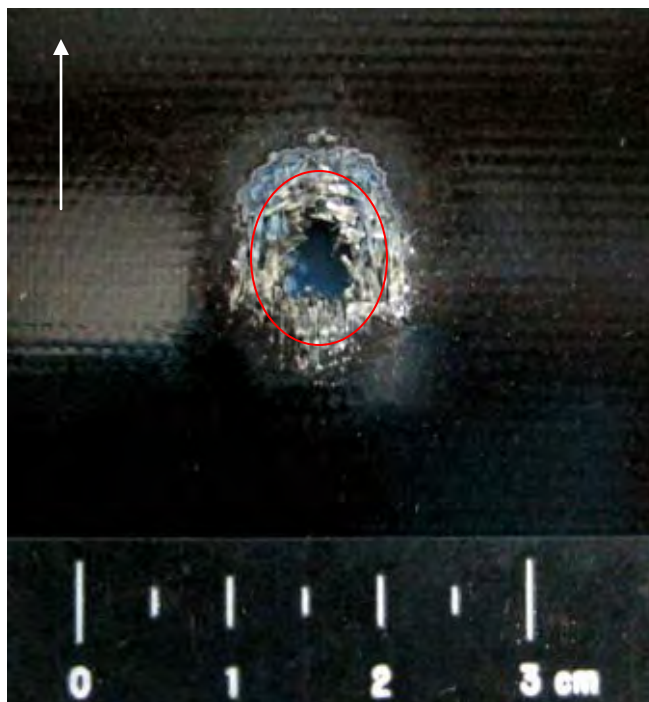
Figure 222 Close-up View of Damage to Back Side of NP 504 Substrate (scale in 1mm increments / white arrow indicates flight path of projectile)

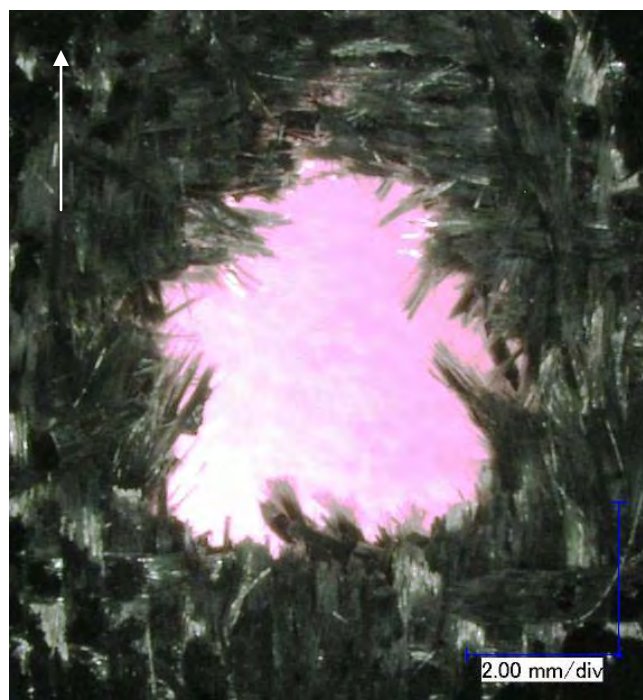
Figure 223 Close-up View of Most Significant Damage to Back Side of NP 504 Substrate (black arrow indicates flight path of projectile / damage within red circle in Figure 222)

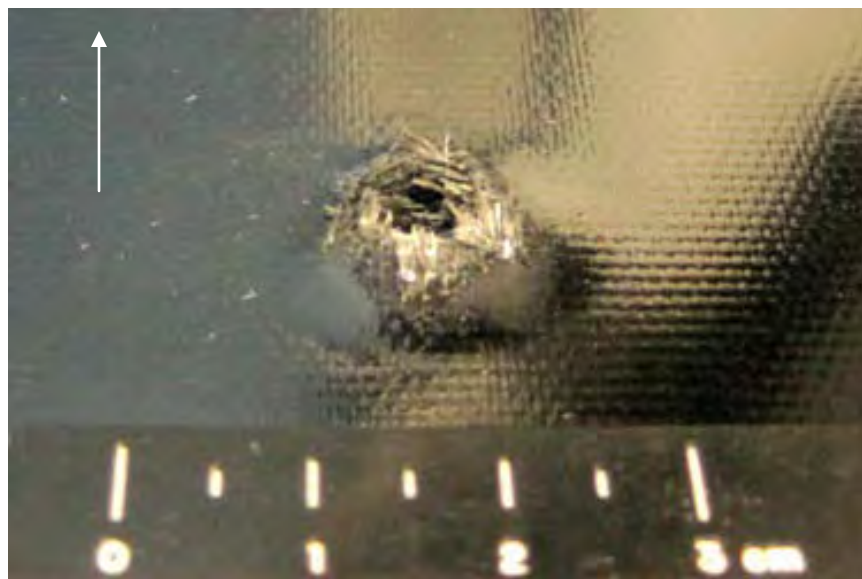
Figure 224 Close-up Oblique Side View of Damage to Back Side of NP 504 Substrate (scale in 5mm increments / white arrow indicates flight path of projectile)

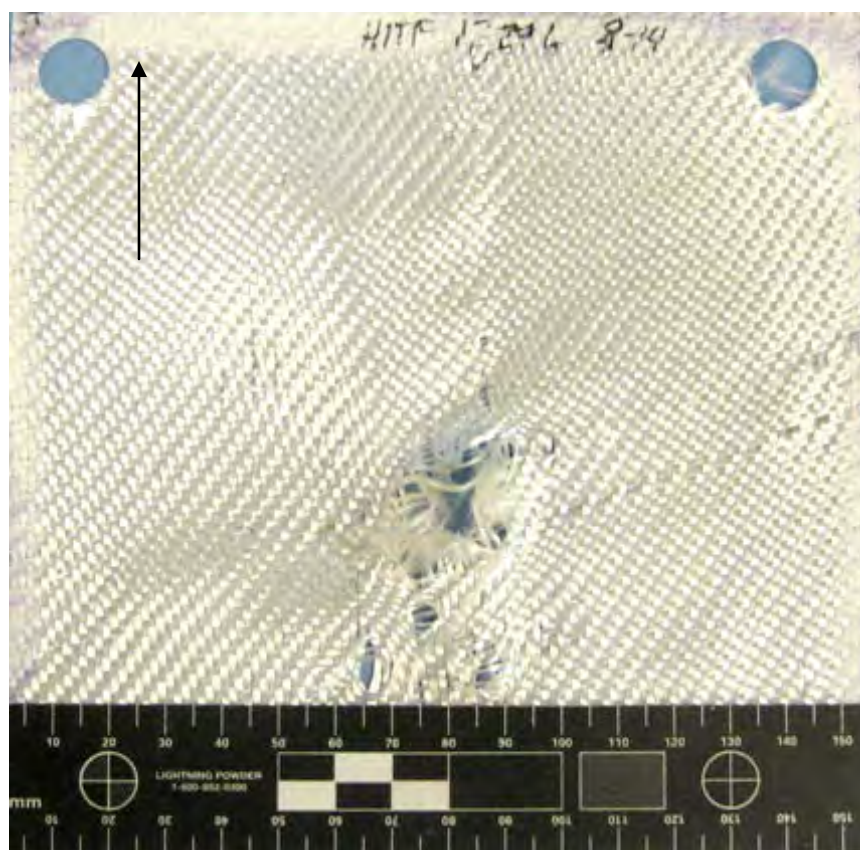
Figure 225 Overall View of Damage to Back Side of Last Fiberglass Layer (scale in 5mm increments / black arrow indicates flight path of projectile)

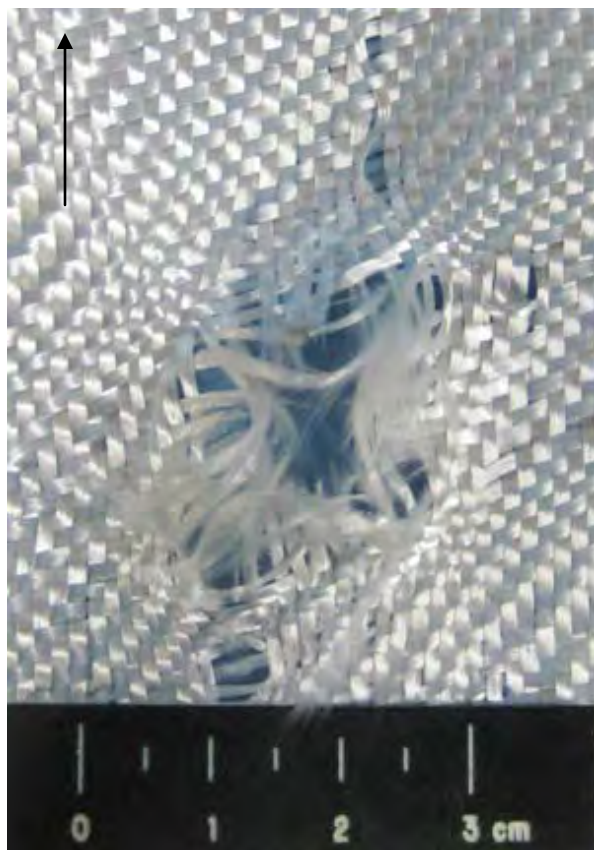
Figure 226 Close-up View of Damage to Back Side of Last Fiberglass Layer (scale in 5mm increments / black arrow indicates flight path of projectile)

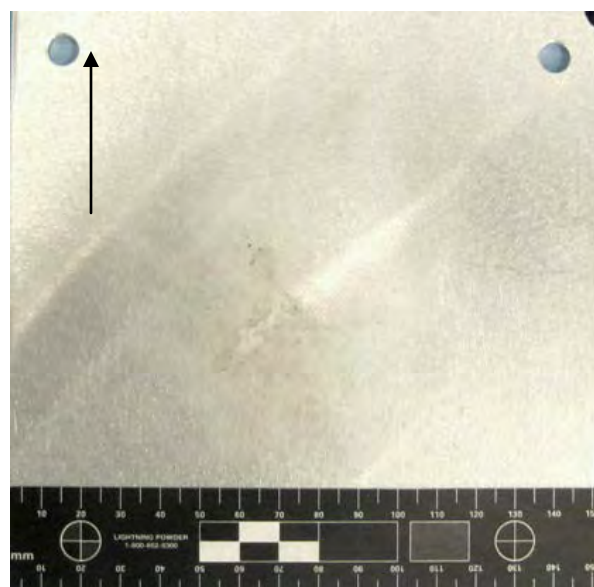
Figure 227 Overall View of Damage to Front of Rear Wall (scale in 5mm increments / black arrow indicates flight path of projectile)

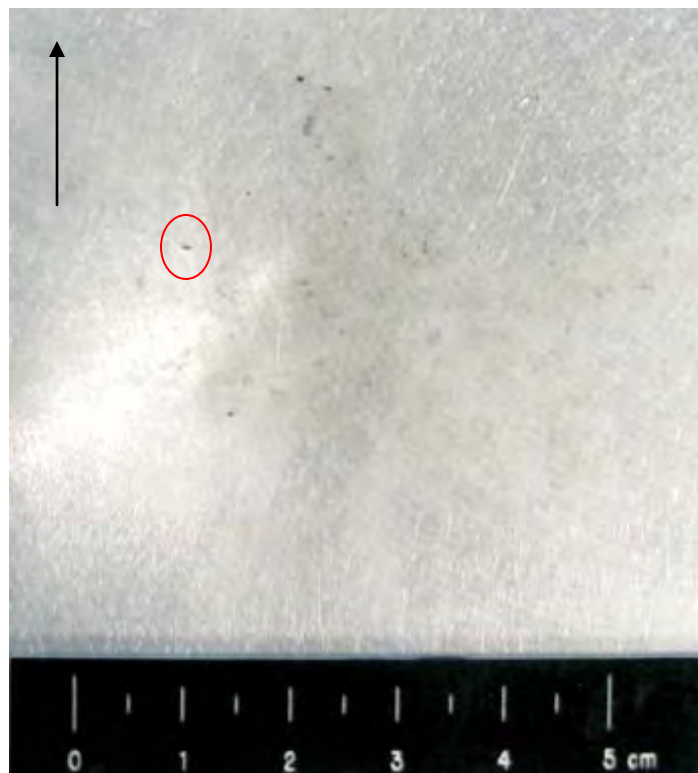
Figure 228 Close-up View of Damage to Front of Rear Wall (scale in 5mm increments / black arrow indicates flight path of projectile)

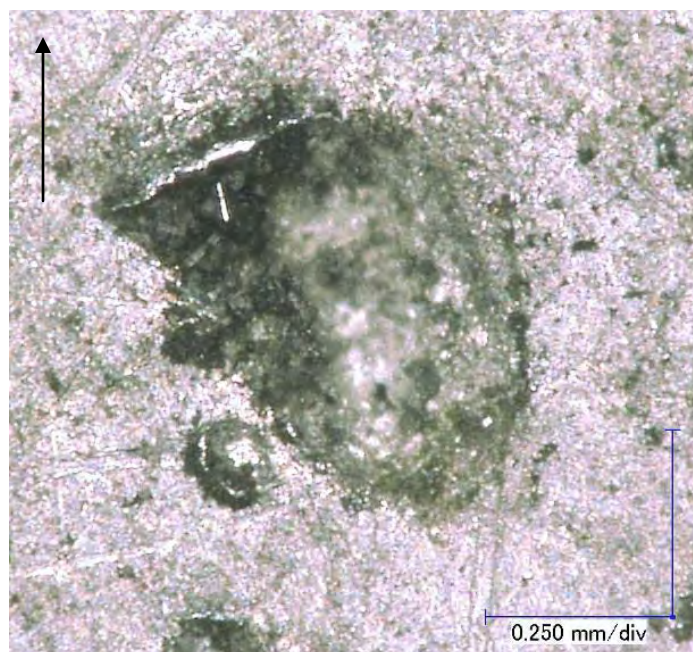
Figure 229 Close-up View of Most Significant Damage to Front of Rear Wall (black arrow indicates flight path of projectile / damage within red circle in Figure 241)

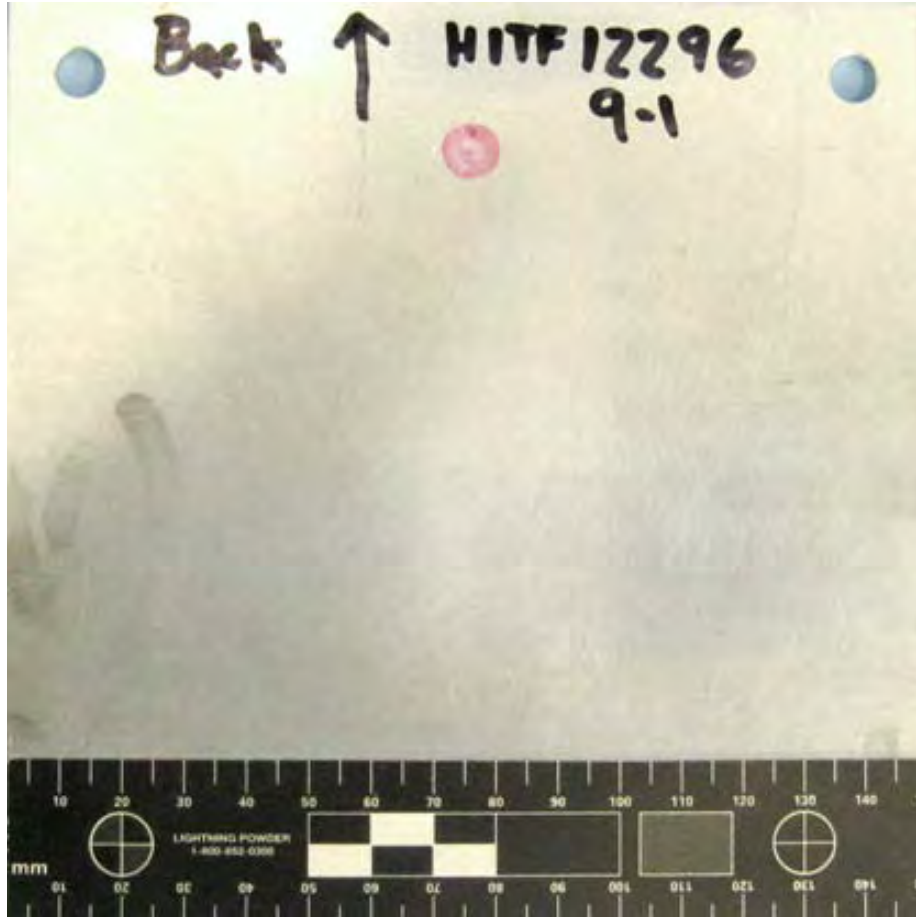
Figure 230 Overall View of Back Side of Rear Wall (scale in 5mm increments / black arrow indicates flight path of projectile)

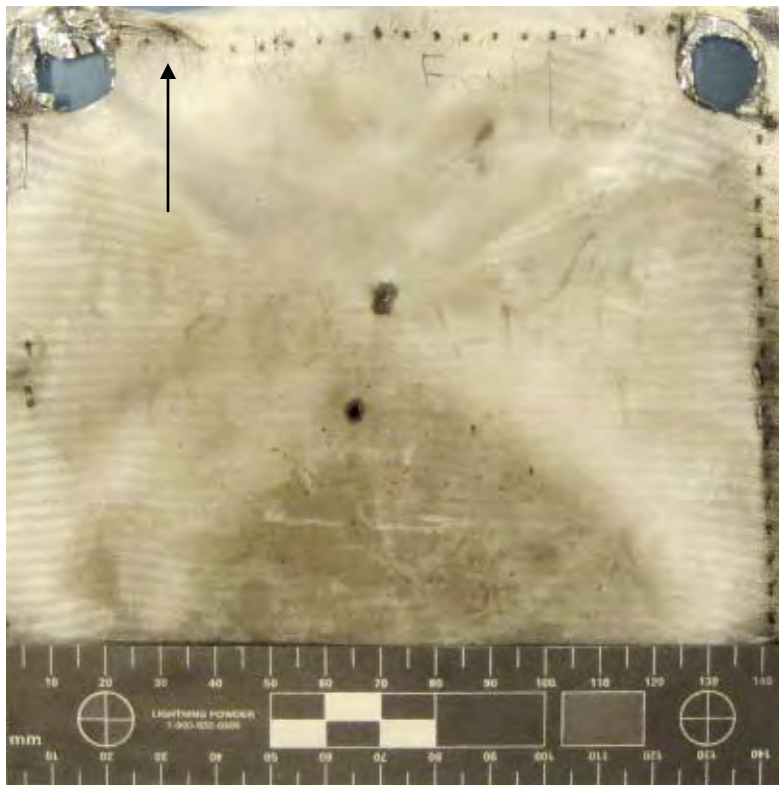
Figure 234 Overall View of Damage to Front of MLI (black arrow indicates flight path of projectile / scale in 5mm increments)

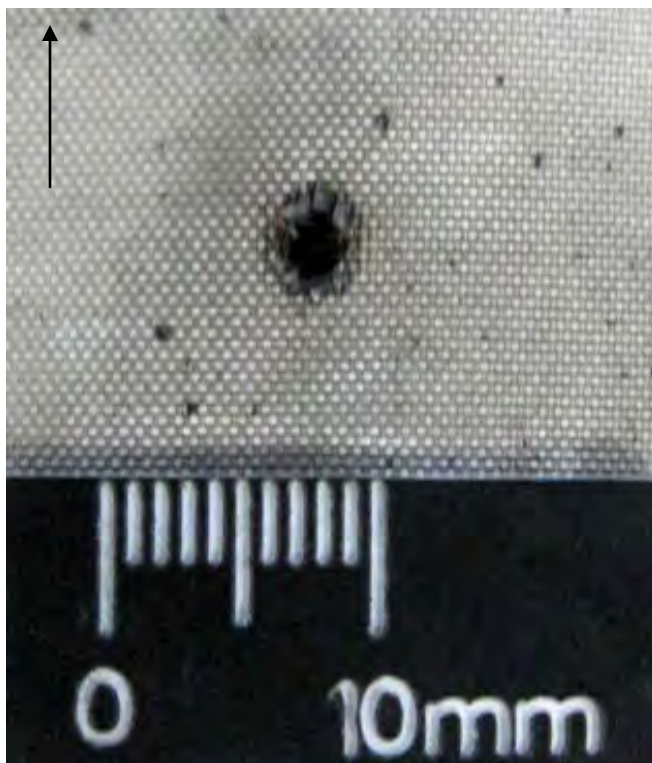
Figure 235 Close-up View of Damage to Front of MLI (scale in 1mm increments / black arrow indicates flight path of projectile)

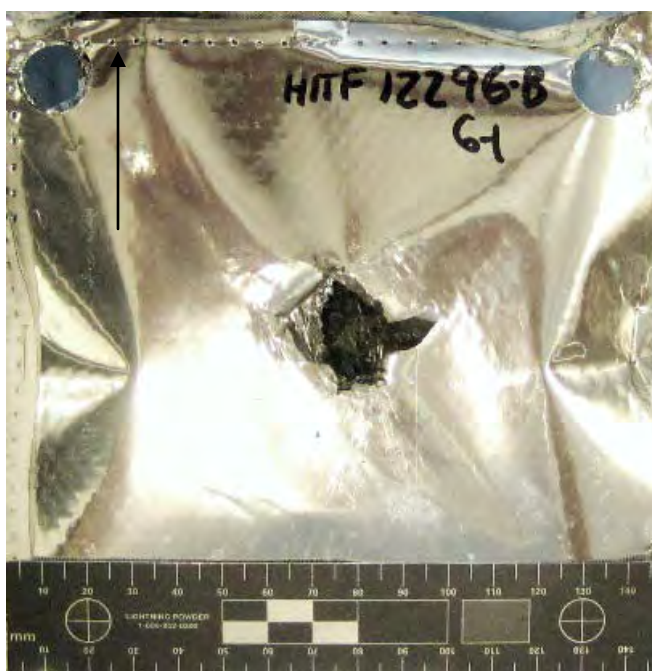
Figure 236 Overall View of Damage to Back Side of MLI (scale in 5mm increments / black arrow indicates flight path of projectile)

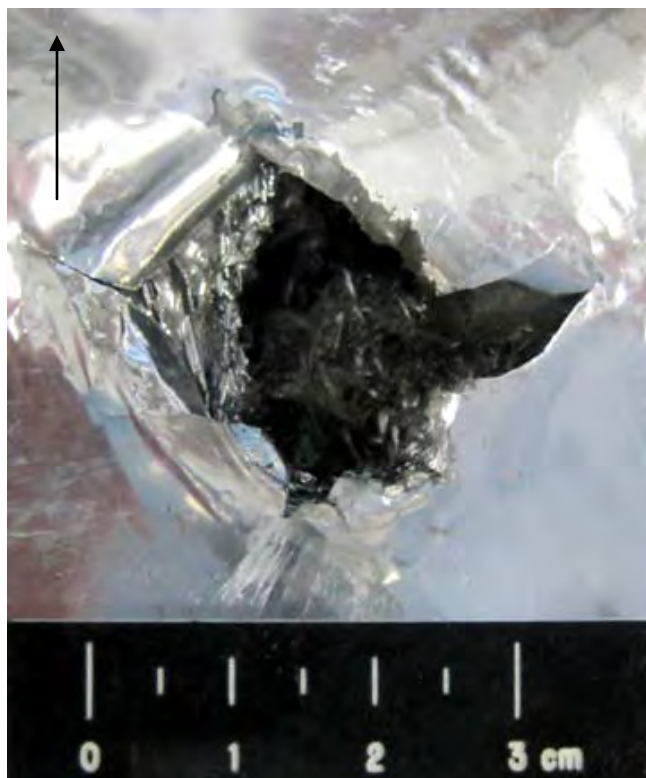
Figure 237 Close-up View of Damage to Back Side of MLI (scale in 5mm increments / black arrow indicates flight path of projectile)

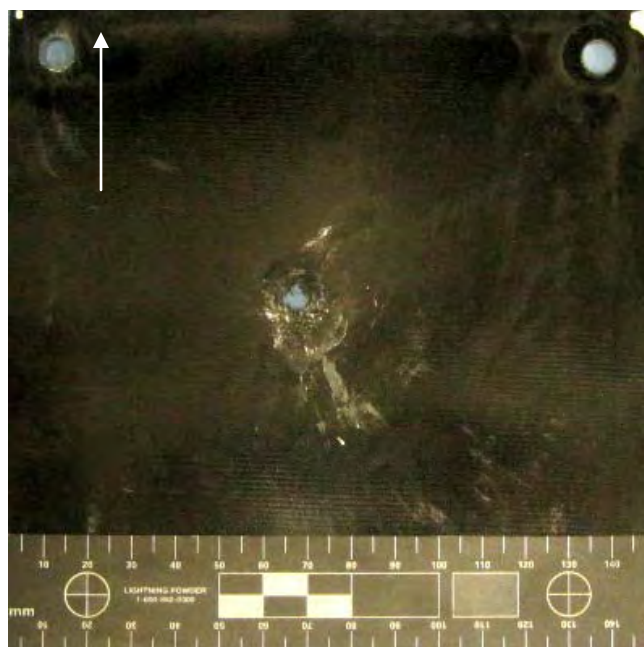
Figure 238 Overall View of Damage to Front of NP 504 Substrate (scale in 5mm increments / white arrow indicates flight path of projectile)

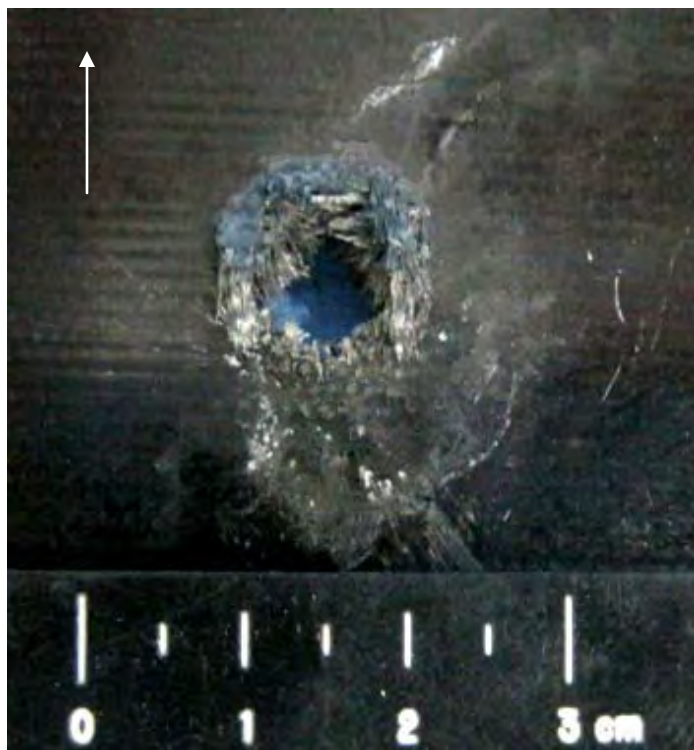
Figure 239 Close-up View of Damage to Front of NP 504 Substrate (scale in 5mm increments / white arrow indicates flight path of projectile)

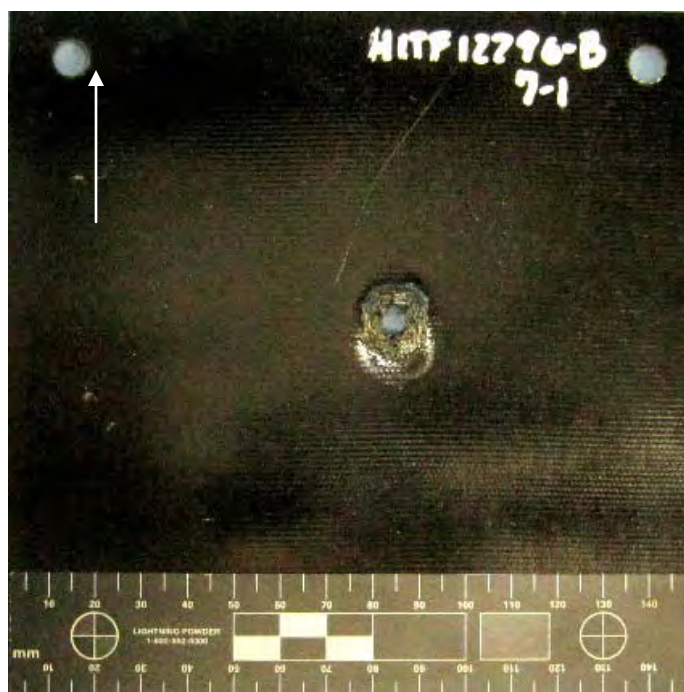
Figure 240 Overall View of Damage to Back Side of NP 504 Substrate (scale in 5mm increments / white arrow indicates flight path of projectile)

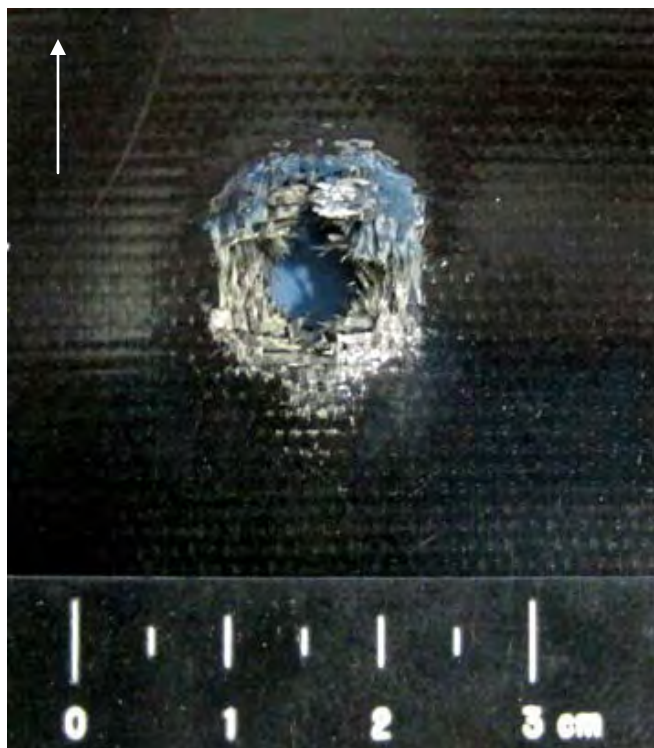
Figure 241 Close-up View of Damage to Back Side of NP 504 Substrate (scale in 1mm increments / white arrow indicates flight path of projectile)

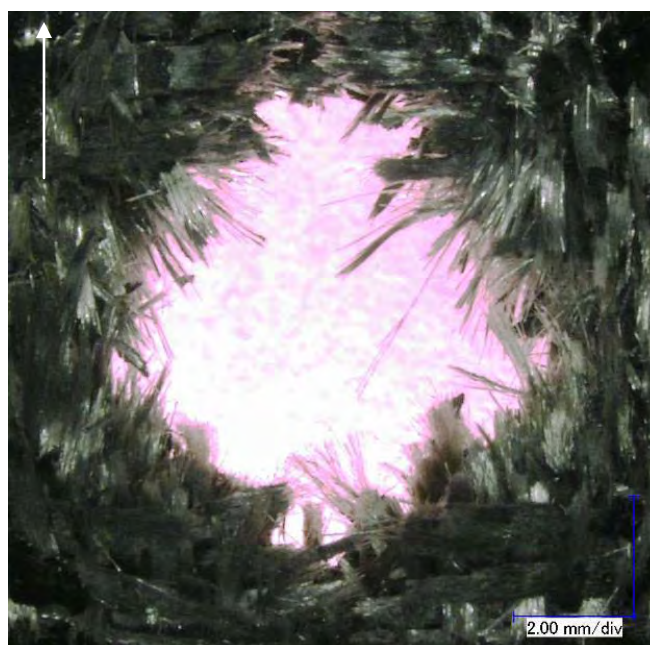
Figure 242 Close-up View of Most Significant Damage to Back Side of NP 504 Substrate (black arrow indicates flight path of projectile / damage within red circle in Figure 241)

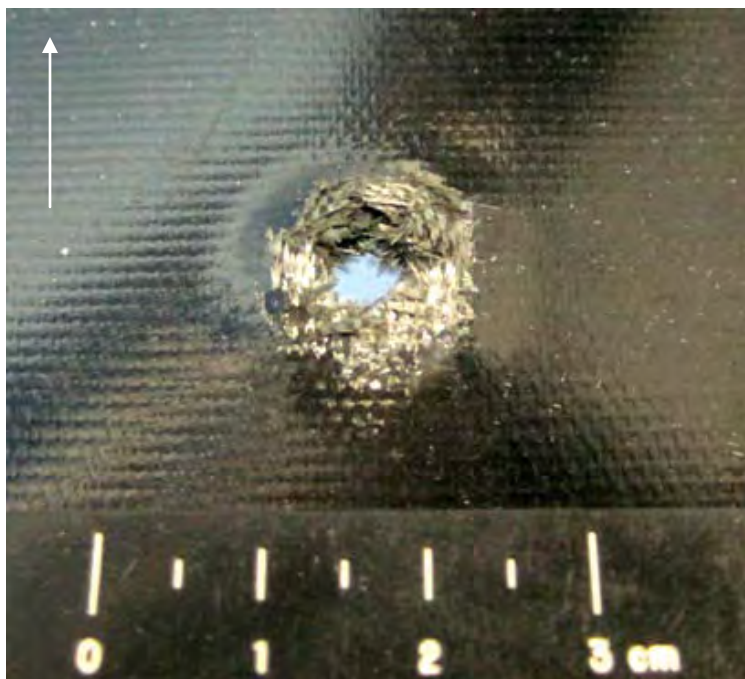
Figure 243 Close-up Oblique Side View of Damage to Back Side of NP 504 Substrate (scale in 5mm increments / white arrow indicates flight path of projectile)

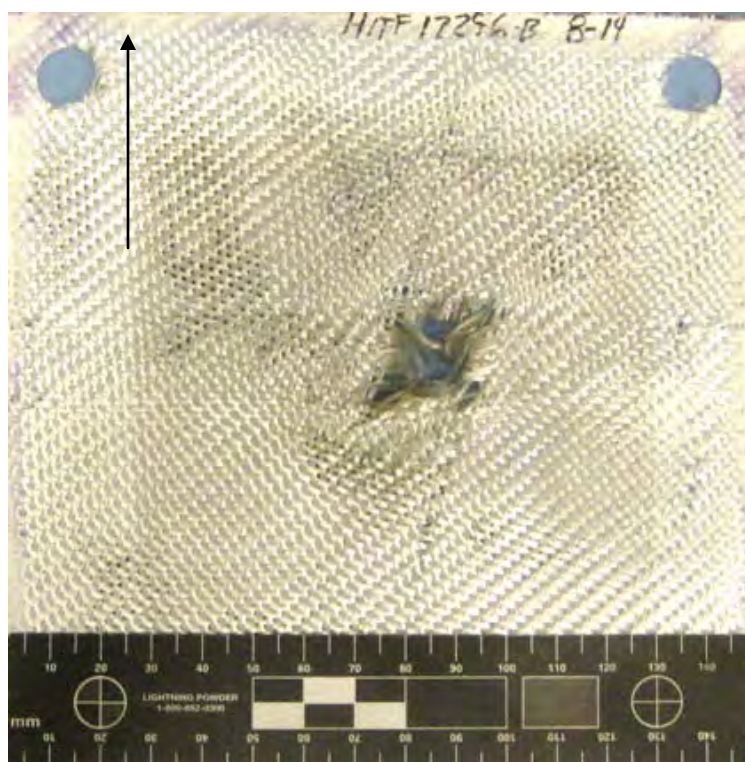
Figure 244 Overall View of Damage to Back Side of Last Fiberglass Layer (scale in 5mm increments / black arrow indicates flight path of projectile)

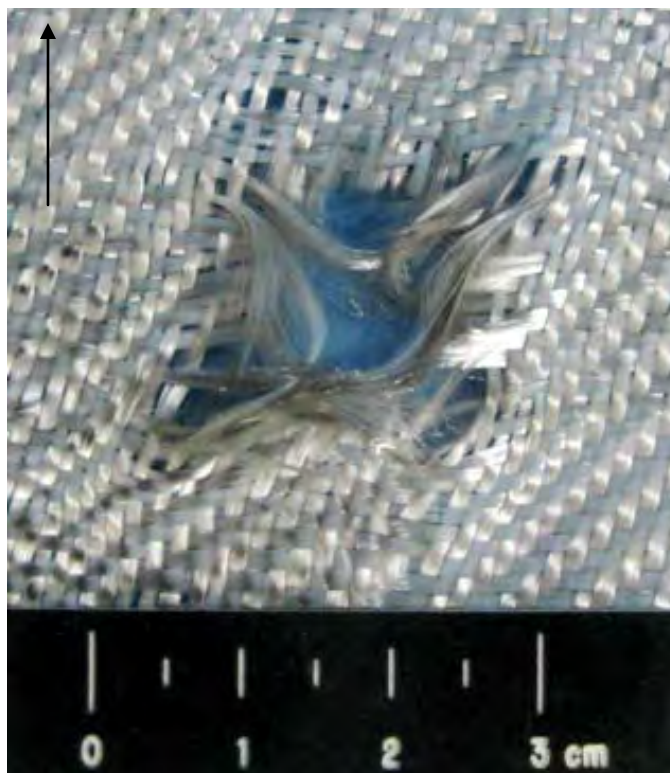
Figure 245 Close-up View of Damage to Back Side of Last Fiberglass Layer (scale in 5mm increments / black arrow indicates flight path of projectile)

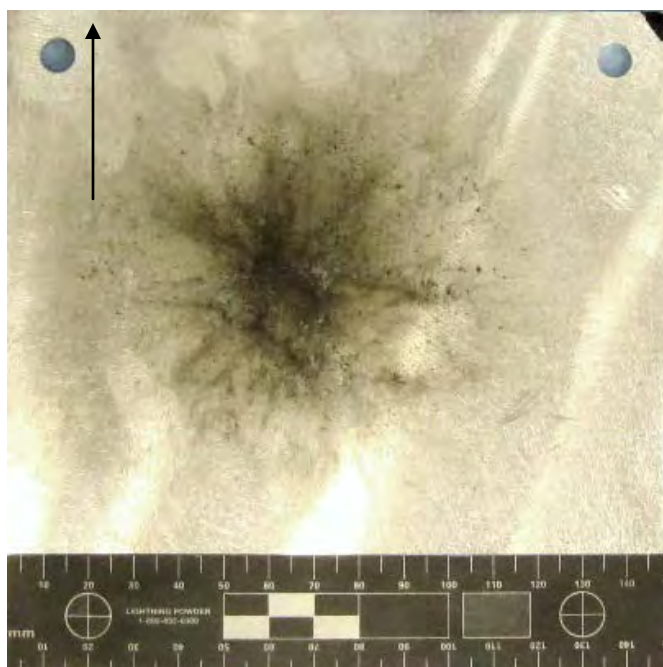
Figure 246 Overall View of Damage to Front of Rear Wall (scale in 5mm increments / black arrow indicates flight path of projectile / uncleaned)

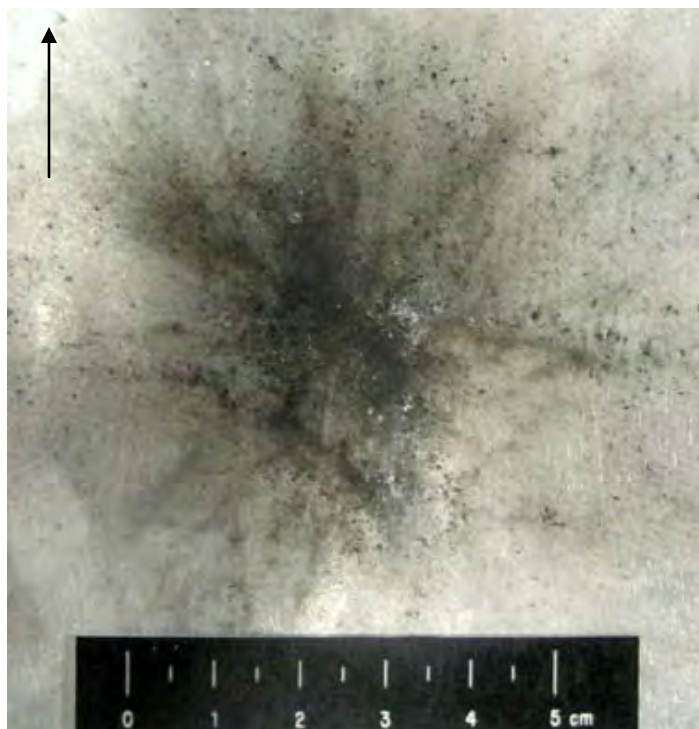
Figure 247 Close-up View of Damage to Front of Rear Wall (scale in 5mm increments / black arrow indicates flight path of projectile / uncleaned)

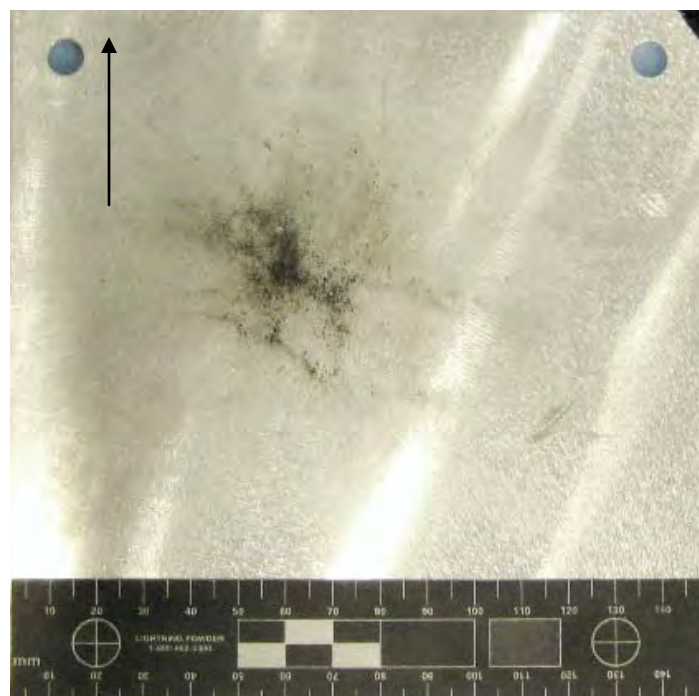
Figure 248 Overall View of Damage to Front of Rear Wall (scale in 5mm increments / black arrow indicates flight path of projectile / cleaned)

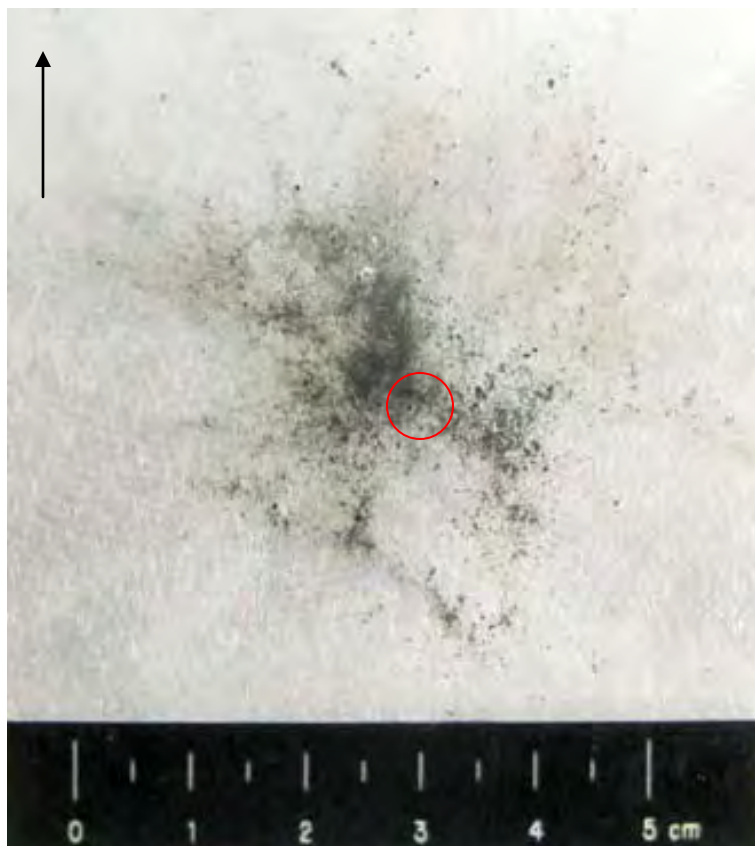
Figure 249 Close-up View of Damage to Front of Rear Wall (scale in 5mm increments / black arrow indicates flight path of projectile / cleaned)

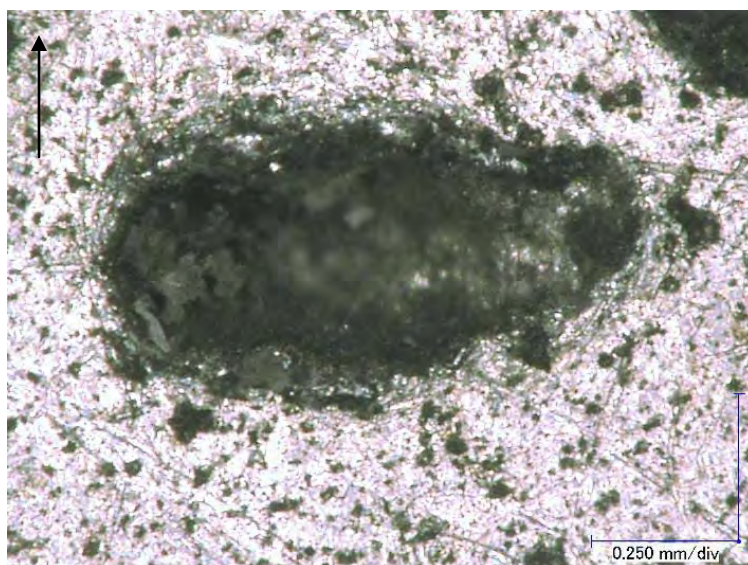
Figure 250 Close-up View of Most Significant Damage to Front of Rear Wall (black arrow indicates flight path of projectile / damage within red circle in Figure 249)

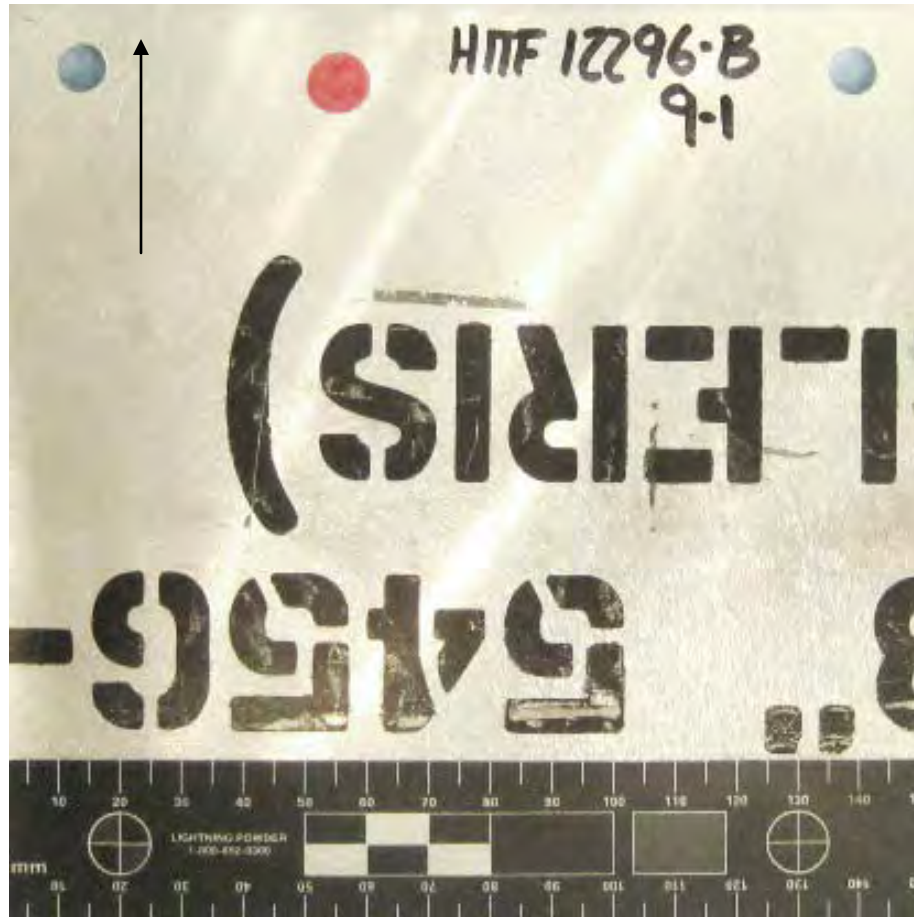
Figure 251 Overall View of Back Side of Rear Wall (scale in 5mm increments / black arrow indicates flight path of projectile)

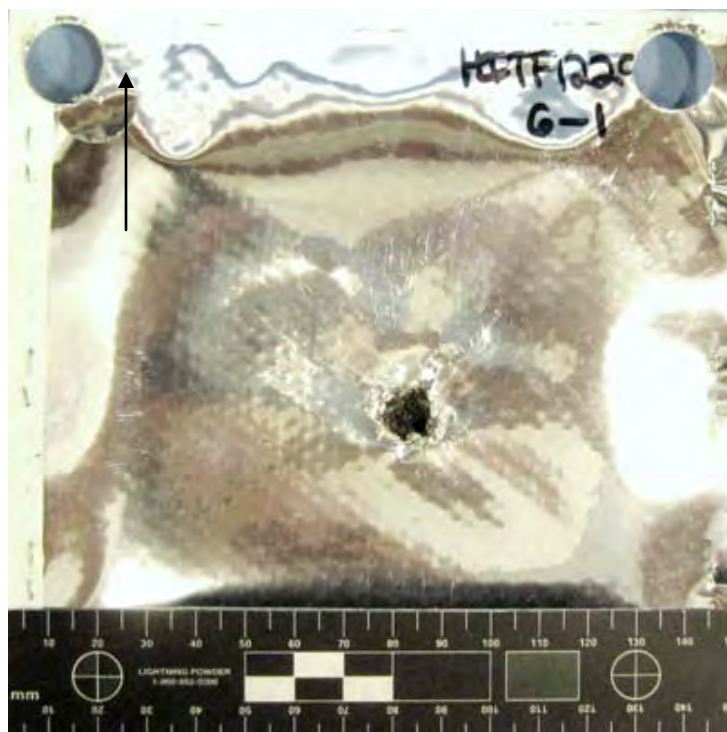
Figure 258 Close-up View of Damage to Back Side of MLI (scale in 5mm increments / black arrow indicates flight path of projectile)

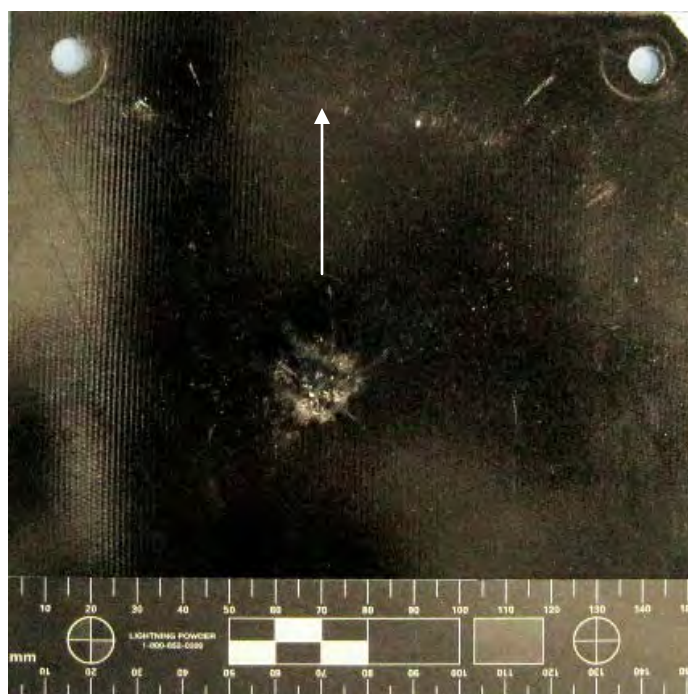
Figure 260 Close-up View of Damage to Front of NP 504 Substrate (scale in 5mm increments / white arrow indicates flight path of projectile)

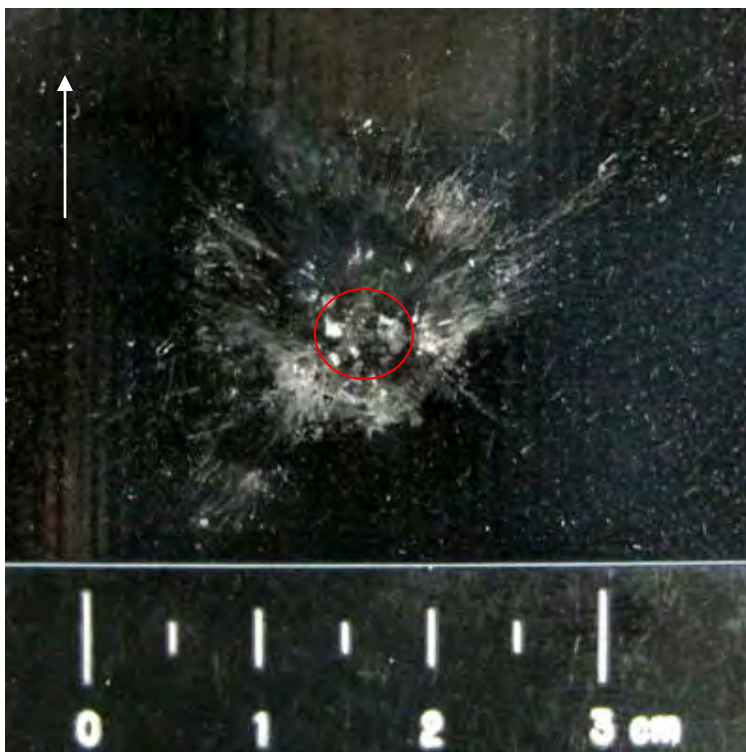
Figure 261 Close-up View of Most Significant Damage to Front of NP 504 Substrate (black arrow indicates flight path of projectile / damage within red circle in Figure 260)

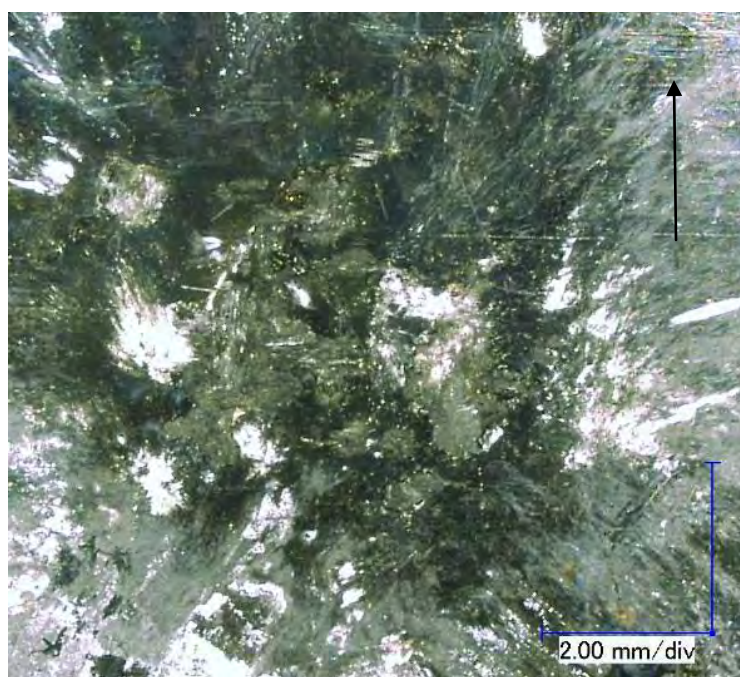
Figure 262 Overall View of Back Side of NP 504 Substrate (scale in 5mm increments / white arrow indicates flight path of projectile)

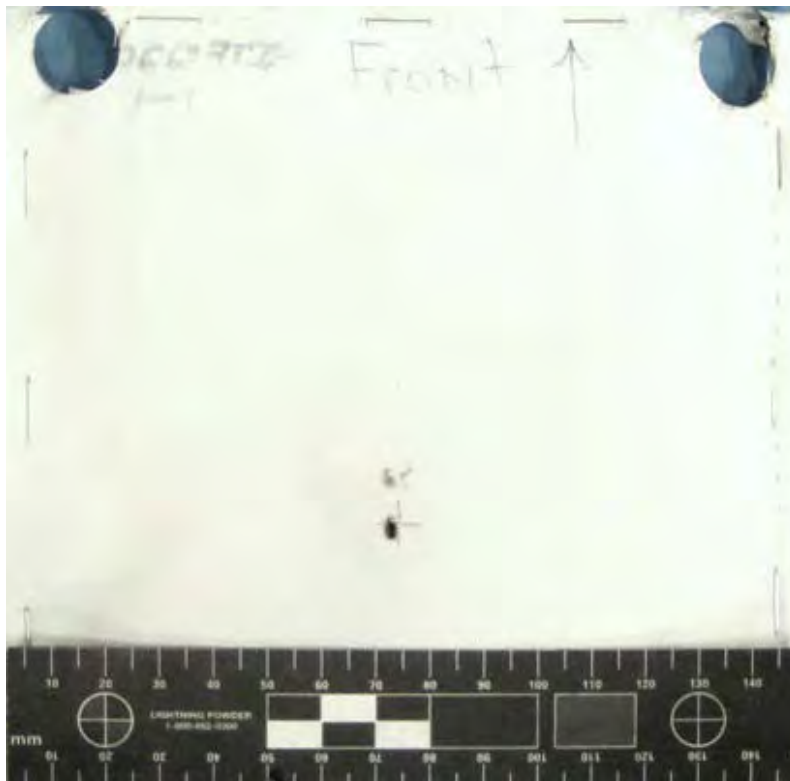
Figure 267 Close-up View of Damage to Front of MLI (scale in 1mm increments / black arrow indicates flight path of projectile / projectile impacted within red circle)
