International Space Station (ISS) Soyuz Vehicle Descent Module Evaluation of Thermal Protection System (TPS) Penetration Characteristics

Hypervelocity Impact Technology Group

February 2013

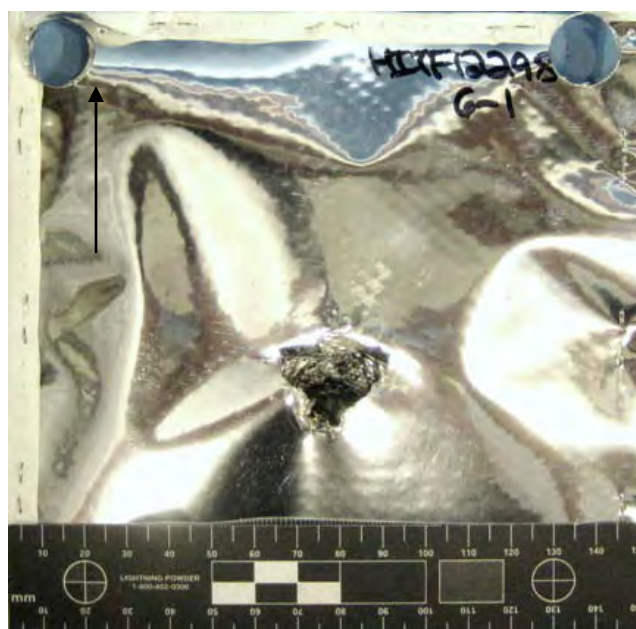
Figure 269 Close-up View of Damage to Back Side of MLI (scale in 5mm increments / black arrow indicates flight path of projectile)

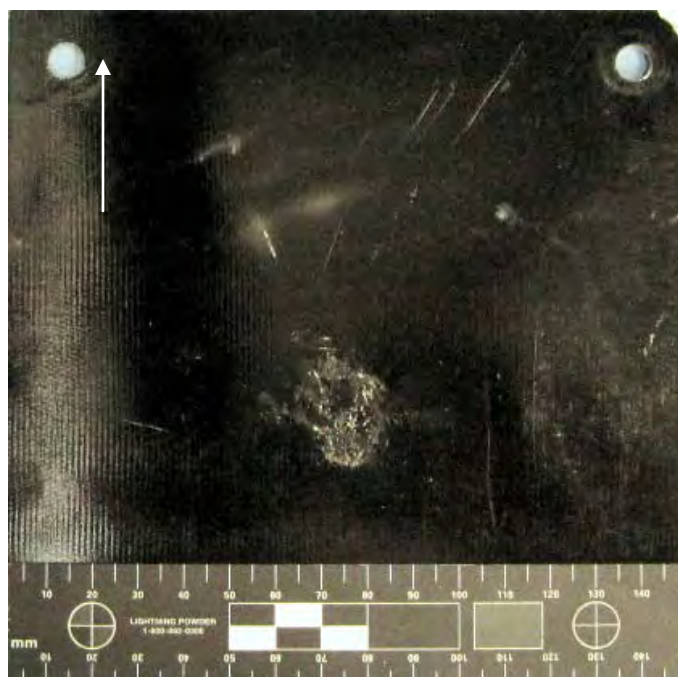
Figure 271 Close-up View of Damage to Front of NP 504 Substrate (scale in 5mm increments / white arrow indicates flight path of projectile)

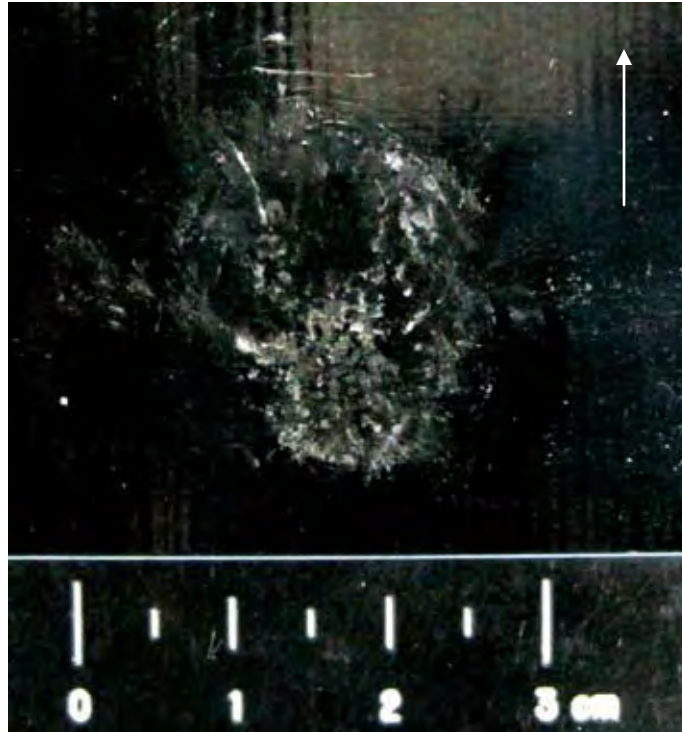
Figure 272 Overall View of Damage to Back Side of NP 504 Substrate (scale in 5mm increments / white arrow indicates flight path of projectile)

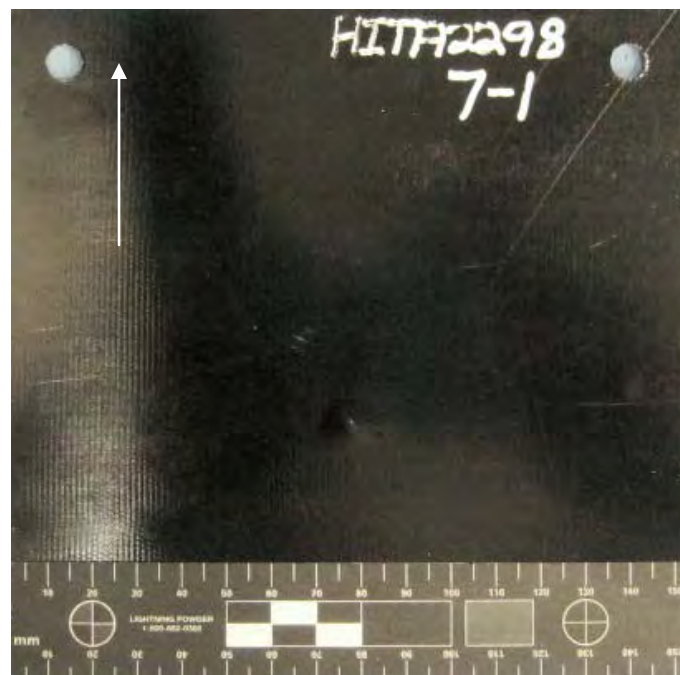
Figure 273 Close-up View of Damage to Back Side of NP 504 Substrate (scale in 1mm increments / white arrow indicates flight path of projectile)

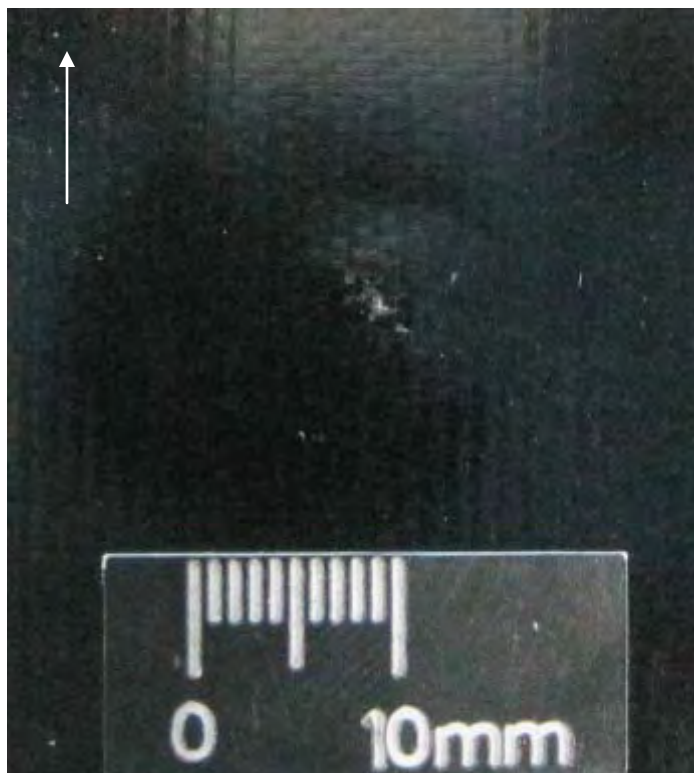
Figure 274 Close-up View of Most Significant Damage to Back Side of NP 504 Substrate (white arrow indicates flight path of projectile / damage within red circle in Figure 273)

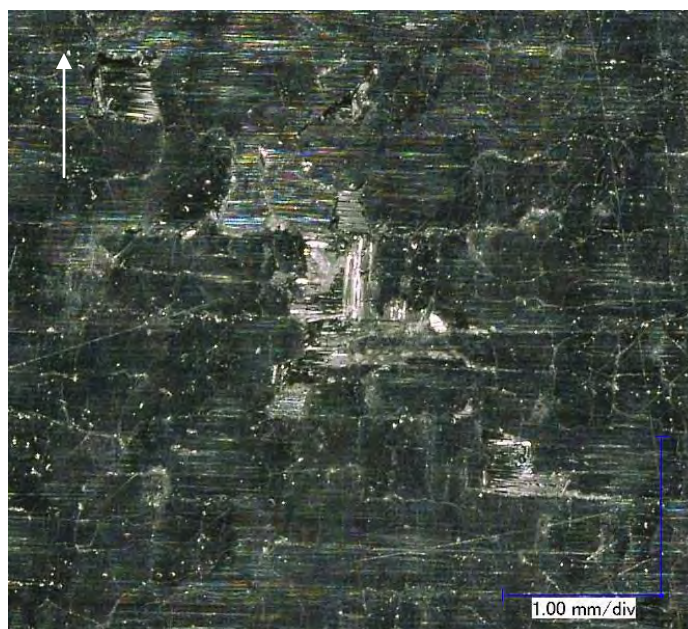
Figure 275 Close-up Oblique Side View of Damage to Back Side of NP 504 Substrate (scale in 1mm increments / white arrow indicates flight path of projectile)

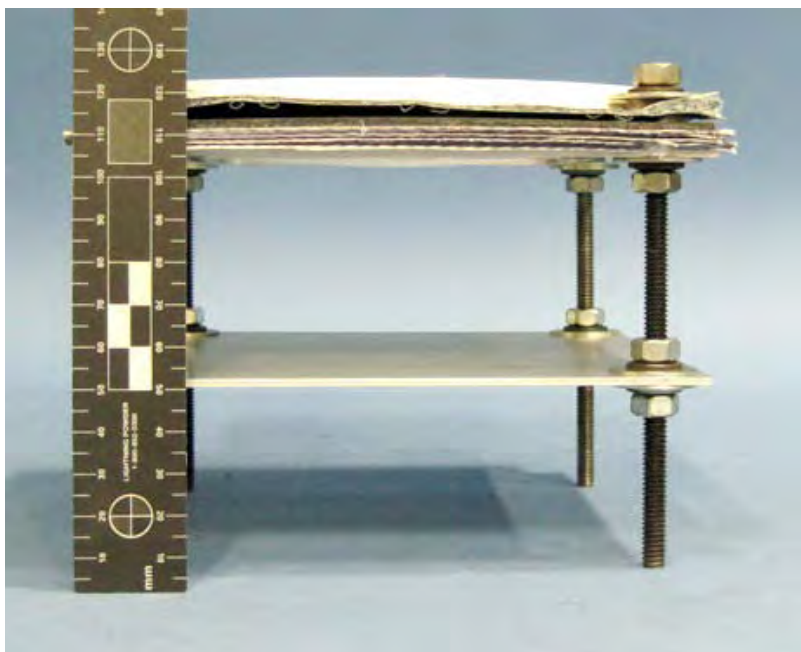
Figure 279 Overall View of Damage to Front of MLI (scale in 5mm increments / black arrow indicates flight path of projectile)

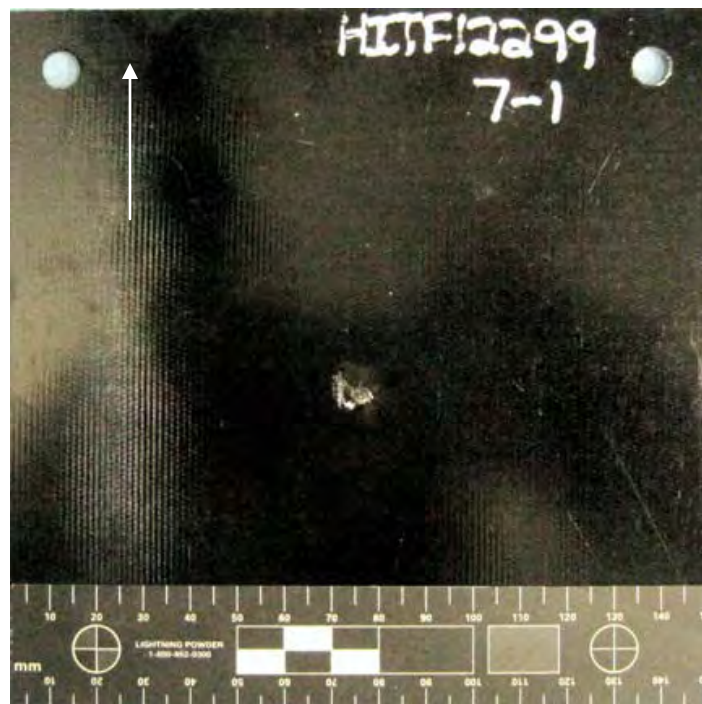
Figure 286 Close-up View of Damage to Back Side of NP 504 Substrate (scale in 1mm increments / white arrow indicates flight path of projectile)

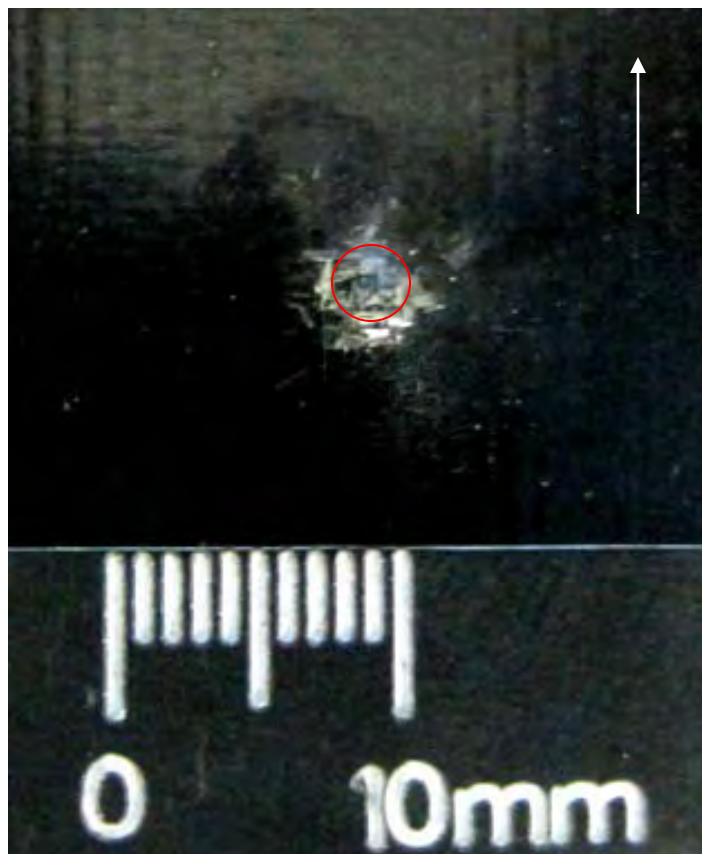
Figure 287 Close-up View of Most Significant Damage to Back Side of NP 504 Substrate (black arrow indicates flight path of projectile / damage within red circle in Figure 286)

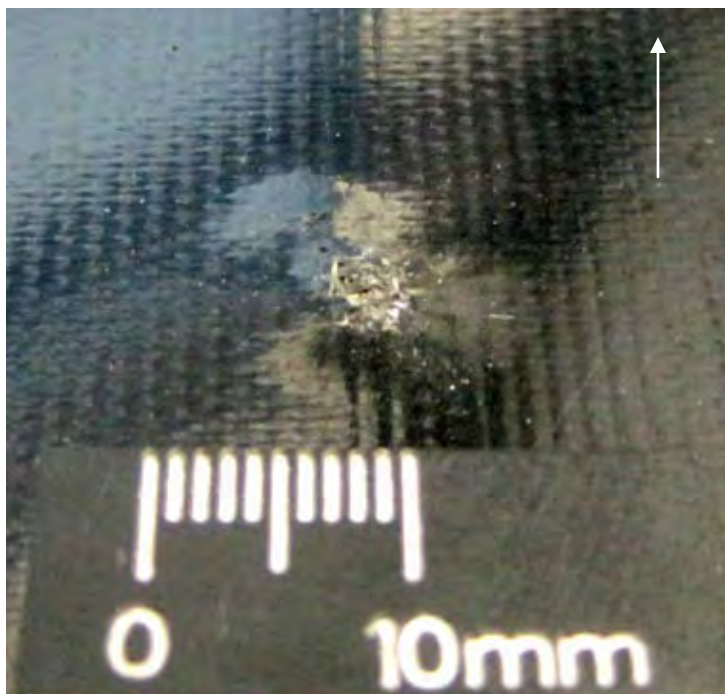
Figure 288 Close-up Oblique Side View of Damage to Back Side of NP 504 Substrate (scale in 1mm increments / white arrow indicates flight path of projectile)

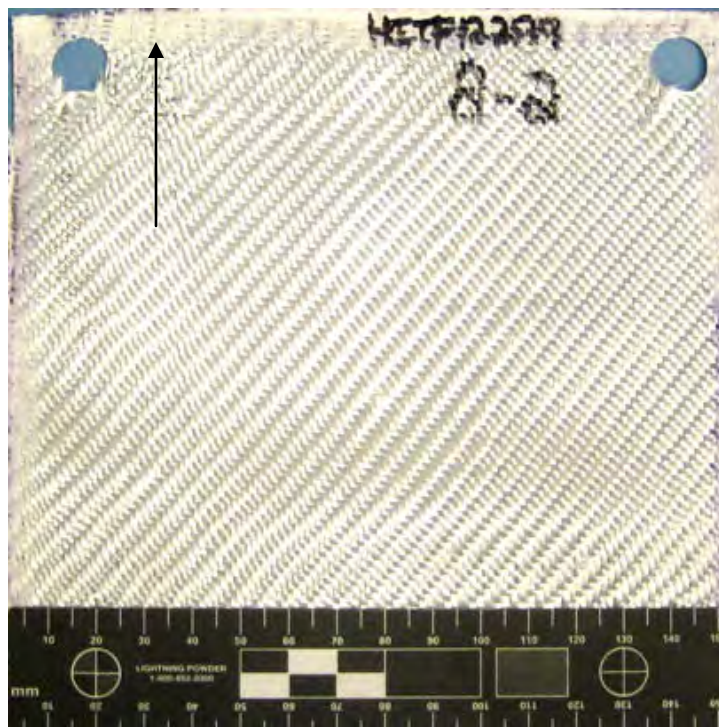
Figure 289 Overall View of Damage to Back Side of 2nd Fiberglass Layer (scale in 5mm increments / black arrow indicates flight path of projectile)

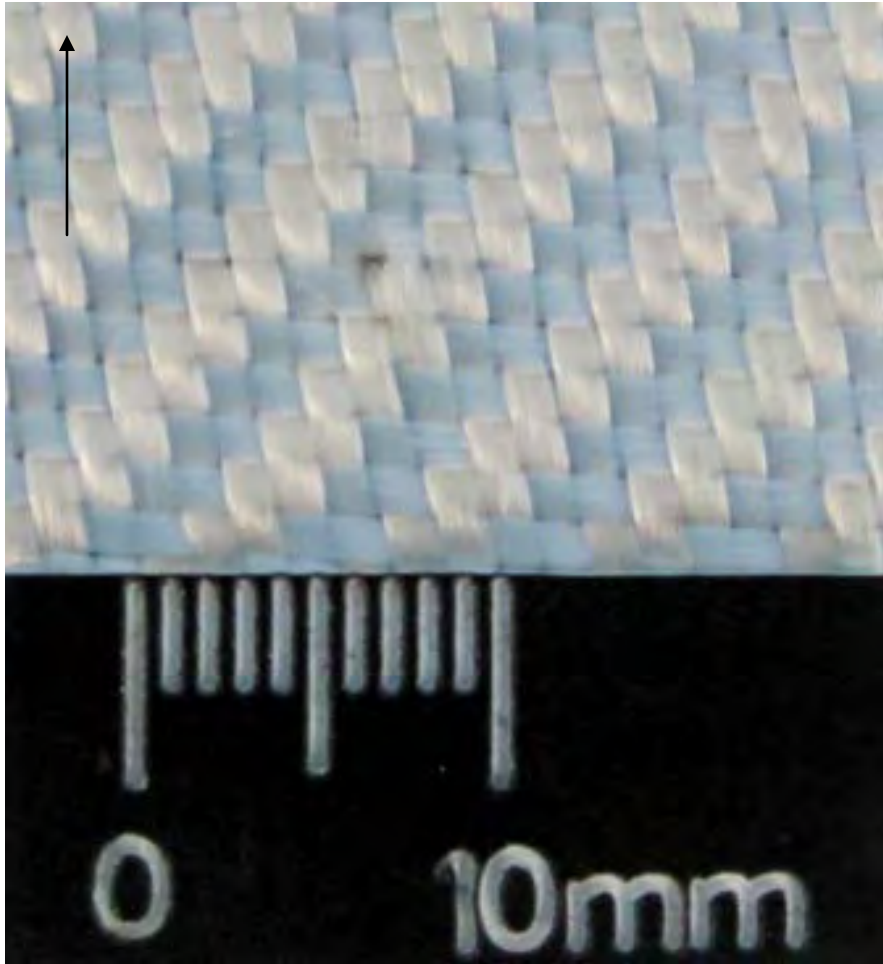
Figure 290 Close-up View of Damage to Back Side of 2nd Fiberglass Layer (scale in 1mm increments / black arrow indicates flight path of projectile)

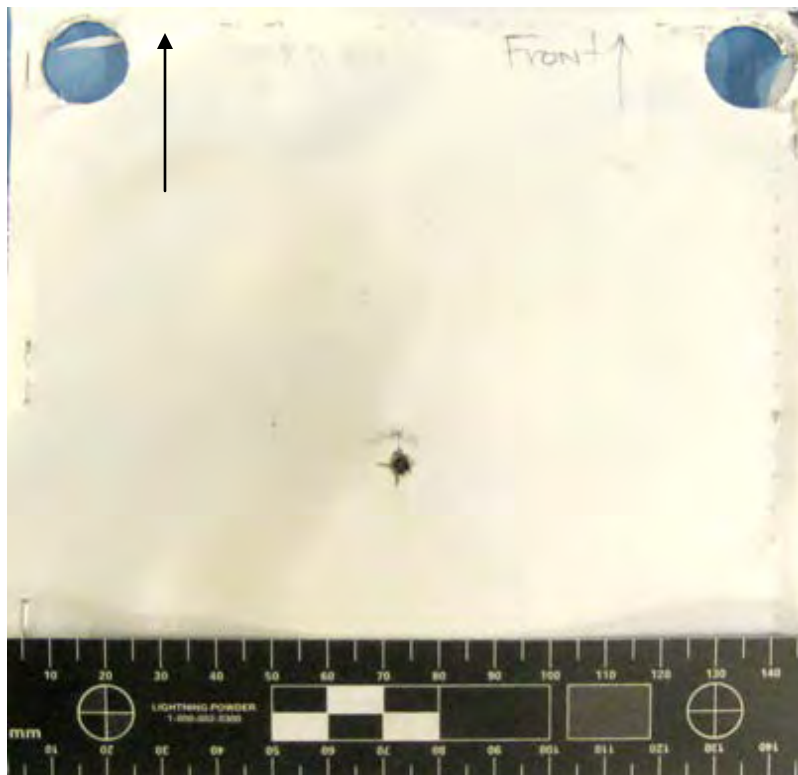
Figure 294 Overall View of Damage to Front of MLI (scale in 5mm increments / black arrow indicates flight path of projectile)

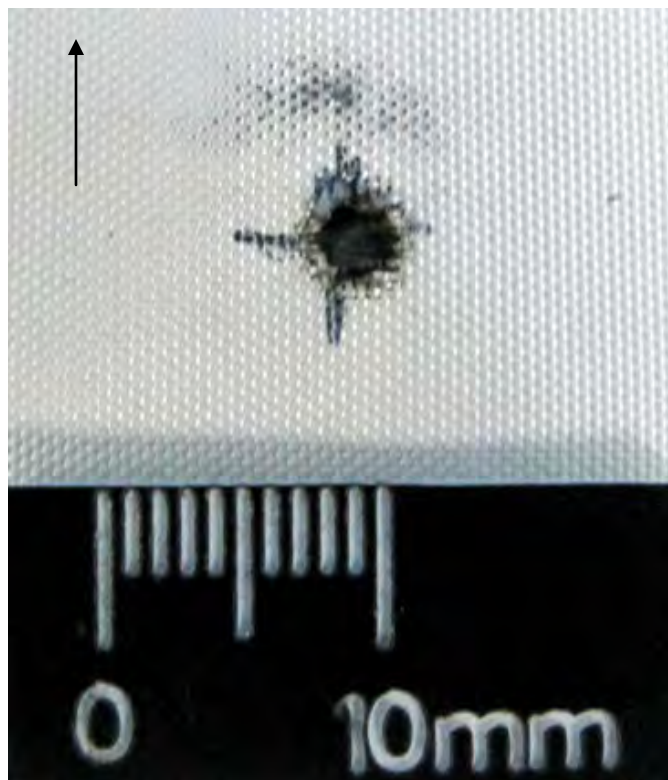
Figure 295 Close-up View of Damage to Front of MLI (scale in 1mm increments / black arrow indicates flight path of projectile)

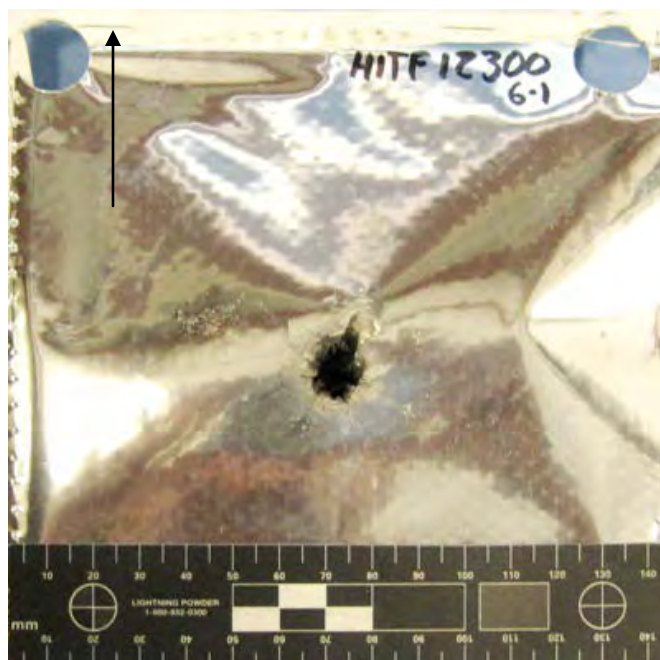
Figure 296 Overall View of Damage to Back Side of MLI (scale in 5mm increments / black arrow indicates flight path of projectile)

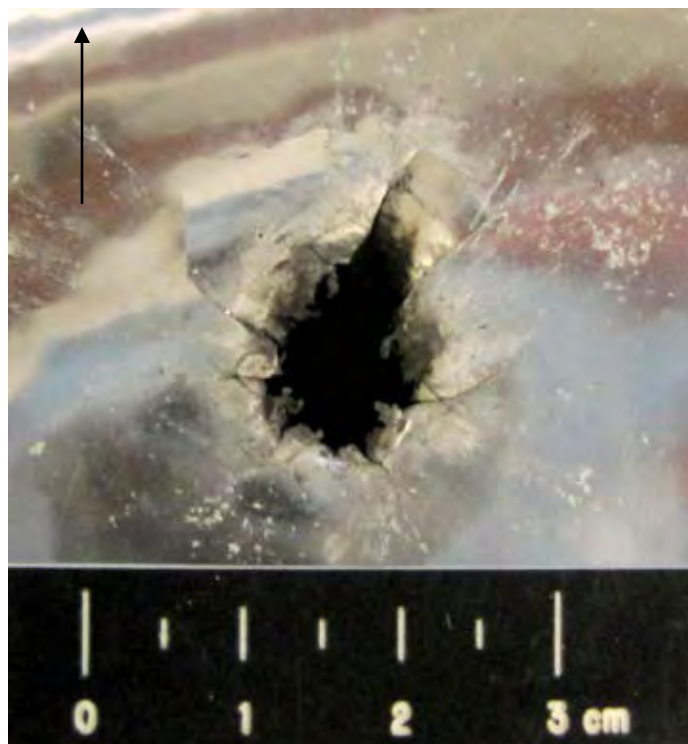
Figure 297 Close-up View of Damage to Back Side of MLI (scale in 5mm increments / black arrow indicates flight path of projectile)

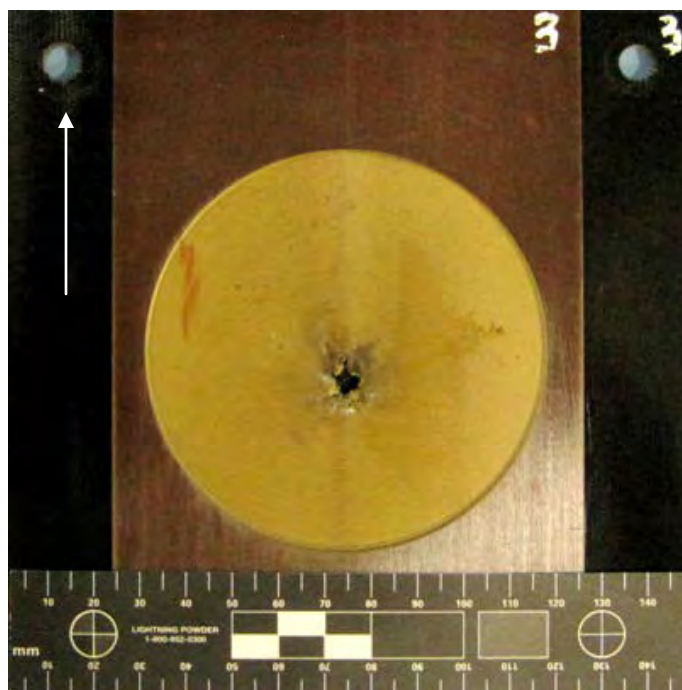
Figure 298 Overall View of Damage to Front of TORLON 5030 (scale in 5mm increments / white arrow indicates flight path of projectile)

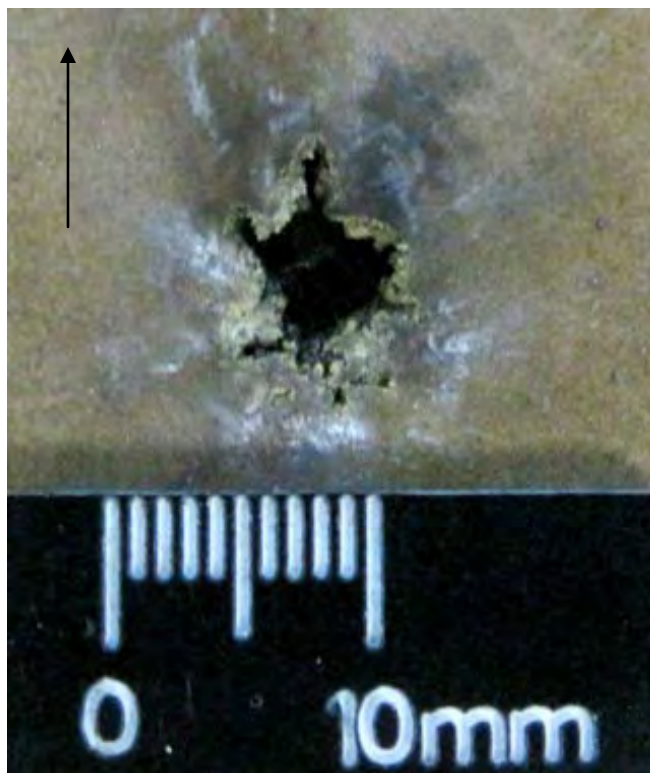
Figure 299 Close-up View of Damage to Front of TORLON 5030 (scale in 5mm increments / white arrow indicates flight path of projectile)

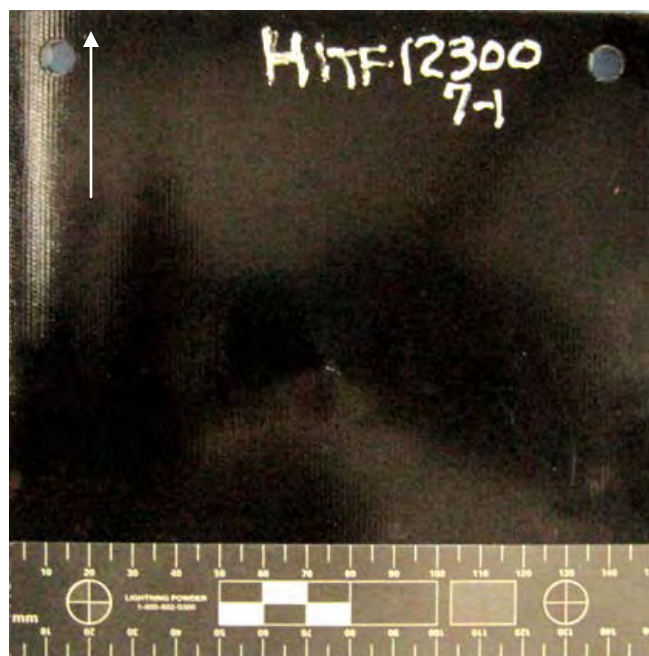
Figure 300 Overall View of Damage to Back Side of NP 504 Substrate (scale in 5mm increments / white arrow indicates flight path of projectile)

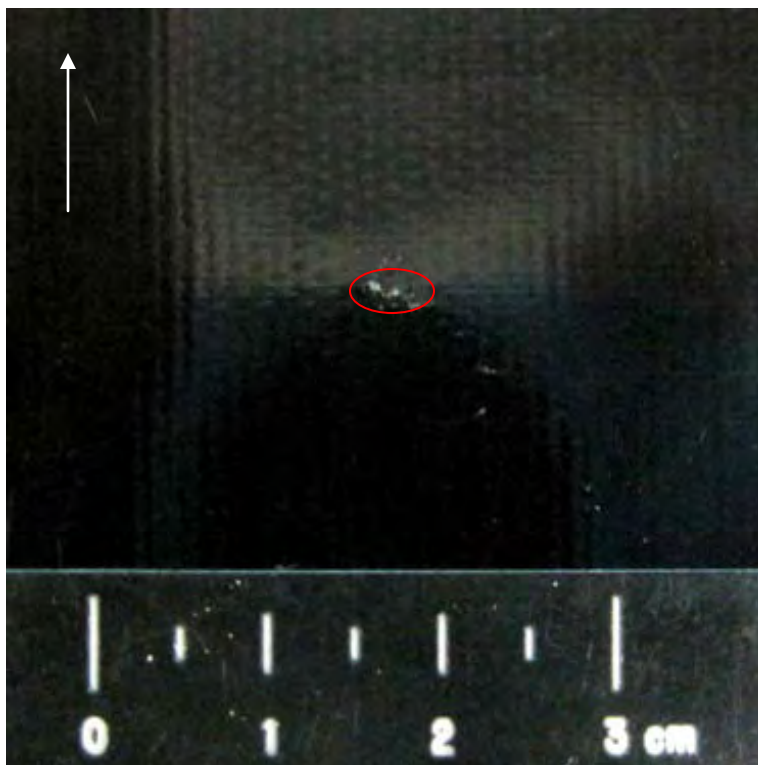
Figure 301 Close-up View of Damage to Back Side of NP 504 Substrate (scale in 1mm increments / white arrow indicates flight path of projectile)

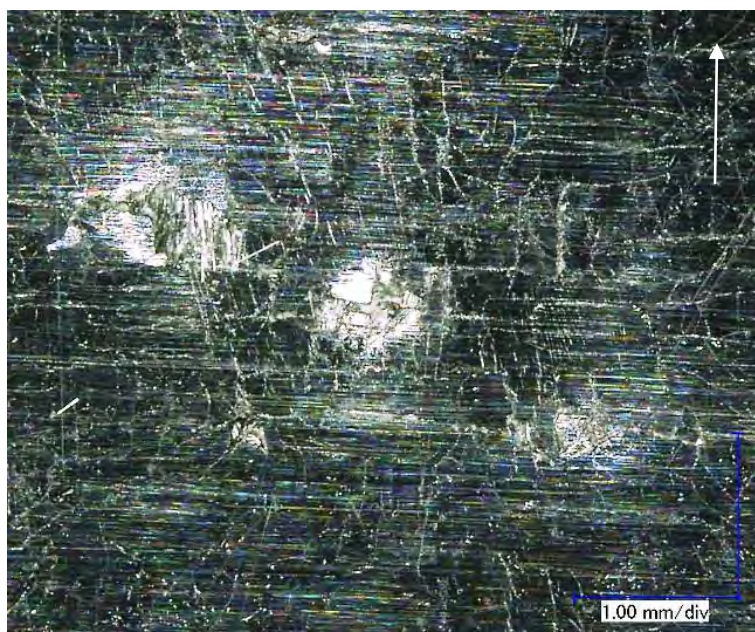
Figure 302 Close-up View of Most Significant Damage to Back Side of NP 504 Substrate (white arrow indicates flight path of projectile / damage within red circle in Figure 301)

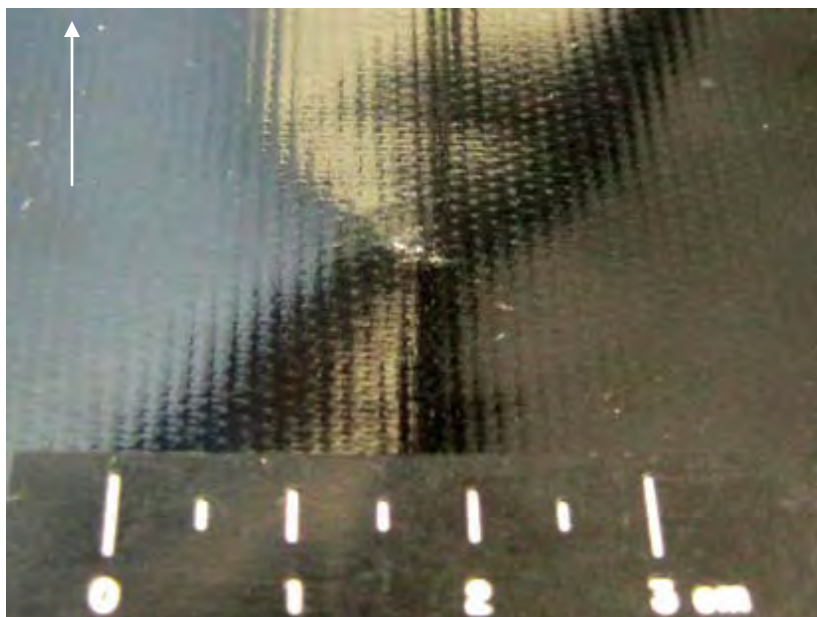
Figure 304 Close-up Oblique Side View of Damage to Back Side of NP 504 Substrate (scale in 5mm increments / white arrow indicates flight path of projectile)

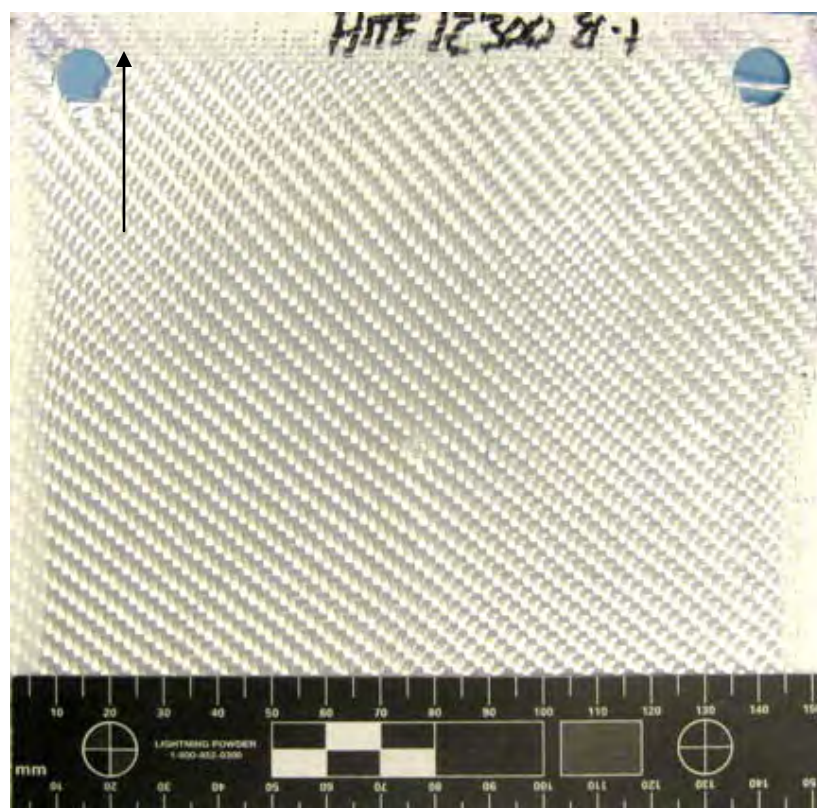
Figure 305 Overall View of Damage to Back Side of 1st Fiberglass Layer (scale in 5mm increments / black arrow indicates flight path of projectile)

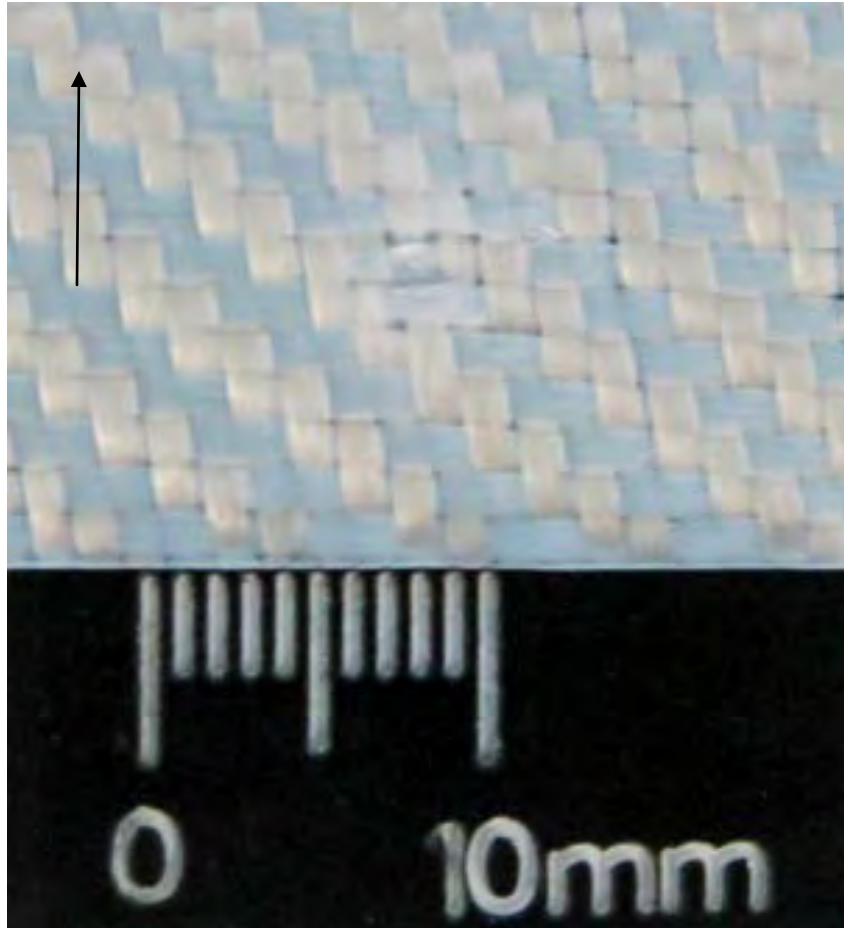
Figure 306 Close-up View of Damage to Back Side of 1st Fiberglass Layer (scale in 1mm increments / black arrow indicates flight path of projectile)

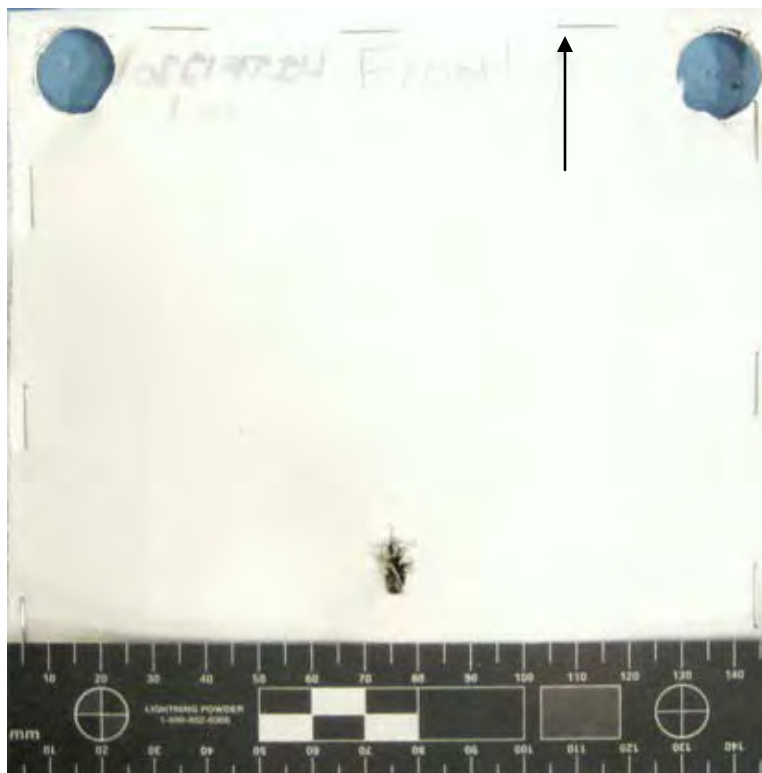
Figure 310 Overall View of Damage to Front of MLI (scale in 5mm increments / black arrow indicates flight path of projectile)

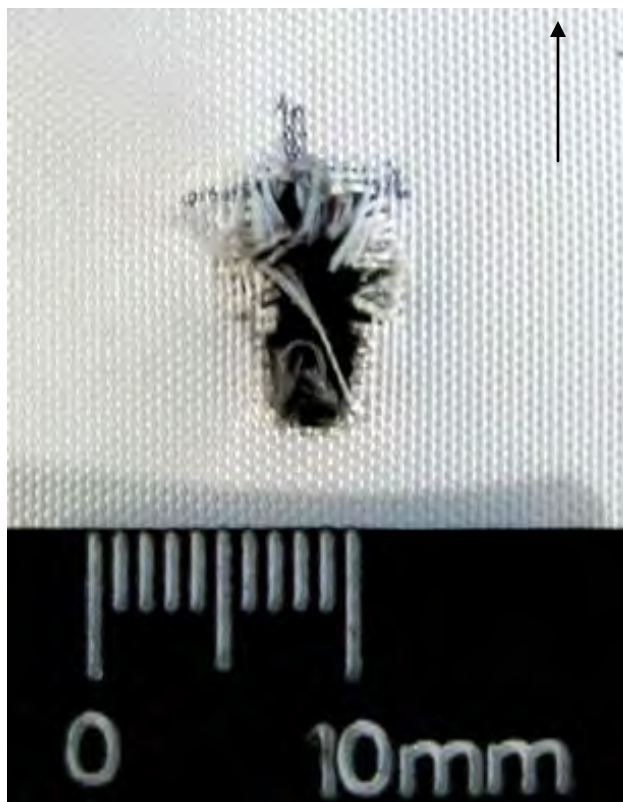
Figure 311 Close-up View of Damage to Front of MLI (scale in 1mm increments / black arrow indicates flight path of projectile)

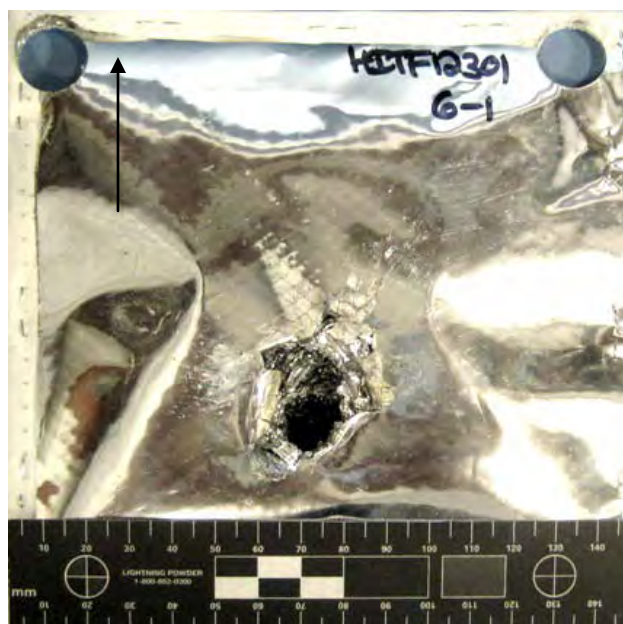
Figure 312 Overall View of Damage to Back Side of MLI (scale in 5mm increments / black arrow indicates flight path of projectile)

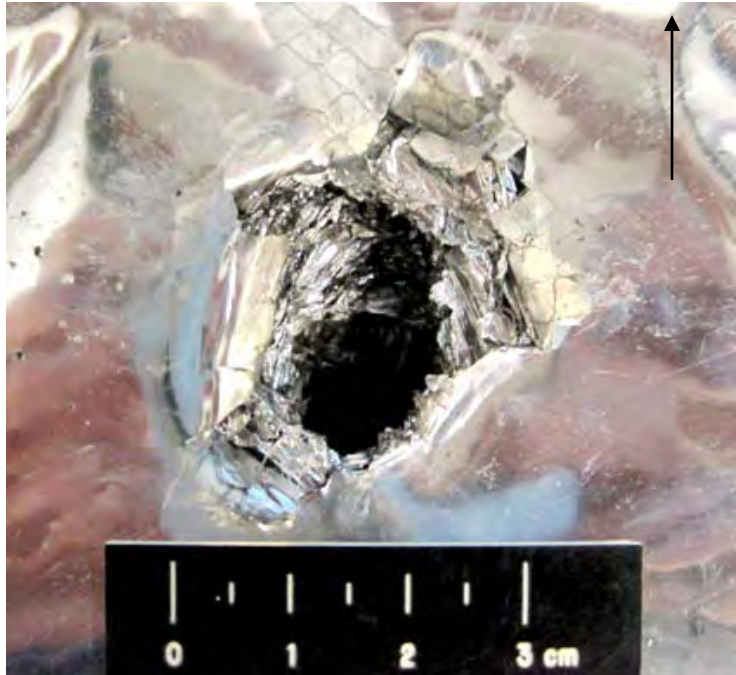
Figure 313 Close-up View of Damage to Back Side of MLI (scale in 5mm increments / black arrow indicates flight path of projectile)

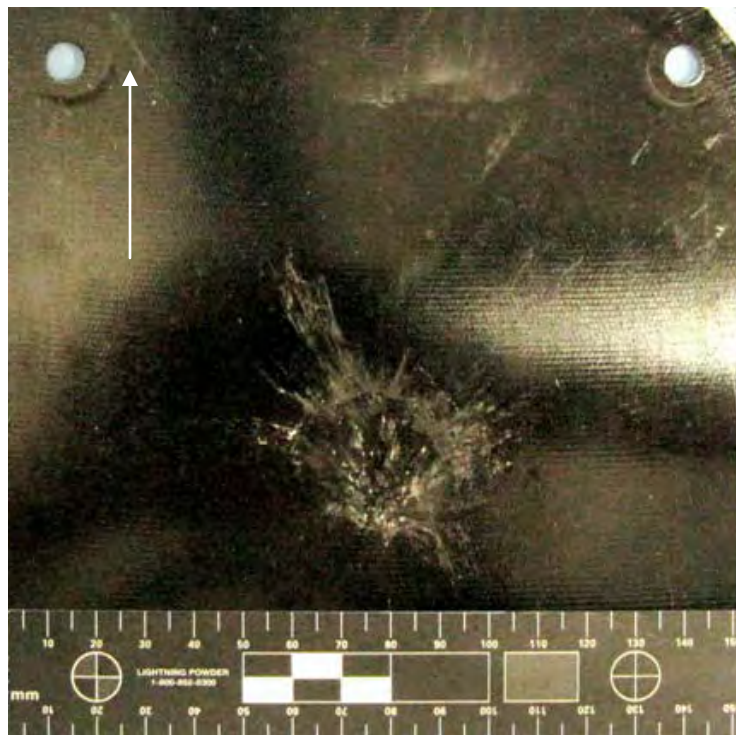
Figure 314 Overall View of Damage to Front of NP 504 Substrate (scale in 5mm increments / white arrow indicates flight path of projectile)

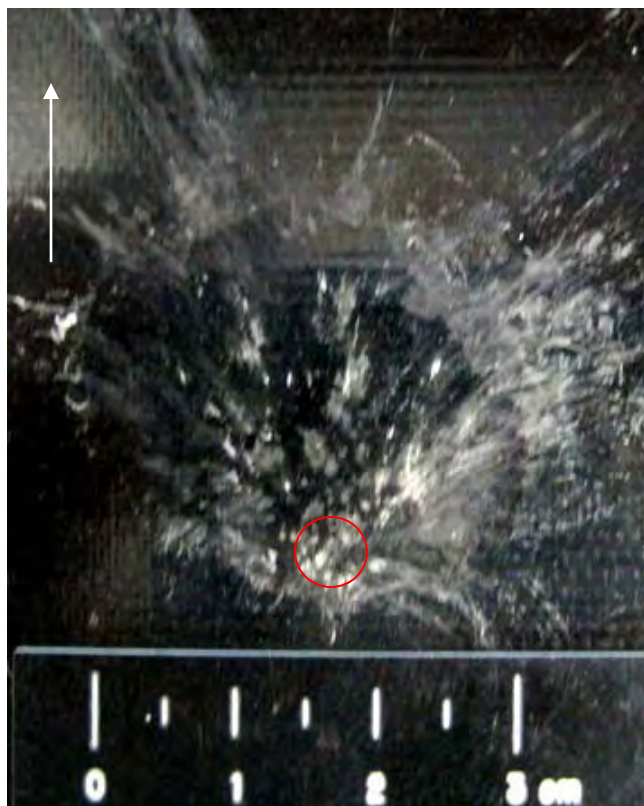
Figure 315 Close-up View of Damage to Front of NP 504 Substrate (scale in 5mm increments / white arrow indicates flight path of projectile)

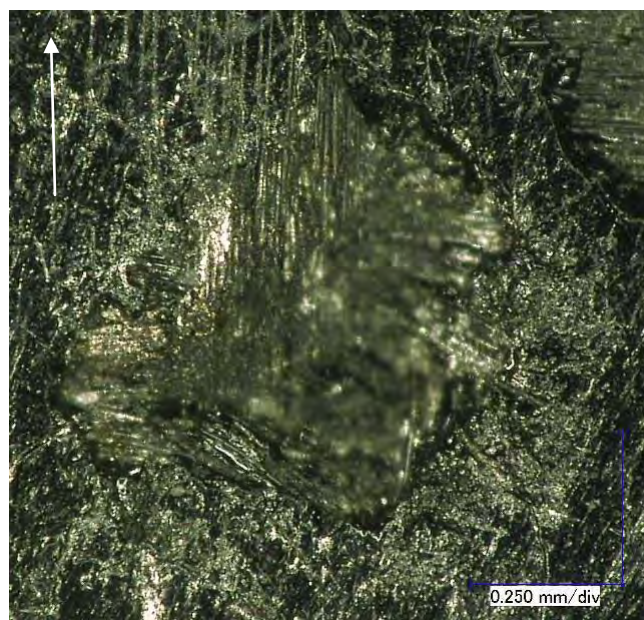
Figure 316 Close-up View of Damage to Front of NP 504 Substrate (white arrow indicates flight path of projectile / damage within red circle in Figure 128)

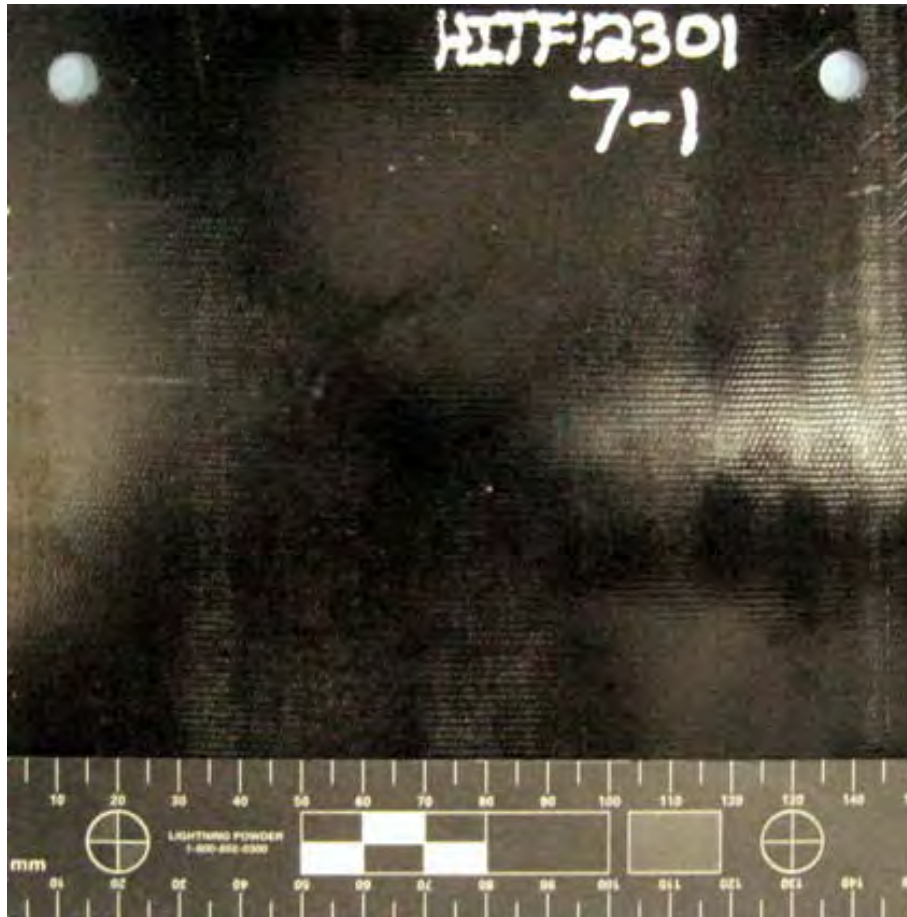
Figure 317 Overall View of Damage to Back Side of NP 504 Substrate (scale in 5mm increments / white arrow indicates flight path of projectile)

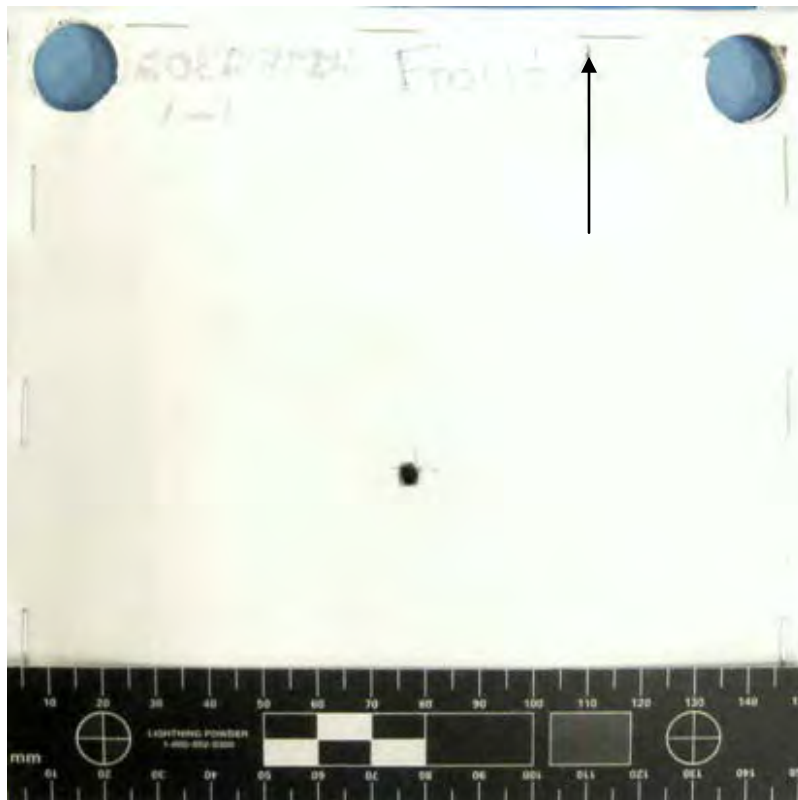
Figure 321 Overall View of Damage to Front of MLI (scale in 5mm increments / black arrow indicates flight path of projectile)

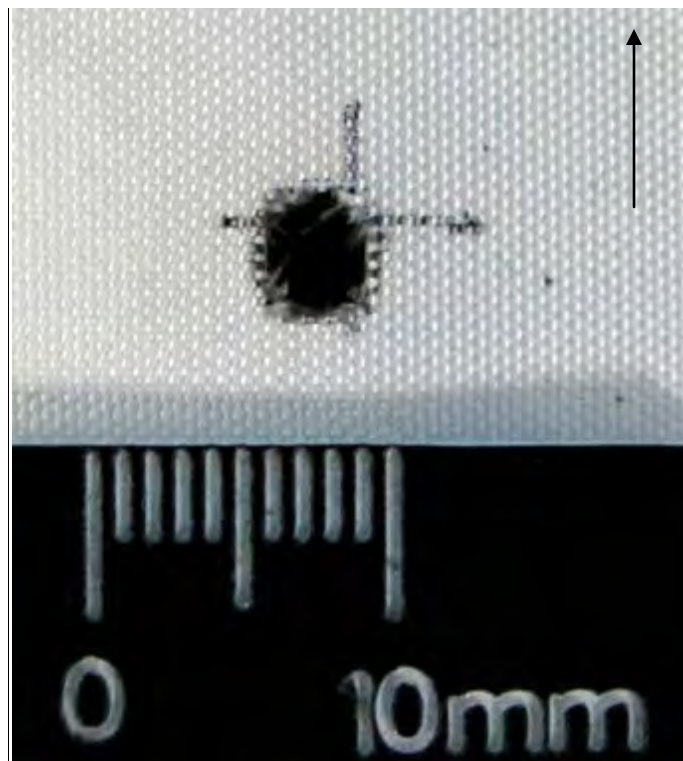
Figure 322 Close-up View of Damage to Front of MLI (scale in 1mm increments / black arrow indicates flight path of projectile)

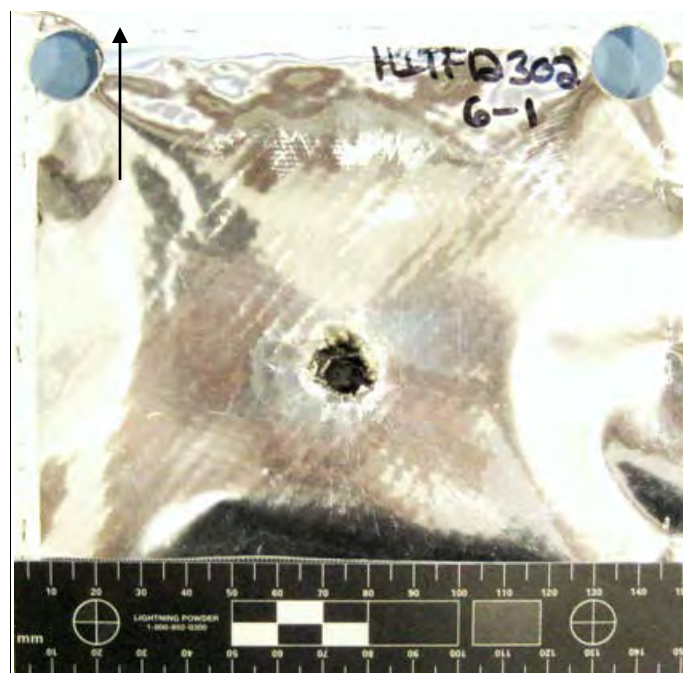
Figure 323 Overall View of Damage to Back Side of MLI (scale in 5mm increments / black arrow indicates flight path of projectile)

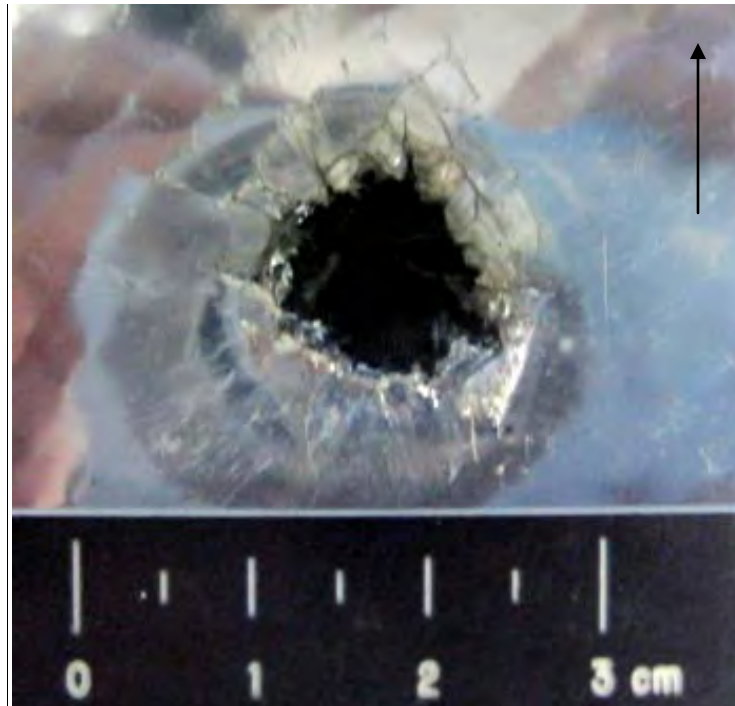
Figure 324 Close-up View of Damage to Back Side of MLI (scale in 5mm increments / black arrow indicates flight path of projectile)

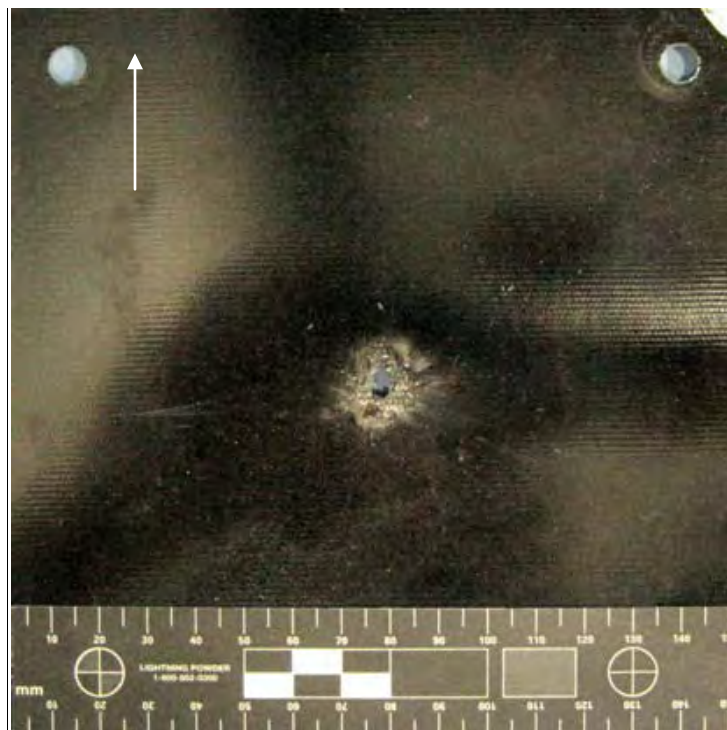
Figure 325 Overall View of Damage to Front of NP 504 Substrate (scale in 5mm increments / white arrow indicates flight path of projectile)

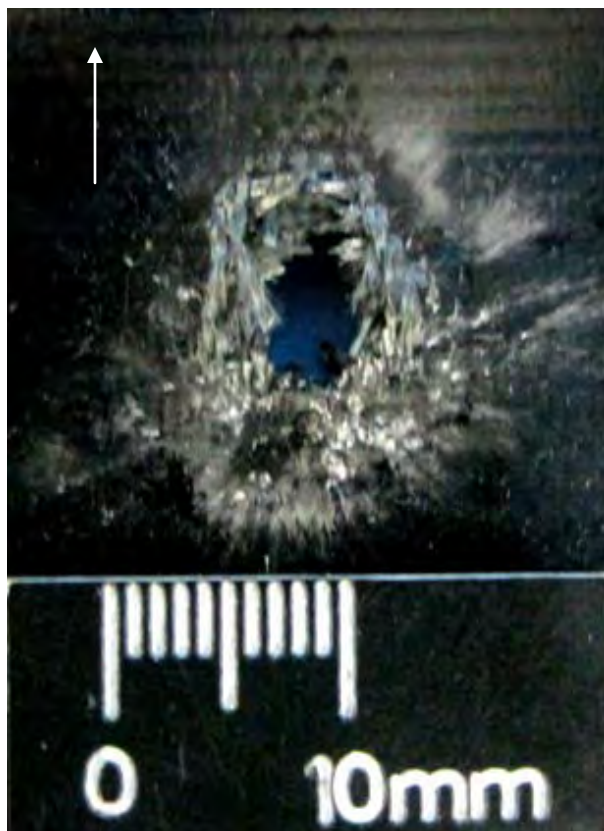
Figure 326 Close-up View of Damage to Front of NP 504 Substrate (scale in 1mm increments / white arrow indicates flight path of projectile)

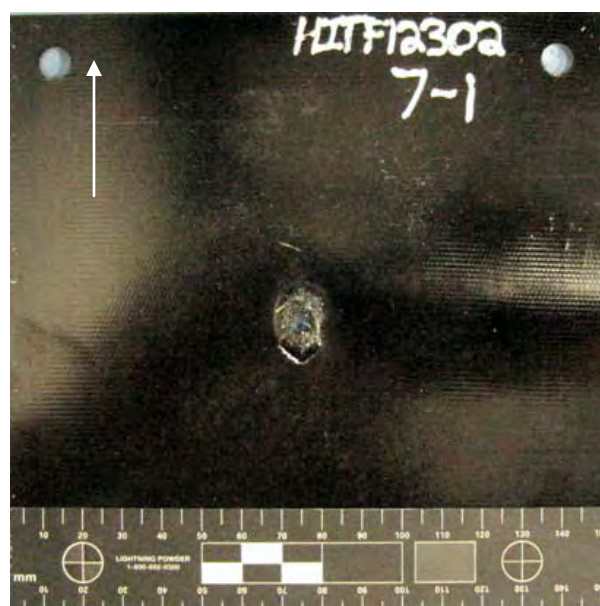
Figure 327 Overall View of Damage to Back Side of NP 504 Substrate (scale in 5mm increments / white arrow indicates flight path of projectile)

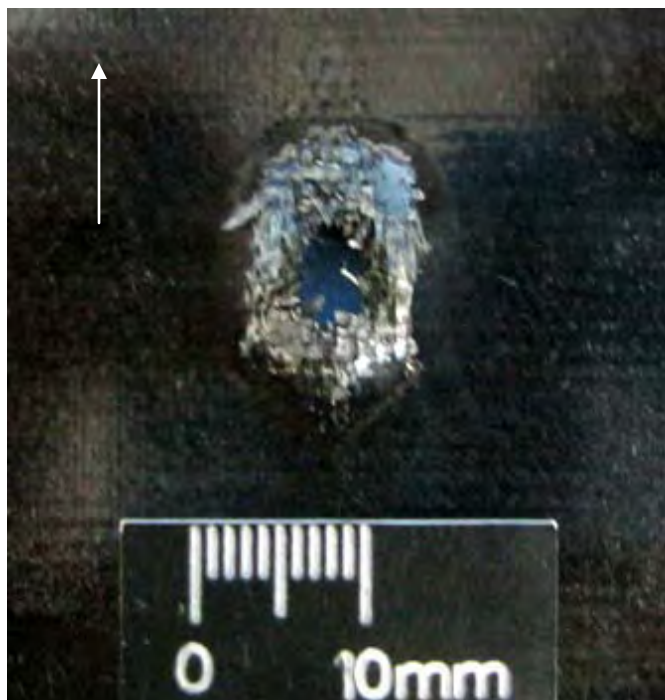
Figure 328 Close-up View of Damage to Back Side of NP 504 Substrate (scale in 1mm increments / white arrow indicates flight path of projectile)

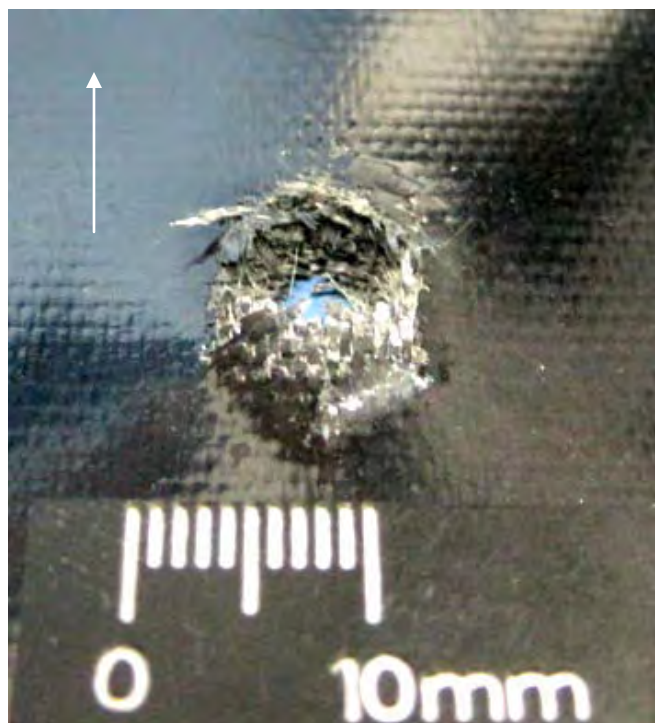
Figure 329 Close-up Oblique Side View of Damage to Back Side of NP 504 Substrate (scale in 1mm increments / white arrow indicates flight path of projectile)
