International Space Station (ISS) Soyuz Vehicle Descent Module Evaluation of Thermal Protection System (TPS) Penetration Characteristics

Hypervelocity Impact Technology Group

February 2013

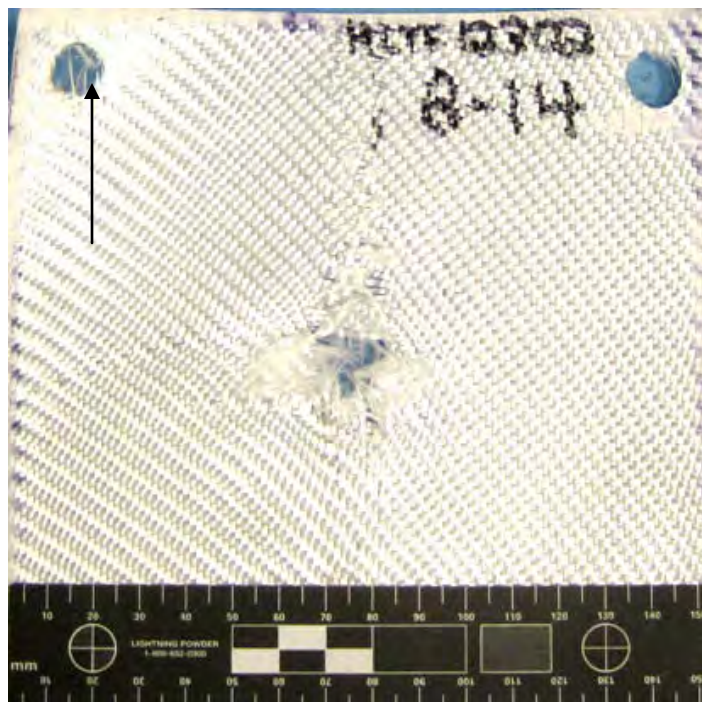
Figure 330 Overall View of Damage to Back Side of Last Fiberglass Layer (scale in 5mm increments / black arrow indicates flight path of projectile)

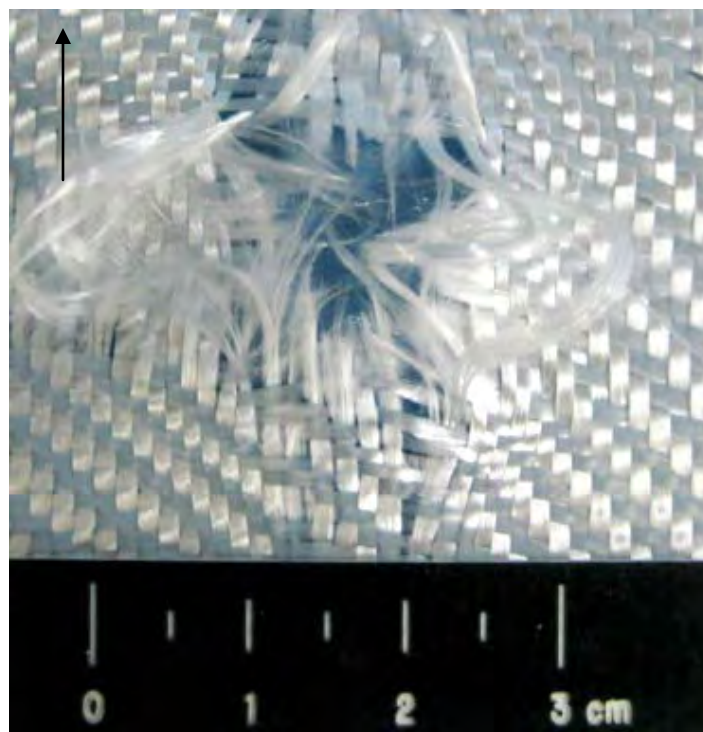
Figure 331 Overall View of Damage to Back Side of Last Fiberglass Layer (scale in 5mm increments / black arrow indicates flight path of projectile)

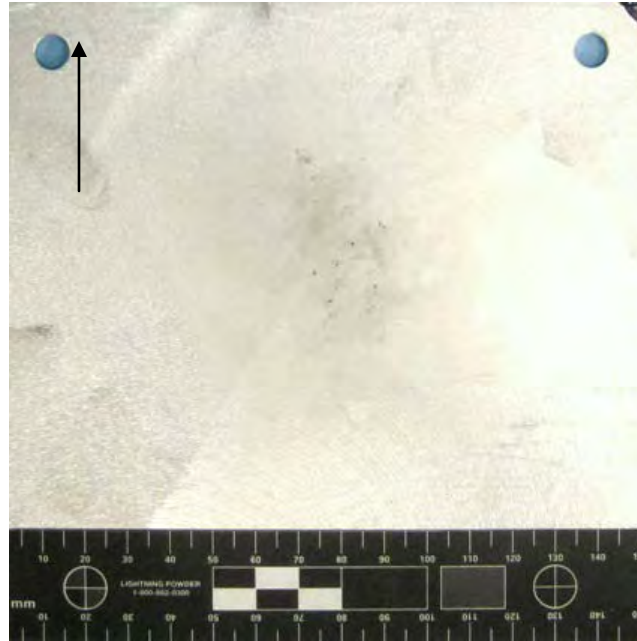
Figure 332 Overall View of Damage to Front of Rear Wall (scale in 5mm increments / black arrow indicates flight path of projectile)

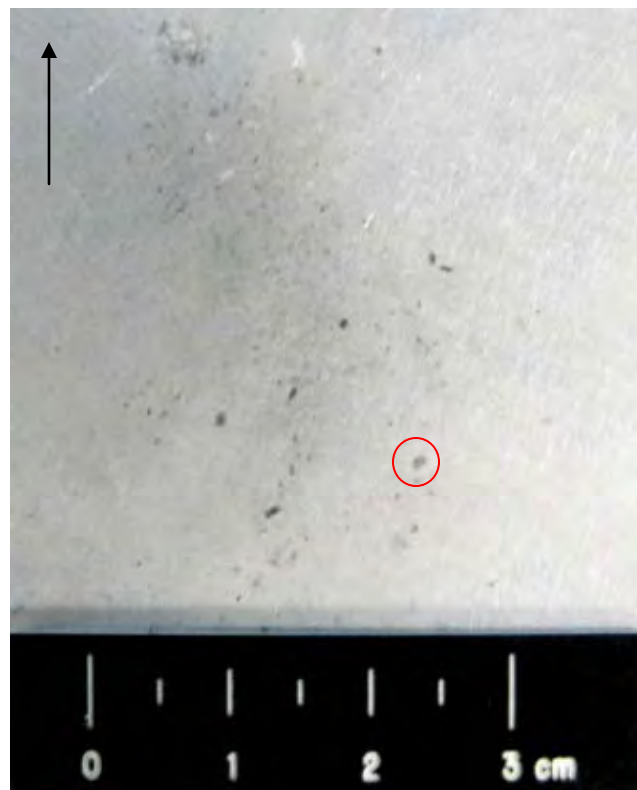
Figure 333 Close-up View of Damage to Front of Rear Wall (scale in 5mm increments / black arrow indicates flight path of projectile)

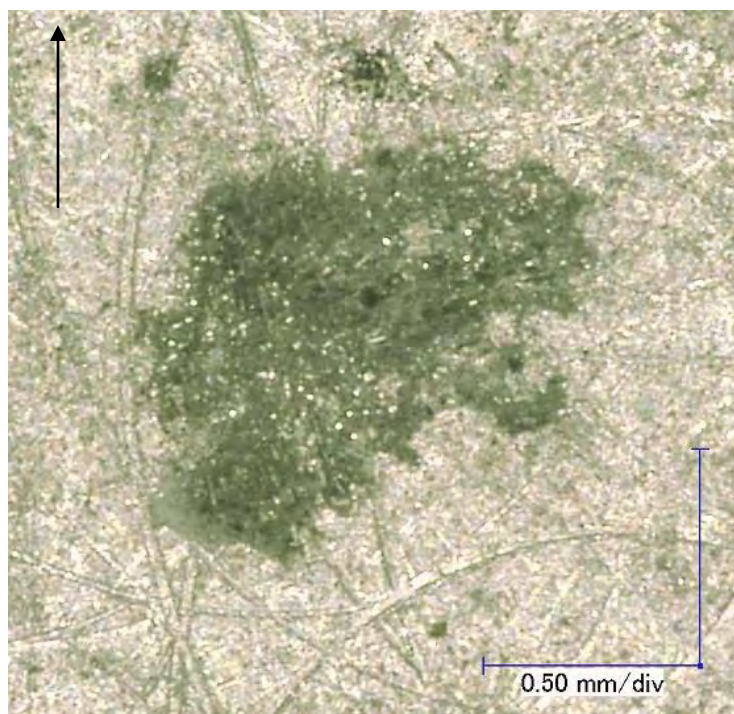
Figure 334 Close-up View of Most Significant Damage to Front of Rear Wall (black arrow indicates flight path of projectile / damage within red circle in Figure 333)

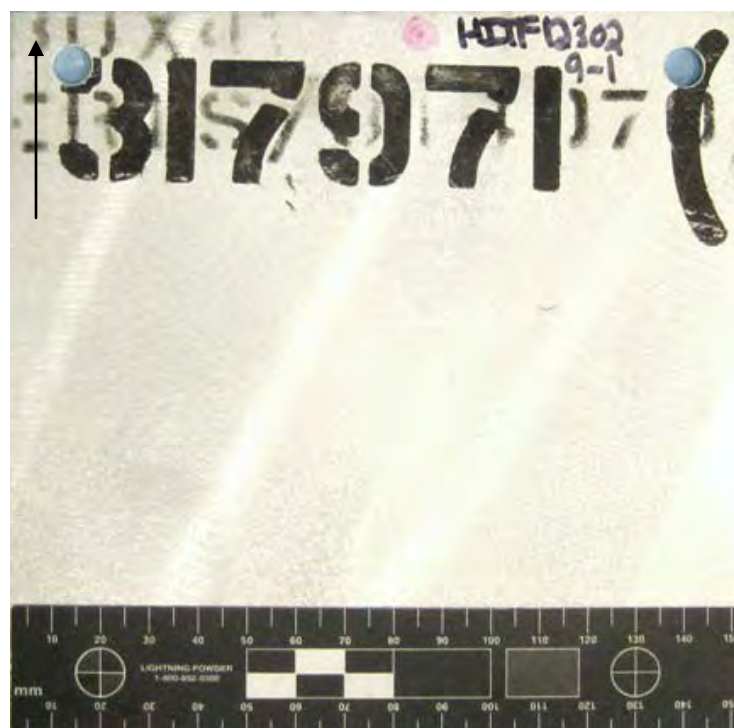
Figure 335 Overall View of Back Side of Rear Wall (scale in 5mm increments / black arrow indicates flight path of projectile)

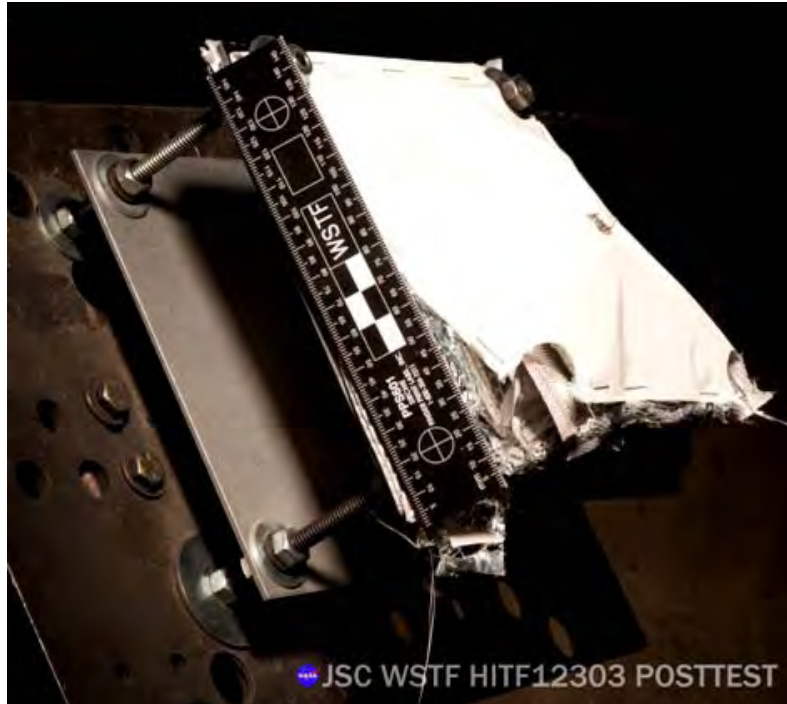
Figure 336 Overall View of Sample in the Target Tank (post-test)

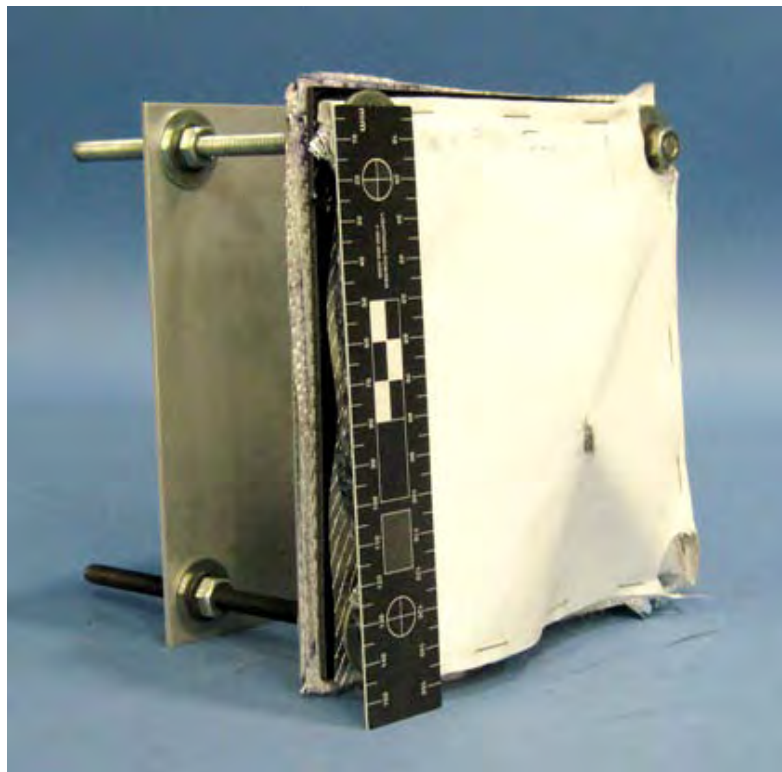
Figure 337 Overall Front Oblique View of Sample (scale in 5mm increments)

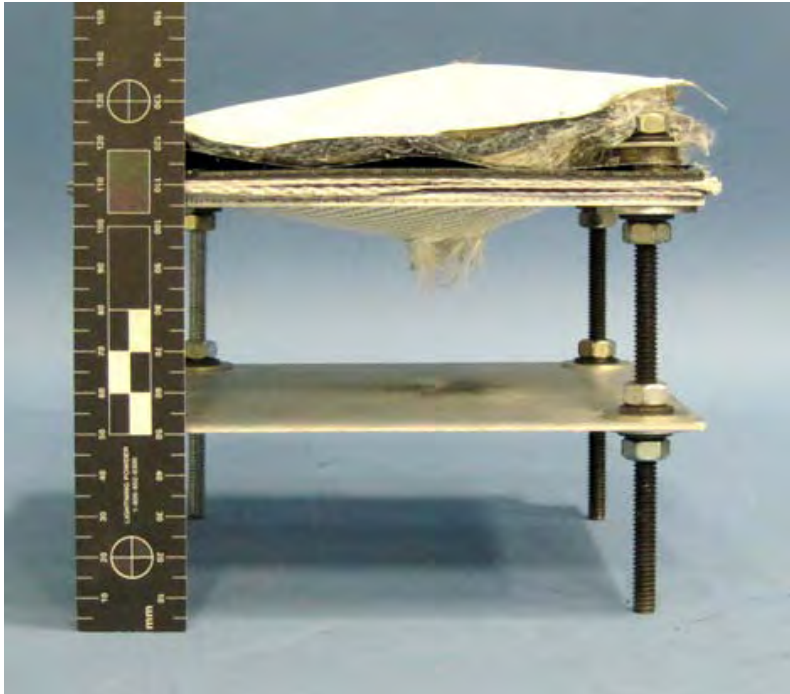
Figure 338 Overall Side View of Sample (scale in 5mm increments)

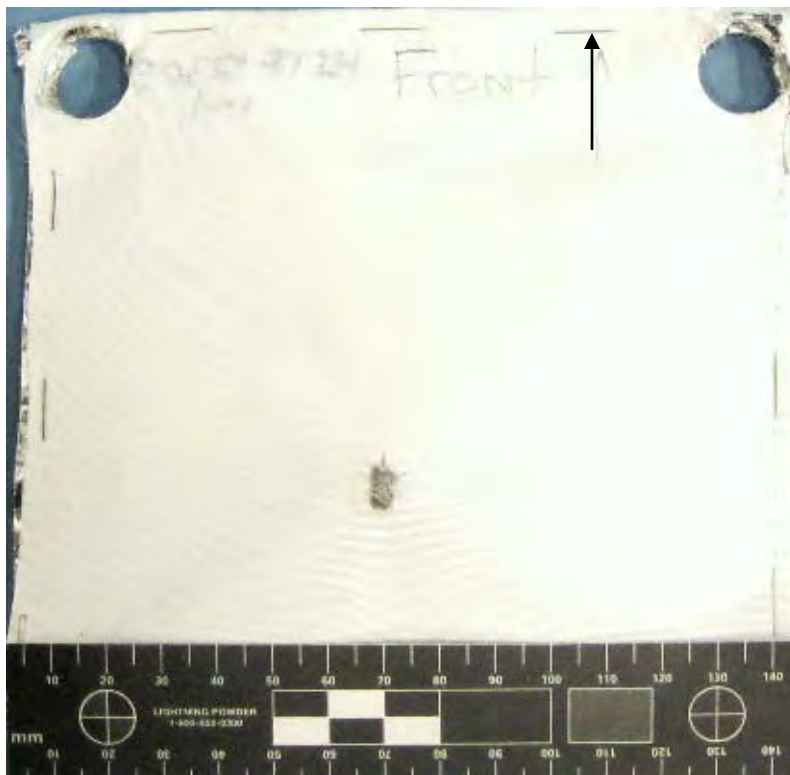
Figure 339 Overall View of Damage to Front of MLI (scale in 5mm increments / black arrow indicates flight path of projectile)

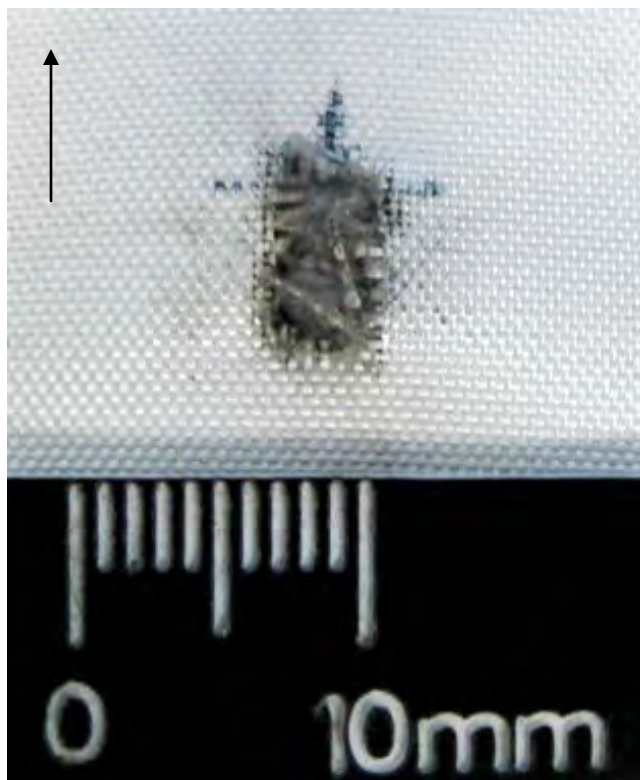
Figure 340 Close-up View of Damage to Front of MLI (scale in 1mm increments / black arrow indicates flight path of projectile)

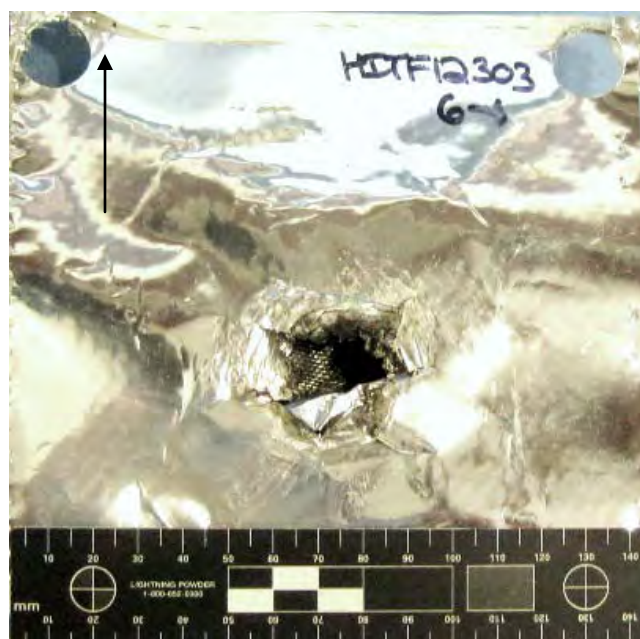
Figure 341 Overall View of Damage to Back Side of MLI (scale in 5mm increments / black arrow indicates flight path of projectile)

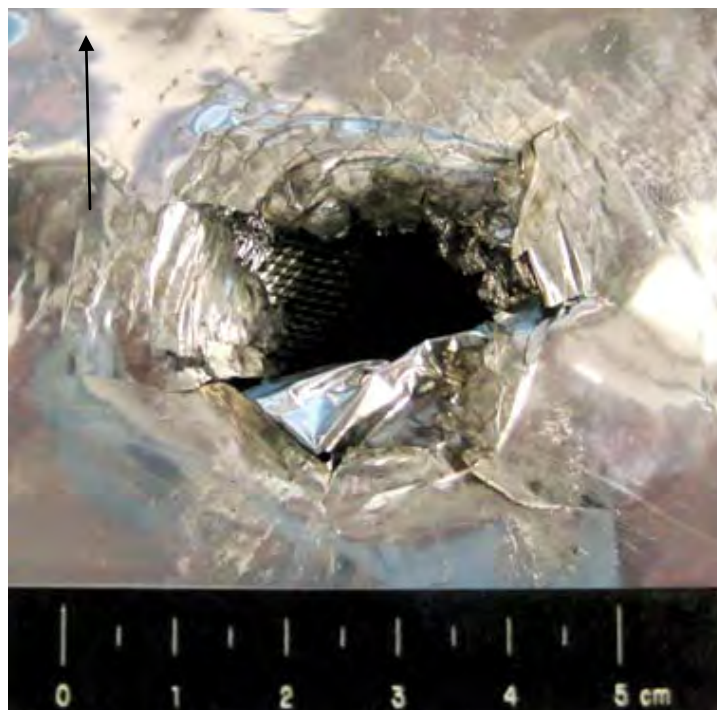
Figure 342 Close-up View of Damage to Back Side of MLI (scale in 5mm increments / black arrow indicates flight path of projectile)

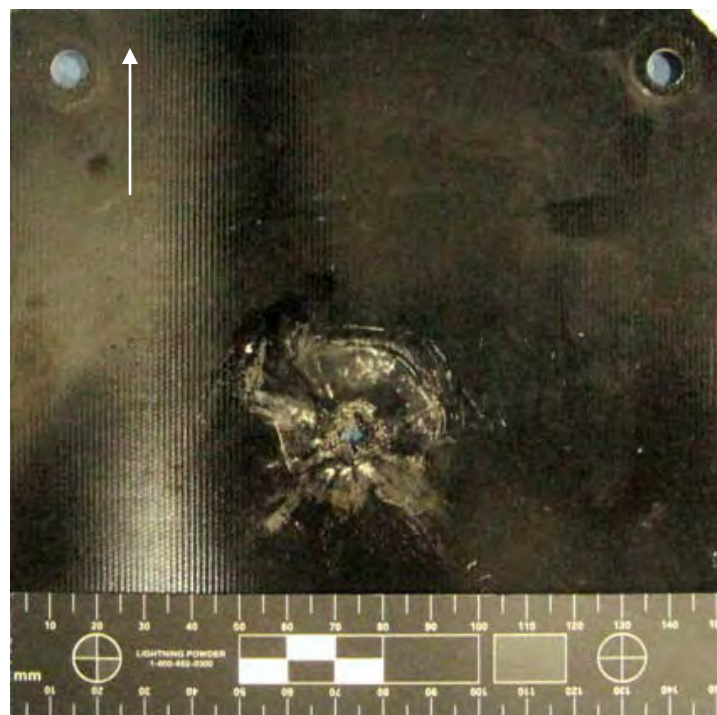
Figure 343 Overall View of Damage to Front of NP 504 Substrate (scale in 5mm increments / white arrow indicates flight path of projectile)

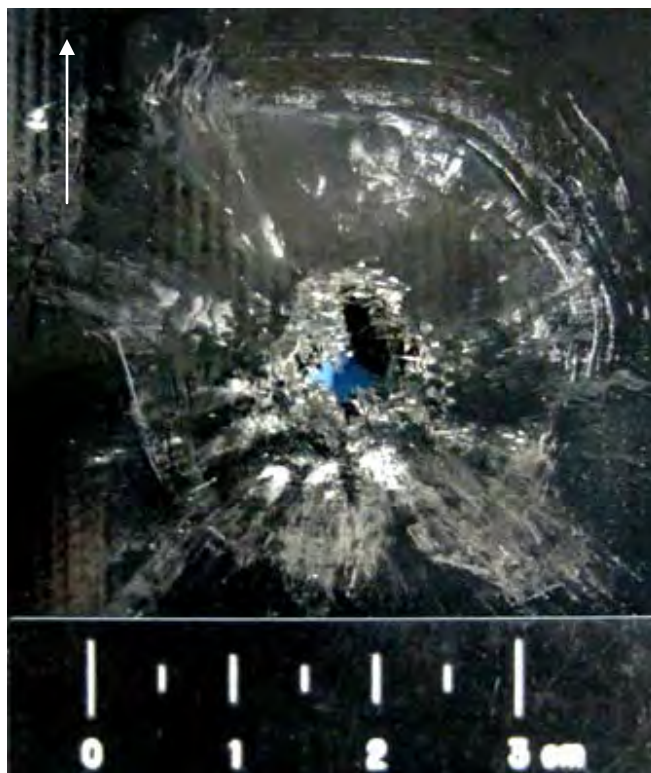
Figure 344 Close-up View of Damage to Front of NP 504 Substrate (scale in 5mm increments / white arrow indicates flight path of projectile)

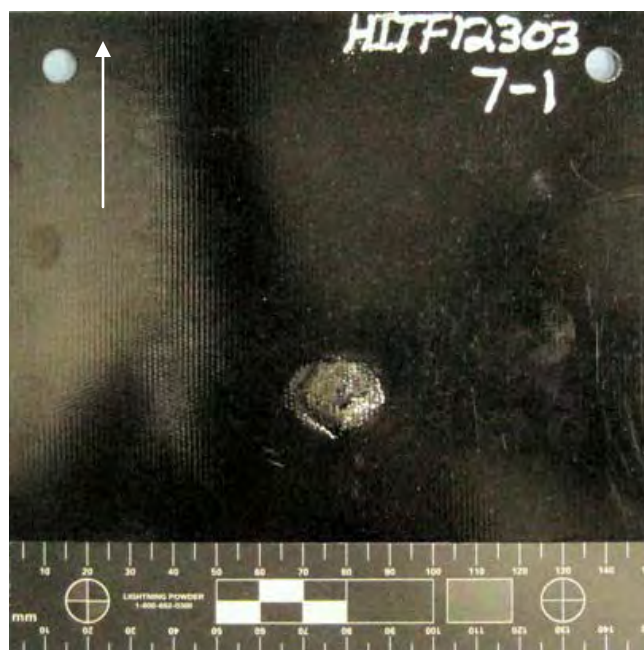
Figure 345 Overall View of Damage to Back Side of NP 504 Substrate (scale in 5mm increments / white arrow indicates flight path of projectile)

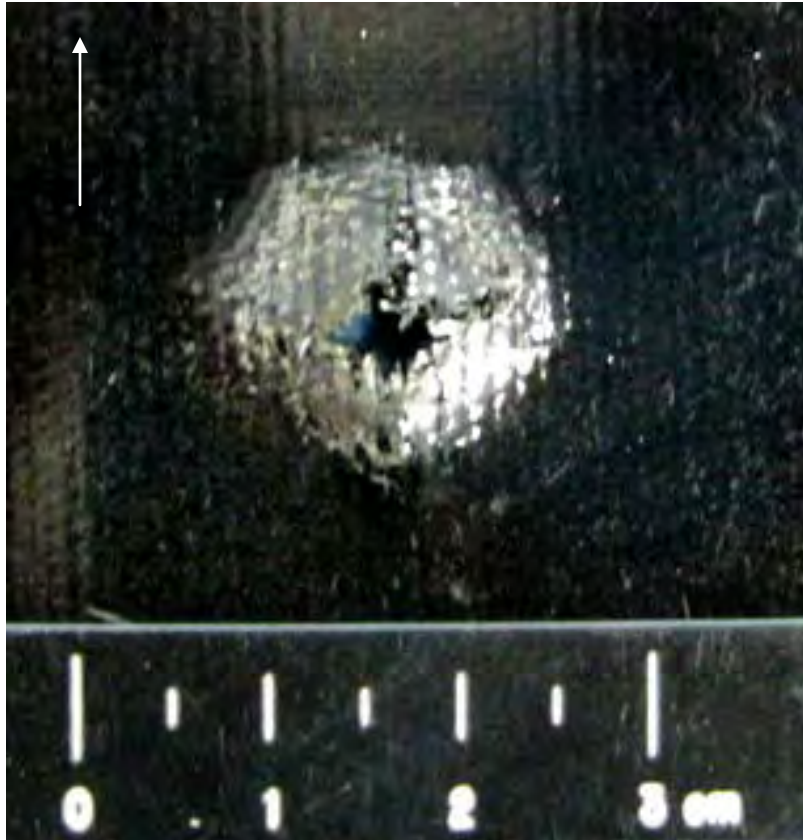
Figure 346 Close-up View of Damage to Back Side of NP 504 Substrate (scale in 5mm increments / white arrow indicates flight path of projectile)

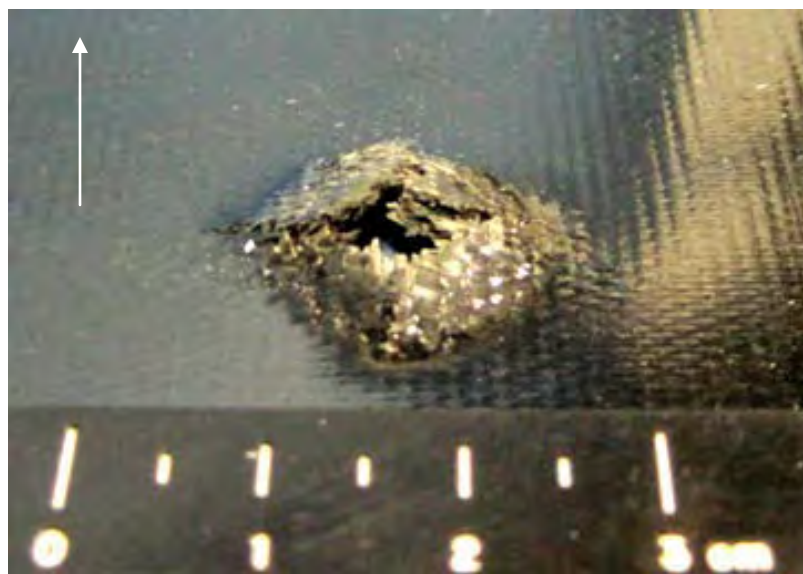
Figure 347 Close-up Oblique Side View of Damage to Back Side of NP 504 Substrate (scale in 5mm increments / white arrow indicates flight path of projectile)

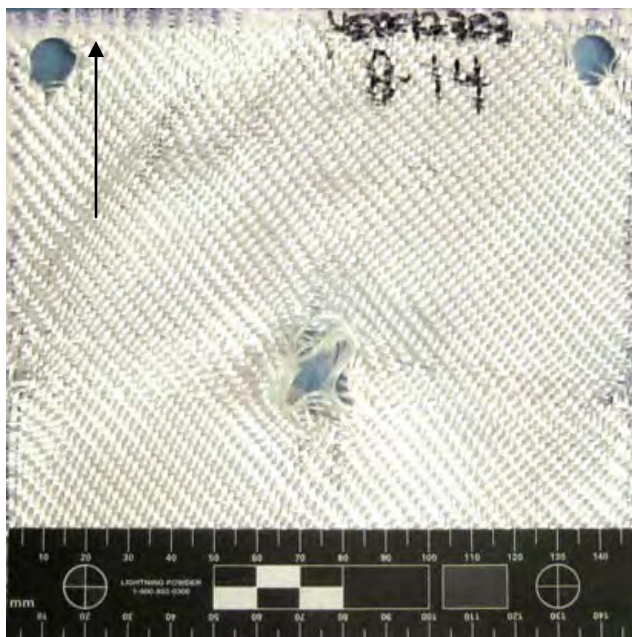
Figure 348 Overall View of Damage to Back Side of Last Fiberglass Layer (scale in 5mm increments / black arrow indicates flight path of projectile)

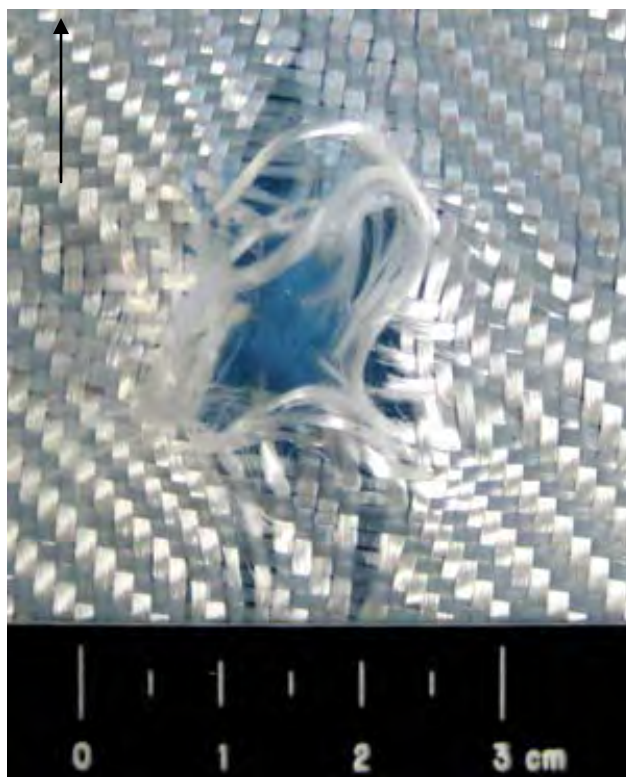
Figure 349 Overall View of Damage to Back Side of Last Fiberglass Layer (scale in 5mm increments / black arrow indicates flight path of projectile)

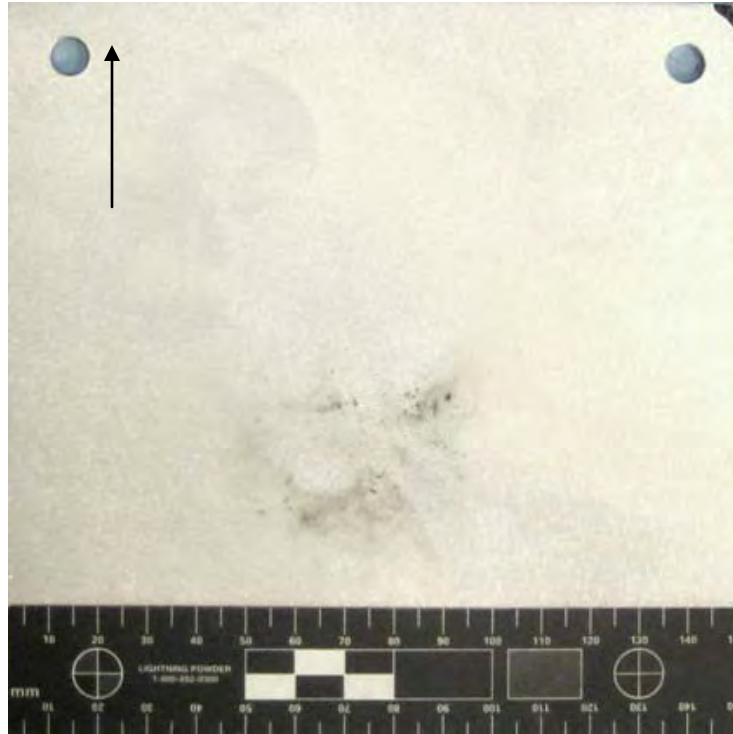
Figure 350 Overall View of Damage to Front of Rear Wall (scale in 5mm increments / black arrow indicates flight path of projectile)

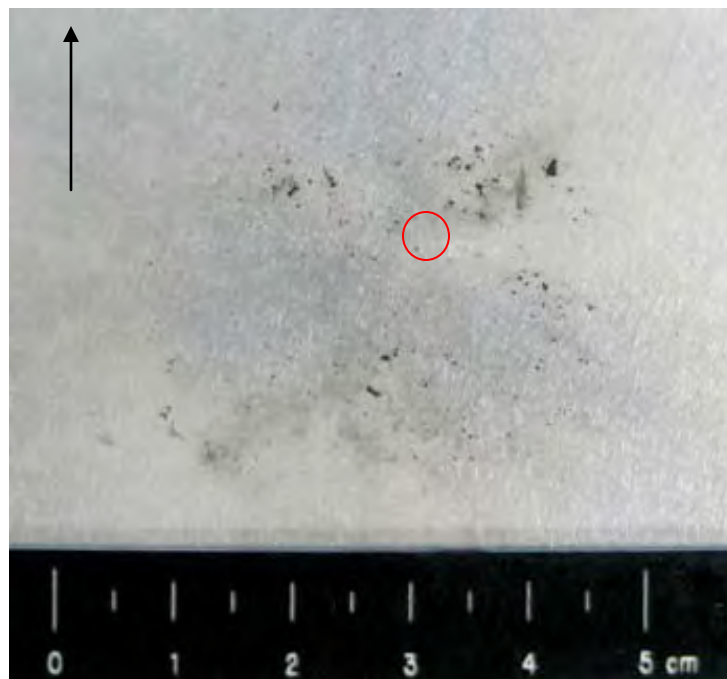
Figure 351 Close-up View of Damage to Front of Rear Wall (scale in 5mm increments / black arrow indicates flight path of projectile)

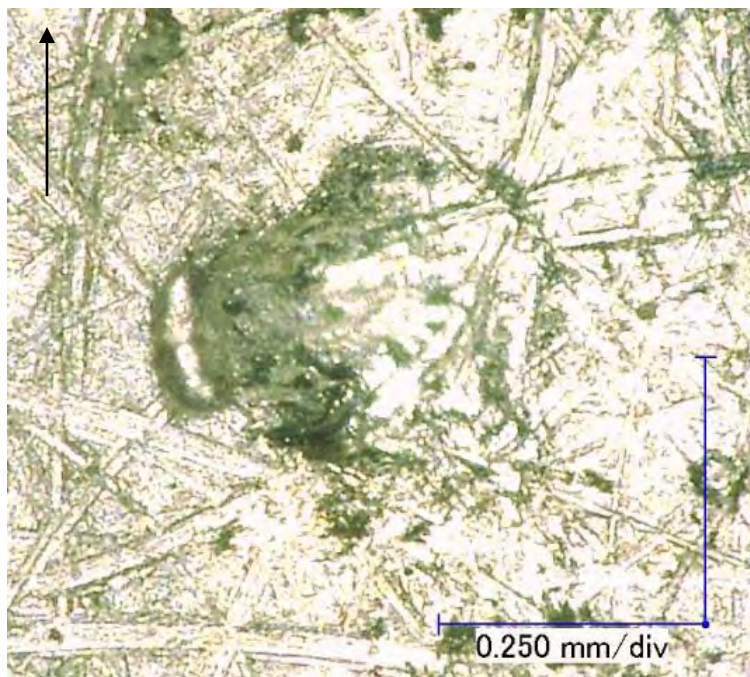
Figure 352 Close-up View of Most Significant Damage to Front of Rear Wall (black arrow indicates flight path of projectile / damage within red circle in Figure 351)

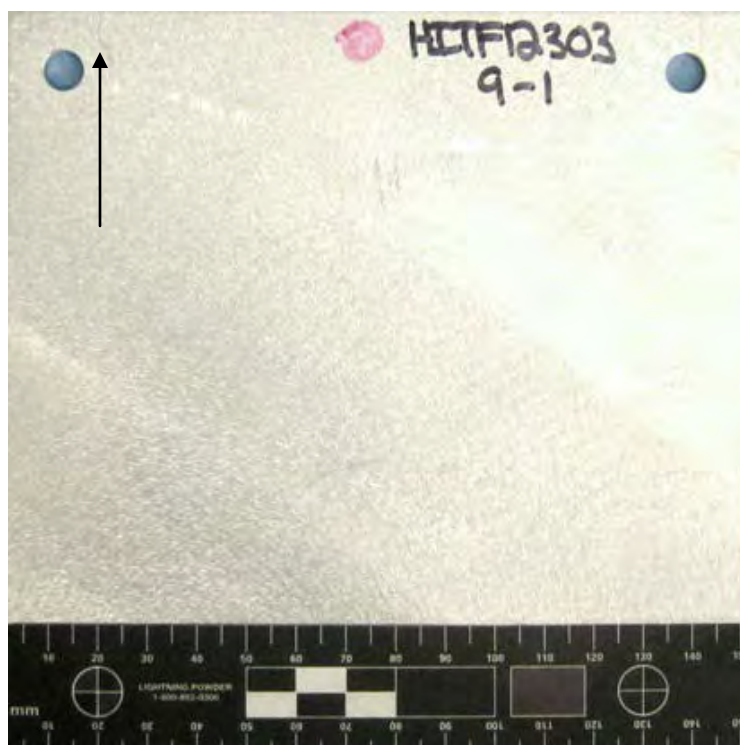
Figure 353 Overall View of Damage to Front of Rear Wall (scale in 5mm increments / black arrow indicates flight path of projectile)

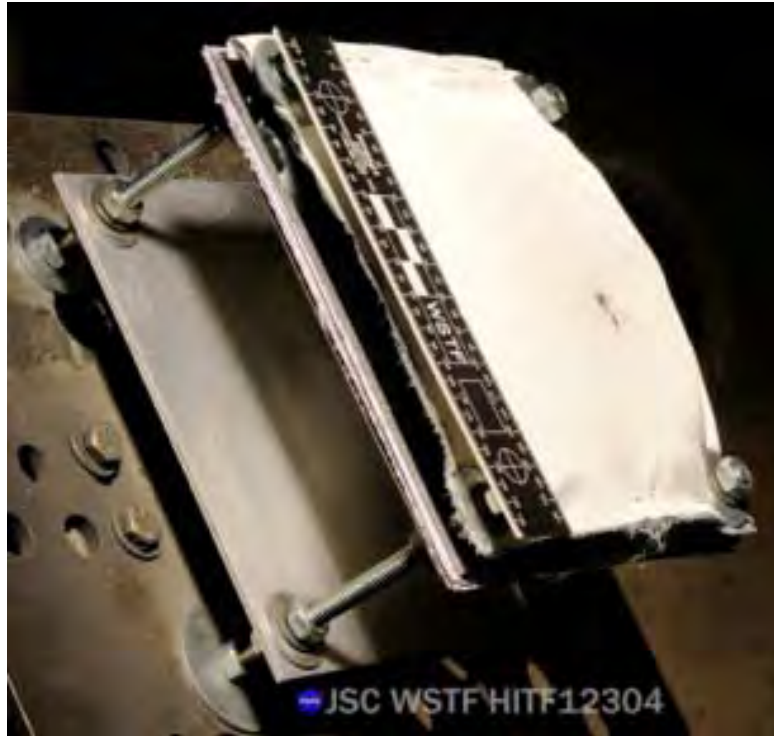
Figure 354 Overall View of Sample in the Target Tank (post-test)

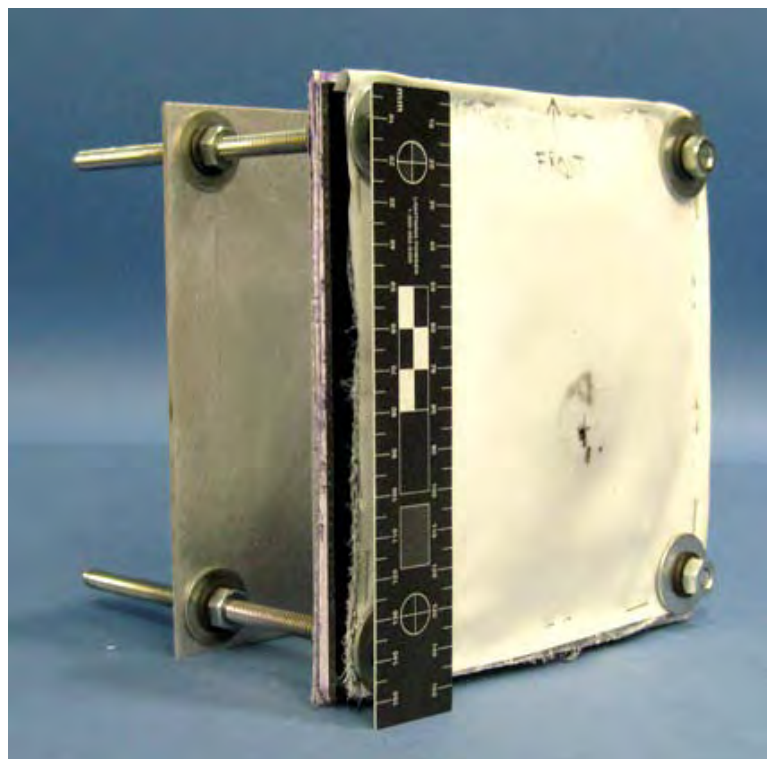
Figure 355 Overall Front Oblique View of Sample (scale in 5mm increments)

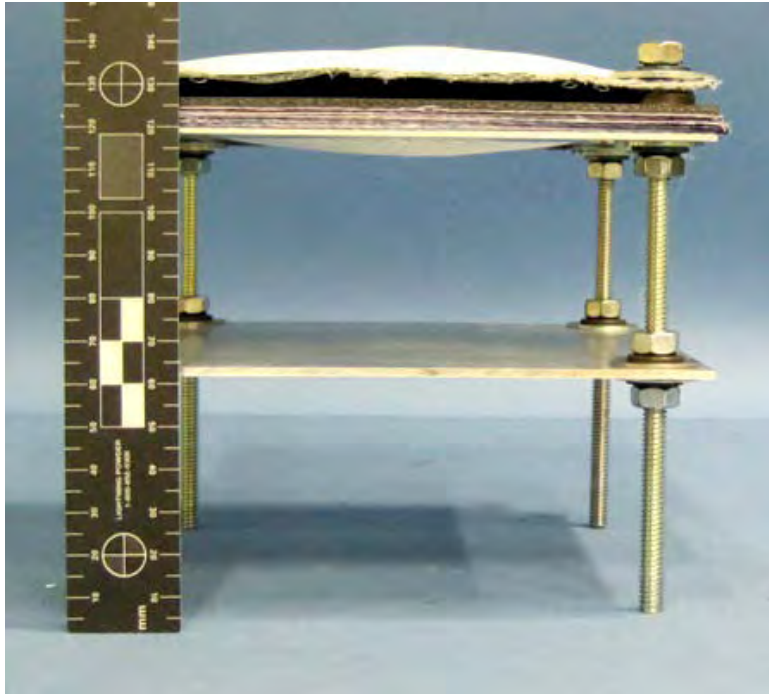
**Figure 356** Overall Side View of Sample (scale in 5mm increments)

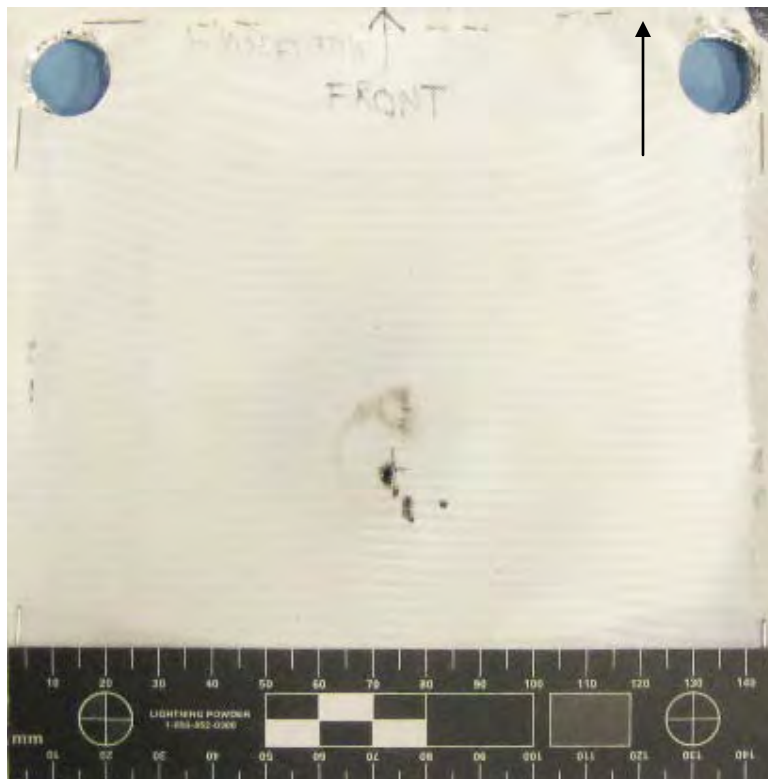
**Figure 357** Overall View of Damage to Front of MLI (scale in 5mm increments / black arrow indicates flight path of projectile)

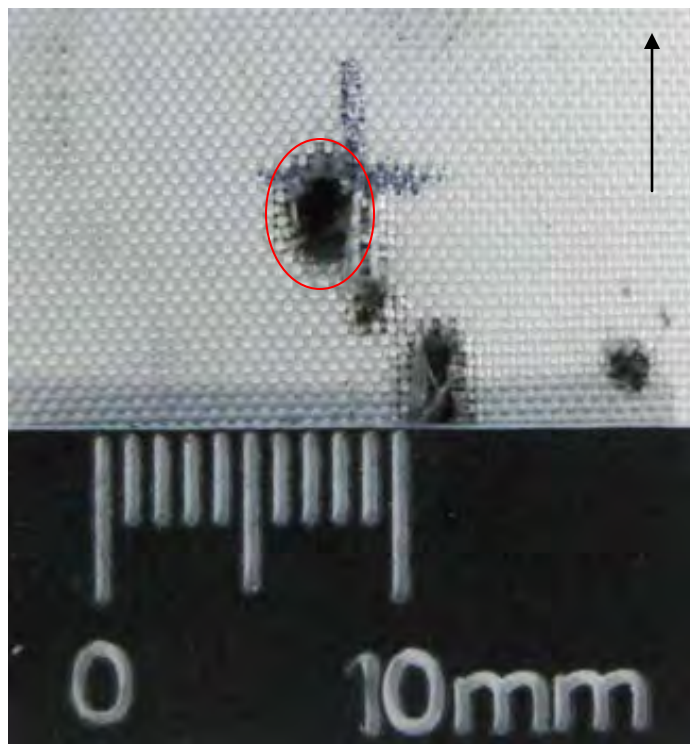
Figure 358 Close-up View of Damage to Front of MLI (scale in 1mm increments / black arrow indicates flight path of projectile / projectile impacted within red circle)

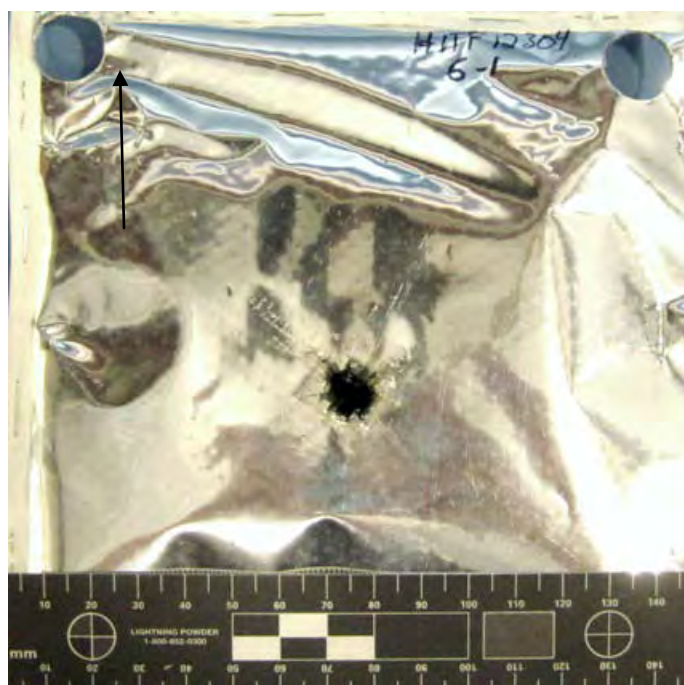
Figure 359 Overall View of Damage to Back Side of MLI (scale in 5mm increments / black arrow indicates flight path of projectile)

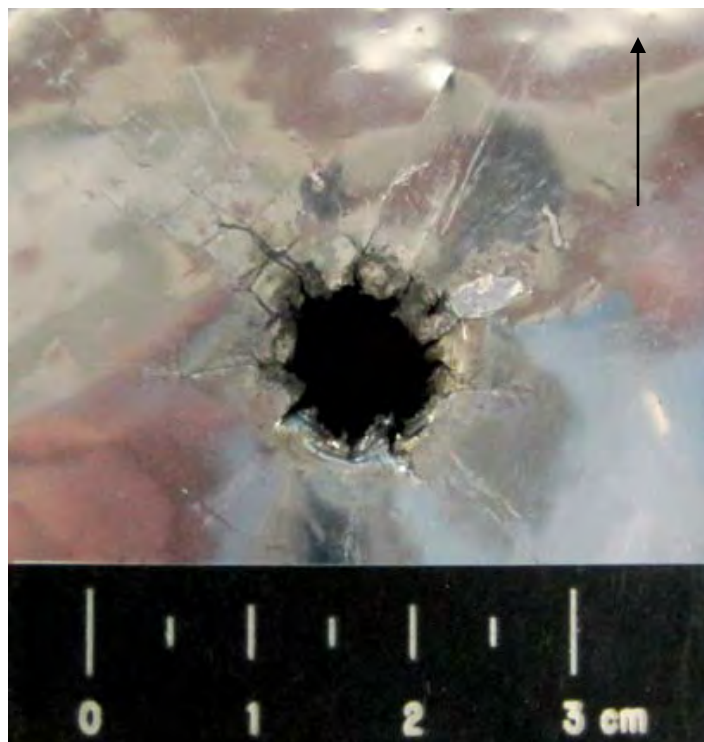
Figure 360 Close-up View of Damage to Back Side of MLI (scale in 5mm increments / black arrow indicates flight path of projectile)

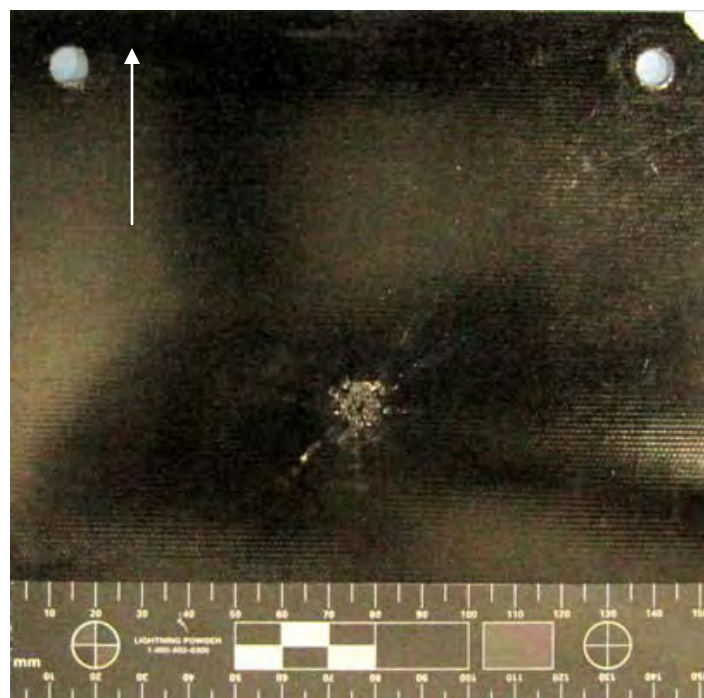
Figure 361 Overall View of Damage to Front of NP 504 Substrate (scale in 5mm increments / white arrow indicates flight path of projectile)

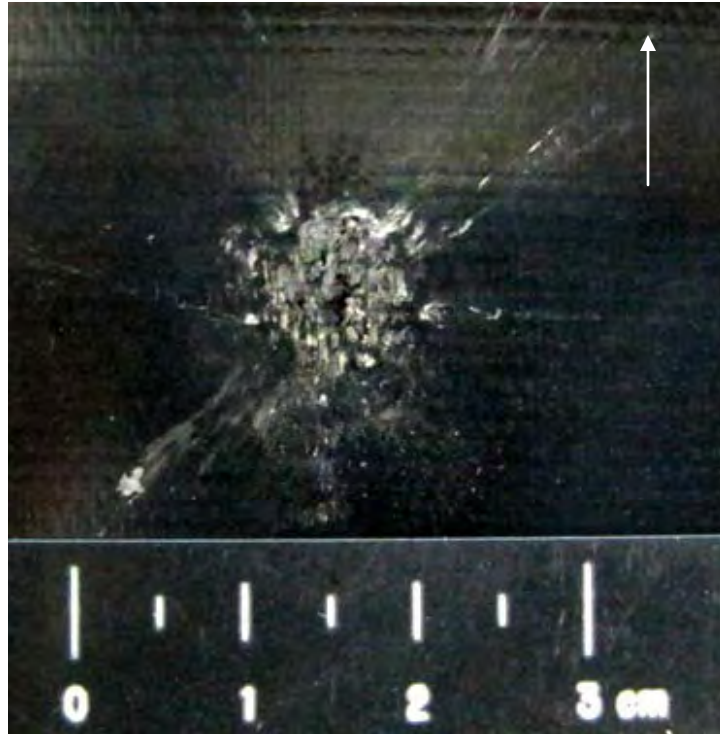
Figure 362 Close-up View of Damage to Front of NP 504 Substrate (scale in 5mm increments / white arrow indicates flight path of projectile)

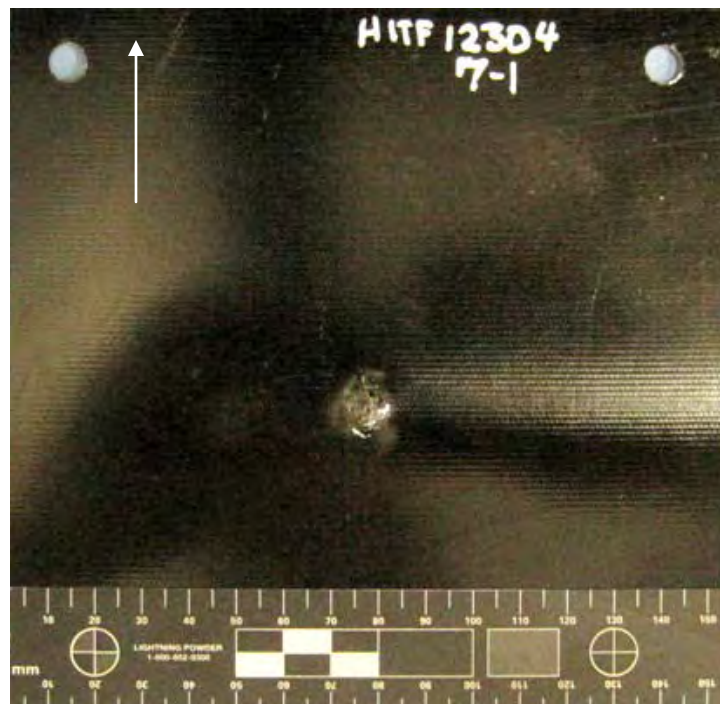
Figure 363 Overall View of Damage to Back Side of NP 504 Substrate (scale in 5mm increments / white arrow indicates flight path of projectile)

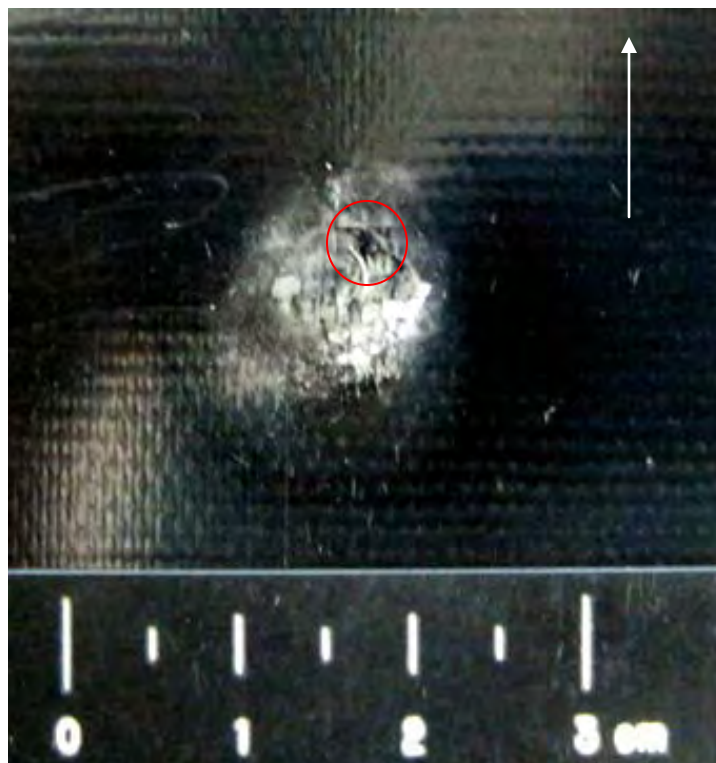
Figure 364 Close-up View of Damage to Back Side of NP 504 Substrate (scale in 5mm increments / white arrow indicates flight path of projectile)

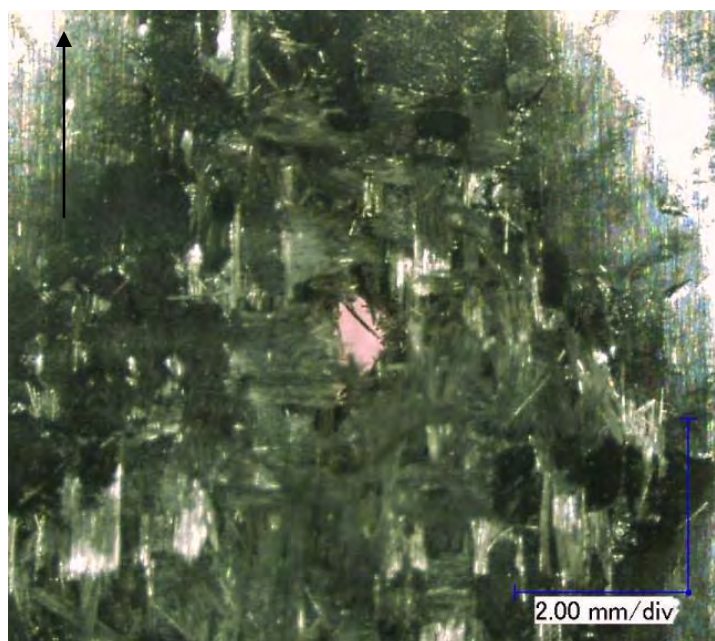
Figure 365 Close-up View of Most Significant Damage to Back Side of NP 504 Substrate (black arrow indicates flight path of projectile / damage within red circle in Figure 364)

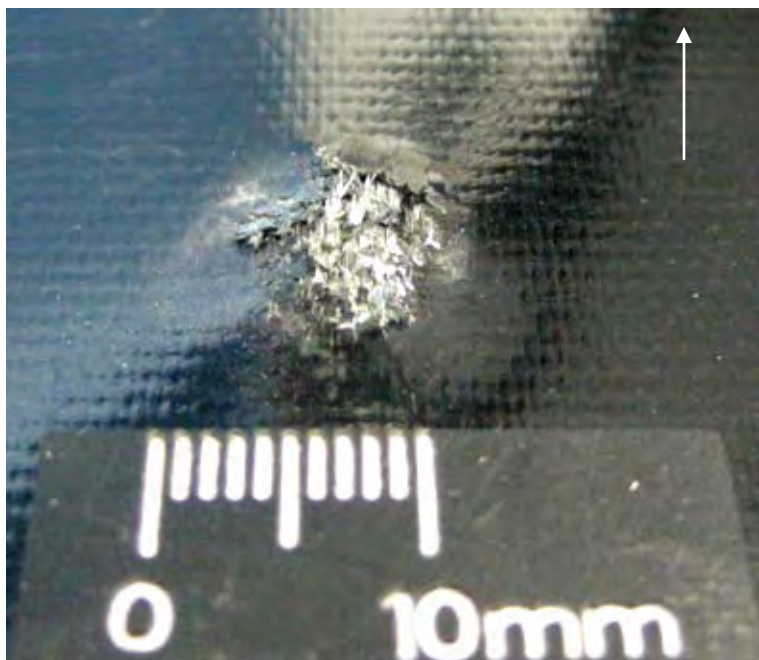
Figure 366 Close-up Oblique Side View of Damage to Back Side of NP 504 Substrate (scale in 1mm increments / white arrow indicates flight path of projectile)

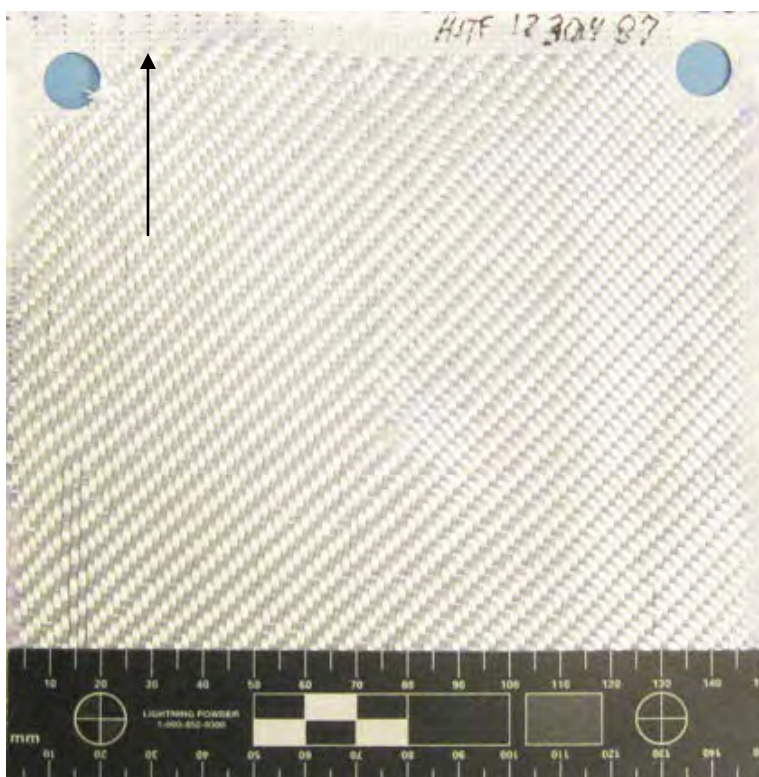
Figure 367 Overall View of Damage to Back Side of 7th Fiberglass Layer (scale in 5mm increments / black arrow indicates flight path of projectile)

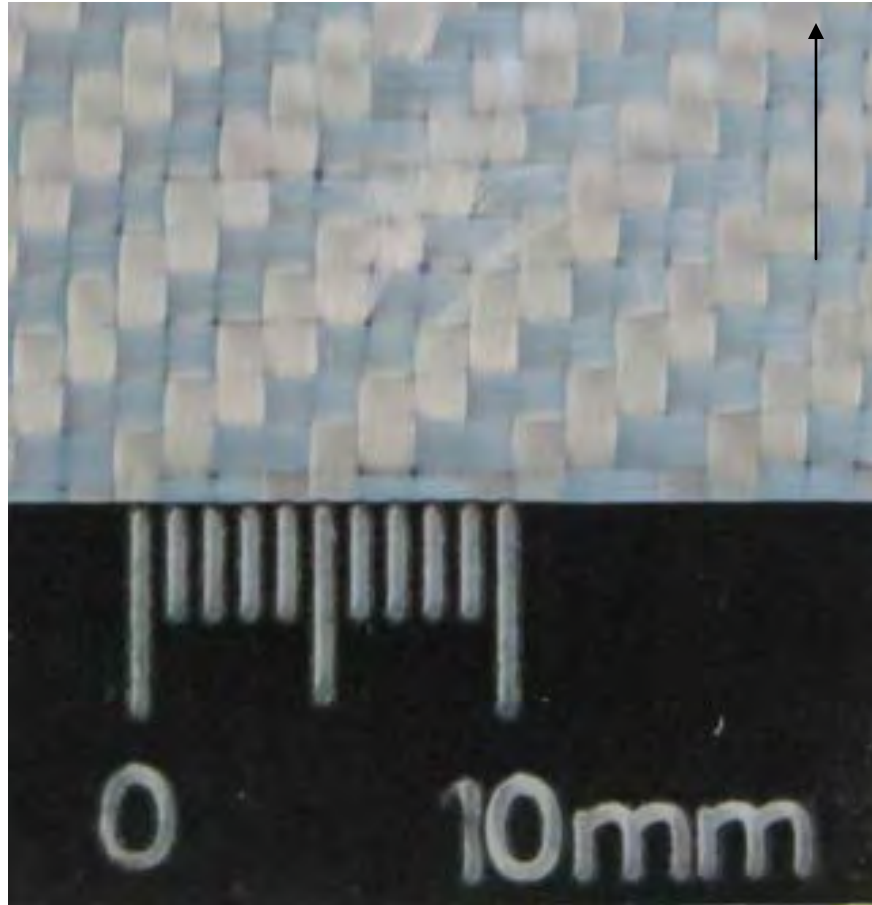
Figure 368 Close-up View of Damage to Back Side of 7th Fiberglass Layer (scale in 1mm increments / black arrow indicates flight path of projectile)

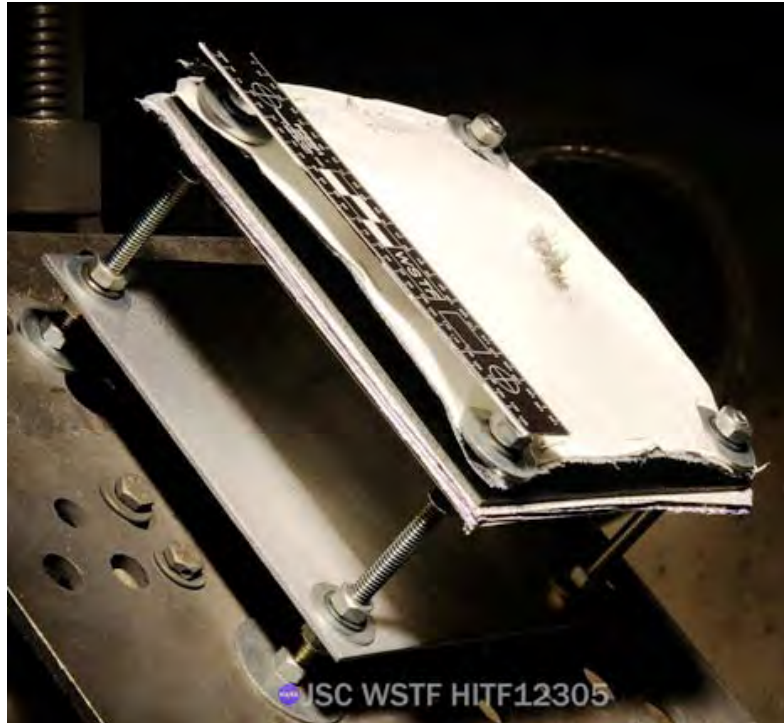
Figure 369 Overall View of Sample in the Target Tank (post-test)

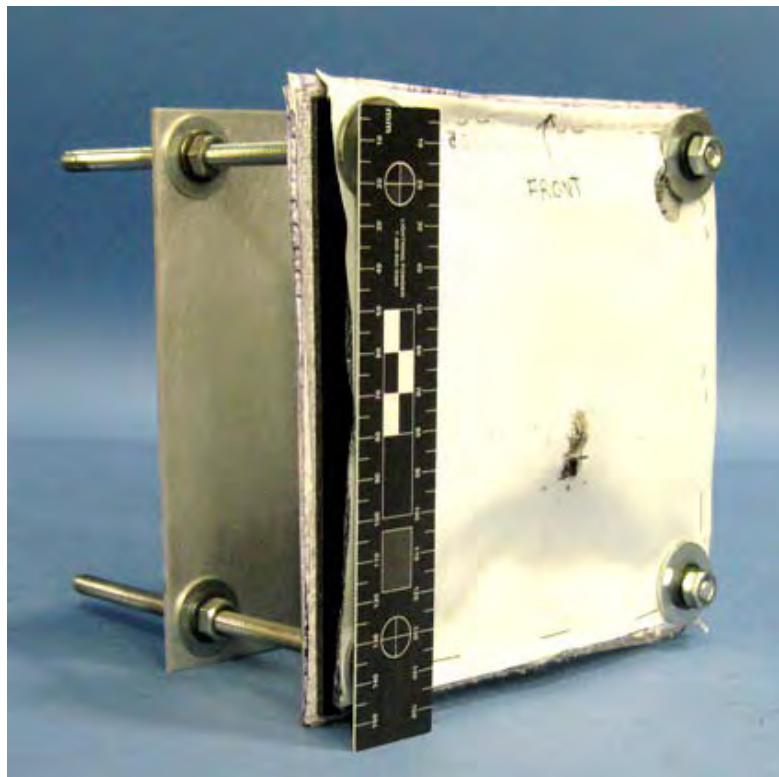
Figure 370 Overall Front Oblique View of Sample (scale in 5mm increments)
