International Space Station (ISS) Soyuz Vehicle Descent Module Evaluation of Thermal Protection System (TPS) Penetration Characteristics

Hypervelocity Impact Technology Group

February 2013

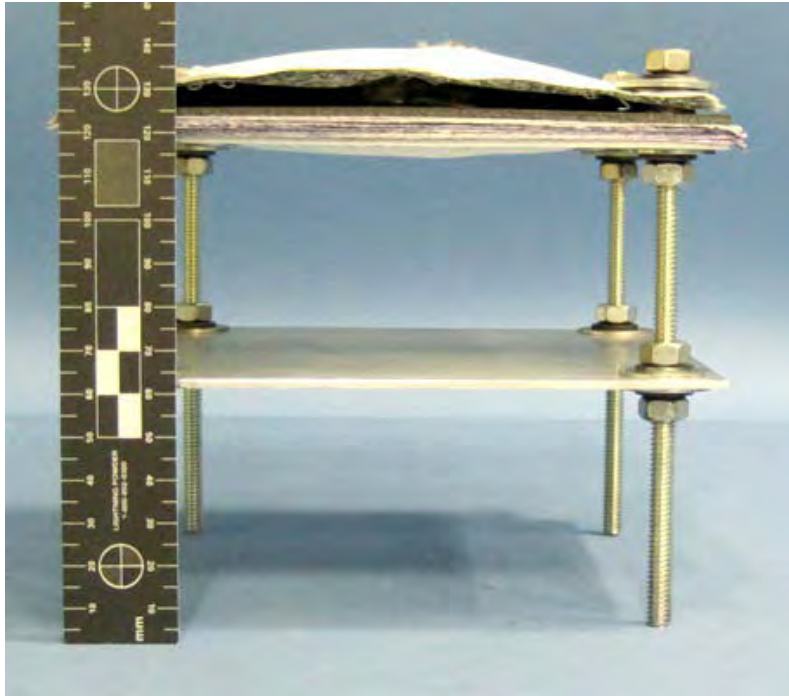
**Figure 371** Overall Side View of Sample (scale in 5mm increments)

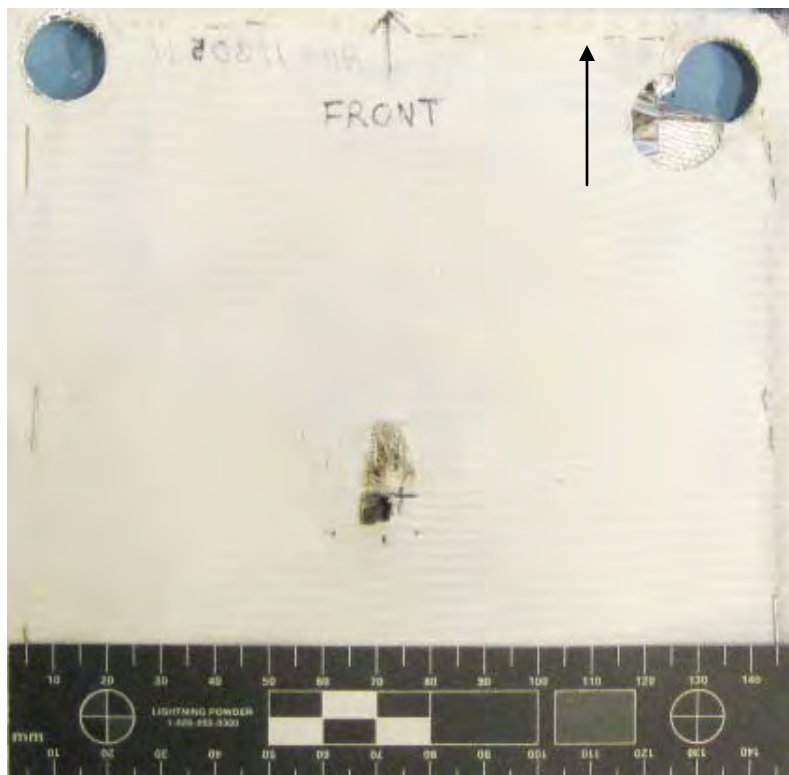
**Figure 372** Overall View of Damage to Front of MLI (scale in 5mm increments / black arrow indicates flight path of projectile)

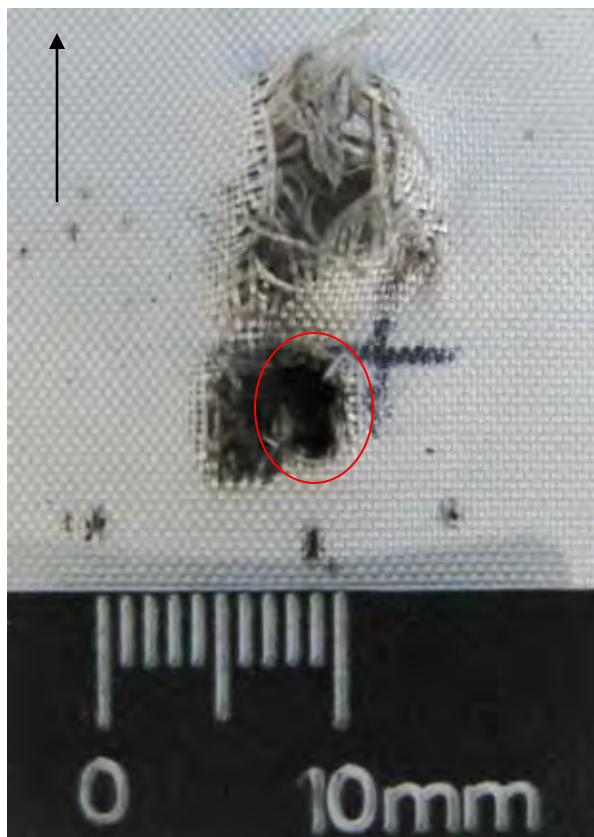
Figure 373 Close-up View of Damage to Front of MLI (scale in 1mm increments / black arrow indicates flight path of projectile / projectile impact within red circle)

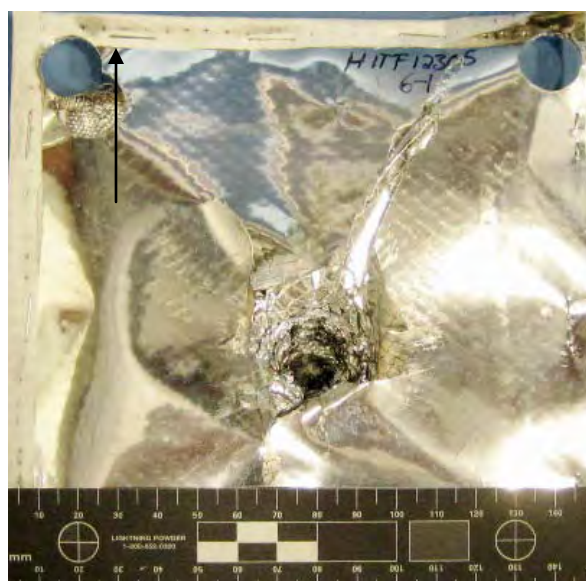
Figure 374 Overall View of Damage to Back Side of MLI (scale in 5mm increments / black arrow indicates flight path of projectile)

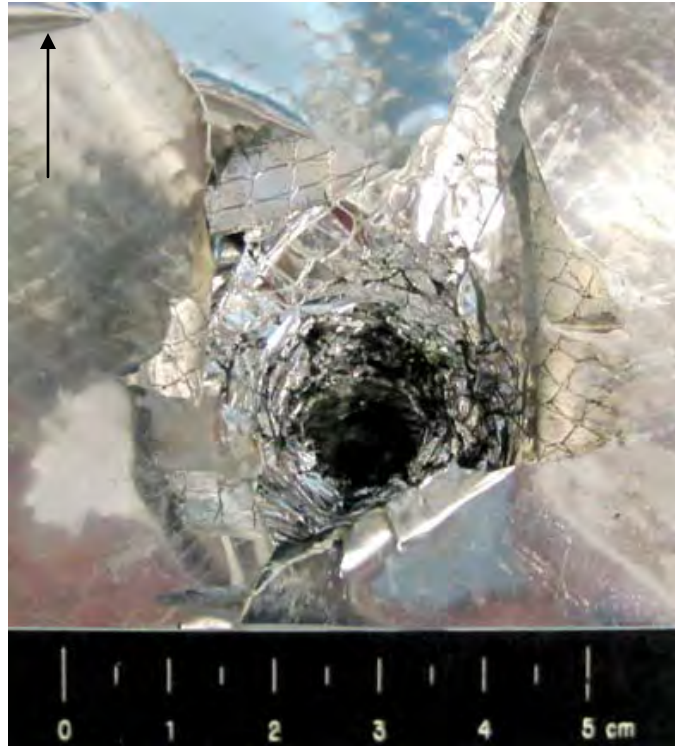
Figure 375 Close-up View of Damage to Back Side of MLI (scale in 5mm increments / black arrow indicates flight path of projectile)

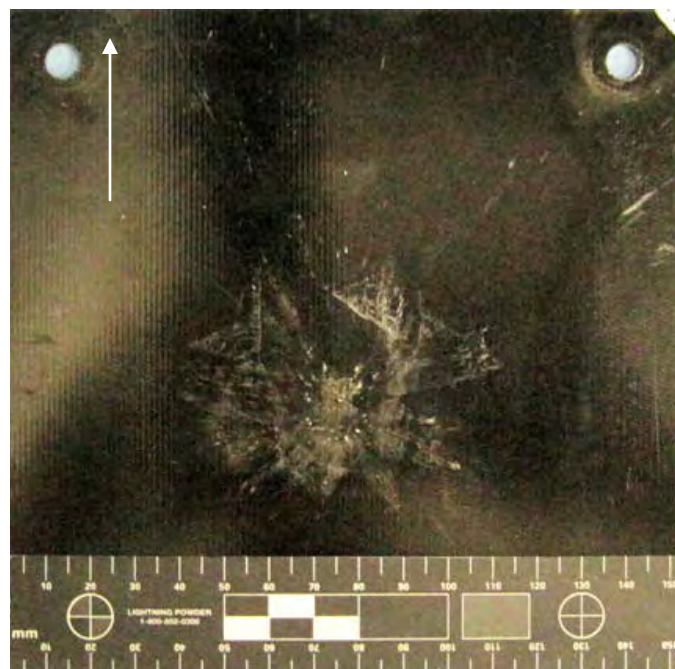
Figure 376 Overall View of Damage to Front of NP 504 Substrate (scale in 5mm increments / white arrow indicates flight path of projectile)

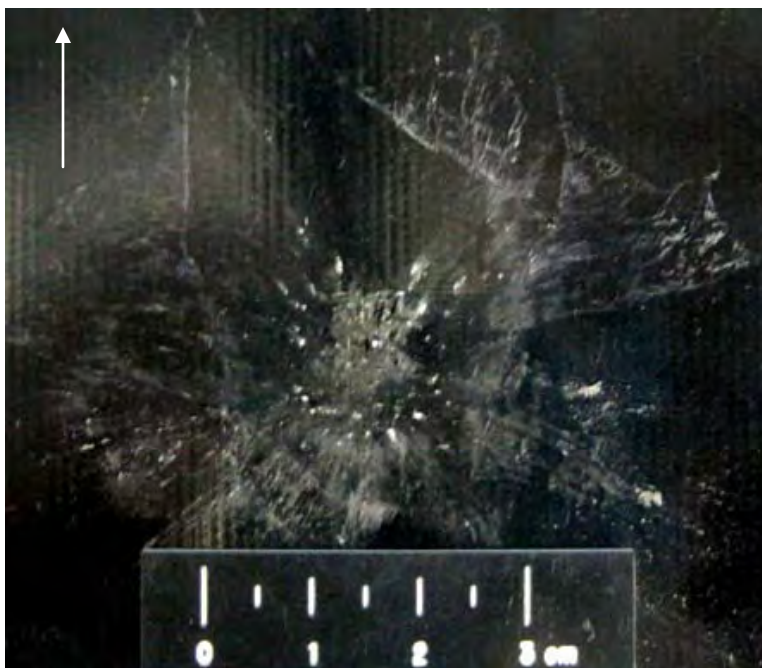
Figure 377 Close-up View of Damage to Front of NP 504 Substrate (scale in 5mm increments / white arrow indicates flight path of projectile)

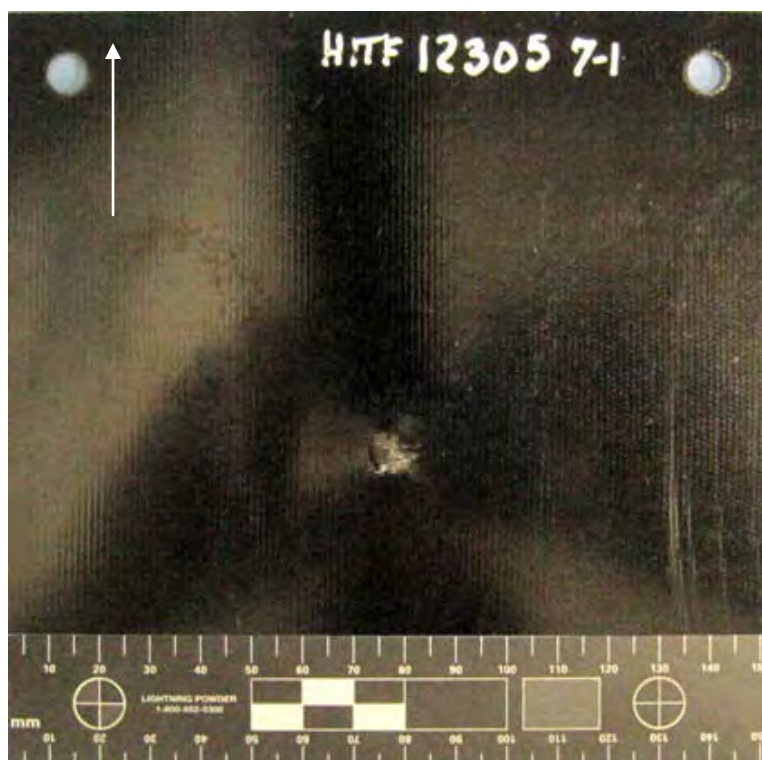
Figure 378 Overall View of Damage to Back Side of NP 504 Substrate (scale in 5mm increments / white arrow indicates flight path of projectile)

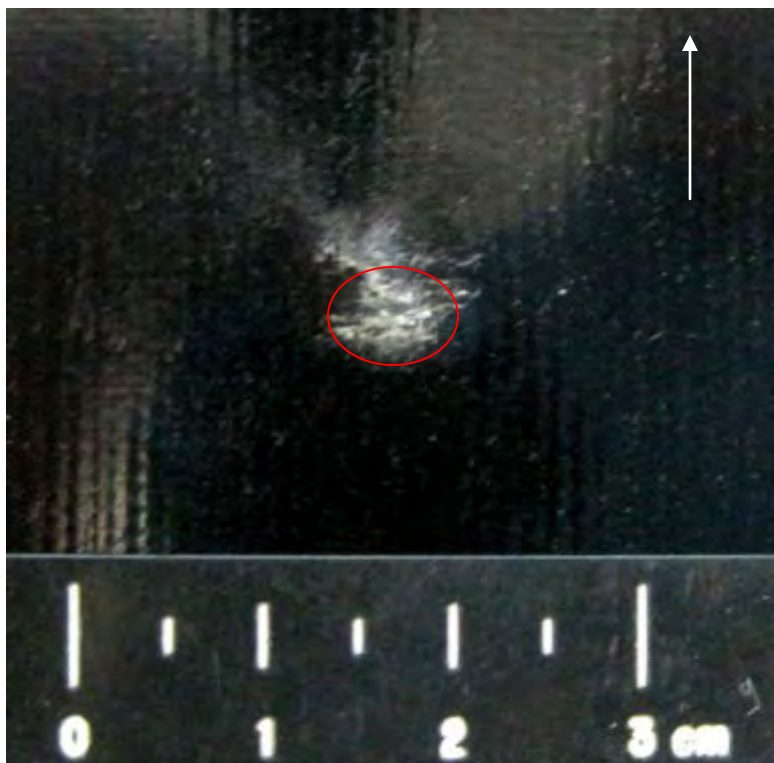
Figure 379 Close-up View of Damage to Back Side of NP 504 Substrate (scale in 5mm increments / white arrow indicates flight path of projectile)

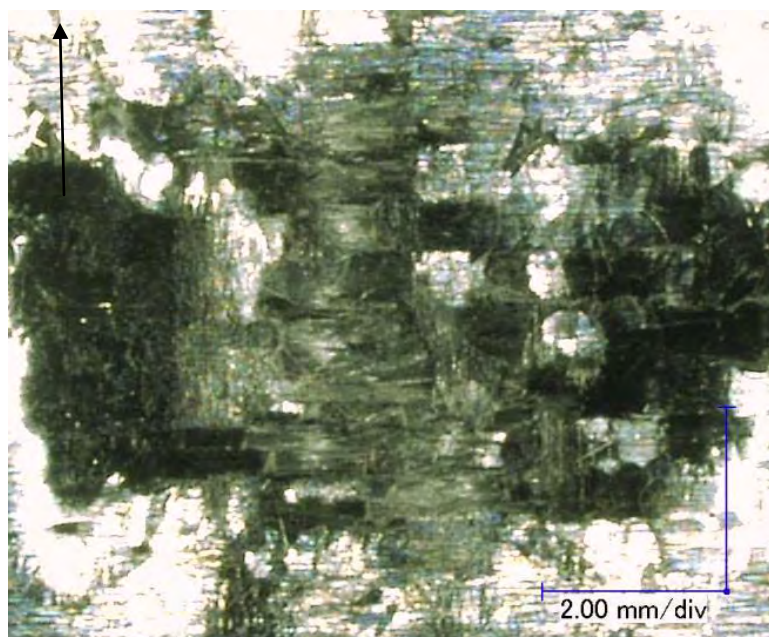
Figure 380 Close-up View of Most Significant Damage to Back Side of NP 504 Substrate (black arrow indicates flight path of projectile / damage within red circle in Figure 379)

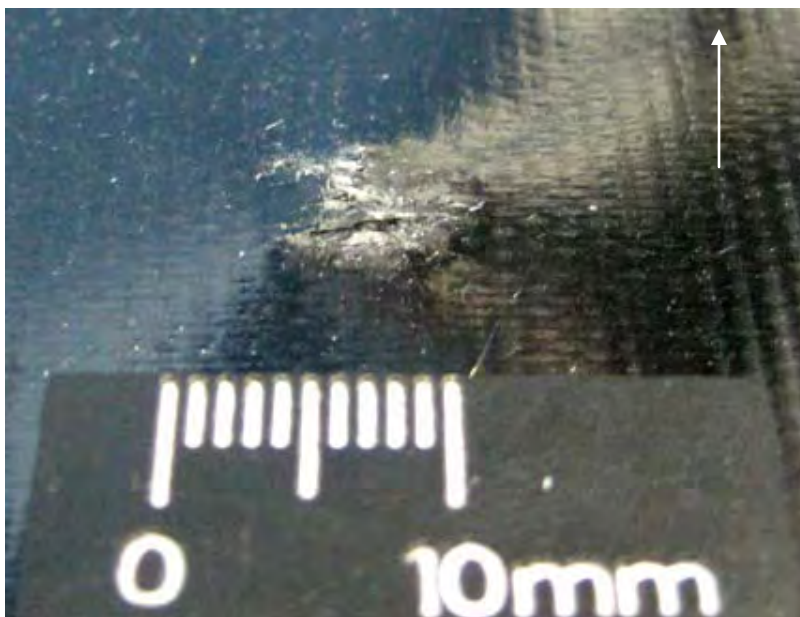
Figure 381 Close-up Oblique Side View of Damage to Back Side of NP 504 Substrate (scale in 1mm increments / white arrow indicates flight path of projectile)

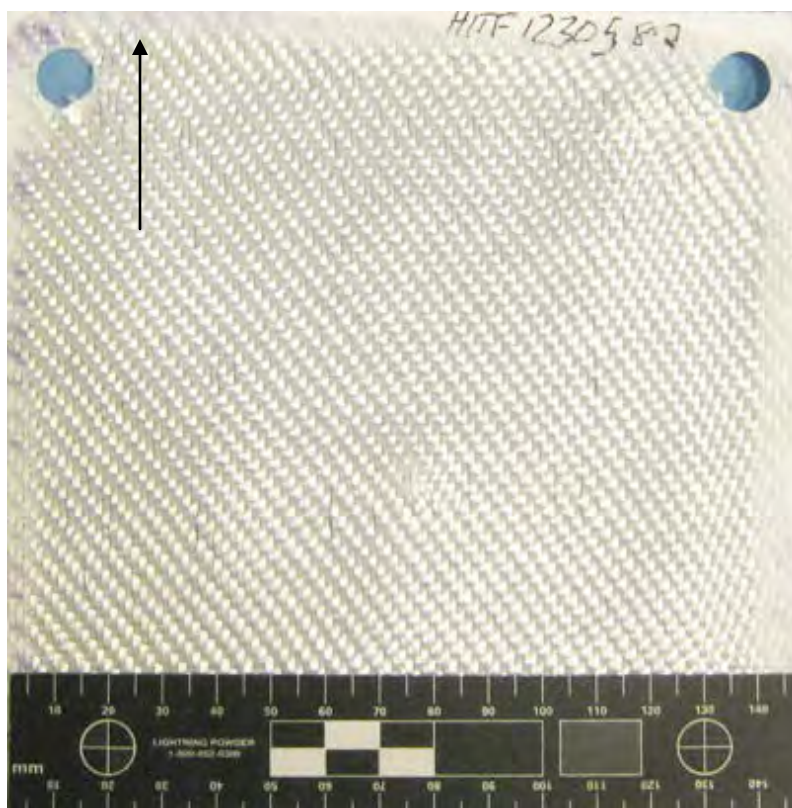
Figure 382 Overall View of Damage to Back Side of 2nd Fiberglass Layer (scale in 5mm increments / black arrow indicates flight path of projectile)

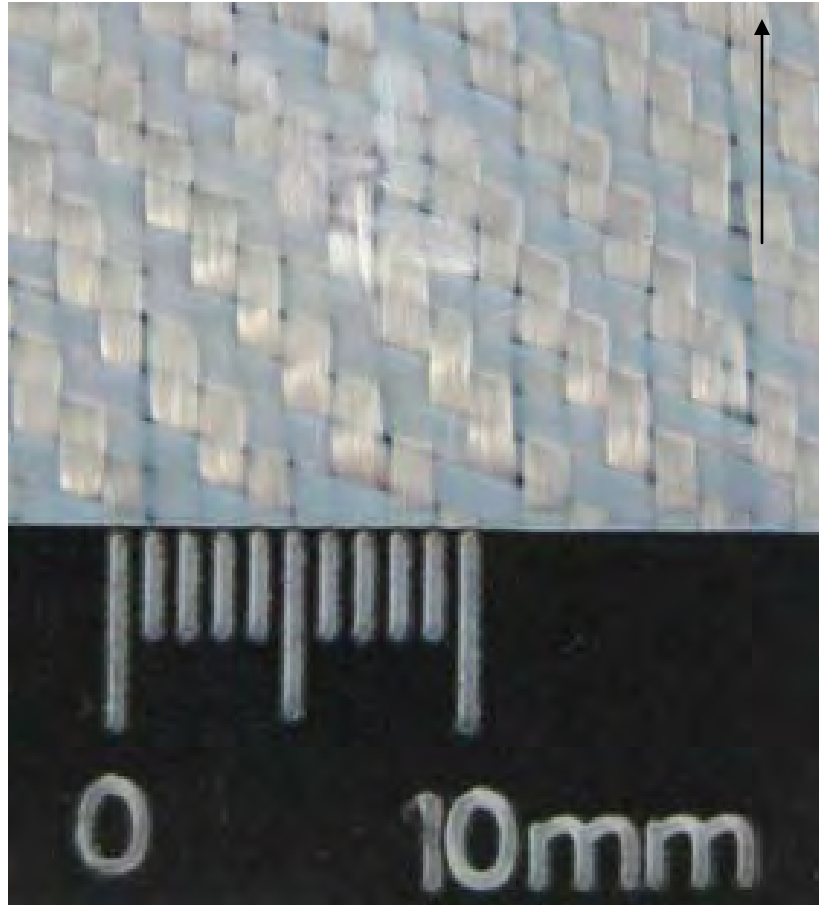
Figure 383 Close-up View of Damage to Back Side of 2nd Fiberglass Layer (scale in 5mm increments / black arrow indicates flight path of projectile)

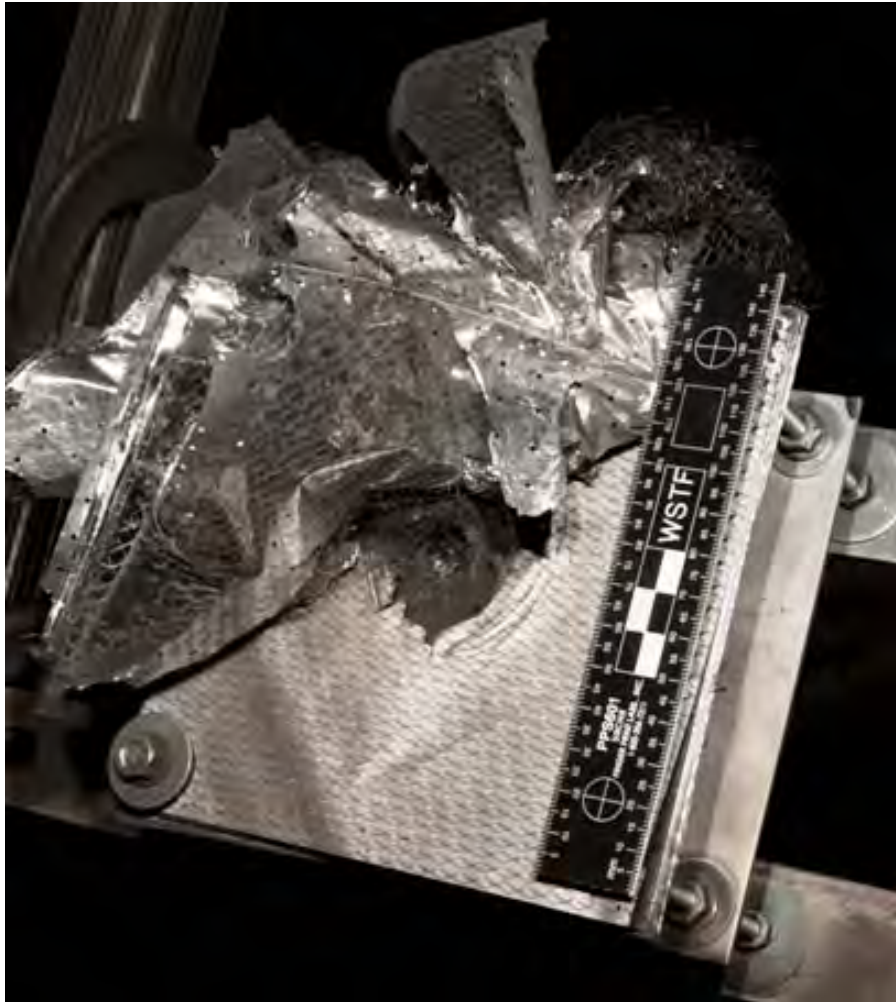
Figure 384 Overall View of Sample in the Target Tank (post-test)

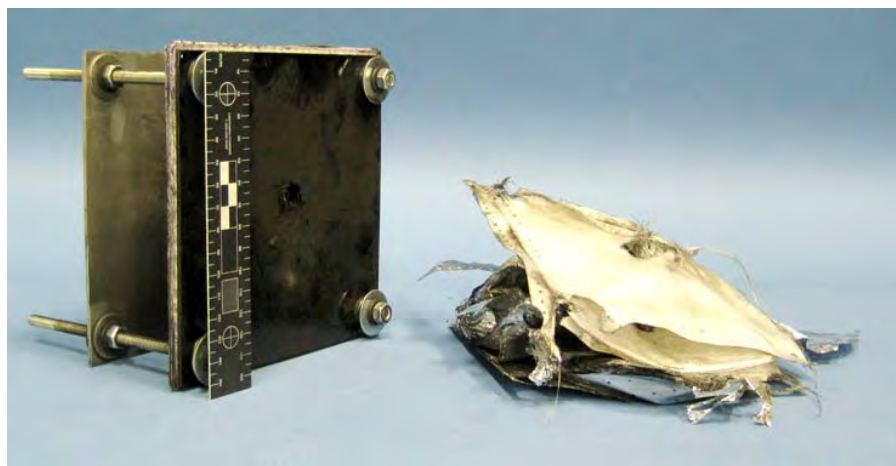
Figure 385 Overall Front Oblique View of Sample and Dislodged MLI Blanket from Test Configuration (scale in 5mm increments)

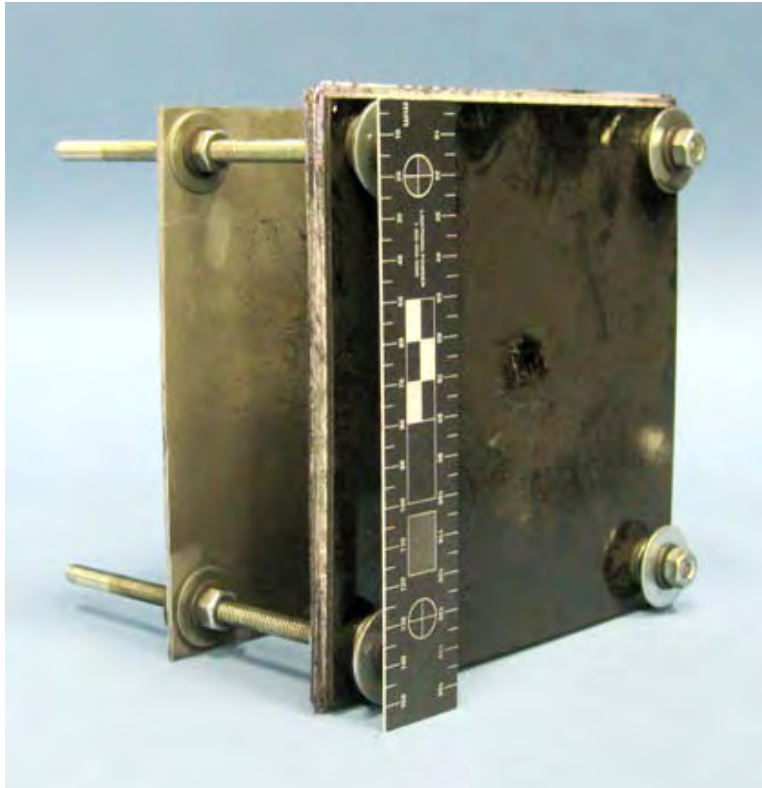
Figure 386 Overall Front Oblique View of Sample (scale in 5mm increments / with MLI displaced from configuration)

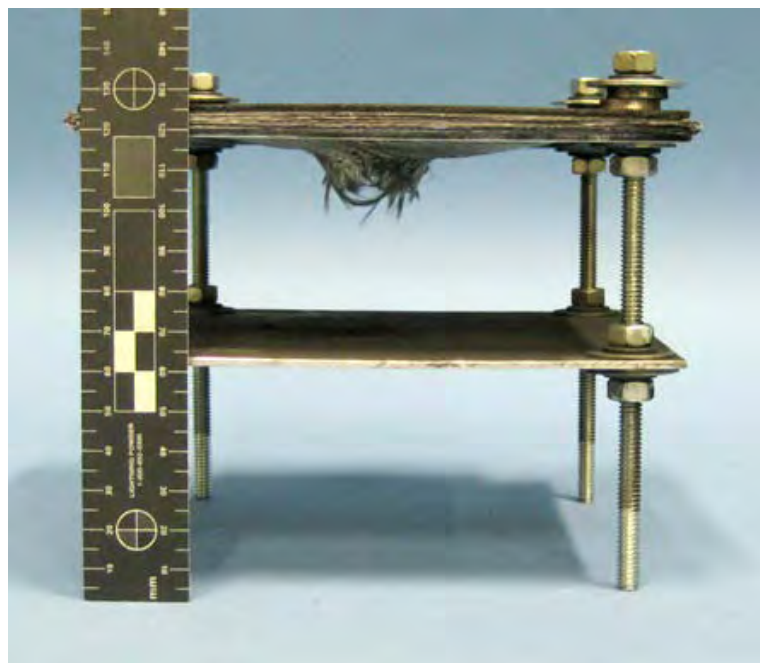
Figure 387 Overall Side View of Sample (scale in 5mm increments)

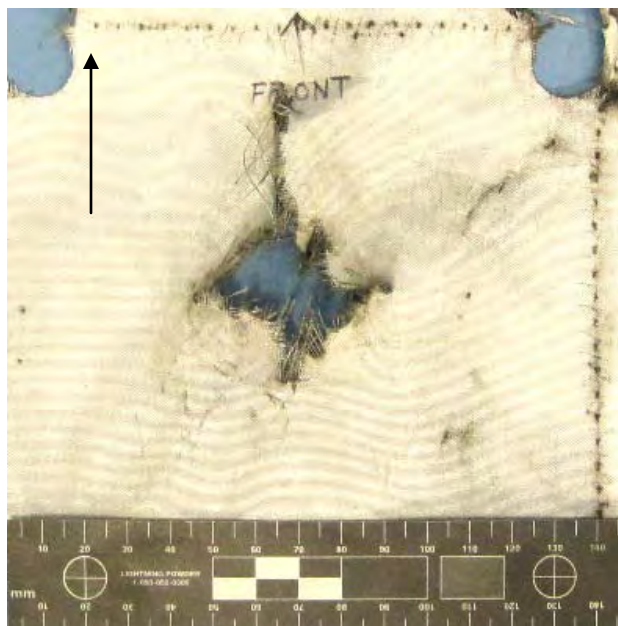
Figure 388 Overall View of Entry Damage to Front Layer of MLI Blanket (black arrow indicates flight path of projectile / scale in 5mm increments)

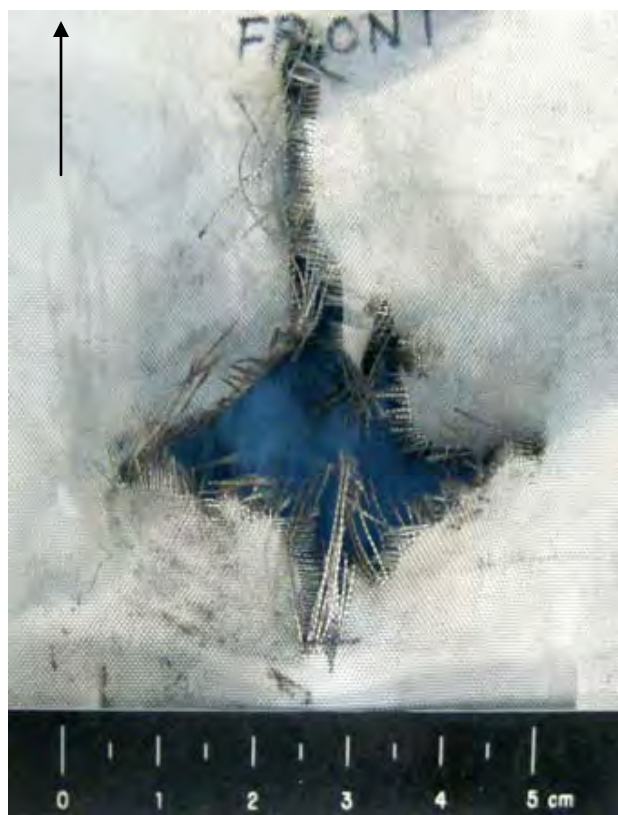
Figure 389 Close-up View of Entry Damage to Front of MLI (scale in 5mm increments / black arrow indicates flight path of projectile)

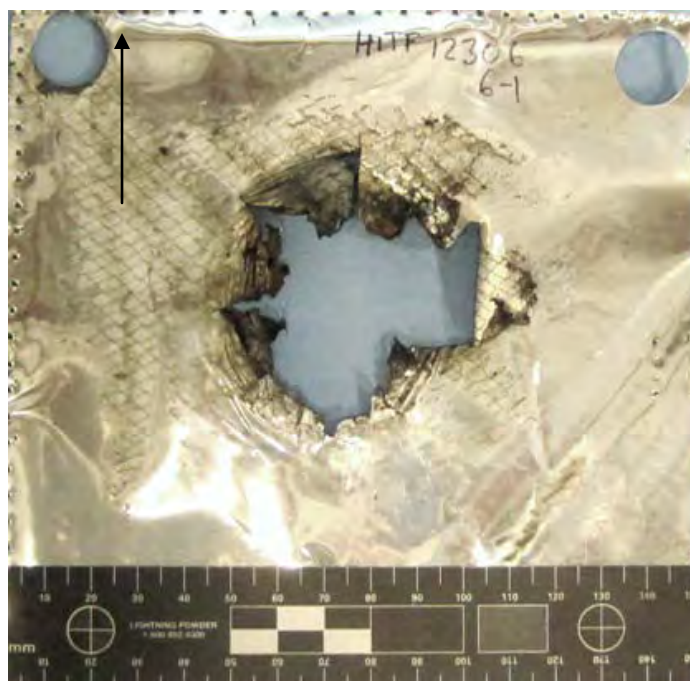
Figure 390 Overall View of Exit Damage to Last Layer of MLI Blanket (scale in 5mm increments / black arrow indicates flight path of projectile)

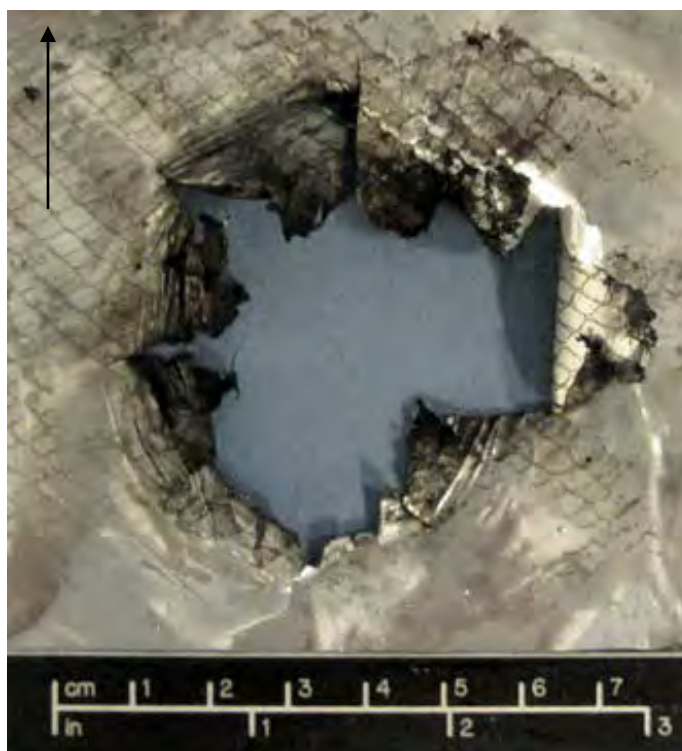
Figure 391 Close-up View of Exit Damage to Last Layer of MLI Blanket (scale in 1cm increments / black arrow indicates flight path of projectile)

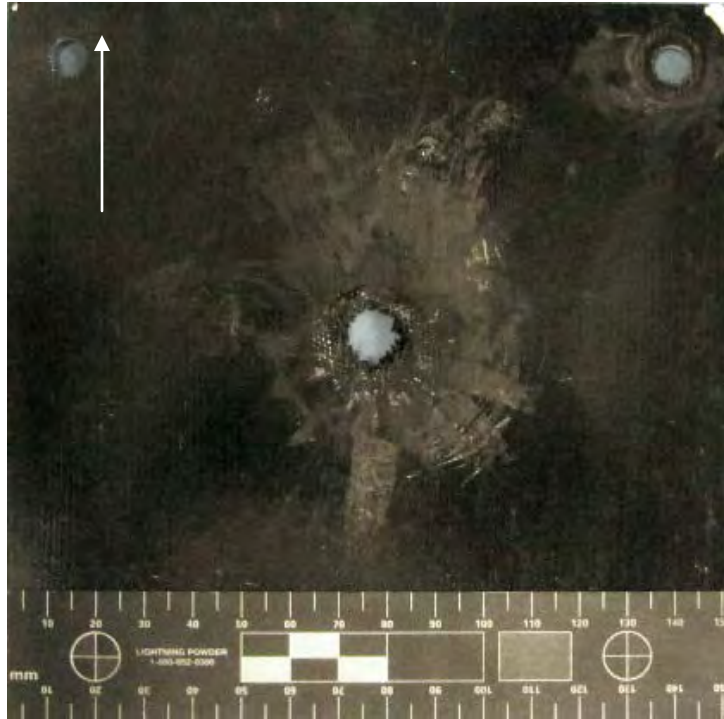
Figure 392 Overall View of Damage to Front of NP 504 Substrate (scale in 5mm increments / white arrow indicates flight path of projectile)

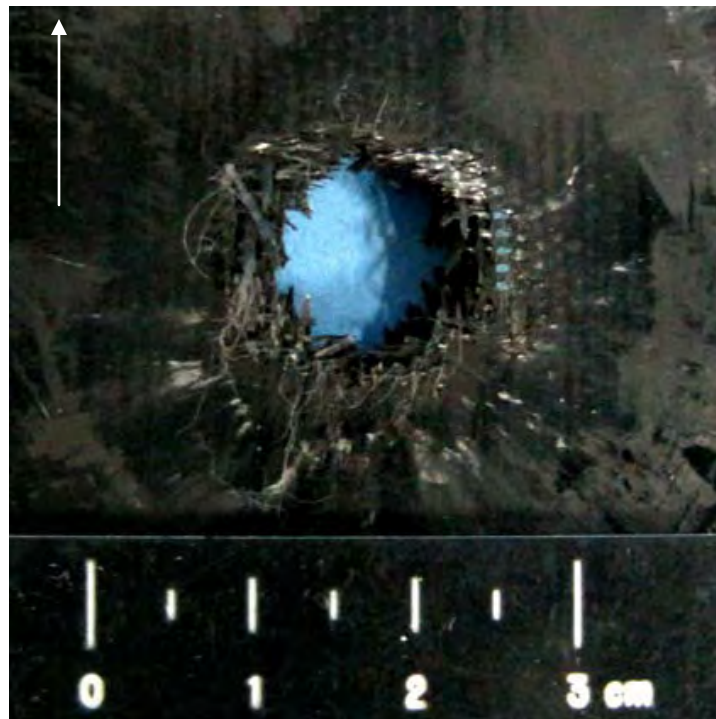
Figure 393 Close-up View of Damage to Front of NP 504 Substrate (scale in 5mm increments / white arrow indicates flight path of projectile)

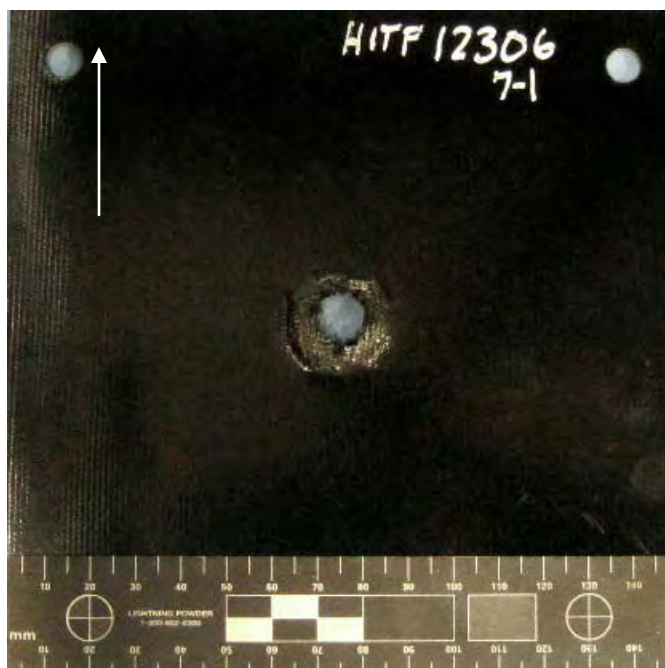
Figure 394 Overall View of Damage to Back Side of NP 504 Substrate (scale in 5mm increments / white arrow indicates flight path of projectile)

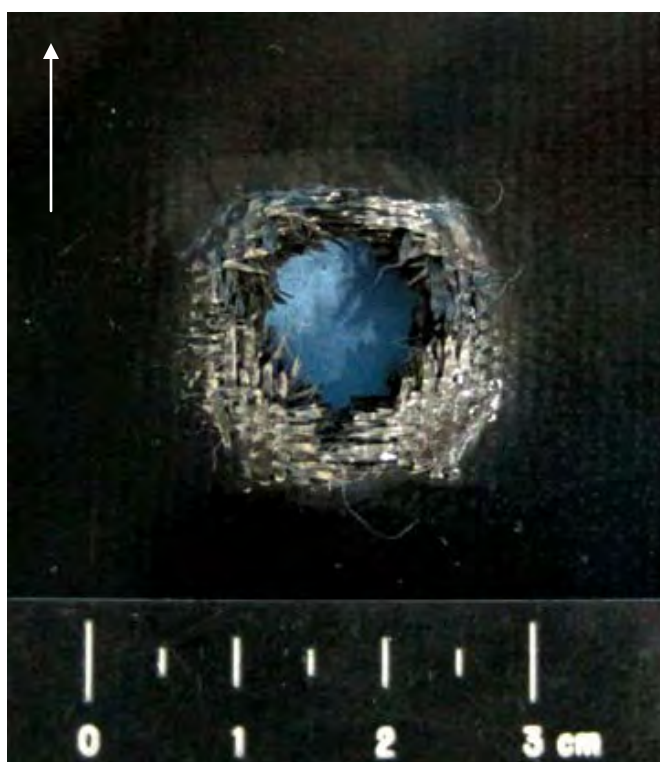
Figure 395 Close-up View of Damage to Back Side of NP 504 Substrate (scale in 1mm increments / white arrow indicates flight path of projectile)

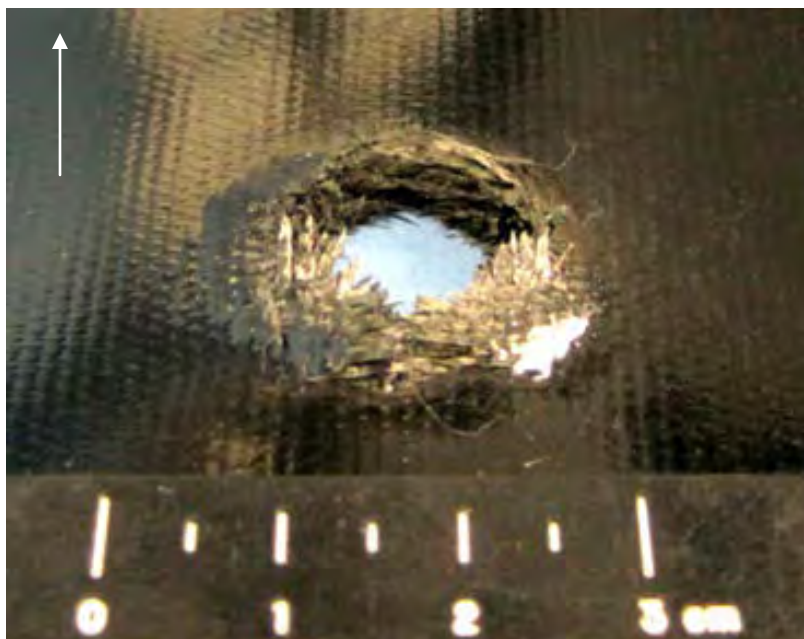
Figure 396 Close-up Oblique Side View of Damage to Back Side of NP 504 Substrate (scale in 5mm increments / white arrow indicates flight path of projectile)

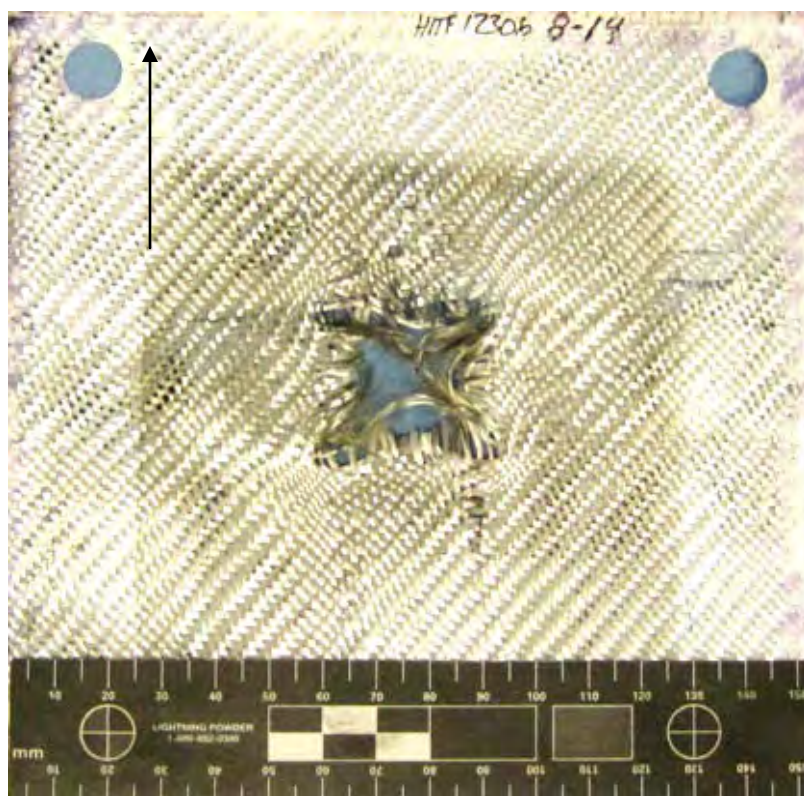
Figure 397 Overall View of Damage to Back Side of Last Fiberglass Layer (scale in 5mm increments / black arrow indicates flight path of projectile)

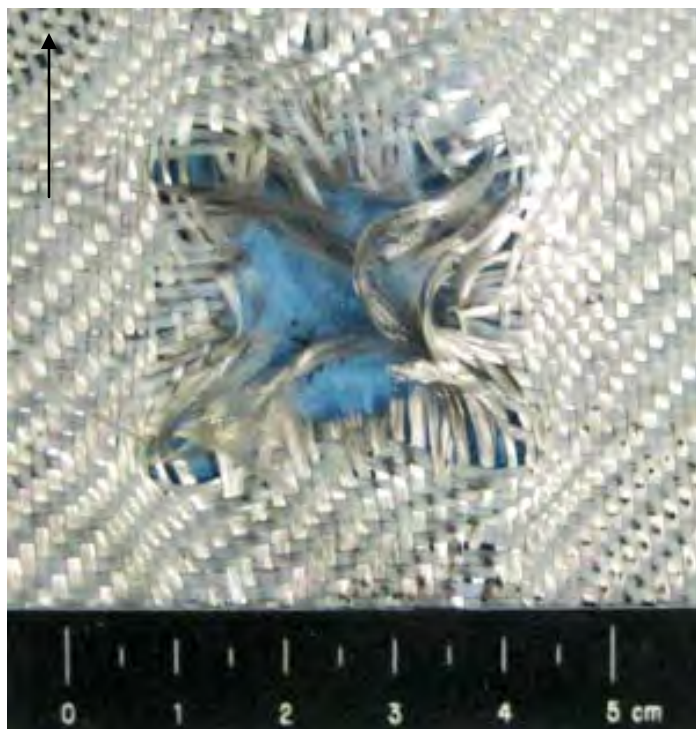
Figure 398 Close-up View of Damage to Back Side of Last Fiberglass Layer (scale in 5mm increments / black arrow indicates flight path of projectile)

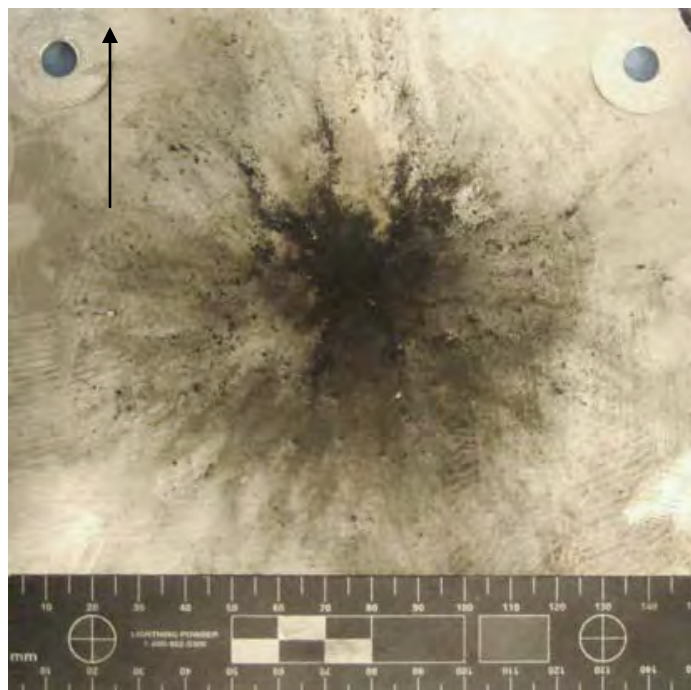
Figure 399 Overall View of Damage to Front of Rear Wall (scale in 5mm increments / black arrow indicates flight path of projectile / uncleaned)

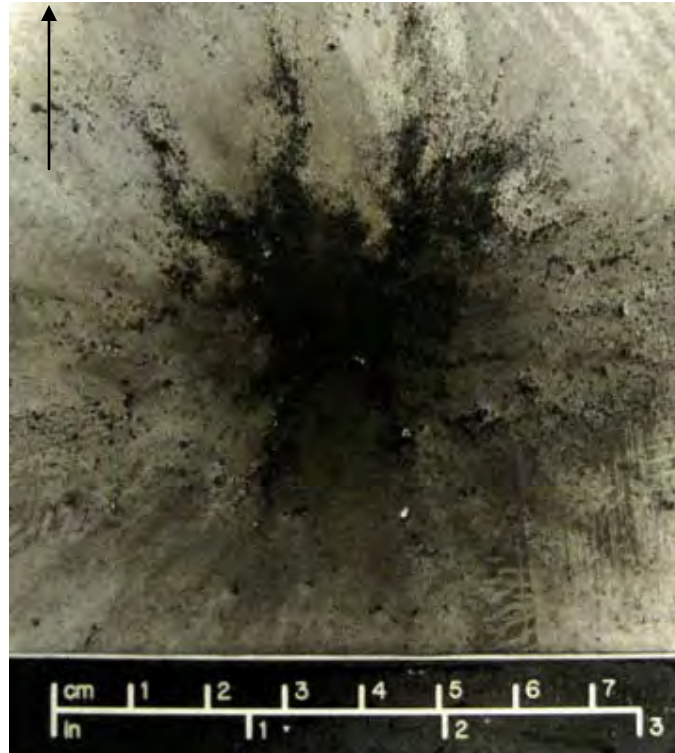
Figure 400 Close-up View of Damage to Front of Rear Wall (scale in 1cm increments / black arrow indicates flight path of projectile / uncleaned)

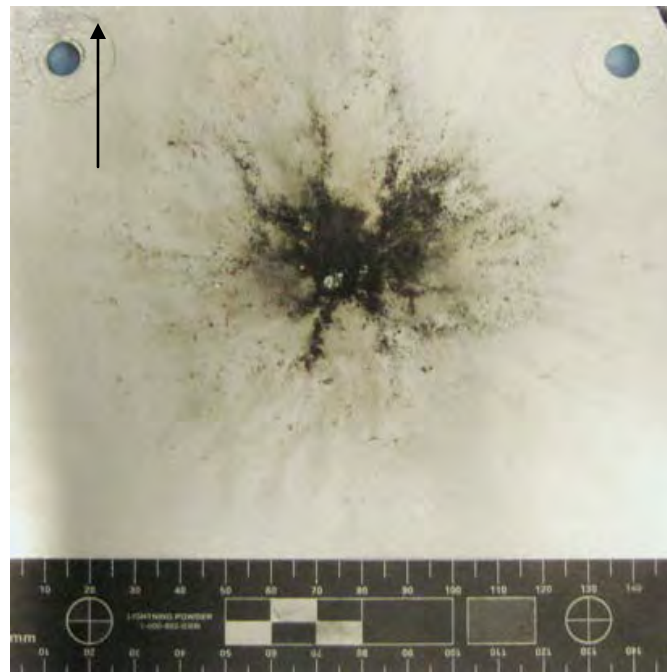
Figure 401 Overall View of Damage to Front of Rear Wall (scale in 5mm increments / black arrow indicates flight path of projectile / cleaned)

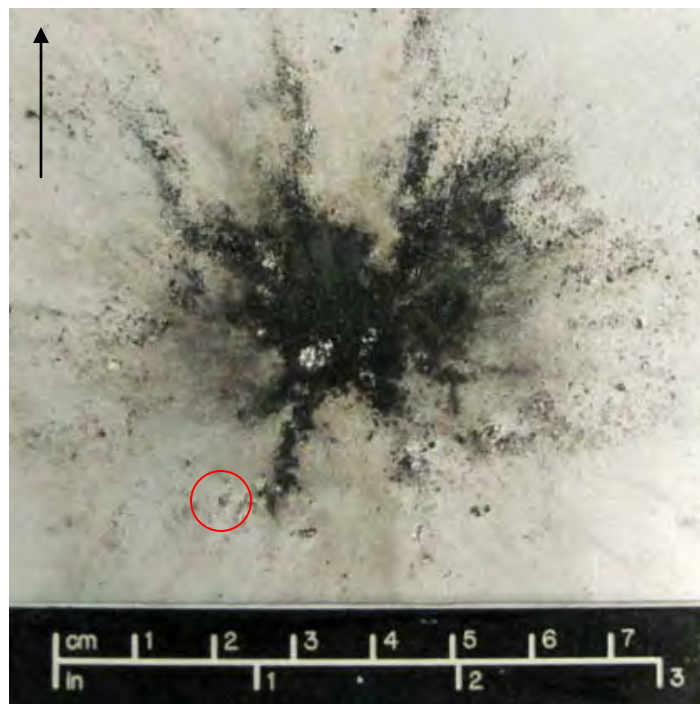
Figure 402 Overall View of Damage to Front of Rear Wall (scale in 1cm increments / black arrow indicates flight path of projectile / cleaned)

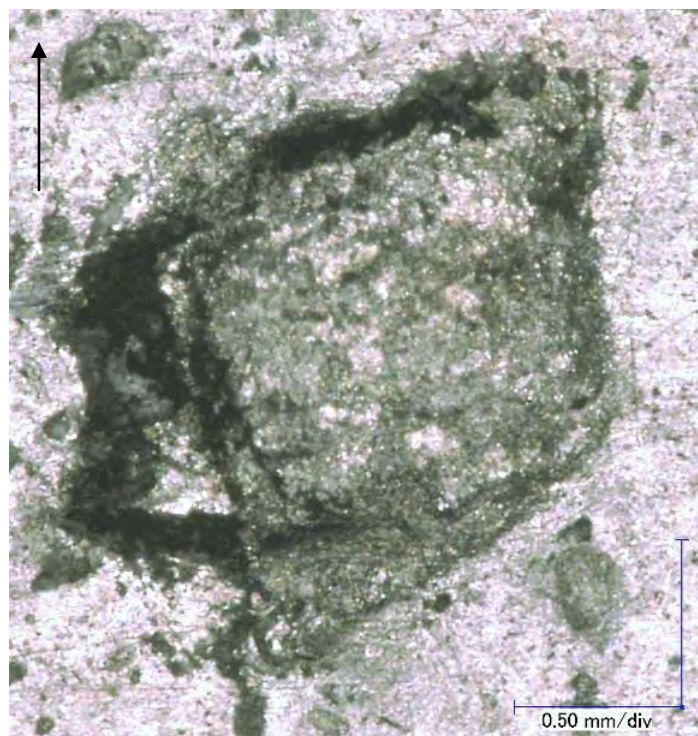
Figure 403 Close-up View of Most Significant Visible Damage to Front of Rear Wall (black arrow indicates flight path of projectile / damage within red circle in Figure 402)

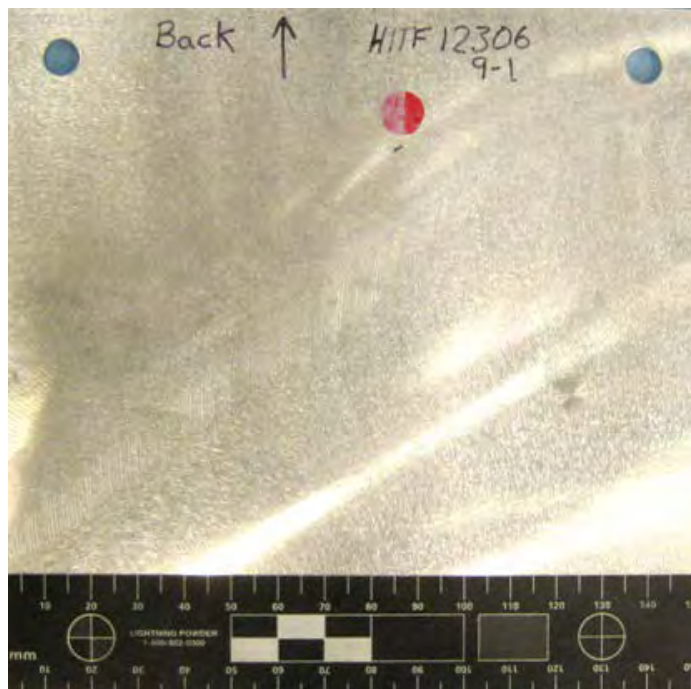
Figure 404 Overall View of Damage on Back Side of Rear Wall (scale in 5mm increments / black arrow indicates flight path of projectile)

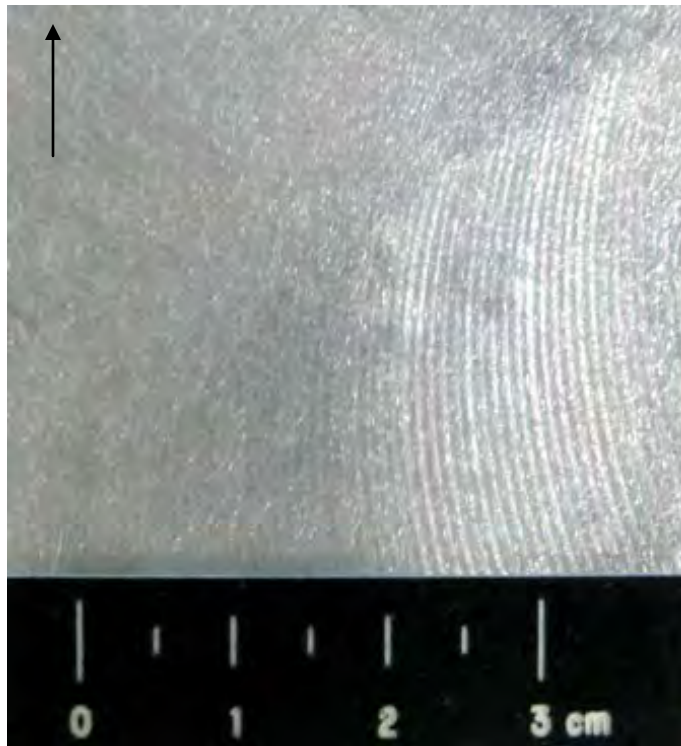
Figure 405 Close-up View of Damage on Back Side of Rear Wall (scale in 5mm increments / black arrow indicates flight path of projectile)

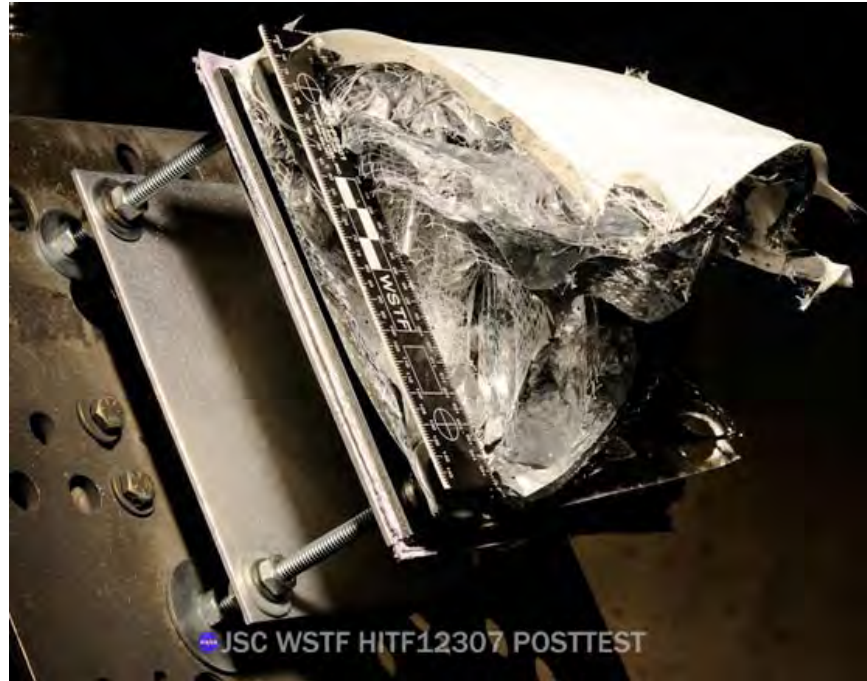
Figure 407 Overall View of Sample in the Target Tank (post-test)

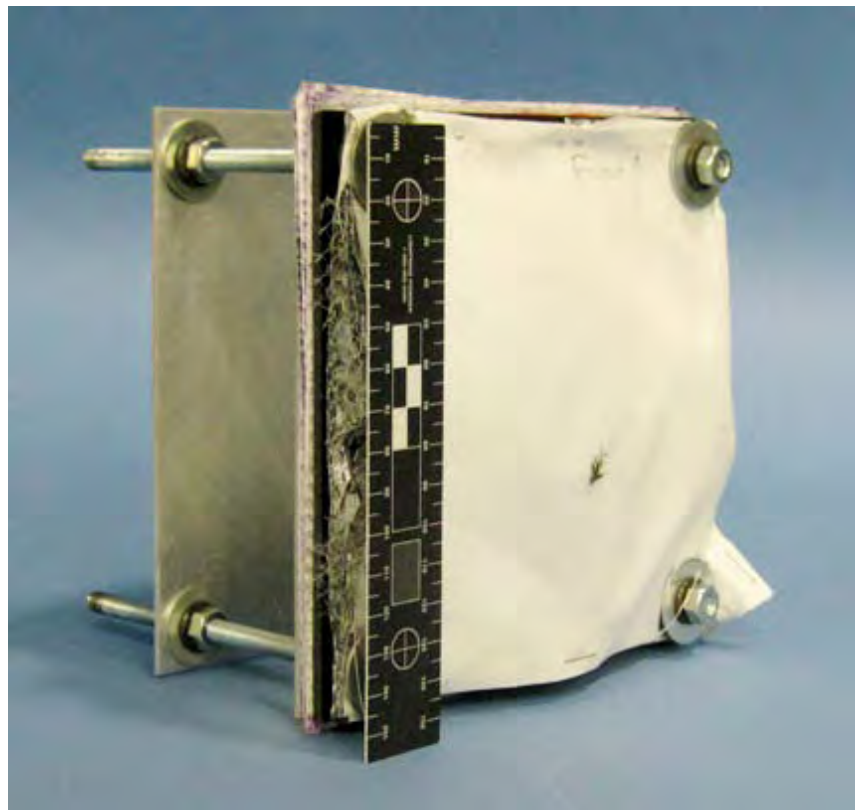
Figure 408 Overall Front Oblique View of Sample (scale in 5mm increments)

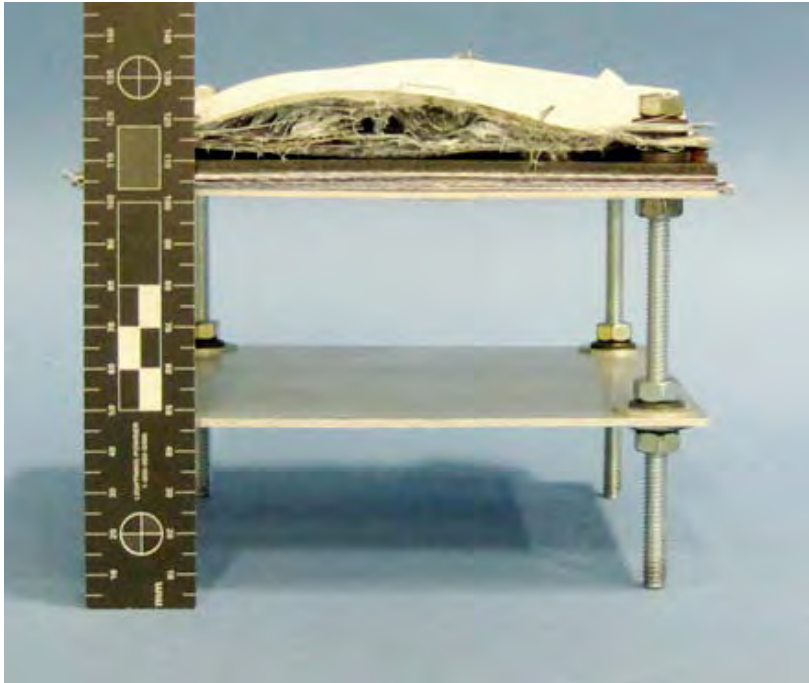
Figure 409 Overall Side View of Sample (scale in 5mm increments)

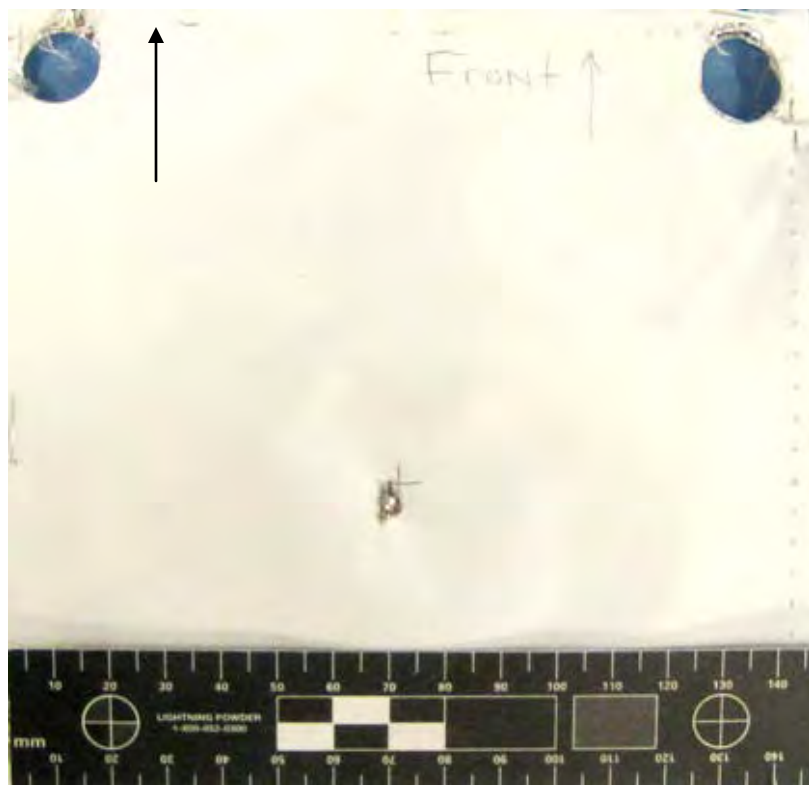
Figure 410 Overall View of Damage to Front of MLI (black arrow indicates flight path of projectile / scale in 5mm increments)

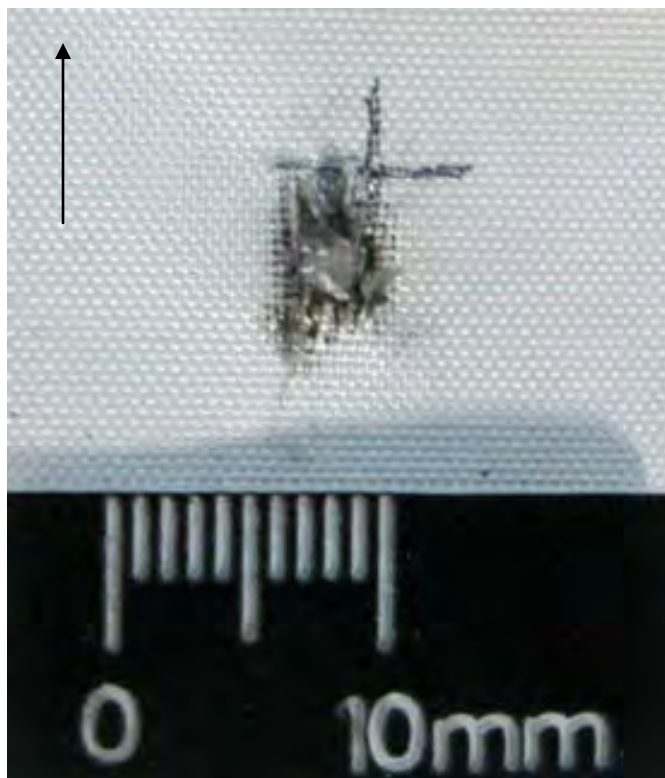
Figure 411 Close-up View of Damage to Front of MLI (scale in 1mm increments / black arrow indicates flight path of projectile)
