International Space Station (ISS) Soyuz Vehicle Descent Module Evaluation of Thermal Protection System (TPS) Penetration Characteristics

Hypervelocity Impact Technology Group

February 2013

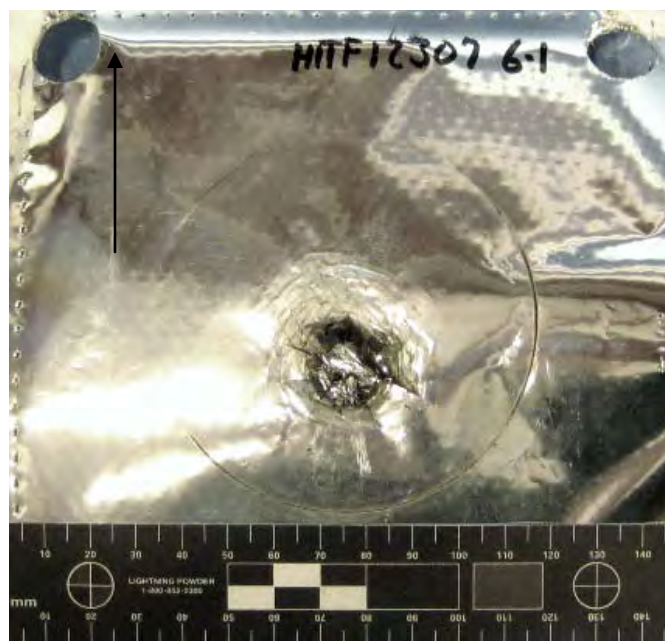
Figure 412 Overall View of Damage to Back Side of MLI (scale in 5mm increments / black arrow indicates flight path of projectile)

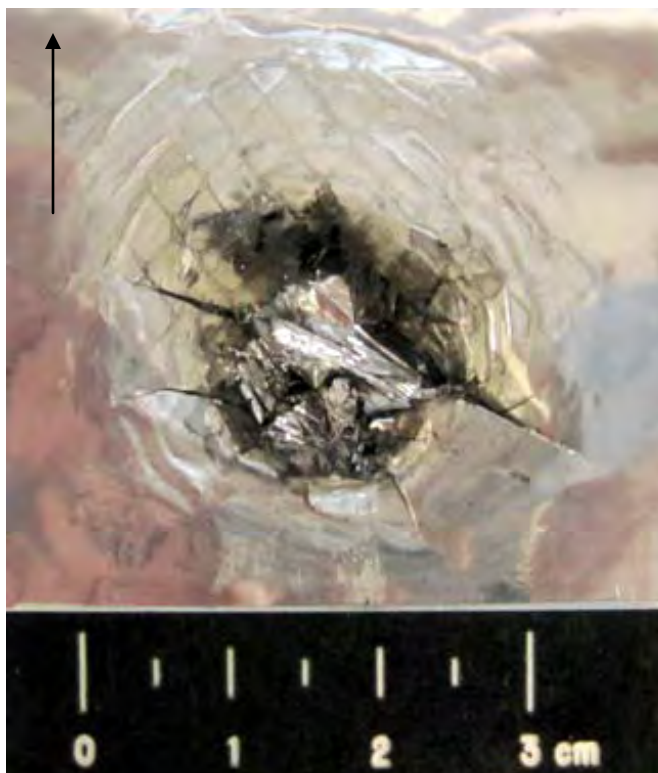
Figure 413 Close-up View of Damage to Back Side of MLI (scale in 5mm increments / black arrow indicates flight path of projectile)

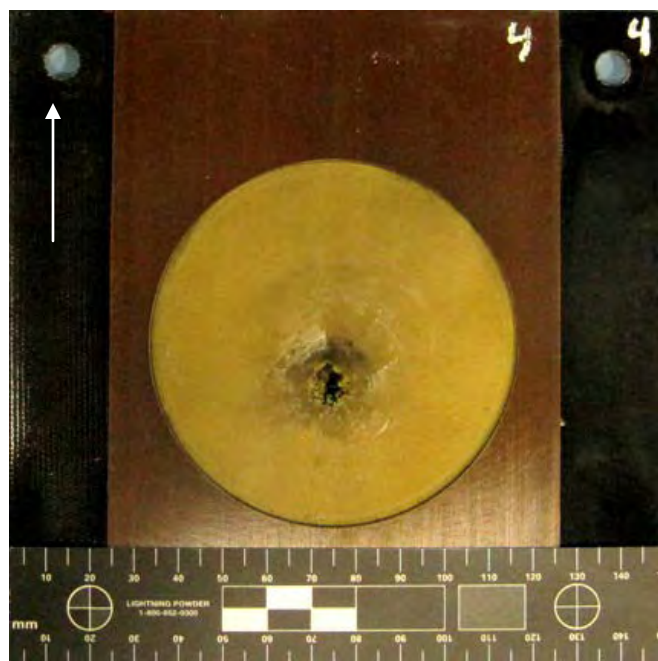
Figure 414 Overall View of Damage to Front of TORLON 5030 (scale in 5mm increments / white arrow indicates flight path of projectile)

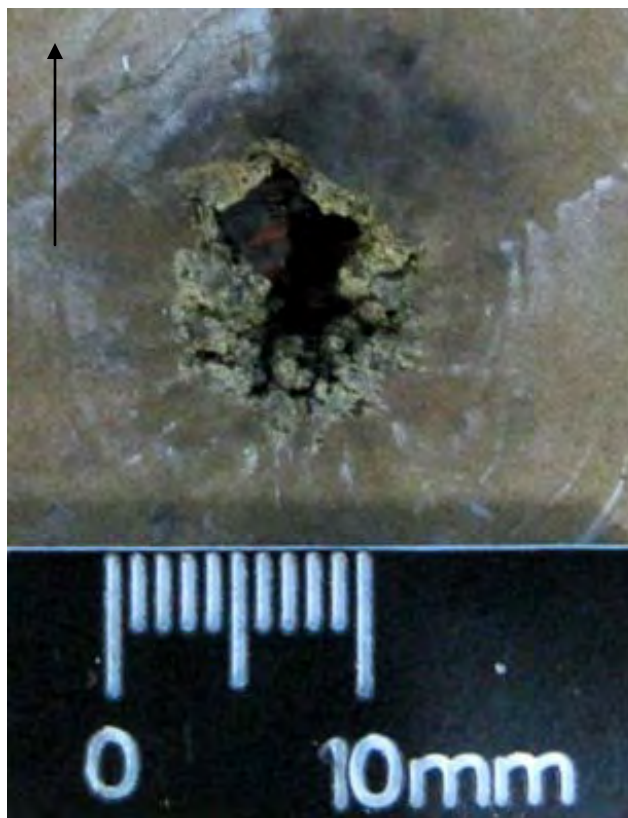
Figure 415 Close-up View of Damage to Front of TORLON 5030 (scale in 1mm increments / black arrow indicates flight path of projectile)

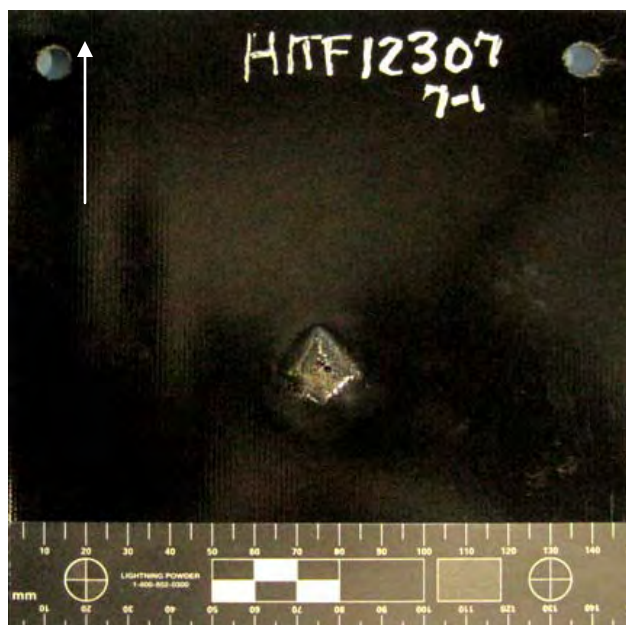
Figure 416 Overall View of Damage to Back Side of NP 504 Substrate (scale in 5mm increments / white arrow indicates flight path of projectile)

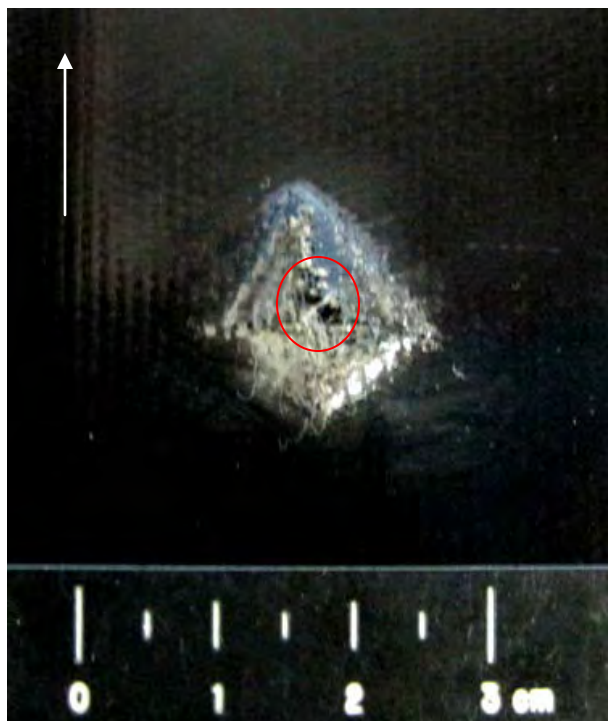
Figure 417 Close-up View of Damage to Back Side of NP 504 Substrate (scale in 5mm increments / white arrow indicates flight path of projectile)

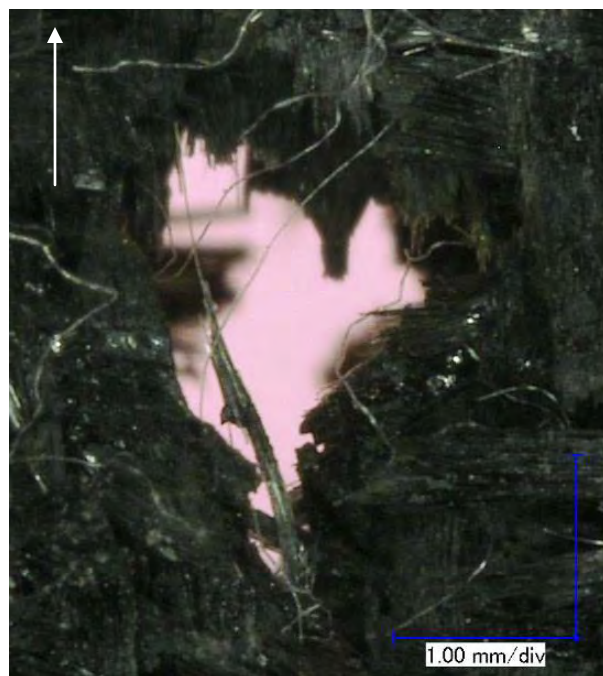
Figure 418 Close-up View of Most Significant Damage to Back Side of NP 504 Substrate (black arrow indicates flight path of projectile / damage within red circle in Figure 417)

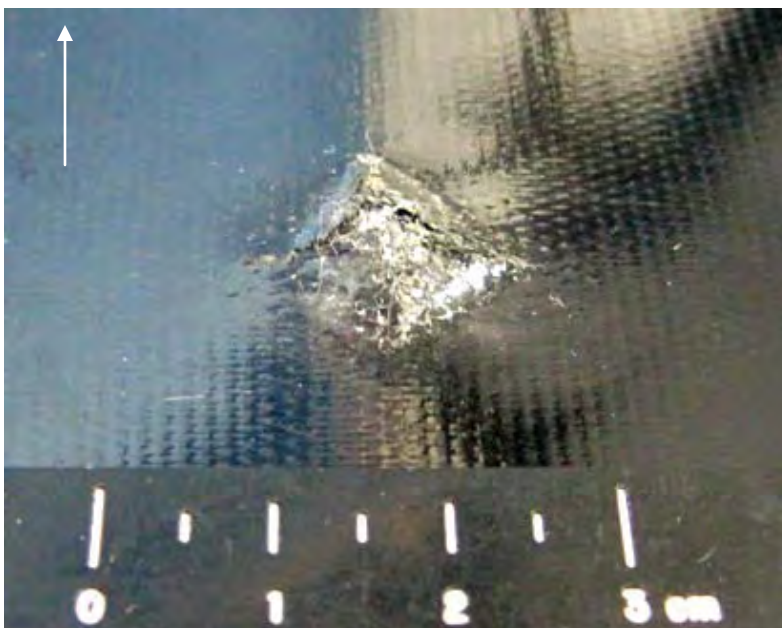
Figure 419 Close-up Oblique Side View of Damage to Back Side of NP 504 Substrate (scale in 5mm increments / white arrow indicates flight path of projectile)

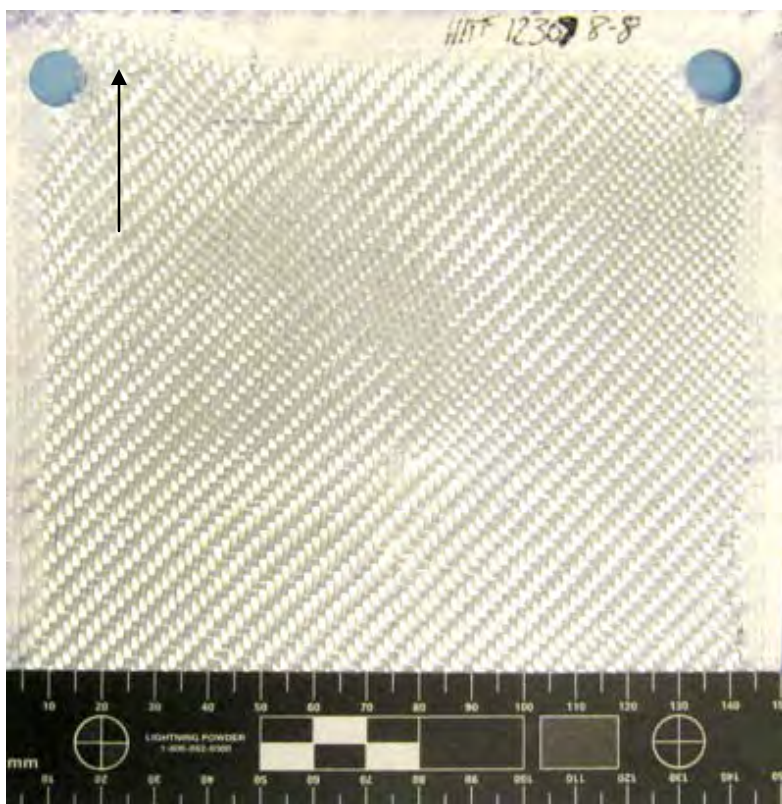
Figure 420 Overall View of Damage to Back Side of 8th Fiberglass Layer (scale in 5mm increments / black arrow indicates flight path of projectile)

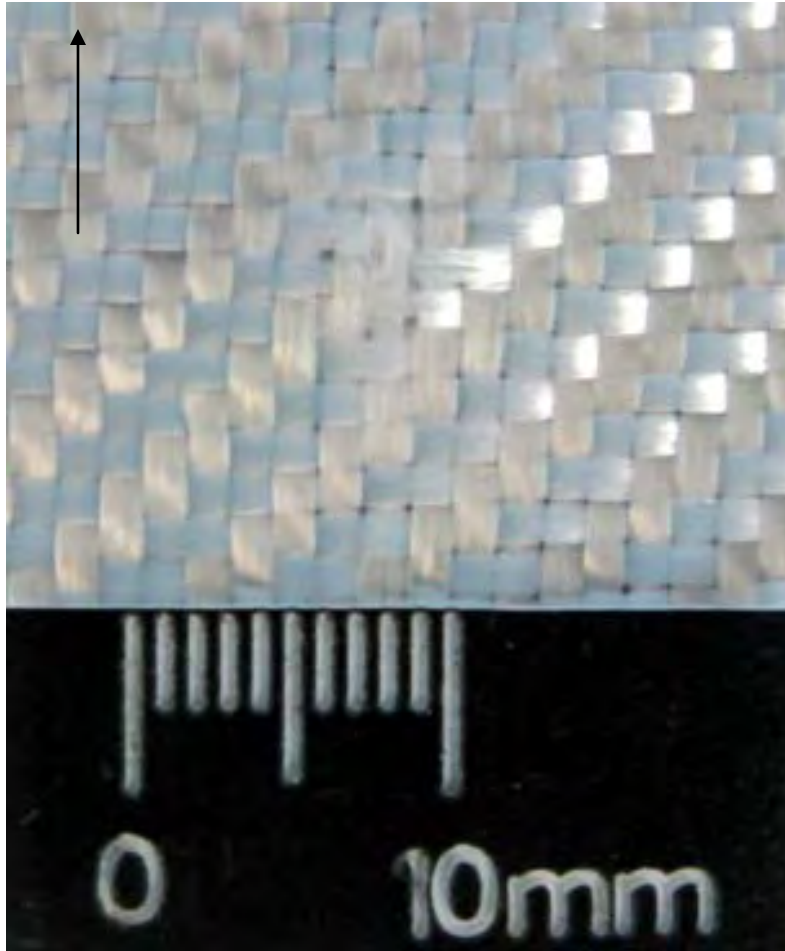
Figure 421 Close-up View of Damage to Back Side of 8th Fiberglass Layer (scale in 5mm increments / black arrow indicates flight path of projectile)

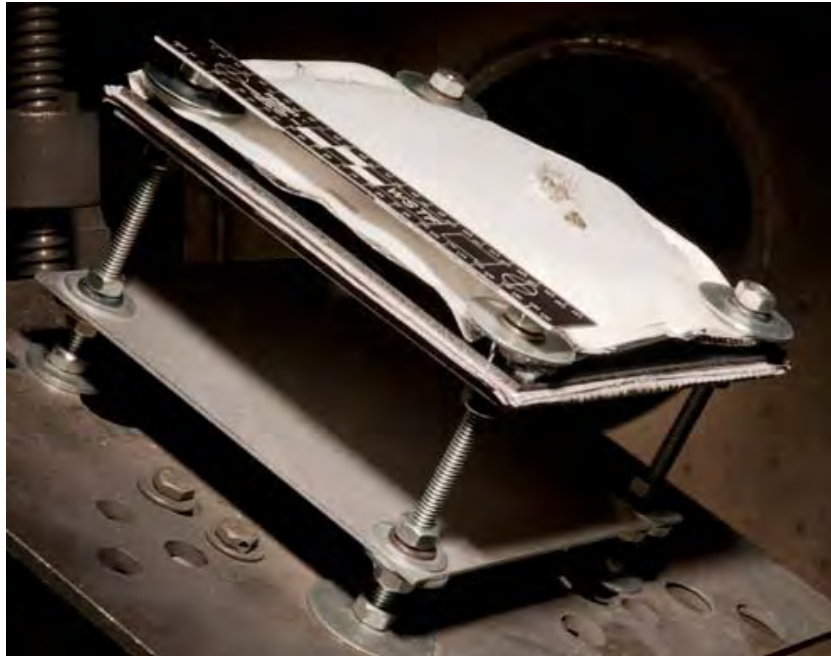
Figure 422 Overall View of Sample in the Target Tank (post-test)

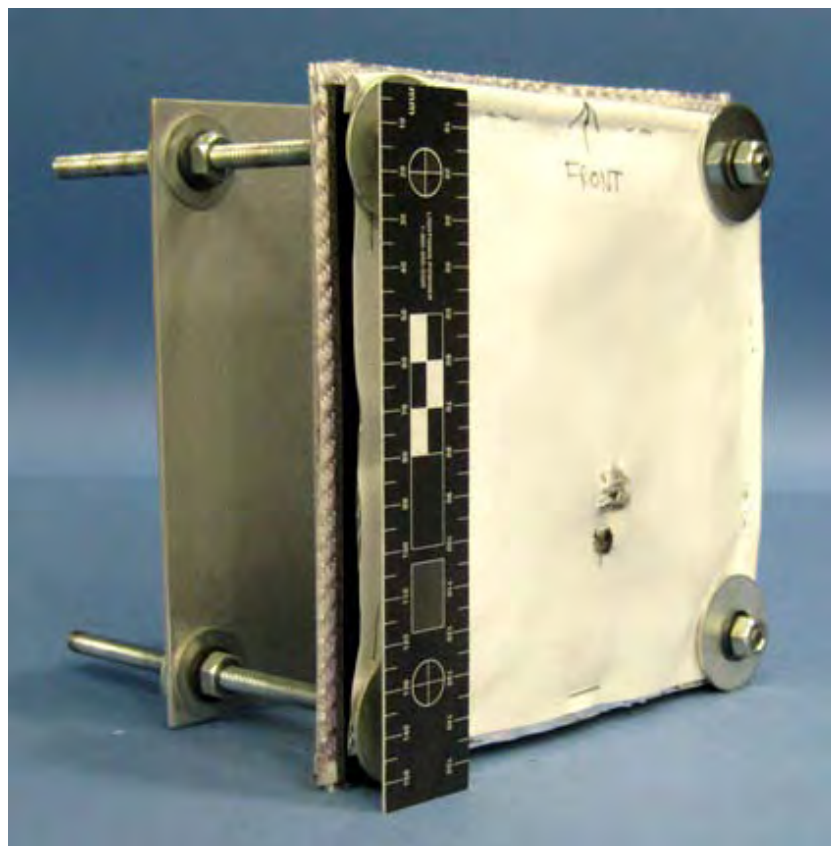
Figure 423 Overall Front Oblique View of Sample (scale in 5mm increments)

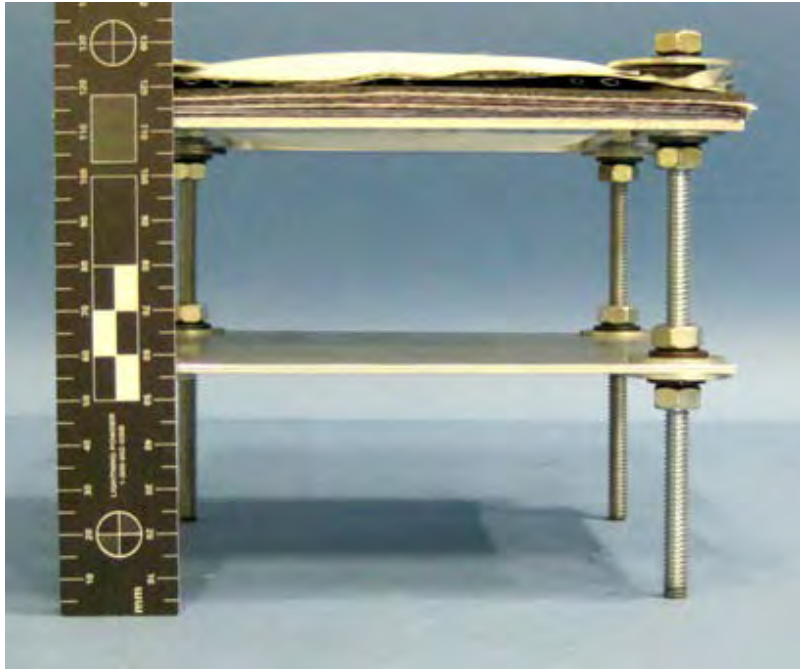
Figure 424 Overall Side View of Sample (scale in 5mm increments)

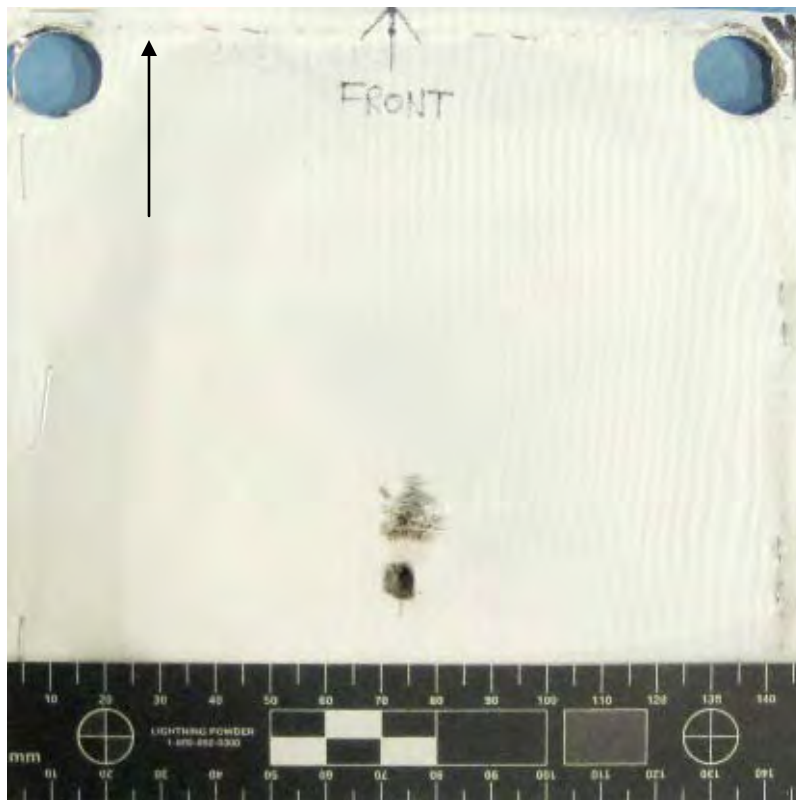
Figure 425 Overall View of Damage to Front of MLI (scale in 5mm increments / black arrow indicates flight path of projectile)

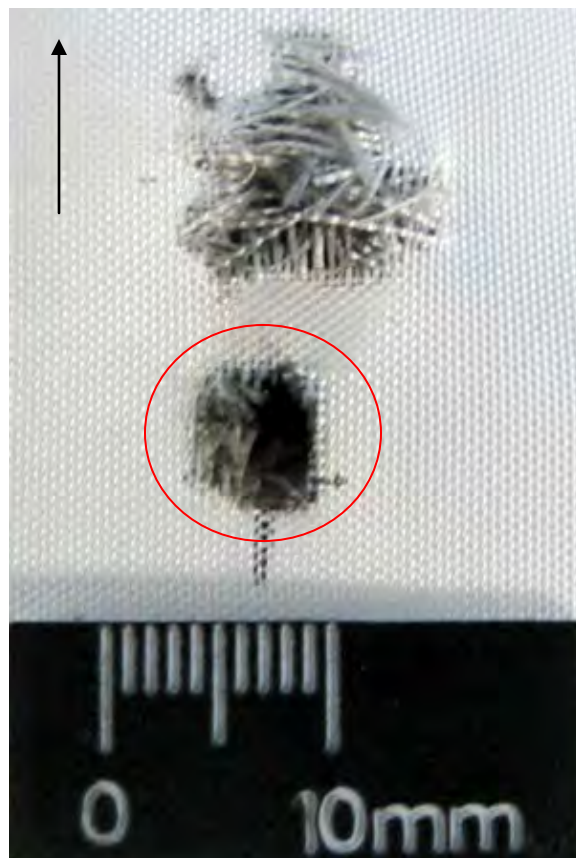
Figure 426 Close-up View of Damage to Front of MLI (scale in 1mm increments / black arrow indicates flight path of projectile / projectile impact within red circle)

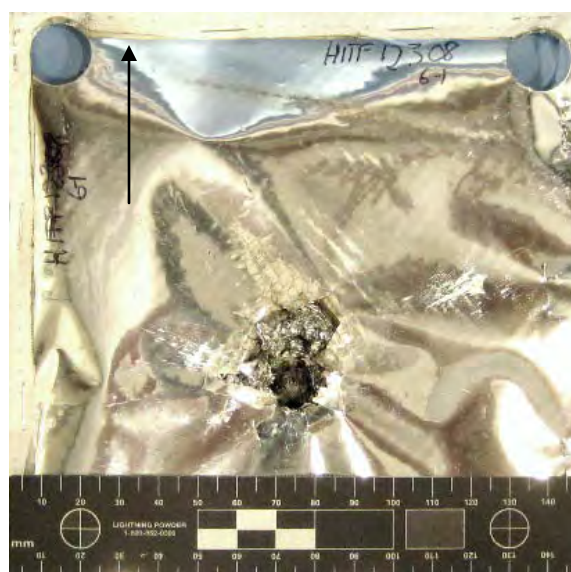
Figure 427 Overall View of Damage to Back Side of MLI (scale in 5mm increments / black arrow indicates flight path of projectile)

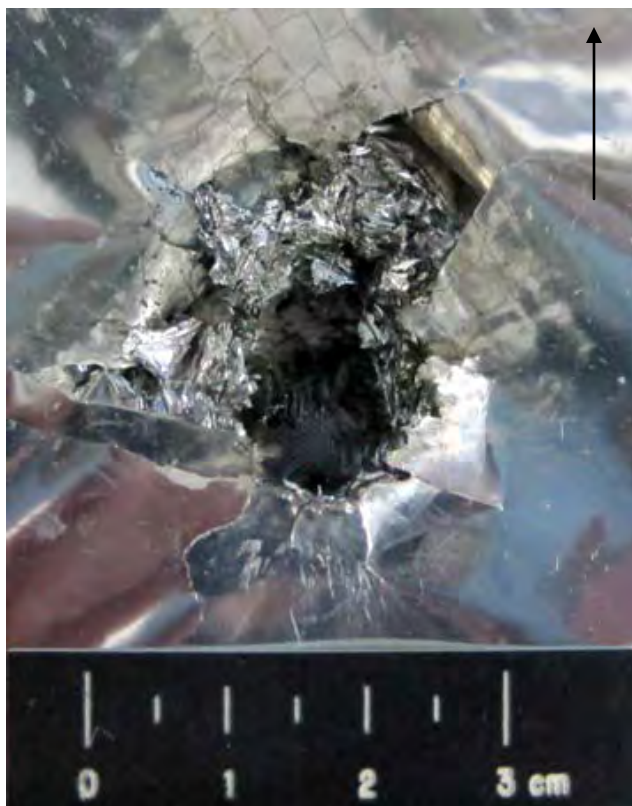
Figure 428 Close-up View of Damage to Back Side of MLI (scale in 5mm increments / black arrow indicates flight path of projectile)

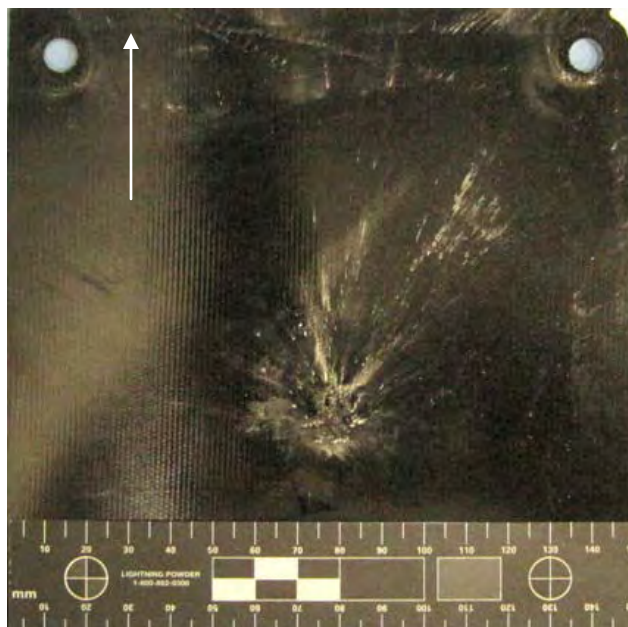
Figure 429 Overall View of Damage to Front of NP 504 Substrate (scale in 5mm increments / white arrow indicates flight path of projectile)

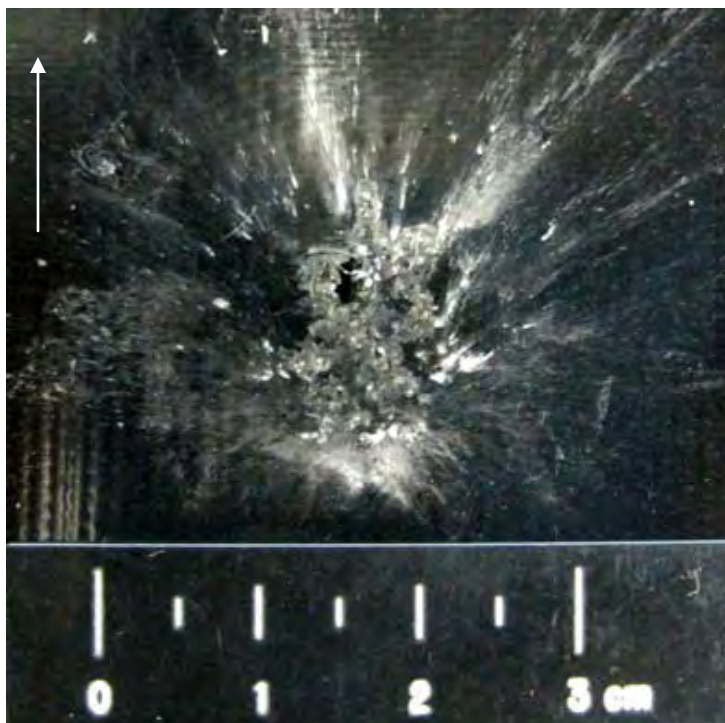
Figure 430 Close-up View of Damage to Front of NP 504 Substrate (scale in 5mm increments / white arrow indicates flight path of projectile)

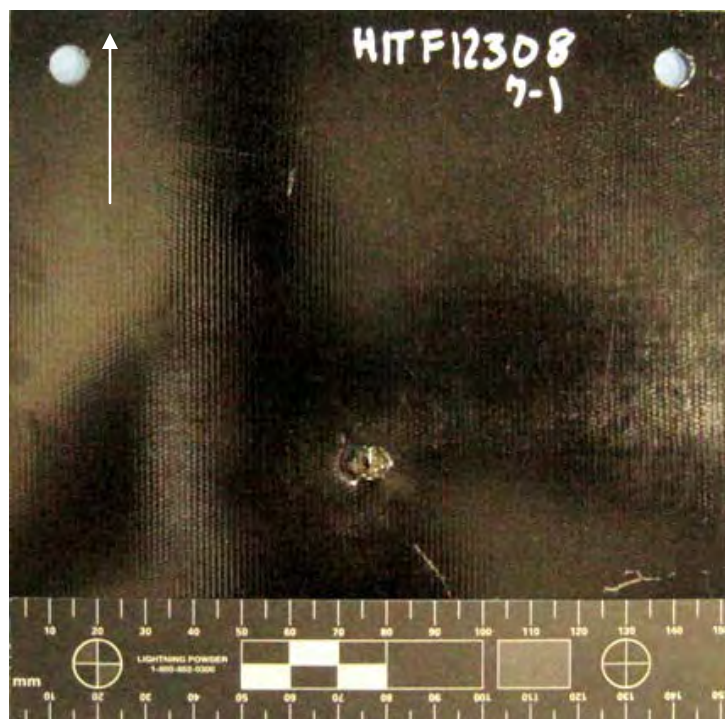
Figure 431 Overall View of Damage to Back Side of NP 504 Substrate (scale in 5mm increments / white arrow indicates flight path of projectile)

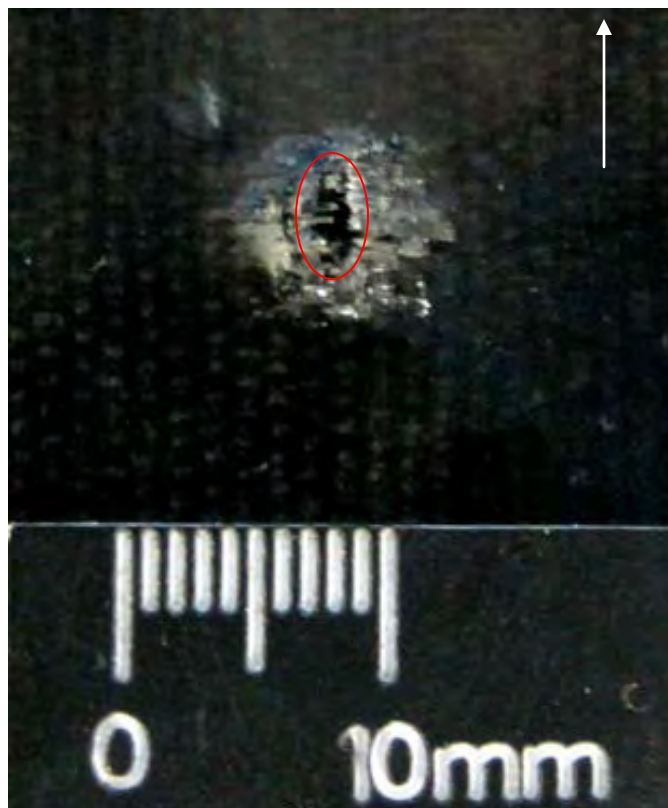
Figure 432 Close-up View of Damage to Back Side of NP 504 Substrate (scale in 1mm increments / white arrow indicates flight path of projectile)

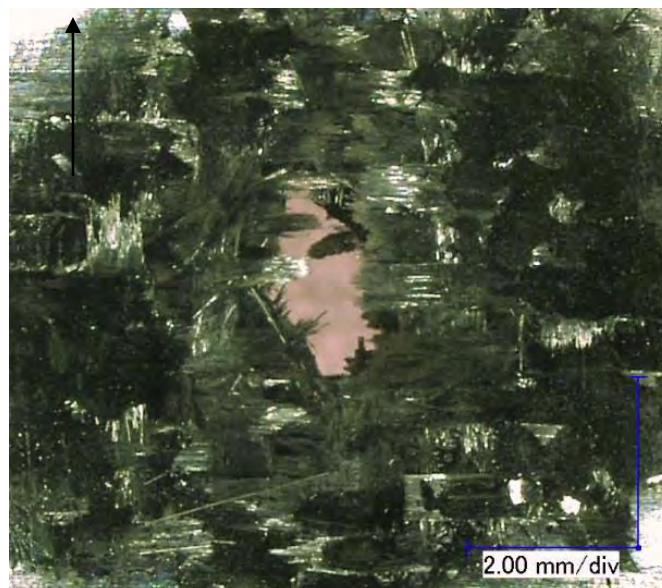
Figure 433 Close-up View of Most Significant Damage to Back Side of NP 504 Substrate (black arrow indicates flight path of projectile / damage within red circle in Figure 247)

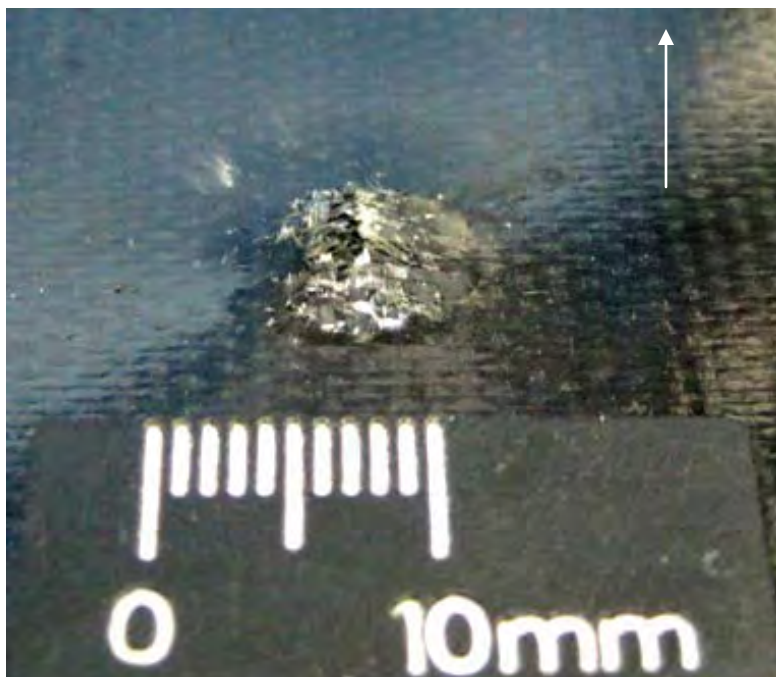
Figure 434 Close-up Oblique Side View of Damage to Back Side of NP 504 Substrate (scale in 1mm increments / white arrow indicates flight path of projectile)

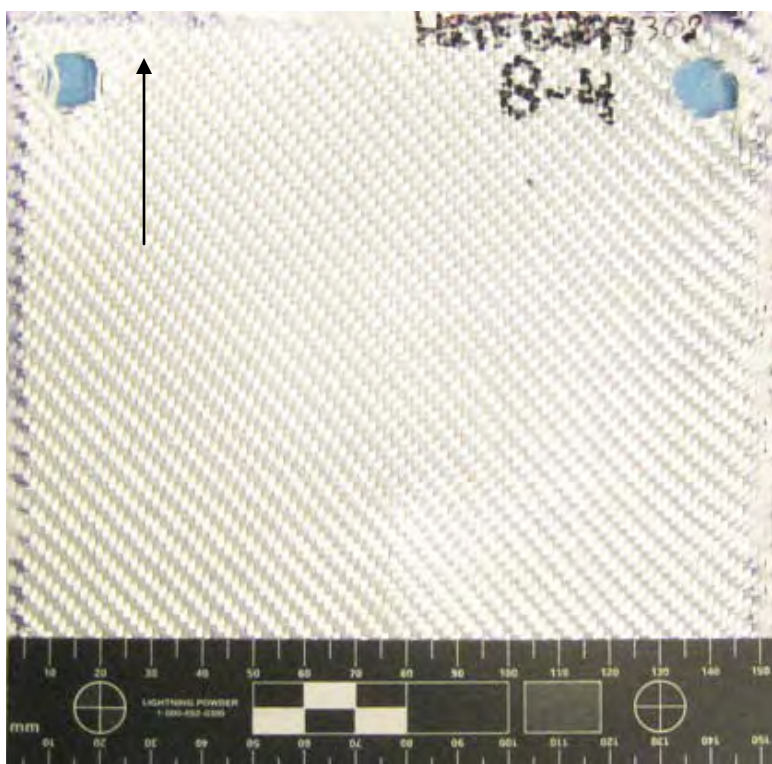
Figure 435 Overall View of Damage to Back Side of 4th Fiberglass Layer (scale in 5mm increments / black arrow indicates flight path of projectile)

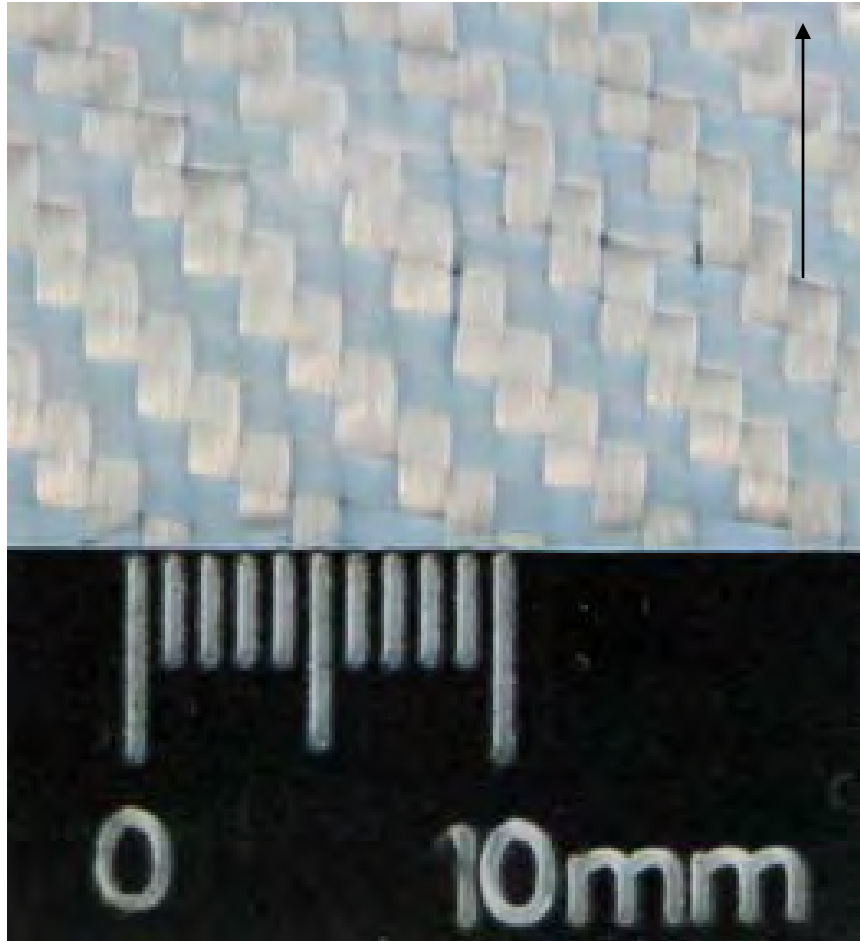
Figure 436 Overall View of Damage to Back Side of 4th Fiberglass Layer (scale in 5mm increments / black arrow indicates flight path of projectile)

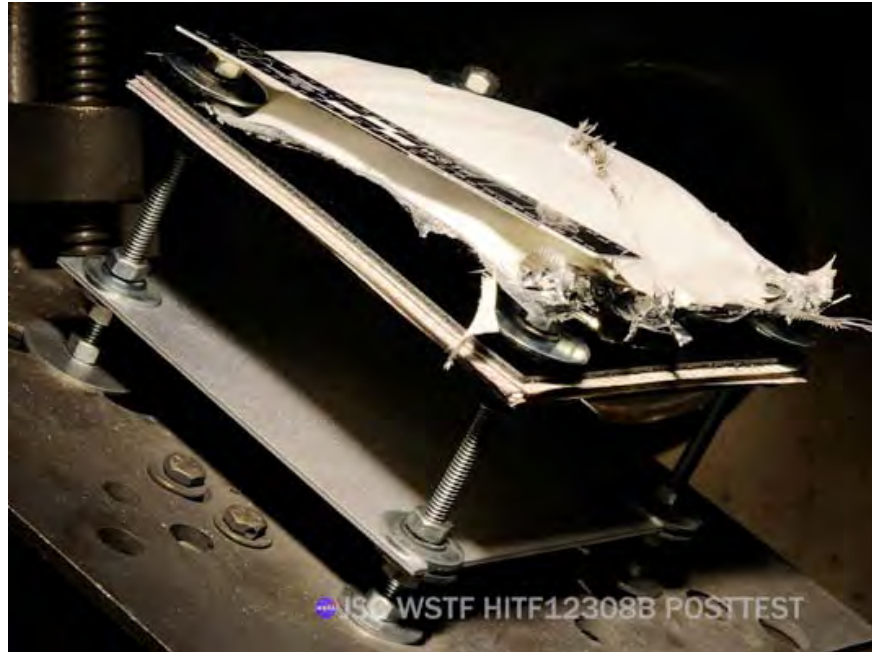
Figure 437 Overall View of Sample in the Target Tank (post-test)

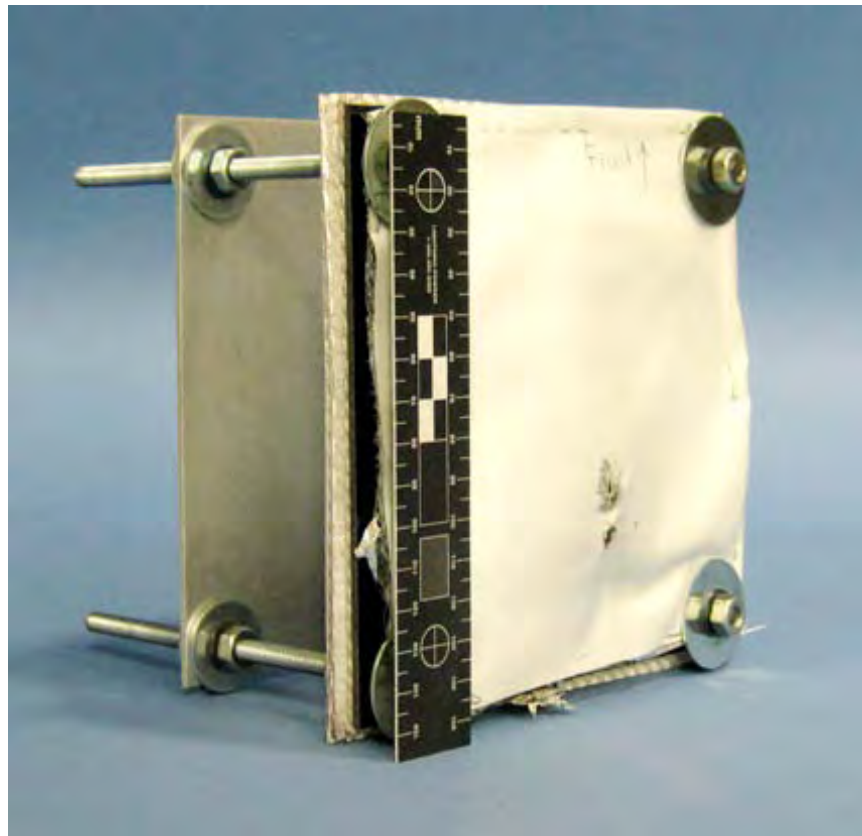
Figure 438 Overall Front Oblique View of Sample (scale in 5mm increments)

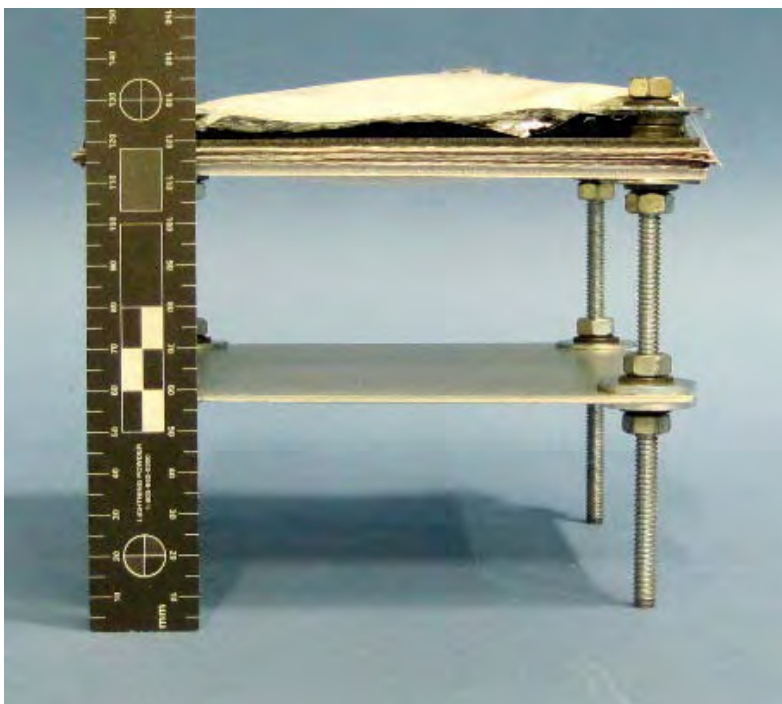
Figure 439 Overall Side View of Sample (scale in 5mm increments)

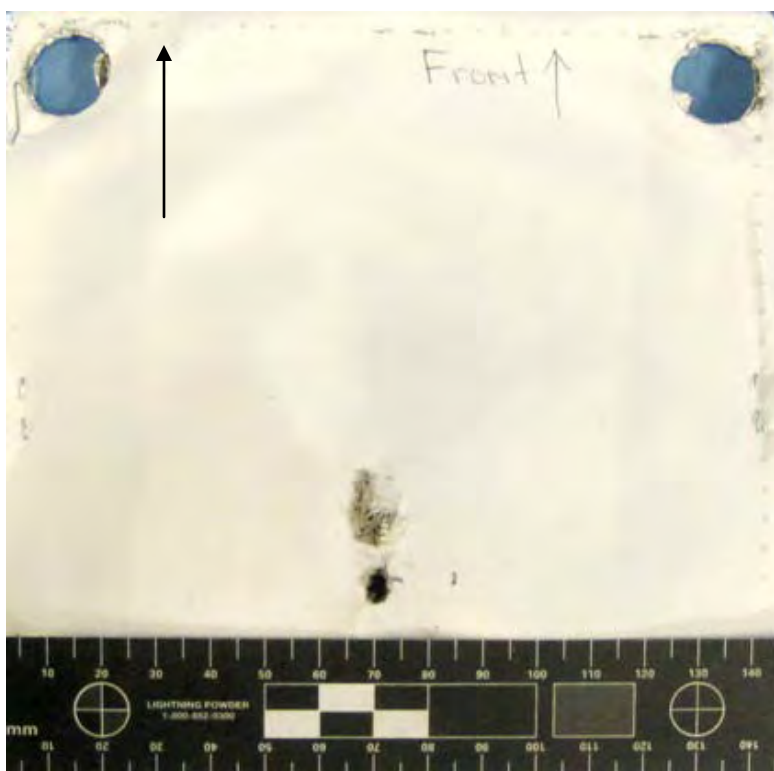
Figure 440 Overall View of Damage to Front of MLI (black arrow indicates flight path of projectile / scale in 5mm increments)

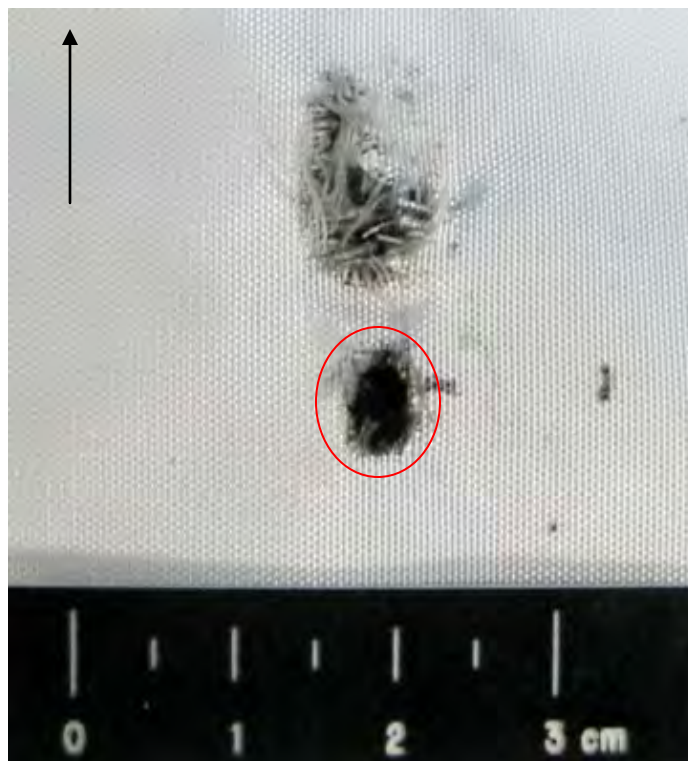
Figure 441 Close-up View of Damage to Front of MLI (scale in 5mm increments / black arrow indicates flight path of projectile / projectile impacted within red circle)

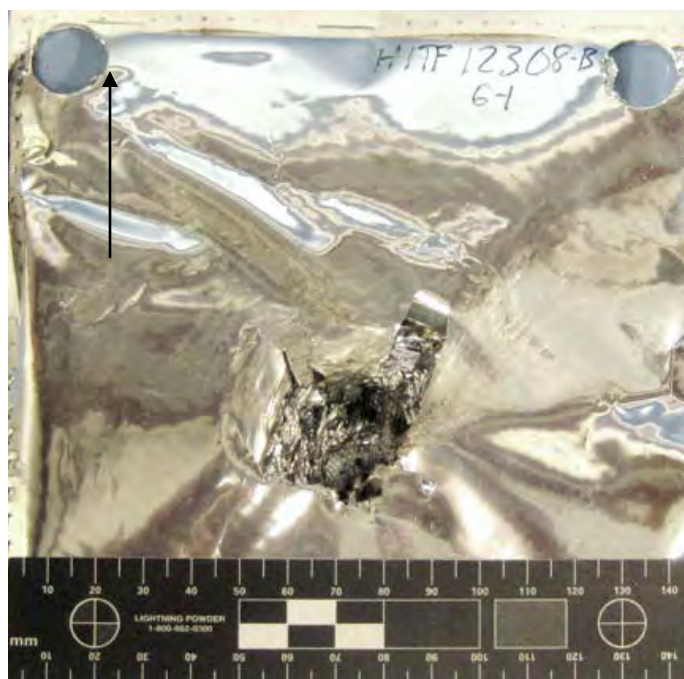
Figure 442 Overall View of Damage to Back Side of MLI (scale in 5mm increments / black arrow indicates flight path of projectile)

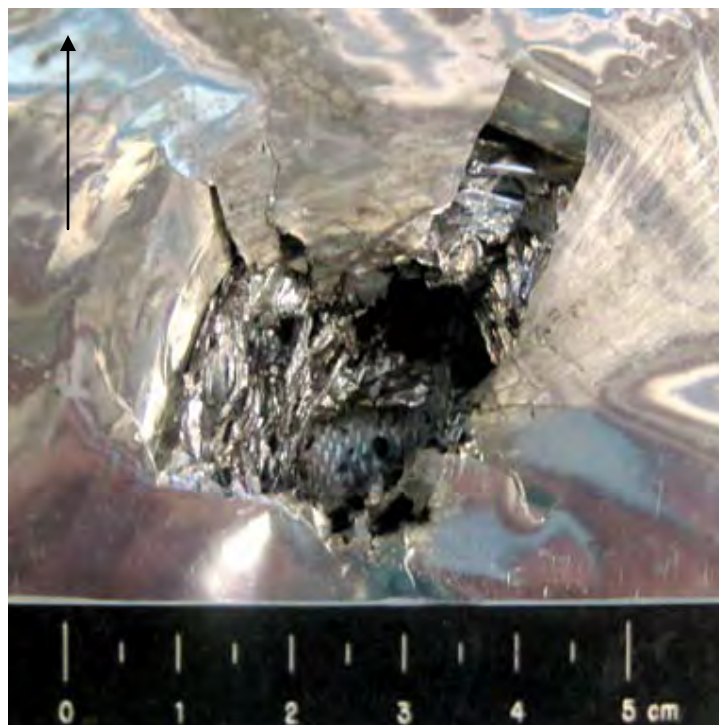
Figure 443 Close-up View of Damage to Back Side of MLI (scale in 5mm increments / black arrow indicates flight path of projectile)

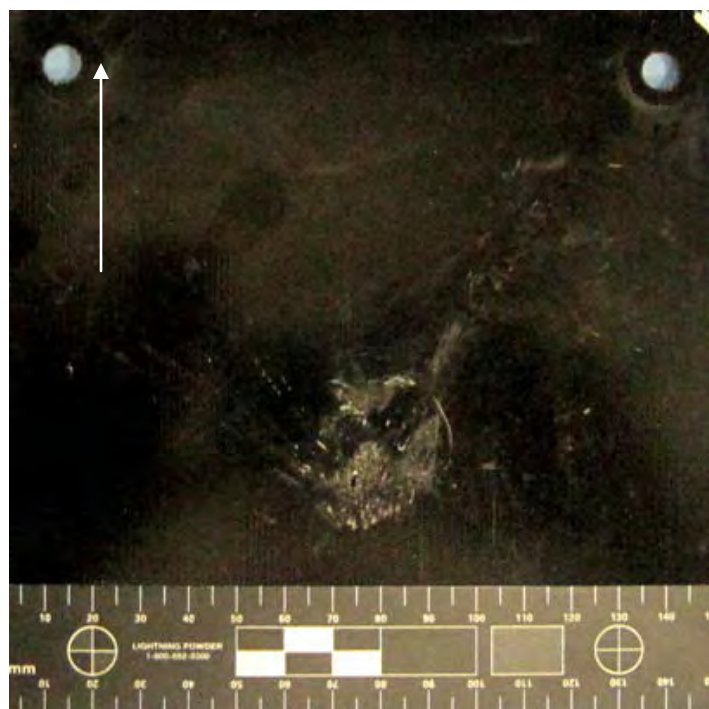
Figure 444 Overall View of Damage to Front of NP 504 Substrate (scale in 5mm increments / white arrow indicates flight path of projectile)

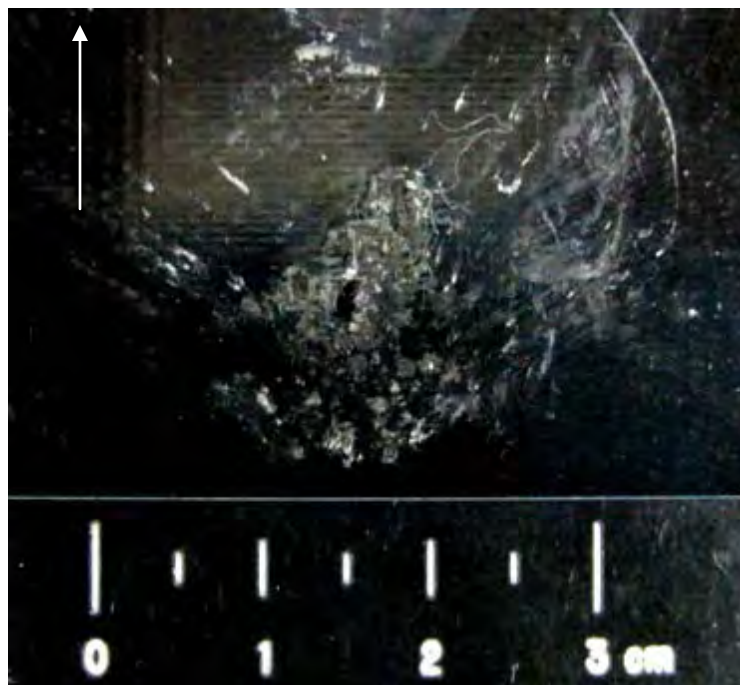
Figure 445 Close-up View of Damage to Front of NP 504 Substrate (scale in 5mm increments / white arrow indicates flight path of projectile)

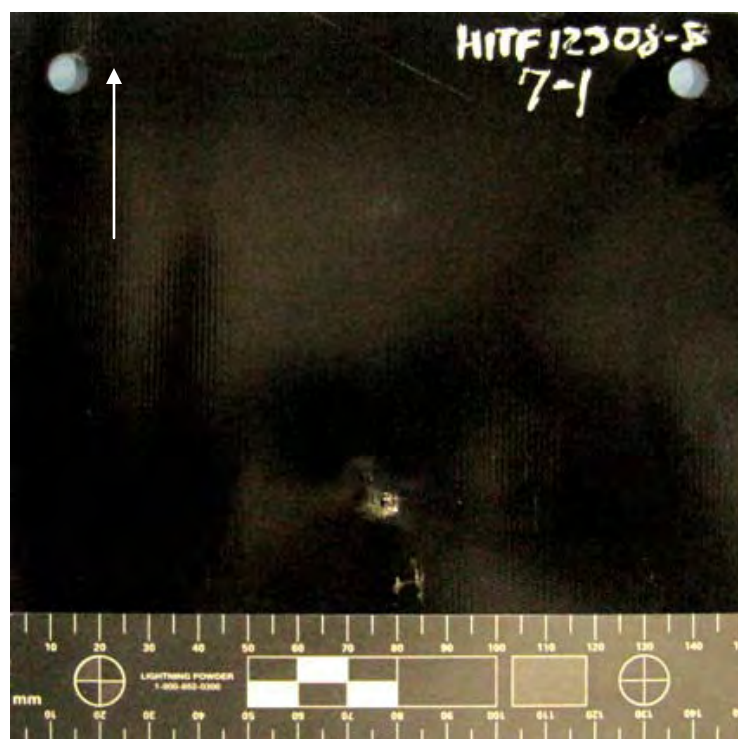
Figure 446 Overall View of Damage to Back Side of NP 504 Substrate (scale in 5mm increments / white arrow indicates flight path of projectile)

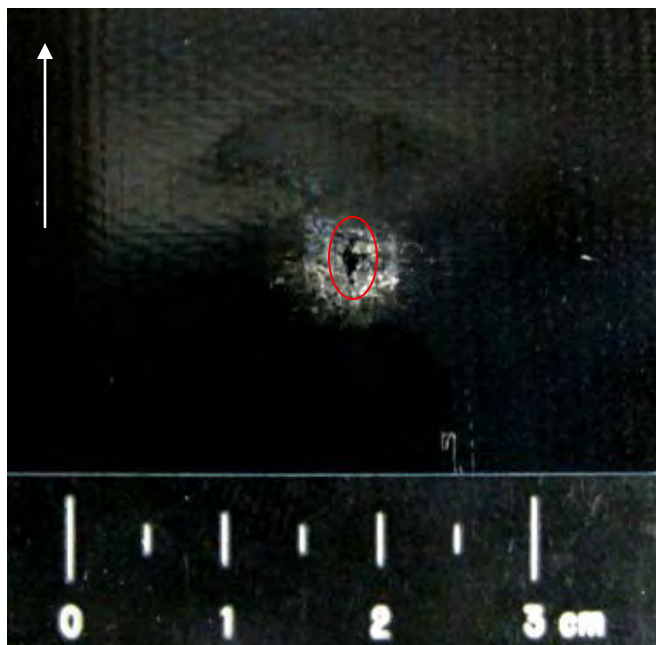
Figure 447 Close-up View of Damage to Back Side of NP 504 Substrate (scale in 5mm increments / white arrow indicates flight path of projectile)

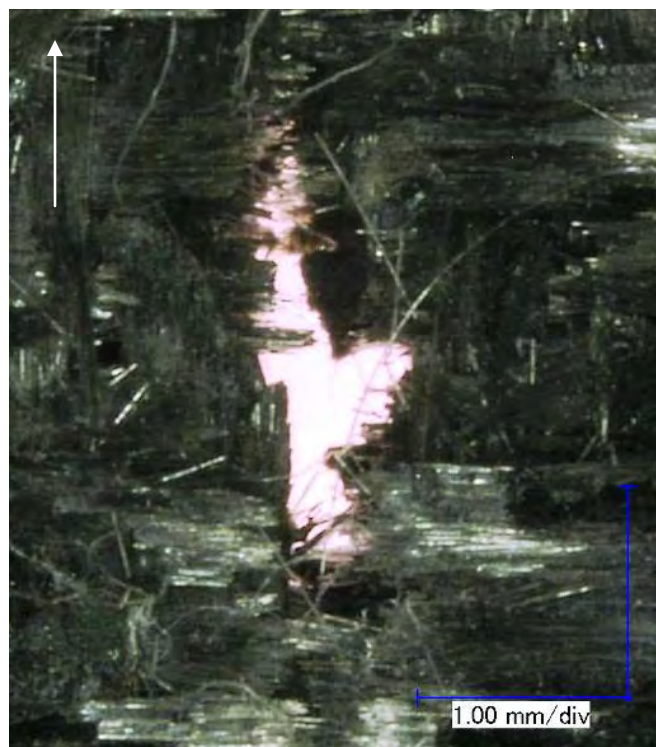
Figure 448 Close-up View of Most Significant Damage to Back Side of NP 504 Substrate (black arrow indicates flight path of projectile / damage within red circle in Figure 472)

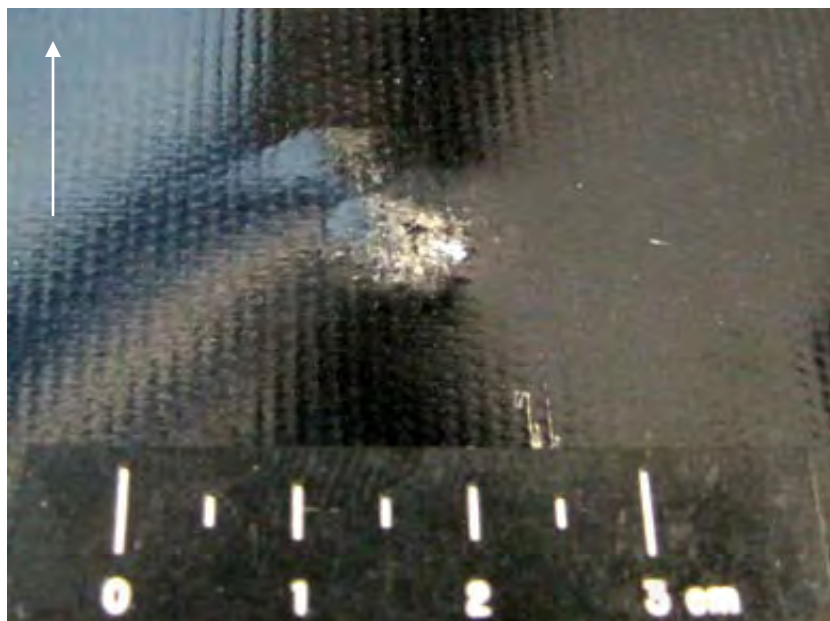
Figure 449 Close-up Oblique Side View of Damage to Back Side of NP 504 Substrate (scale in 5mm increments / white arrow indicates flight path of projectile)

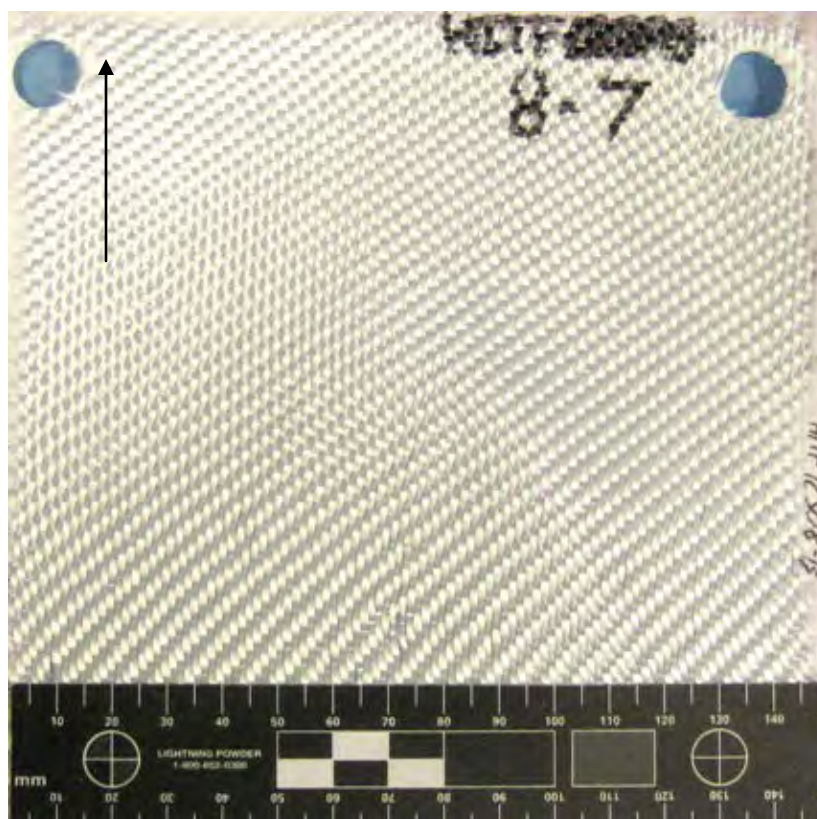
Figure 450 Overall View of Damage to Back Side of Last Fiberglass Layer (scale in 5mm increments / black arrow indicates flight path of projectile)

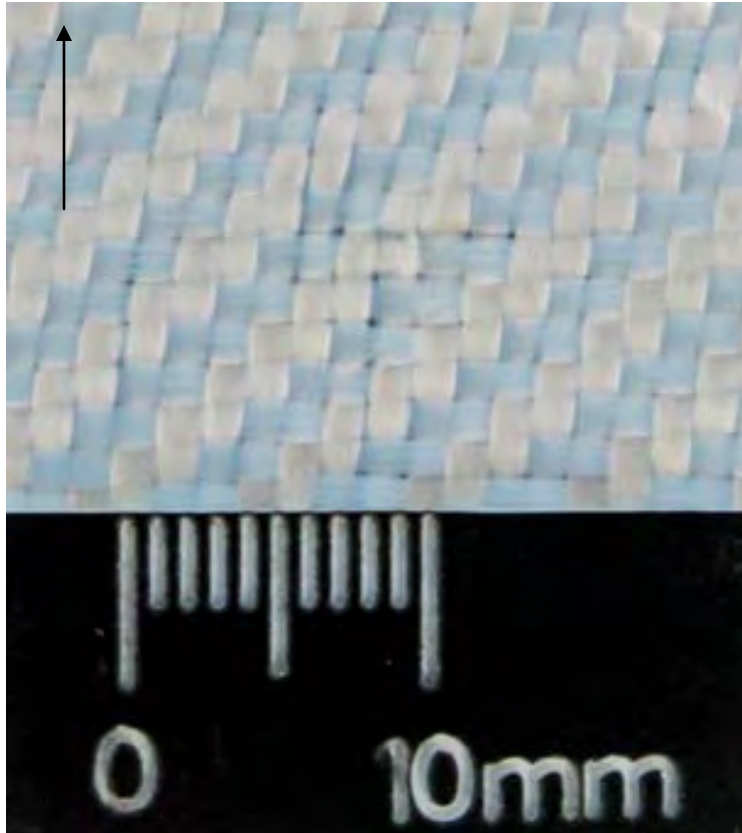
Figure 451 Close-up View of Damage to Back Side of 7th Fiberglass Layer (scale in 1mm increments / black arrow indicates flight path of projectile)
