International Space Station (ISS) Soyuz Vehicle Descent Module Evaluation of Thermal Protection System (TPS) Penetration Characteristics

Hypervelocity Impact Technology Group

February 2013

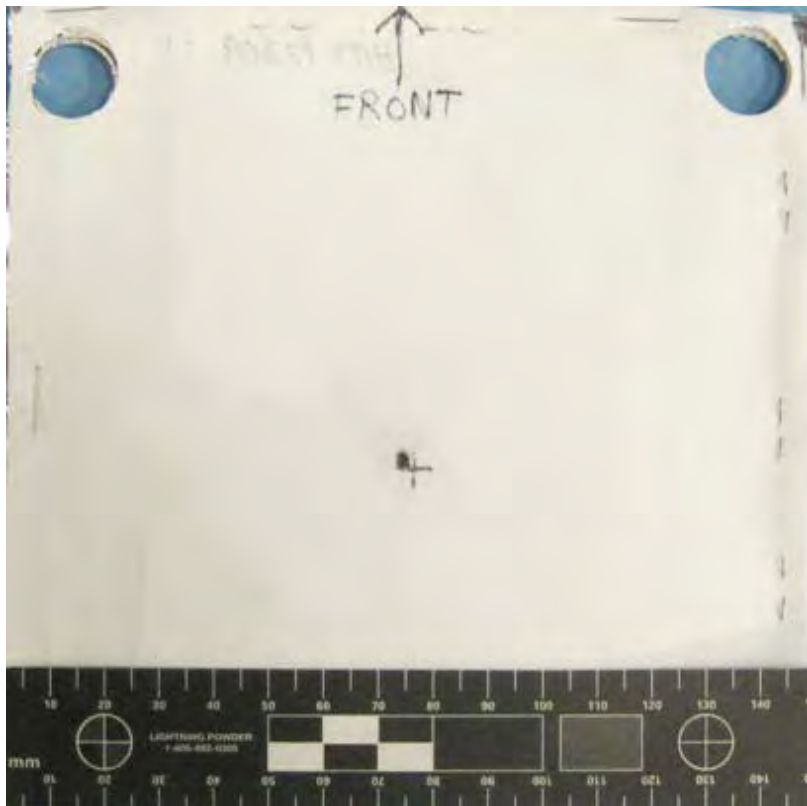
Figure 455 Overall View of Damage to Front of MLI (scale in 5mm increments / black arrow indicates flight path of projectile)

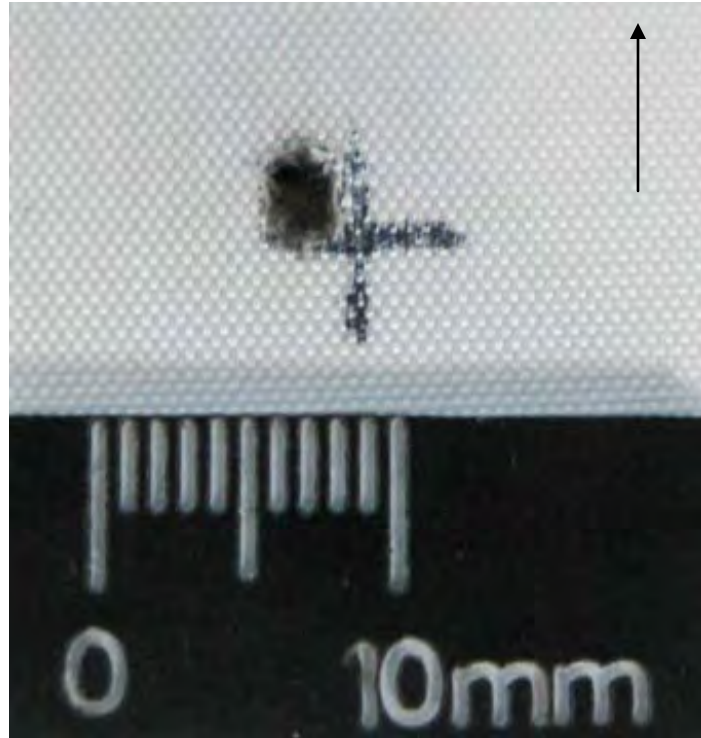
Figure 456 Close-up View of Damage to Front of MLI (scale in 1mm increments / black arrow indicates flight path of projectile)

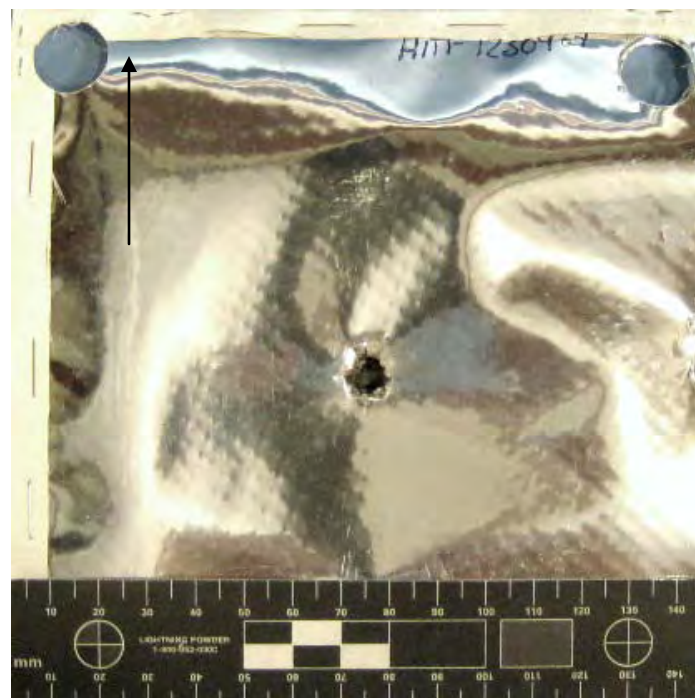
Figure 457 Overall View of Damage to Back Side of MLI (scale in 5mm increments / black arrow indicates flight path of projectile)

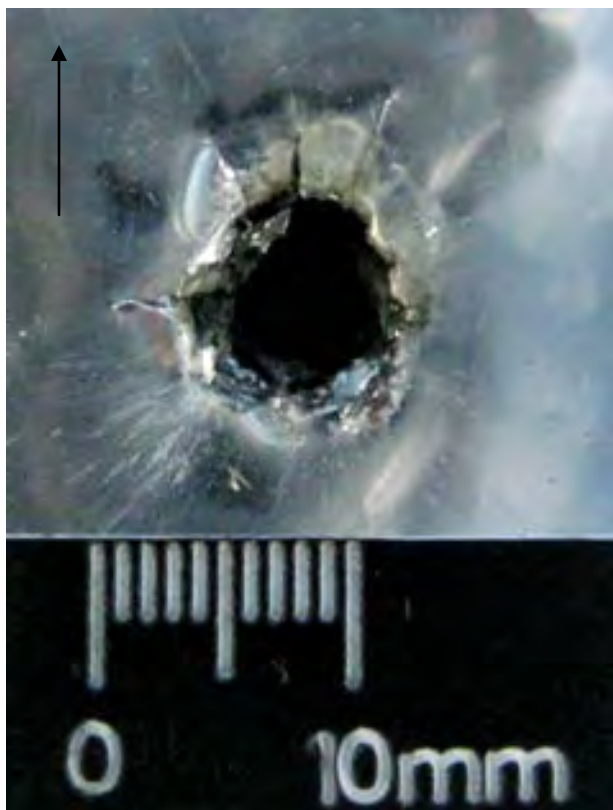
Figure 458 Close-up View of Damage to Back Side of MLI (scale in 1mm increments / black arrow indicates flight path of projectile)

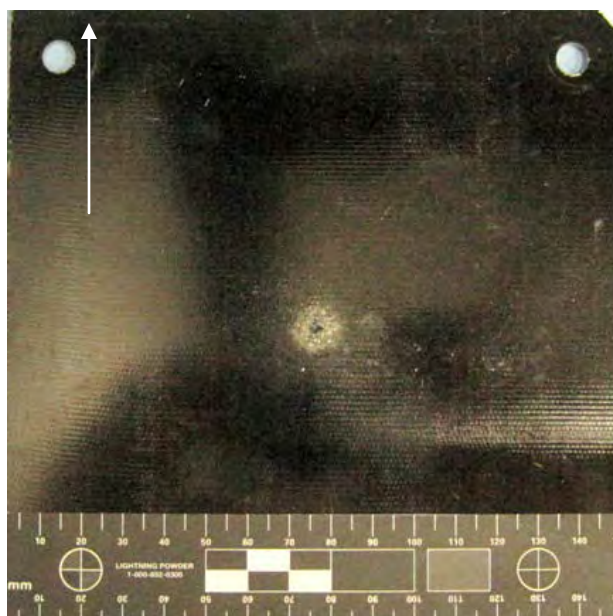
Figure 459 Overall View of Damage to Front of NP 504 Substrate (scale in 5mm increments / white arrow indicates flight path of projectile)

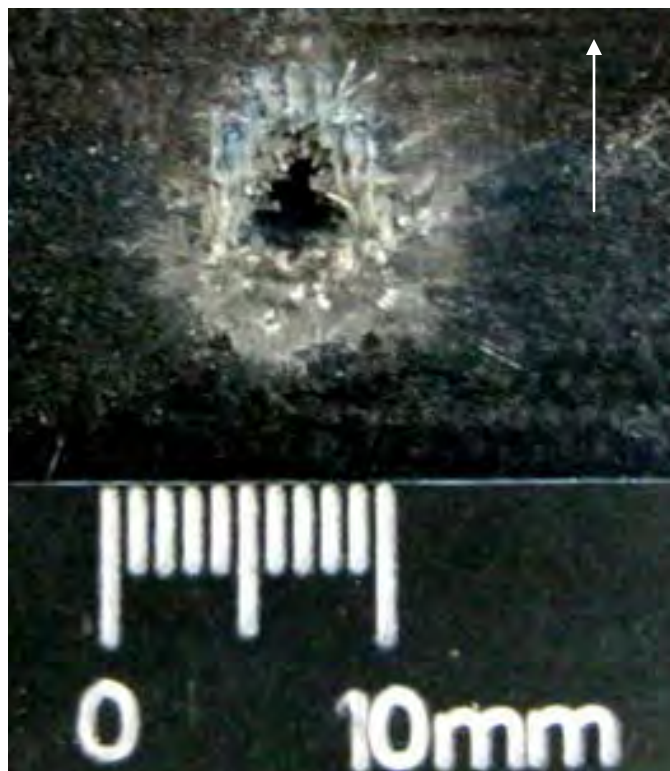
Figure 460 Close-up View of Damage to Front of NP 504 Substrate (scale in 1mm increments / white arrow indicates flight path of projectile)

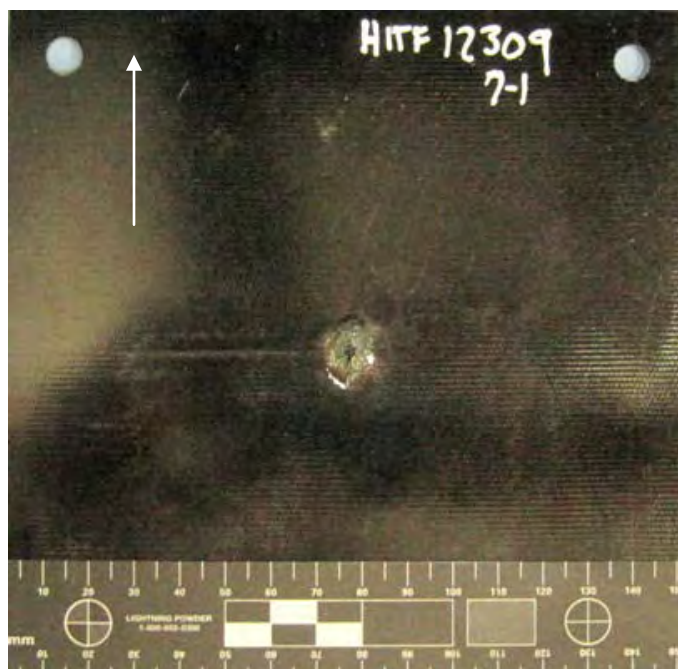
Figure 461 Overall View of Damage to Back Side of NP 504 Substrate (scale in 5mm increments / white arrow indicates flight path of projectile)

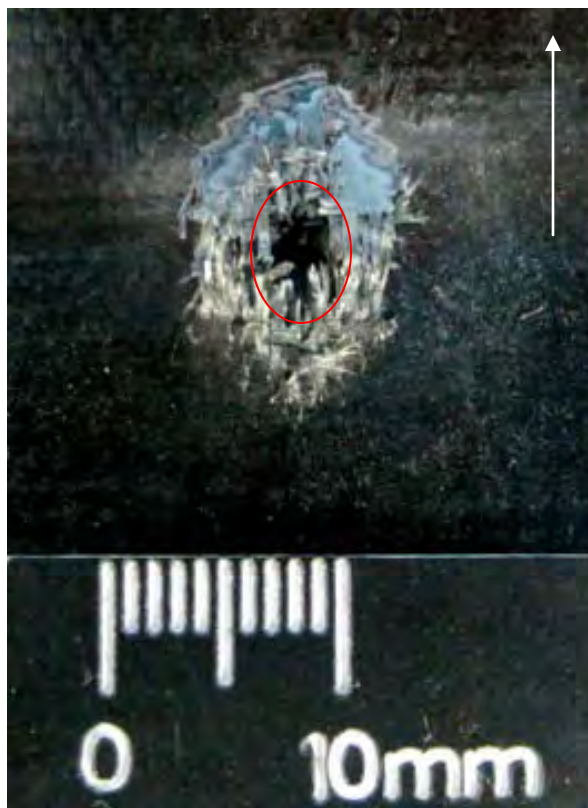
Figure 462 Close-up View of Damage to Back Side of NP 504 Substrate (scale in 1mm increments / white arrow indicates flight path of projectile)

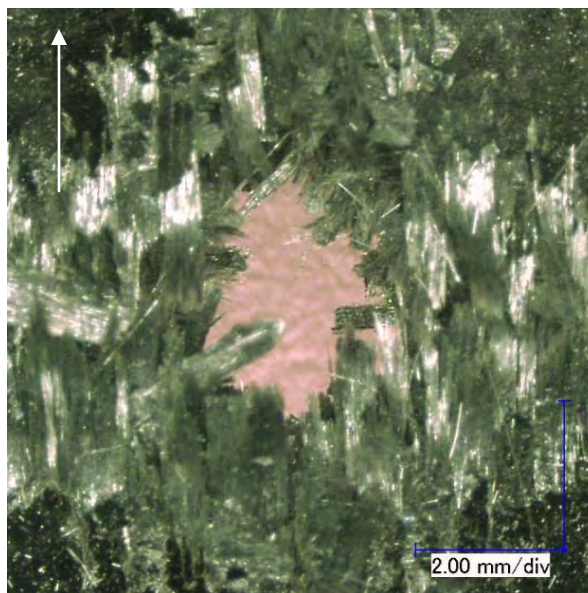
Figure 463 Close-up View of Most Significant Damage to Back Side of NP 504 Substrate (white arrow indicates flight path of projectile / damage within red circle in Figure 462)

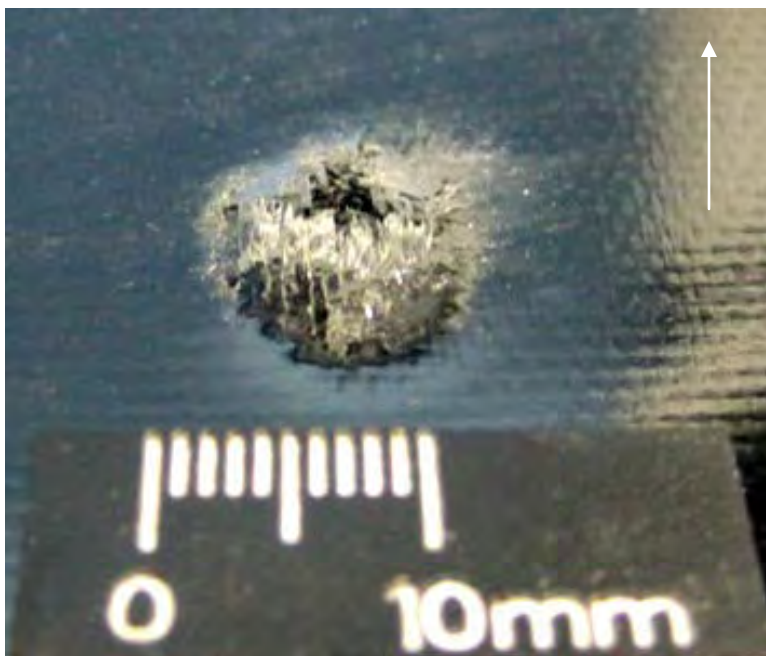
Figure 464 Close-up Oblique Side View of Damage to Back Side of NP 504 Substrate (scale in 1mm increments / white arrow indicates flight path of projectile)

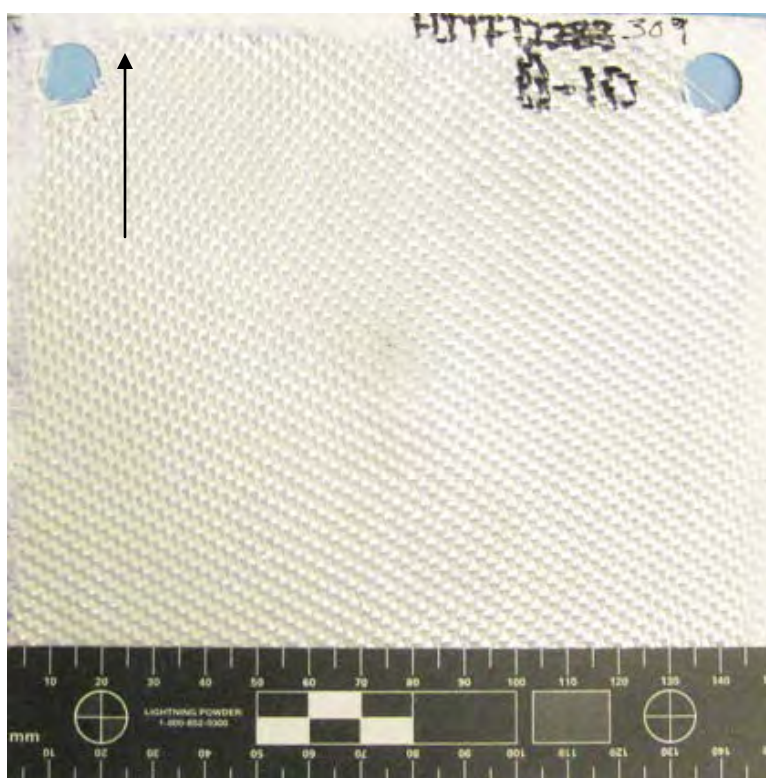
Figure 465 Overall View of Damage to Back Side of 10th Fiberglass Layer (scale in 5mm increments / black arrow indicates flight path of projectile)

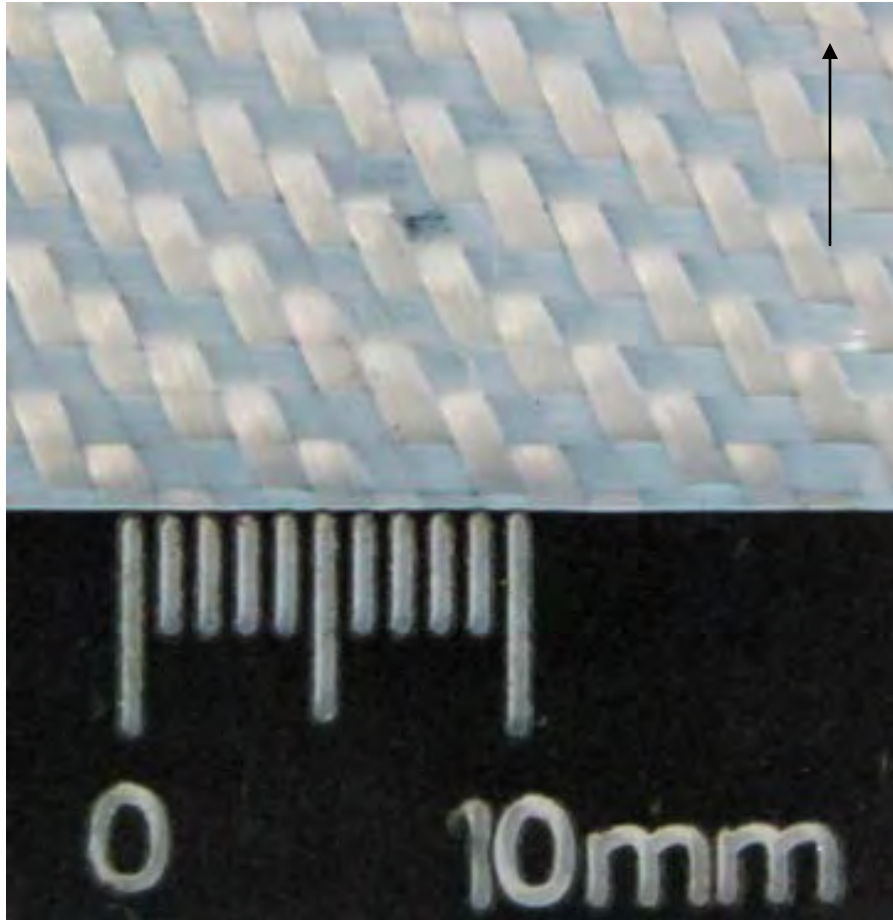
Figure 466 Close-up View of Damage to Back Side of 10th Fiberglass Layer (scale in 1mm increments / black arrow indicates flight path of projectile)

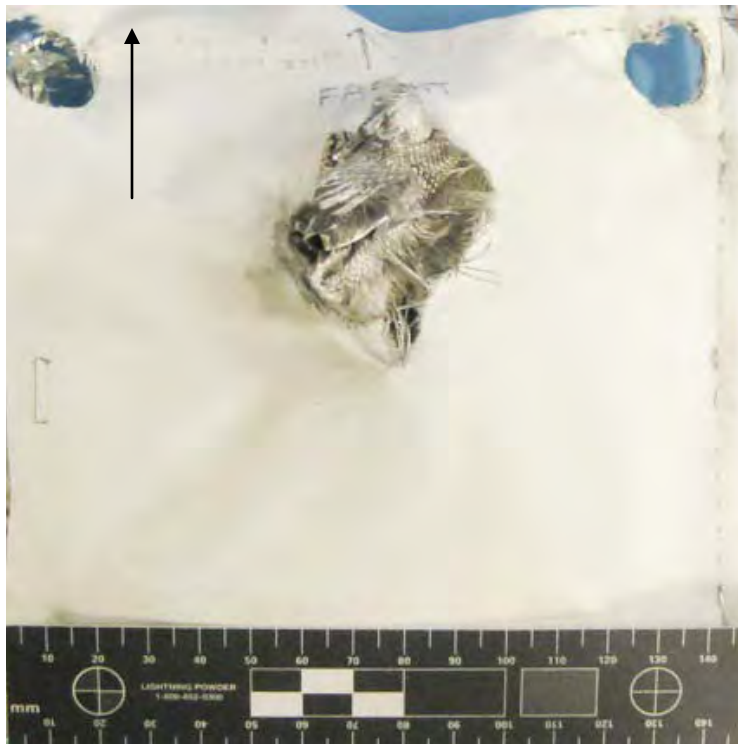
Figure 470 Overall View of Damage to Front of MLI (scale in 5mm increments / black arrow indicates flight path of projectile)

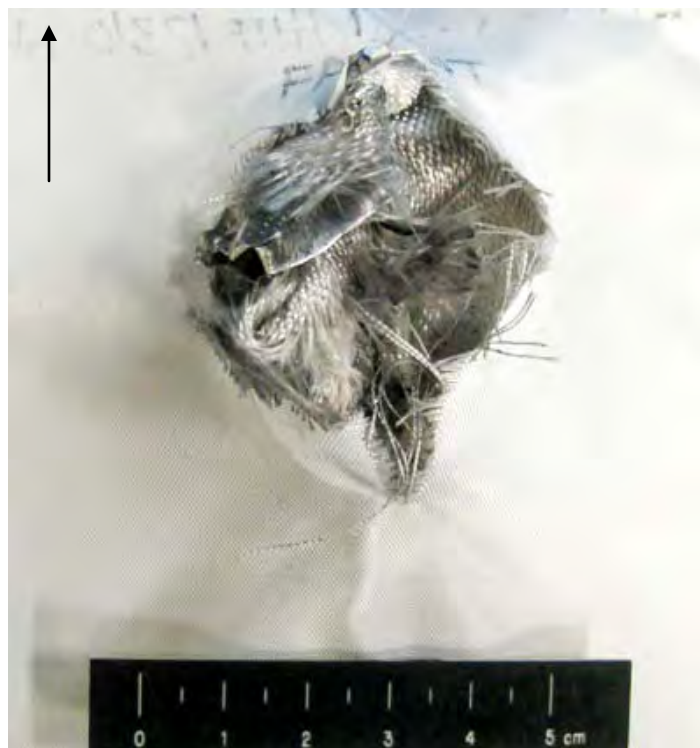
Figure 471 Close-up View of Damage to Front of MLI (scale in 5mm increments / black arrow indicates flight path of projectile)

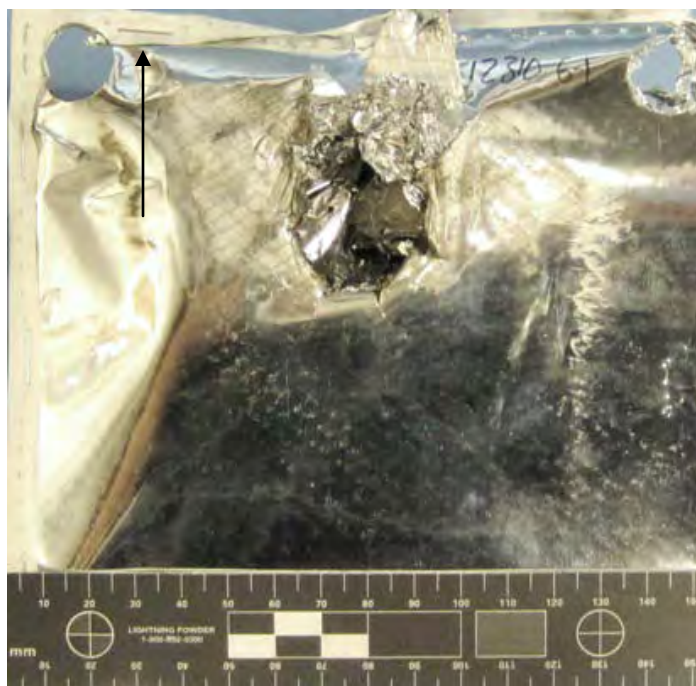
Figure 472 Overall View of Damage to Back Side of MLI (scale in 5mm increments / black arrow indicates flight path of projectile)

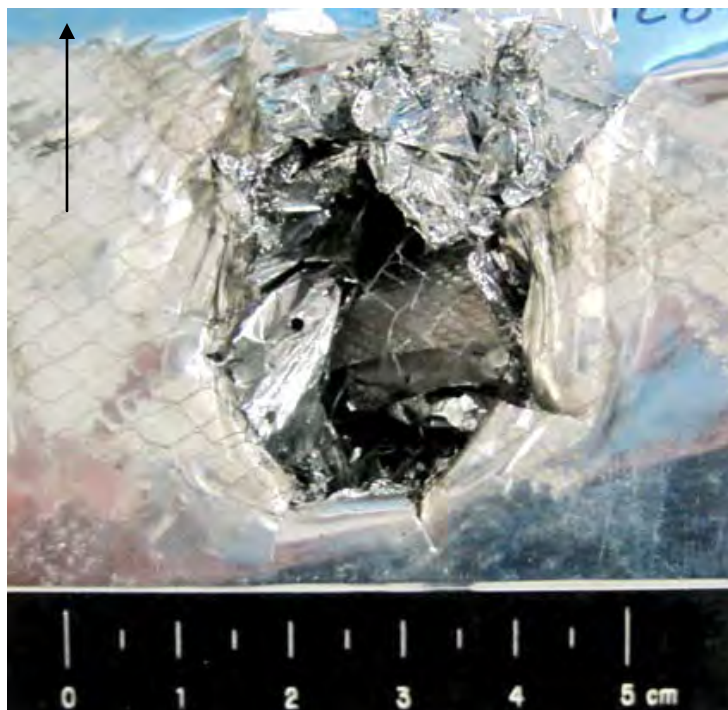
Figure 473 Close-up View of Damage to Back Side of MLI (scale in 5mm increments / black arrow indicates flight path of projectile)

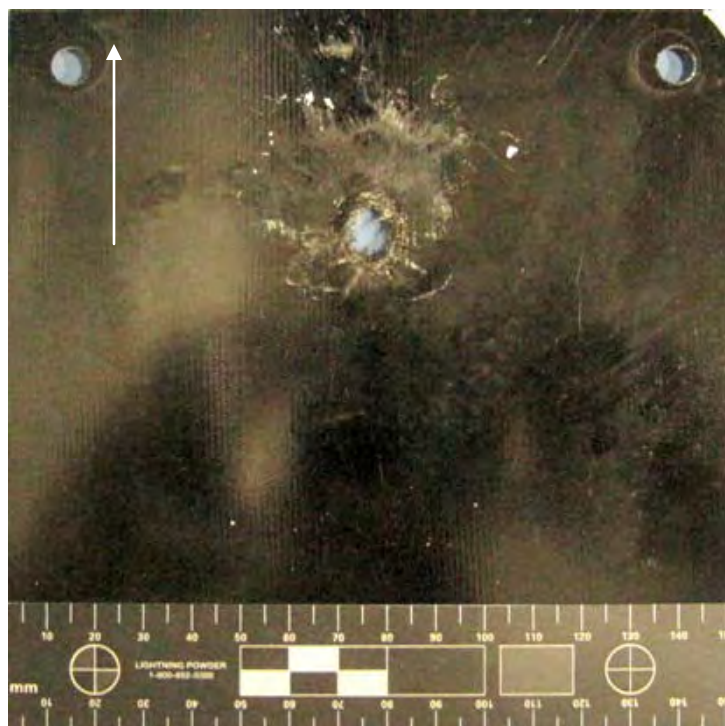
Figure 474 Overall View of Damage to Front of NP 504 Substrate (scale in 5mm increments / white arrow indicates flight path of projectile)

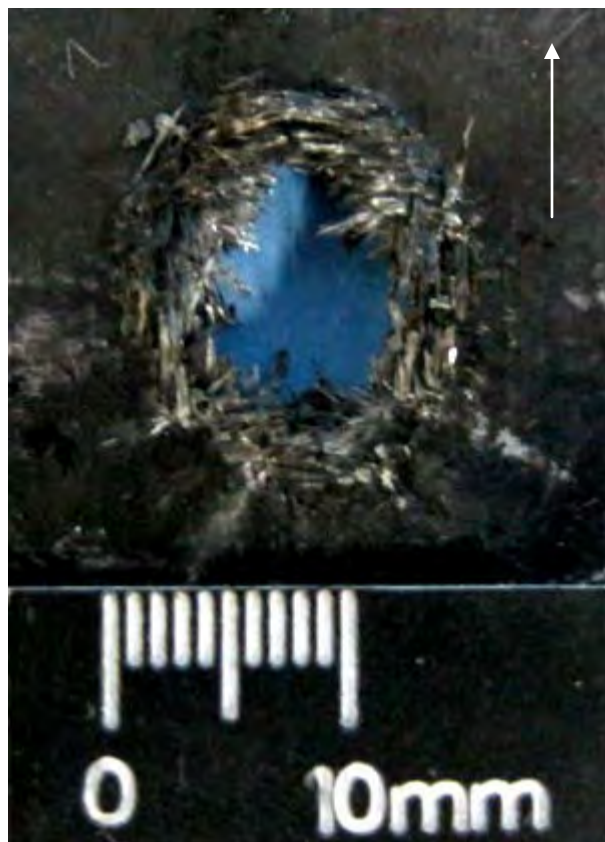
Figure 475 Close-up View of Damage to Front of NP 504 Substrate (scale in 1mm increments / white arrow indicates flight path of projectile)

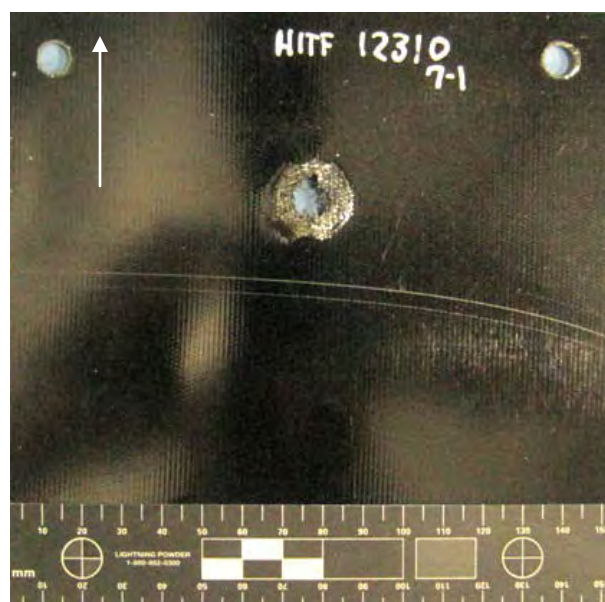
Figure 476 Overall View of Damage to Back Side of NP 504 Substrate (scale in 5mm increments / white arrow indicates flight path of projectile)

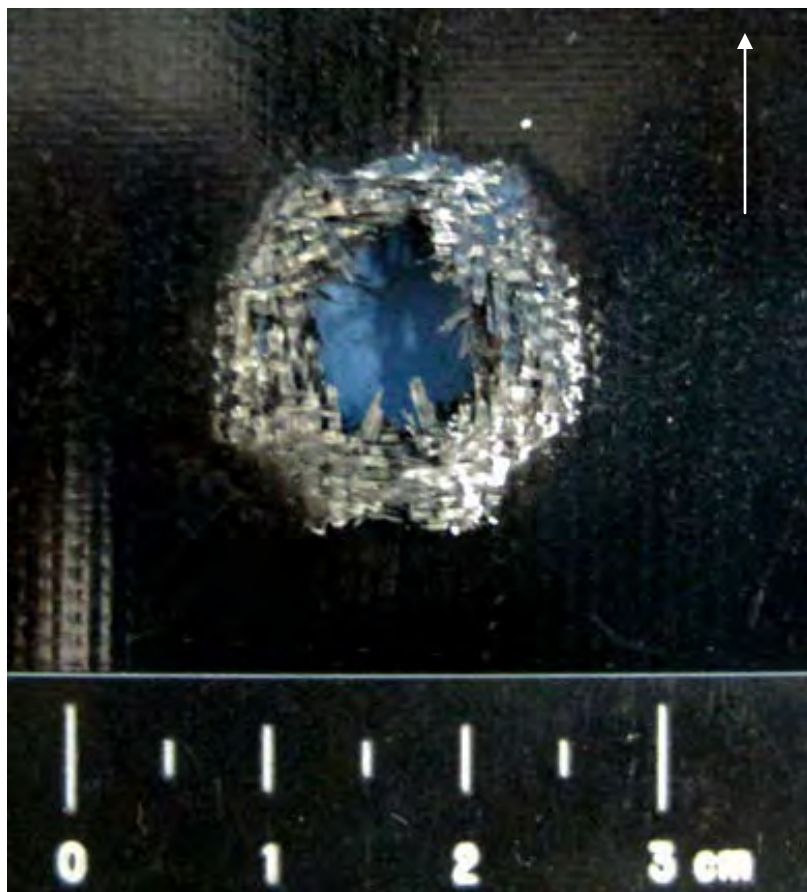
Figure 477 Close-up View of Damage to Back Side of NP 504 Substrate (scale in 5mm increments / white arrow indicates flight path of projectile)

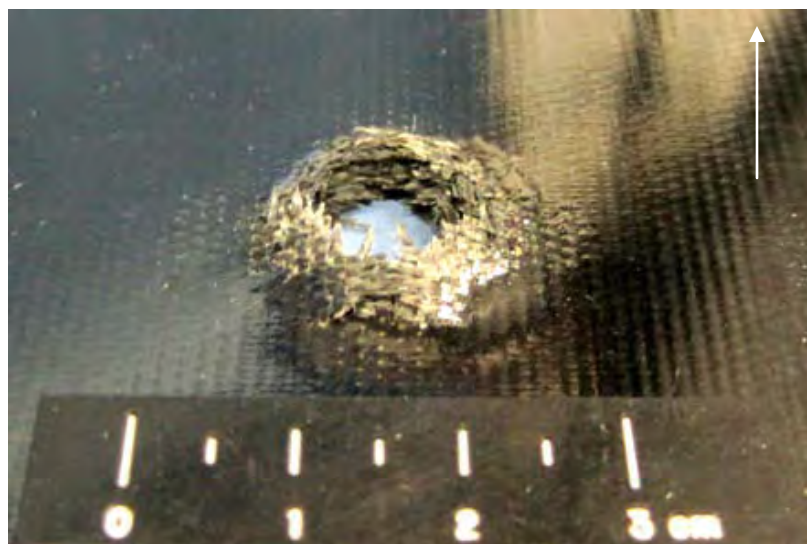
Figure 478 Close-up Oblique Side View of Damage to Back Side of NP 504 Substrate (scale in 5mm increments / white arrow indicates flight path of projectile)

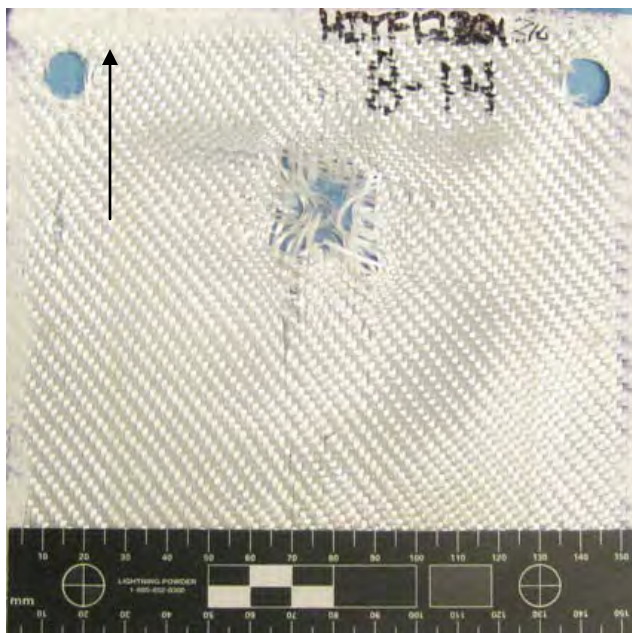
Figure 479 Overall View of Damage to Back Side of Last Fiberglass Layer (scale in 5mm increments / black arrow indicates flight path of projectile)

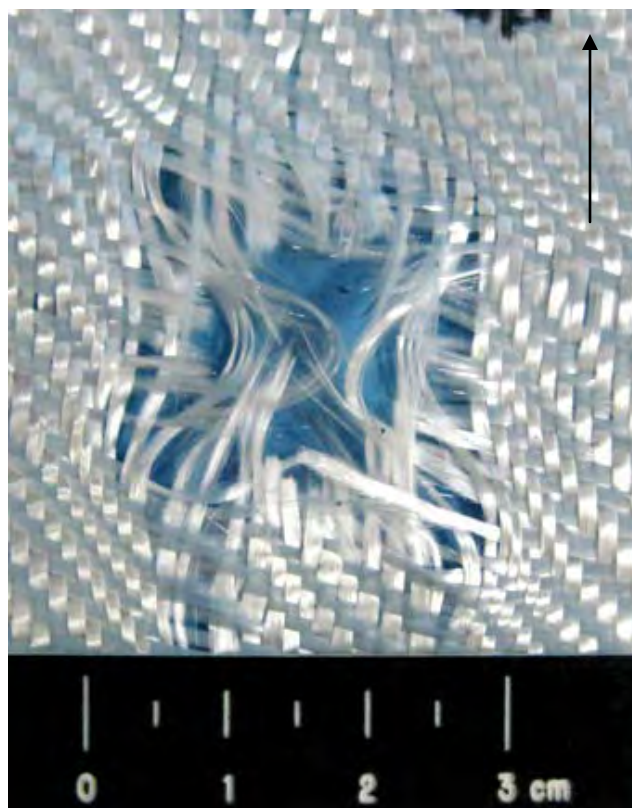
Figure 480 Overall View of Damage to Back Side of Last Fiberglass Layer (scale in 5mm increments / black arrow indicates flight path of projectile)

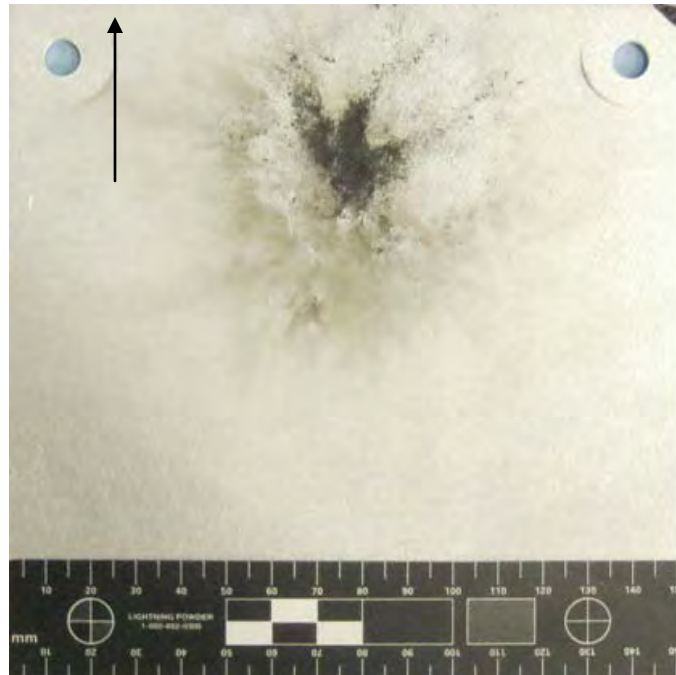
Figure 481 Overall View of Damage to Front of Rear Wall (scale in 5mm increments / black arrow indicates flight path of projectile)

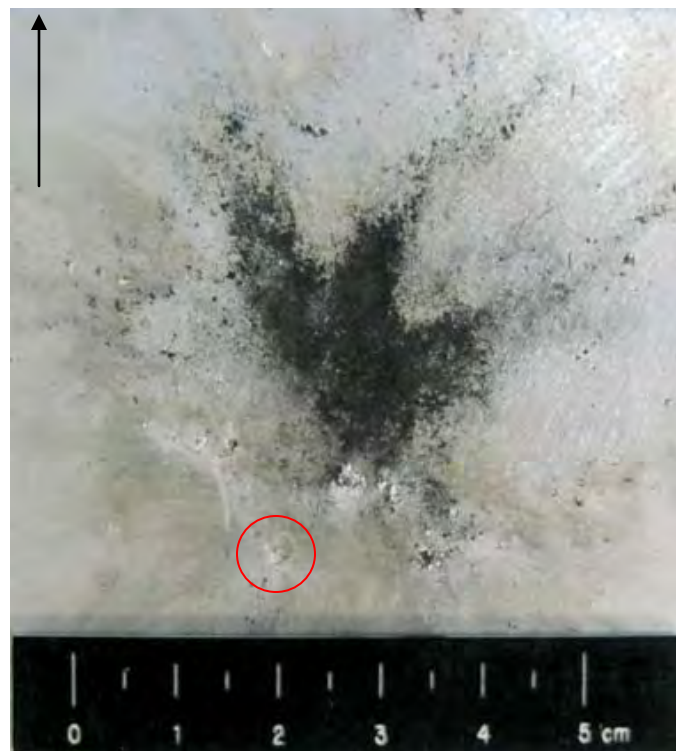
Figure 482 Close-up View of Damage to Front of Rear Wall (scale in 5mm increments / black arrow indicates flight path of projectile)

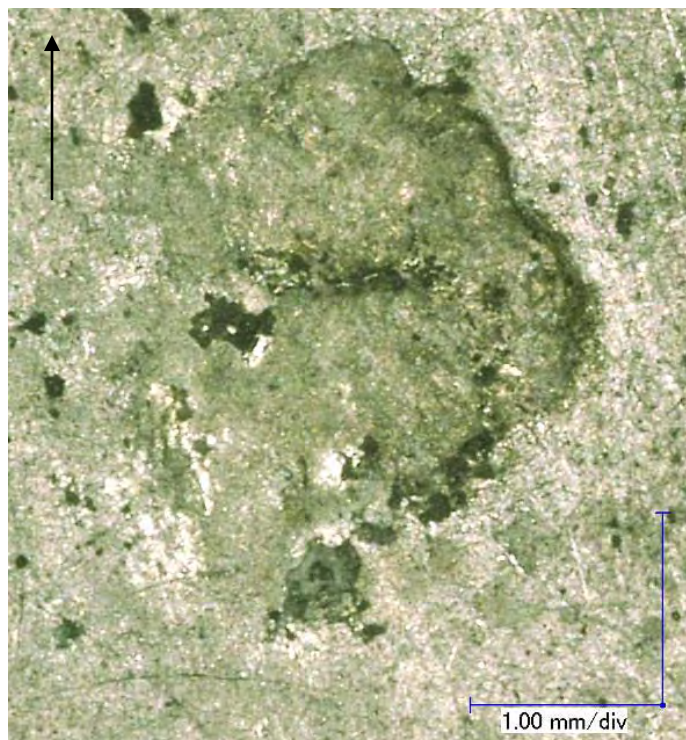
Figure 483 Close-up View of Most Significant Damage to Front of Rear Wall (black arrow indicates flight path of projectile / damage within red circle in Figure 482)

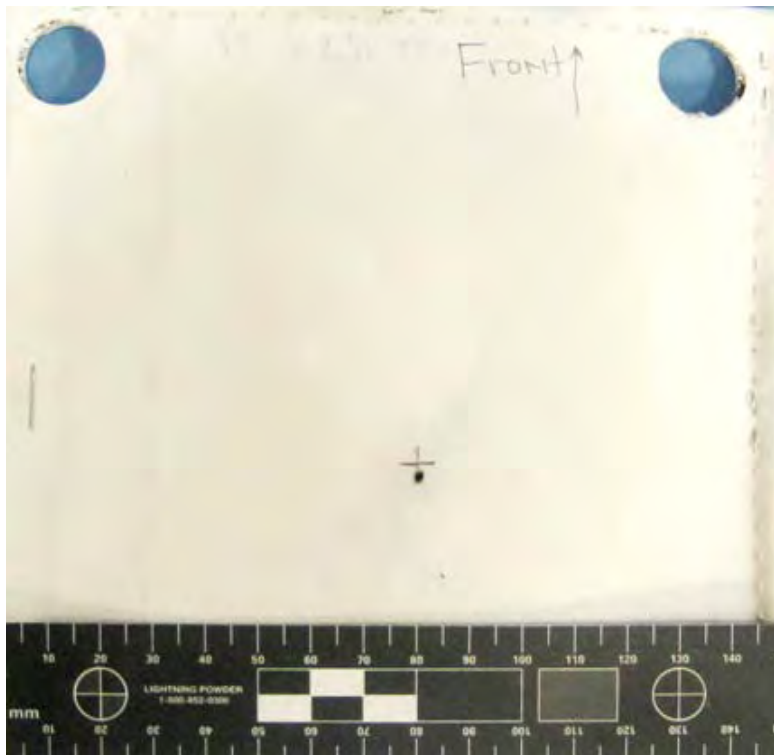
Figure 489 Overall View of Damage to Front of MLI (black arrow indicates flight path of projectile / scale in 5mm increments)

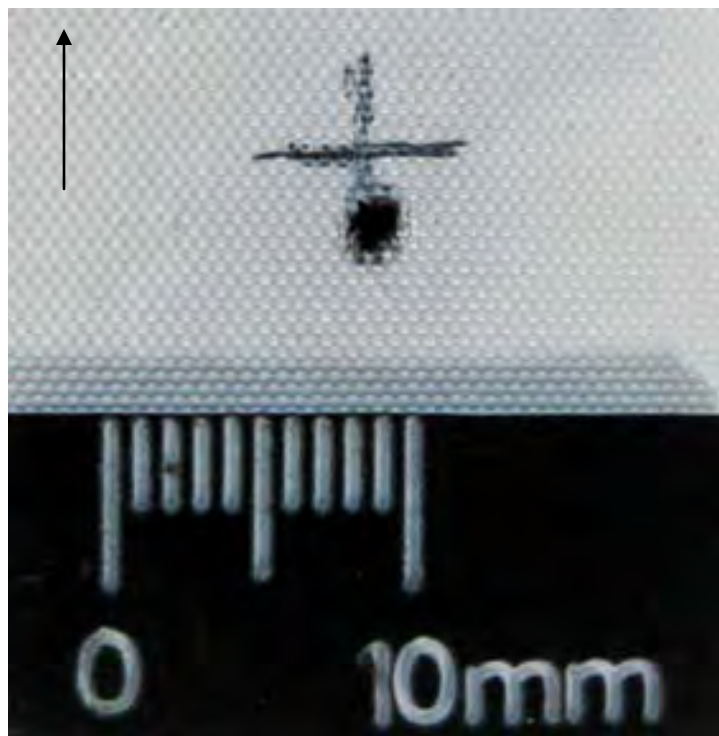
Figure 490 Close-up View of Damage to Front of MLI (scale in 1mm increments / black arrow indicates flight path of projectile)

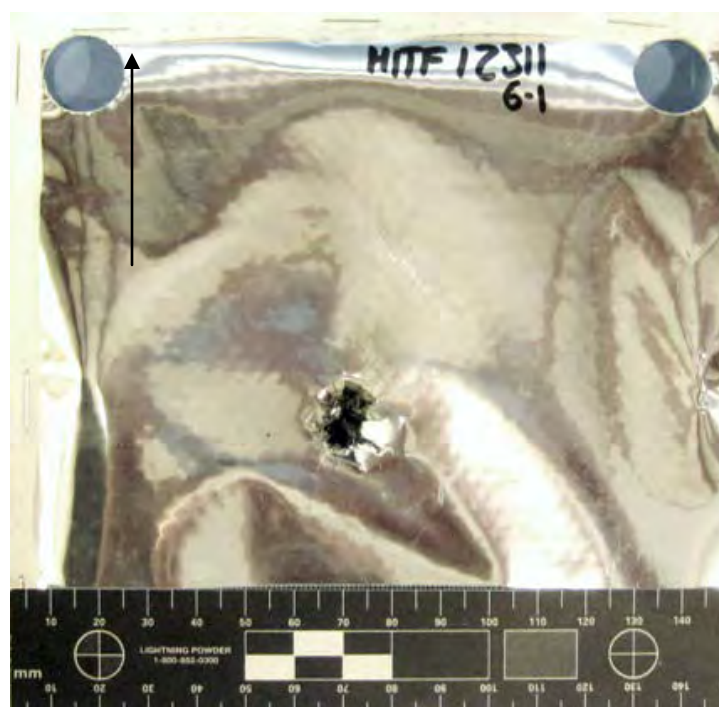
Figure 491 Overall View of Damage to Back Side of MLI (scale in 5mm increments / black arrow indicates flight path of projectile)

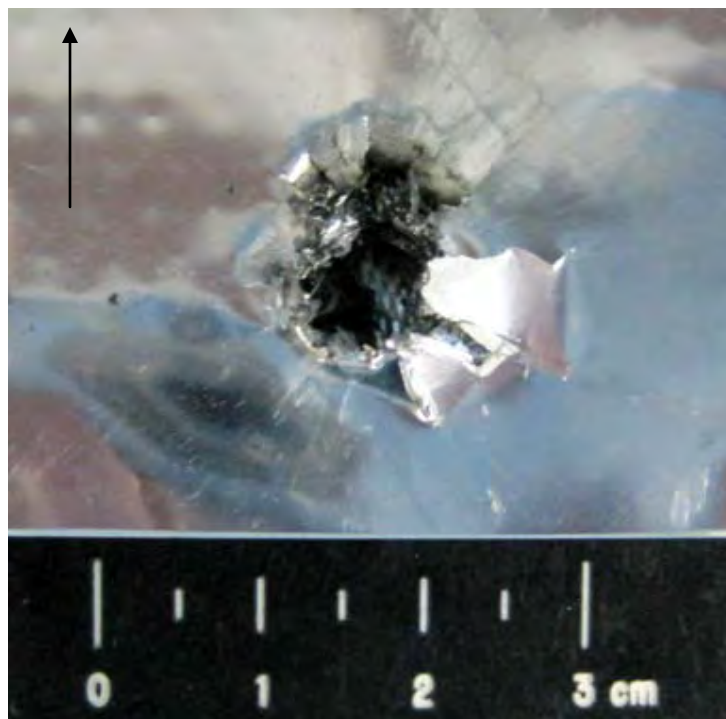
Figure 492 Close-up View of Damage to Back Side of MLI (scale in 5mm increments / black arrow indicates flight path of projectile)

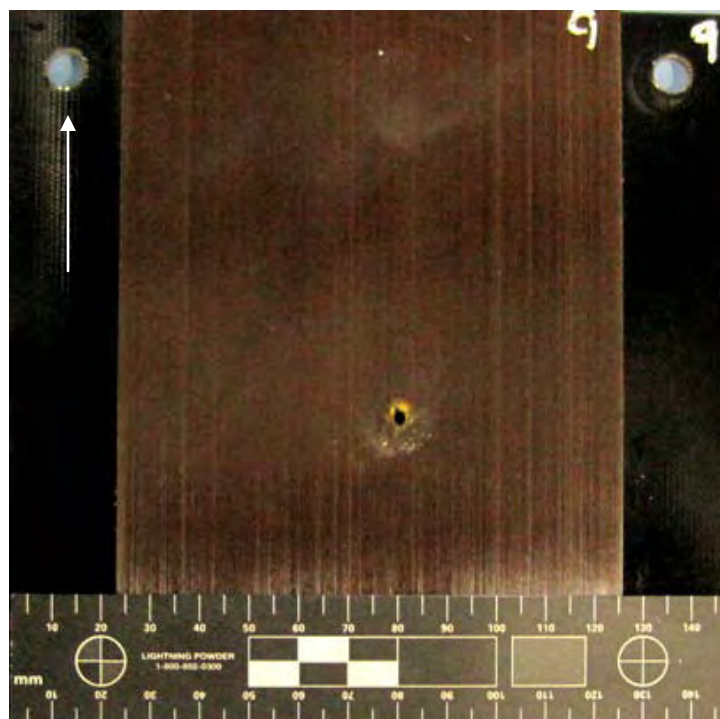
Figure 493 Overall View of Damage to Front of TORLON 5030 (scale in 5mm increments / white arrow indicates flight path of projectile)

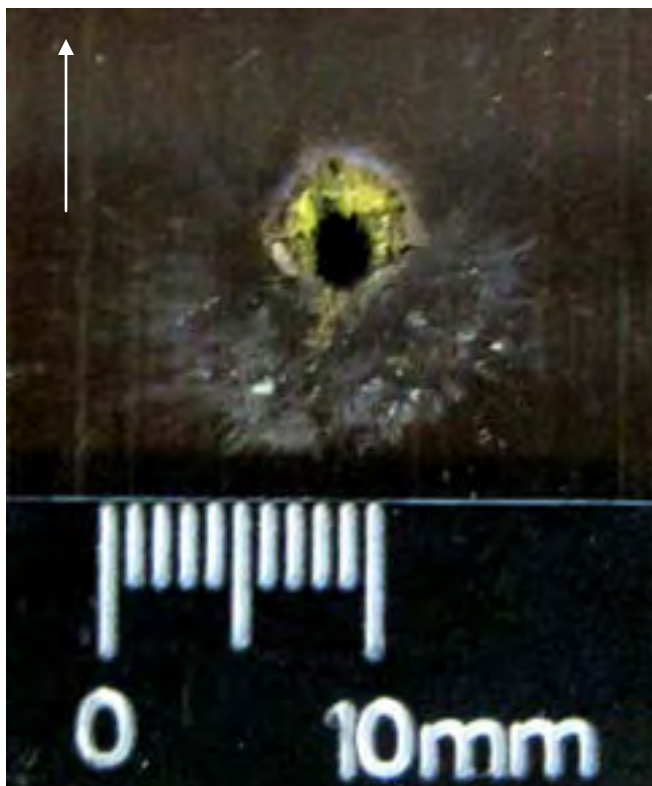
Figure 494 Close-up View of Damage to Front of TORLON 5030 (scale in 1mm increments / white arrow indicates flight path of projectile)

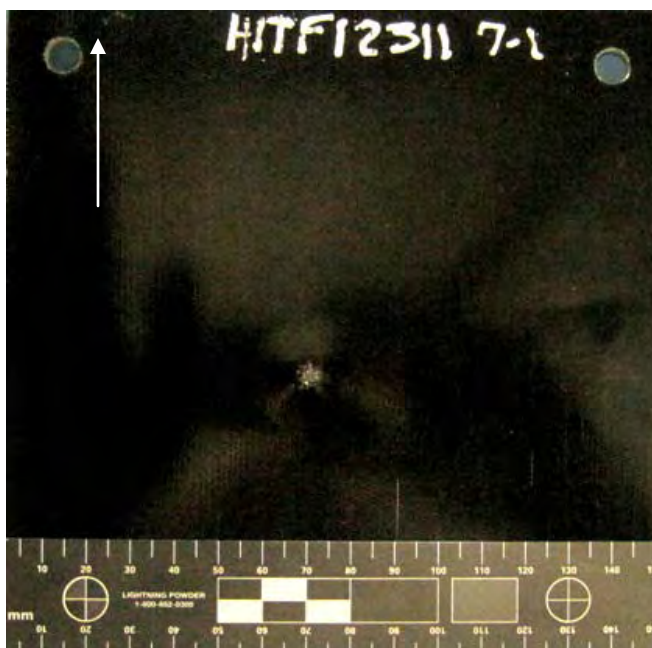
Figure 495 Overall View of Damage to Back Side of NP 504 Substrate (scale in 5mm increments / white arrow indicates flight path of projectile)

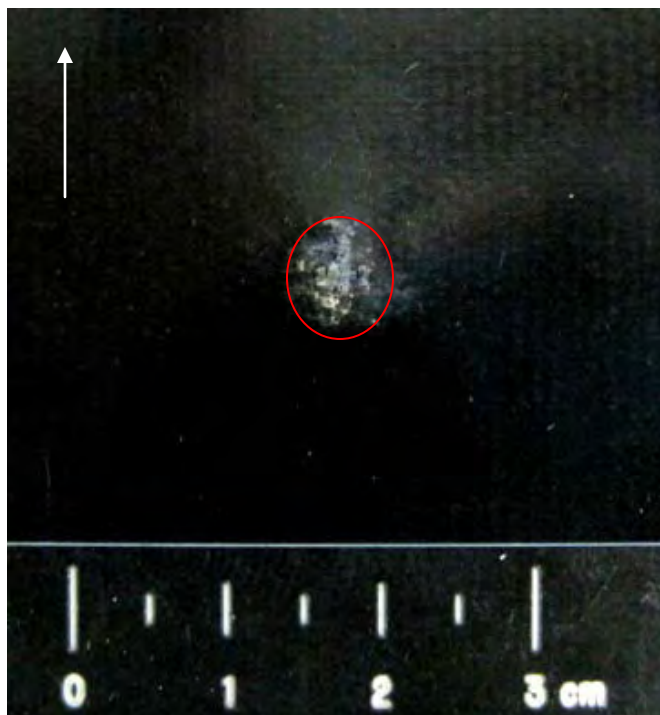
Figure 496 Close-up View of Damage to Back Side of NP 504 Substrate (scale in 5mm increments / white arrow indicates flight path of projectile)

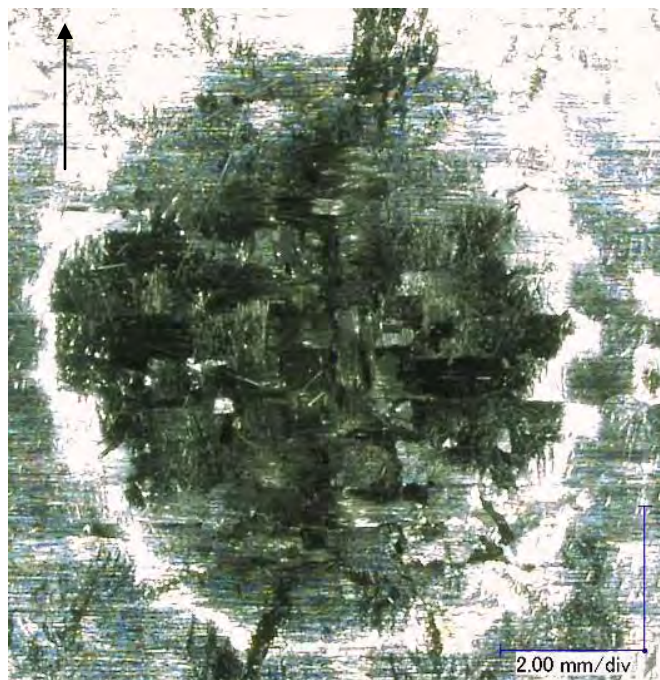
Figure 497 Close-up View of Most Significant Damage to Back Side of NP 504 Substrate (black arrow indicates flight path of projectile / damage within red circle in Figure 496)

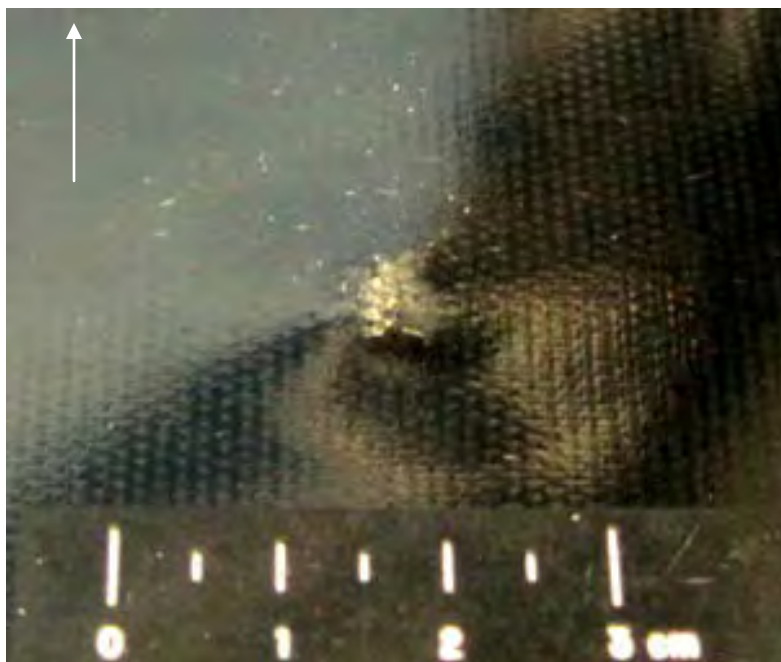
Figure 498 Close-up Oblique Side View of Damage to Back Side of NP 504 Substrate (scale in 5mm increments / white arrow indicates flight path of projectile)

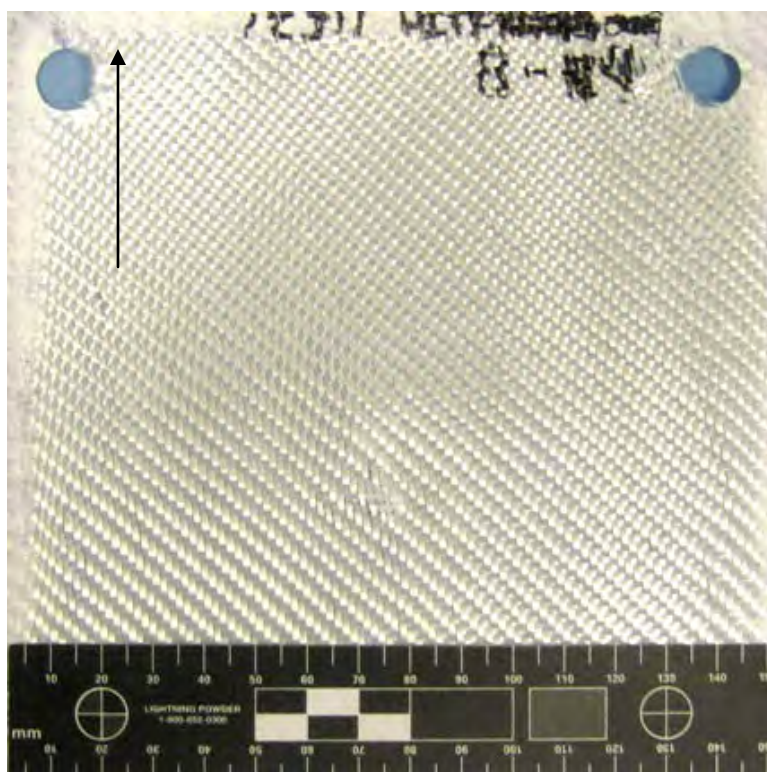
Figure 499 Overall View of Damage to Back Side of Last Fiberglass Layer (scale in 5mm increments / black arrow indicates flight path of projectile)

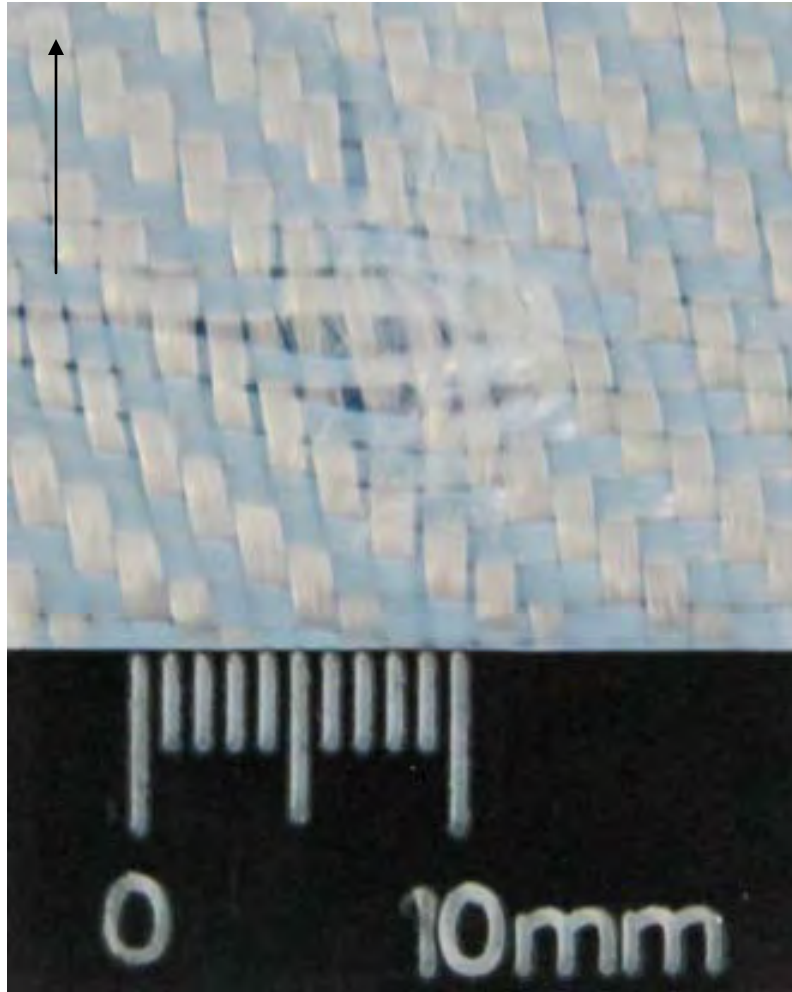
Figure 500 Close-up View of Damage to Back Side of Last Fiberglass Layer (scale in 1mm increments / black arrow indicates flight path of projectile)

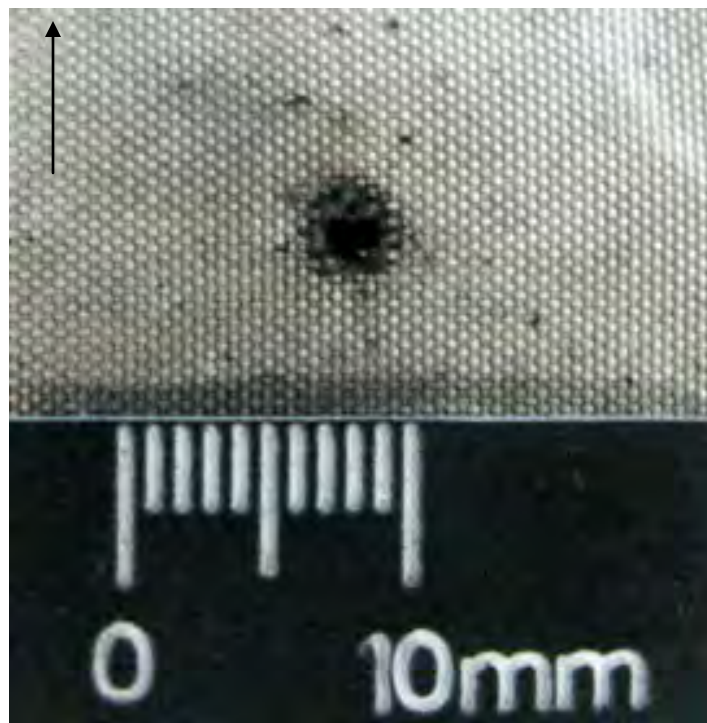
Figure 505 Close-up View of Damage to Front of MLI (scale in 1mm increments / black arrow indicates flight path of projectile)

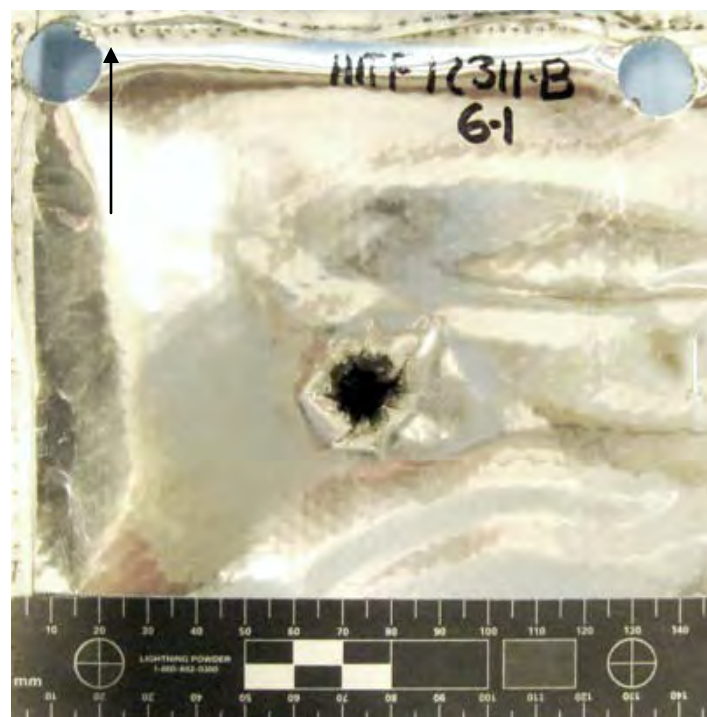
Figure 506 Overall View of Damage to Back Side of MLI (scale in 5mm increments / black arrow indicates flight path of projectile)

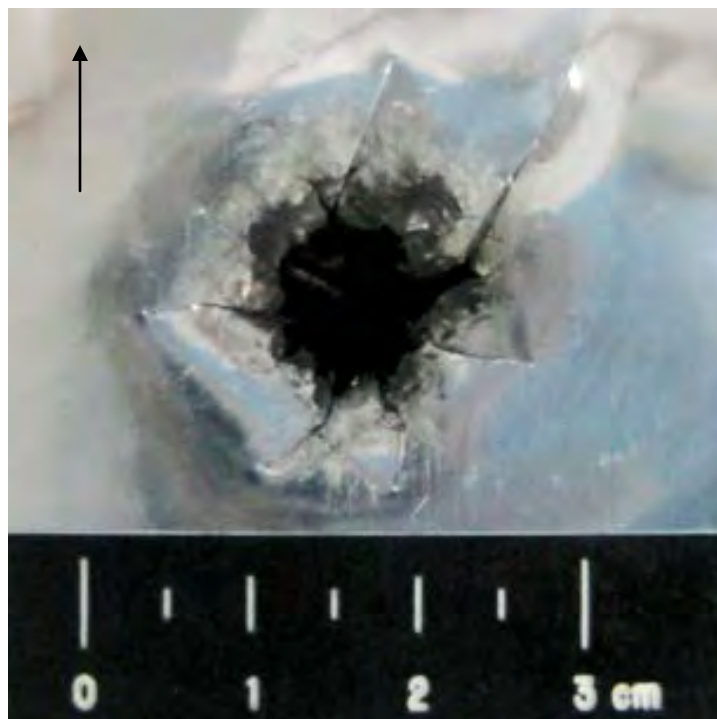
Figure 507 Close-up View of Damage to Back Side of MLI (scale in 5mm increments / black arrow indicates flight path of projectile)
