International Space Station (ISS) Soyuz Vehicle Descent Module Evaluation of Thermal Protection System (TPS) Penetration Characteristics

Hypervelocity Impact Technology Group

February 2013

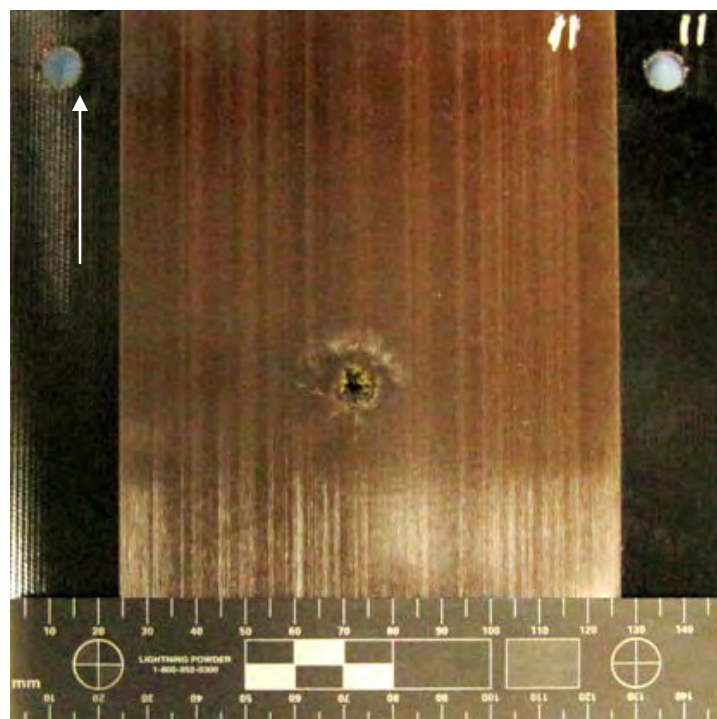
Figure 508 Overall View of Damage to Front of TORLON 5030 (scale in 5mm increments / white arrow indicates flight path of projectile)

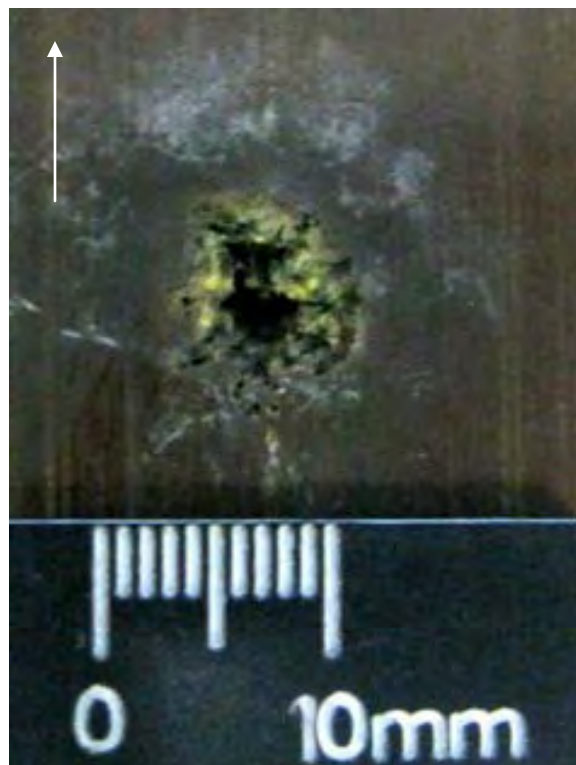
Figure 509 Close-up View of Damage to Front of TORLON 5030 (scale in 1mm increments / white arrow indicates flight path of projectile)

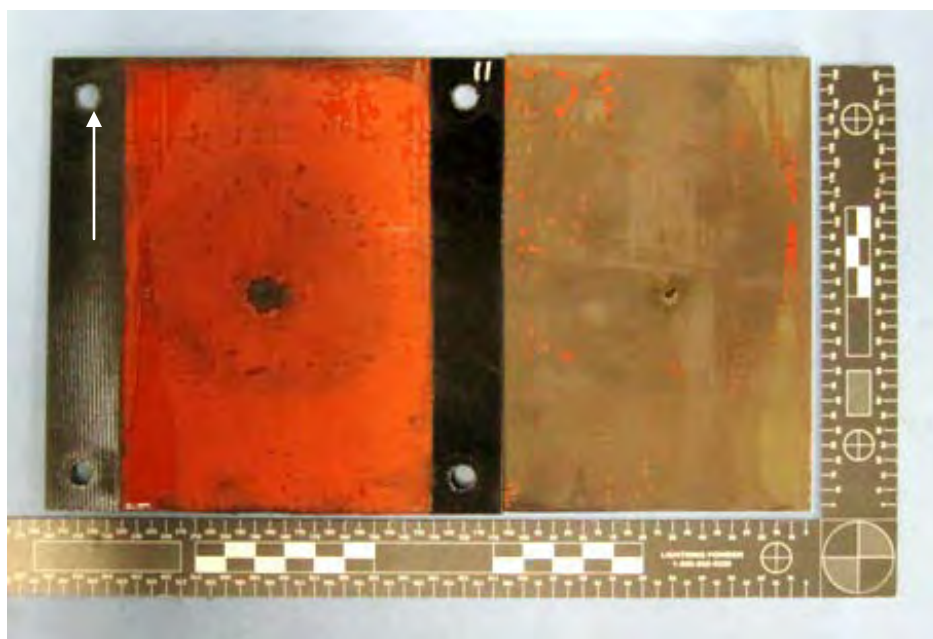
Figure 510 Overall View of Delamination of NP 504 Substrate and TORLON 5030 which exposed the Exit Damage of the TORLON 5030 and Entry Damage to the NP 504 Substrate (scale in 5mm increments / white arrow indicates flight path of projectile)

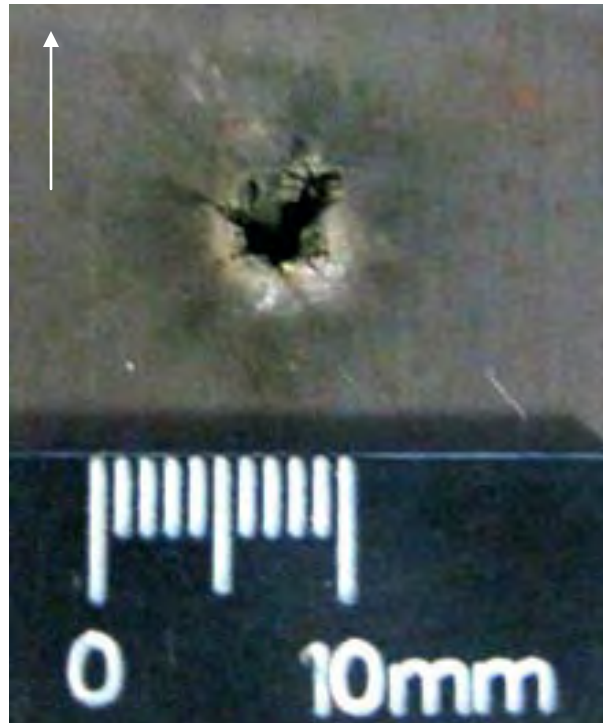
Figure 511 Close-up View of Exit Damage to TORLON 503 (scale in 1mm increments / white arrow indicates flight path of projectile)

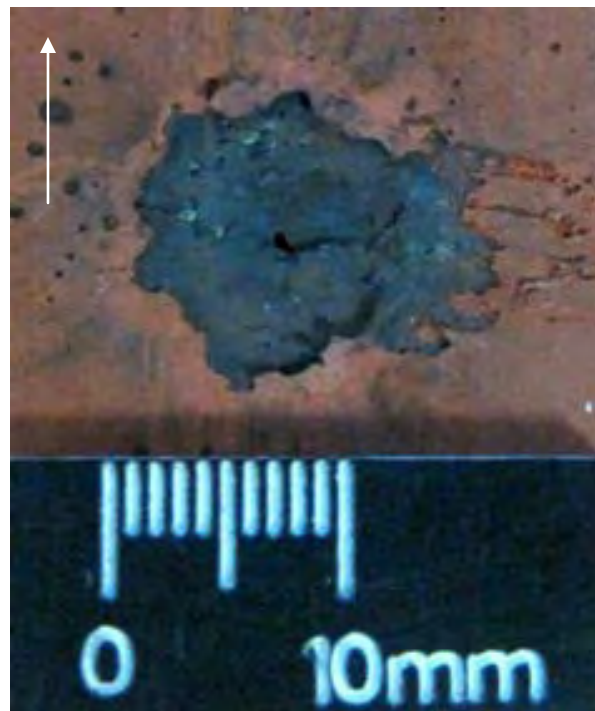
Figure 512 Close-up View of Entry Damage to NP 504 Substrate (scale in 1mm increments / white arrow indicates flight path of projectile)

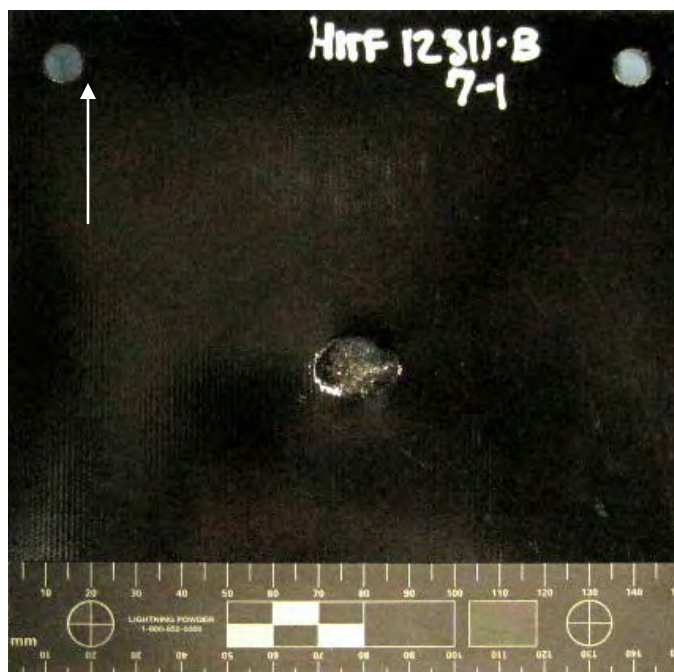
Figure 513 Overall View of Damage to Back Side of NP 504 Substrate (scale in 5mm increments / white arrow indicates flight path of projectile)

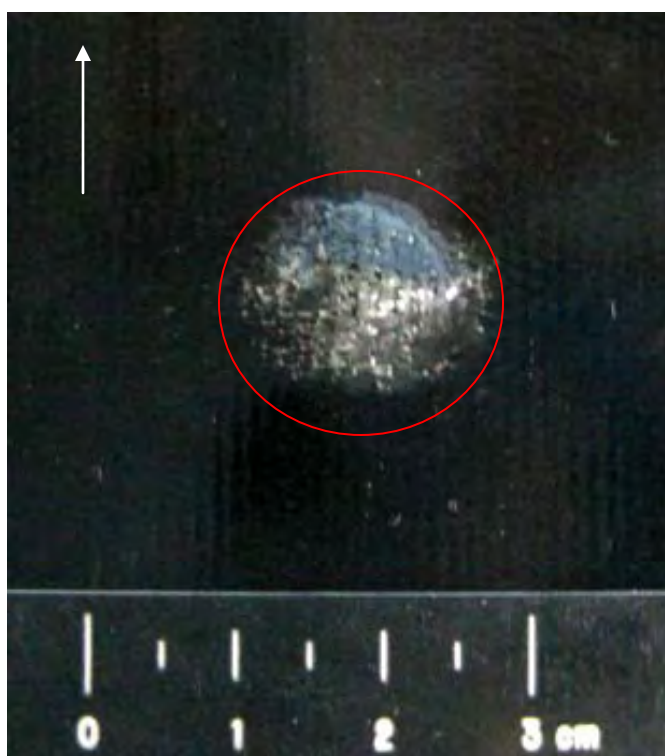
Figure 514 Close-up View of Damage to Back Side of NP 504 Substrate (scale in 5mm increments / white arrow indicates flight path of projectile)

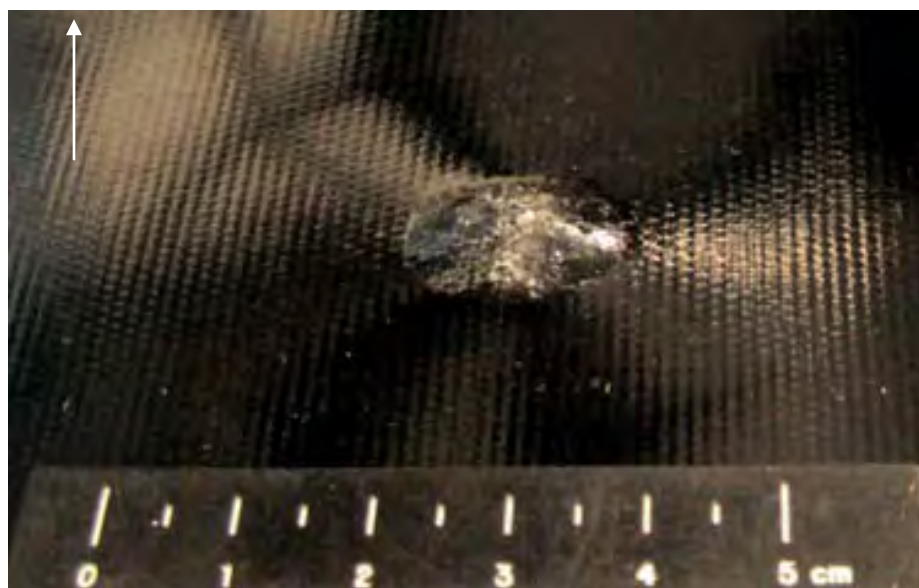
Figure 516 Close-up Oblique Side View of Damage to Back Side of NP 504 Substrate (scale in 5mm increments / white arrow indicates flight path of projectile)

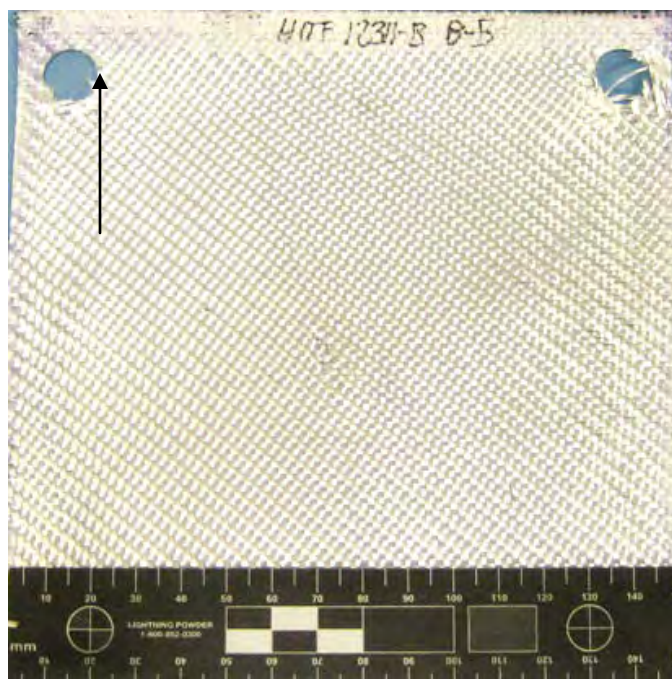
Figure 517 Overall View of Damage to Back Side of Last Fiberglass Layer (scale in 5mm increments / black arrow indicates flight path of projectile)

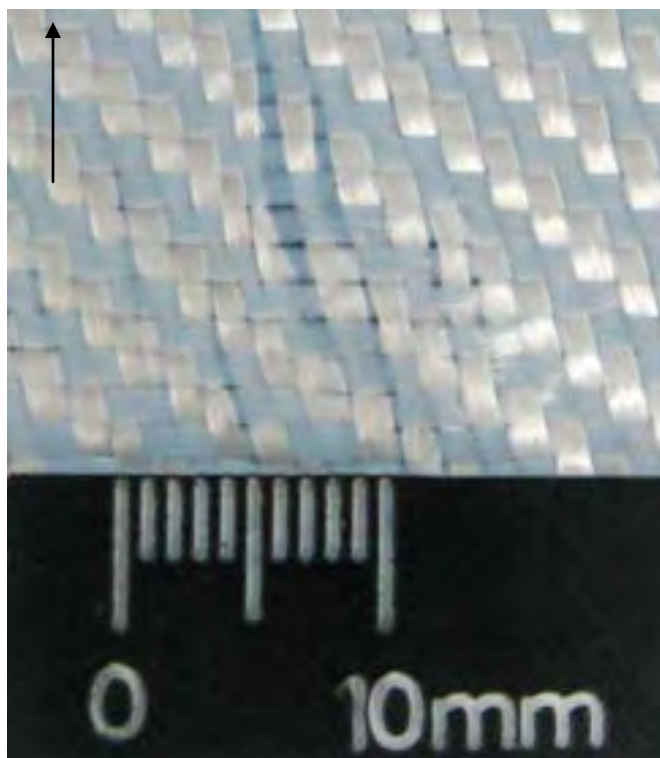
Figure 518 Close-up View of Damage to Back Side of 5th Fiberglass Layer (scale in 1mm increments / black arrow indicates flight path of projectile)

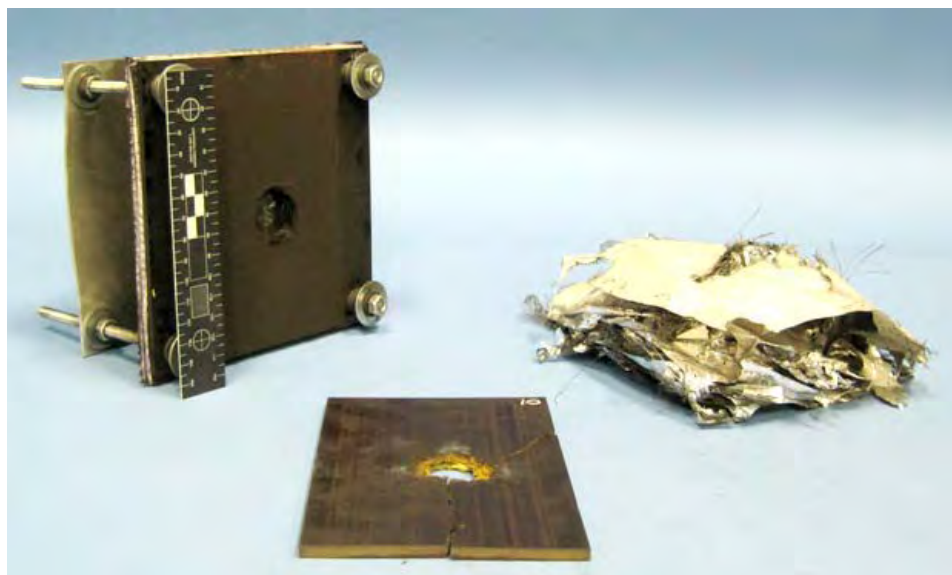
Figure 520 Overall View of TORLON 5030 Delaminated from NP 504 Substrate and MLI Blanket Displaced from Test Configuration All Bi-products of the Impact Test (scale in 5mm increments)

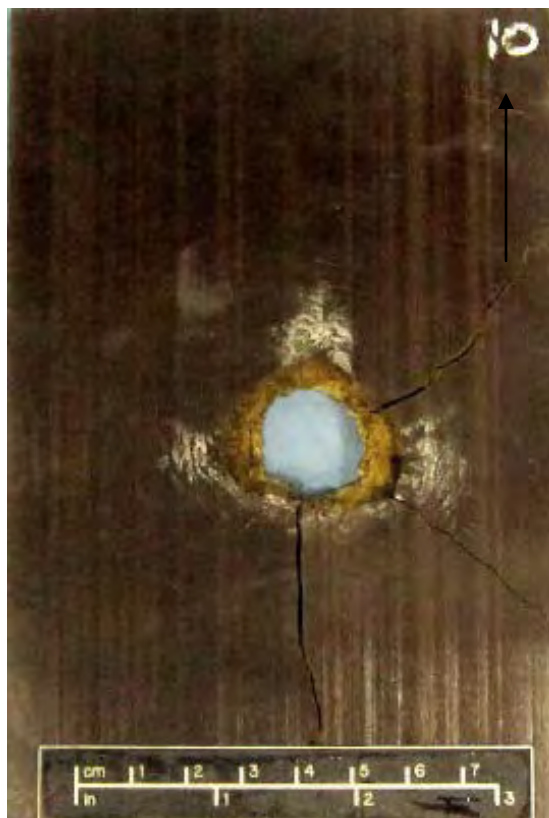
Figure 523 Overall View of Damage to Front of TORLON 5030 Delaminated from Substrate (black arrow indicates flight path of projectile / scale in 1cm increments)

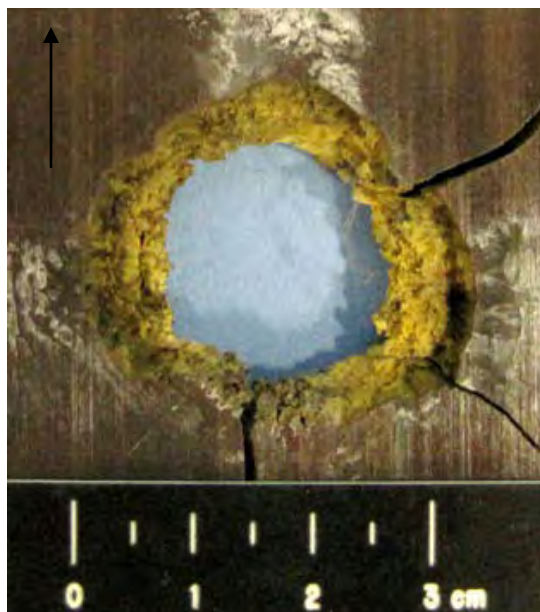
Figure 524 Overall View of Damage to Front of TORLON 5030 Delaminated from Substrate (black arrow indicates flight path of projectile / scale in 5mm increments)

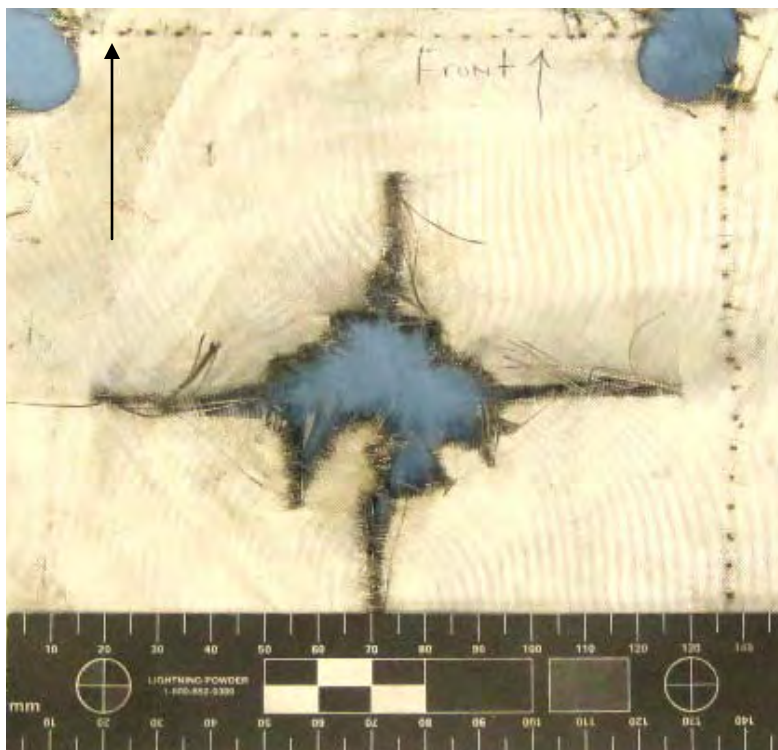
Figure 525 Overall View of Entry Damage to Front Layer of MLI Blanket (black arrow indicates flight path of projectile / scale in 5mm increments)

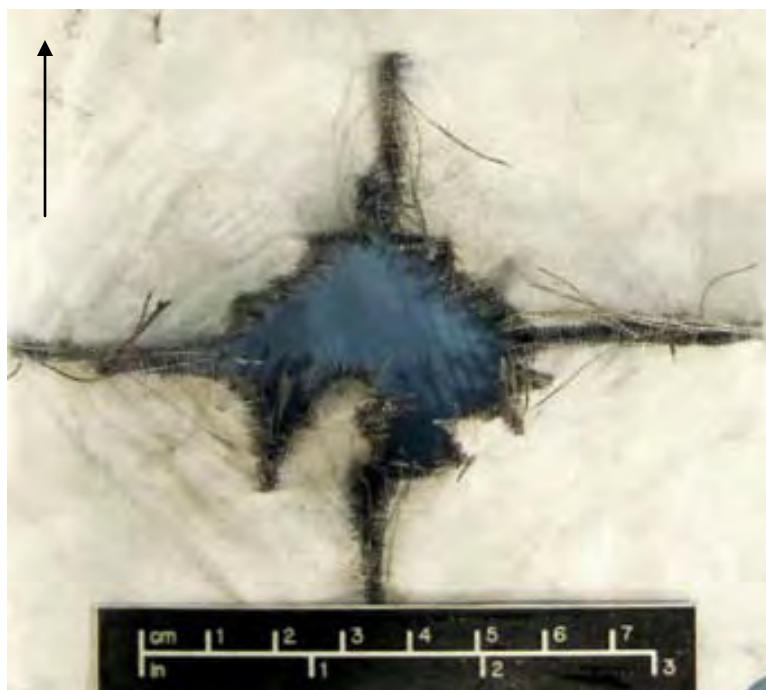
Figure 526 Close-up View of Entry Damage to Front of MLI (scale in 1cm increments / black arrow indicates flight path of projectile)

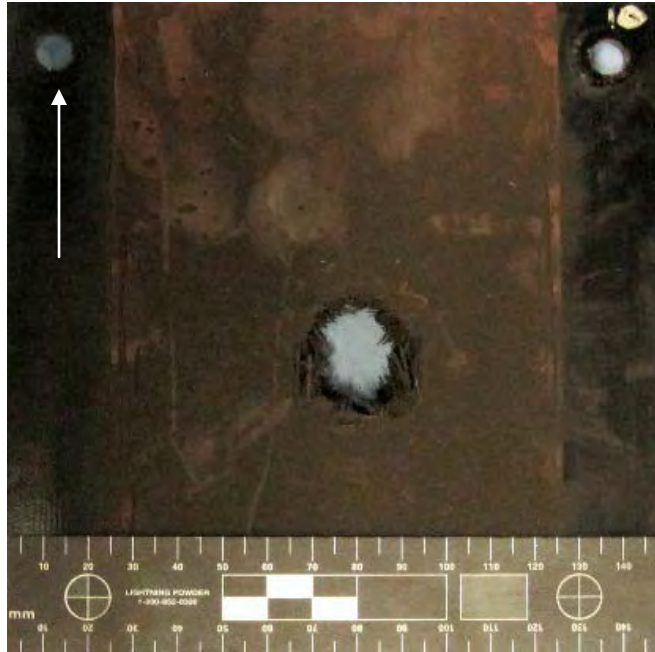
Figure 527 Overall View of Damage to Front NP 504 Substrate with TORLON 5030 Delaminated (scale in 5mm increments / white arrow indicates flight path of projectile)

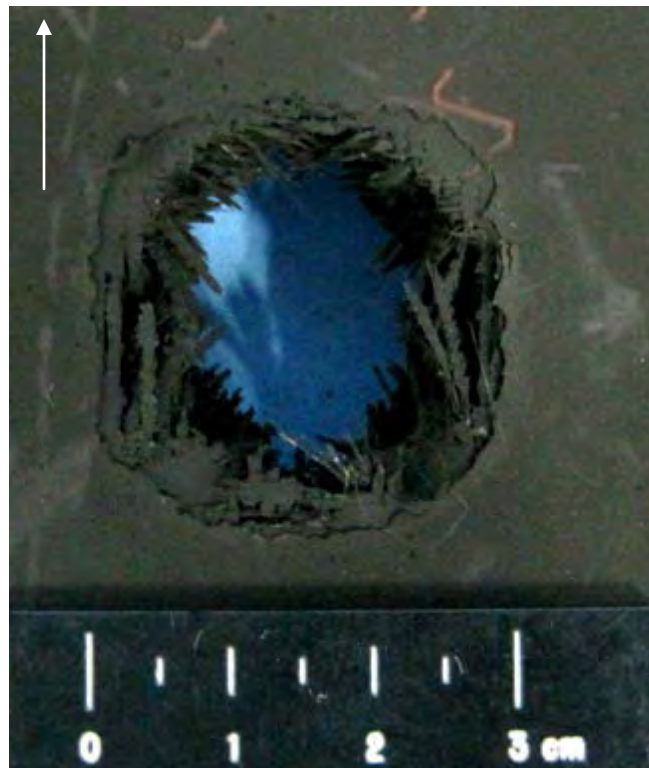
Figure 528 Close-up View of Damage to Front NP 504 Substrate with TORLON 5030 Delaminated (scale in 5mm increments / white arrow indicates flight path of projectile)

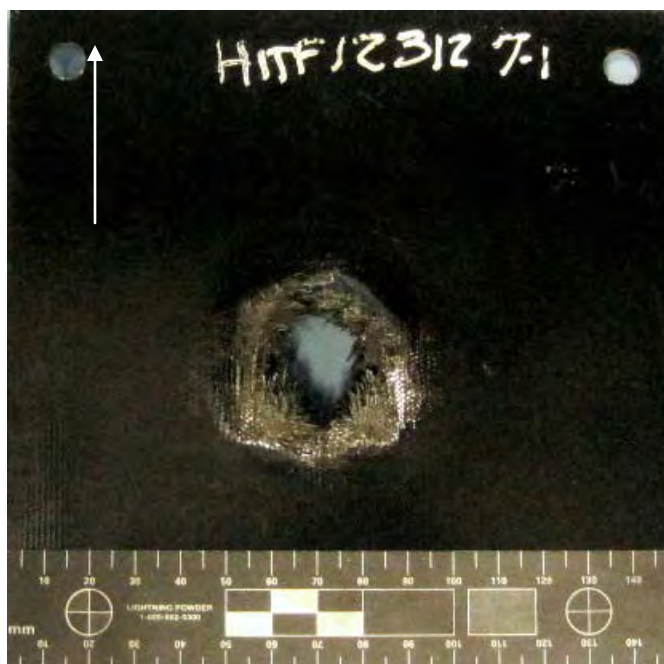
Figure 529 Overall View of Damage to Back Side of NP 504 Substrate (scale in 5mm increments / black arrow indicates flight path of projectile)

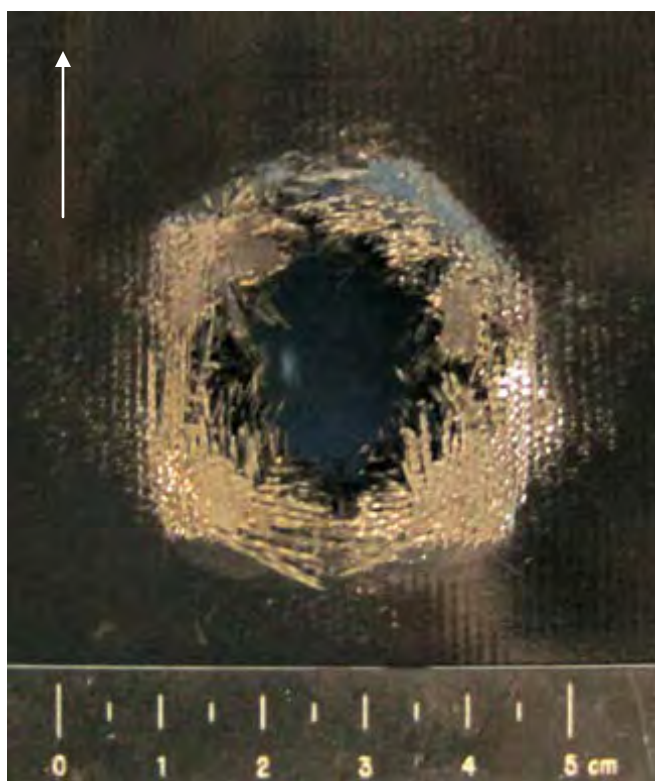
Figure 530 Close-up View of Damage to Back Side of NP 504 Substrate (scale in 5mm increments / black arrow indicates flight path of projectile)

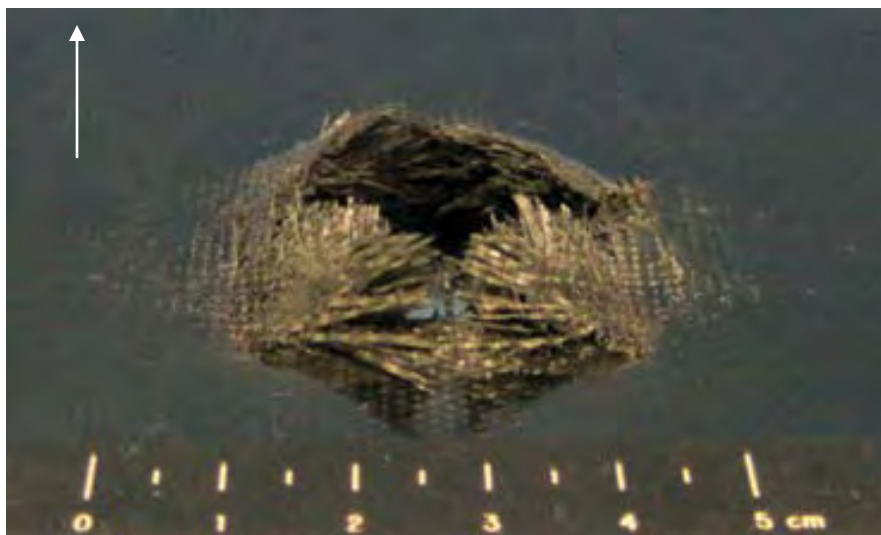
Figure 531 Close-up Oblique Side View of Damage to Back Side of NP 504 Substrate (scale in 5mm increments / white arrow indicates flight path of projectile)

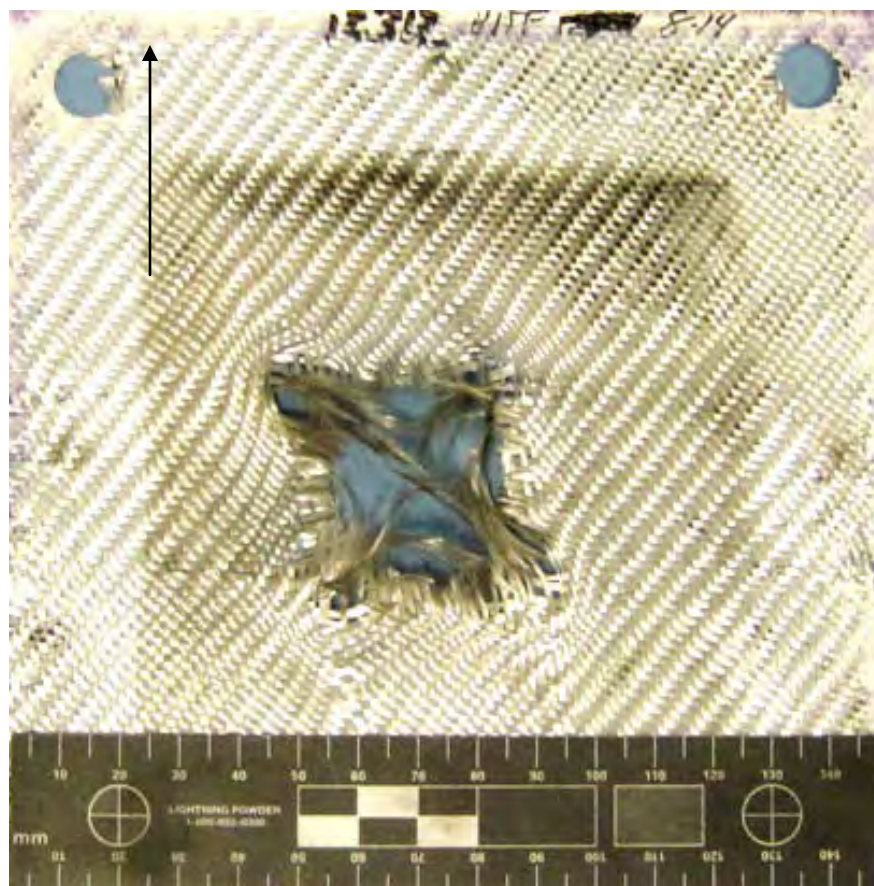
Figure 532 Overall View of Damage to Back Side of Last Fiberglass Layer (scale in 5mm increments / black arrow indicates flight path of projectile)

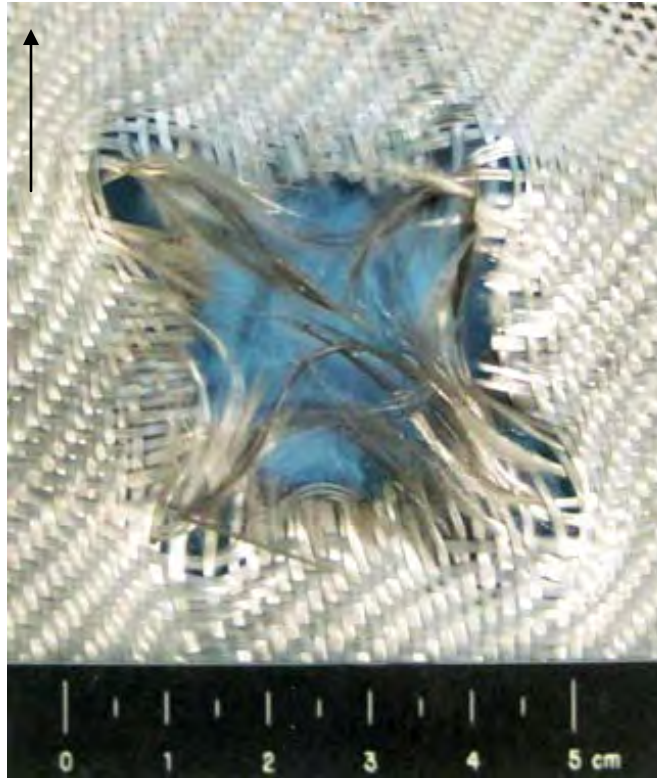
Figure 533 Close-up View of Damage to Back Side of Last Fiberglass Layer (scale in 5mm increments / black arrow indicates flight path of projectile)

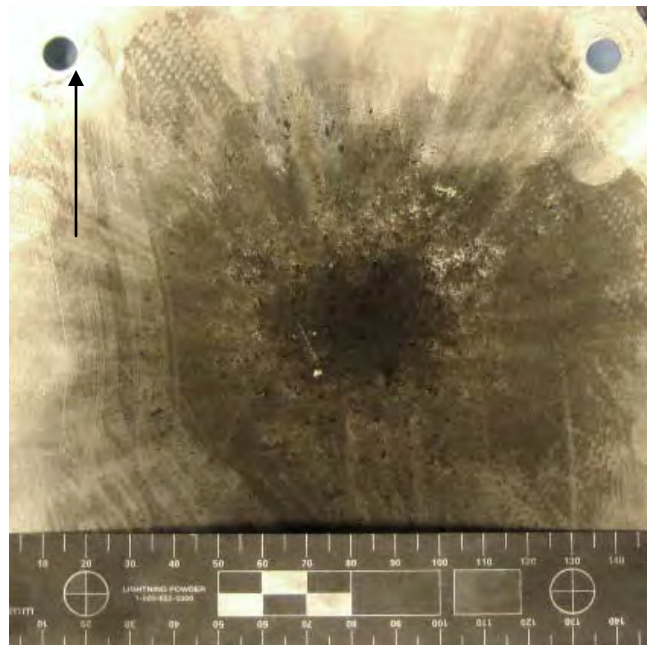
Figure 534 Overall View of Damage to Front of Rear Wall (scale in 5mm increments / black arrow indicates flight path of projectile / uncleaned)

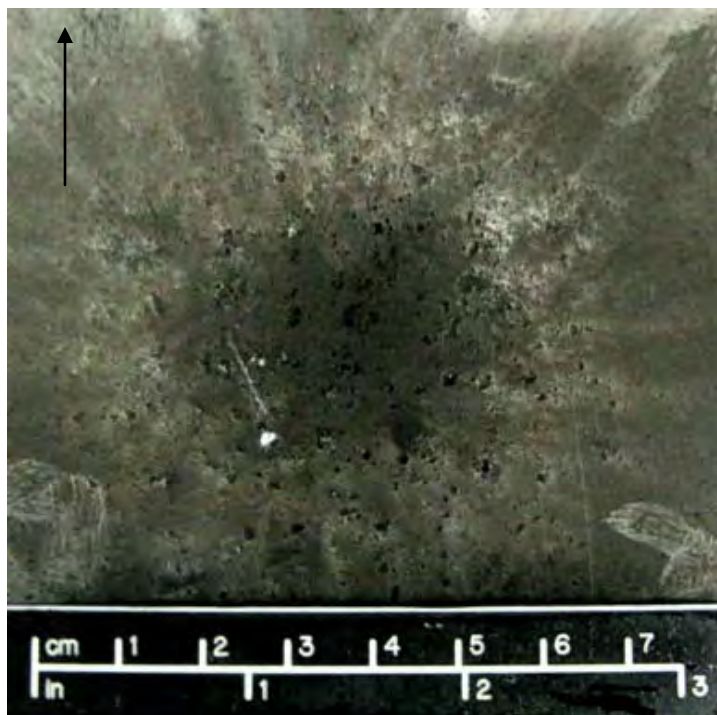
Figure 535 Close-up View of Damage to Front of Rear Wall (scale in 1cm increments / black arrow indicates flight path of projectile / uncleaned)

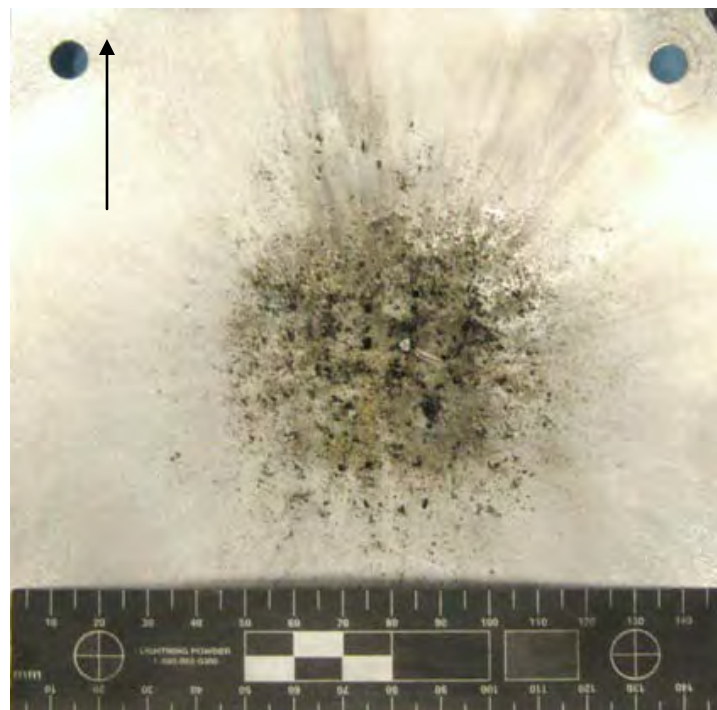
Figure 536 Overall View of Damage to Front of Rear Wall (scale in 5mm increments / black arrow indicates flight path of projectile / cleaned)

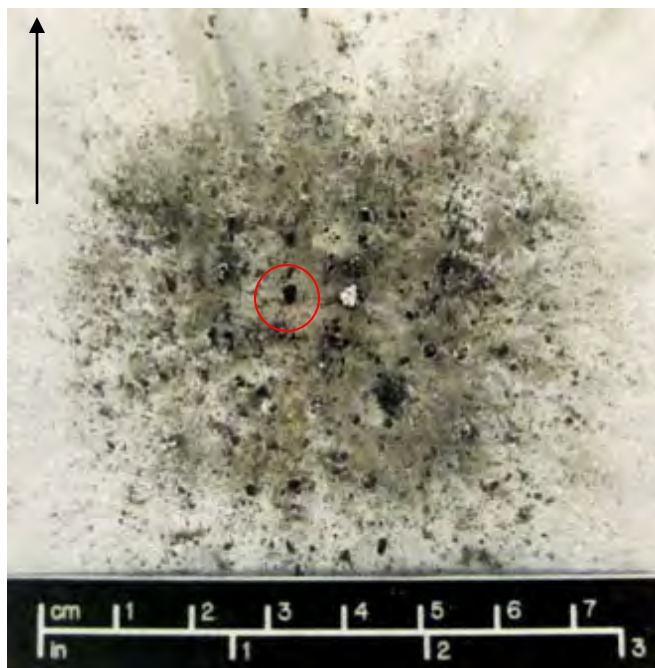
Figure 537 Close-up View of Damage to Front of Rear Wall (scale in 1cm increments / black arrow indicates flight path of projectile / cleaned)

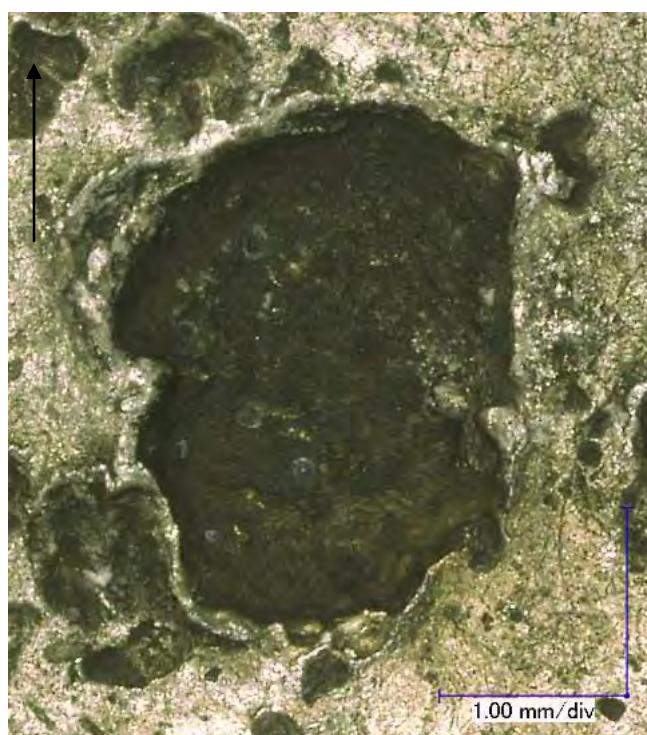
Figure 538 Close-up View of Most Significant Damage to Back Side of NP 504 Substrate (black arrow indicates flight path of projectile / damage within red circle in Figure 537)

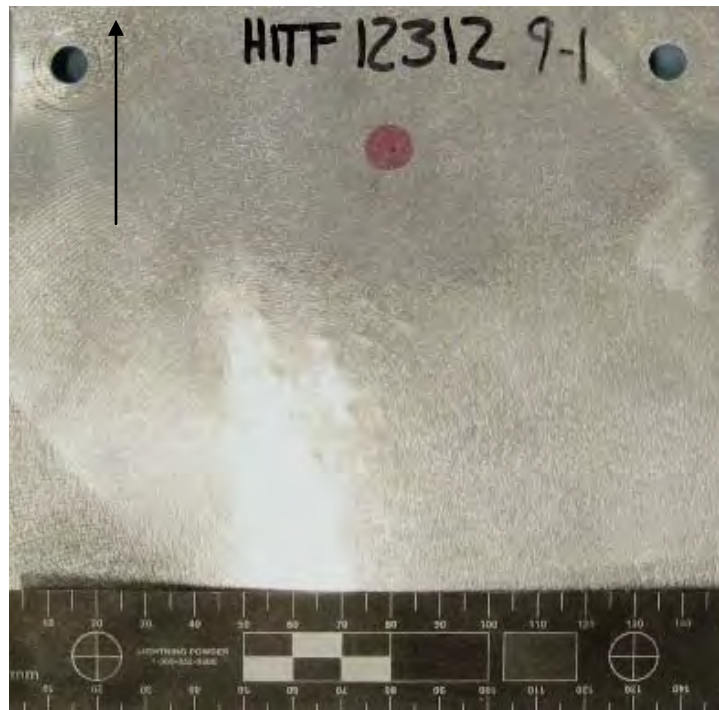
Figure 539 Overall View of Damage to Back Side of Rear Wall (scale in 5mm increments / black arrow indicates flight path of projectile)

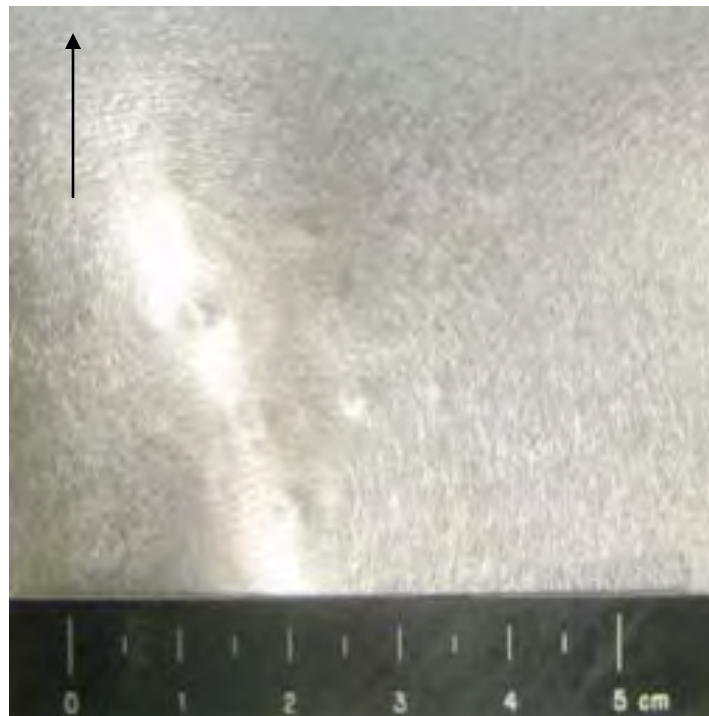
Figure 540 Close View of Damage to Back Side of Rear Wall (scale in 5mm increments / black arrow indicates flight path of projectile)

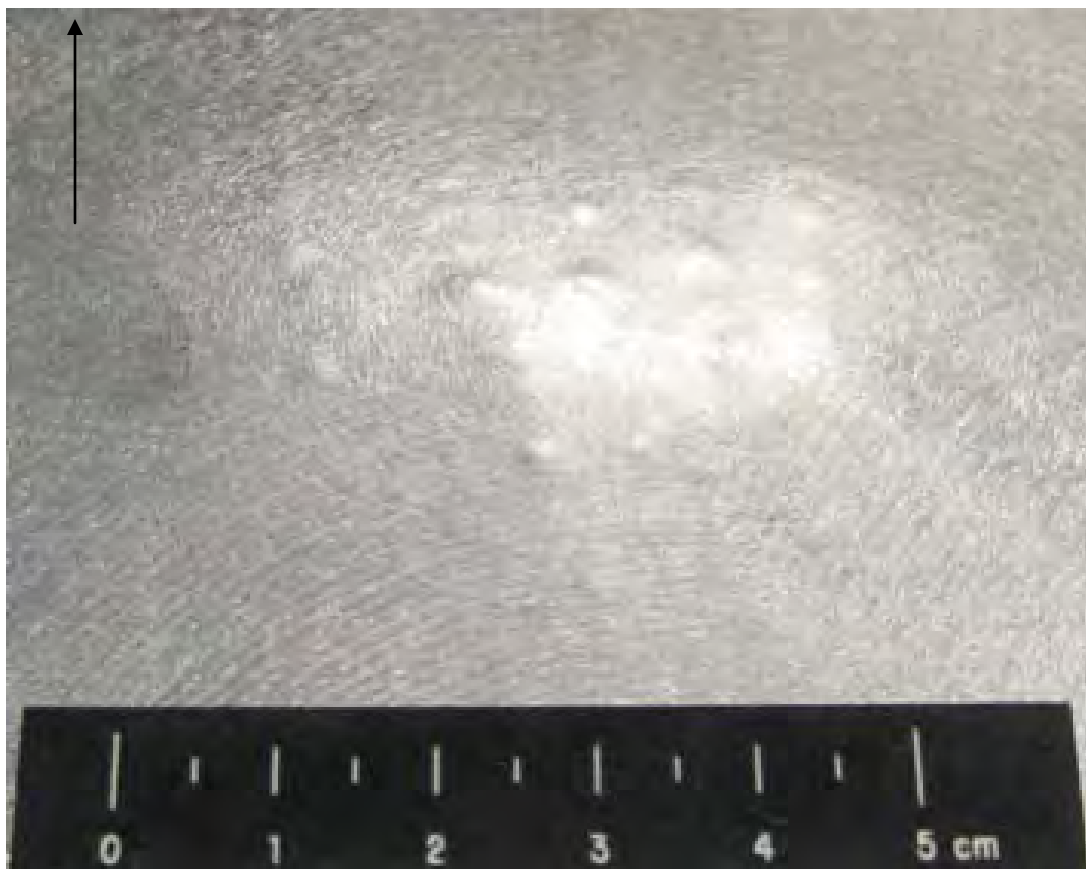
Figure 541 Close-up Oblique Side View of Damage to Back Side of NP 504 Substrate (scale in 5mm increments / black arrow indicates flight path of projectile)

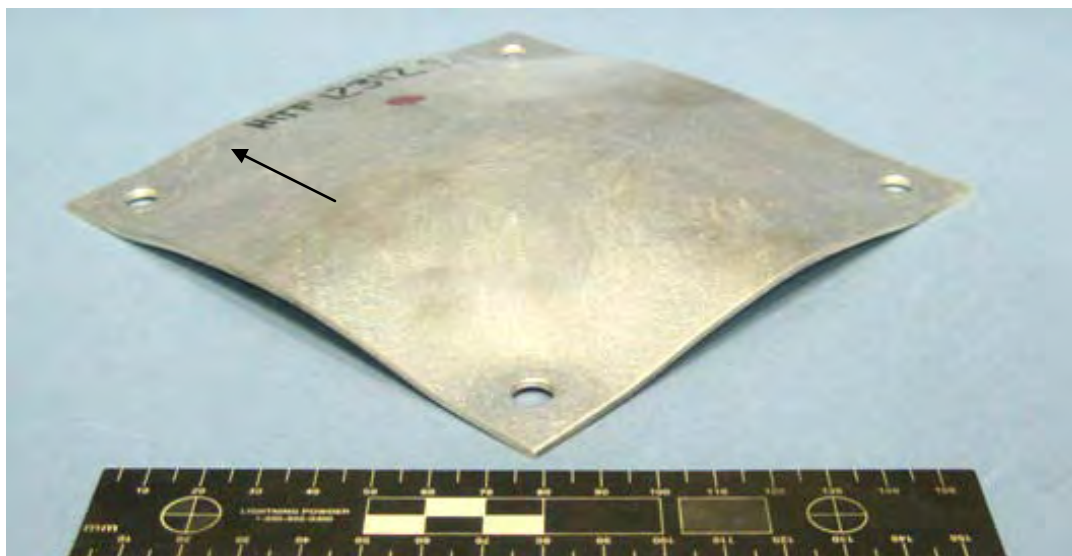
Figure 542 Overall Oblique Side View of Damage to Back Side of NP 504 Substrate (scale in 5mm increments / black arrow indicates flight path of projectile)

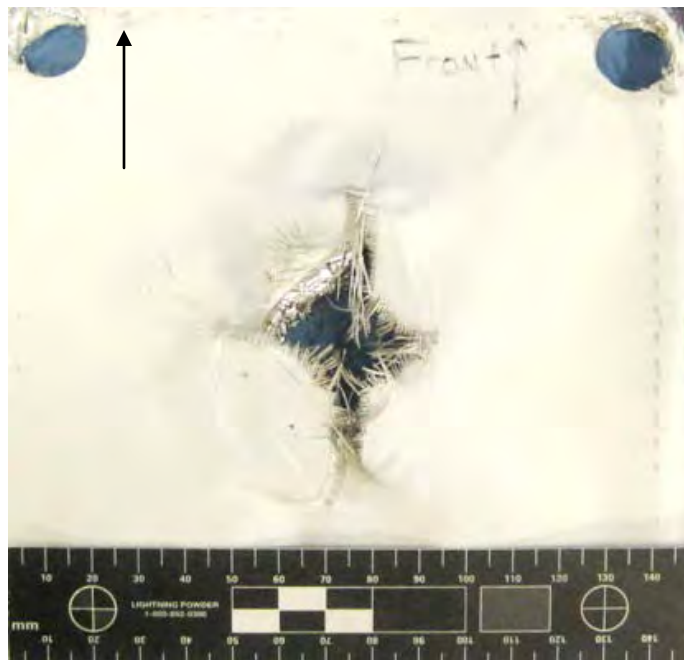
Figure 546 Overall View of Damage to Front of MLI (black arrow indicates flight path of projectile / scale in 5mm increments)

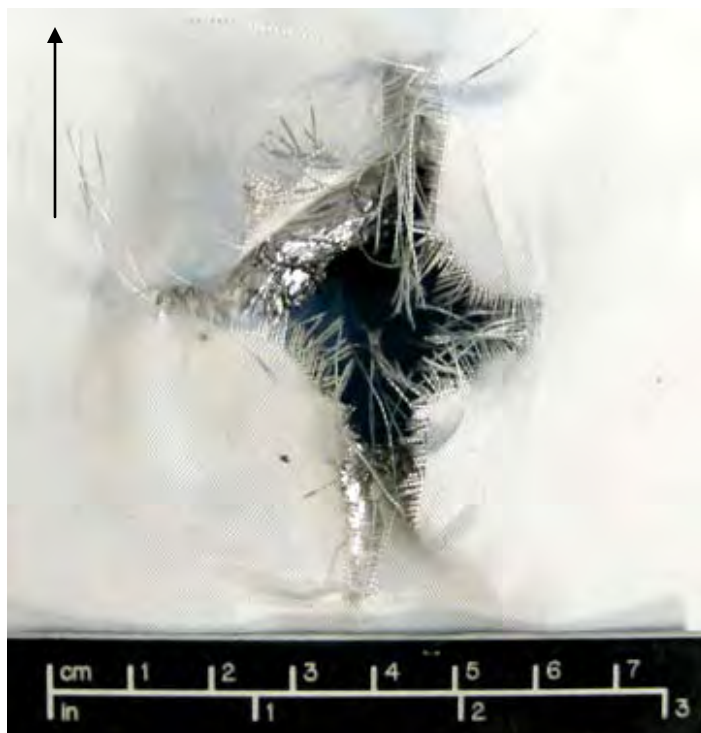
Figure 547 Close-up View of Damage to Front of MLI (scale in 5mm increments / black arrow indicates flight path of projectile)

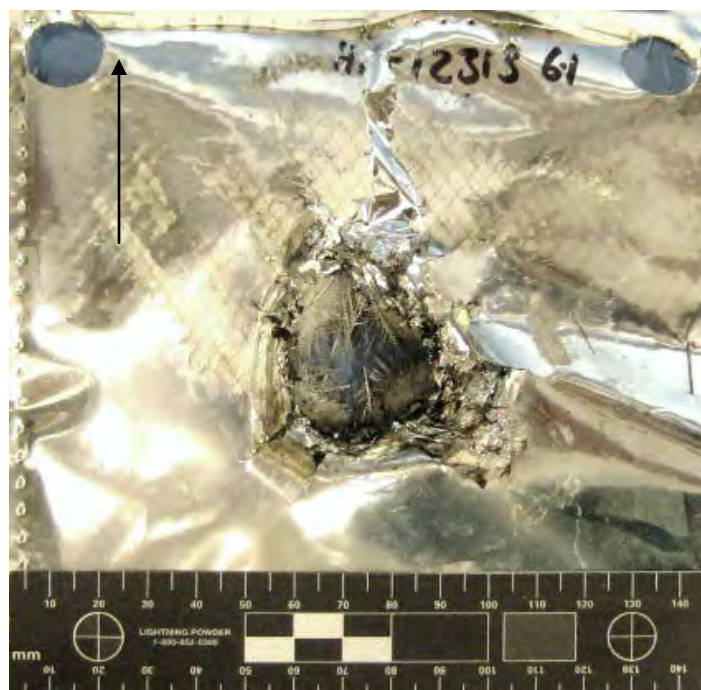
Figure 548 Overall View of Damage to Back Side of MLI (scale in 5mm increments / black arrow indicates flight path of projectile)

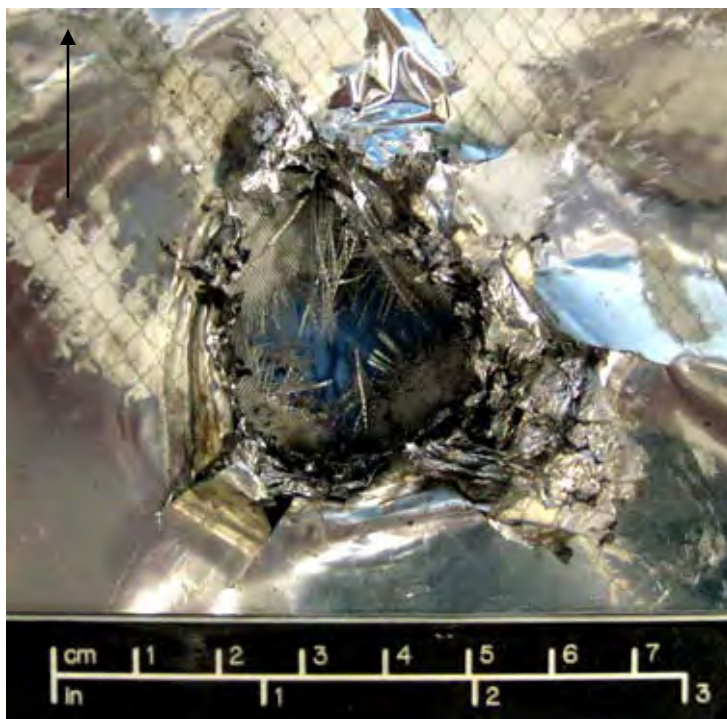
Figure 549 Close-up View of Damage to Back Side of MLI (scale in 5mm increments / black arrow indicates flight path of projectile)

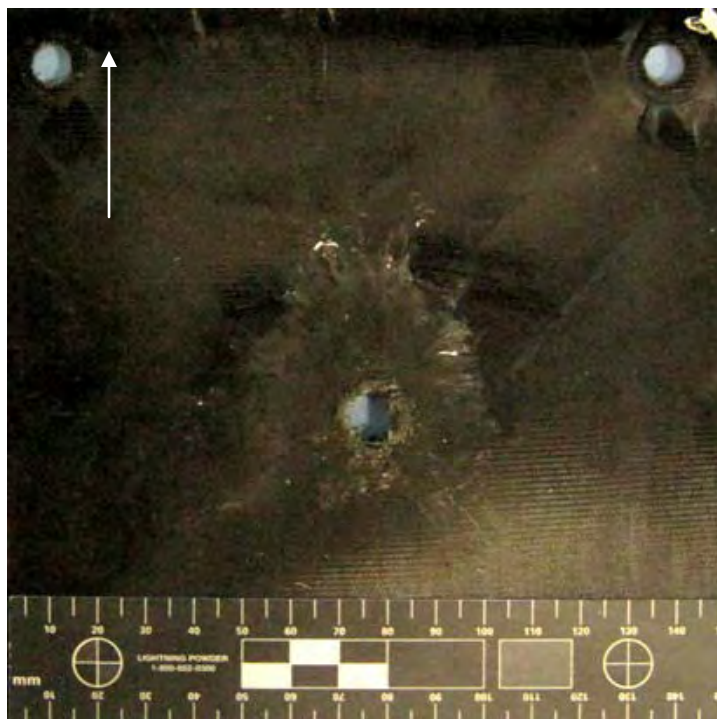
Figure 550 Overall View of Damage to Front of NP 504 Substrate (scale in 5mm increments / white arrow indicates flight path of projectile)

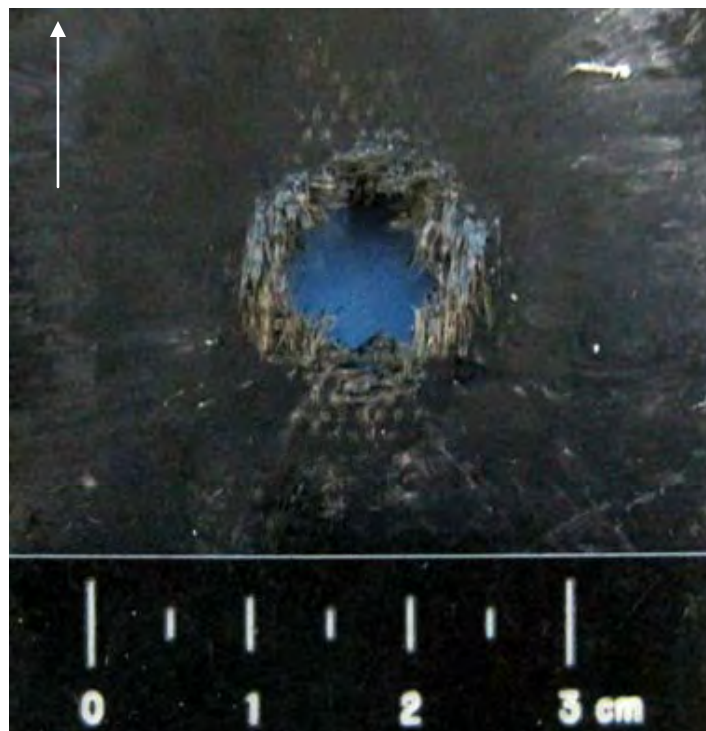
Figure 551 Close-up View of Damage to Front of NP 504 Substrate (scale in 5mm increments / white arrow indicates flight path of projectile)

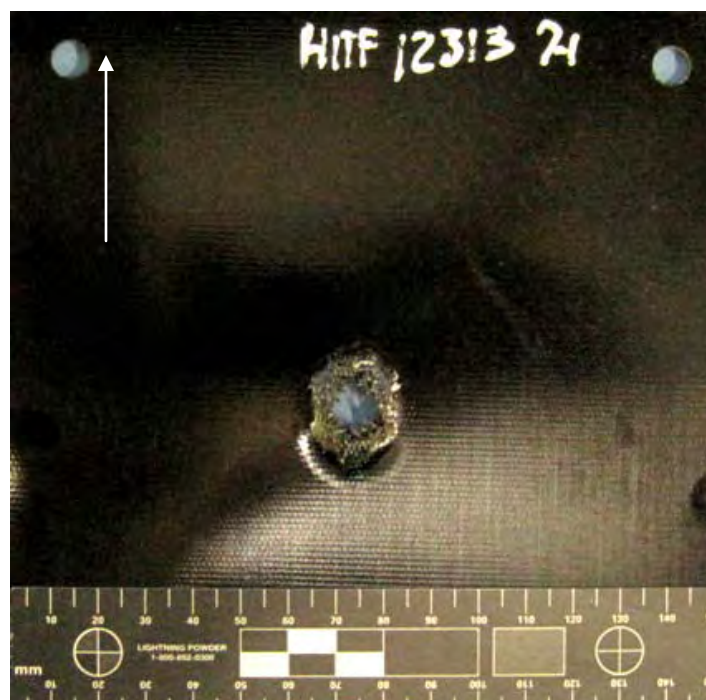
Figure 552 Overall View of Damage to Back Side of NP 504 Substrate (scale in 5mm increments / white arrow indicates flight path of projectile)

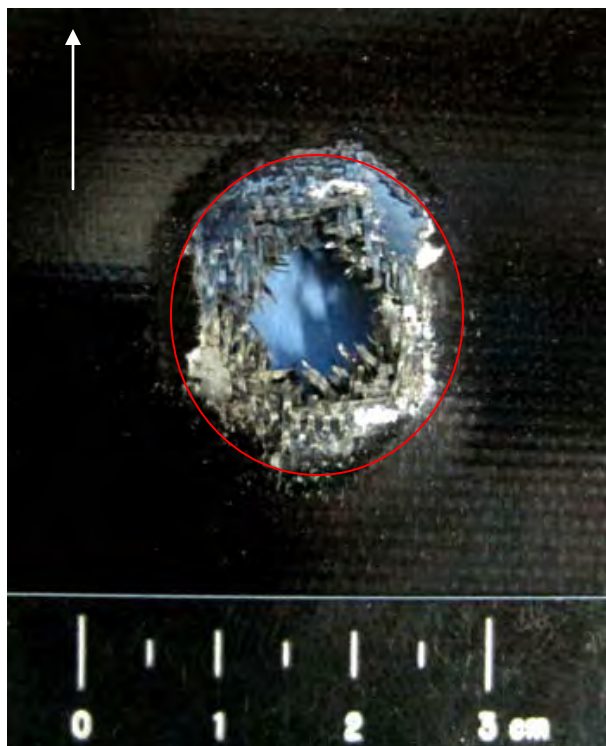
Figure 553 Close-up View of Damage to Back Side of NP 504 Substrate (scale in 5mm increments / white arrow indicates flight path of projectile)

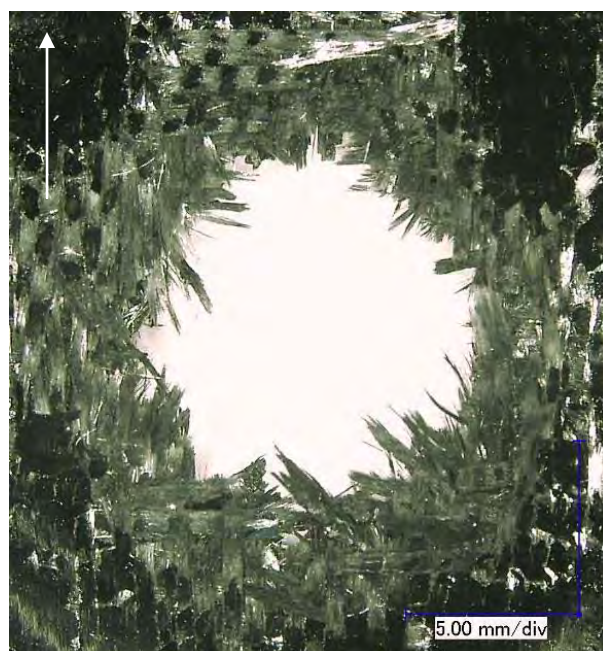
Figure 554 Close-up View of Most Significant Damage to Back Side of NP 504 Substrate (black arrow indicates flight path of projectile / damage within red circle in Figure 584)

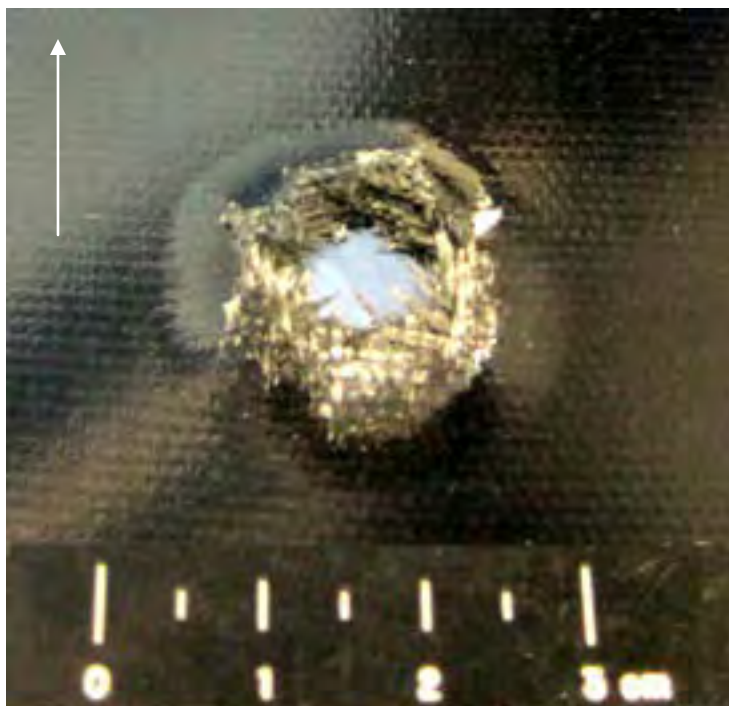
Figure 555 Close-up Oblique Side View of Damage to Back Side of NP 504 Substrate (scale in 5mm increments / white arrow indicates flight path of projectile)

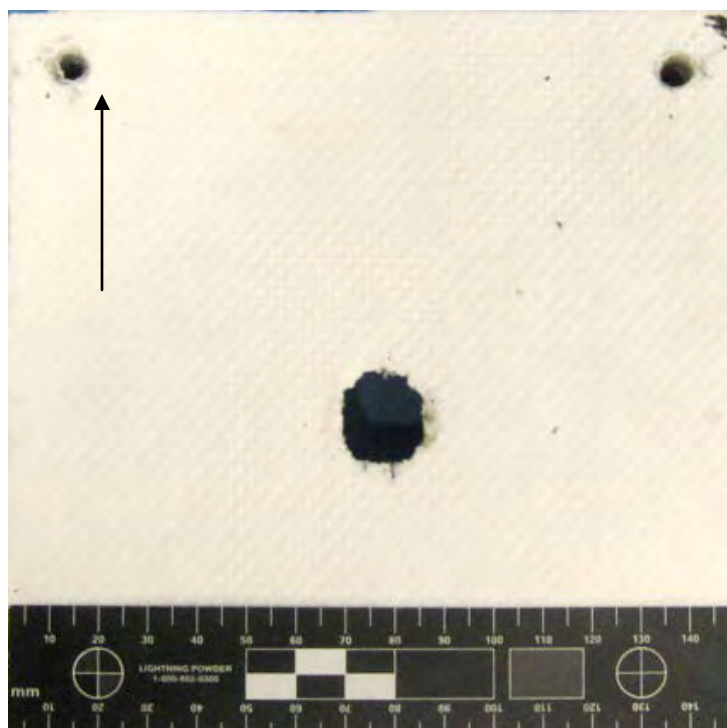
Figure 556 Overall View of Damage to Front of Saffil Layer (scale in 5mm increments / black arrow indicates flight path of projectile)
