International Space Station (ISS) Soyuz Vehicle Descent Module Evaluation of Thermal Protection System (TPS) Penetration Characteristics

Hypervelocity Impact Technology Group

February 2013

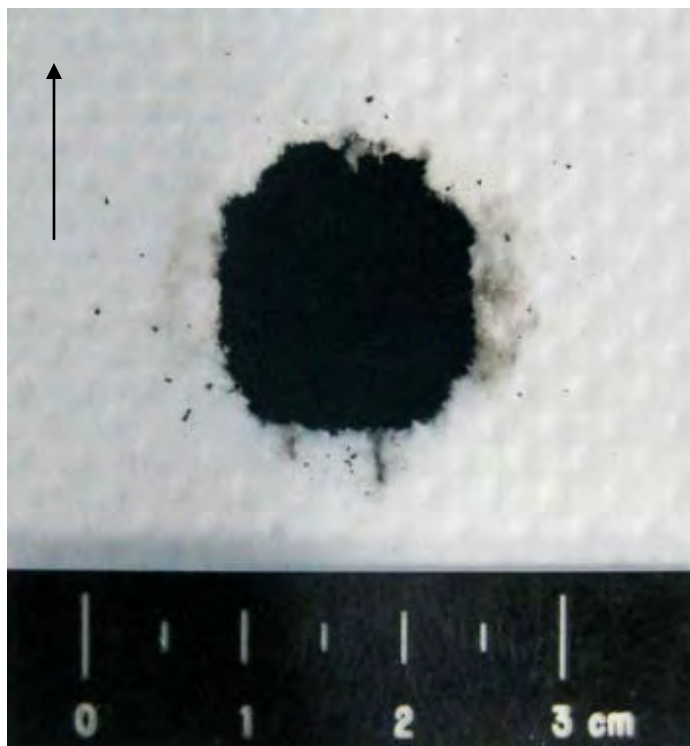
Figure 557 Close-up View of Damage to Front of Saffil Layer (scale in 5mm increments / black arrow indicates flight path of projectile)

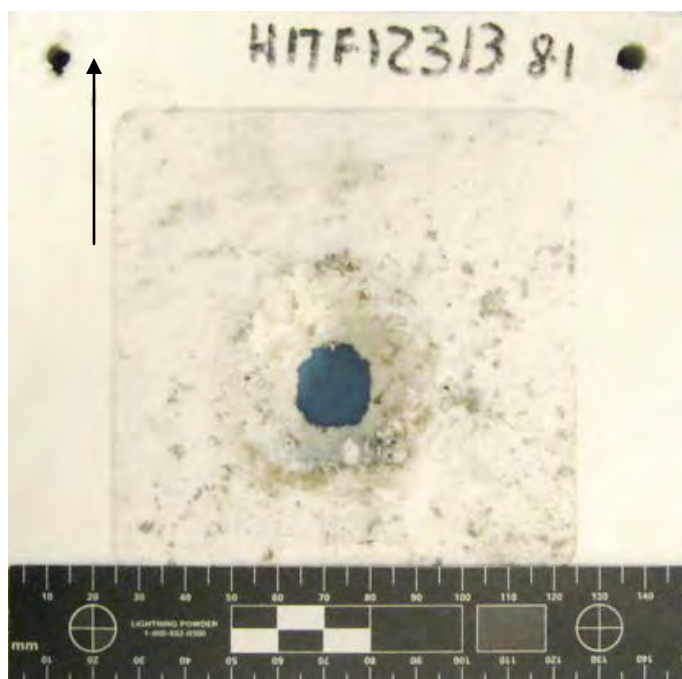
Figure 558 Overall View of Damage to Front of Rear Wall (scale in 5mm increments / black arrow indicates flight path of projectile)

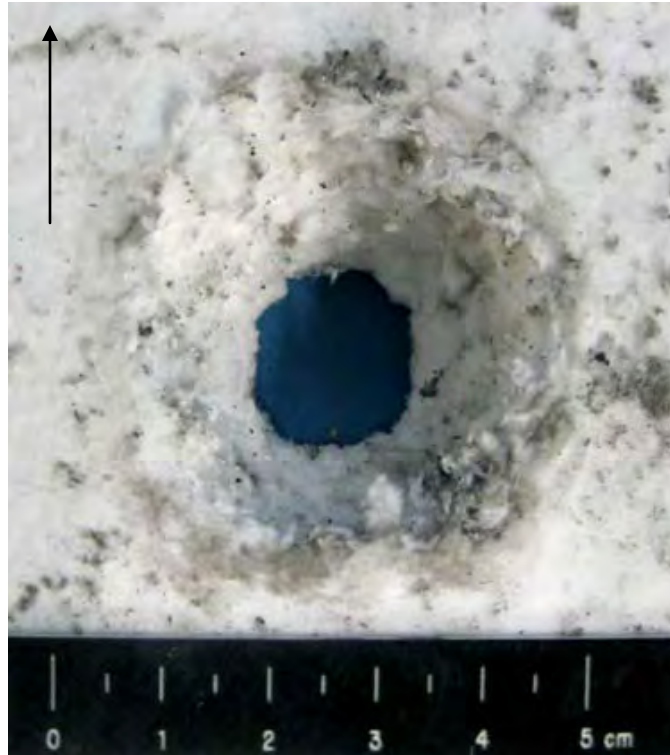
Figure 559 Close-up View of Damage to Front of Saffil (scale in 5mm increments / black arrow indicates flight path of projectile)

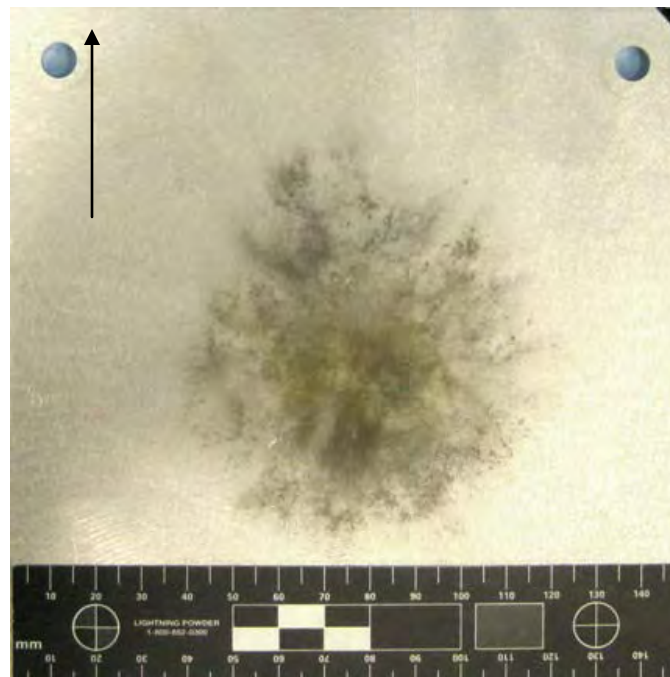
Figure 560 Overall View of Damage to Front of Rear Wall (scale in 5mm increments / black arrow indicates flight path of projectile)

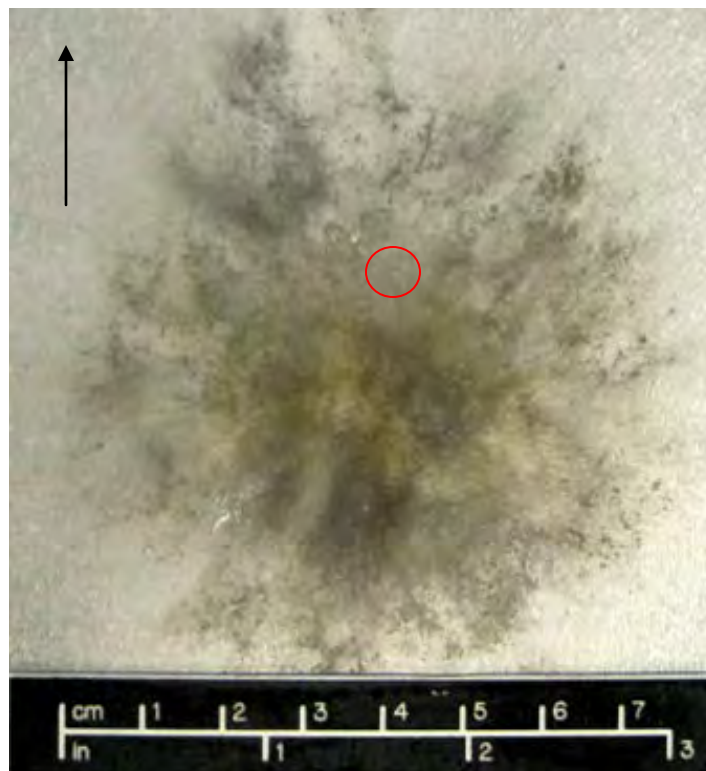
Figure 561 Close-up View of Damage to Front of Rear Wall (scale in 1cm increments / black arrow indicates flight path of projectile)

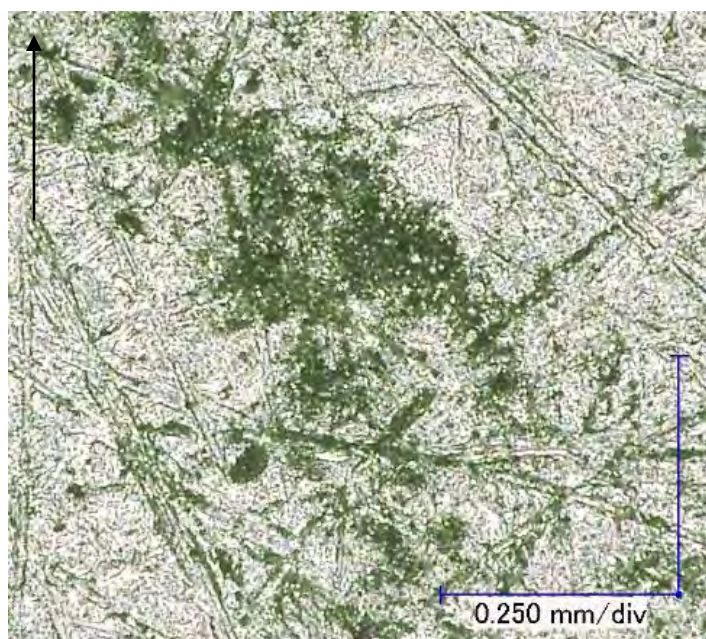
Figure 562 Close-up View of Most Significant Damage to Front of Rear Wall (black arrow indicates flight path of projectile / damage within red circle in Figure 592)

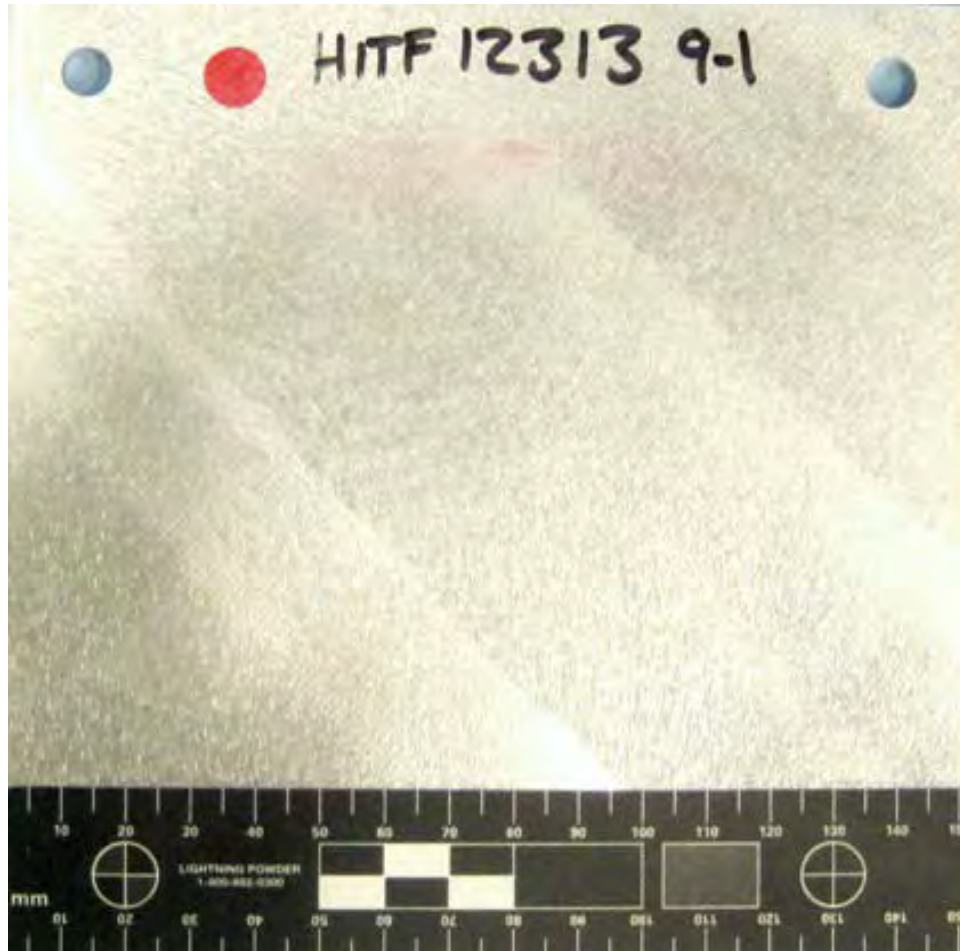
Figure 563 Overall View of Back Side of Rear Wall (scale in 5mm increments / black arrow indicates flight path of projectile)

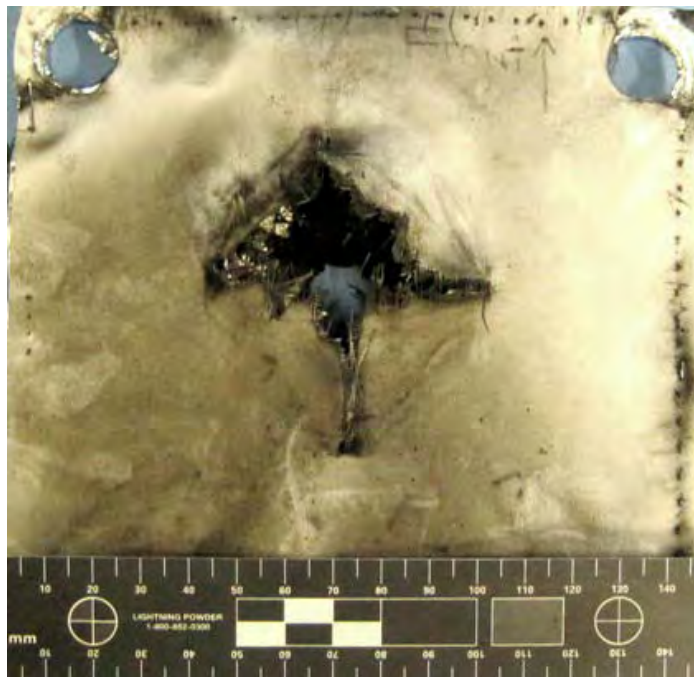
Figure 567 Overall View of Damage to Front of MLI (scale in 5mm increments / black arrow indicates flight path of projectile)

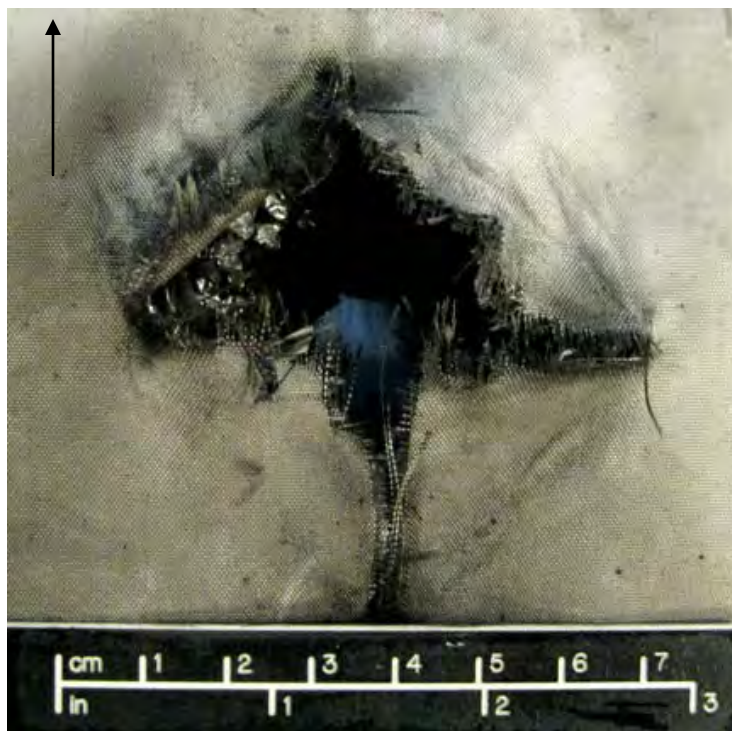
Figure 568 Close-up View of Damage to Front of MLI (scale in 1cm increments / black arrow indicates flight path of projectile)

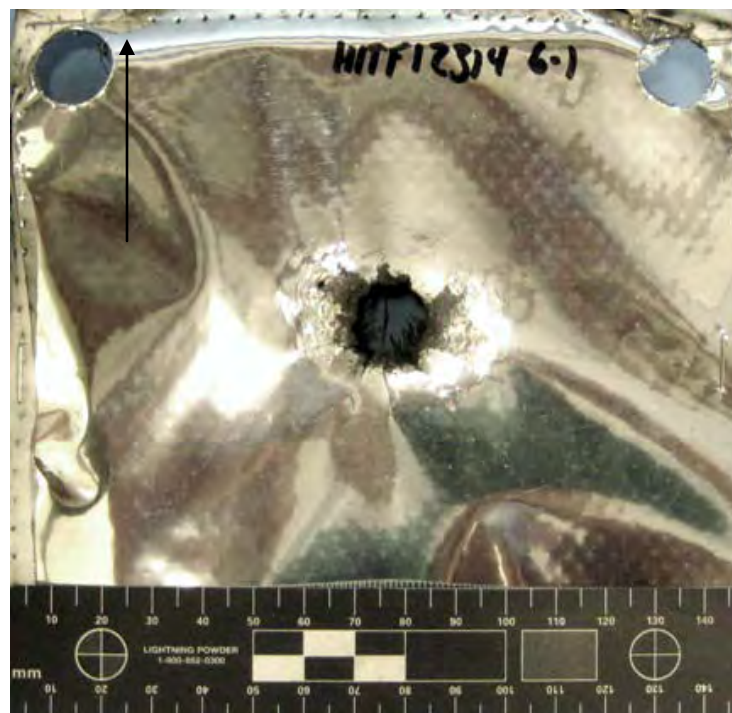
Figure 569 Overall View of Damage to Back Side of MLI (scale in 5mm increments / black arrow indicates flight path of projectile)

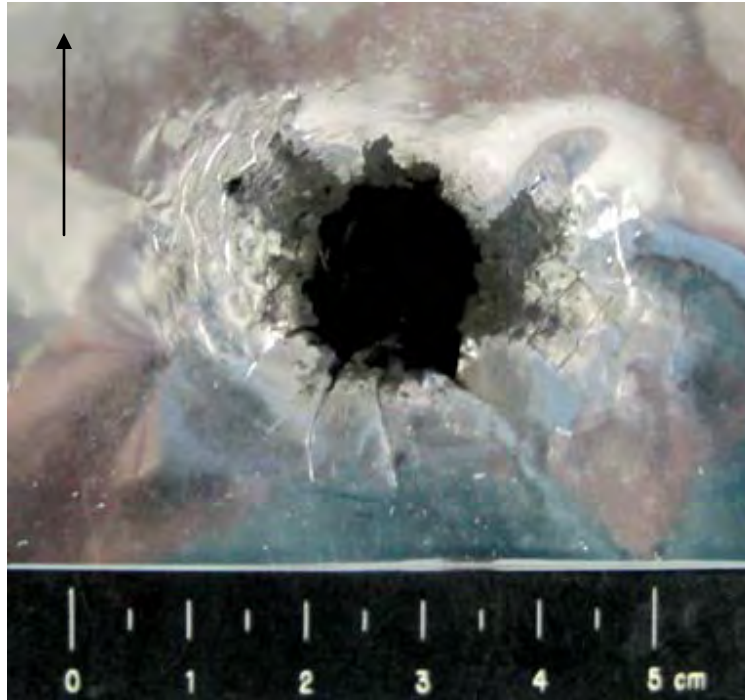
Figure 570 Close-up View of Damage to Back Side of MLI (scale in 5mm increments / black arrow indicates flight path of projectile)

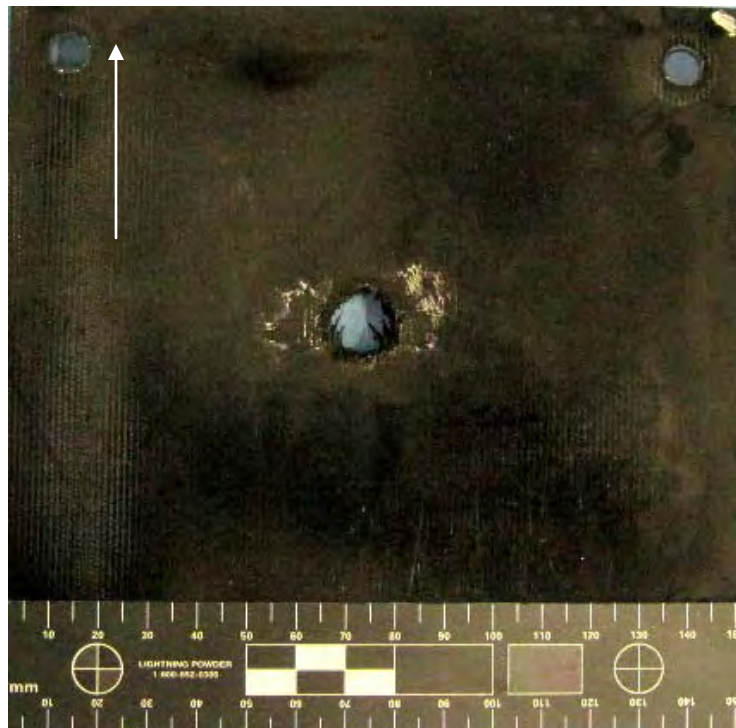
Figure 571 Overall View of Damage to Front of NP 504 Substrate (scale in 5mm increments / white arrow indicates flight path of projectile)

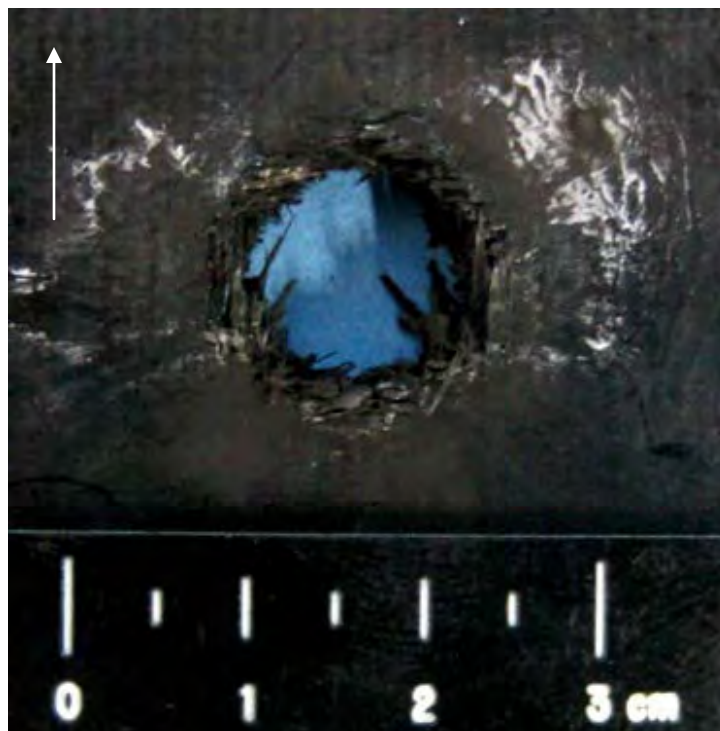
Figure 572 Close-up View of Damage to Front of NP 504 Substrate (scale in 5mm increments / white arrow indicates flight path of projectile)

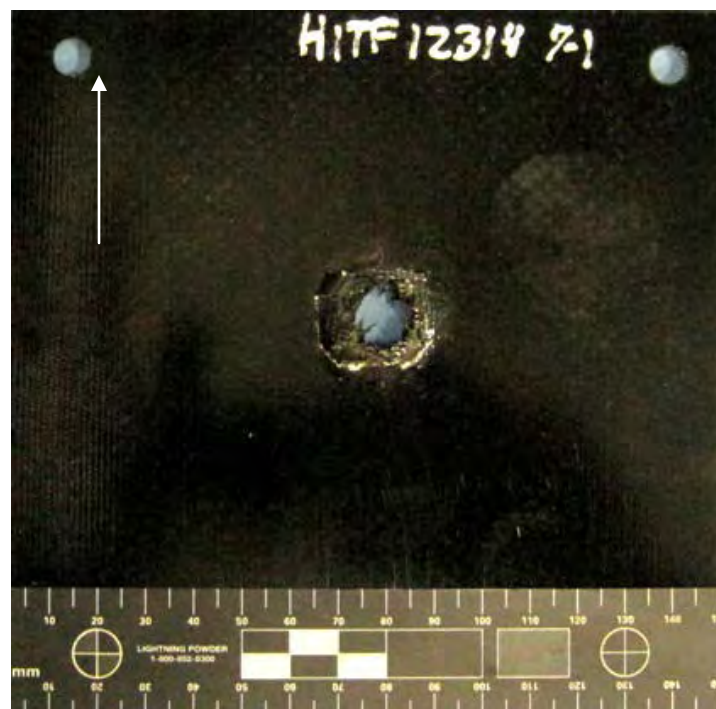
Figure 573 Overall View of Damage to Back Side of NP 504 Substrate (scale in 5mm increments / white arrow indicates flight path of projectile)

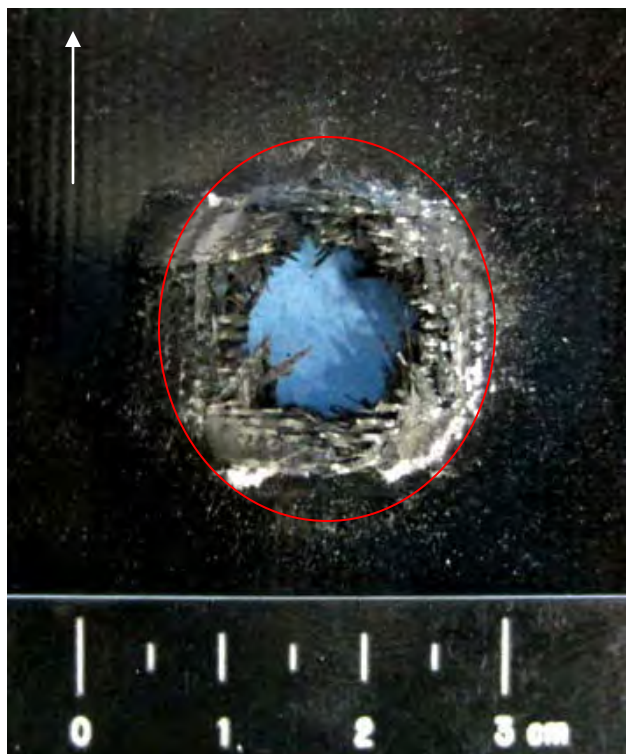
Figure 574 Close-up View of Damage to Back Side of NP 504 Substrate (scale in 5mm increments / white arrow indicates flight path of projectile)

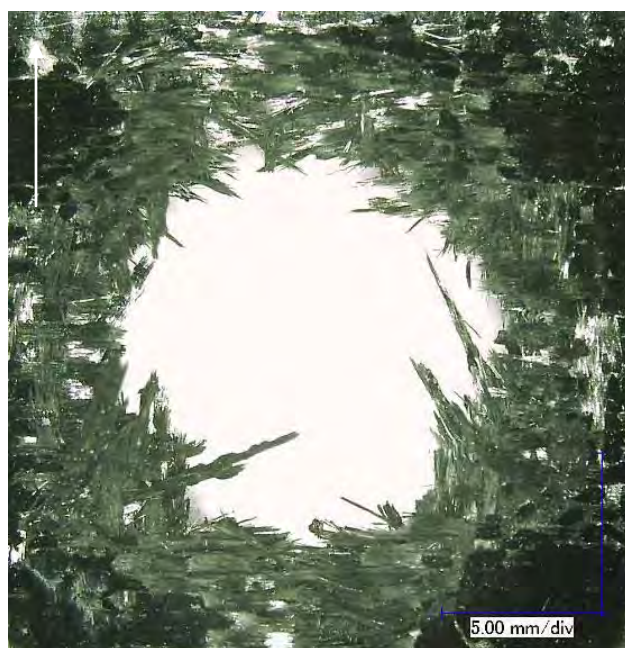
Figure 575 Close-up View of Most Significant Damage to Back Side of NP 504 Substrate (black arrow indicates flight path of projectile / damage within red circle in Figure 574)

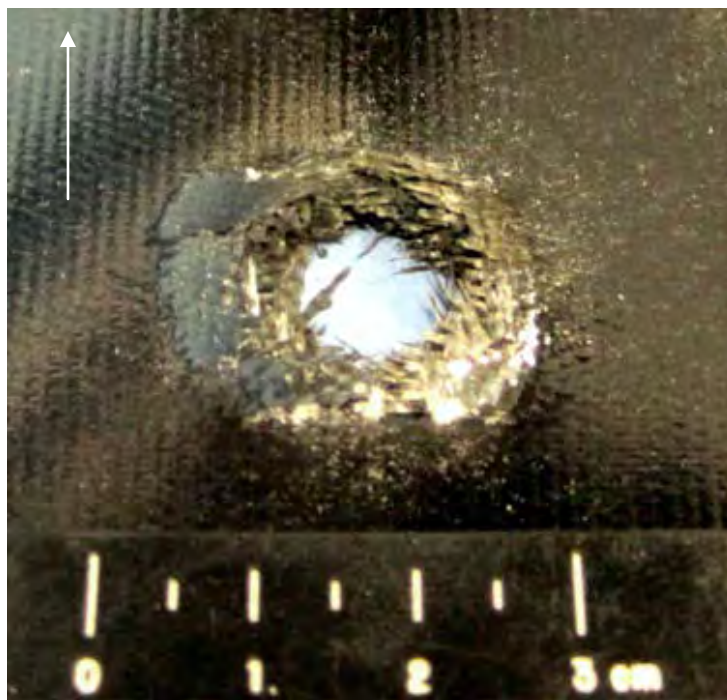
Figure 576 Close-up Oblique Side View of Damage to Back Side of NP 504 Substrate (scale in 5mm increments / white arrow indicates flight path of projectile)

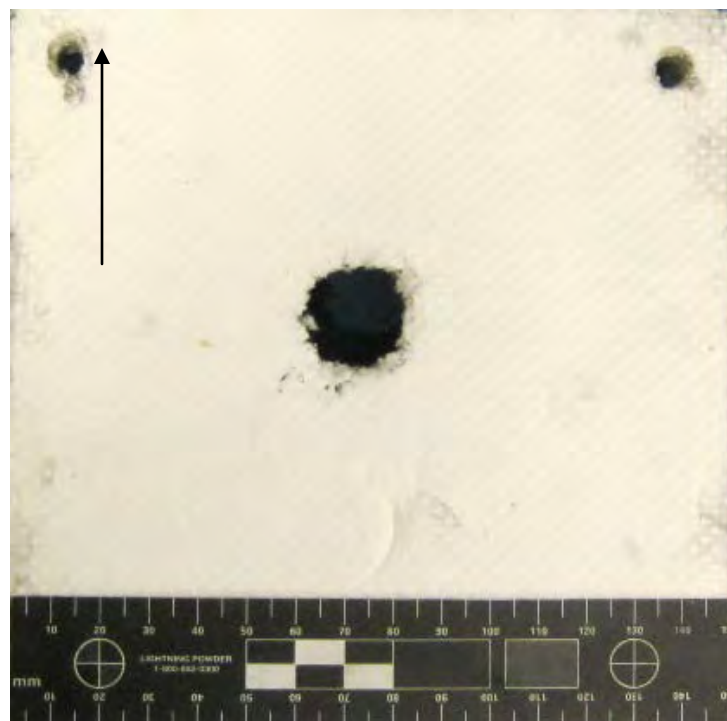
Figure 577 Overall View of Damage to Front of Saffil Layer (scale in 5mm increments / black arrow indicates flight path of projectile)

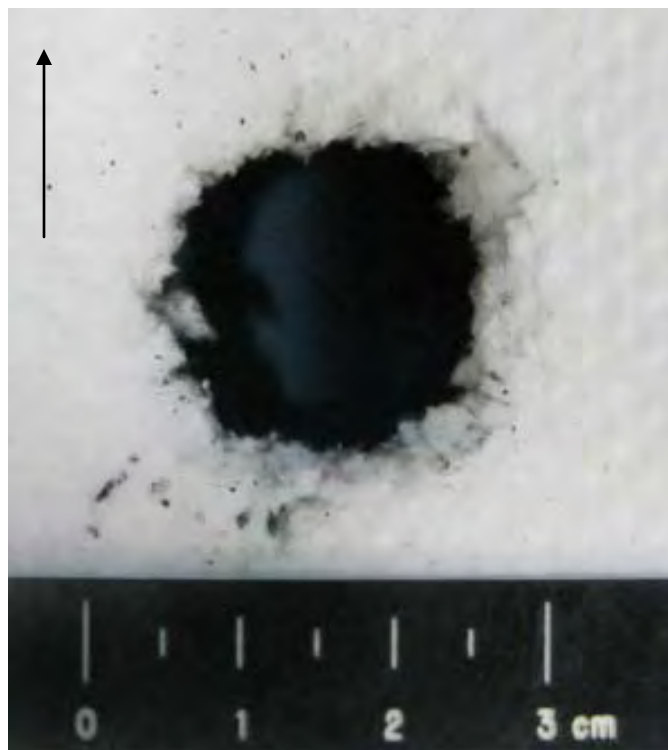
Figure 578 Close-up View of Damage to Front of Saffil Layer (scale in 5mm increments / black arrow indicates flight path of projectile)

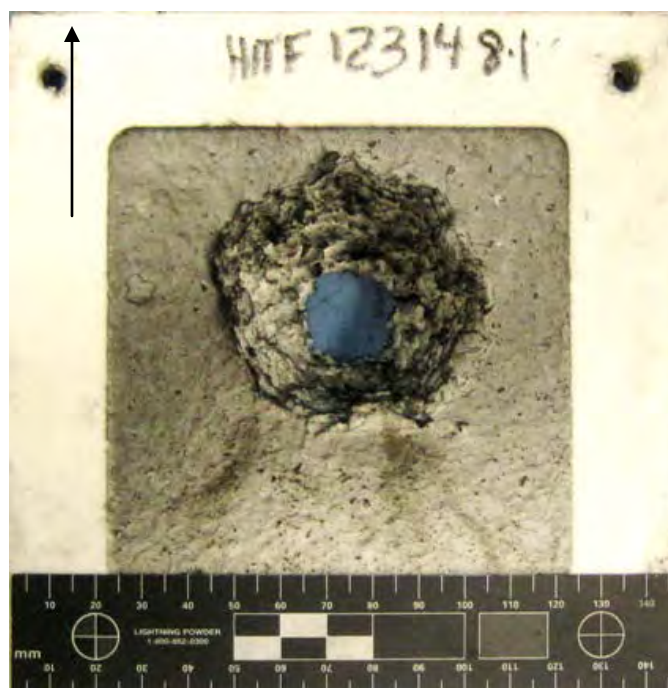
Figure 579 Overall View of Damage to Back Side of Saffil Layer (scale in 5mm increments / black arrow indicates flight path of projectile)

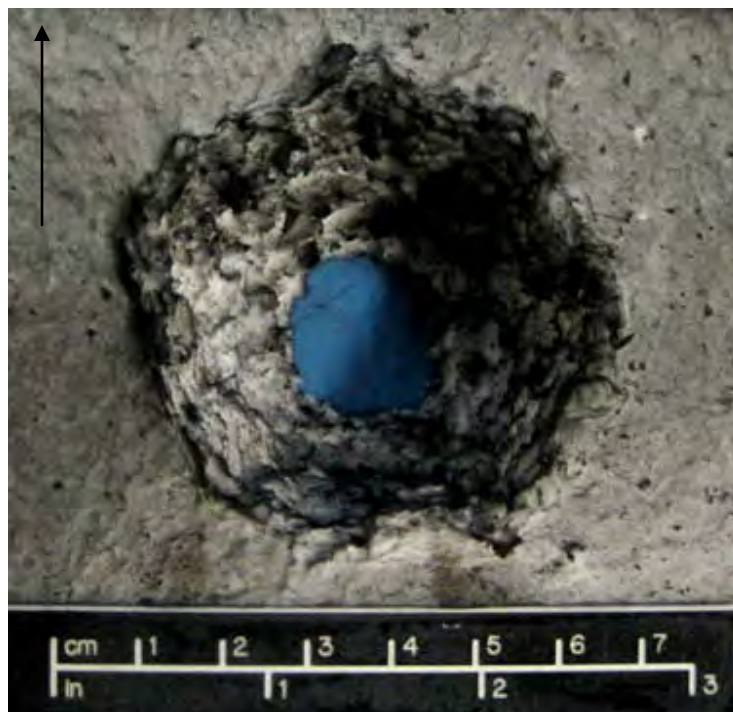
Figure 580 Close-up View of Damage to Back Side of Saffil Layer (scale in 1cm increments / black arrow indicates flight path of projectile)

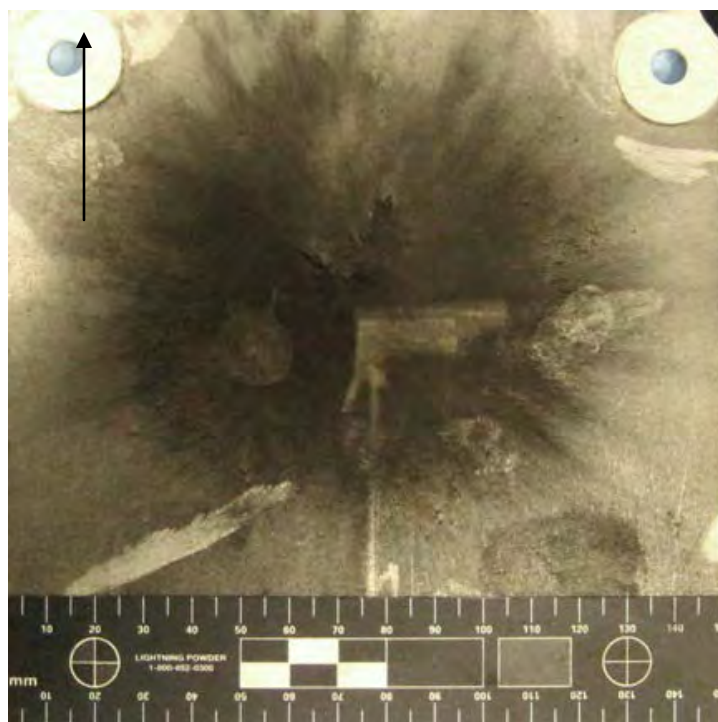
Figure 581 Overall View of Damage to Front of Rear Wall (scale in 5mm increments / black arrow indicates flight path of projectile / uncleaned)

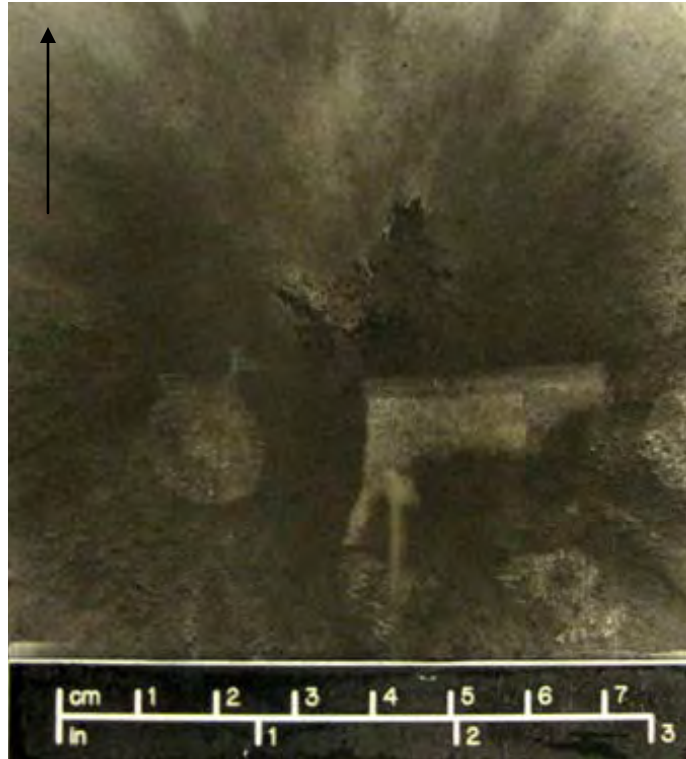
Figure 582 Overall View of Damage to Front of Rear Wall (scale in 1cm increments / black arrow indicates flight path of projectile / uncleaned)

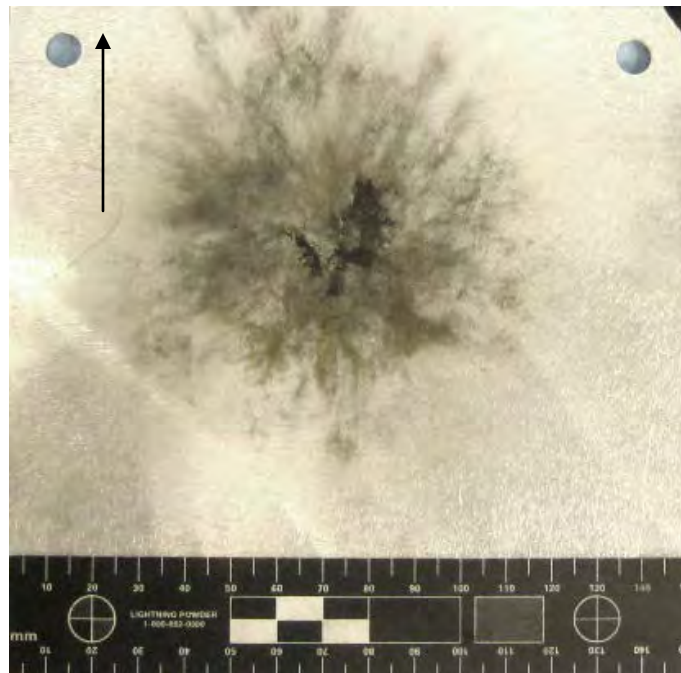
Figure 583 Overall View of Damage to Front of Rear Wall (scale in 5mm increments / black arrow indicates flight path of projectile / cleaned)

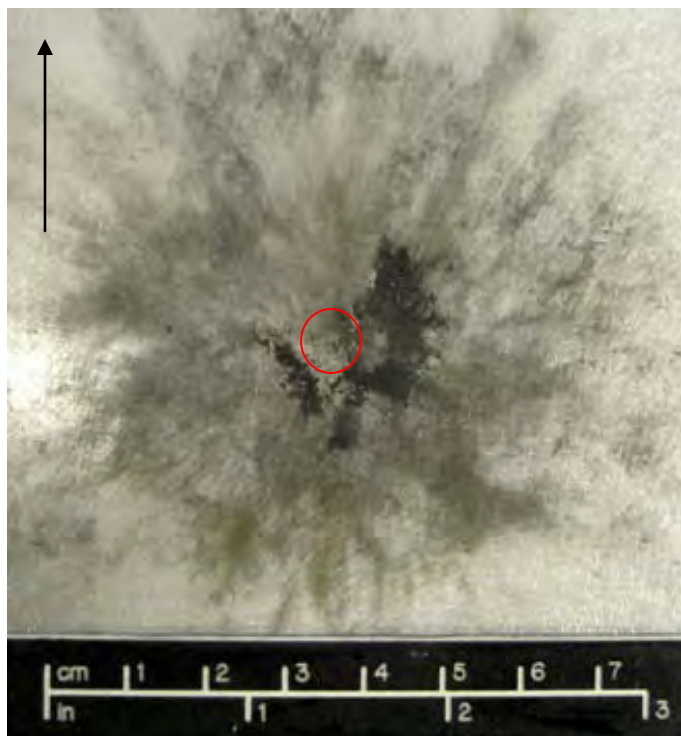
Figure 584 Close-up View of Damage to Front of Rear Wall (scale in 1cm increments / black arrow indicates flight path of projectile / cleaned)

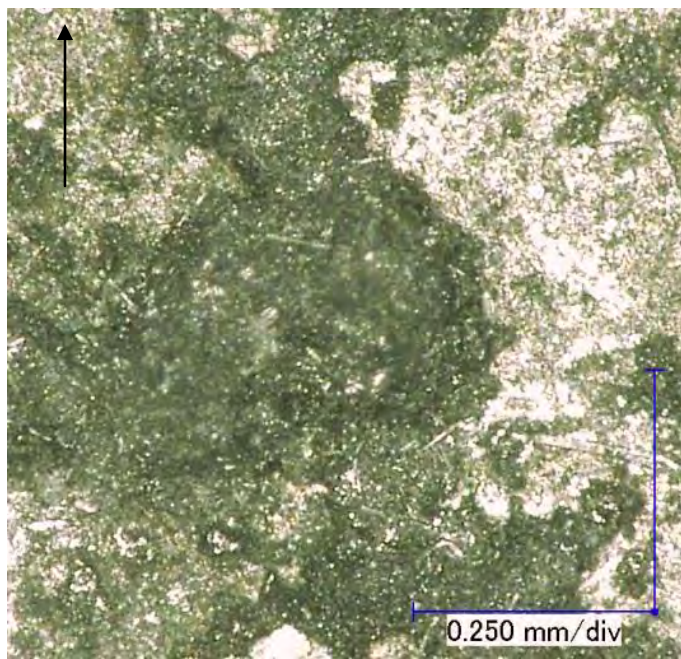
Figure 585 Close-up View of Most Significant Damage to Front of Rear Wall (black arrow indicates flight path of projectile / cleaned / damage within red circle in Figure 616)

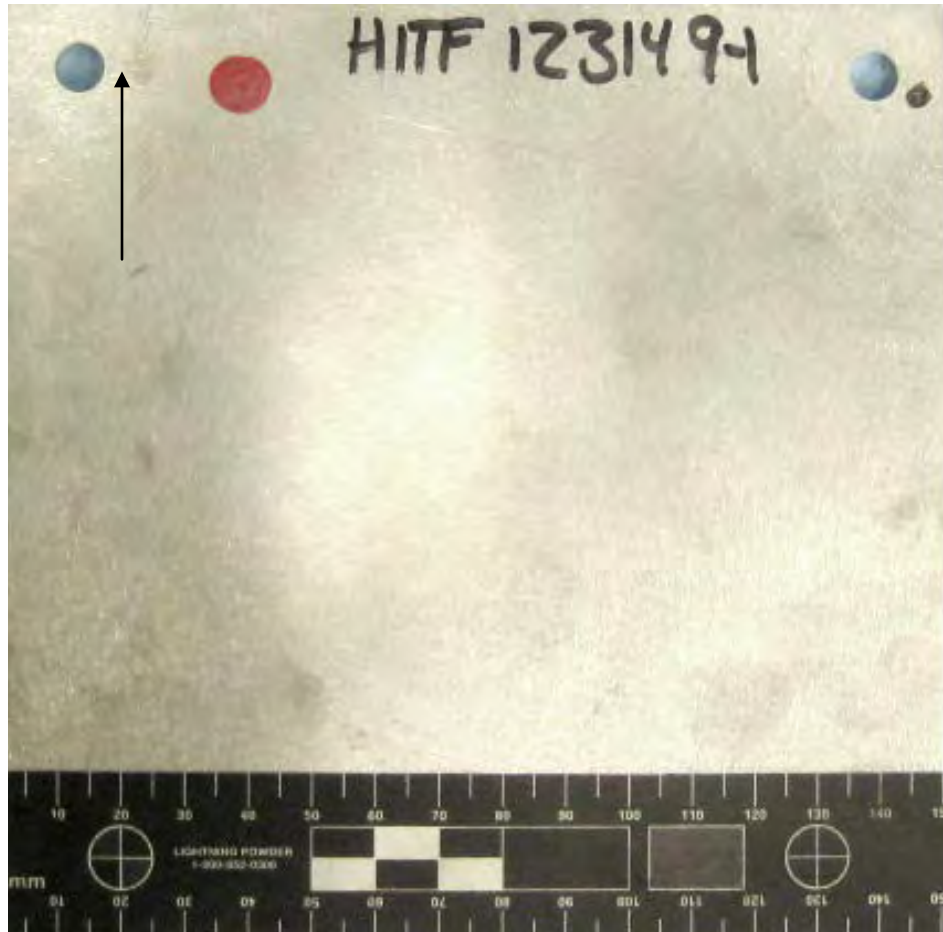
Figure 586 Overall View of Damage to Back Side of Rear Wall (scale in 5mm increments / black arrow indicates flight path of projectile)

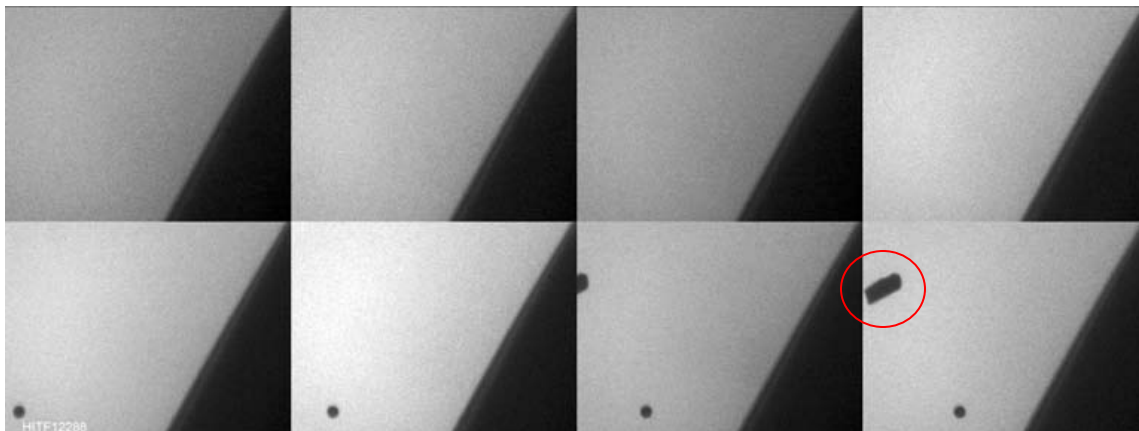
HITF12288 / Test #6

Figure C15 Projectile and Sabot Petal Captured Prior to Impact (via SIMX-8 Camera / sabot petal within red circle)

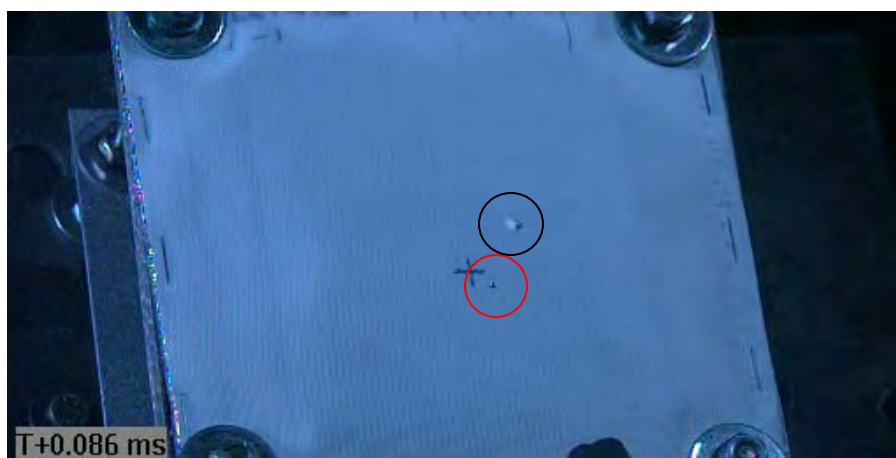
Figure C16 Image of Projectile and Sabot Petal Captured Prior to Impact (via Phantom v711 / projectile within red circle / sabot petal within black circle)

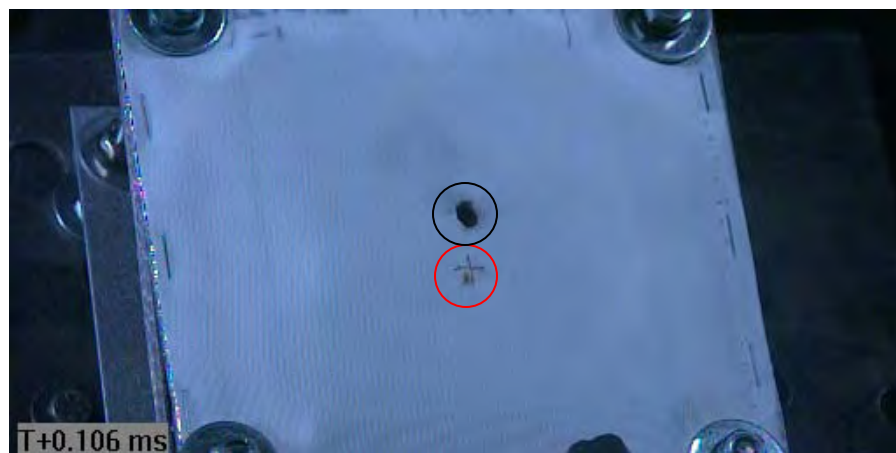
Figure C17 Image of Projectile and Sabot Petal Impacting Target (via Phantom v711 / projectile impact within red circle / sabot petal impact within black circle)

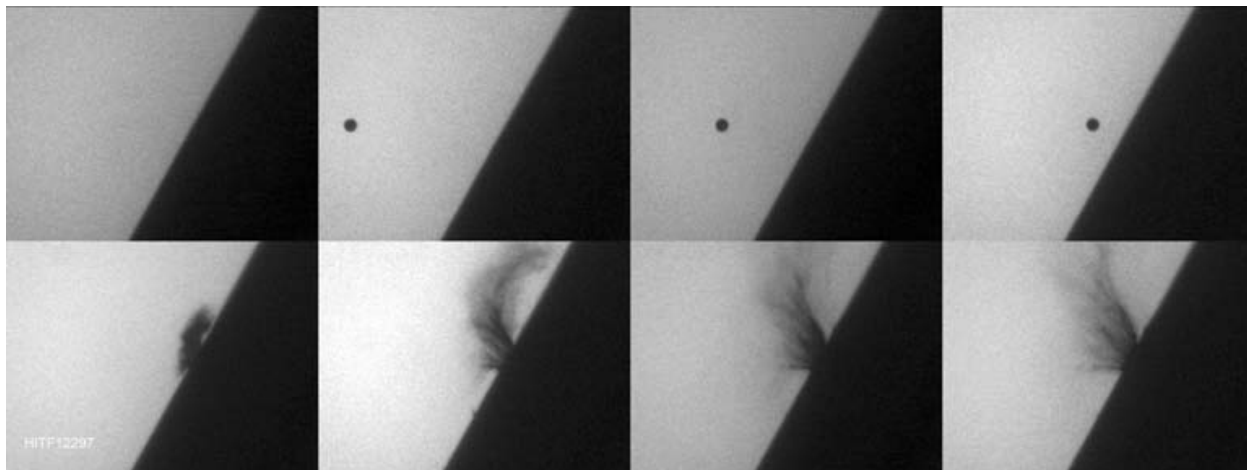
HITF12297 / Test #15

Figure C45 Projectile Captured Prior to Impact and Impacting Target (via SIMX-8 Camera)

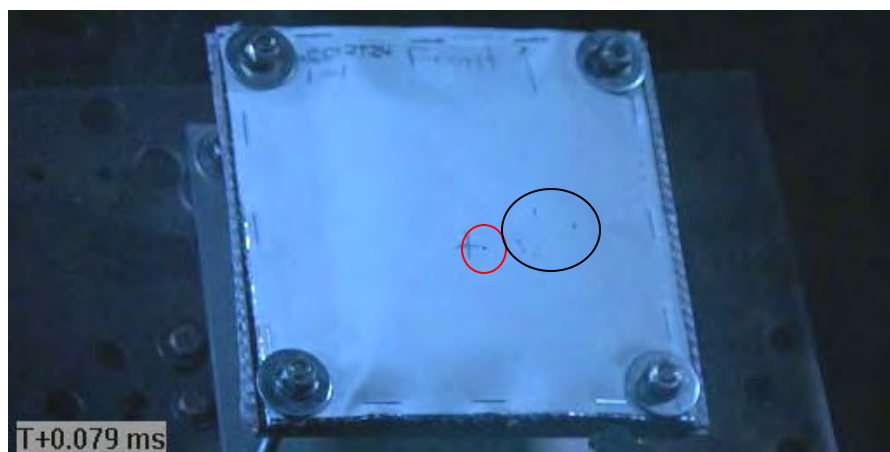
Figure C46 Image of Projectile and Secondary Debris Captured Prior to Impact (via Phantom v711 / projectile within red circle / secondary debris within black circle)

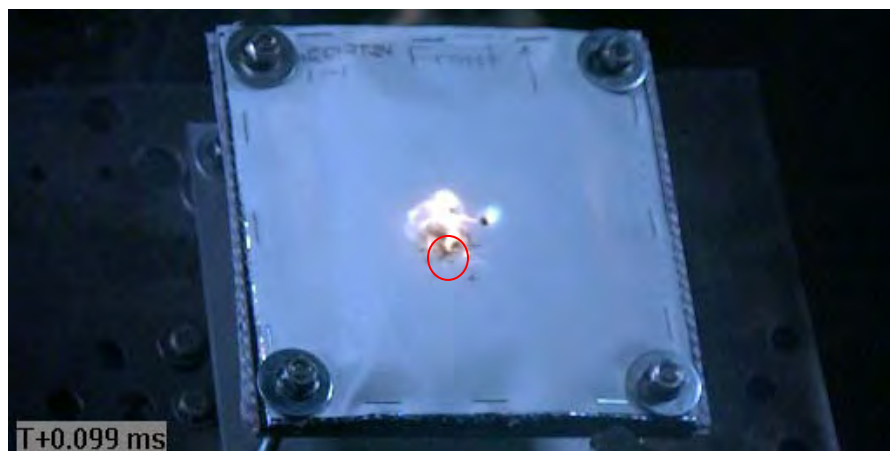
Figure C47 Image of Projectile and Secondary Debris Impacting Target (via Phantom v711 / projectile impacting within red circle, the remaining impacts are secondary debris)

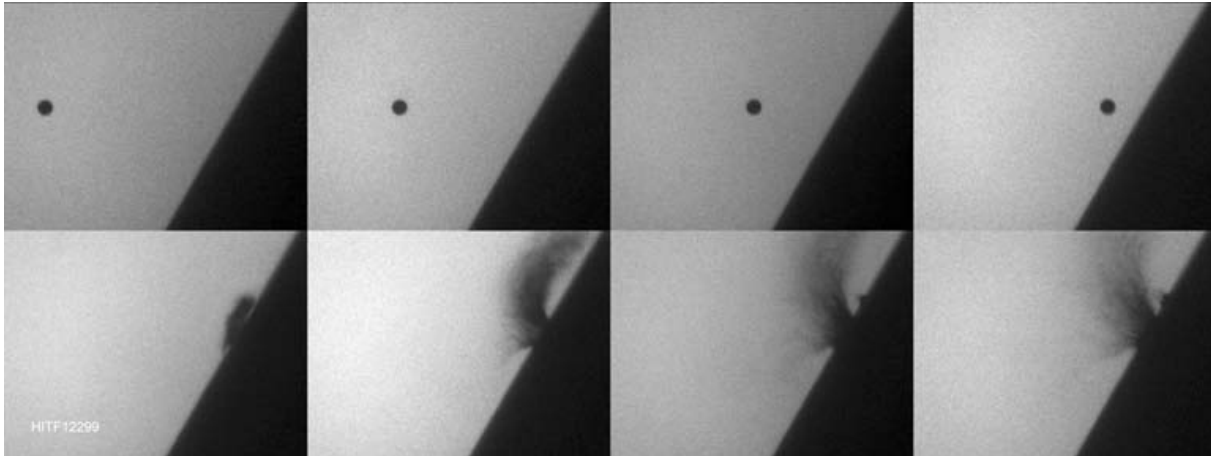
HITF12299 / Test #17

Figure C51 Projectile Captured Prior to Impact and Impacting Target (via SIMX-8 Camera)

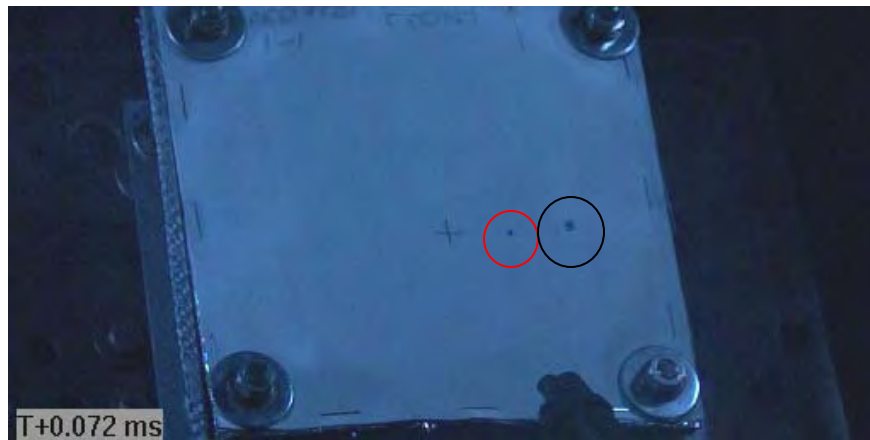
Figure C52 Image of Projectile and Secondary Debris Captured Prior to Impact (via Phantom v711 / projectile within red circle / secondary debris within black circle)

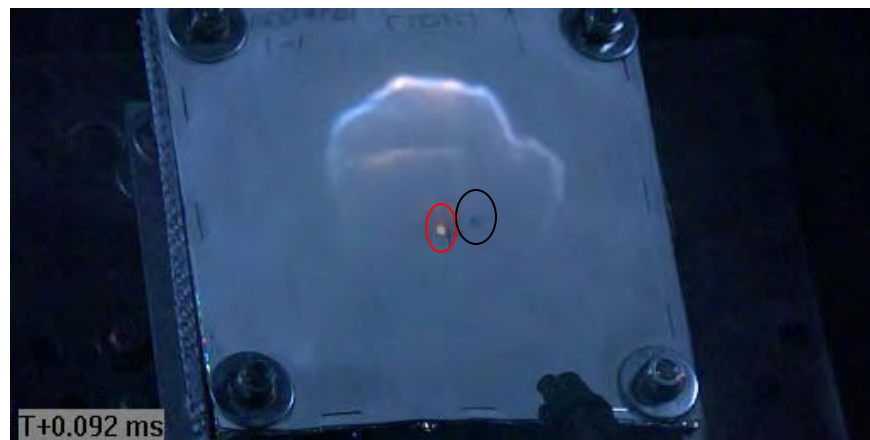
Figure C53 Image of Projectile Impacting Target and Secondary Debris Just Prior to Impacting Target (via Phantom v711 / projectile impacting within red circle / secondary debris within black circle and impacted directly above projectile entry damage)

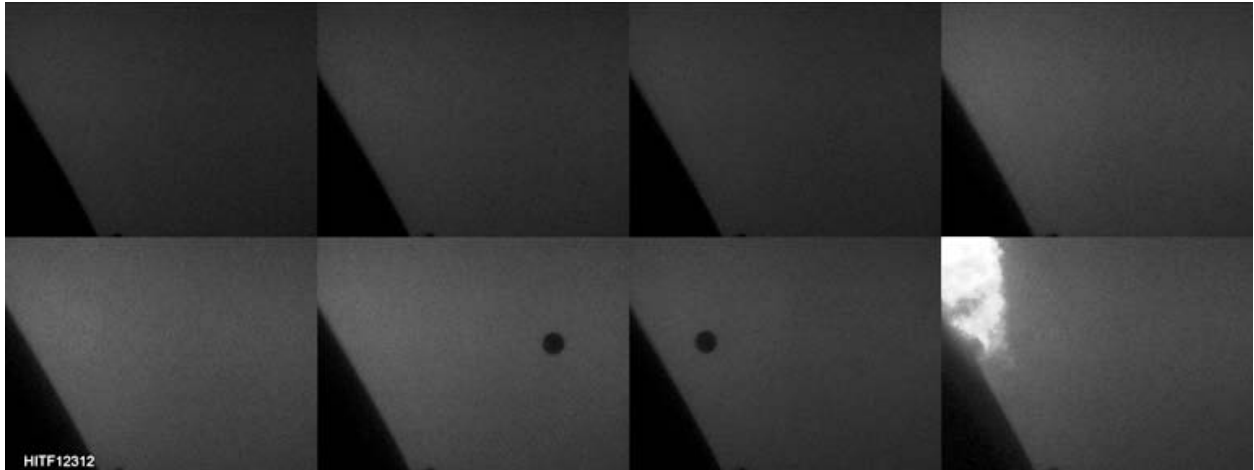
HITF12312 / Test #30

Figure C95 Projectile Captured Prior to Impact and Impacting Target (via SIMX-8 Camera)

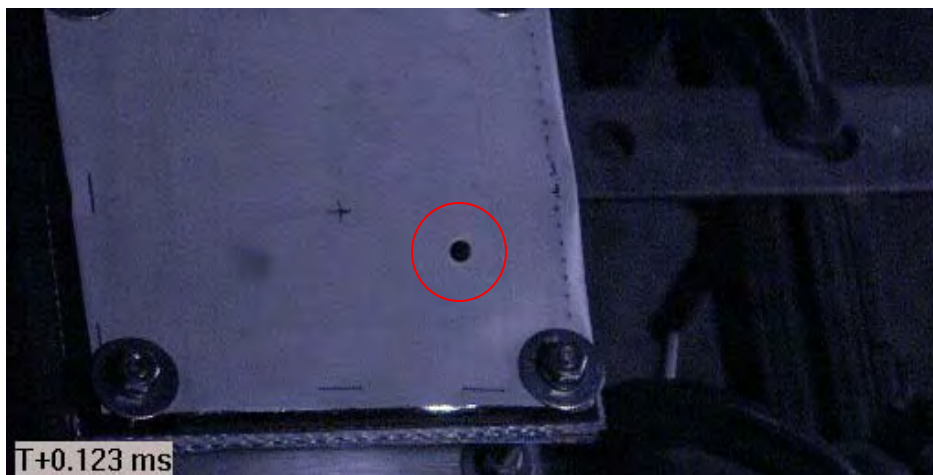
Figure C96 Image of Projectile Captured Prior to Impact (via Phantom v711 / projectile within red circle)

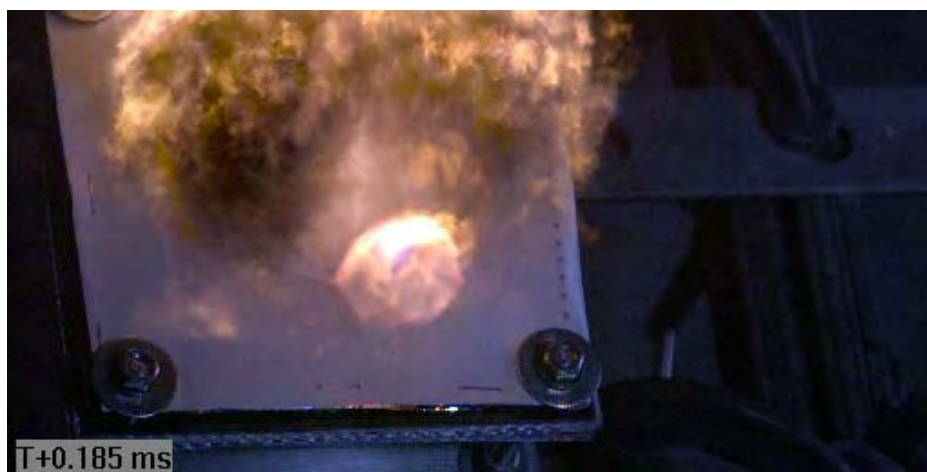
Figure C97 Image of Projectile Impacting Target (via Phantom v711)

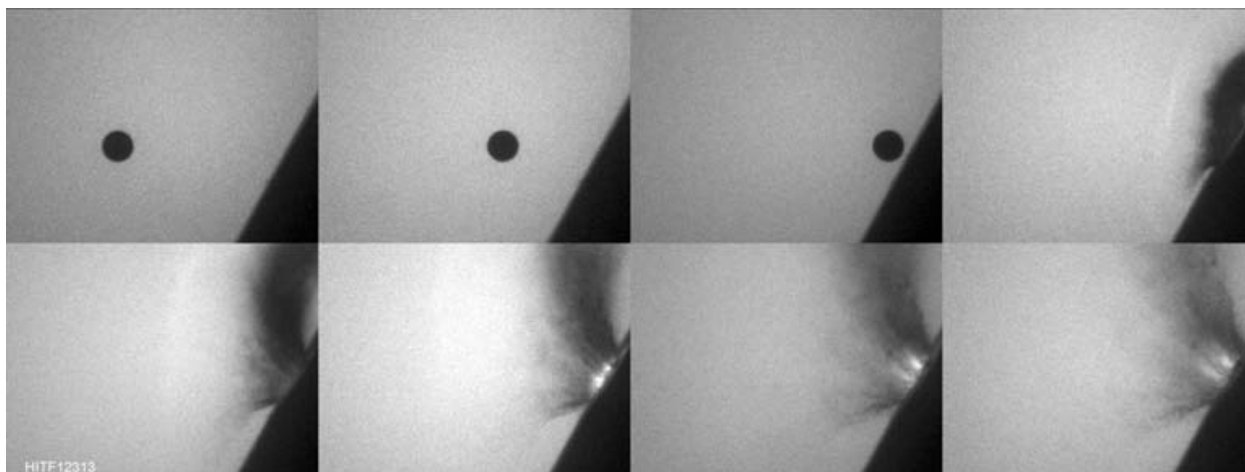
HITF12313 / Test #31

Figure C98 Projectile Captured Prior to Impact and Impacting Target (via SIMX-8 Camera)

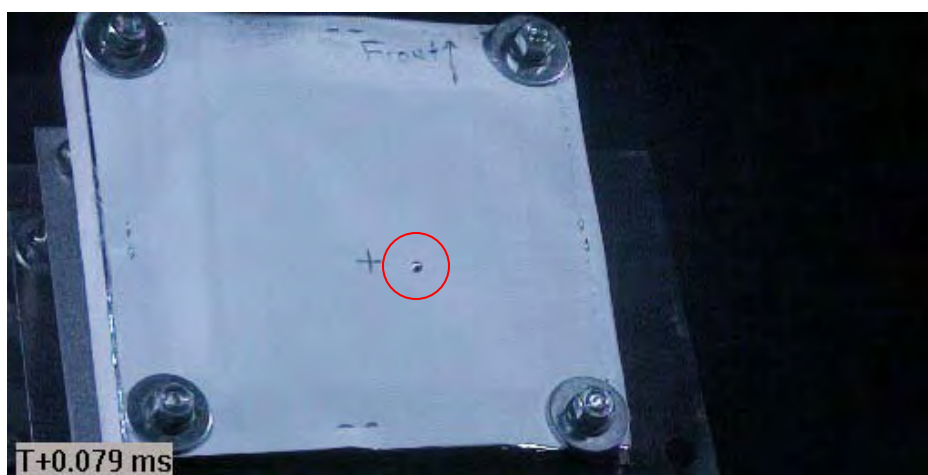
Figure C99 Image of Projectile Captured Prior to Impact (via Phantom v711 / projectile within red circle)

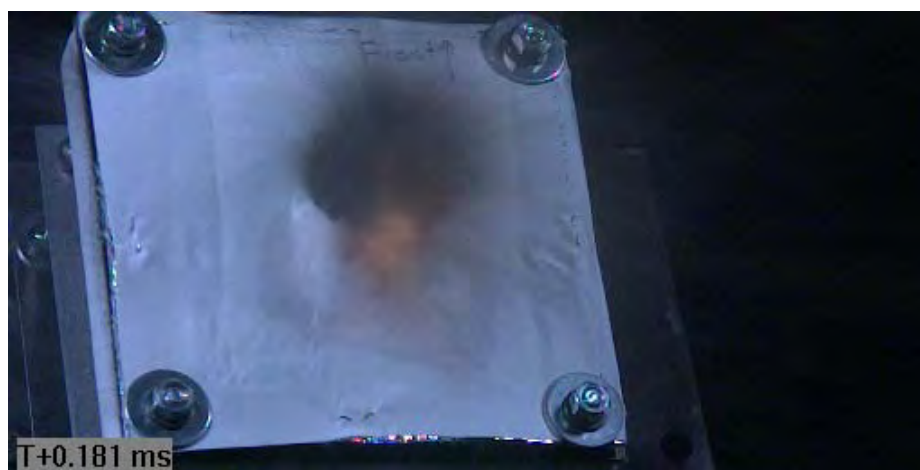
Figure C100 Image of Projectile Impacting Target (via Phantom v711)
