International Space Station (ISS) Soyuz Vehicle Descent Module Evaluation of Thermal Protection System (TPS) Penetration Characteristics

Hypervelocity Impact Technology Group

February 2013

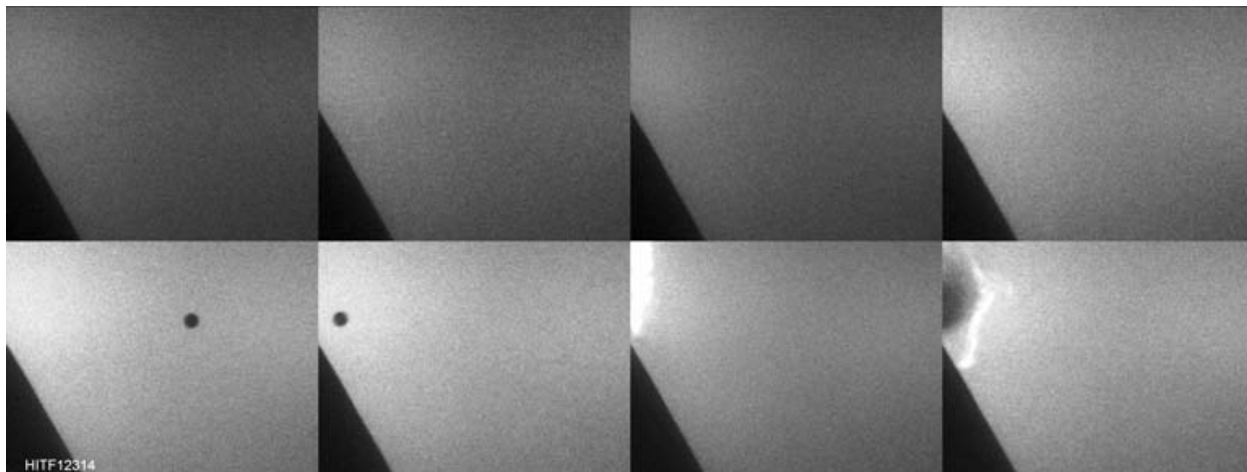
HITF12314 / Test #32

Figure C101 Projectile Captured Prior to Impact and Impacting Target (via SIMX-8 Camera)

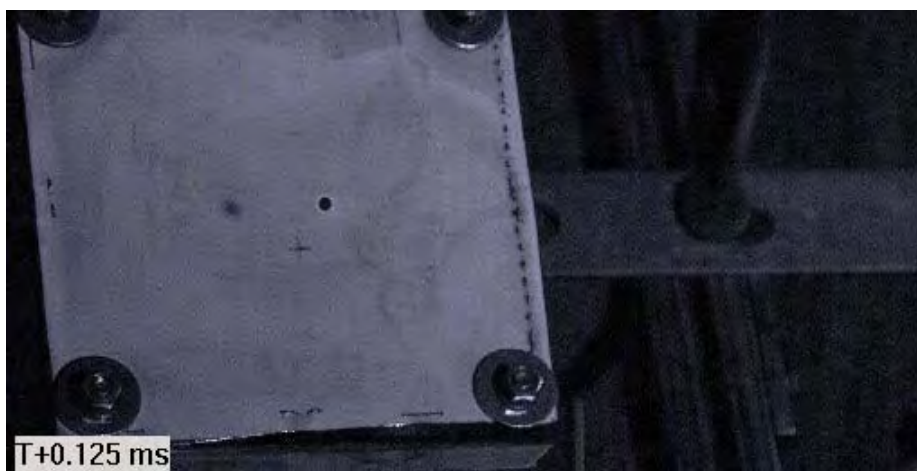
Figure C102 Image of Projectile Captured Prior to Impact (via Phantom v711 / projectile within red circle)

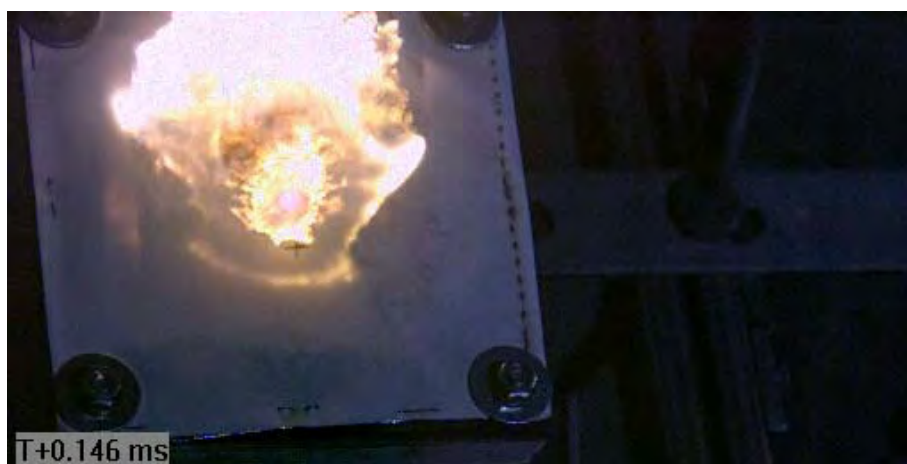
Figure C103 Image of Projectile Impacting Target (via Phantom v711)
