DETERMINE ISS SOYUZ ORBITAL MODULE BALLISTIC LIMITS FOR STEEL PROJECTILES HYPERVELOCITY IMPACT TESTING

Hypervelocity Impact Technology Group (HVIT)
Astromaterials Research and Exploration Science (ARES) Directorate
Human Exploration Science Office, KX

July 2013

Prepared for the
ISS Systems Engineering and Integration Office

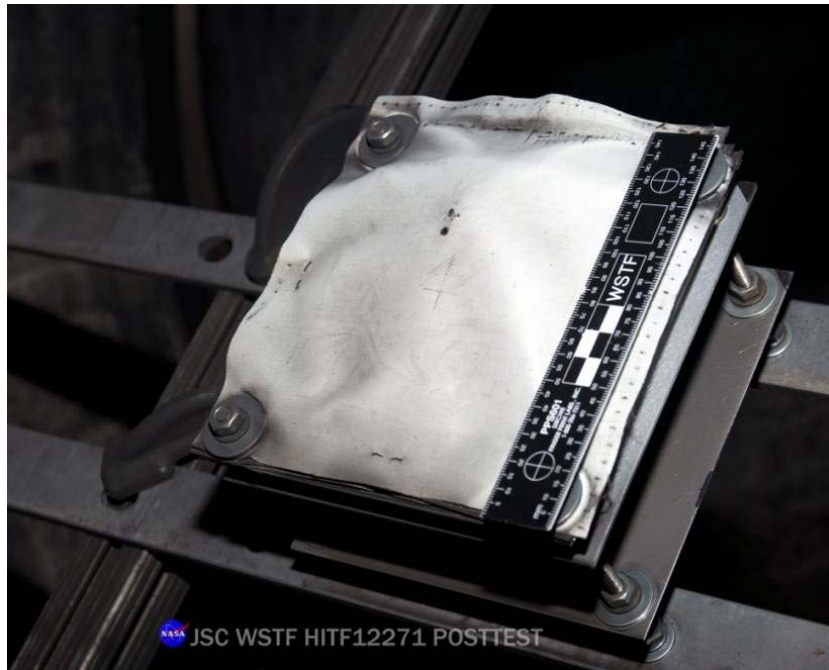
Test #11, HITF12271

Test No.	Actual Projectile Diameter (mm)	Actual Projectile Mass (g)	Actual Impact Velocity (km/s)	Impact Angle (deg)	Results
11 HITF12271	1.5	0.01331	6.14	45	<p>Fail</p> <p>Beta cloth entry damage = 1.60mm x 2.05mm hole Mylar Film damage = 52.09mm x 24.07mm hole Fiberglass damage = 7.83mm x 9.30mm hole Al 6061 Foil damage = 6.22 x 7.26mm hole Fiberglass damage = 6.31 x 6.85mm hole MLI exit damage = 13.47mm x 18.16mm hole Al 6061-T6 plate damage = 7.36mm x 10.58mm hole Al 5456-0 RW damage = 1.96mm x 2.69mm hole Al 2024-T3 WP damage = 0.66mm x 0.78mm x 0.15mm deep crater & several smaller</p>
12 HITF12272	1.4	0.01074	6.17	45	<p>Pass</p> <p>Beta cloth entry damage = 1.49mm x 1.97mm hole Mylar Film damage = 18.24mm x 27.07mm hole Fiberglass damage = 3.89 x 6.40mm hole Al 6061 Foil damage = 5.09 x 6.25mm hole Fiberglass damage = 4.56 x 5.38mm hole MLI exit damage = 13.22mm x 19.74mm hole Al 6061-T6 plate damage = 6.98mm x 10.45mm hole Al 5456-0 RW damage = 0.88mm x 1.17mm x 0.98mm deep crater with a 0.48mm high bump on back Al 2024-T3 WP damage = no damage</p>

Figure 180: Post-test of ISS Soyuz Orbital Module Test #11 (HITF12271) article mounted in 0.50-caliber target tank.
