Morpheus Free Flight 2 Test Failure Investigation

Steve Munday & Jon Olansen
NASA Johnson Space Center
Engineering Directorate
November 2012

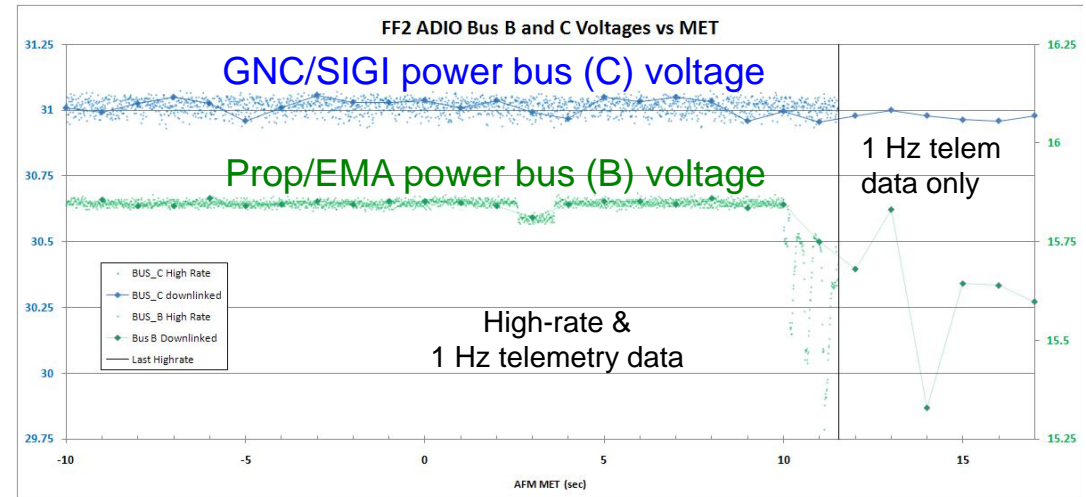
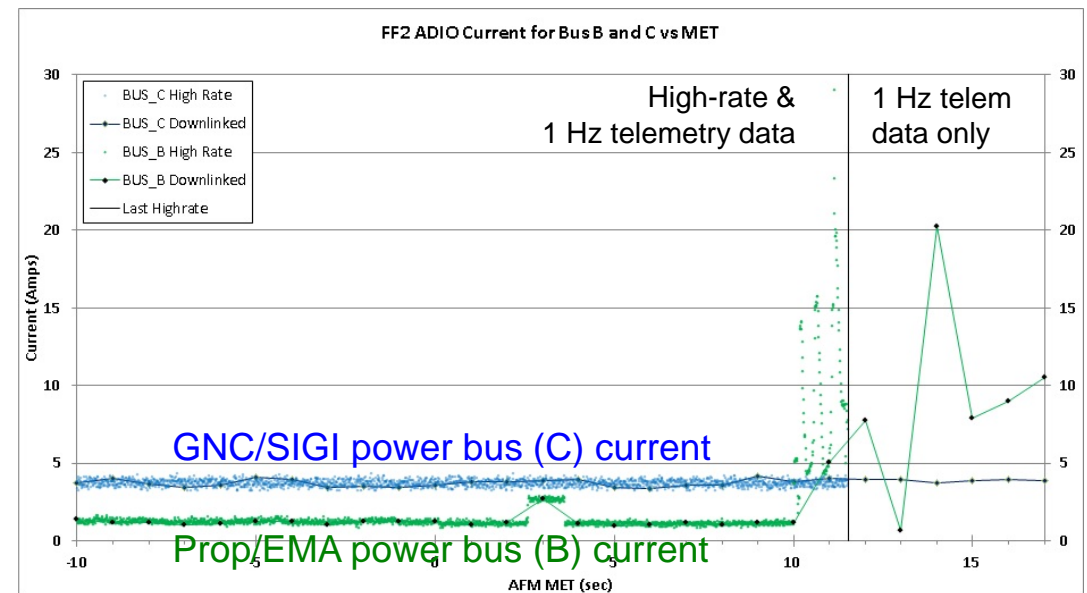
- Power: bus voltage & current data (right) show no power loss
- Propulsion
 - Engine performance, tank temp and pressure data were nominal
 - EMA position feedback data showed nominal tracking of GNC commands
- Structure: video and forensics show no evidence of structural failure before impact
- Software
 - Downlinked FSW parameters were nominal, responding appropriately
 - MMCC GSW nominal
- Weather and winds benign, within LCC
- Survivors
 - HD4 engine injector plate
 - RCS thruster bodies
 - Javad GPS antenna
 - ALHAT HDS mass simulator
 - FTS boxes ejected, one still operational
 - Footpad insulation made by KSC
 - *Morpheus Team expertise!*

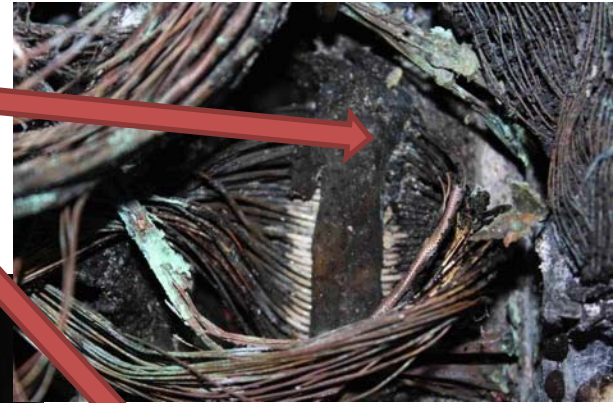
DIO/1553 TM Connector

Wires are firmly in connectors but no continuity through melted connectors

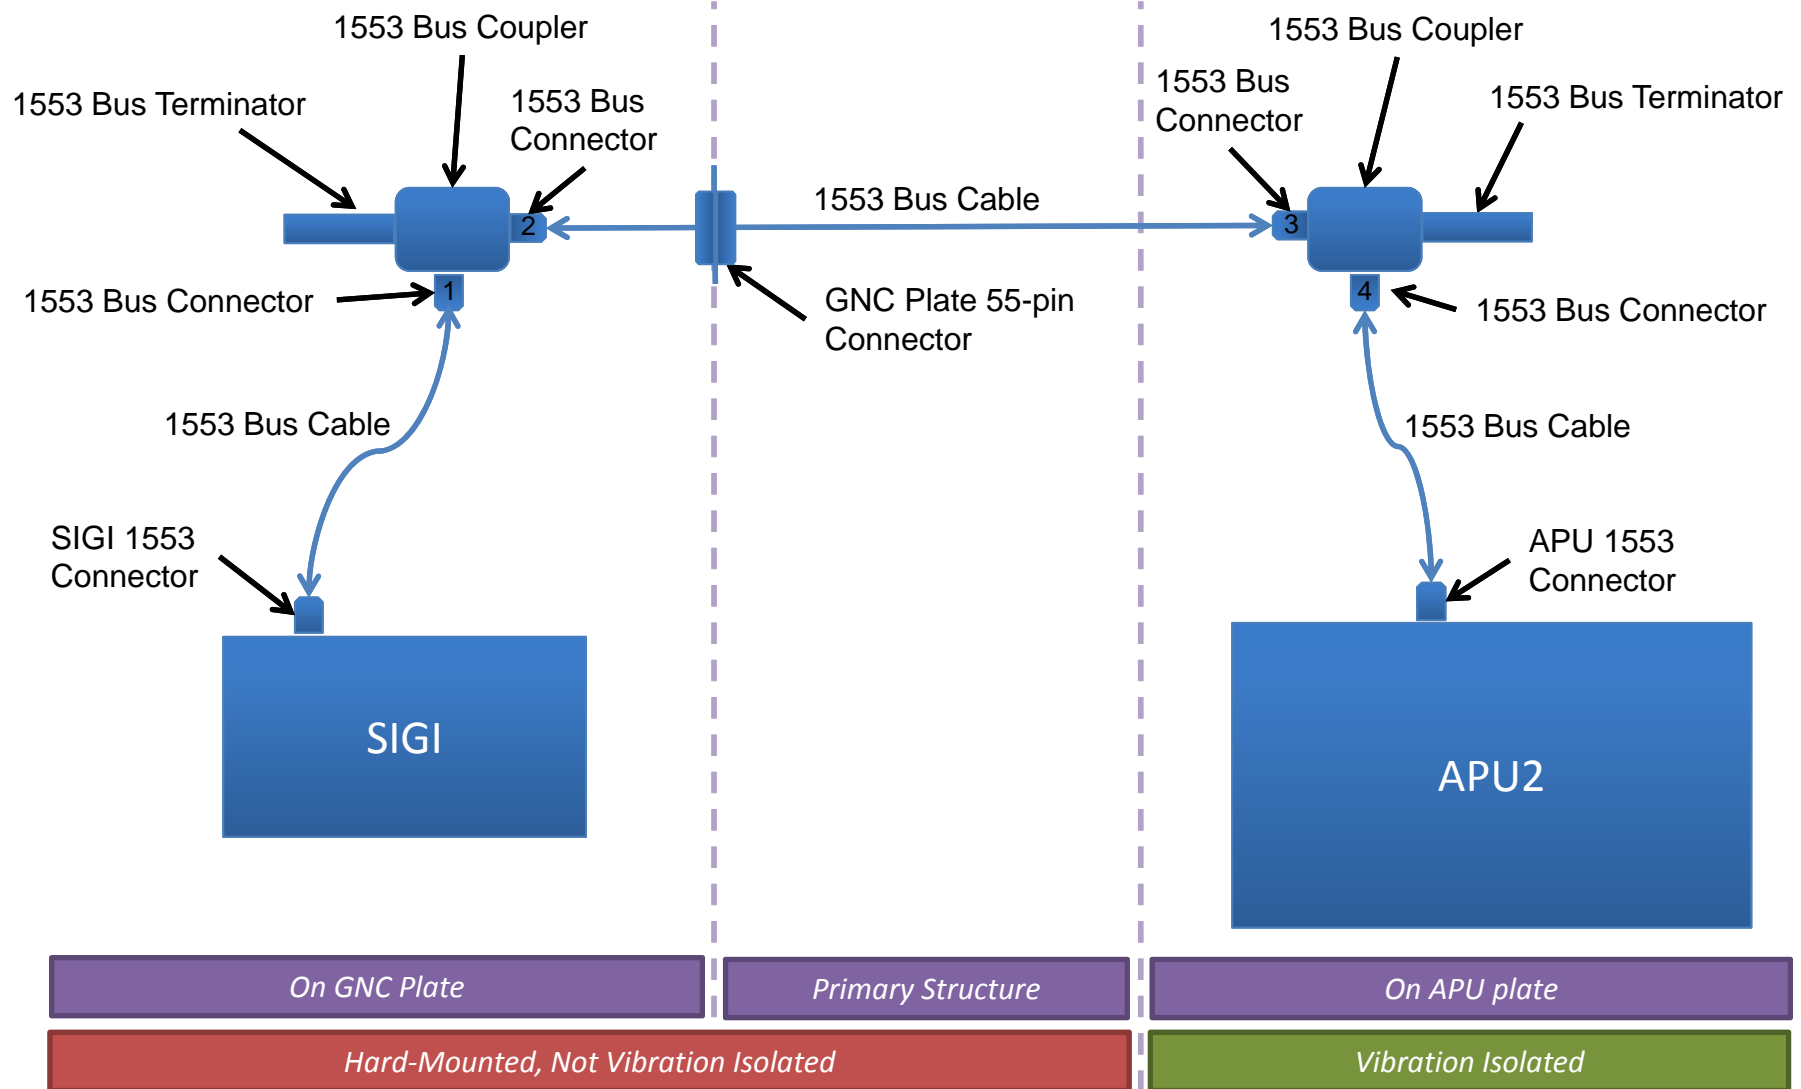
1553 Bus Functional Schematic

- 1553 bus **couplers**
 - GNC plate coupler hard-mounted to plate, deck & primary structure, not isolated from vibration; coupler on APU vibe-isolated.
 - In 2009, L-M Mission Success Bulletin #09-17 cited a few lots of couplers (from a different manufacturer) for having cracked solder joints on terminal lugs due to vibration & thermal environments, affecting Atlas and Orion PA1
- 1553 bus **connectors**
 - Spring-pressure over-center BNC connectors
 - Can be connected without locking if there is sufficient friction in connection; unlikely given no connector issues in previous tests, not demated since Feb
 - High vibration environment could cause connectors to back off, even if locked
- 1553 bus **terminators**
 - Same unlikely connection issue as connectors, not demated since Feb
 - Long, cantilevered terminators are susceptible to high vibration environment
