Micrometeoroid and Orbital Debris (MMOD) Risk Overview

**Eric Christiansen
NASA Johnson Space Center
July 2014**

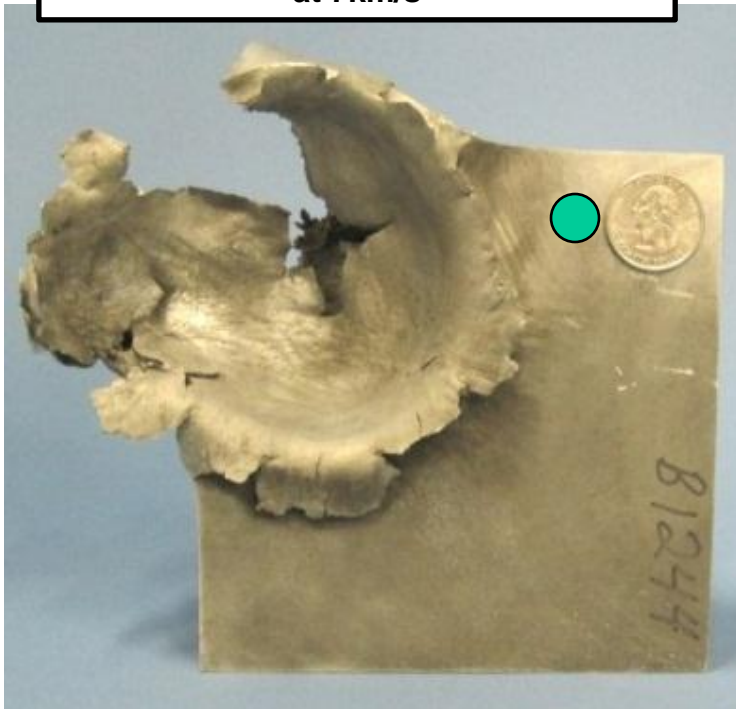
Damage from a 1.3cm diameter sphere at 7km/s

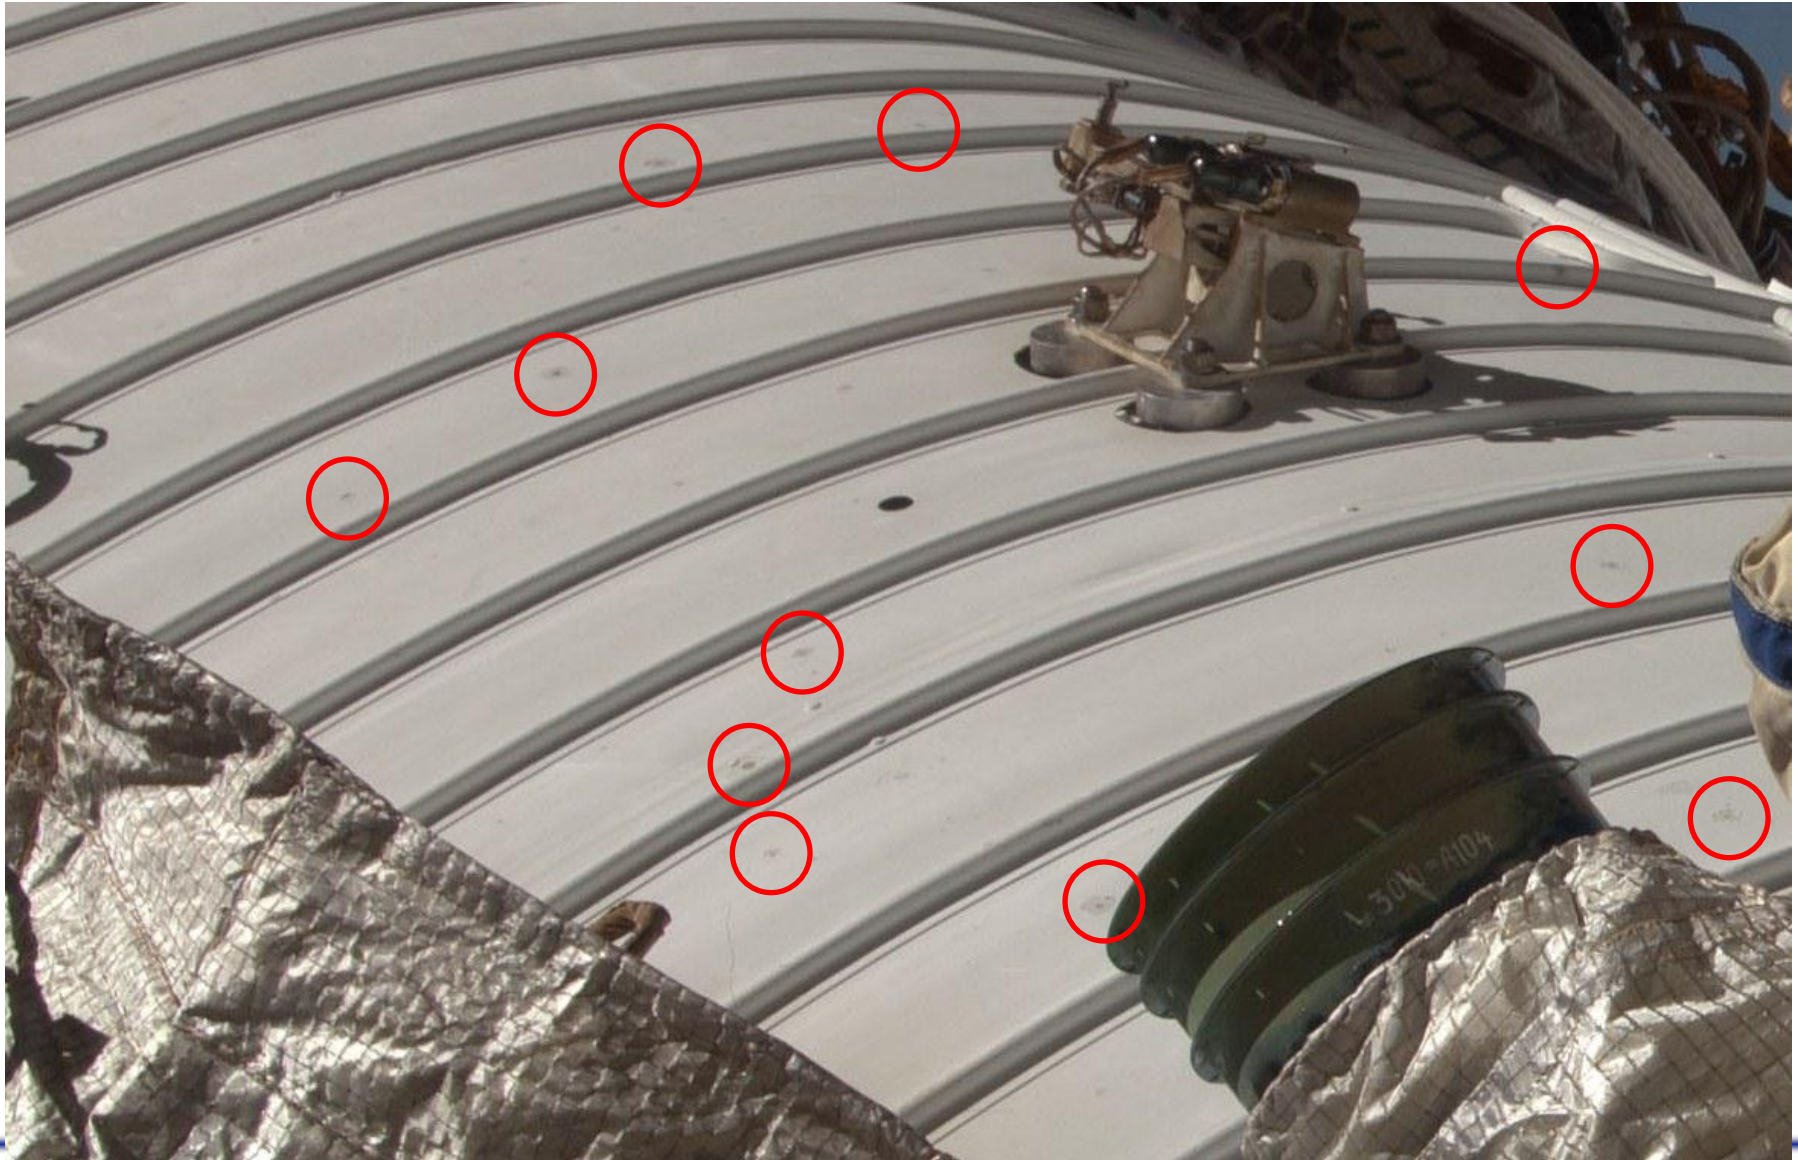
MMOD Damage to ISS Radiators

- **MMOD impact damages observed to ISS radiator panels during Russian EVA (June 2013)**

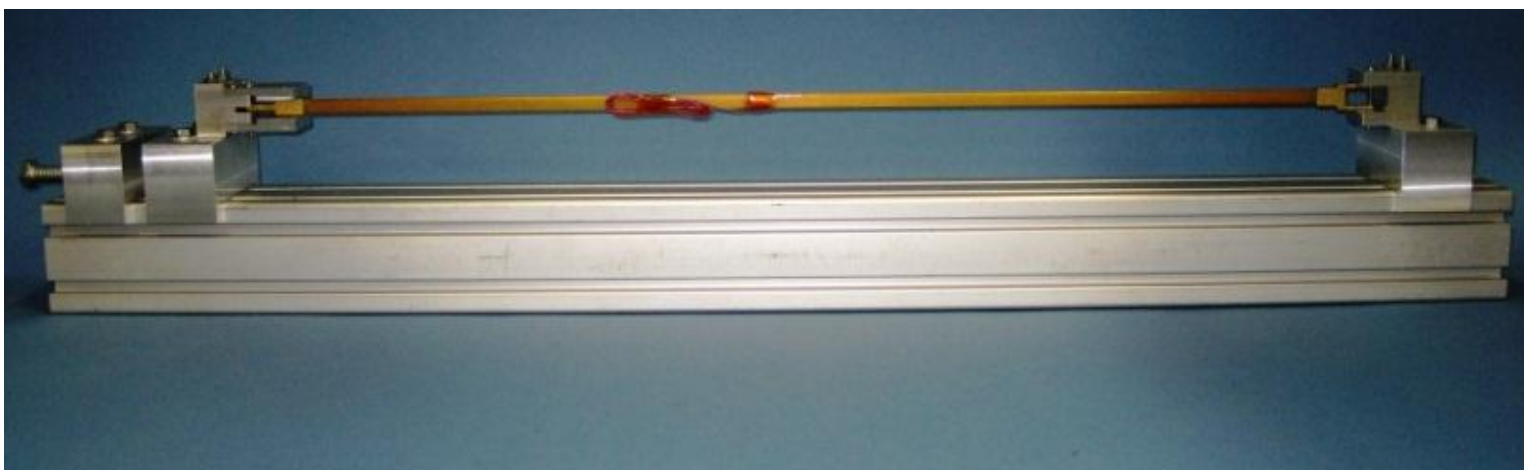
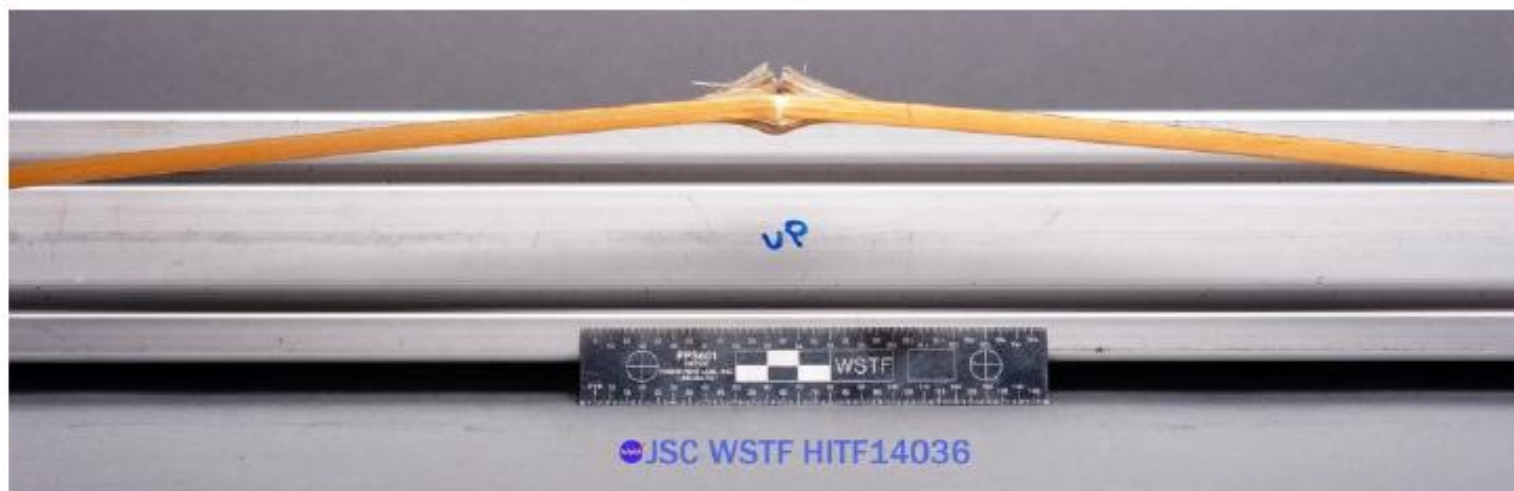
Hypervelocity impact tests

- **Mast elements have been hypervelocity impact tested and structurally tested to assess residual strength for ISS life extension**

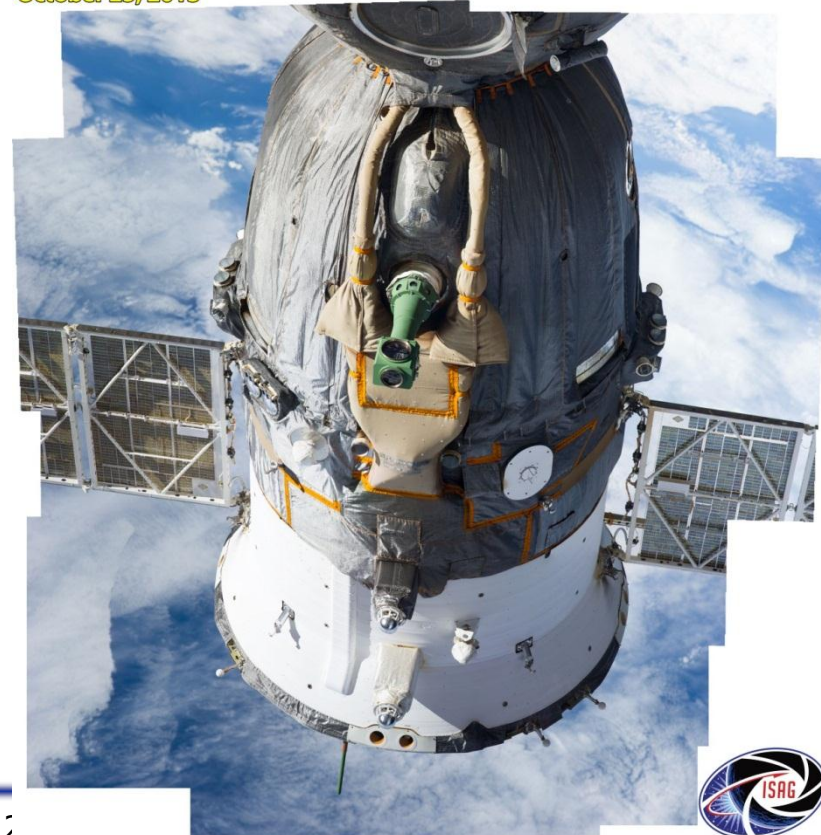
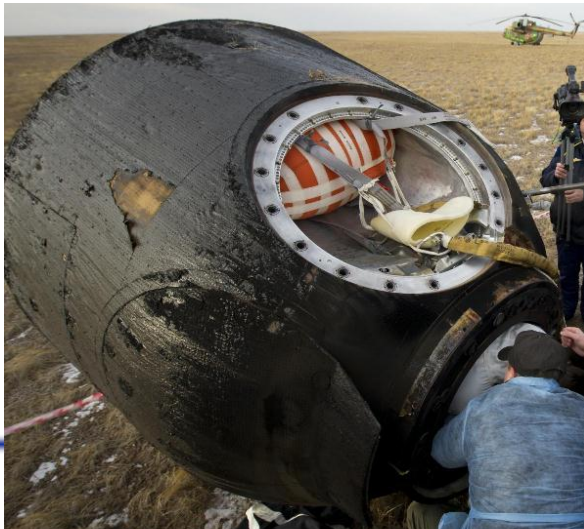
- **MMOD risk to thermal protection system (TPS) of ISS crew return vehicles (Soyuz, Commercial vehicles) is high**
 - Concern is TPS damage that can lead to loss-of-vehicle during reentry
 - Issue can be mitigated by inspection and repair or safe-haven (not Program baseline)

INC 37 Soyuz 35S
Cupola W5
D3s w/180mm lens
October 25, 2013
