Failure Investigation of WB-57 Aircraft Engine Cowling

Microscopy & Microanalysis 2014

Symposium P06 – Failure Analysis of Structural Materials
06 August, 2014

Failure Analysis of WB-57 Aircraft Engine Cowling

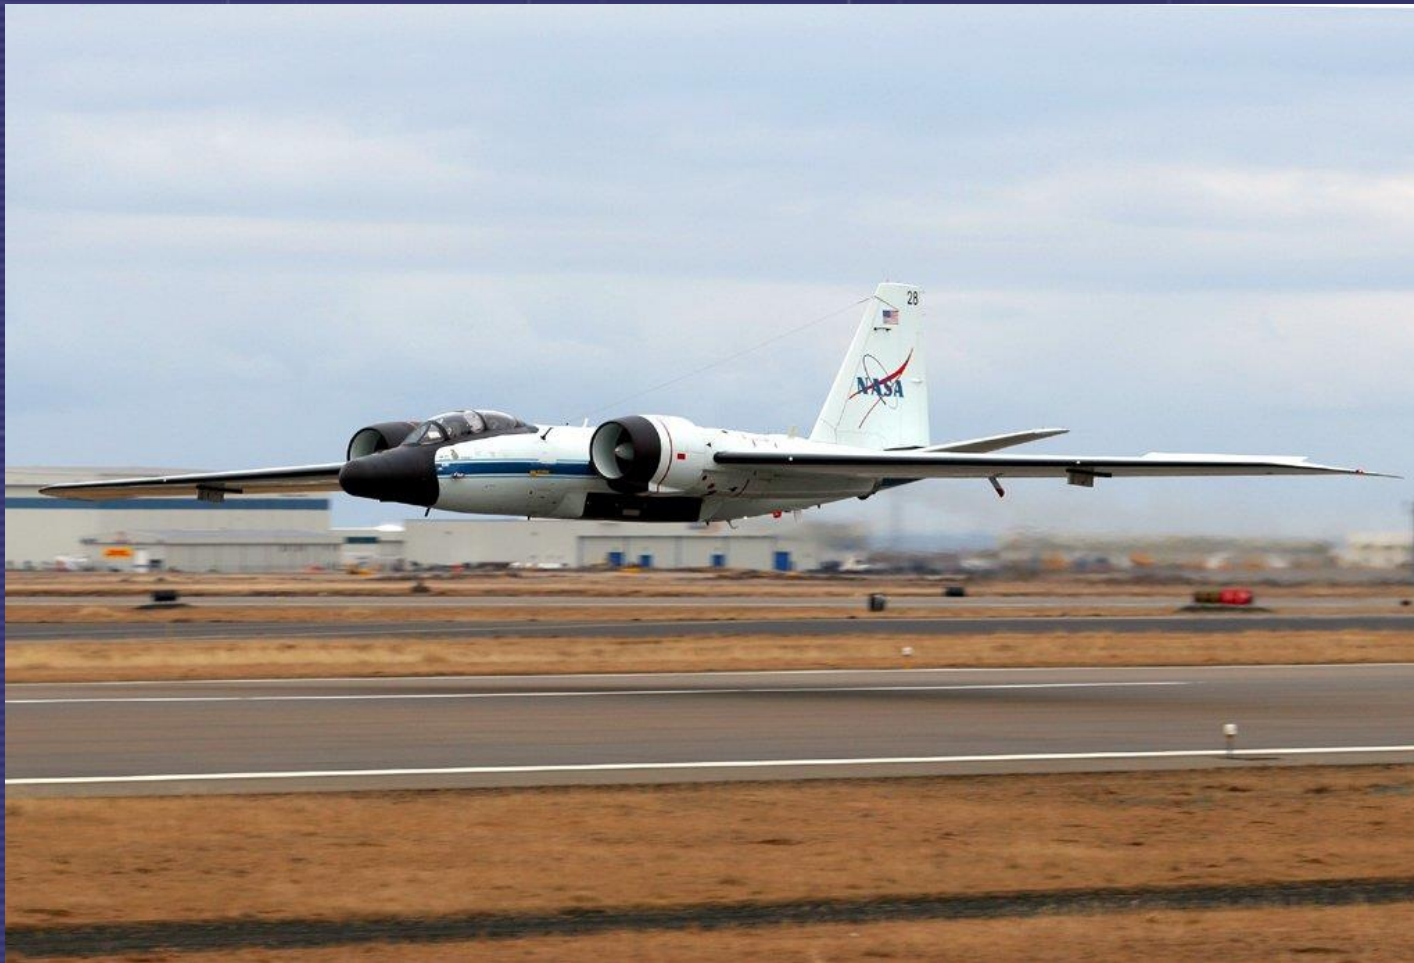
Aircraft Photo:

- Flight Conditions:
 - Returning from a 6 hour flight.
 - Altitude: 30,000 feet.
 - Configuration: Clean.
 - Airspeed: Un-accelerated, auto-pilot engaged, indicated 175 knots.
 - Environmental Conditions: Calm air.
- Crew Observations:
 - 2-man crew heard a mechanical bang.
 - Felt a slight shudder followed by a few seconds of high frequency vibration.
 - No other abnormalities leading up to, or for the remaining 1 hour of flight.
 - Made an uneventful landing.
 - Upon taxi into the chocks, the recovery ground crew noticed the high frequency long wire antenna had become disconnected from the vertical stabilizer and was trailing over the left inboard wing.
 - The left engine upper center removable cowling panel was missing.
 - Noticeable damage to the left engine inboard cowling fixed structure.
 - The missing cowling panel was never recovered.

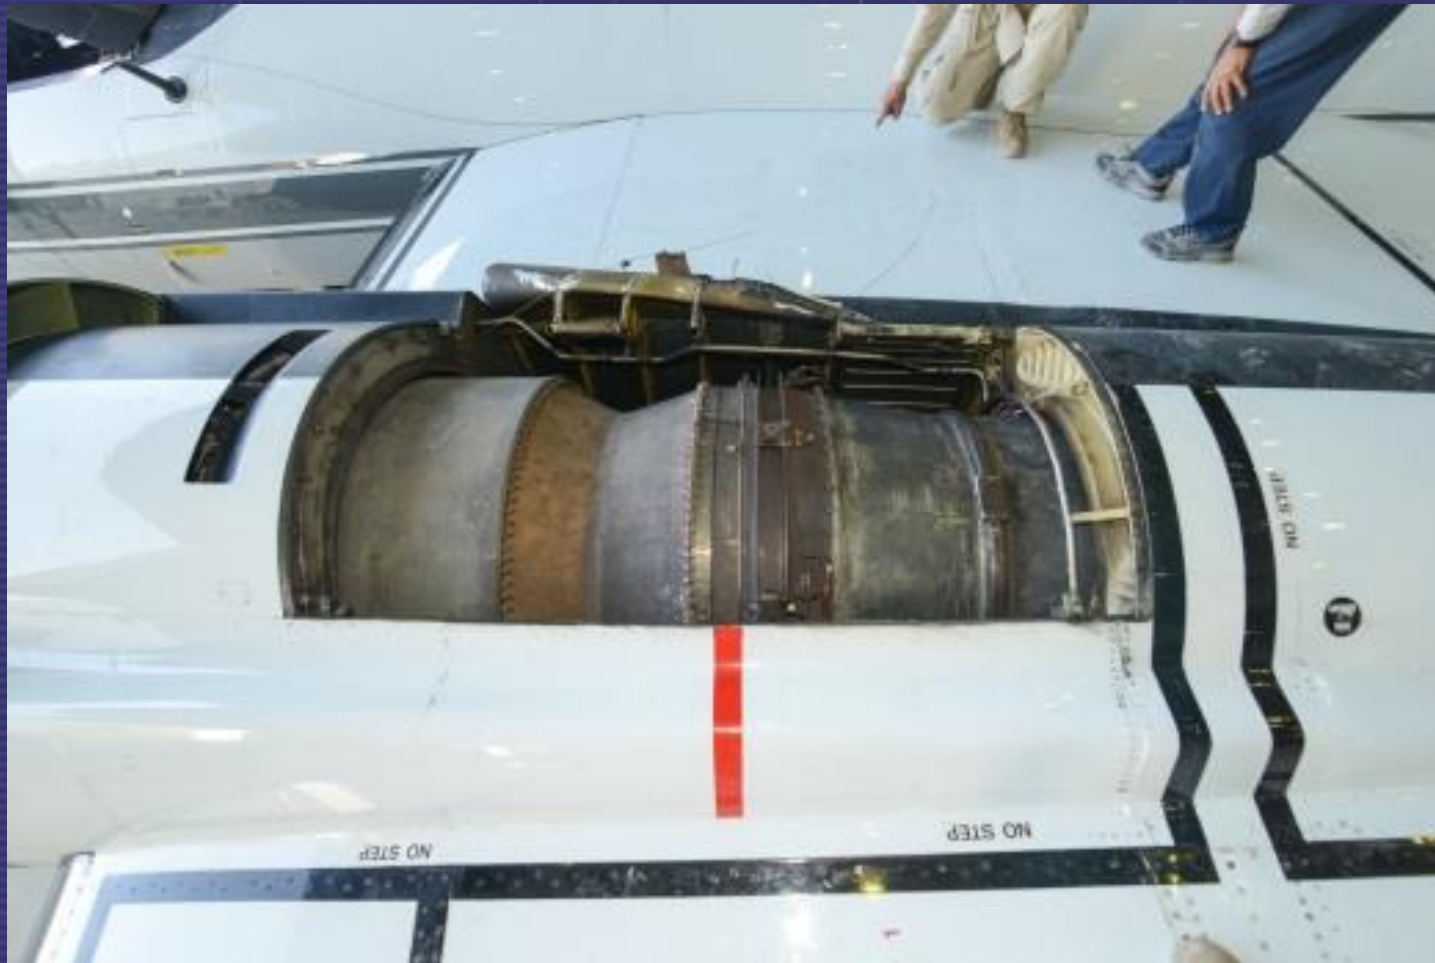
Aircraft Photo:

Fig 1. WB-57 Aircraft Left Engine w/Missing Cowling. Location of four remaining bushings circled in yellow.

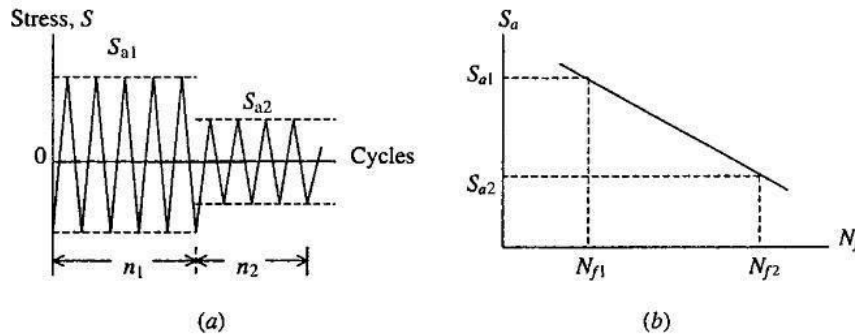
Bushing Fatigue Life

Figure 9.3 Constant amplitude stress blocks and $S-N$ curve. (a) Constant amplitude stress blocks. (b) $S-N$ curve.

Cycles to failure is greatly influenced by stress in part
 (where $N = \#$ of cycles to failure is plotted on *log scale*)
