NASA/TM-2014-218538 (Corrected Copy)
NESC-RP-14-00957

A Comprehensive Analysis of the X-15 Flight 3-65 Accident

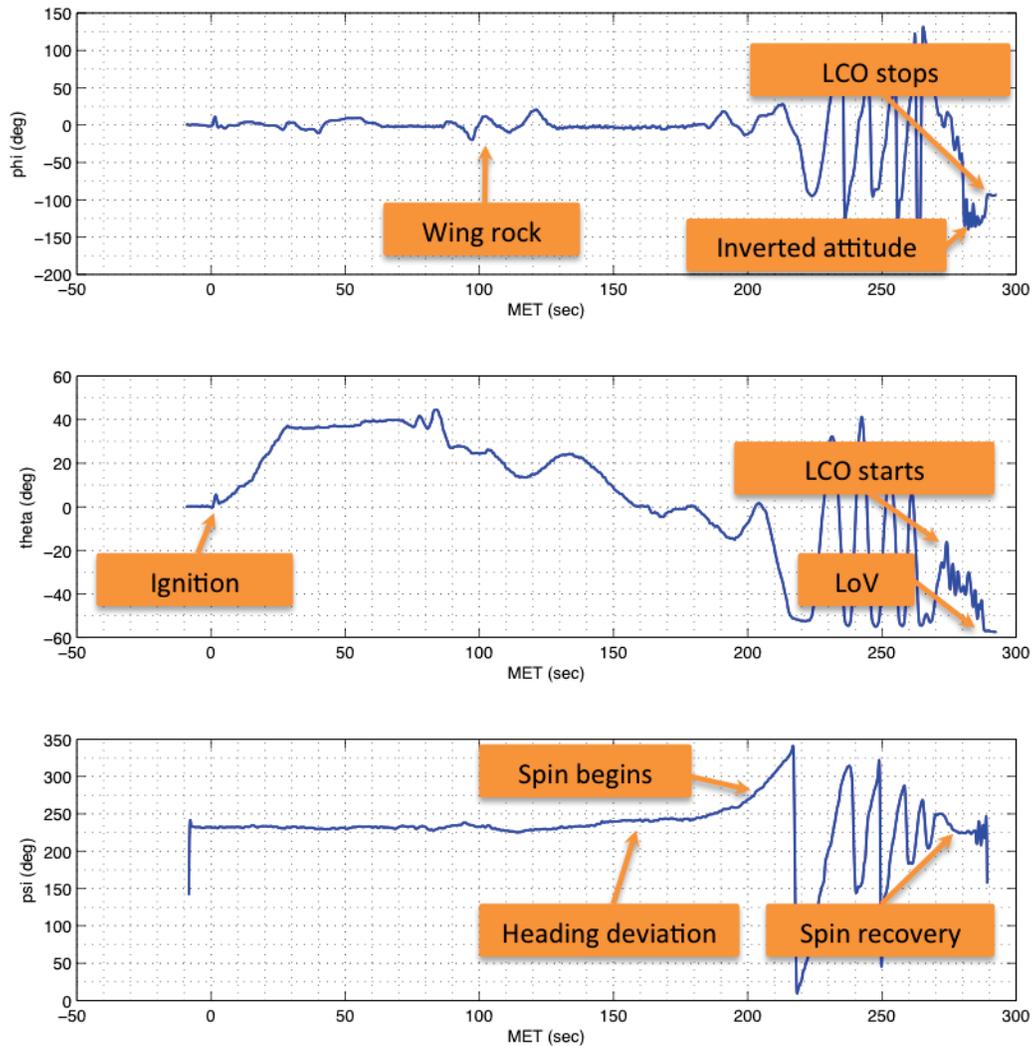
Figure 7.3-1. X-15 3-65 Reconstructed Flight Data (attitude angles⁹)

Reconstructed flight data depicting key events with respect to the aircraft attitude angles are shown in Figure 7.3.1. These data were derived from filtered measurements of the IMU resolver angles recovered from the original stripchart recordings. The correctness of the IMU angle data was verified by the post-accident investigation team via correlation of the estimated attitude with a known solar angle in recovered film footage from onboard cameras [ref. 3]. The remaining trajectory data appear in Appendix B.

In Figure 7.3-1, MET is referenced to ignition, which occurred at 10:30:08 PST. The onset of spin entry at approximately 10:33:30 PST (MET + 202 seconds) was based on the rapid increase in yaw rate and the observation of the first traversal of the sun across the instrument panel as seen from the cockpit camera. Note that the aircraft was tumbling after approximately MET + 215 seconds, and the attitude resolver angles wrap through 360 degrees, but are masked by noise filtering.

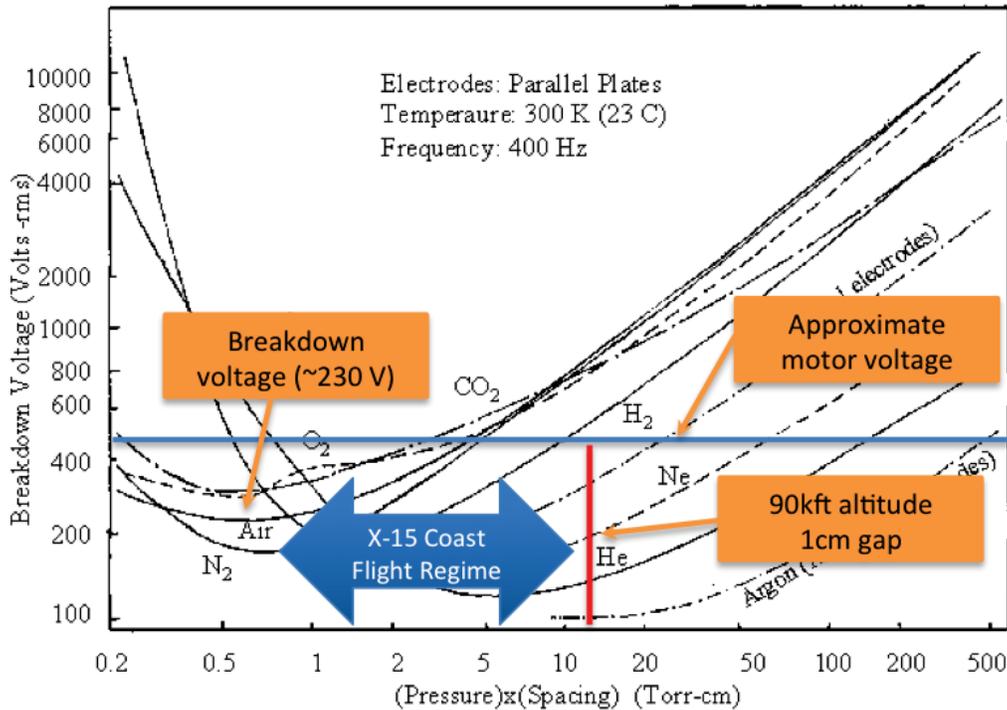
Figure 8.1-1. Paschen Curve for 400 Hz Potential at 300 degrees Kelvin [ref. 32]

Dielectric breakdown in low-pressure gases is a known phenomenon in high-voltage systems [refs. 30–32]. Dielectric breakdown phenomena obey the semi-empirical Paschen's Law, which describes the minimum breakdown potential (in V) associated with a parallel plate electrode configuration as a function of the product of pressure and gap distance (pd). The breakdown voltage approaches a minimum at a specific value of the pressure-gap product and increases elsewhere (see Figure 8.1-1, reproduced from data appearing in reference 32).

Even at the critical pd value, quiescent breakdown in air generally will not occur below 300V. However, deviations from the basic Paschen law result from various factors, including the presence of nonuniform or oscillating electric fields (e.g., conductors with sharp radii and AC potentials, respectively). In the latter case, 400 Hz AC potentials as were used in the X-15 AC power bus reduce the threshold to about 230V. Unknown to the traverse probe experiment developers, the commercial-off-the-shelf (COTS) AC motor selected from existing inventory contained a transformer circuit that multiplied the 115V input by a factor of about 4, yielding a peak potential in the experiment exceeding 630V. Under reduced-pressure conditions, arcing was practically guaranteed across uninsulated gaps of modest spacing. As the design was not thoroughly reviewed for environmental compatibility or tested in simulated altitude conditions prior to installation on the aircraft, the breakdown phenomena was first seen in flight. The investigating board theorized that during the relatively short exposure to the high-altitude environment on the previous two flights, arcing may have occurred, but could have gone undetected as no particularly sensitive electronics were installed on the other X-15 aircraft [ref. 3].

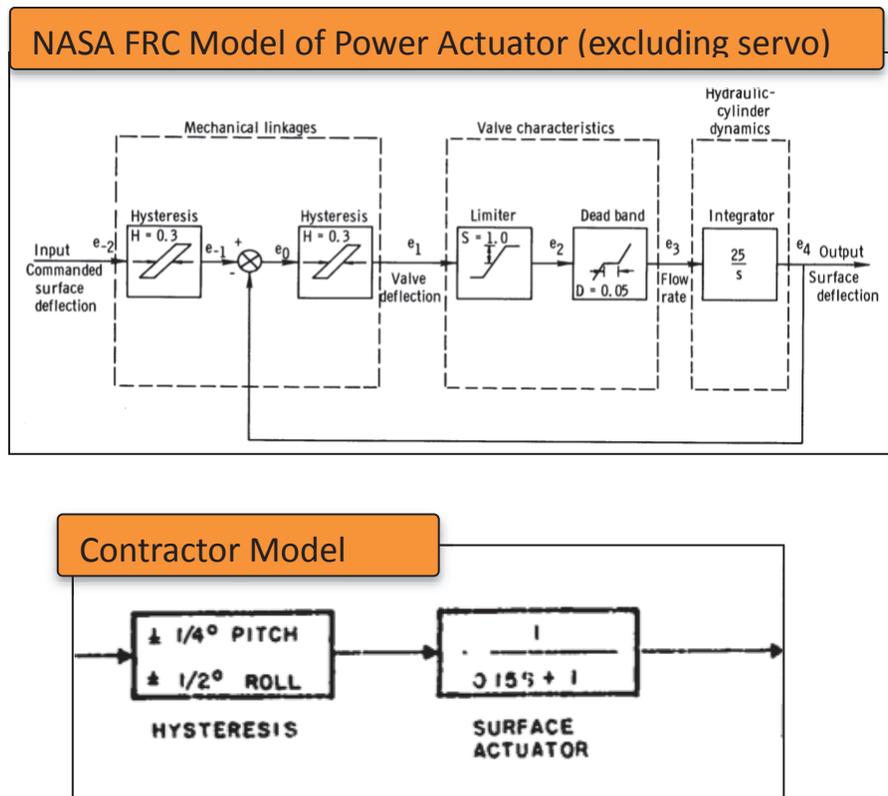
Figure 8.5-1. Surface Actuator Models Used in Design [refs. 34 and 35]

However, while NASA FRC had used a nonlinear model of the servo and power actuator with more extensive HWIL simulation to verify the filter design, the contractor apparently did not have access to the same type of model data and used a simple first-order lag model with hysteresis only (Figure 8.5-1). As such, a latent design sensitivity was introduced into the inner loop of the MH-96 SAS that would allow the SAS rate loop to become unstable in the presence of actuator rate saturation.

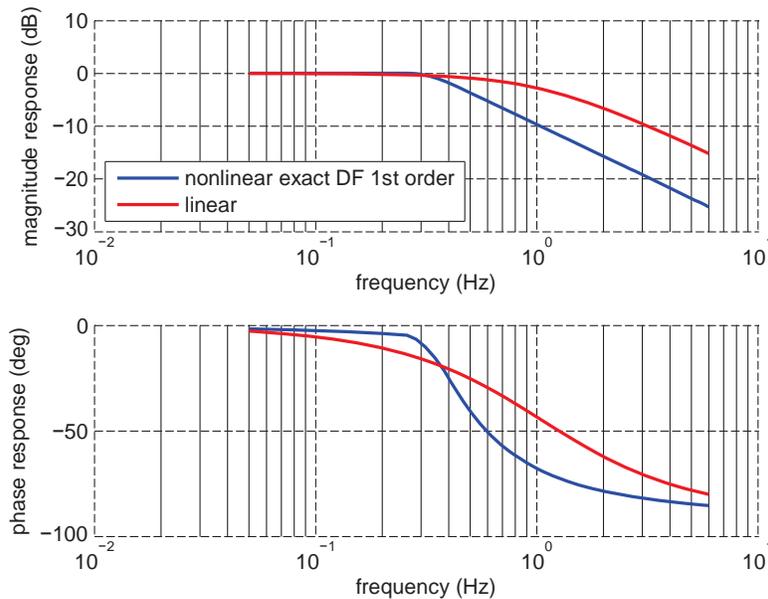
Figure 8.5-2. X-15 Power Actuator under Rate Saturation, 15-degree Amplitude

The transition from the desirable small-amplitude LCO to the large-amplitude destructive LCO was an artifact of the rate-limited power actuator with its semi-integrating servo loop. A known effect of power actuator rate limits is the introduction of an amplitude-dependent equivalent phase lag in the inner loop, which plays an important role in the sensitivity to pilot-induced oscillations (PIO). As can be seen in Figure 8.5-2, the presence of rate limits severely degrades the equivalent nonlinear frequency response of the X-15 actuator. The severe landing PIO encountered on X-15 Flight 1-1-5 was an effect of the same rate-limited actuators, albeit in a different failure mode [ref. 36].

damping was particularly low, as it did during Flight 3-65, then the rigid-body oscillation was divergent, even with fixed adaptive gains.

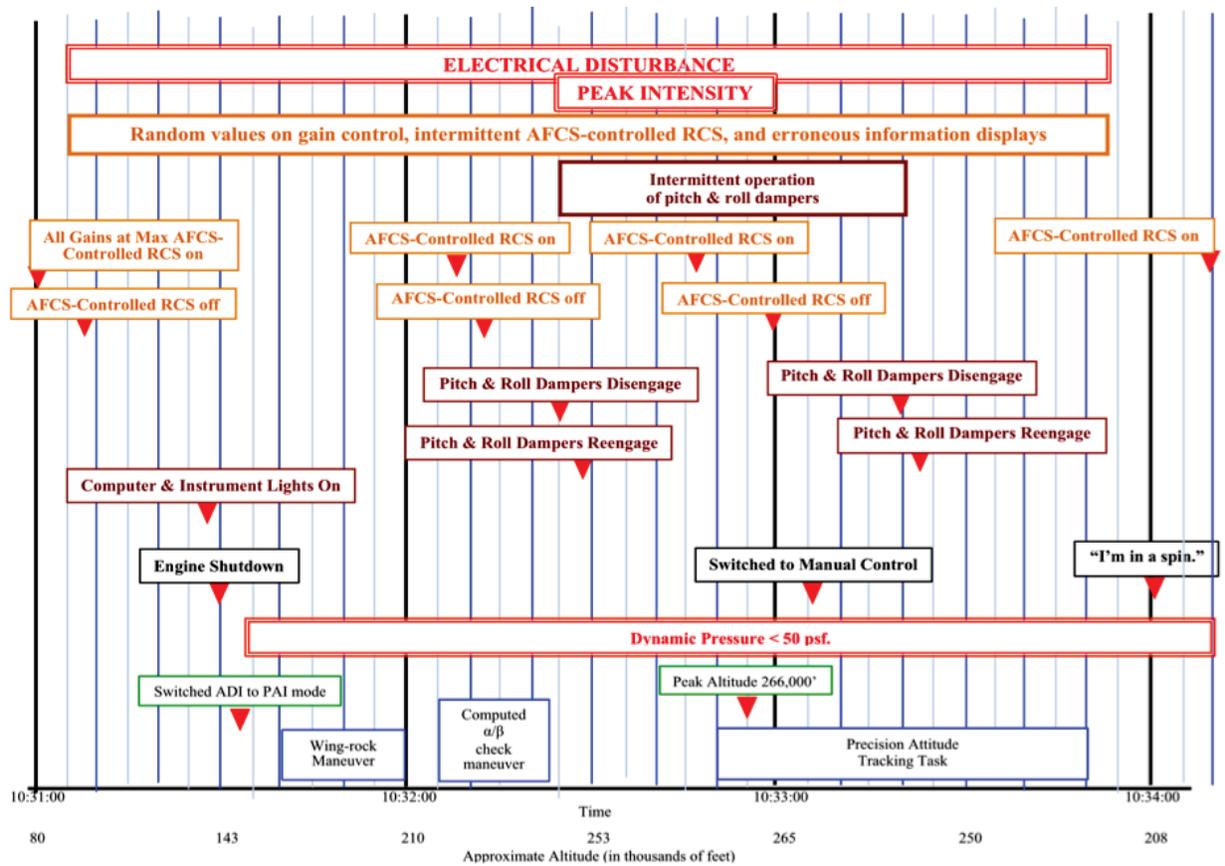
Figure 9.1-1. 3-65 Event Timeline

Figure 9.1-1 illustrates the timeline of the major events leading to the loss of the pilot and the aircraft, and diagrams the sequence of key events during the 3 minutes following the initial traverse probe electrical disturbance. Note that the timeline in Figure 9.1-1 ends at about 10:34:17 PST (MET + 249 seconds), or about 37 seconds before breakup. The time history of the MH-96 AFCS gains is shown in Figure 9.1-2.

Beginning at 10:31:07 PST (MET + 59 seconds), the electrical disturbance caused erratic fluctuations in the automated gain control from maximum to minimum as seen in Figure 9.1-2, which caused the pilot's access to the RCS through the right side stick to be intermittent throughout the 2-minute, 46-second duration of the electrical disturbance.

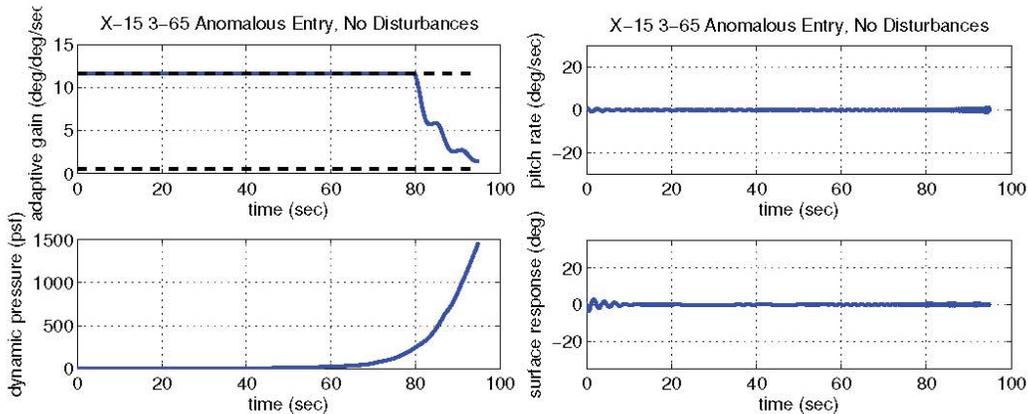
Figure A.14: MH-96 3-65 entry, no disturbances

The high dynamic pressure and dynamic pressure rate seen during the 3-65 anomalous reentry was within the design capability of the MH-96 adaptation gain dynamic range and adaptation rate so long as no exogenous disturbances caused saturation of the control surface actuators. This can be verified through simulation of the adaptation dynamics during the planned 3-65 entry (to approximately 800 psf) and the anomalous entry (exceeding 1500 psf). In both cases, since the system is operating in a ballistic mode prior to the entry, the adaptive gain is at maximum. Even when using the accident flight dynamic pressure

profile, the adaptive law is successful in establishing the desired servoactuator limit cycle and modulating the forward gain to the proper value (Figure A.14). This analysis result contradicts the author's early hypothesis that the adverse LCO was precipitated by a dynamic pressure rate-of-change exceeding the capability of the MH-96 gain changer.

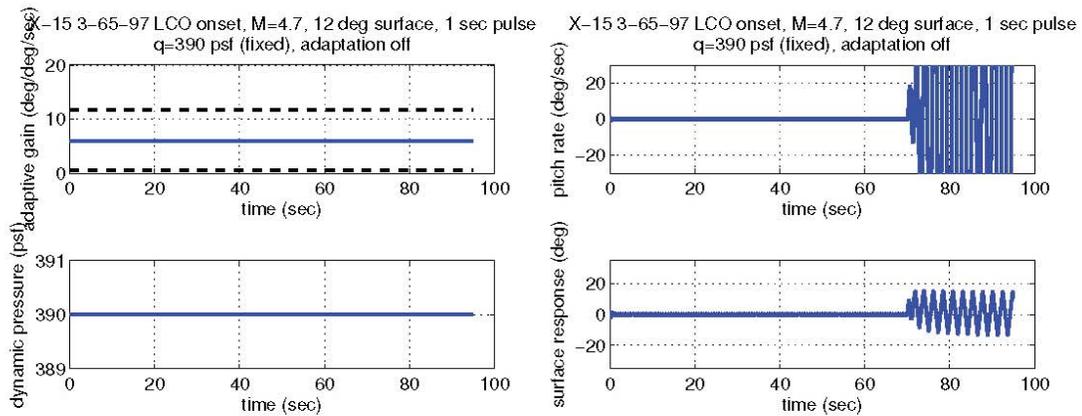
Figure A.16: Fixed dynamic pressure, large pilot input, fixed gain

The same divergent LCO can be induced in the system even in a fixed gain condition with fixed dynamic pressure, if the pilot input magnitude is large enough to induce rate limiting in the actuator (Figure A.16). This occurs with moderate gain levels exceeding those of the fixed-gain SAS but much below the MH-96 maximum gain. This implies that a more serious mechanism involving the fundamental stability of the SAS inner loop is responsible for the limit cycle behavior, since in the fixed-gain case the behavior persists.

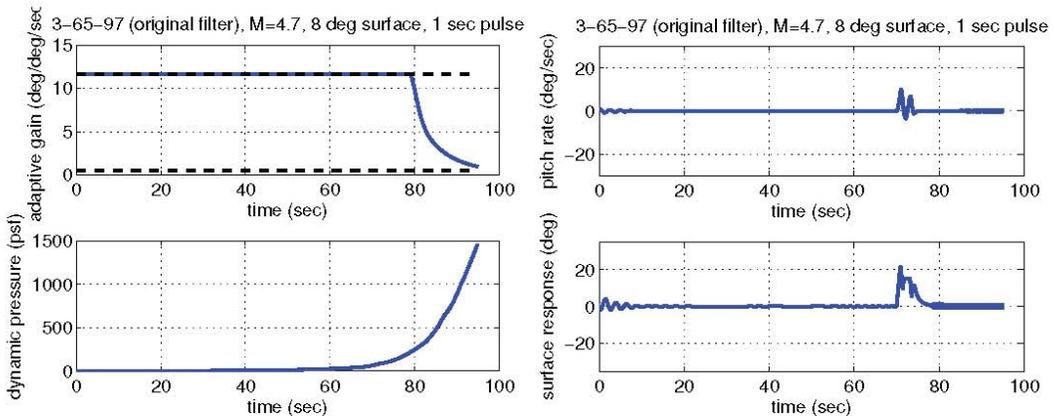
Figure A.17: 3-65 entry, large pilot input, original filter

It is illustrative to consider that the introduction of lag due to the implementation of the structural notch filter may be related to the apparent rate-limit divergent limit cycle oscillation. Under the time-varying 3-65 entry conditions, the system is simulated with an identical pilot input but with the original loop filter design (Eq. A.7). Although rate limiting is induced for a short time, the actuator does not couple with the short-period mode and thus no divergent oscillation is induced (Figure A.17).

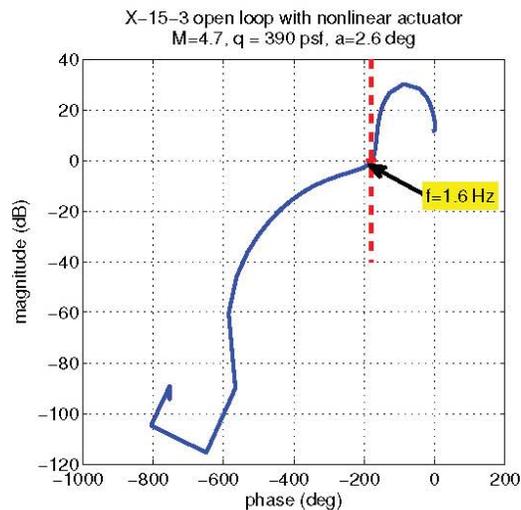
Figure A.21: X-15 servoactuator small-amplitude LCO prediction

Using the servoactuator DF in-the-loop at the stated forward gain condition, the small-amplitude LCO is accurately predicted by the numerical analysis. Since the forward gain in the DF analysis matches the converged gain, the system intercepts the critical point. The $-\pi$ phase line is shown for comparison. It should be noted that the short period mode, appearing at approximately 0.4 Hz, has relatively little equivalent phase margin at this condition at stable values of the forward gain.

It was noted before in the analysis of the high-frequency desired LCO that the short-period mode had very little phase margin when operating at the critical gain (Figure A.21). In the design of the MH-96, an implicit assumption was that the system phase shaping (via filters in the rate feedback path) provided for a linear phase margin that was approximately invariant with respect to the forward gain. Based on a comparison of the original system response with the flight configuration using the structural notch filter, it appears that the introduction of the notch filter substantially degraded the phasing of the short period mode due to the introduction of additional low-frequency lag (Figure A.23). Even under these conditions, the original design maintains more than 30 degrees of phase margin for the short-period mode.

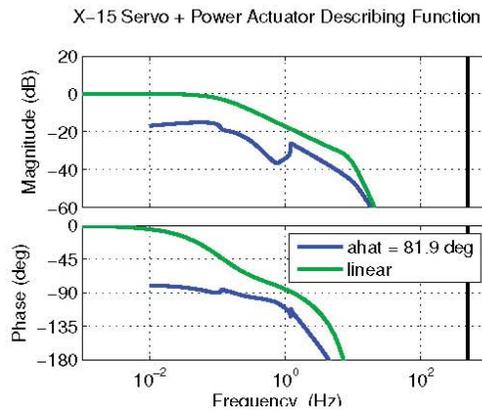
Figure A.22: X-15 servoactuator large-amplitude describing function

Based upon the time-domain analysis, it was observed that the large-amplitude LCO tended to be precipitated by large inputs causing actuator rate saturation coupled with an excitation of the short-period pitch mode. In order to determine the possible transition amplitude for the adverse LCO, the amplitude-frequency parameter space was searched for a DF such that the short-period mode would approach critical stability when at the 3-65 entry conditions (maximum forward gain, 390 psf). The transition amplitude for this condition consists of a large servo command of approximately 80 degrees peak equivalent, or a command-to-authority factor of about 6:1. Large servo commands exceeding the servocylinder limit of 1 inch (15 degrees equivalent) will cause saturation in the servo, the power actuator, or both. The effects of saturation on the actuator frequency response are shown in Figure A.22. Near the short-period frequency, the effective phase lag is increased by approximately 25 degrees.

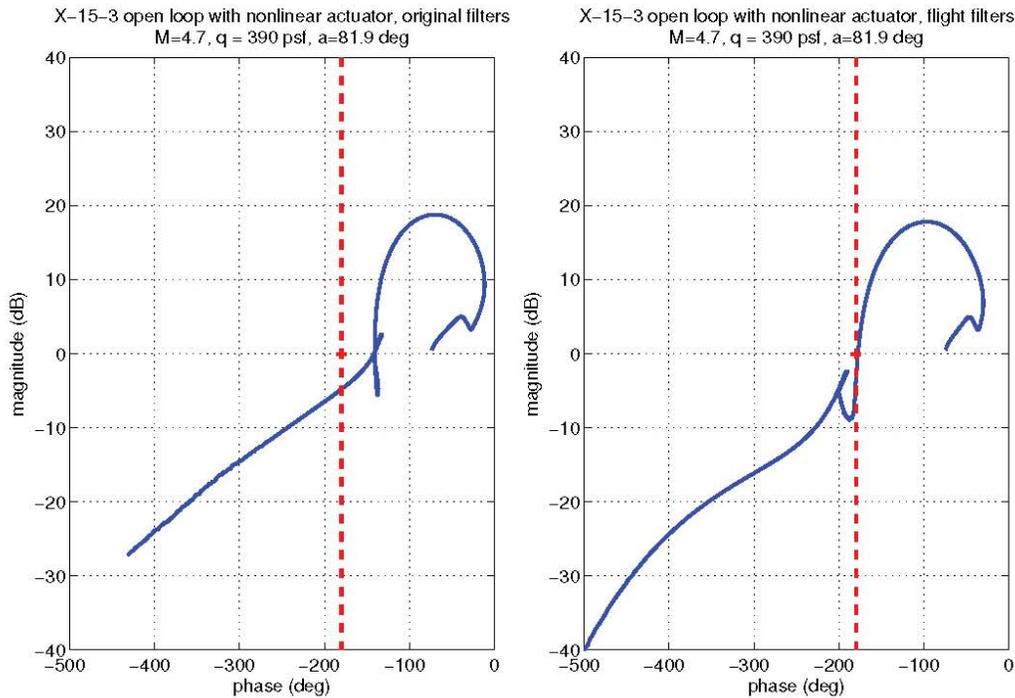
Figure A.23: X-15 servoactuator large-amplitude LCO prediction

The coupled response with the servoactuator DF in-the-loop is shown in Figure . At a transition amplitude, the short-period mode phase margin approaches zero, predicting a periodic oscillation in the closed loop near a frequency of 0.55 Hz (simulation shows a frequency consistent with the short-period mode at 0.43 Hz). While not as accurate a predictor of the oscillation frequency as in the low-amplitude case, this is to be expected using the approximation technique since the dominant complex poles near this frequency are clearly associated with the short-period mode.

Under the proper circumstances (including a flight condition where the bare airframe damping is small combined with a saturated servoactuator), the effective system lag was sufficient to destabilize the rigid body. This appears to have been a latent flaw in the design of the notch filter, whereas the original system design was not susceptible. However, the original filters did not provide sufficient attenuation for the problematic stabilator resonant modes, and lacking a detailed design study, it is unclear as to whether *any* design would have been feasible given the limitations in the analog filter implementation. Furthermore, while describing function techniques and the “equivalent lag” effects of saturated actuators were known at the time, it cannot be reasonably expected that the designers would have been able to analyze the robustness of the system in the level of detail presented herein due to limitations in computational resources.

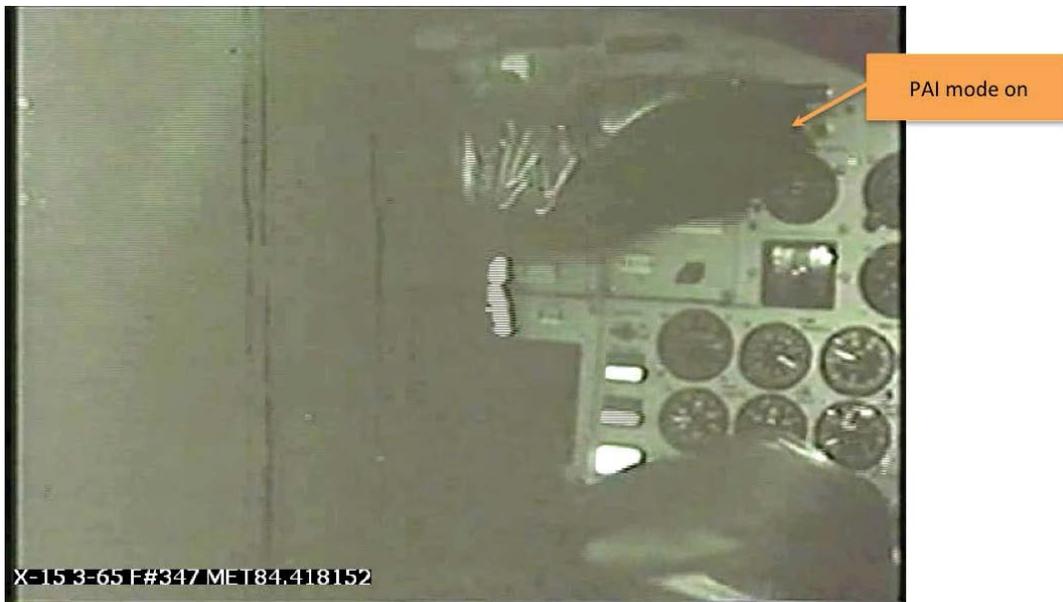
Figure B-11. Cockpit Film – Pilot Engages PAI (MET = 84 seconds, 10:31:32 PST)

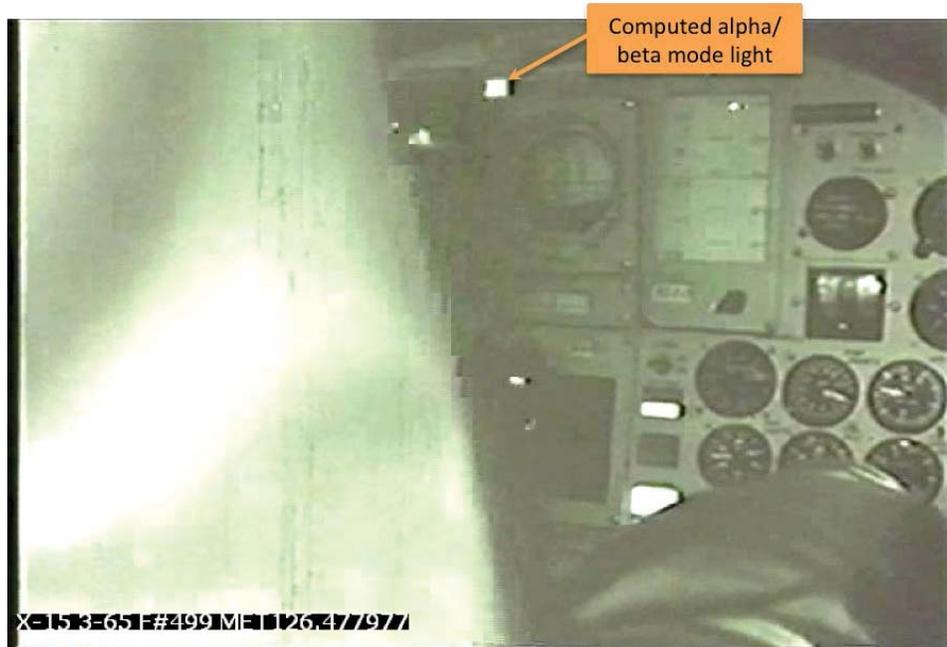
Figure B-13. Cockpit Film – Pilot Selects Computed IFDS Aerodynamic Angles <50 psf (MET = 126 seconds, 10:32:14 PST)

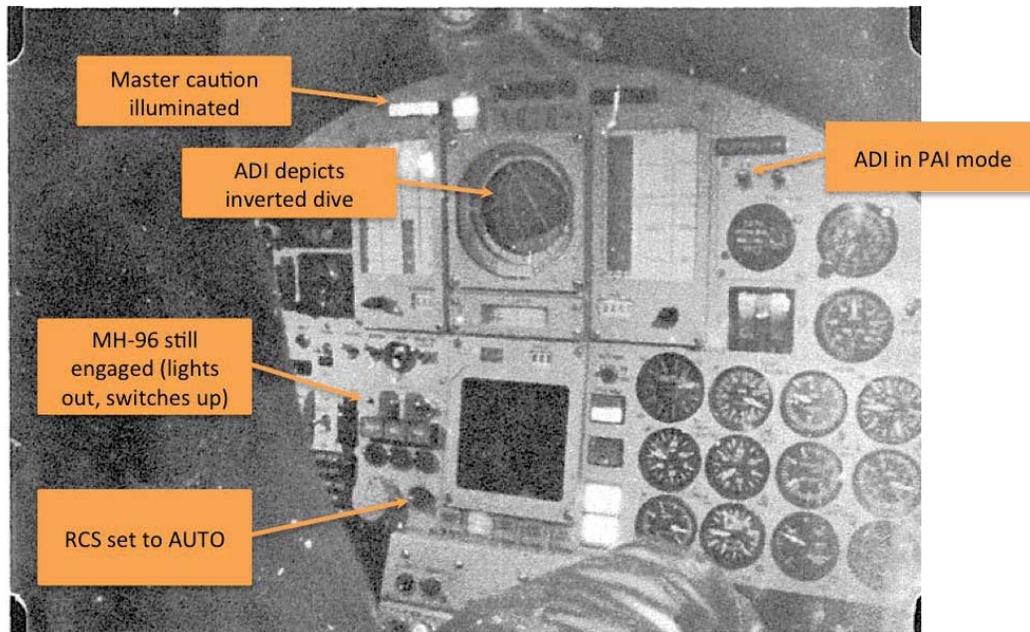
Figure B-17. Cockpit Film – Last Camera Frame (MET = 286 seconds, 10:34:54 PST)
