**A Historical Analysis of Crane Mishaps  
at Kennedy Space Center**

Crystal Wolfe

Kennedy Space Center

Date: 25 07 2014

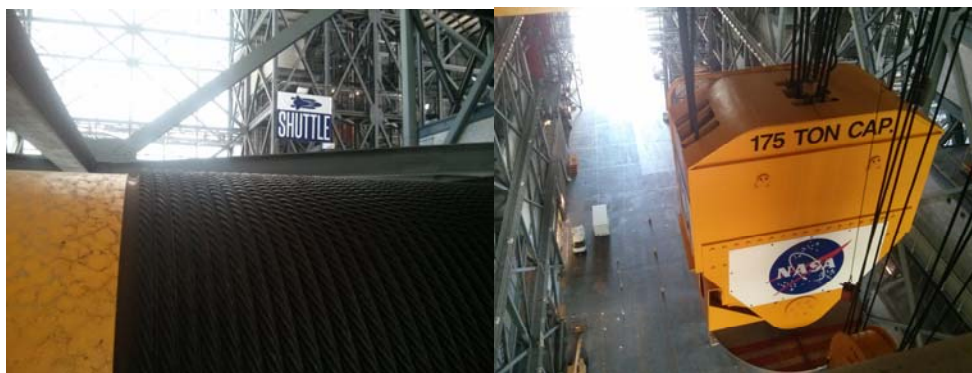
Figure 3 shows properly spooled and reeved rope on the 175-ton overhead crane in the Vehicle Assembly Building (VAB). At the left end of the spool, an empty groove can be seen. This groove is designed to a specific depth based on the diameter of the wire rope being used. If the rope were to cross the edge of this groove under load, it would likely be sliced, causing rope failure. Similarly, if the rope inside one of the hook blocks left the path of the sheaves, it could also lead to rope failure or damage to the sheaves.

**Figure 3. Properly spooled and reeved wire rope on the Vehicle Assembly Building 175-ton overhead crane.** *Left: Spool on drum. Right: Primary and auxiliary hook blocks with reeving.* Credit: author.
