NASA Electronic Parts and Packaging (NEPP) Program

Effect of Preconditioning and Soldering on Failures of Chip Tantalum Capacitors

NEPP task 2014

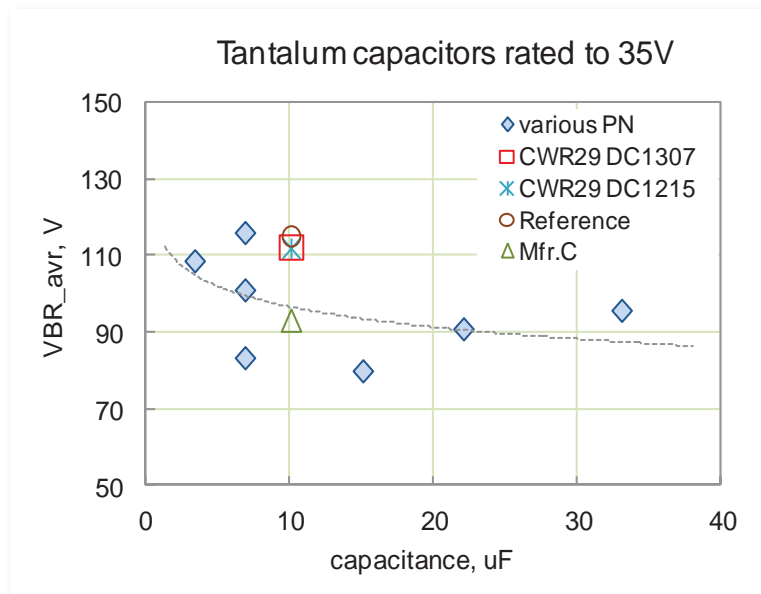
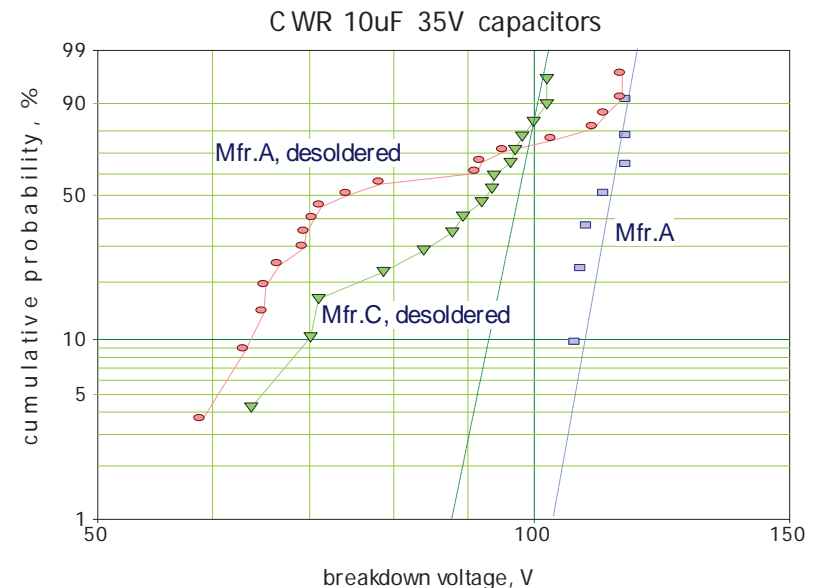
Breakdown Voltages in Capacitors Desoldered from MCE Boards

- ✓ Intrinsic breakdown voltages in 10uF capacitors from Mfr.A exceed $3 \times VR$ and are above average values typical for capacitors rated to 35V.
- ✓ All types of capacitors removed from the units had low-voltage tails of VBR distributions indicating presence of large proportion of defects in the dielectric.

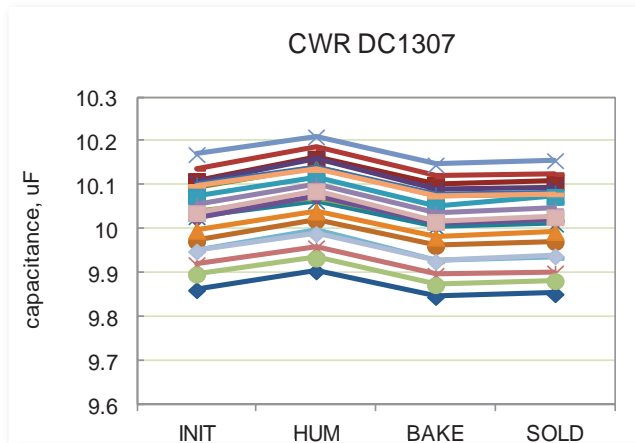
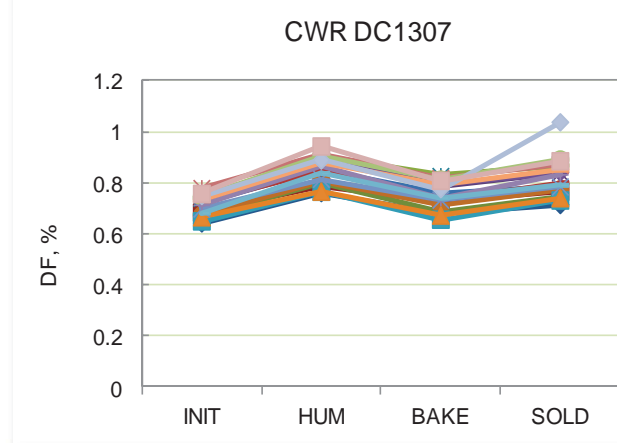
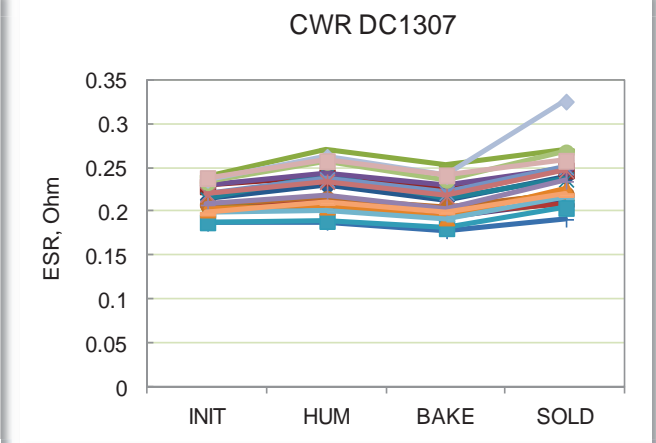
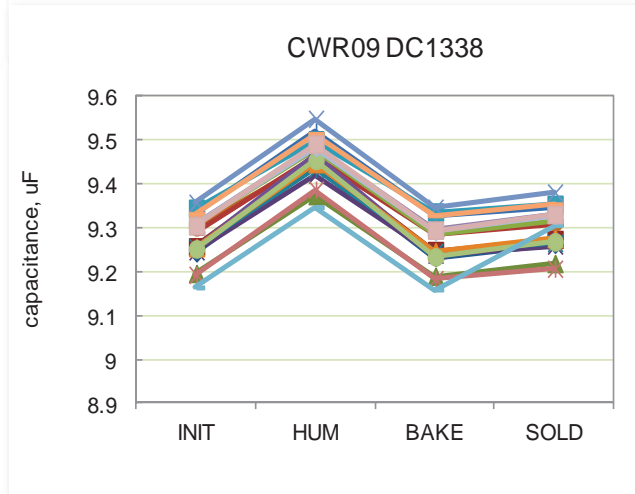
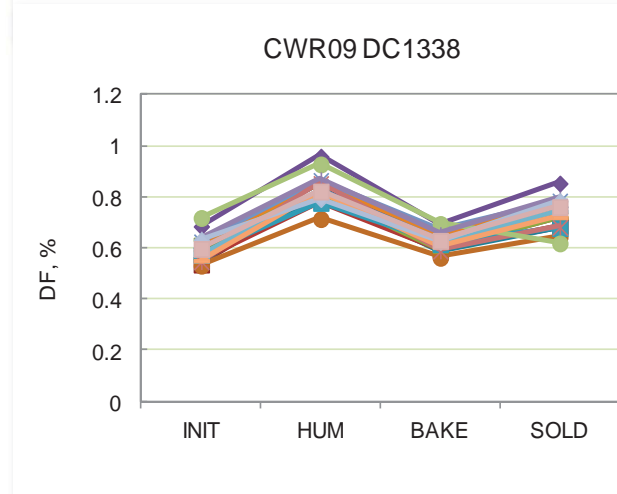
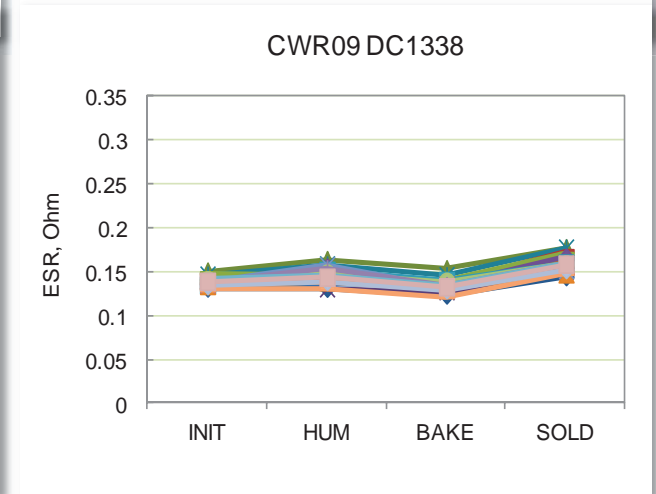
Effect of Preconditioning and Soldering on AC Characteristics of Gr.III Capacitors

- ❑ All 160 capacitors passed electrical measurements for C, DF, and ESR.
- ❑ No substantial variations through preconditioning and soldering (ESR raise ~16%).
- ❑ An increase of capacitance after moisture soak (0.41% for CWR29 and 2.1% for Ref.) is consistent with literature data [12] and indicates good coverage during MnO₂ impregnation.

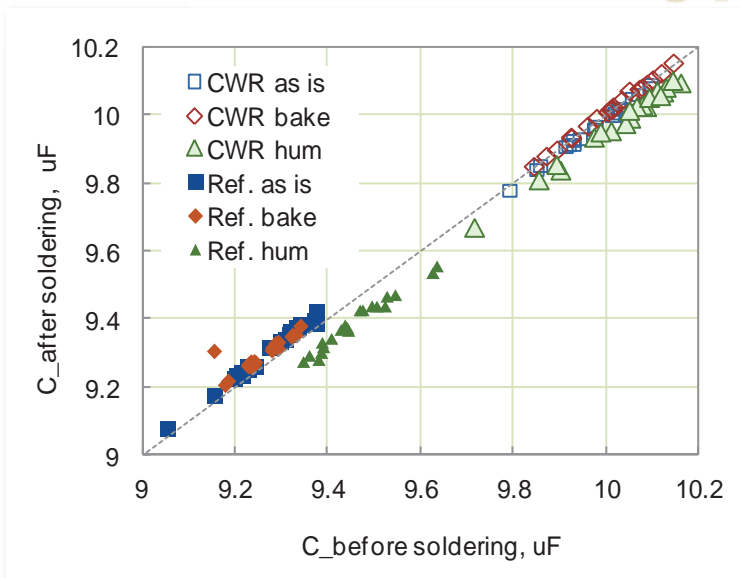
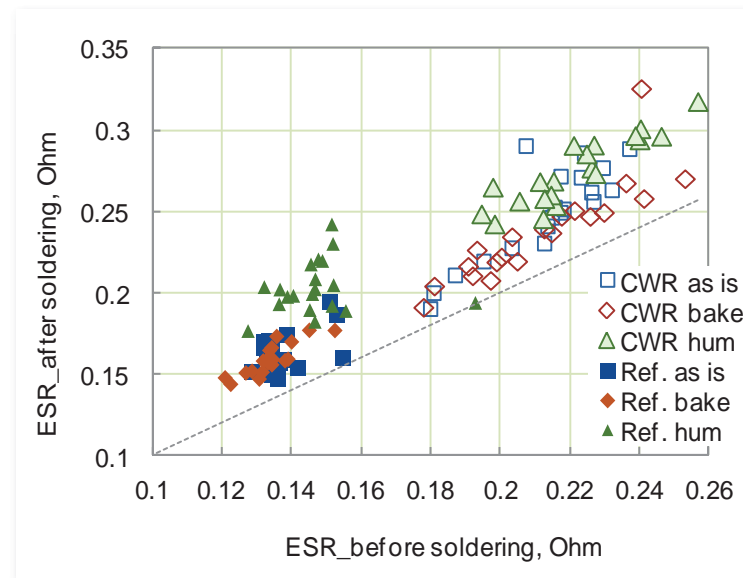
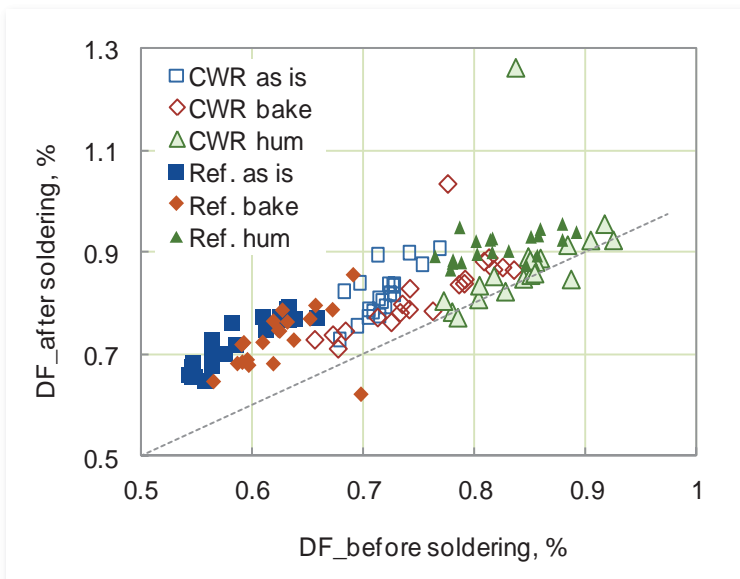
Effect of Reflow Soldering on AC Characteristics

- ✓ All post-soldering AC characteristics were within the specification limits.
- ✓ Minimal changes occur for parts after baking.
- ✓ Parts soaked in moisture had decreased C.
- ✓ ESR increases as a result of soldering for all types of preconditioning; however, degradation was greater in capacitors after moisture soak.

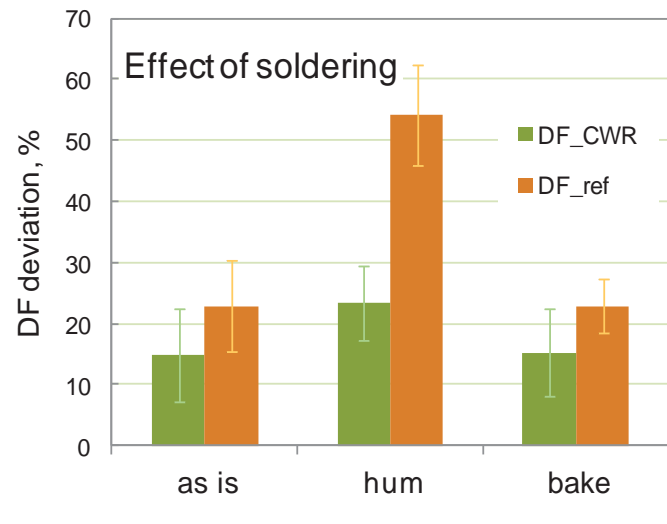
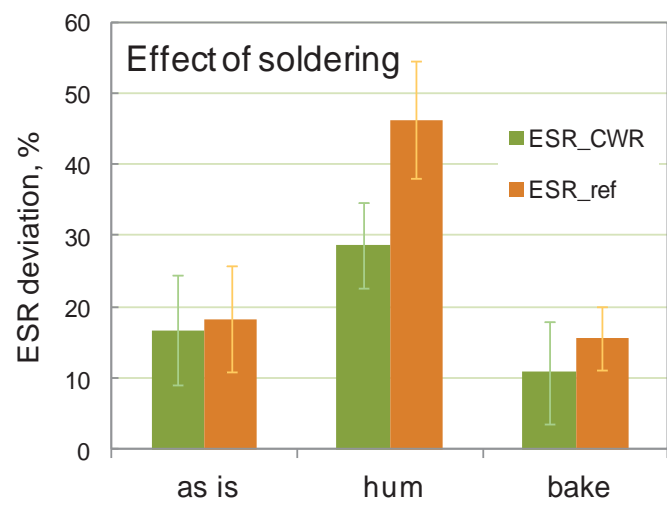
Effect of Reflow Soldering on AC Characteristics, Cont'd

- ✓ No substantial changes in capacitance.
- ✓ Degradation of DF and ESR is greater for reference parts for all types of preconditioning.
- ✓ Parts after baking increase ESR on 10% to 16%, but in the presence of moisture the increase is 29% to 46%.

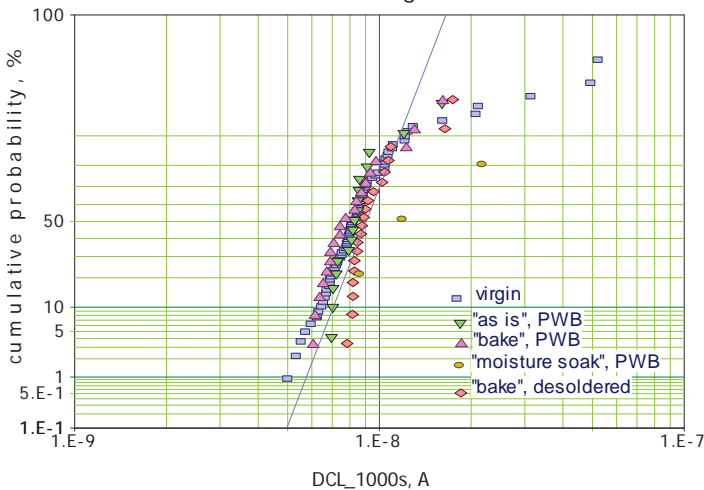
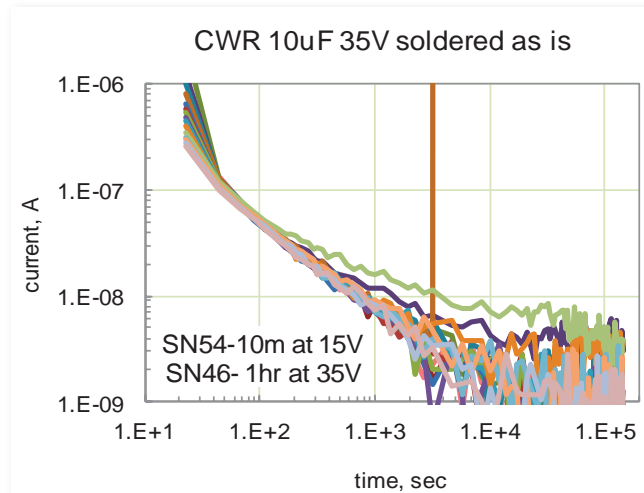
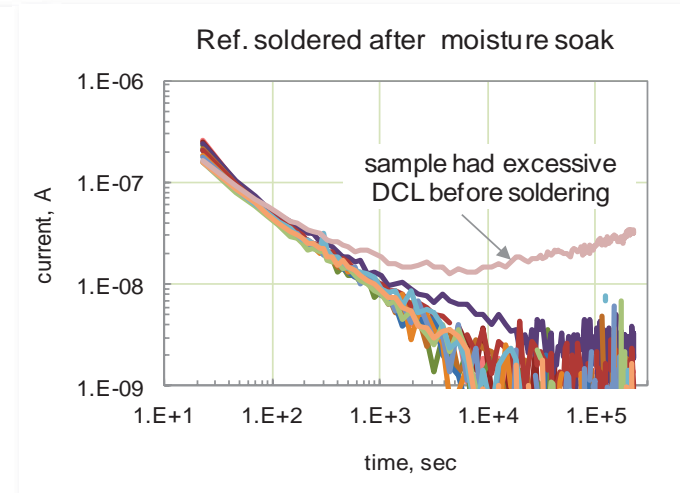
Effect of soldering, CWR29

- ✓ One CWR29 sample from Gr.II (“as is”) failed after 10 min at 15V and another after 1 hr at 35V.
- ✓ No difference in distributions of leakage current for not-failed capacitors with different preconditioning.
- ✓ Non-failed CWR29 samples from the group that was soaked in moisture before soldering had low leakage currents.
- ✓ Desoldering of baked capacitors did not change DCL distributions.

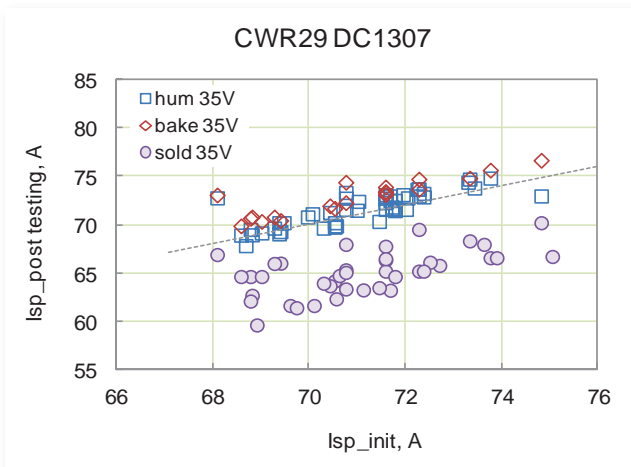
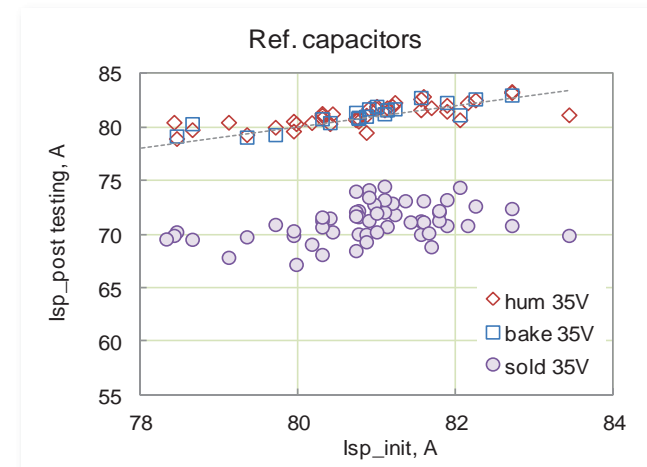
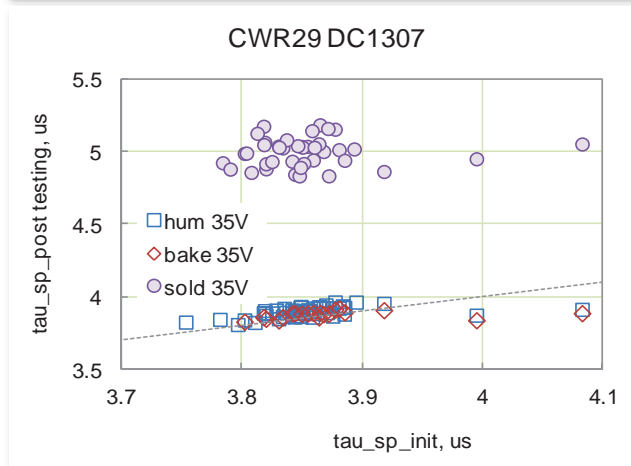
Correlation between current spike amplitudes measured initially, after different preconditioning, and after soldering

- ✓ SCT of soldered samples resulted in current spikes of a lesser amplitude (decrease ~10%) and greater width (increase ~30%).
- ✓ The result are due to increased ESR, and to using ~4" wires to interconnect the parts with the set-up that increased inductance of the circuit.

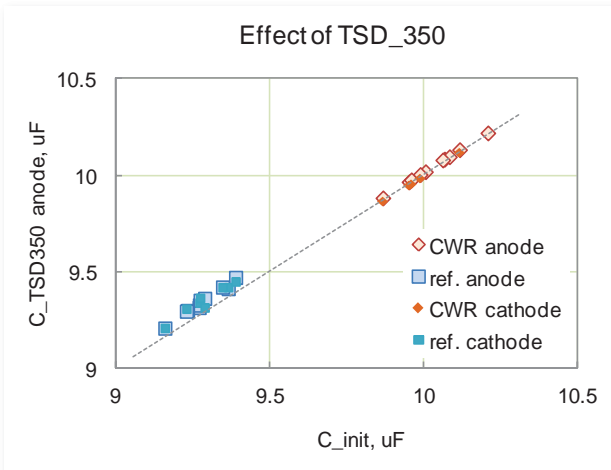
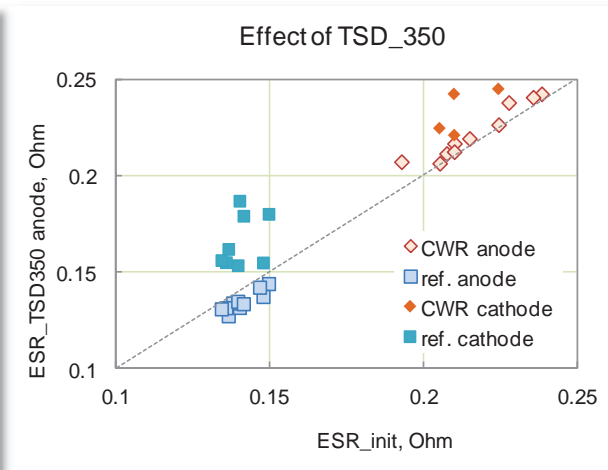
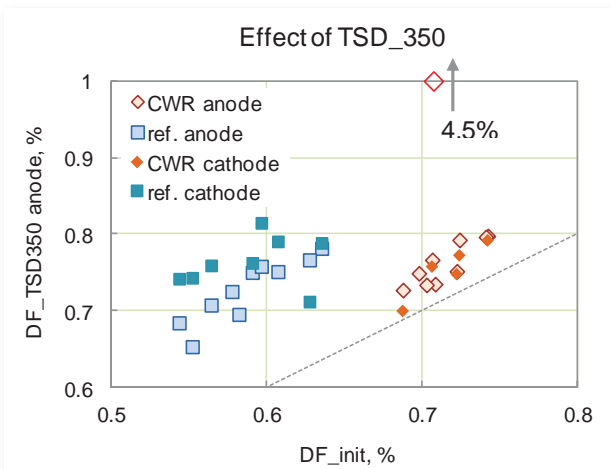
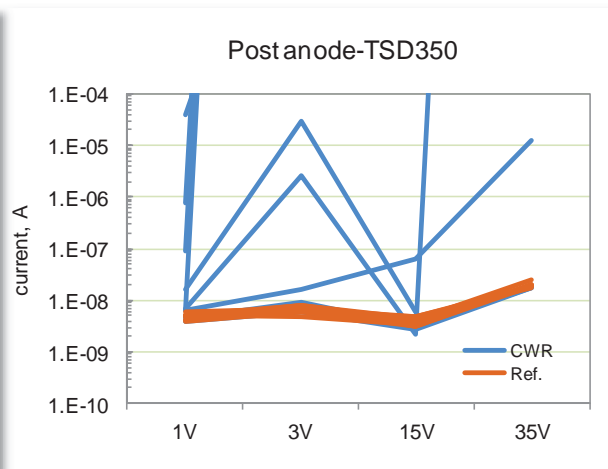
Effect of TSD350 on AC and DC Characteristics

- ✓ All AC characteristics were within the specification.
- ✓ One CWR29 part increased DF almost an order of magnitude (this part had also large DCL at 1V).
- ✓ Anode-side TSD practically did not change ESR; whereas ESR increased on 11% in CWR and 18% in ref. capacitors (similar to the effect of reflow soldering).
- ✓ Two CWR29 parts failing DCL at 3V recovered at 15V, but then failed again at 35V.
- ✓ No degradation of DCL for the reference capacitors.

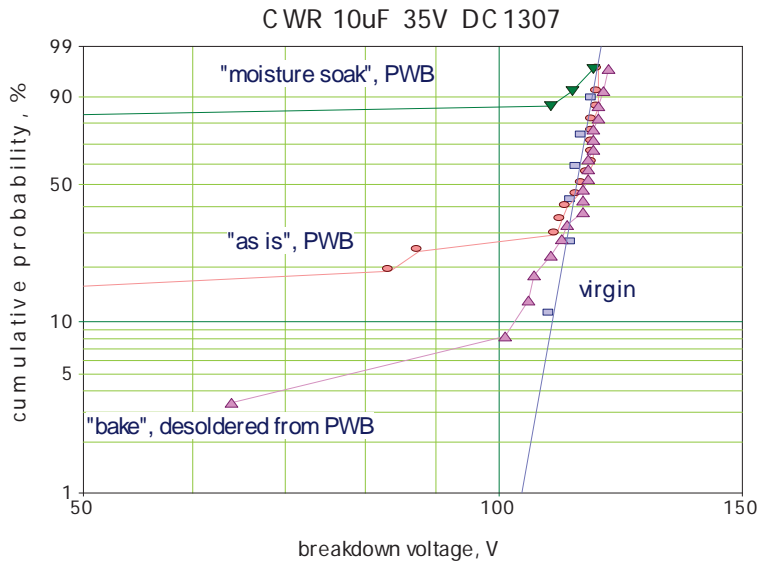
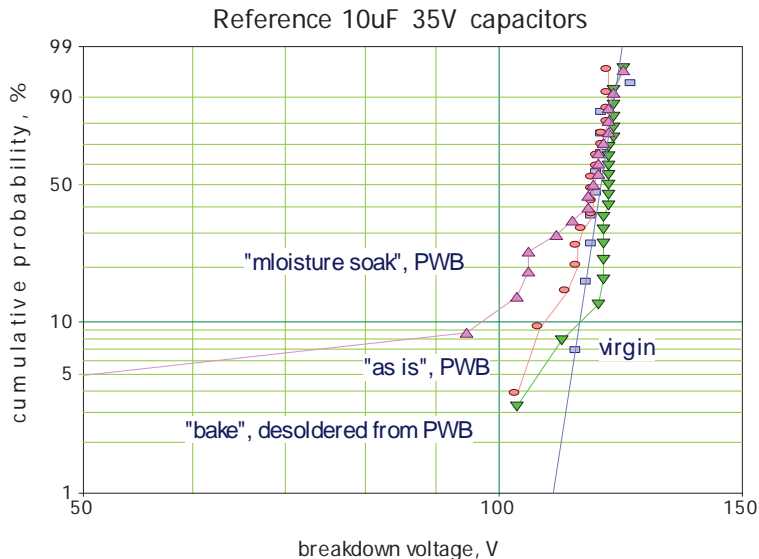
Effect of Soldering on Breakdown Voltages

- ✓ Most non-failed parts had intrinsic VBRs.
- ✓ Tails of the distributions indicate defects in Ta_2O_5 .
- ✓ There is a trend of increasing the number of defects after soldering capacitors with greater moisture content.
- ✓ Desoldering can cause damage to dielectric.
- ✓ 95% of CWR95 parts failed short circuit, whereas ~50% of the reference parts self-healed after scintillation breakdown.

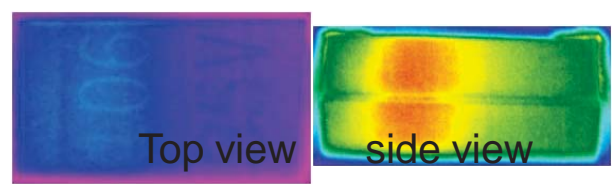
CWR29 capacitors soldered in “as is” condition

Top view
side view
SN41, VBR=118V;

✓ After breakdown tested CWR29 capacitors had damage at the anode side, whereas all reference capacitors had damage at the cathode side.

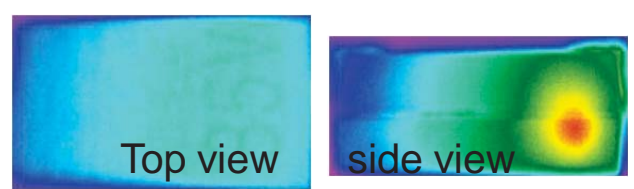
CWR09 (Ref.) capacitors soldered after moisture soak

Top view
side view
SN44, VBR=94.7V

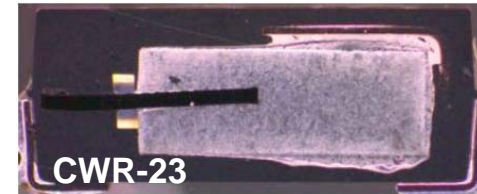
CWR29 capacitors

SN21 failed SCT, 98.7Ω ; SN22 failed SCT, $2.3k\Omega$; SN23 failed SCT, $5.2k\Omega$; SN24 high DCL, VBR=50V

- ✓ All parts except for one reference capacitor had damage at the riser wire shoulder of the anode slug.
- ✓ Reference capacitor SN1 most likely failed at the anode-side corner of the slug.

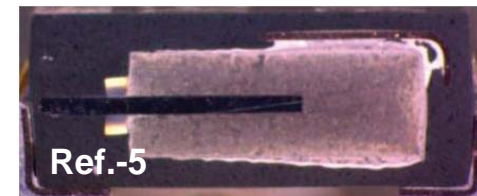
CWR09 (Ref.) capacitors

SN1, failure suspect*, VBR = 113V; SN5, failure suspect*, VBR=115V; SN10, normal, VBR=140V

* The part was not tested properly by SCT, but passed all following tests.

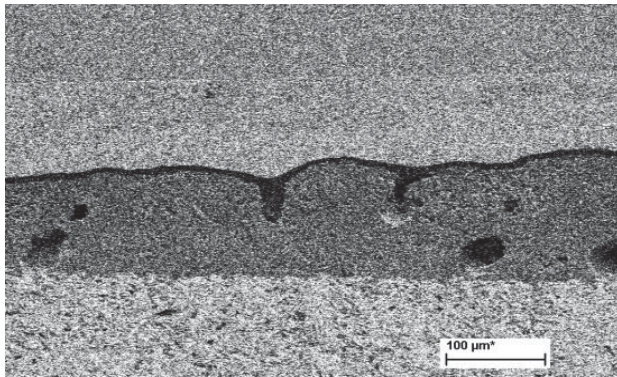
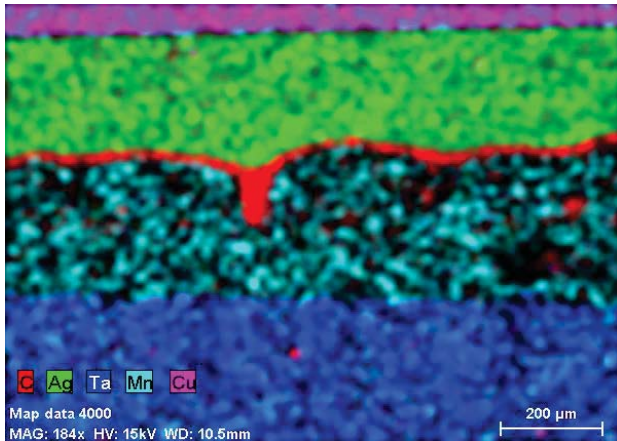
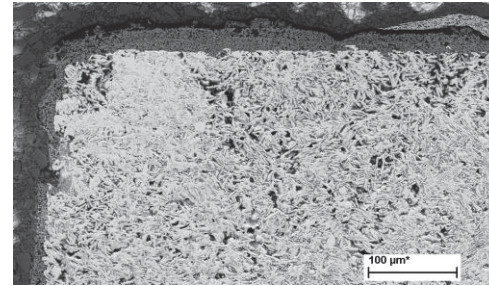
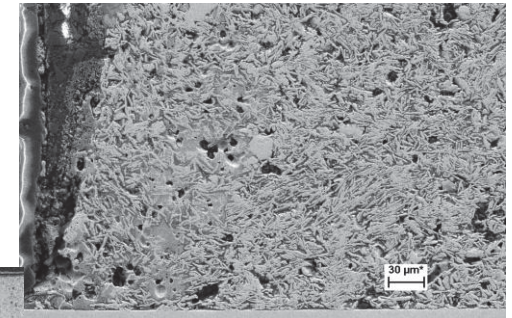
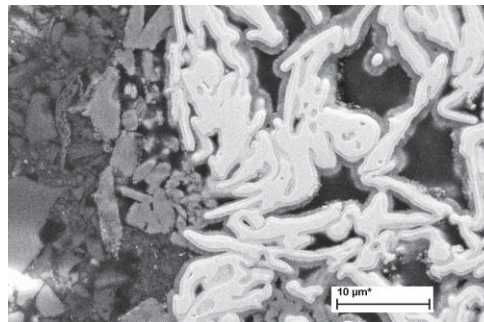
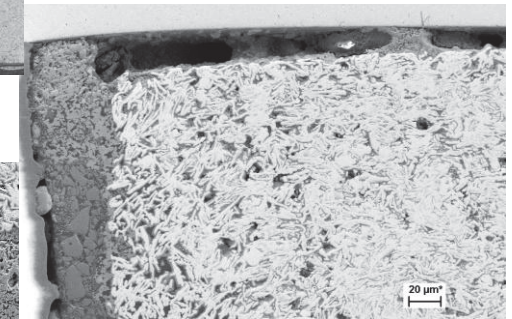
SEM Images and X-ray Mapping for CWR09 (Ref.) Capacitors

- ✓ Results for reference parts were similar to CWR29 capacitors.
- ✓ SEM and EDS analysis of cross-sectioned samples were not successful in revealing defects that might be responsible for the difference in behavior of CWR29 and reference capacitors.
