End-of-test Performance and Wear Characterization of NASA's Evolutionary Xenon Thruster (NEXT) Long-Duration Test

Rohit Shastry, Daniel A. Herman, George C. Soulas, Michael J. Patterson

NASA Glenn Research Center, Cleveland, OH 44135, USA

Presented at the 50th AIAA/ASME/SAE/ASEE Joint Propulsion Conference

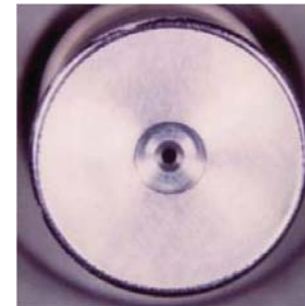
NSTAR DCA @ 0 h

- In-situ camera images of NEXT discharge cathode assembly indicate minimal change ($< 5\%$) in cathode orifice diameter
- Decreasing trend in keeper orifice diameter over last 10-15 kh found to be likely due to camera lighting degradation – repaired lighting confirms minimal change ($< 5\%$)
- Change in cathode orifice chamfer diameter confirmed at $\sim 20\text{-}25\%$ increase over 51 kh
 - Post-test inspection is needed to confirm dimension and determine overall shape of chamfer
- Change to graphite keeper material has resulted in intact electrode even after 51 kh – excessive keeper erosion observed in NSTAR has been mitigated

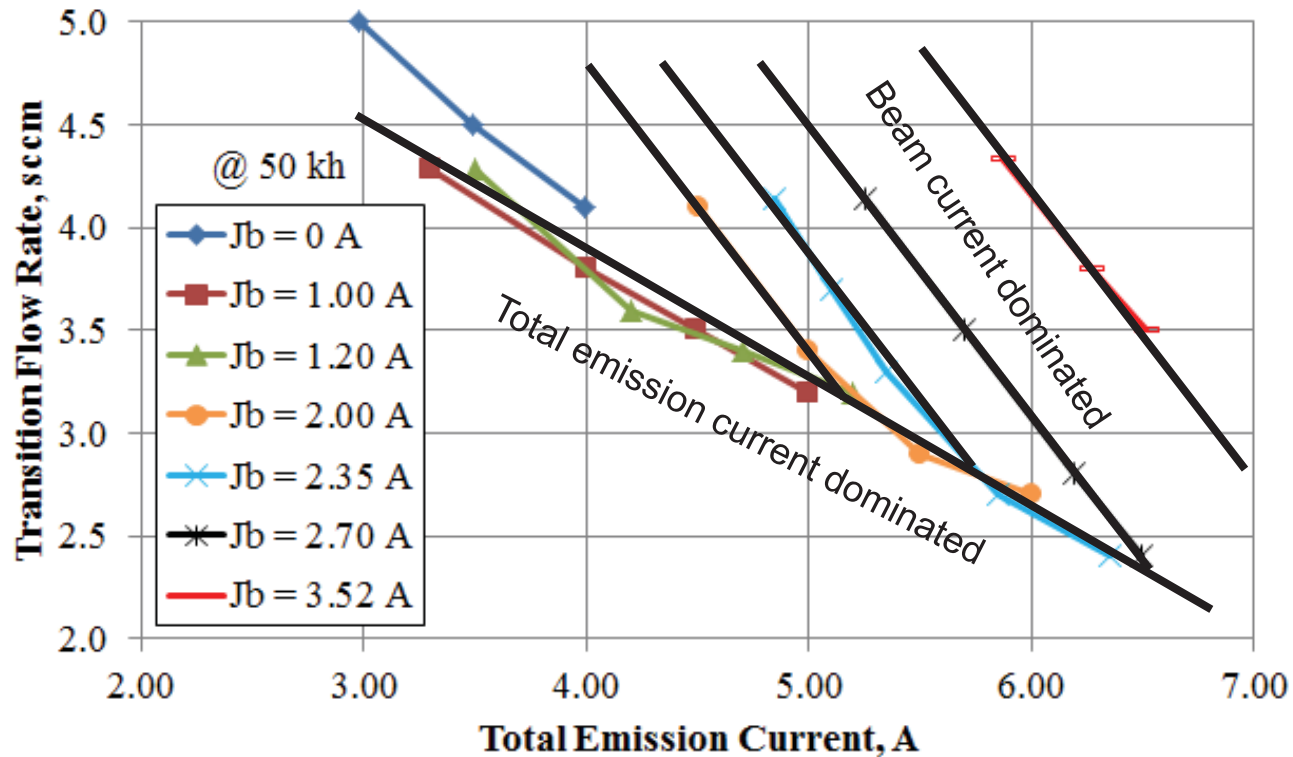
Neutralizer Keeper Current Modulation

- Two distinct behaviors present
 - Total emission current dominated – for $J_B/(J_B + J_{NK}) \leq 0.4$
 - Beam current dominated – for $J_B/(J_B + J_{NK}) \geq 0.4$
- BOL flow rates cannot be used to maintain spot mode over lifetime without increasing J_{NK} above 4.0 A

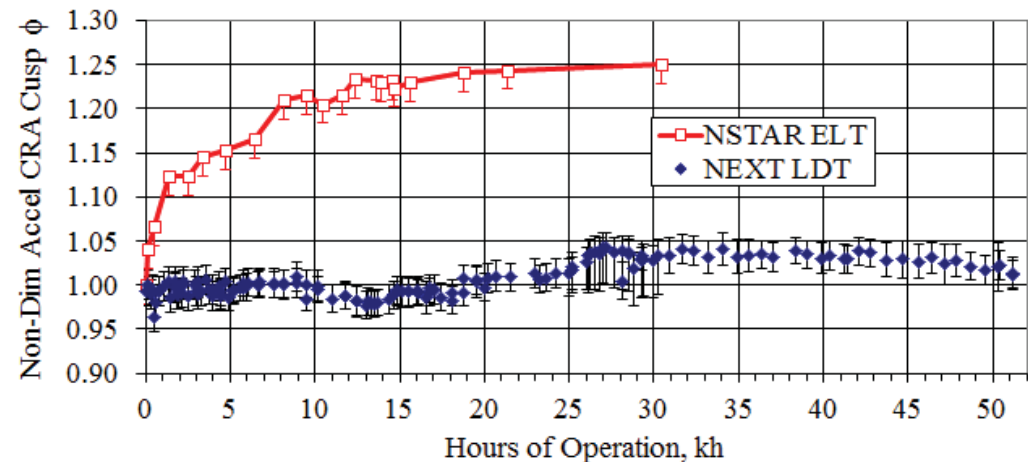
Ion Optics Cold Grid Gap

- Decrease in ion optics cold grid gap partially responsible for first failure mode of NSTAR
- Measured grid gap not available during 36-50 kh due to in-situ lighting degradation
 - Diagnostic repair allowed confirmation that cold grid gap has not changed over course of test
- Lack of change in grid gap and aperture cusp diameter has mitigated first failure mode observed during NSTAR ELT
- Presently first failure mode is expected to be penetration of pit-and-groove pattern through accelerator grid, causing loss of structural integrity of optics
