# **Failure Analysis Results and Corrective Actions Implemented for the Extravehicular Mobility Unit 3011 Water in the Helmet Mishap**

**Water entered the Extravehicular Mobility Unit (EMU) helmet during extravehicular activity (EVA) #23 aboard the International Space Station on July 16, 2013, resulting in the termination of the EVA approximately 1 hour after it began. It was estimated that 1.5 liters of water had migrated up the ventilation loop into the helmet, adversely impacting the astronaut's hearing, vision, and verbal communication. Subsequent on-board testing and ground-based test, tear-down, and evaluation of the affected EMU hardware components determined that the proximate cause of the mishap was blockage of all water separator drum holes with a mixture of silica and silicates. The blockages caused a failure of the water separator degassing function, which resulted in EMU cooling water spilling into the ventilation loop, migrating around the circulating fan, and ultimately pushing into the helmet. The root cause of the failure was determined to be ground-processing shortcomings of the Airlock Cooling Loop Recovery (ALCLR) Ion Filter Beds, which led to various levels of

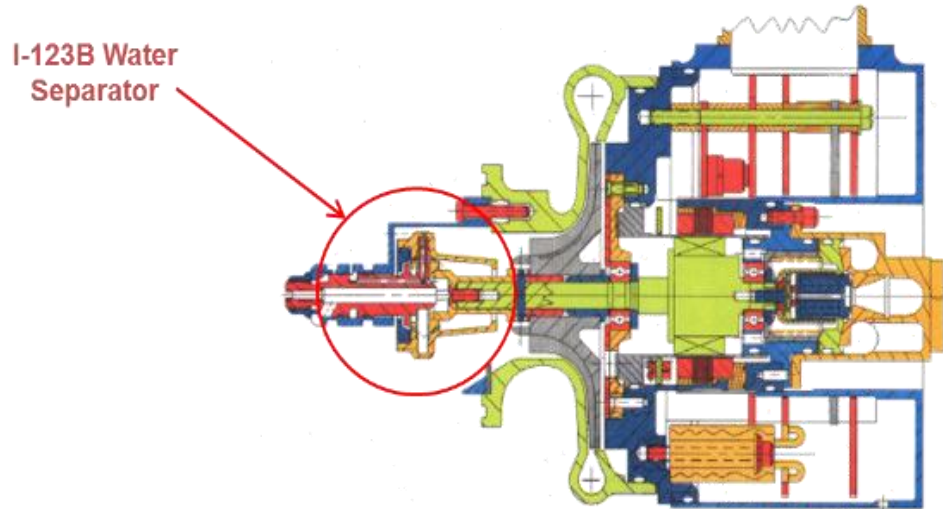
The EMU fan, pump, and water separator are coupled together through a common shaft and magnetic coupling to form what is called the FPS (Figure 1). The fan circulates oxygen over the crew member's head and throughout the suit, and pulls waste gases (e.g., carbon dioxide) and oxygen through a carbon-dioxide-removal cartridge. The pump, which is isolated from the ventilation loop via a magnetic coupling, circulates coolant loop water through the EMU's sublimator heat exchanger and throughout the LCVG. Humidity from the crew member's exhalation and sweat is also condensed in the sublimator and sent to the water separator where the water is removed and returned to the water loops. In addition to this condensate, water from the EMU coolant loop is continuously flowing through the water separator to facilitate constant coolant loop circulation for degassing purposes.<sup>2</sup>

**Figure 1. Cutaway view of the EMU FPS.**

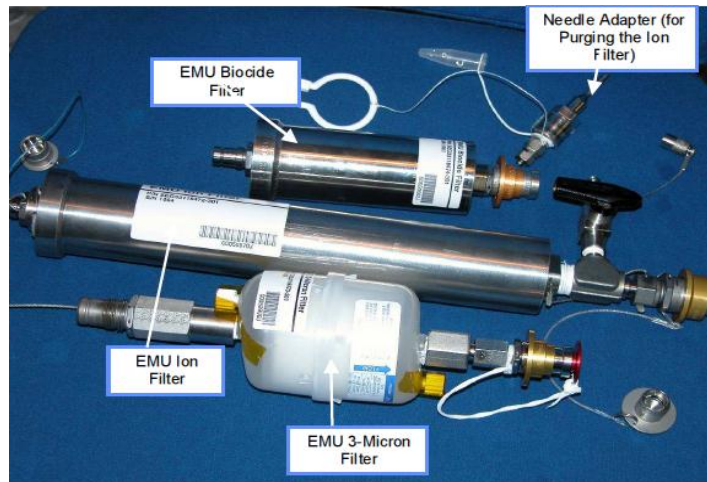
The ALCLR water processing kit (Figure 4) was devised to scrub and remediate the various chemical and biological contaminants and by-products that were found to have fouled the magnetically coupled pump in the EMU Transport Water Loop FPS. The heart of the kit is the EMU Ion Filter, which is a 50:50 by volume packed bed of mixed anion/cation exchange resin and activated carbon. This component is periodically installed inline to the EMU and Airlock Heat Exchanger coolant loop and serves the purpose of removing inorganic and organic constituents such as nickel and iron corrosion products and organic acids with the ion exchange resin. Furthermore, uncharged organic contaminants are removed with the activated carbon.<sup>4</sup>

**Figure 4. ALCLR processing kit components.**

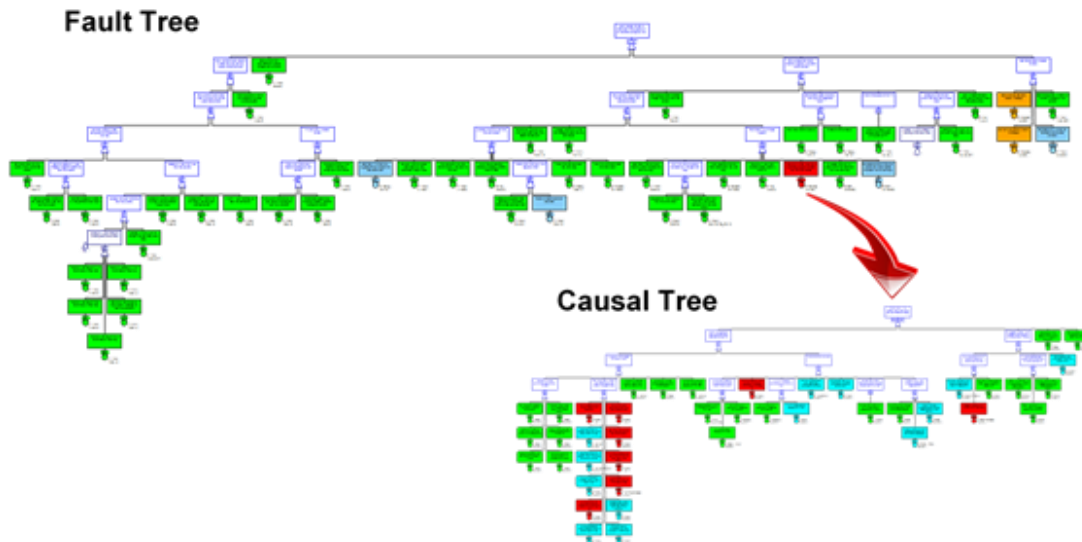
**Figure 8. Relationship of fault tree to causal tree.**

The scope of the failure investigation effort was defined by the activities related to the evaluation of first a proximate cause fault tree, and then a causal tree. The proximate cause for this failure investigation was determined by a fault tree. Within days of the failure, a fault tree was created that included all credible hardware failure mechanisms that could result in the observed failure signature during EVA 23. The top event, or failure signature, was “Liquid leakage internal to EMU 3011 free volume on 07/16/2013 during EVA 23.” Potential leakage sources included: bodily fluids that migrated to the helmet; EMU element failures that would result in water leakage into the suit free volume, then migrate to the helmet; and EMU element failures that would import water directly to the helmet or introduce it through the vent loop. This fault tree scoped the actions necessary to determine the proximate cause of the failure.<sup>1</sup>
