Clearance Analysis of CTC2 (on ELC4) to S-TRRJ HRS Radiator Rotation Envelope

Donn Liddle

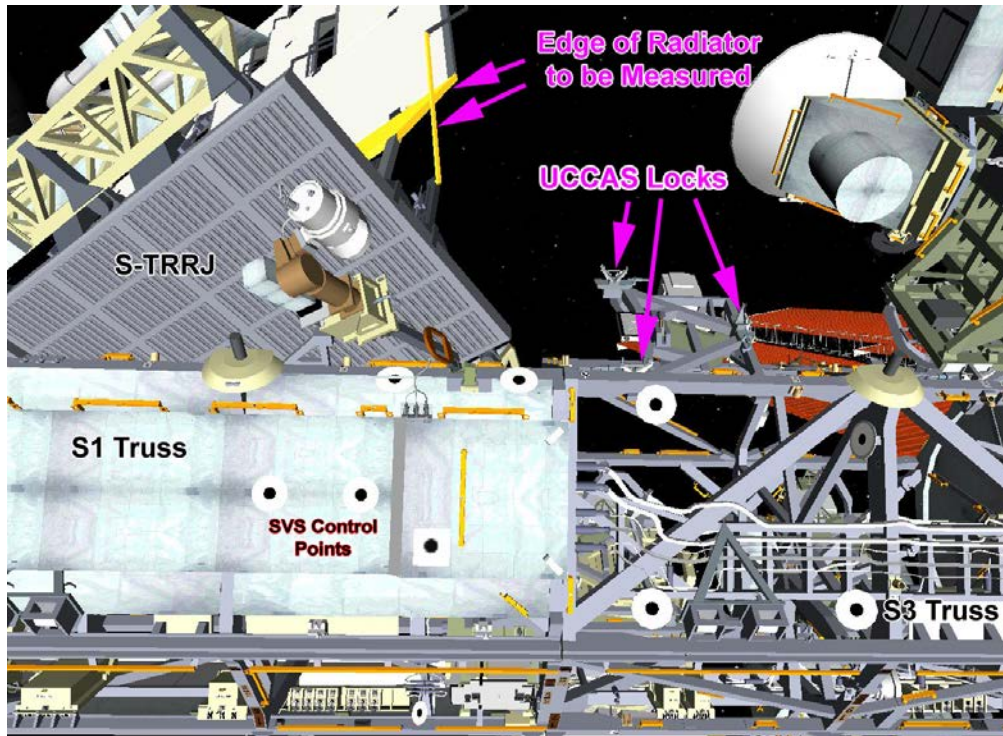
Figure 2.– Phase I measurements.

The location and orientation of the UCCAS fittings, which support and hold the ELC4 in place, would be measured relative to the ISS Analytical Coordinate System (ISSACS) as defined by nine preexisting Space Vision System (SVS) targets affixed to the forward/zenith side of the S1 and S3 truss segments (see figure 2). The location of the outboard edge of the S-TRRJ radiator would also be measured when positioned at the angle of closest approach to CTC2 ($\gamma = 35.0$ degrees). This data would allow the Digital Pre-Assembly Group to predict how the ELC4 would sit on the UCCAS and how that would translate into the clearance between CTC2 and the S-TRRJ radiators.

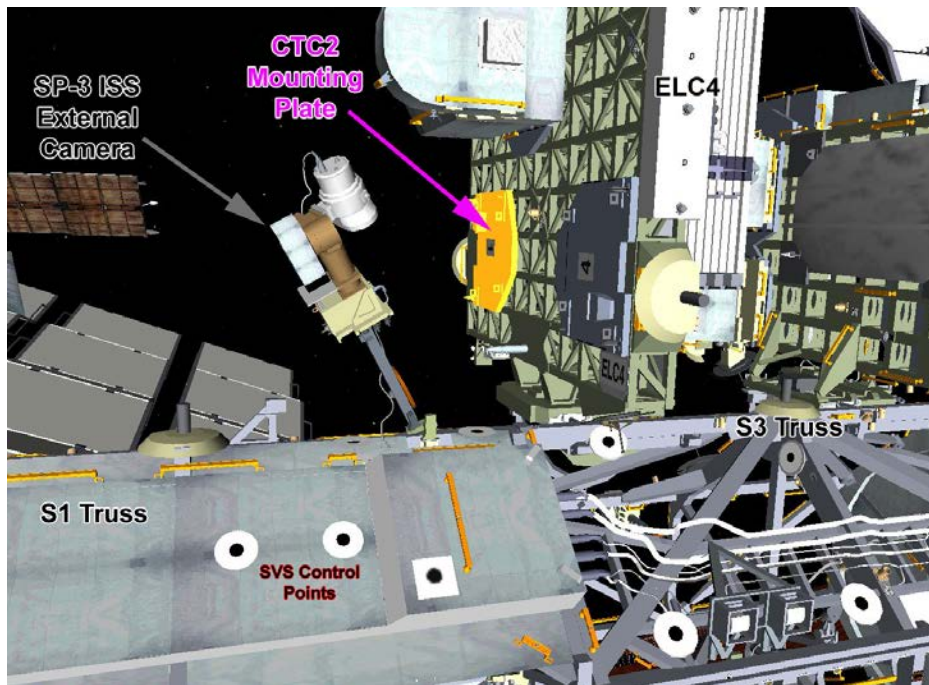
Figure 3.— Phase II measurements.

After the ELC4 was delivered and installed into the UCCAS, the position of the CTC2 mounting plate on the inboard face of ELC4, would be measured in the ISSACS coordinate system relative to the SVS control points used in Phase I. Although CTC2 would not yet be mounted on ELC4, the working envelope of CTC2 could be mathematically added to the measured position of ELC4 to produce a best estimate for CTC2's mounted location. Comparing CTC2's best estimated location to the S-TRRJ radiator (measured in Phase I); relative to the ISSACS coordinate system, would provide a direct measurement of the expected clearance.

“The combined measurement showed a clearance of 10.84” between the radiator and the CTC-2 (a bit better than expected). When we account for worst case conditions (worst possible thermal effects + worst on-orbit loads + uncertainty in our measurements & models) we still show an analyzed clearance of 7.89” (again, the best clearance we’ve seen).”
