Development Testing and Subsequent Failure Investigation of a Spring Strut Mechanism

Abstract

The NASA Engineering and Safety Center (NESC) and Lockheed Martin (LM) performed random vibration testing on a single spring strut development unit to assess its ability to withstand qualification-level random vibration environments. Failure of the strut while exposed to random vibration resulted in a follow-on failure investigation, design changes, and additional development tests. This paper focuses on the results of the failure investigations referenced in detail in the NESC final report [1] including identified lessons learned to aid in future design iterations of the spring strut and to help other mechanism developers avoid similar pitfalls.

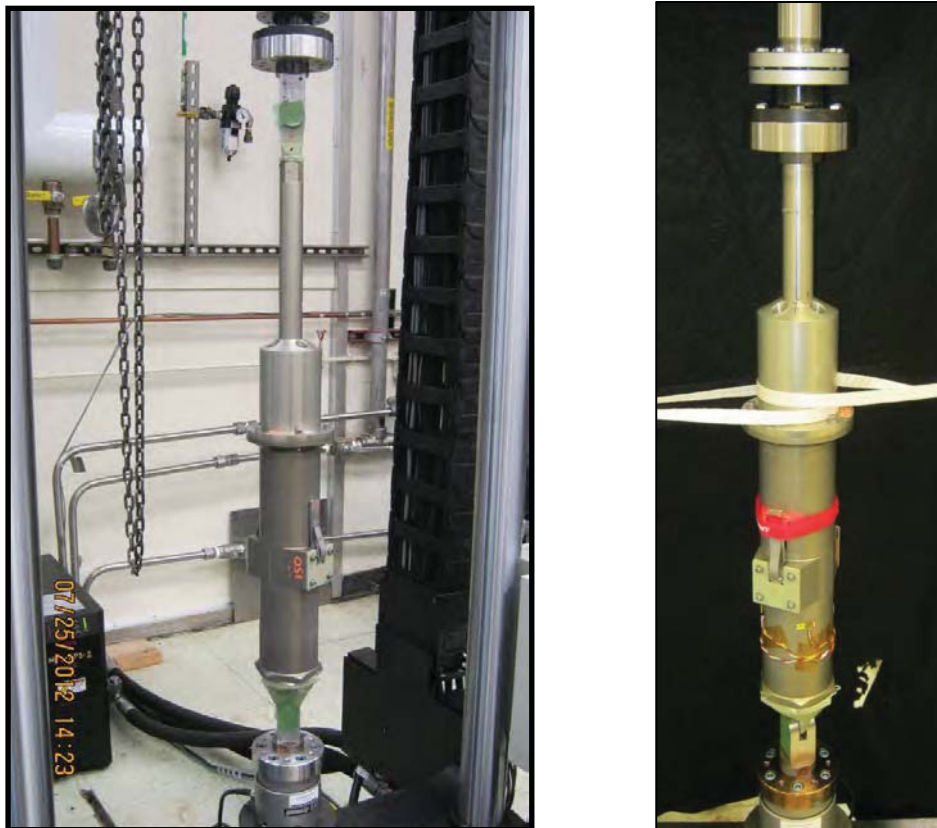
Figure 7. Test Setup for Performance Testing (Pre-Vibe [left] and Post-Vibe [right])

After failure during the random vibration testing, the strut was returned to the performance testing facility with a truncated secondary piston to remove the failed portion of the strut. Using a cupping interface, post-vibe performance deployment tests were performed with the strut assembled in the load frame. The post-vibration performance test served primarily to assess whether there were any large excursions from the nominal force-deflection curve. These excursions could be indicative of significant damage to the spring strut sliding surface. The post-vibration performance test satisfied the nominal expected end of travel force of $165 \text{ N} \pm 27 \text{ N}$ ($37 \pm 6 \text{ lbf}$) and resulted in nominal engagement of the anti-back travel latches. Force versus displacement within the expected tolerance yielded acceptable force margin based on the next high assembly assumptions and calculations. A comparison of the pre- and post-random vibration performance test is shown in Figures 8.
