Space Shuttle Stiffener Ring Foam Failure Analysis, a Non-conventional Approach.

Philip M. Howard

NASA

Materials Science Division

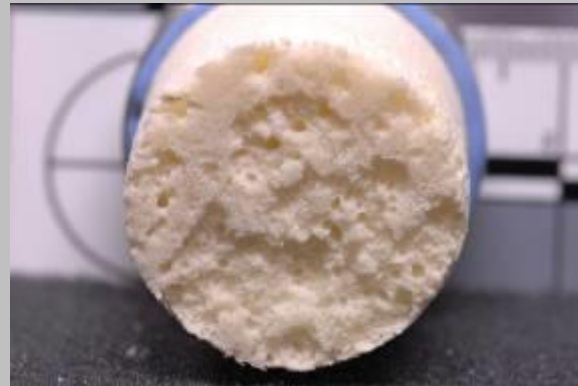
- ATK define the foam failures qualitatively by visual inspection of the presence or absence of foam residue on the de-bonded surface.
- Foam Failures fall into two categories
 - Adhesive
 - Cohesive
 - Mixture of both

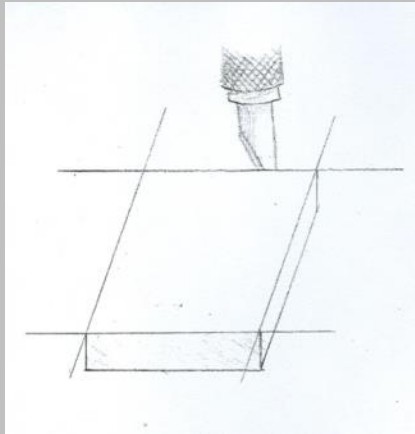
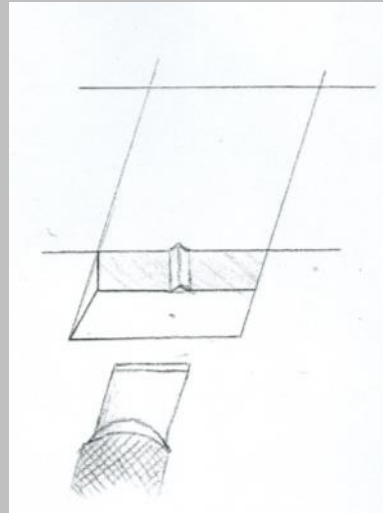
Cross Sectioning of Foam

- Plastic slide with double
- sided tape

• 1st cut 1 mm
section single edge
razor

• 2nd cut 0.5-1mm
section double
edge razor
