Title ELECTRON MICROSCOPY ABRASION ANALYSIS No. Copies Required 30Page 1 of 1

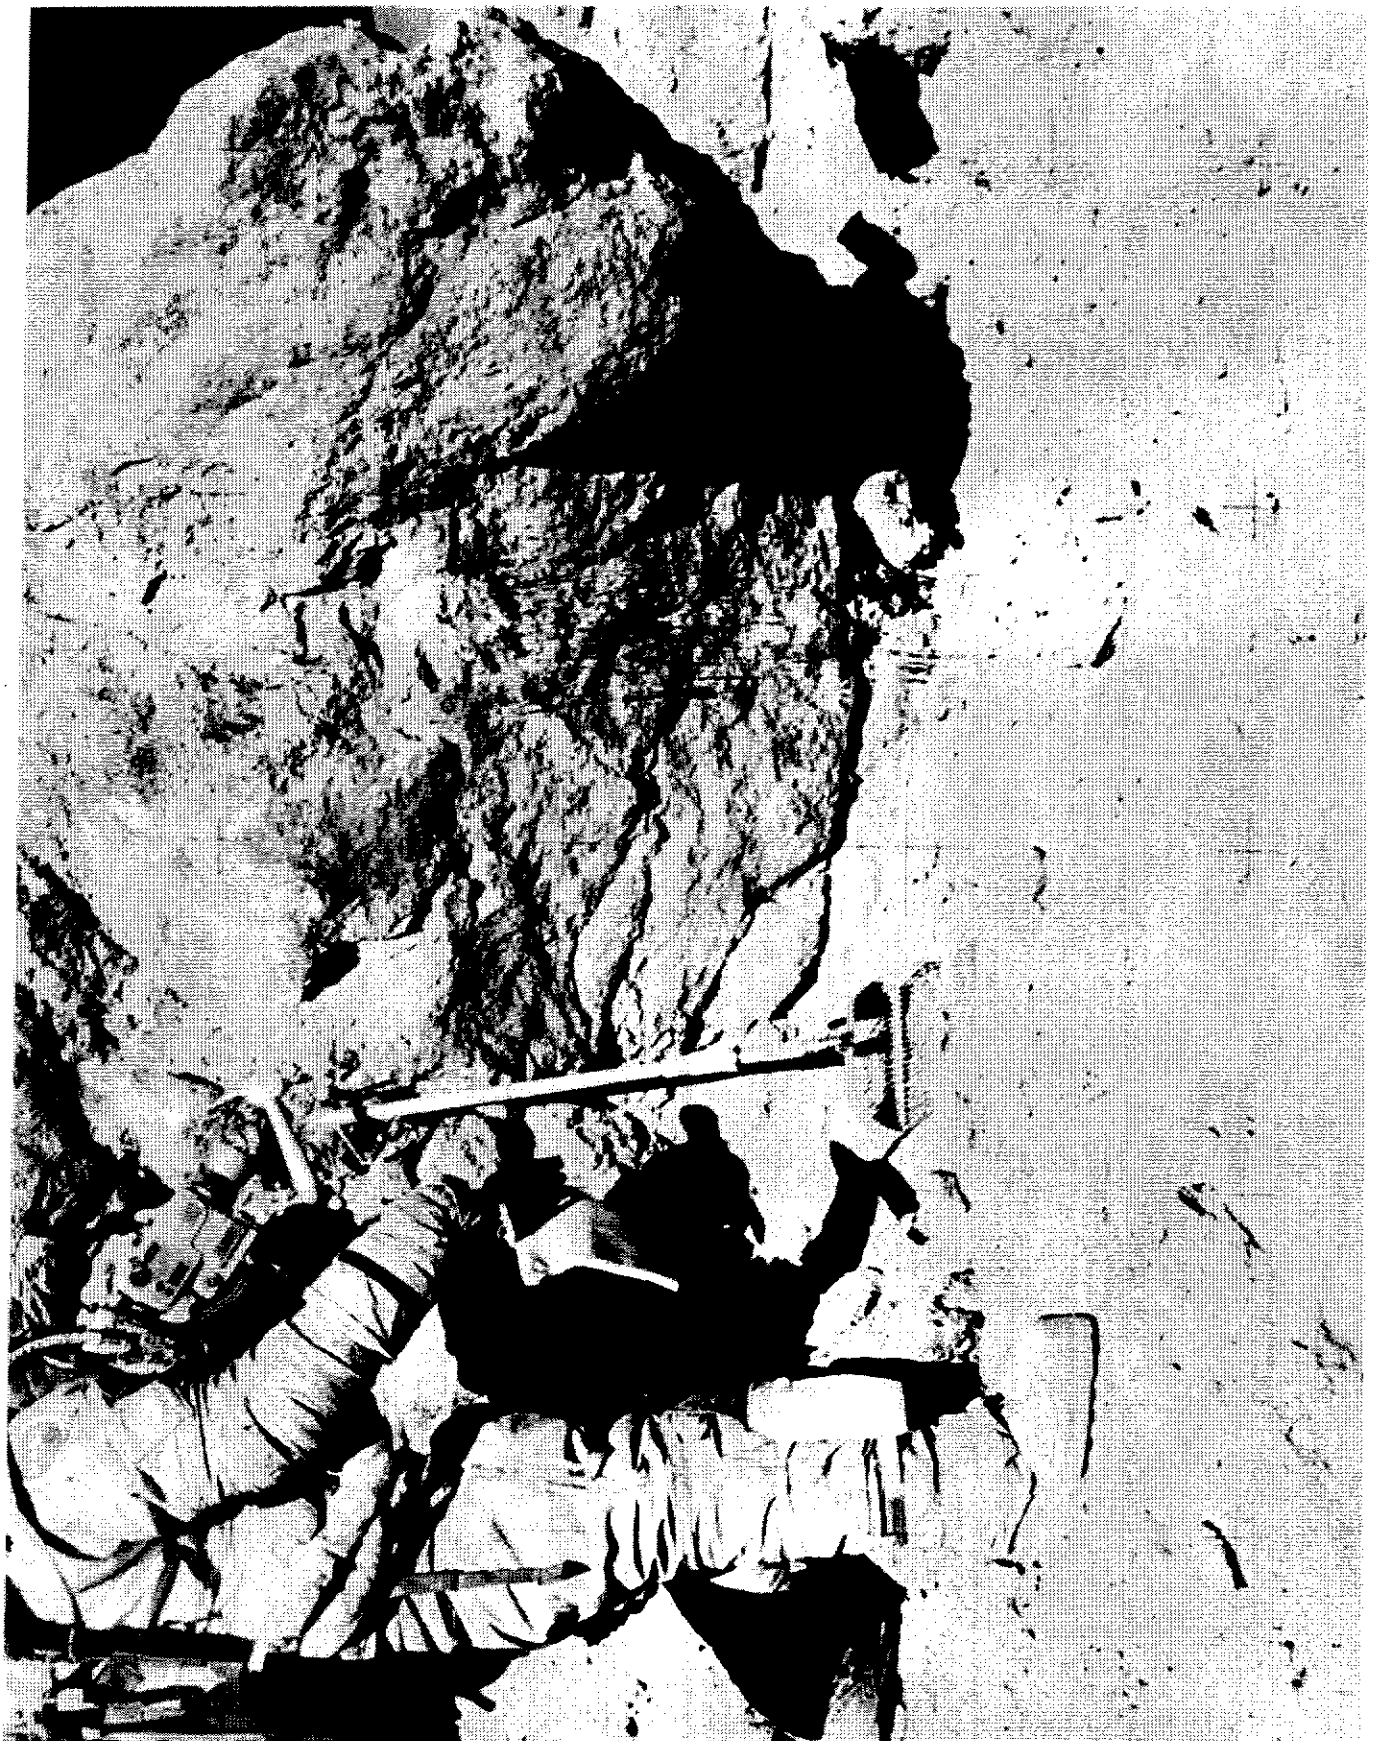
Figure 1 shows an Apollo 16 astronaut collecting lunar surface samples. The soot-like dust covers the entire lunar terrain. The

astronaut's EVA suit is contaminated by dust, especially the lower leg and knee area, lower arms and elbows, and gloves. It is easy to see that the dust is also soiling the other EVA equipment.

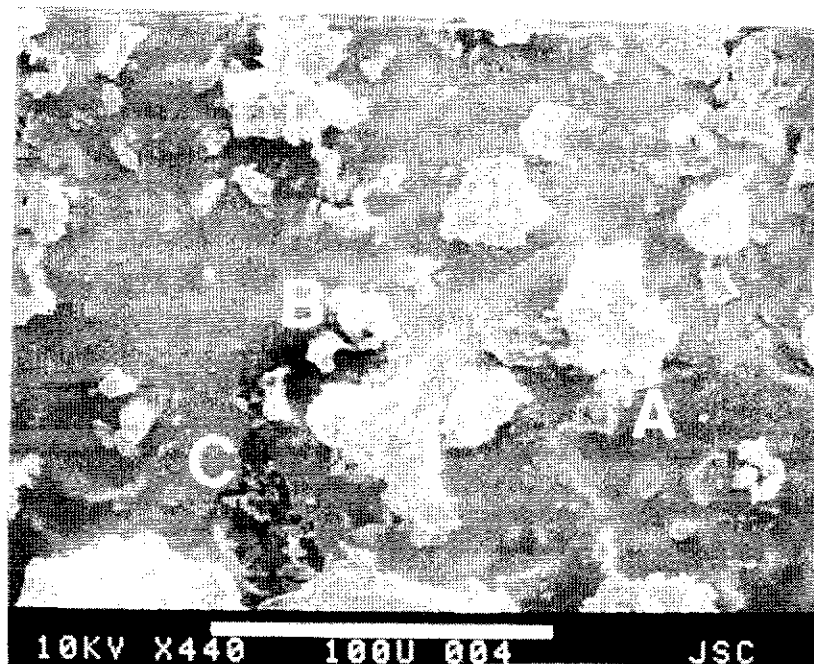
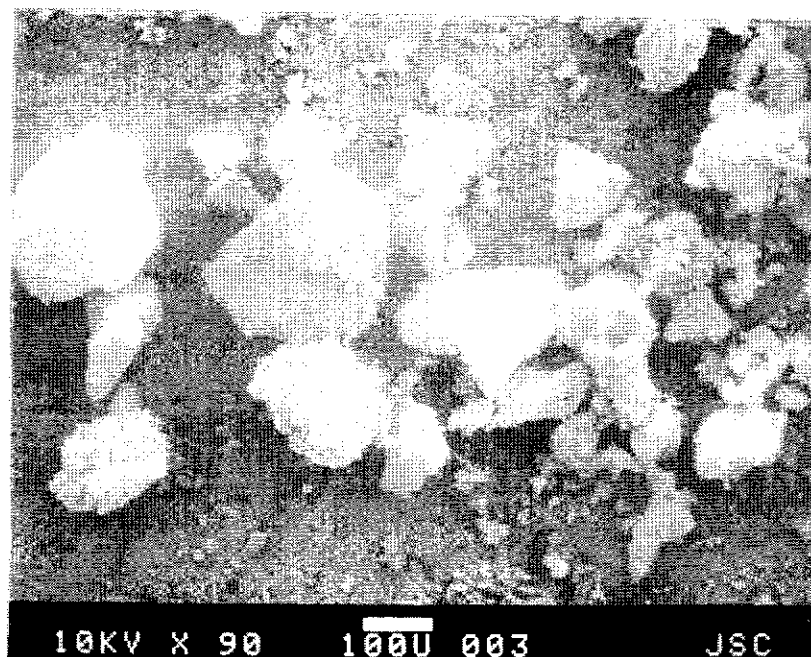
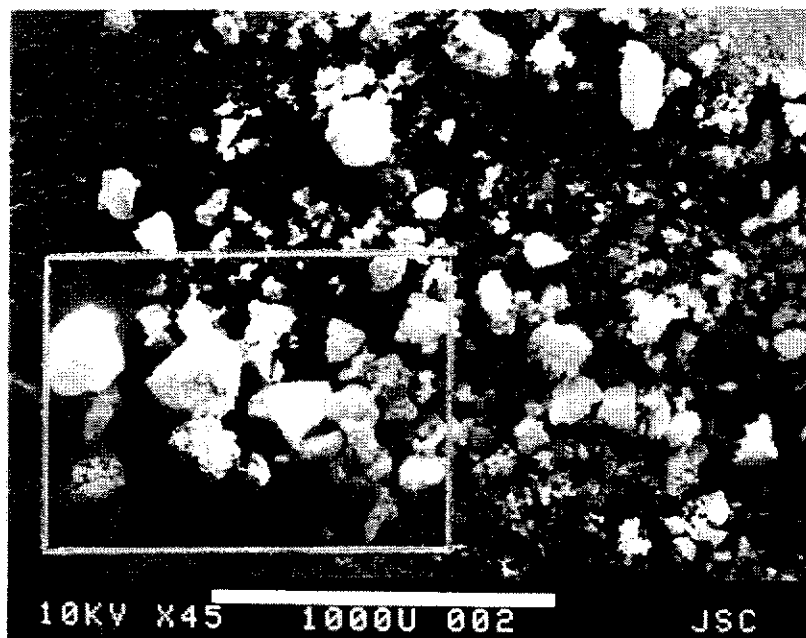
The simulant particles seen in Figures 7, 8 and 9 are all irregularly-shaped with the refractory glass having sharp edges and the volcanic rock looking powdery. These micrographs give the reader an example of what the dust simulant will look like on the tumbled fabrics during the SEM analysis.

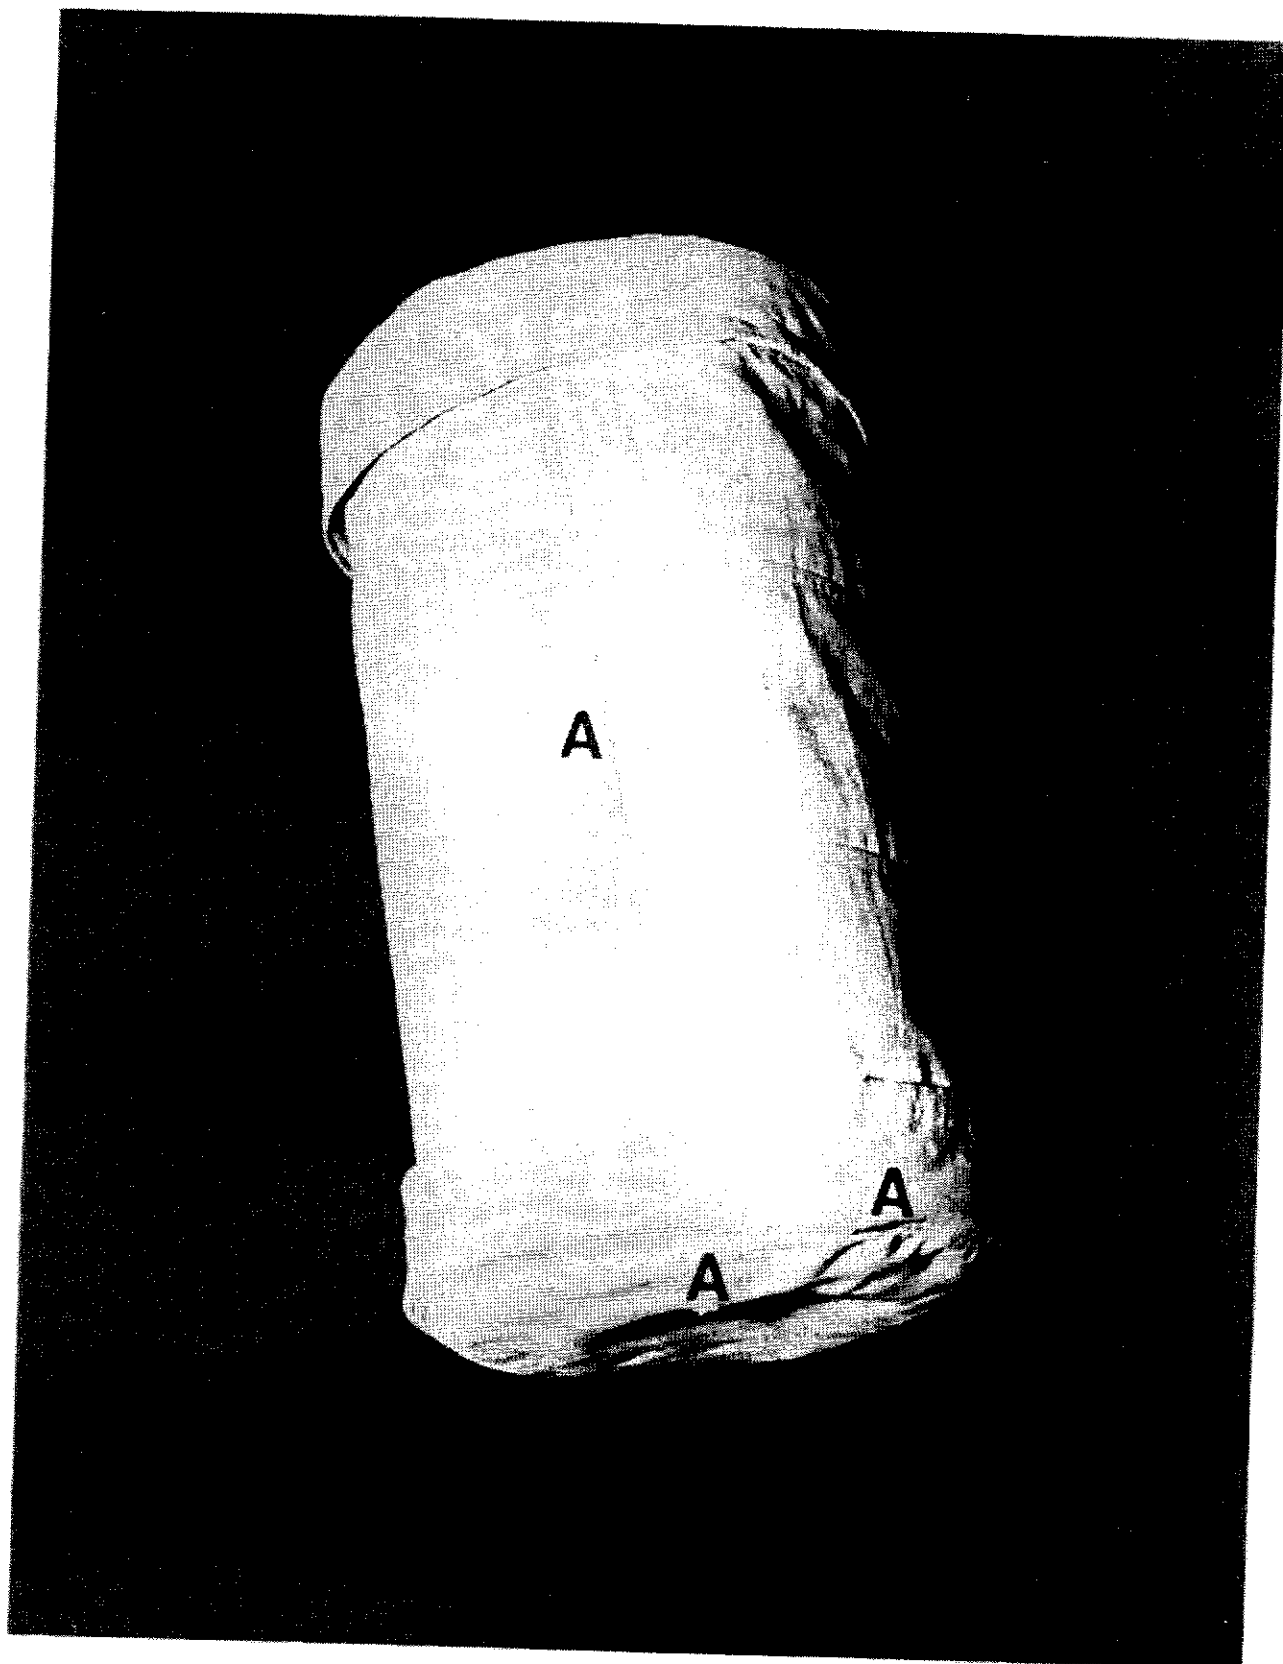
Figure 11 is a photo of the unpressurized test cylinder after eight hours of tumbling with the lunar dust simulant. Before the photo was taken, the excess dust was shaken off the test article and the outside of the fabric cylinder was vacuum cleaned. Still, there is a significant amount of powdery dust adhering to the surface of the cylinder. The dust seems to be uniformly distributed on the body of the cylinder with a high concentration of dust in areas of high relief and a low concentration in areas where the fabric has been indented. Minor tears (see A) appear along the restraint seam, cylinder corners and on the endcaps. There are no visible tears on the body of the cylinder where the dust is fairly evenly distributed. Note that the severity of the tumbling procedure did not cause the seams to pull loose.

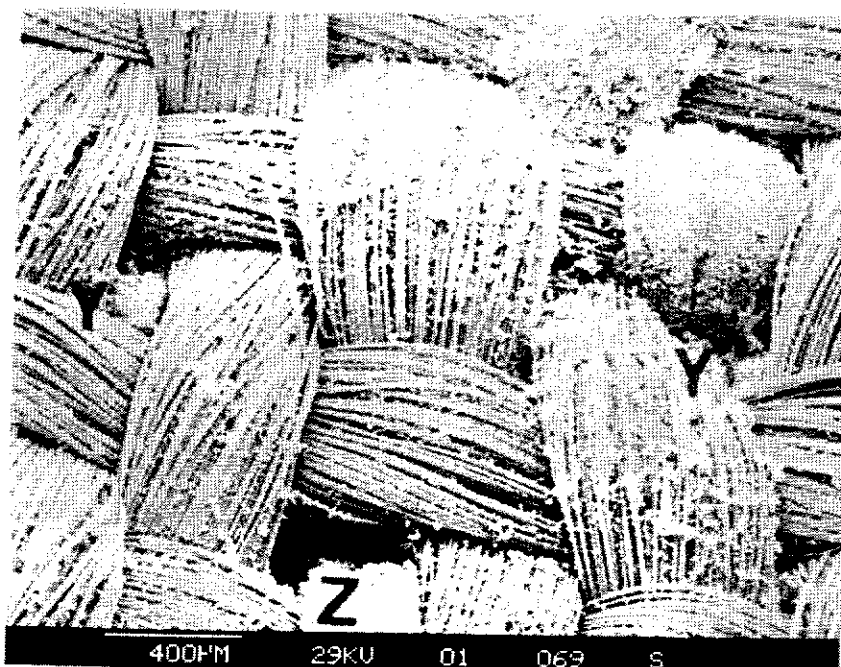
Figure 26

After tumbling, there is an even layer of fine particles covering the back face of the Orthofabric. These particles are in between the fibers of the Nomex and Kevlar bundles; they have also filled up the gaps in the fiber weave (Y) indicating migration of the lunar dust simulant from the front to the back face of the fabric. The gap (W) in the weave seen in Figure 25 is visible here (Z) but is not completely filled with dust. Unlike the front, it appears that there is little fiber damage to the back face; this is most likely because the back was not directly exposed to the tumbling.

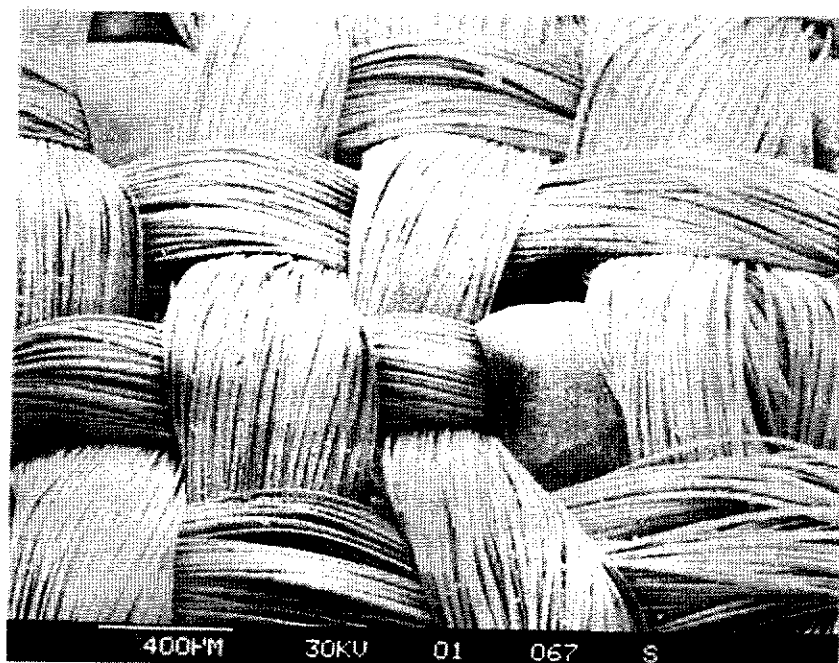
Figure 27

The ultrasound cleaning procedure has removed nearly all of the particles from the back face of the fabric. Compared to Figure 25, the specimen is as clean as the new fabric. This view illustrates that there was little, if any, damage to the Nomex, Kevlar or Gore-Tex fibers on the back face of the fabric.

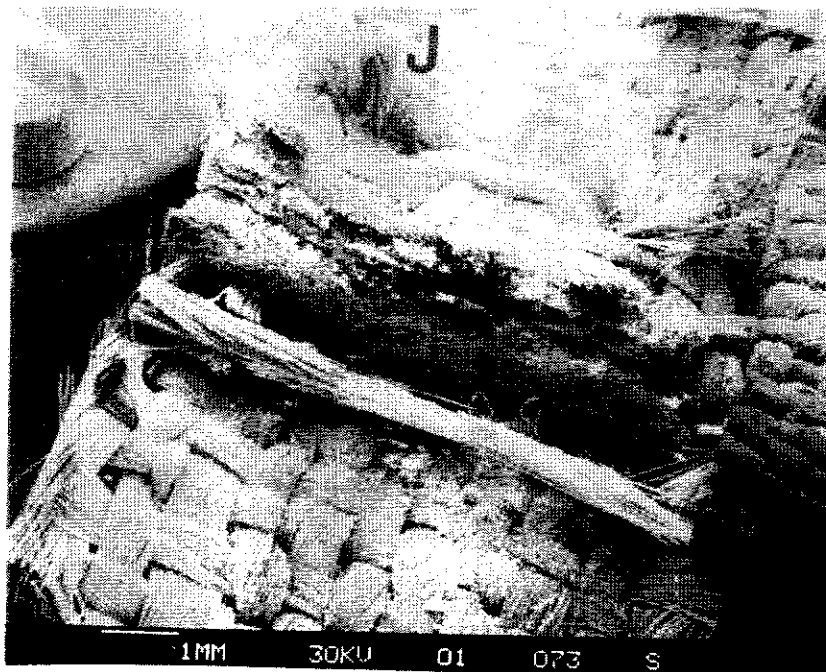
Figure 32

Looking at the back face after tumbling shows a high concentration of dust at the seam (J). When obtaining the seam sample from the tumbled test cylinder, it was visually observed that there was a significant amount of dust on the insulation layers of the test article underneath the seams. As with the gaps in the back face of the fiber weave, this micrograph is evidence that there is an unobstructed path at the seam for the dust to follow through the fabric. The cut fibers have frayed a little more; but like Figure 29, there is not any evidence of fiber abrasion at this magnification, only a lot of dust on the fabric.

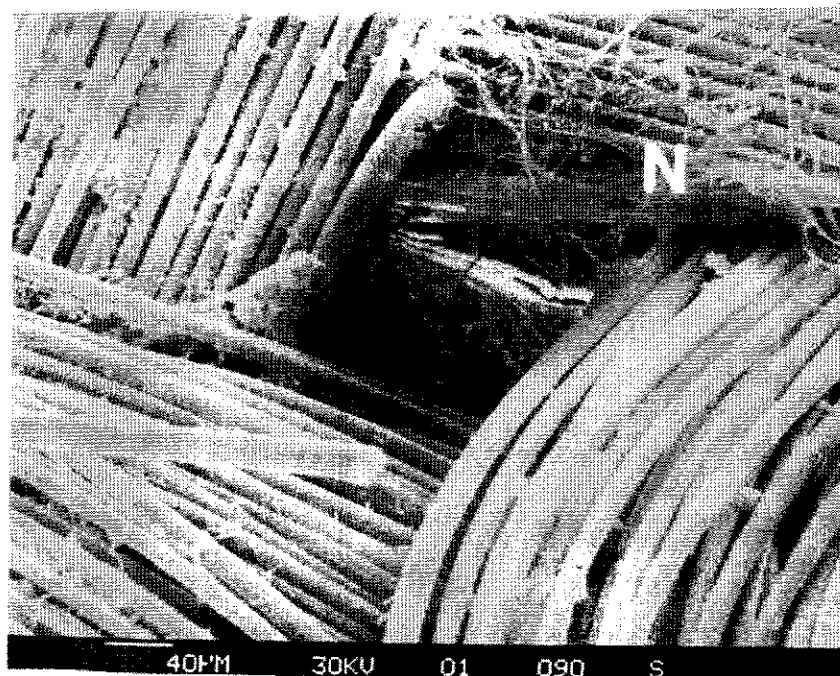
Figure 36

After the ultrasound cleaning, the gap shown in Figure 35 is essentially free of dust. The surrounding Kevlar fibers show evidence of abrasion; at the entrance to the gap, Kevlar fibrils (N) are present. This abrasion is probably due to a combination of the large amount of lunar dust simulant migrating through the fabric at this location along with possible fabric to fabric friction along the fold during the tumbling process.

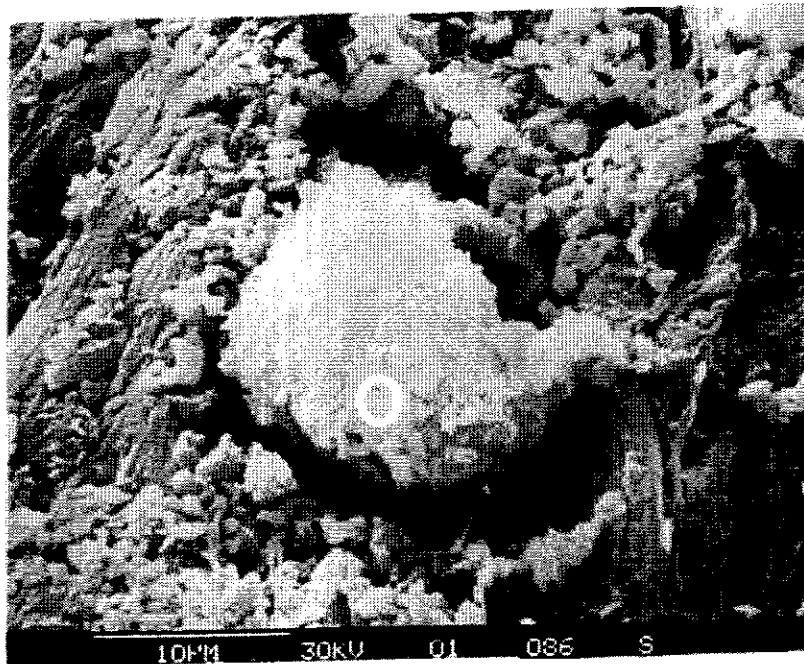
Figure 37

This figure is a close-up view (2500x) of a single Gore-Tex fiber. The fiber was found on the front face of the Orthofabric weave after tumbling where the Gore-Tex received the most severe damage. In the center of the micrograph (O) is a large dust simulant glass particle covered with volcanic rock and fiber debris. The particle has rolled back and forth, tearing away at the fiber and has created a large crater on the surface. This action describes a wear mechanism similar to plowing along with cyclic microcutting. Plowing is the action of a particle moving across a surface and scratching a groove; here the particle stays in one place after the initial penetration. Cyclic microcutting involves scooping the excess material out of the groove and releasing the material as a particle(s) of fiber debris. There is a significant amount of debris on the rest of the fiber, probably from the described wear mechanism and from the tumble test abrading particles of the lunar dust simulant.

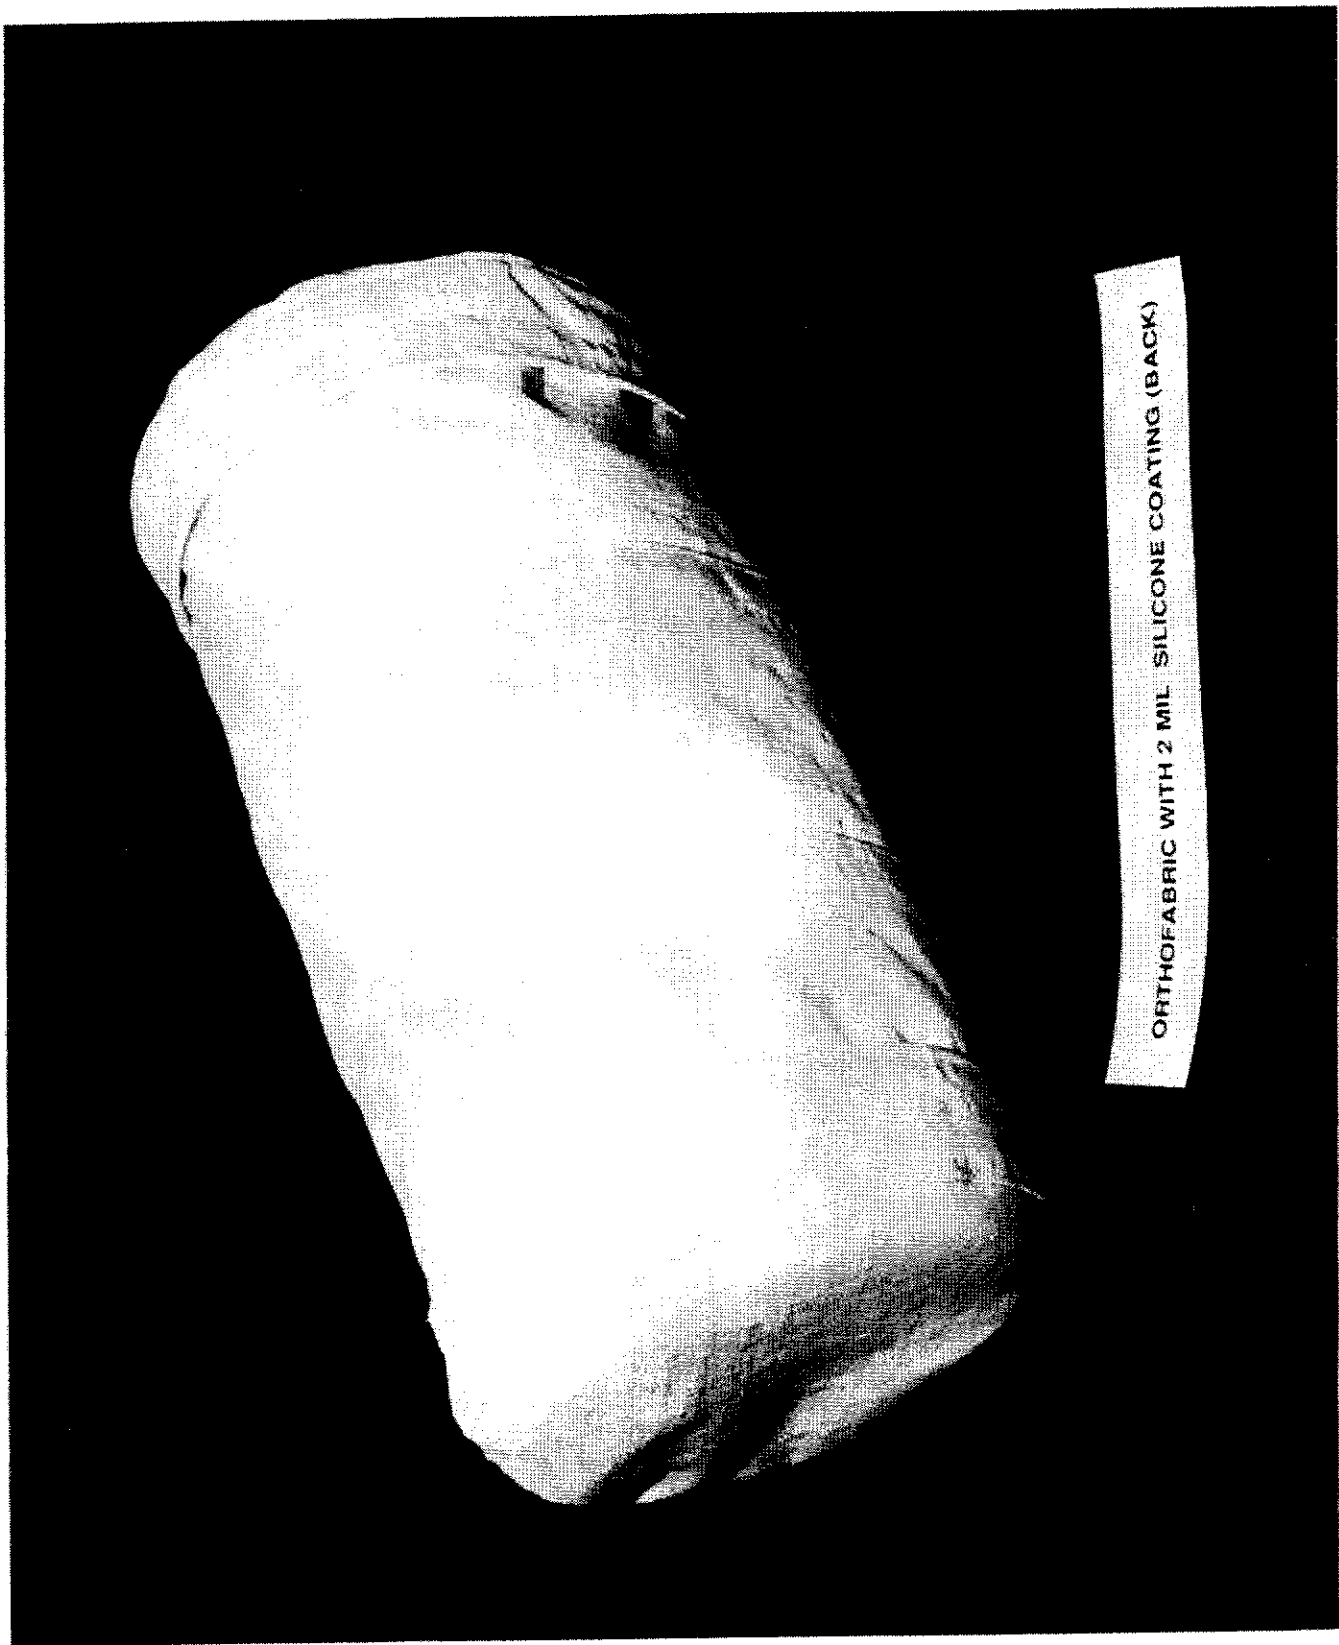
Figure 40 is a photo of the unpressurized, coated Orthofabric test article. The photo illustrates the weave of the new, clean fabric; however, the coating on the back is not visible in this view. The stitching is even and neat, all seams have been finished, and the end plugs are securely attached with Velco closers.

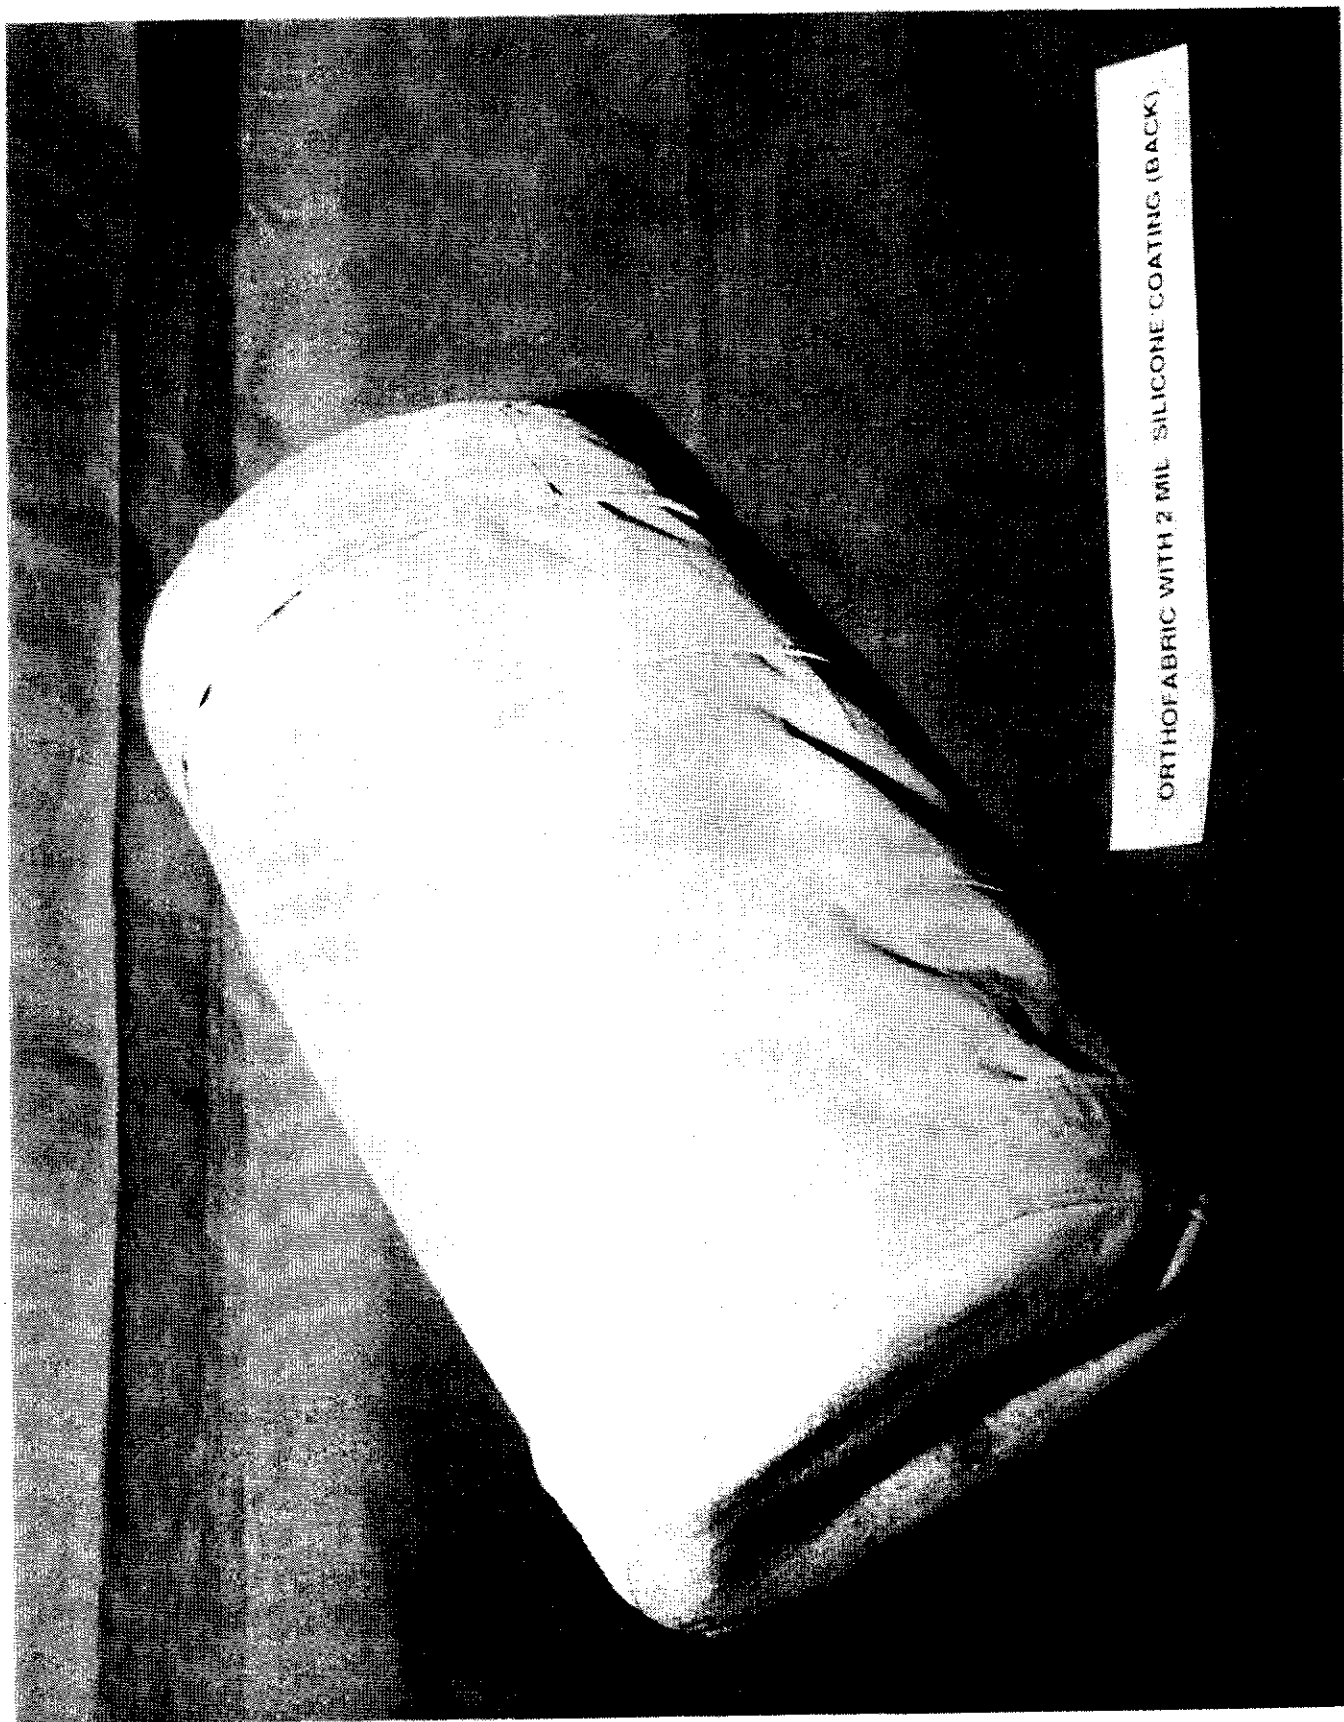
Figure 41 is a photo of the unpressurized test cylinder after eight hours of tumbling with the lunar dust simulant. As with the test cylinder from Chapter 9, the excess dust was shaken off the test article and the outside of the fabric cylinder was vacuum cleaned before this photo was taken. The lunar dust simulant is evenly distributed on the body of the cylinder with a high concentration of dust in areas of high relief and a low concentration in areas where the fabric has been indented. After tumbling, the fabric seems to be in good condition; there are no tears or any other types of visible surface damage evident in this photo.

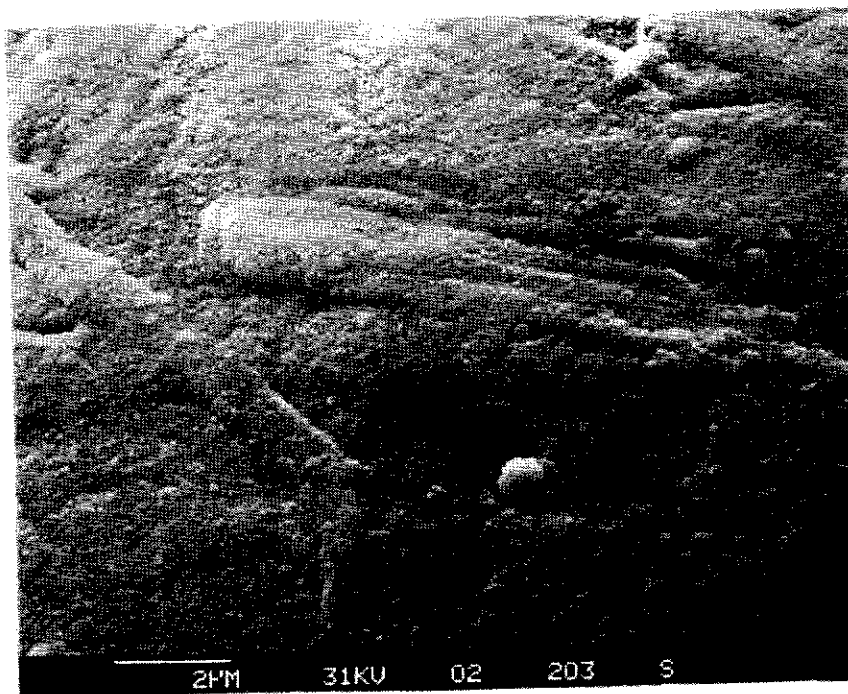
Figure 46

This micrograph is a closer look (7600x) at the new coating found in a depression in the front-face weave (Figure 43 at B). The coating has saturated through the fabric weave resulting in a self-formed surface that is fairly smooth.

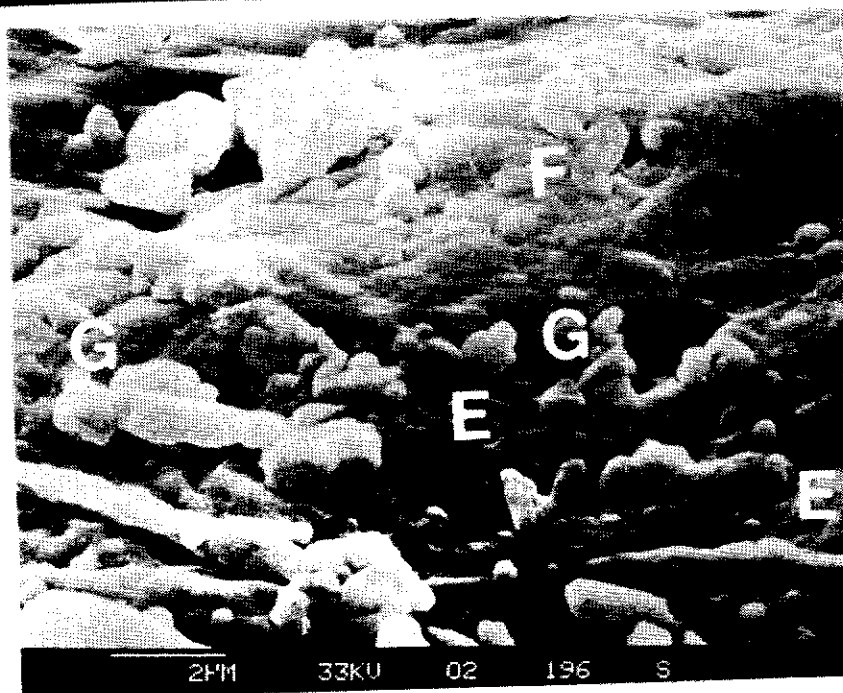
Figure 47

Here is the same view presented in Figure 46 after tumbling. It is difficult to determine which particles are the lunar dust simulant and which are fiber debris. The dust particles have become partially embedded in the coating during the tumble test; this is the reason the particles are difficult to identify. Even with the large amount of particles present in the micrograph, it is obvious that the smooth surface seen in the previous figure has been severely abraded. The extensive abrasive wear includes the formation of grooves (E), with and without the release of silicone debris (F), and particles impacting the surface forming craters and lips (G).

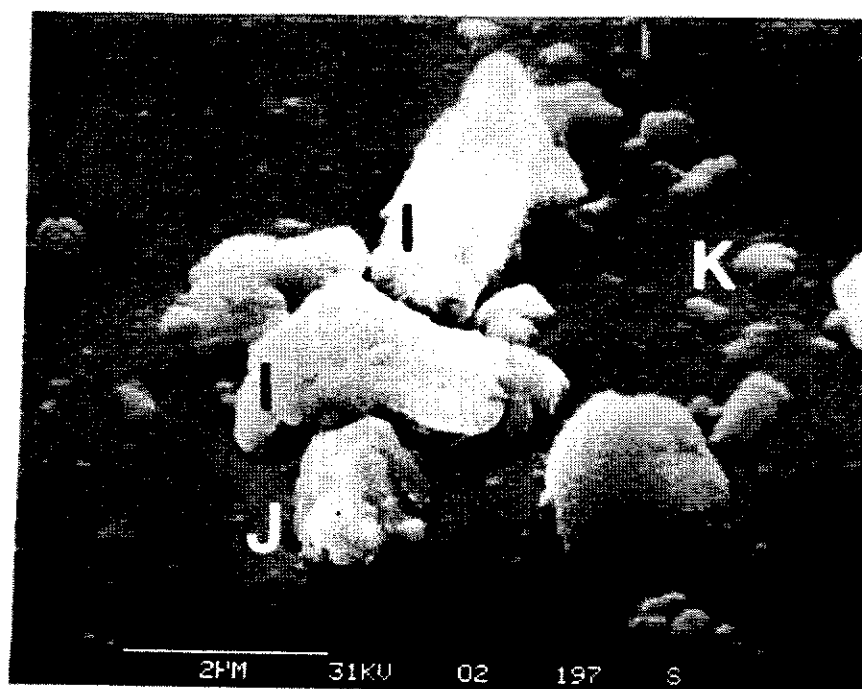
Figure 53

Sample: 2  
View: Back  
Condition: Tumbled  
Ref: 2 microns  
Mag: 14,000x

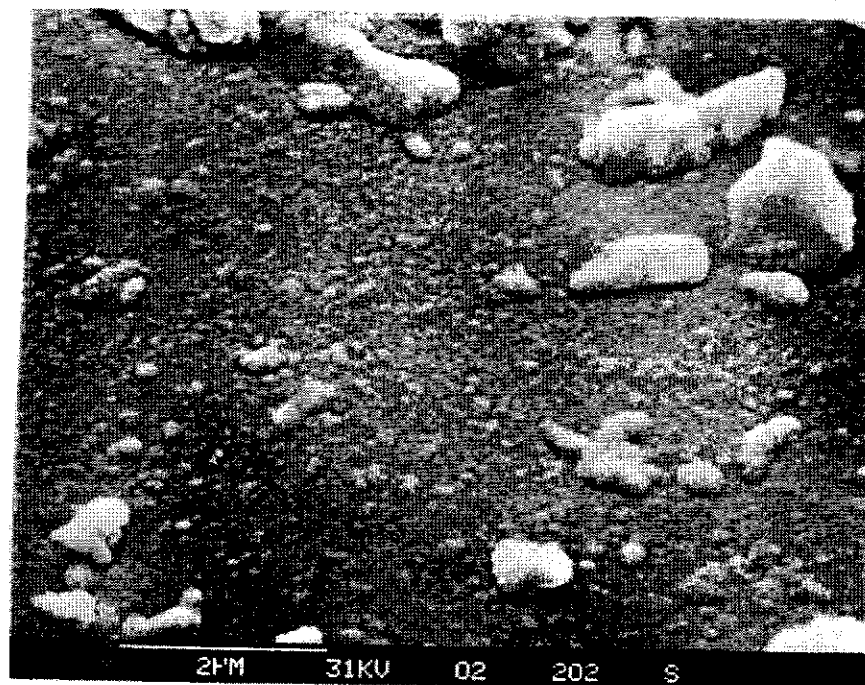
Figure 54

Sample: 2  
View: Back  
Condition: Cleaned  
Ref: 2 microns  
Mag: 14,100x

The cleaning procedure has removed the large particles. Figures 53 and 54 clearly demonstrate that the abrasive wear to the back face coating is minor. Only a few lunar simulant particles remain with a small amount of silicone coating debris.

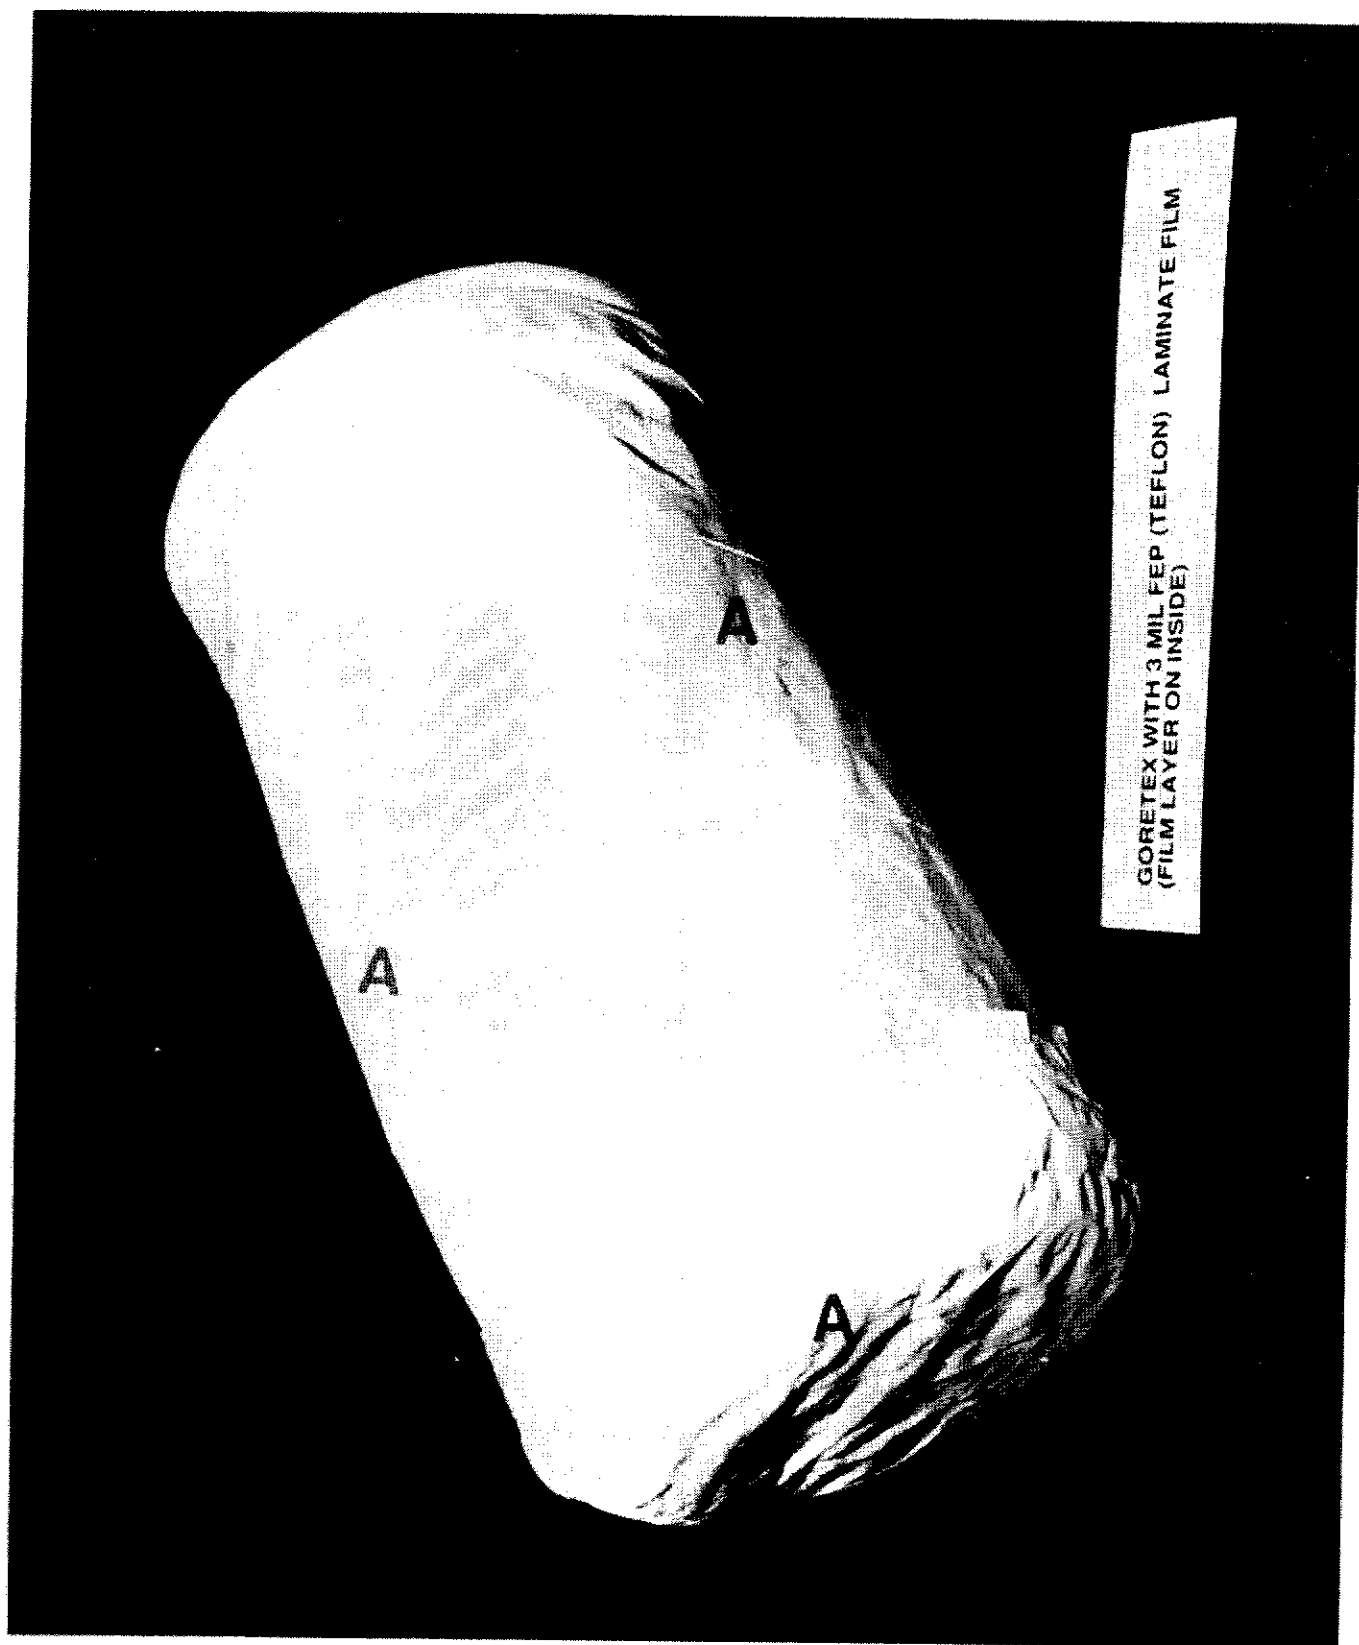
Figure 55 (NASA-JSC photo # S91-25161) and Figure 56 (NASA-JSC photo # S91-26395) illustrate the before and after tumble test appearance of the back face laminated Gore-Tex sample.

**Note:** The labels in Figures 55 and 56 were incorrectly printed. The woven Gore-Tex evaluated in this test was laminated with 2 mil. of FEP, not 3 mil. as written on the photo label.

Figure 55 is a photo of the unpressurized Gore-Tex test article. The new, clean fabric appears slightly wrinkled (A). An observation made when inspecting the new fabric was that the laminate makes the woven Gore-Tex somewhat stiff. When folded, a crease is formed in the laminate. The fabric of the test article became wrinkled during manufacture. All stitching is even and neat, the seams have been finished and the endplugs are securely attached with Velcro closures. The back face laminate is not visible in this view.

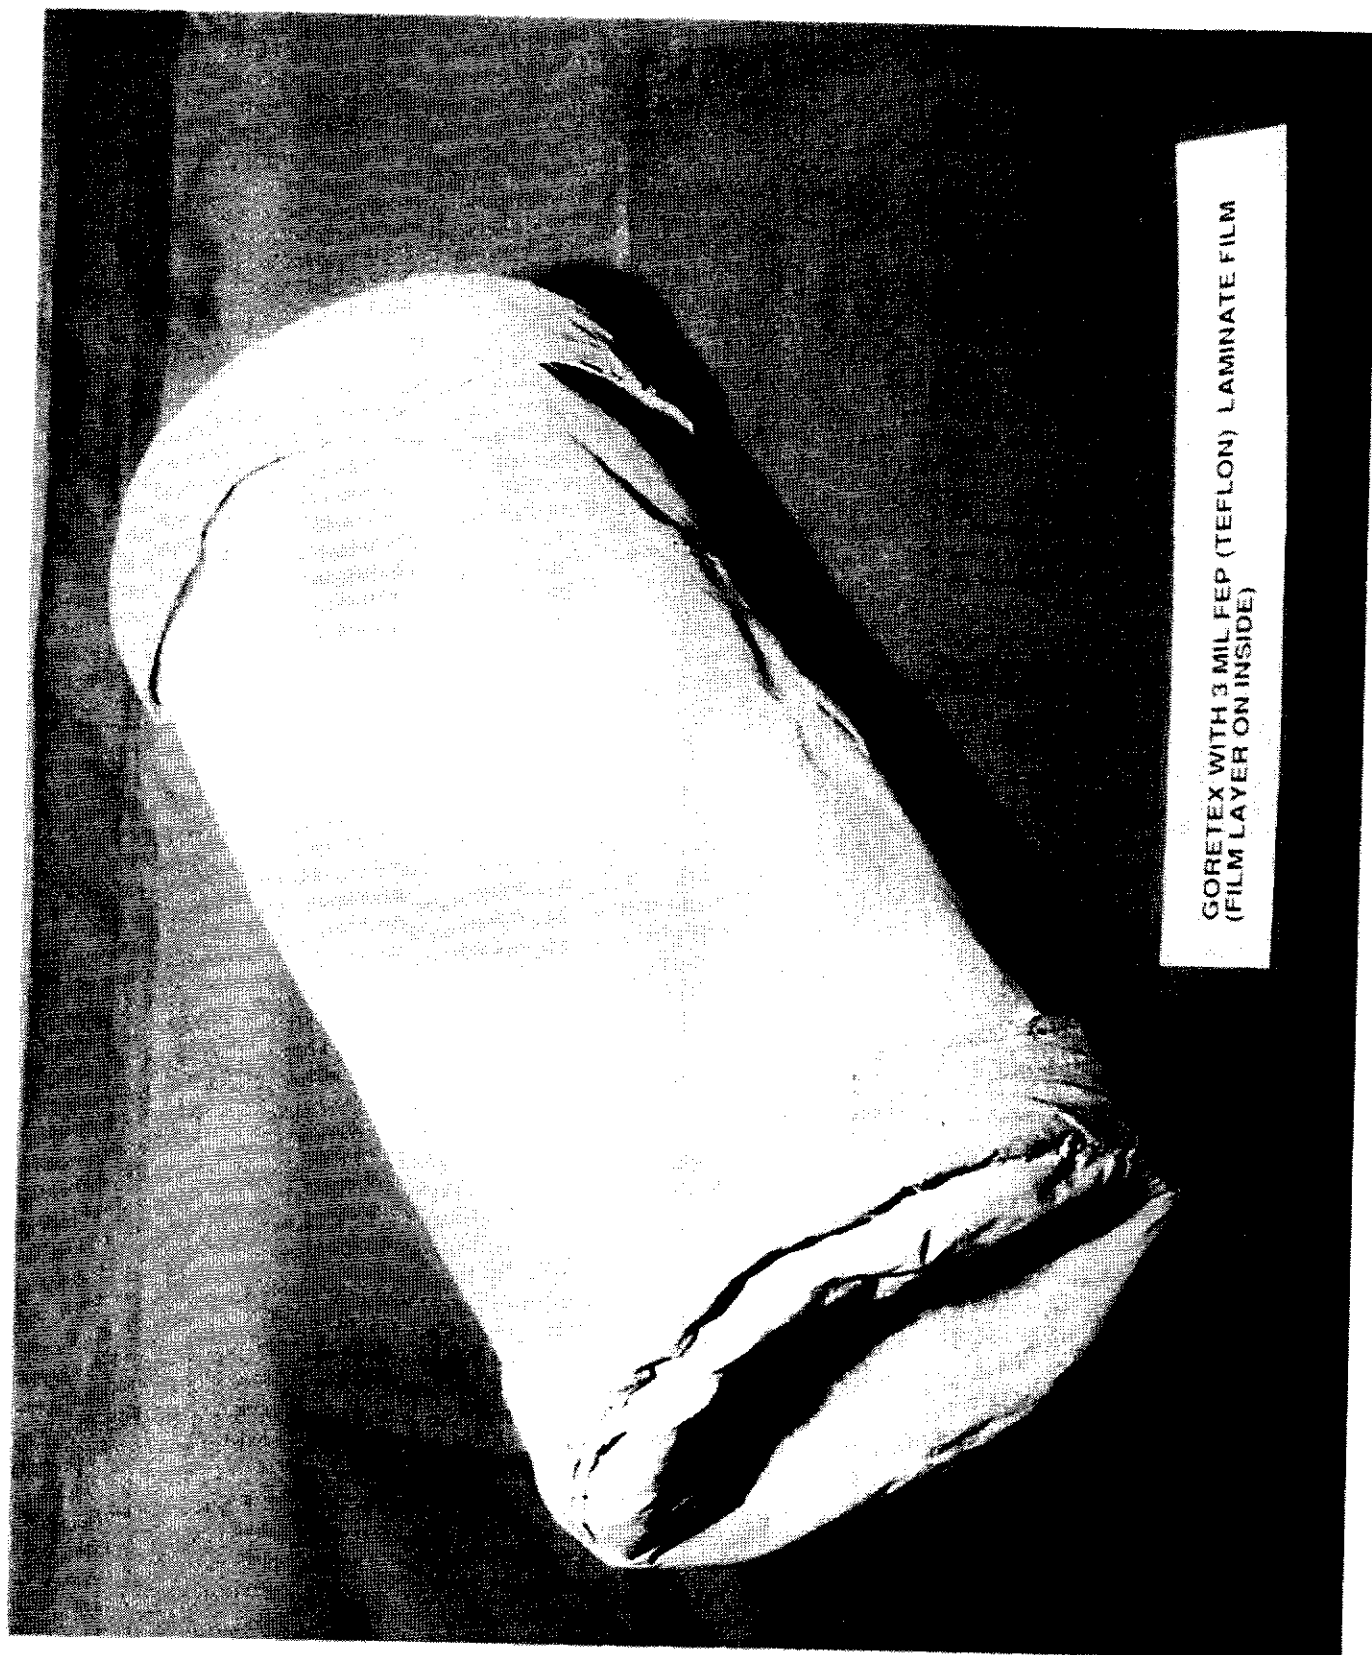
Figure 56 illustrates the effects of eight hours of tumbling on the test article. As with the previous samples, the excess dust was shaken off the test article and the outside of the cylinder was vacuum cleaned before the photo was taken. There is a significant amount of lunar dust simulant adhering to the fabric. The dust is uniformly distributed on the body of the test cylinder with a slightly higher concentration of dust in areas of high relief and a low concentration in areas where the fabric has been indented, such as the endcaps. There are no tears or any other types of visible surface damage evident in this photo.

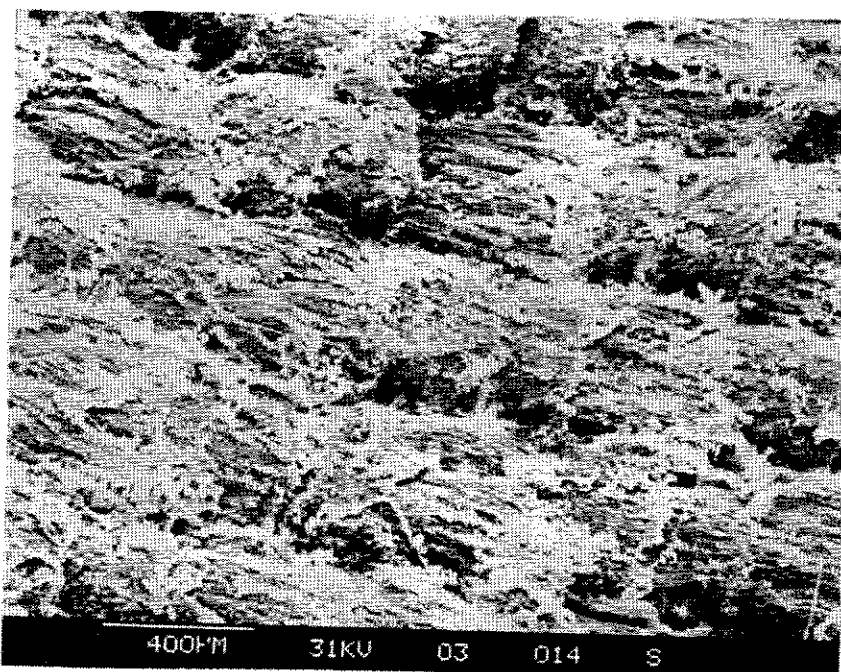
Sample: 3  
View: Front  
Condition: Tumbled  
Ref: 400 microns  
Mag: 50x
