Title ELECTRON MICROSCOPY ABRASION ANALYSIS No. Copies Required 30Page 1 of 1

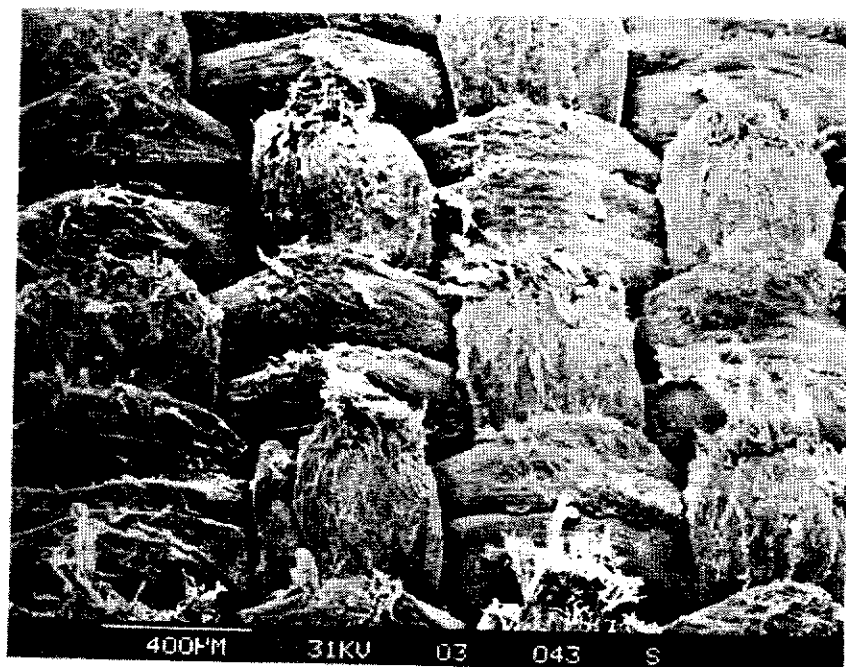
Sample: 3  
View: Front  
Condition: Cleaned  
Ref: 400 microns  
Mag: 50x

The ultrasound cleaning procedure did remove all the loose particles of lunar dust simulant and fiber debris from the tumbled fabric. As previously observed, the Gore-Tex fibers are shredded and heavily damaged.

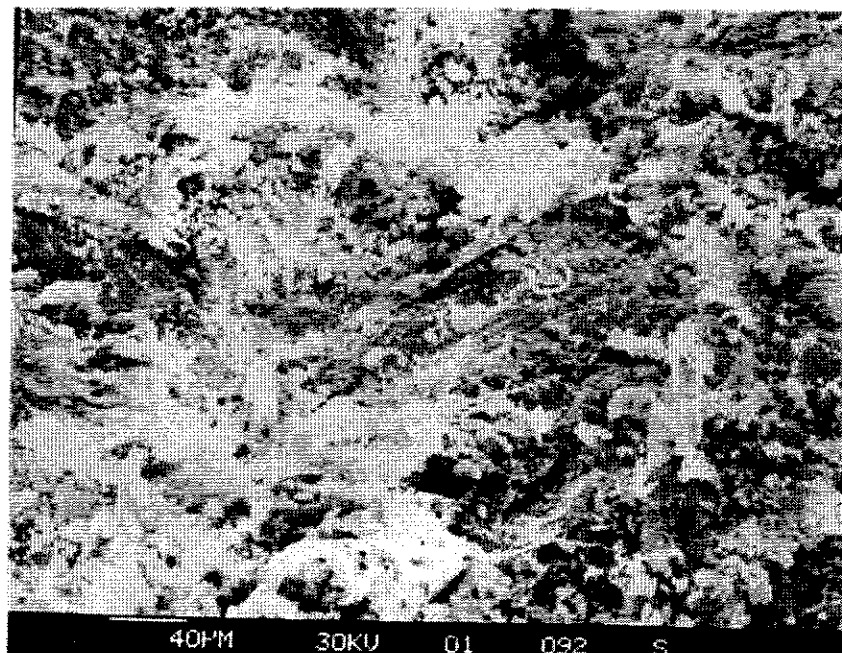
Sample: 3  
View: Front  
Condition: Tumbled  
Ref: 40 microns  
Mag: 240x

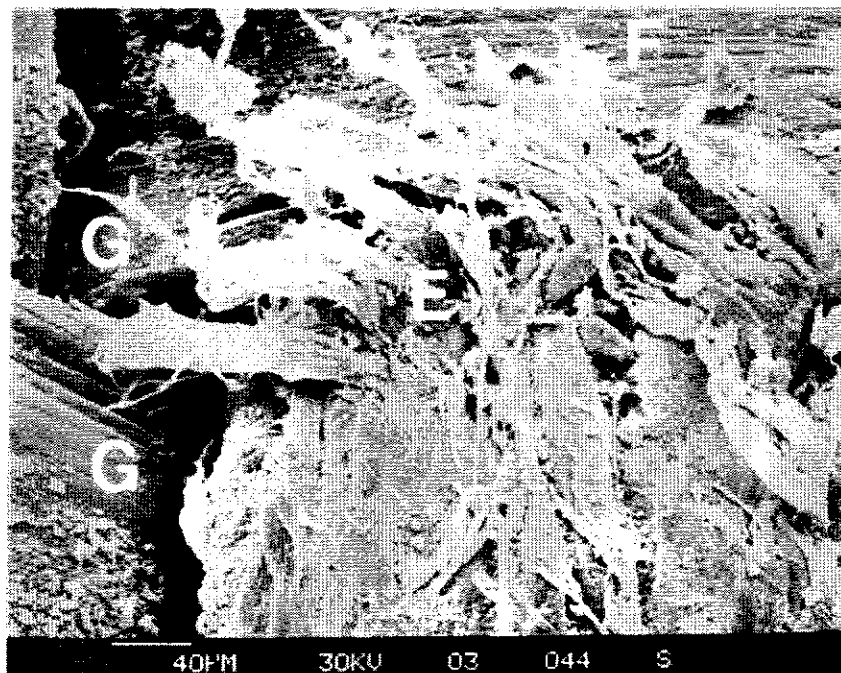
Sample: 3  
View: Front  
Condition: Cleaned  
Ref: 40 microns  
Mag: 250x

After cleaning all the loose fiber debris and dust simulant off the specimen, the tumble test damage to the Gore-Tex fibers is apparent. The severe abrasive wear leads to the shredding of the fibers (E); this result can be attributed to the repeated impact of the dust particles which plow grooves in the surface of the fiber. These grooves may or may not cause the formation of fiber debris through microcutting. Along the top of the micrograph (F) is evidence that the abrasive particles have enhanced the original grooves found in the new Gore-Tex fibers. From this photo angle, it is difficult to tell if any particles are penetrating the weave through the interstices (G).

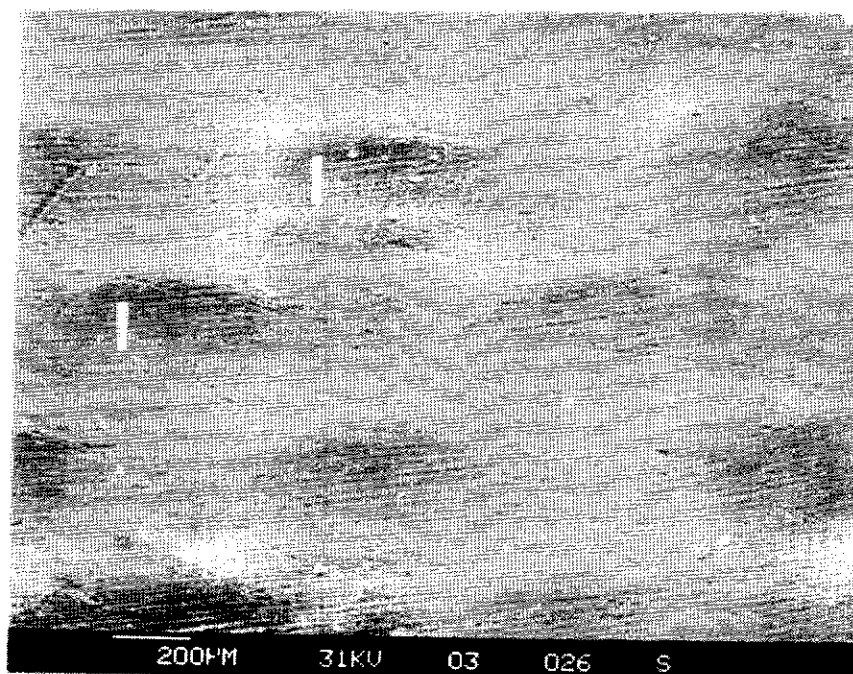
Sample: 3  
View: Back  
Condition: Tumbled  
Ref: 200 microns  
Mag: 50x

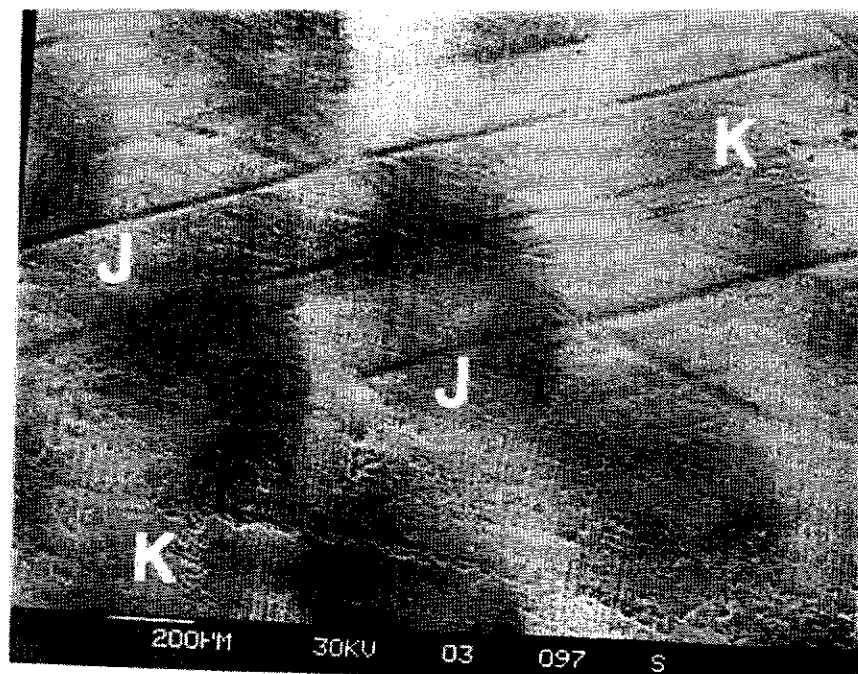
Sample: 3  
View: Back  
Condition: Cleaned  
Ref: 200 microns  
Mag: 55x

The ultrasound cleaning procedure has removed all of the loose dust and debris particles. The most obvious wear mechanism present is grooving (J); there are several long, continuous grooves in the laminate. Also visible are sections where the laminate appears pitted (K).

The back face laminate is considered heavily abraded if viewed at the 570x magnification (Figure 69), but only appears slightly damaged in the 55x magnification micrograph (Figure 66). The wear mechanism of grooving is evident along with the formation of craters and pits in the laminate surface.

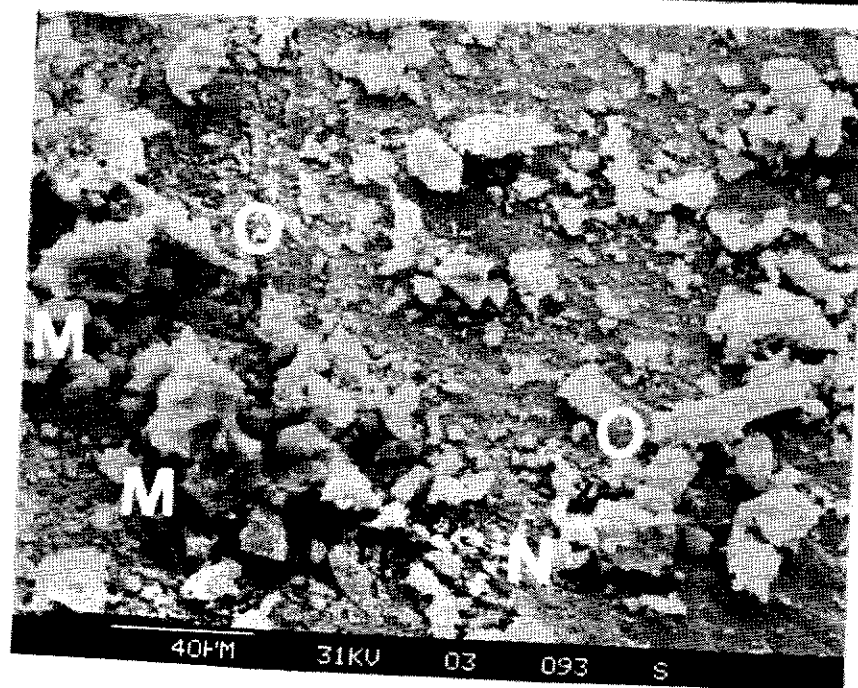
Sample: 3  
View: Back  
Condition: Tumbled  
Ref: 40 microns  
Mag: 470x

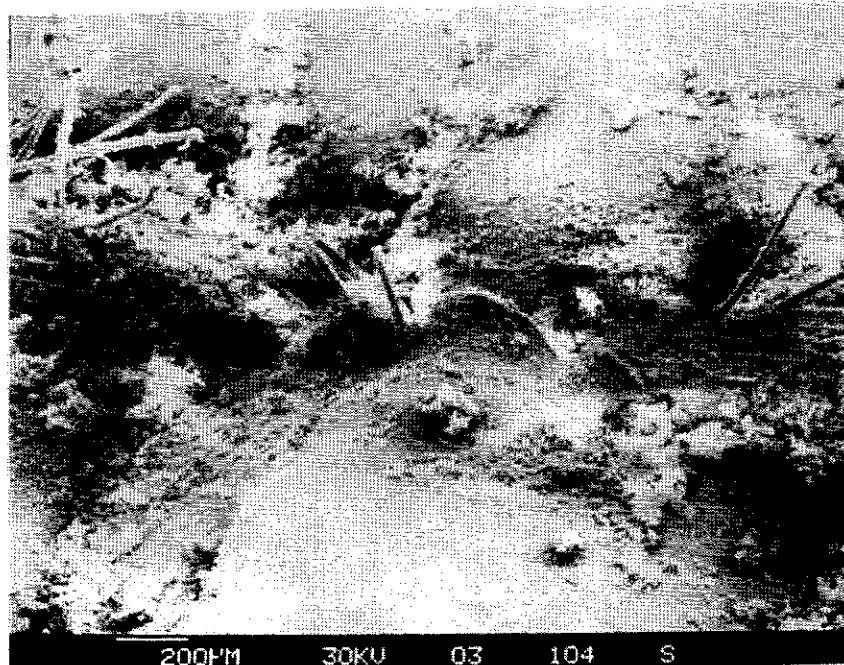
Sample: 3  
View: Back  
Condition:  
Seam, Tumbled  
Ref: 200 microns  
Mag: 46x

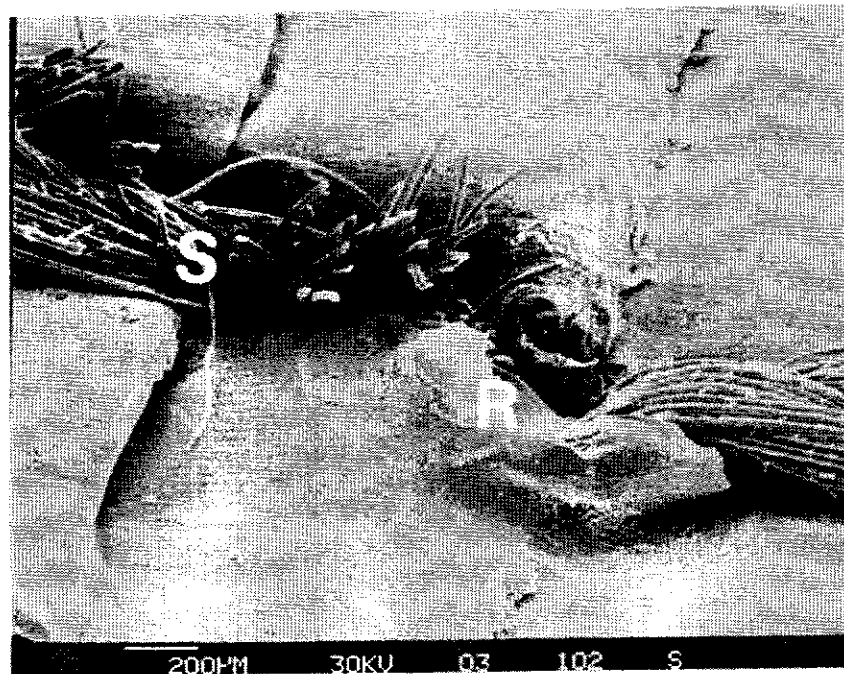
Sample: 3  
View: Back  
Condition:  
Seam, Cleaned  
Ref: 200 microns  
Mag: 47x

The ultrasound cleaning technique has removed a majority of loose dust and debris particles, including all the particles that had filled gapping needle hole (R). The laminate on the back of the fabric was successful in preventing dust migration; however, this preventive measure was undermined by the seam construction technique. Note the Nomex thread (S) is frayed from the abrasive effects of tumbling and from the particles traveling through the fabric.

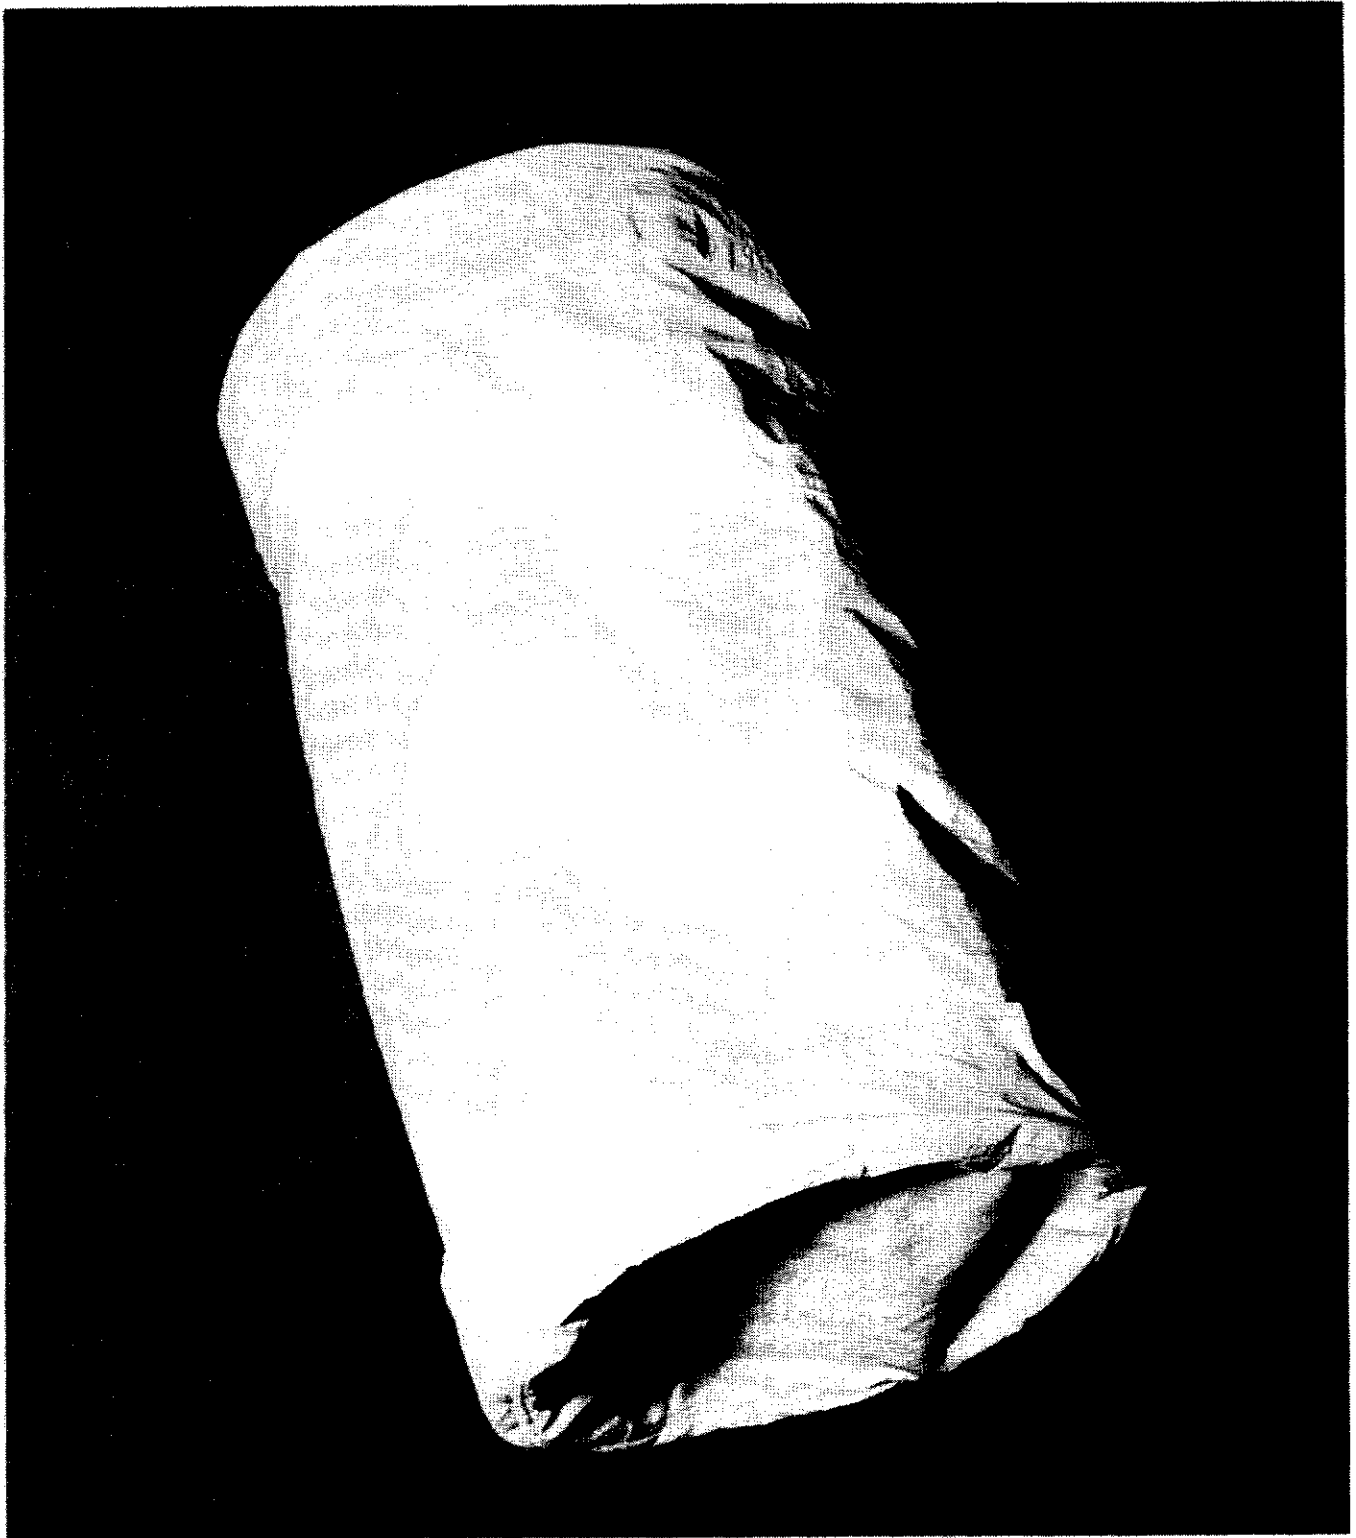
Figure 73 (NASA-JSC photo # S90-49806) and Figure 74 (NASA-JSC photo # S90-51411) illustrate the before and after tumble test appearance of the woven Gore-Tex with the front face laminated.

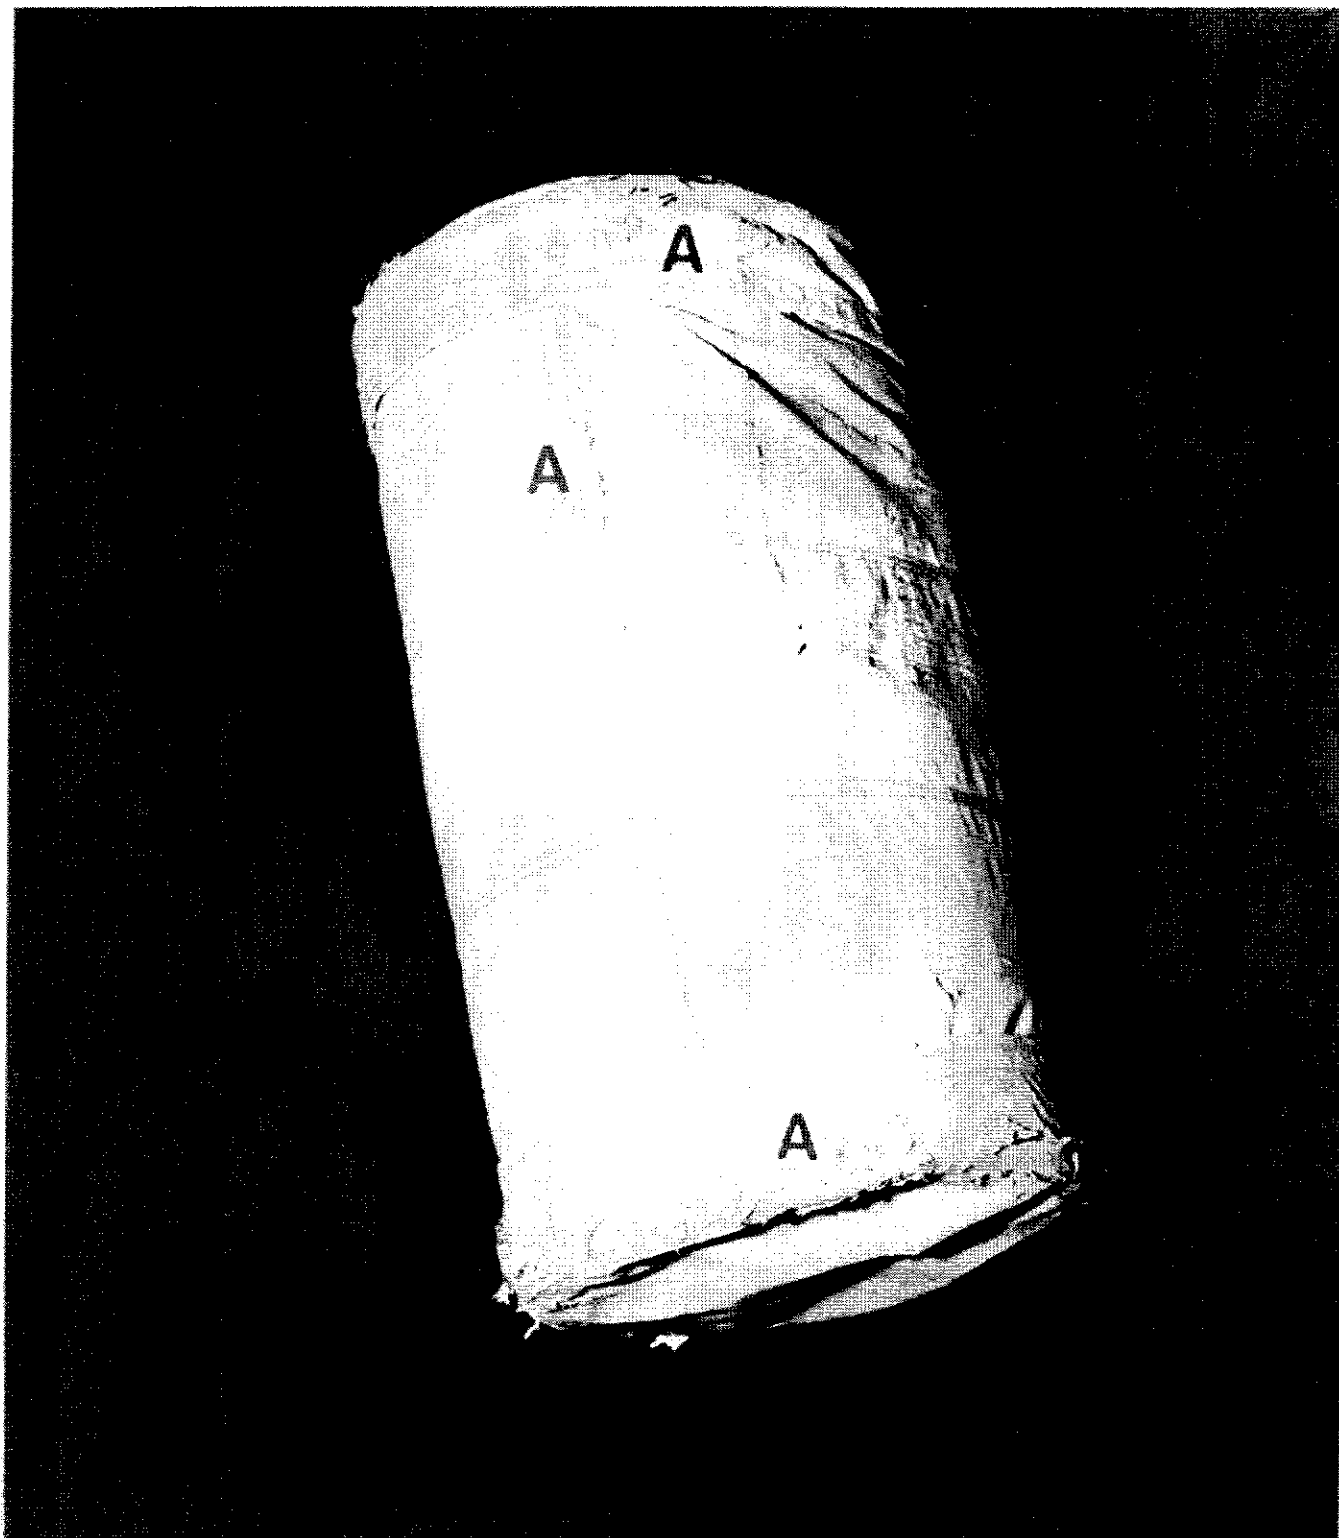
Figure 74

The tumble test damage to Sample 4 is immediately obvious as shown in Figure 74. The laminate has been peeled away from the fabric (A) at the seam and endcaps. However, the visual inspection of the areas beneath where the laminate was peeled away revealed that there was no visible damage to the woven fabric. Also noted was the absence of the even layer of dust on the surface of the test cylinder as was observed in the other tumble test samples. The visual inspection conclusion is that where the laminate remained on the fabric after tumbling, it was successful in keeping the surface of the fabric free from dust; however, the laminate itself was critically abraded in too many areas to be considered as a candidate fabric in this study.

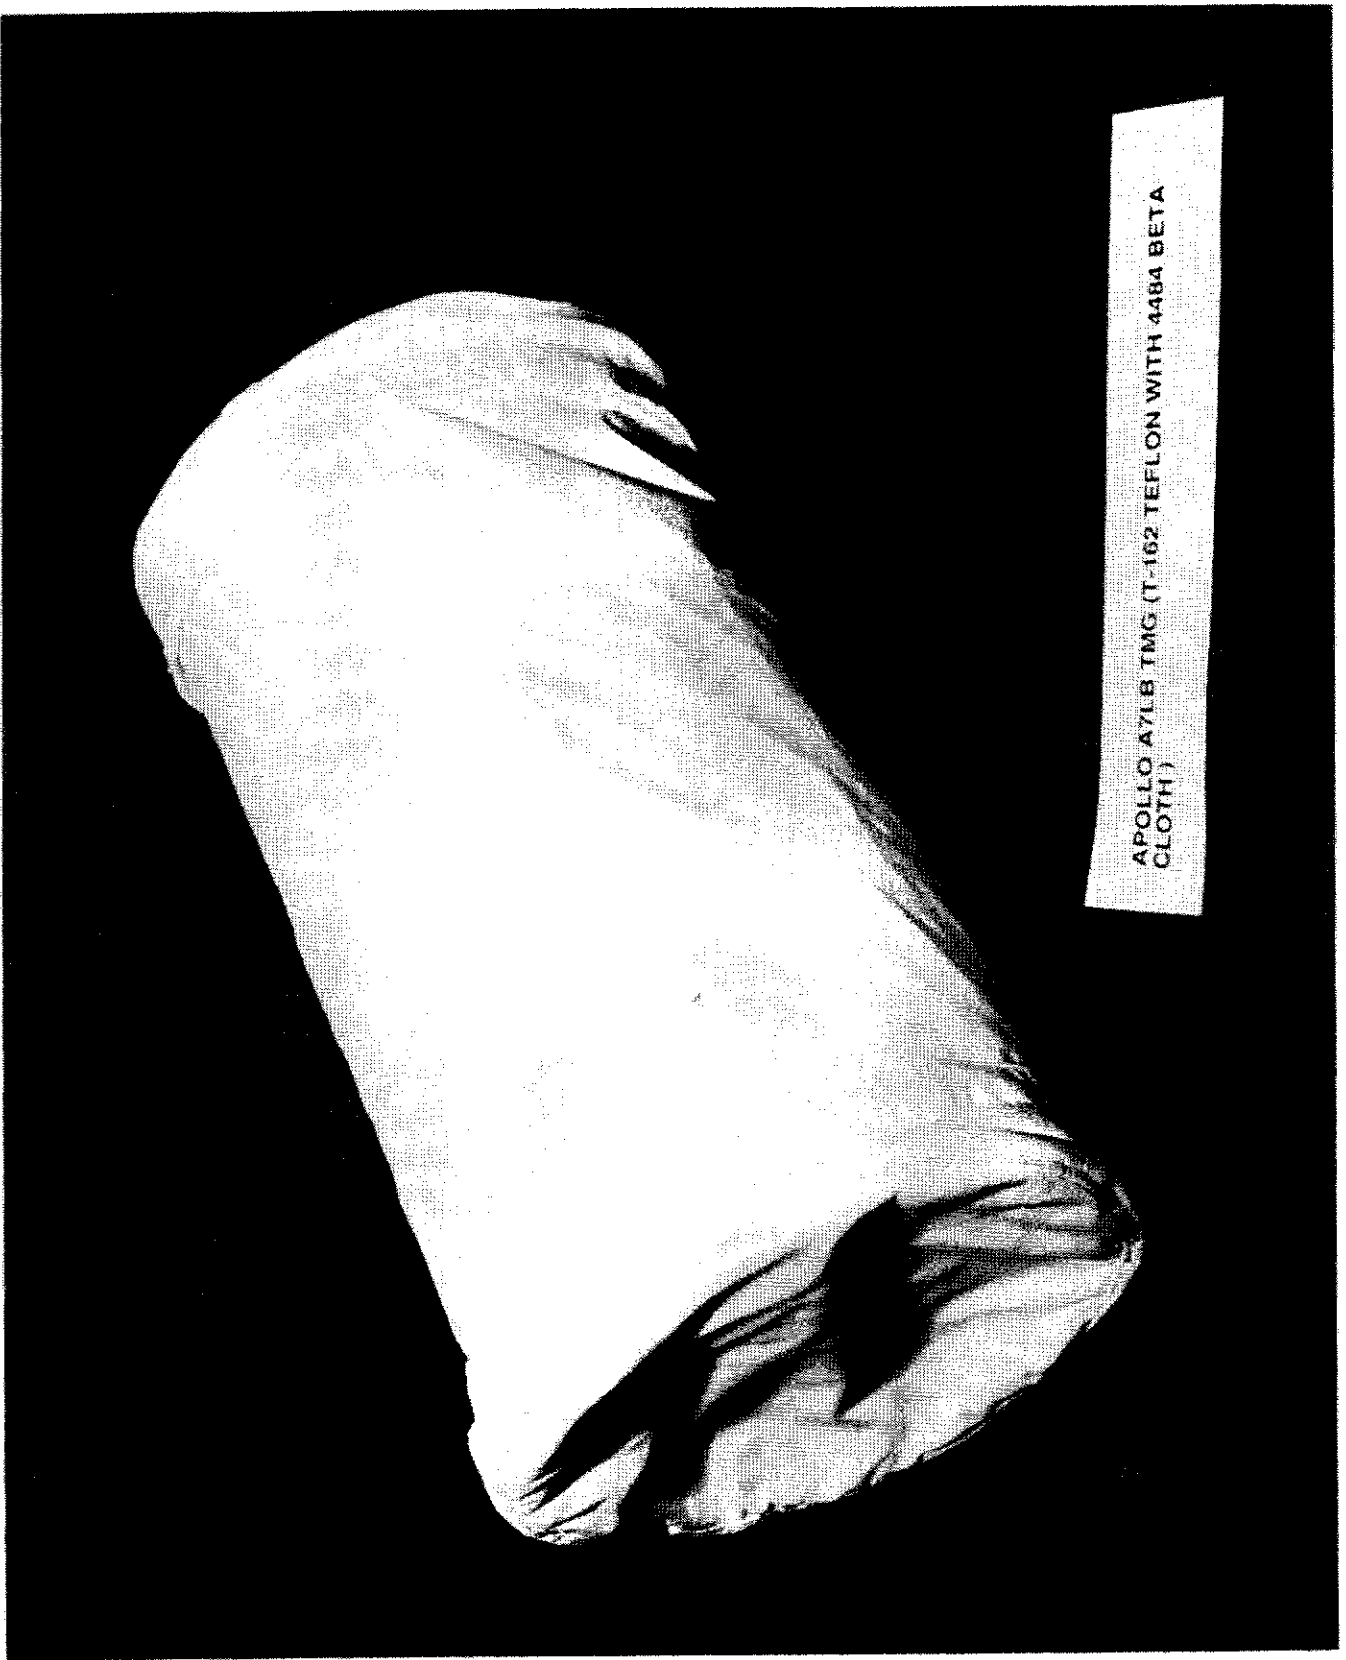
Figure 75 is a photo of the unpressurized T162 test article. The new, clean fabric has been assembled with neat, even stitching. The seams have been finished and the endplugs are securely attached with Velcro closures.

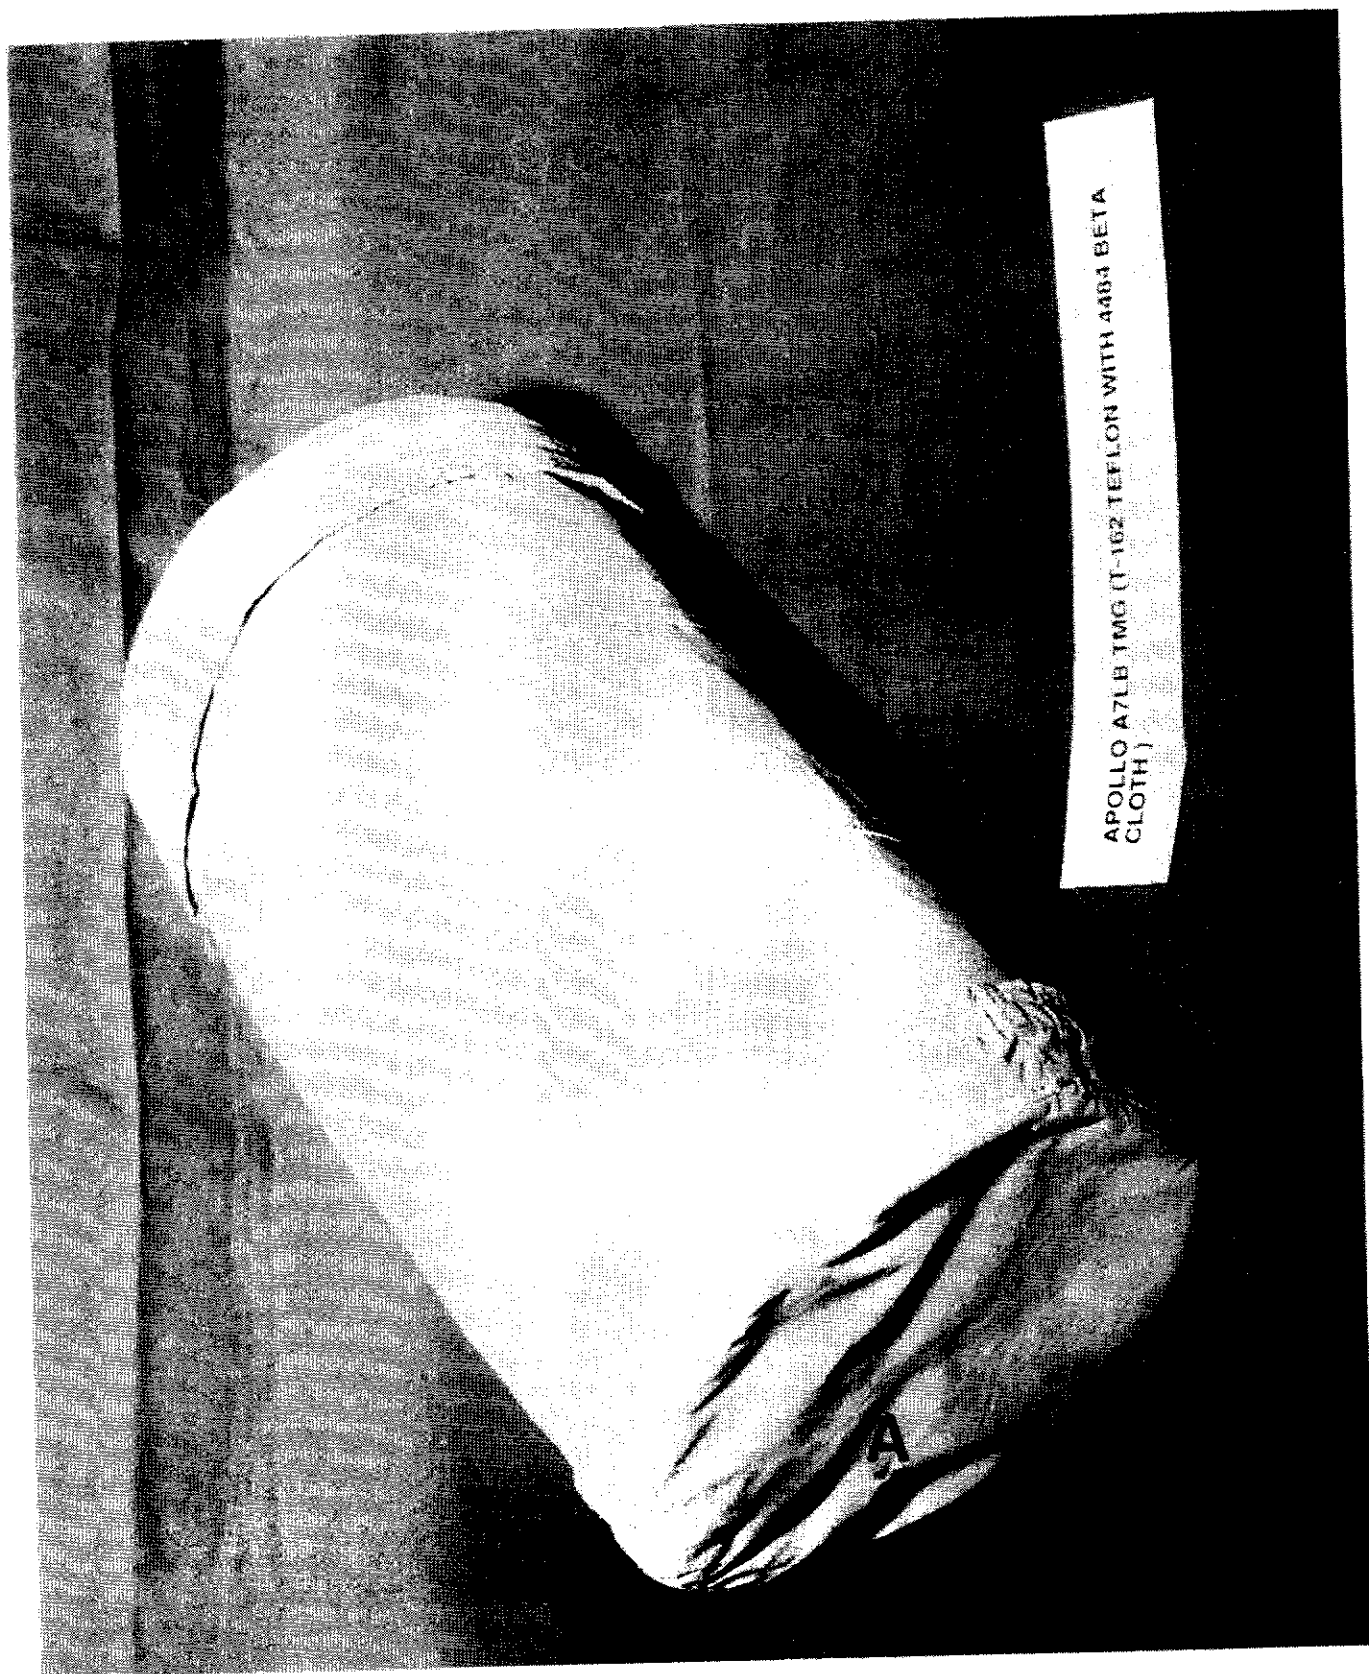
Figure 76 illustrates the effects of eight hours of tumbling on the test article. This cylinder was treated in the same manner as all others after the tumble test. There is a significant amount of lunar dust simulant adhering to the fabric. The dust is uniformly distributed on the body of the test cylinder with a slightly higher concentration of dust in areas of high relief and a low concentration in areas where the fabric has been indented. The only evidence of surface damage is a small tear (A) on the endcap.

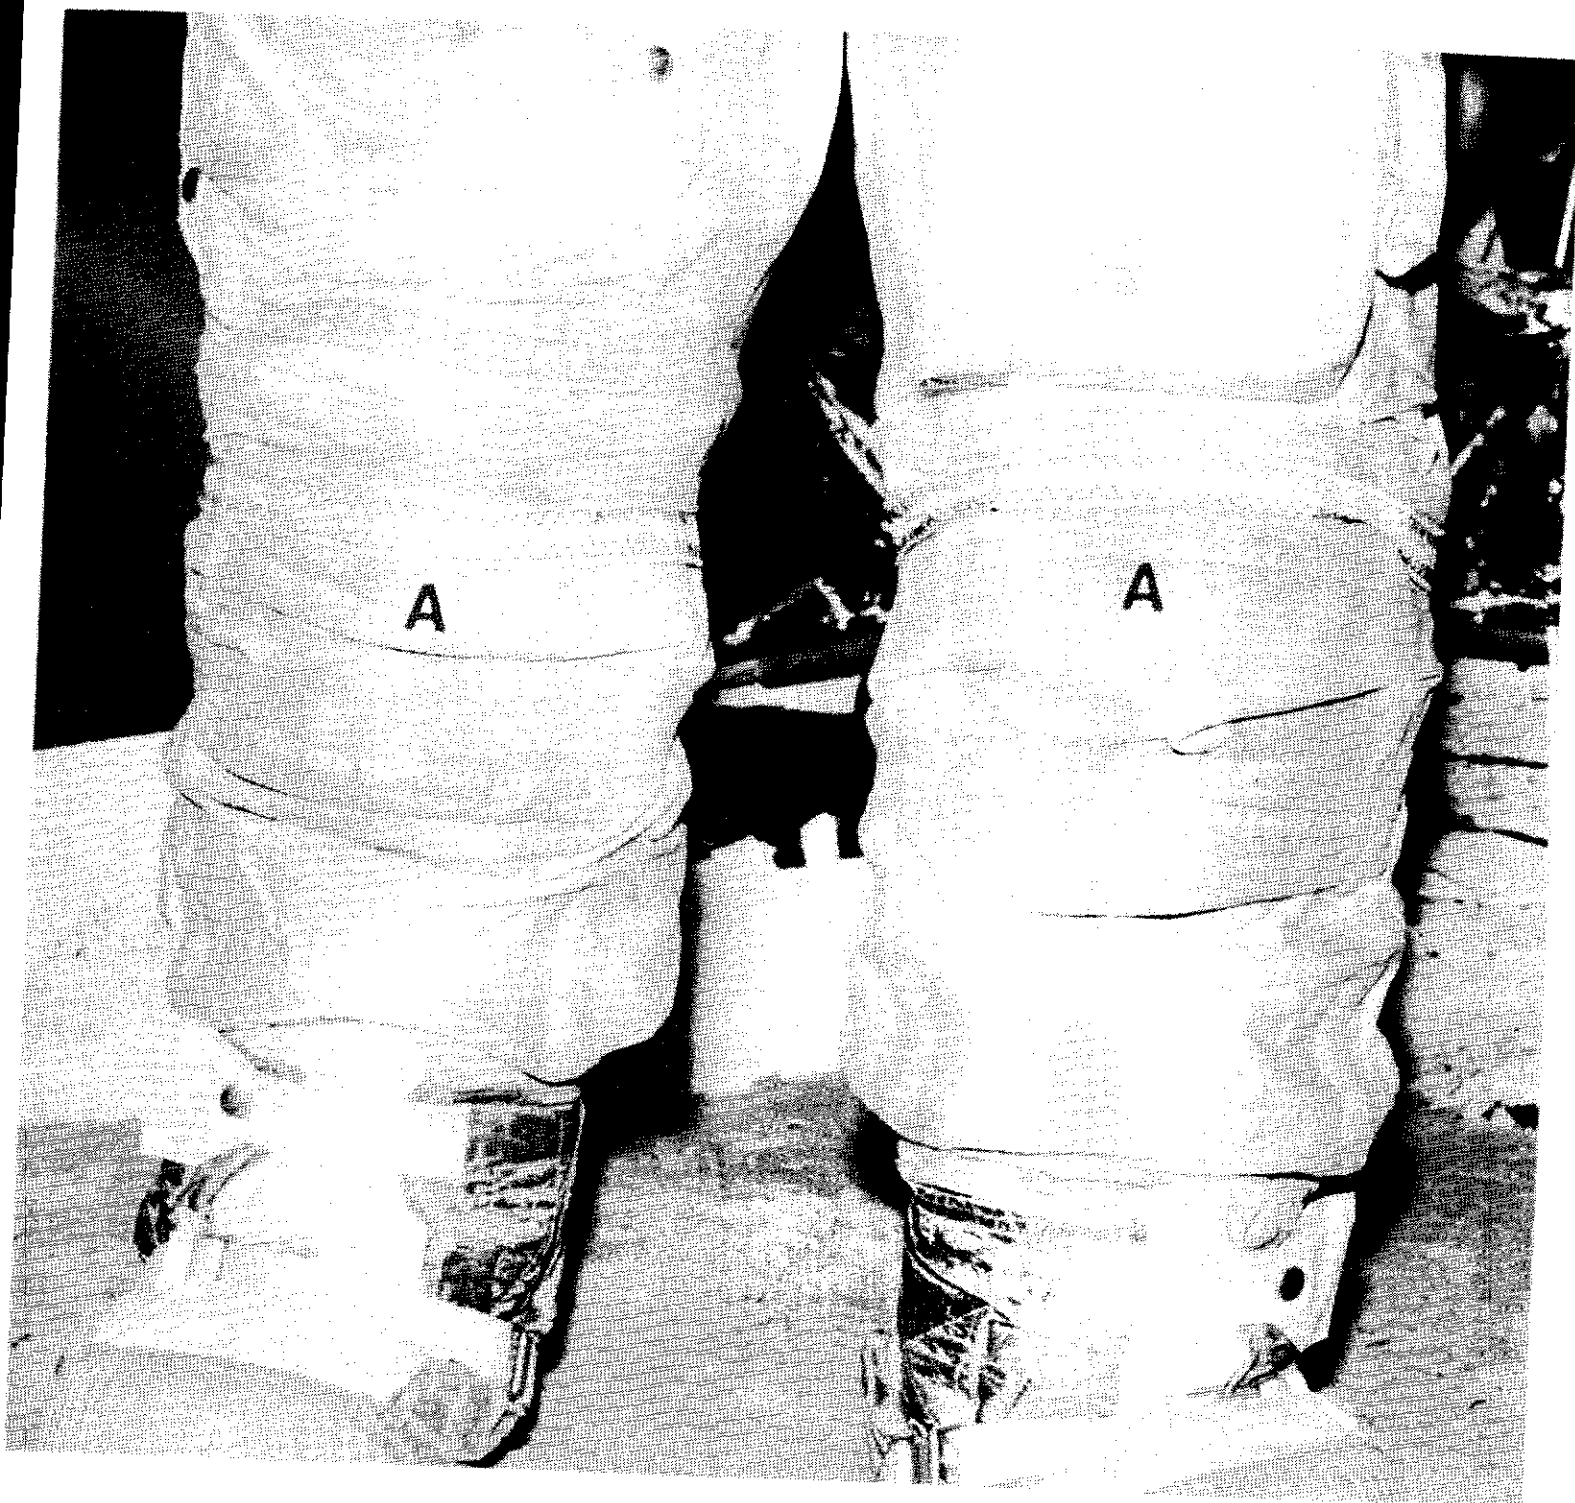
Figure 93 is a photo of Pete Conrad's SSA. This SSA has been preserved in a glass case and is on display at NASA-JSC; the suit is internally supported to show how it looked when worn by the astronaut. Although this TMG was not use in the SEM analysis, it illustrates where the suit was soiled by the lunar dust. The area of interest is the knee section (A) which was one of the most heavily abraded areas of the SSA; there is a significant amount of lunar dust present. The dust is uniformly distributed on the knee section with a slightly higher concentration of dust in areas of high relief and a low concentration in areas where the fabric has been indented. This is the same obervation that was made during the visual inspection of the tumbled test cylinders of Samples 1, 2, 3 and 5.

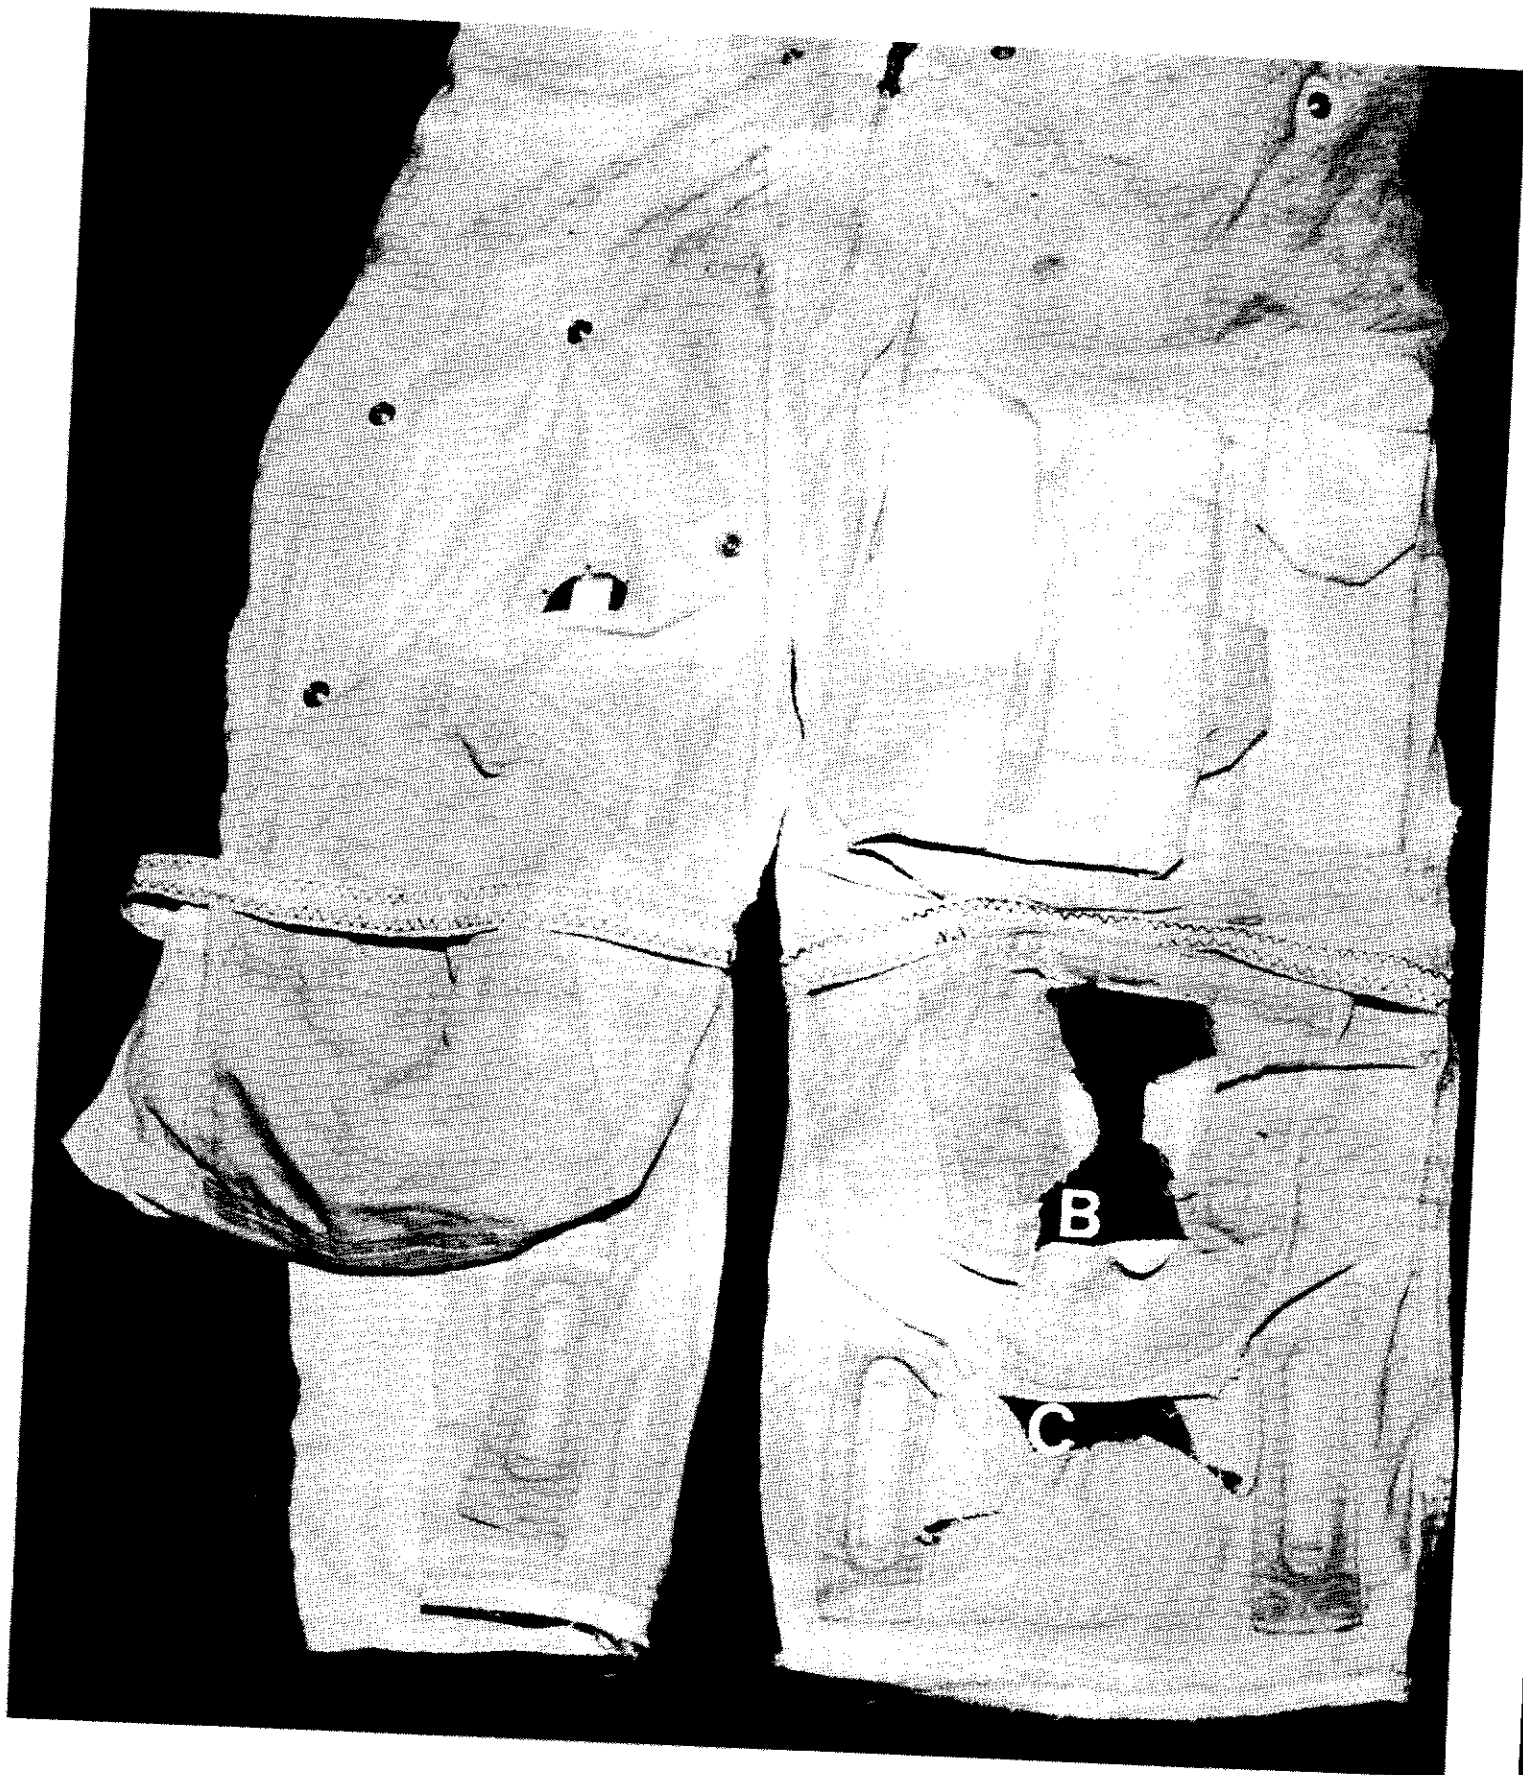
Figure 94 is a photo of Alan Bean's SSA TMG. Sample 6 was cut from the center of the left knee (B). The White Sands Test Facility performed a particle size range distribution test on this TMG in 1970; for this test, a sample was also cut from the left knee (C), approximately three inches below the area that was examined in this test.

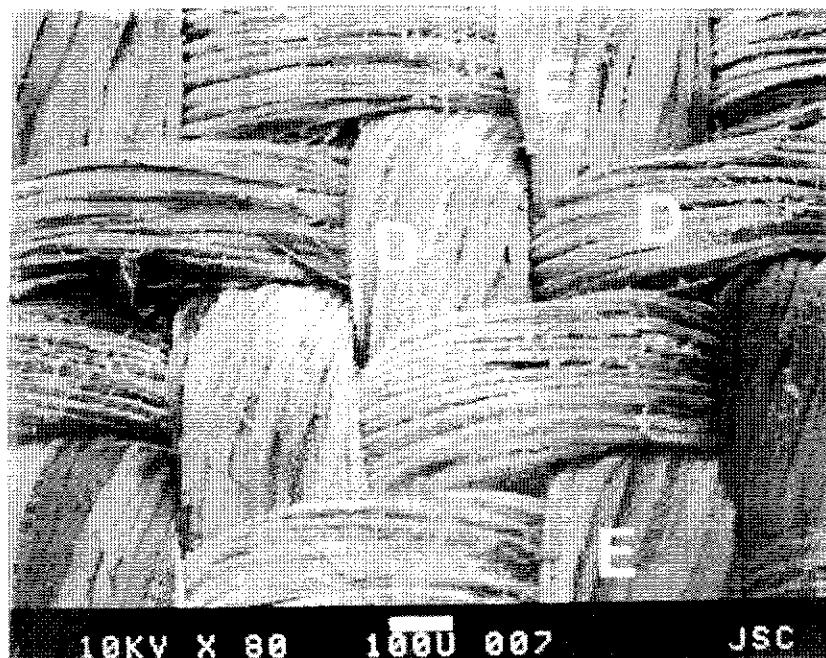
Figure 96

Sample: 6  
View: Front  
Condition:  
Lunar EVA use  
Ref: 100 microns  
Mag: 80x

This micrograph is a representative view of the front face Apollo 12 T162 that was abraded during real-time EVA use. It is easy to see the characteristic plain weave in this micrograph, whereas the weave was indistinguishable on the tumbled samples. The abrasion damage to the fibers is minimal compared to the heavy abrasion that the T162 encountered during the tumble test (Figure 79). This was expected due to the following two reasons: First, the tumble test was designed to represent 8 hours of 'worst case' EVA exposure; whereas the Apollo 12 T162 did not experience 8 continuous hours of 'worst case' EVA although it was exposed to the dust for about the same length of time (7 hours, 45 minutes). Second, the tumble test element was in constant contact with the lunar dust simulant; the Apollo 12 TMGs were not always in constant contact with the lunar dust. The shredding of the fibers that was observed on the tumbled samples is also starting to occur on the Apollo specimen. Interaction with the lunar dust has resulted in the formation of fibrils (D) which are present on all the front face yarns. Some of the fibers are also splitting apart (E). The formation of fibrils and the split fibers are the first steps in the formation of the tufts which were present on both the front face Gore-Tex and T162 samples after tumbling. The abrasive wear mechanisms responsible for the damage to the Gore-Tex and T162 fibers in the tumble test are also responsible for the damage to the Apollo 12 T162; these include plowing with the formation of grooves and impact damage from the lunar dust particles.

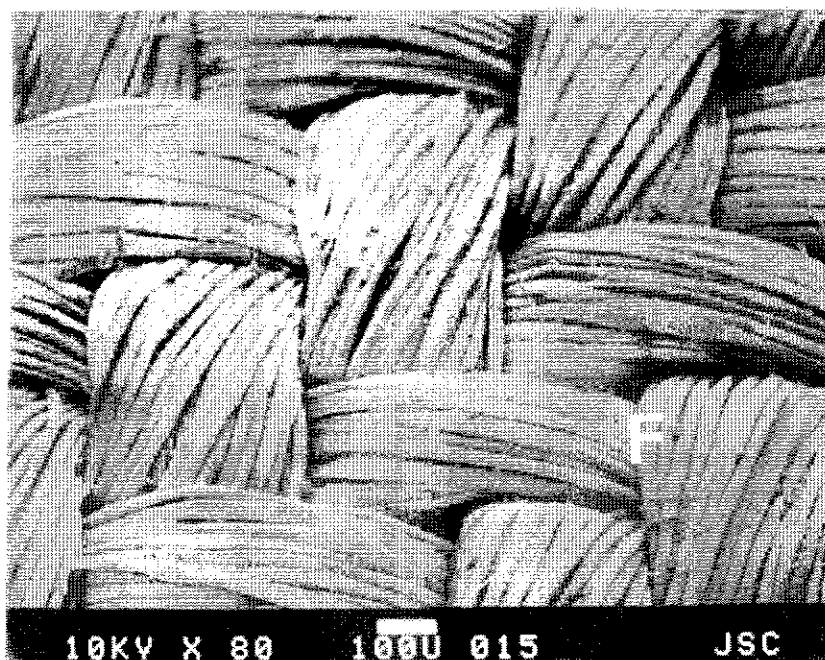
Figure 97

Sample: 6  
View: Back  
Condition:  
Lunar EVA use  
Ref: 100 microns  
Mag: 80x

This micrograph view is similar to the laboratory T162 specimen shown in Figure 89. The back face of the Apollo sample shows slightly more abrasion damage than that of Figure 89; however, a direct comparison should not be made since both since neither the magnification nor the reference resolution of the micrographs matches. It is difficult to tell if there are any particles of lunar dust on the fabric; however, small pieces of fiber debris (F) are easily identifiable. As with the laboratory T162 sample, the lunar dust is able to successfully penetrate the interstices of the weave, and the needle holes and gap between the two pieces of fabric joined at the seams.

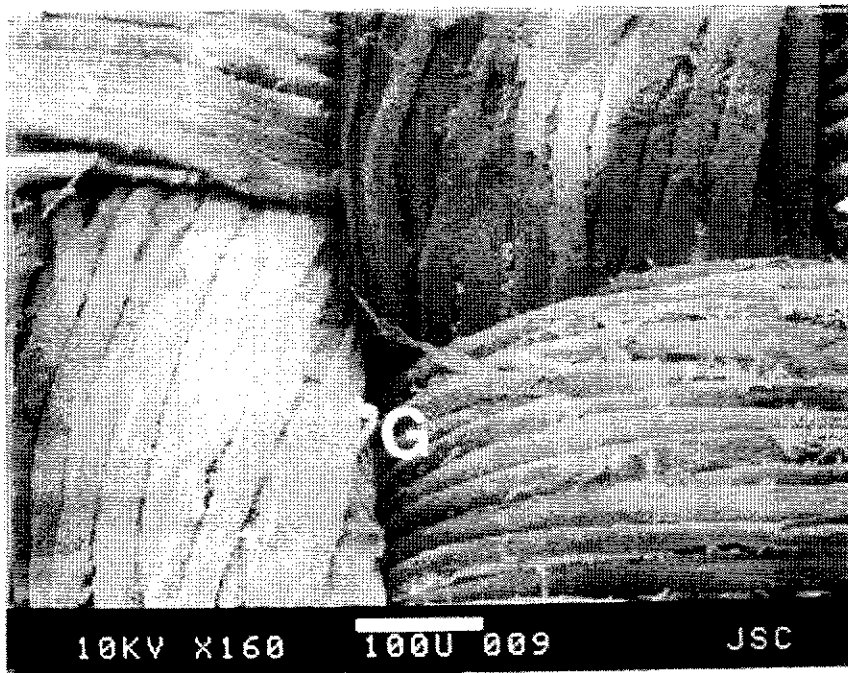
Here is a closer view (160x), of the interstices in the weave (G) on the front face of the Apollo 12 T162 sample. The minimal amount of abrasion on this front face specimen does not resemble the heavy abrasive damage seen on the tumbled and cleaned front face T162 specimen (Figure 83). However, the abrasion does resemble that of the back face laboratory specimen in Figure 92. This view illustrates the fibrils that were observed in Figure 96. No loose particles are present.

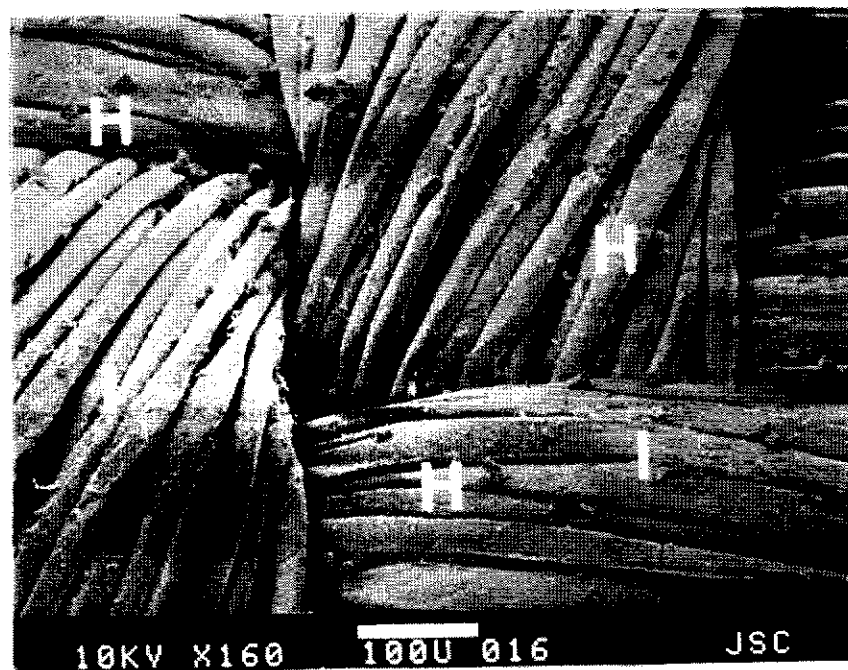
Figure 99

The fibers on the back face have experienced less abrasive damage than those on the front as shown in the previous figure. Lunar dust particles (H) have successfully migrated through the fabric. Fibril formation is starting to occur (I). The same wear mechanisms are present as described for Figure 96.
