Title ELECTRON MICROSCOPY ABRASION ANALYSIS No. Copies Required 30Page 1 of 1

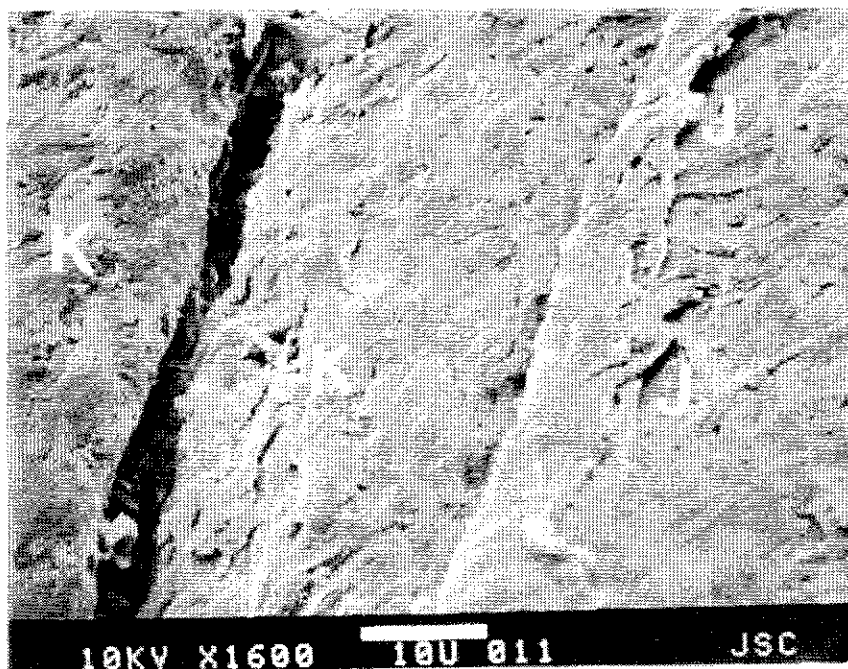
Figure 100

Sample: 6  
View: Front  
Condition:  
Lunar EVA use  
Ref: 10 microns  
Mag: 1600x

This high magnification view (1600x) is of the front face of the woven T162 illustrating the lunar dust abrasive damage to the fibers. Impacts from the dust particles have caused the formation of scales (J). Evidence of the tribofracture mechanism of microcutting is seen all over the fiber (K); this is where material has been cut away from the fiber surface. The interaction of the lunar dust particles with the T162 fibers, which has resulted in the scales and removal of material from the fiber surface, is the first step in the formation of fibrils and later on tufts that are observed on the laboratory T162 tumbled specimens. Note that there are no loose particles on the surface of the fibers.

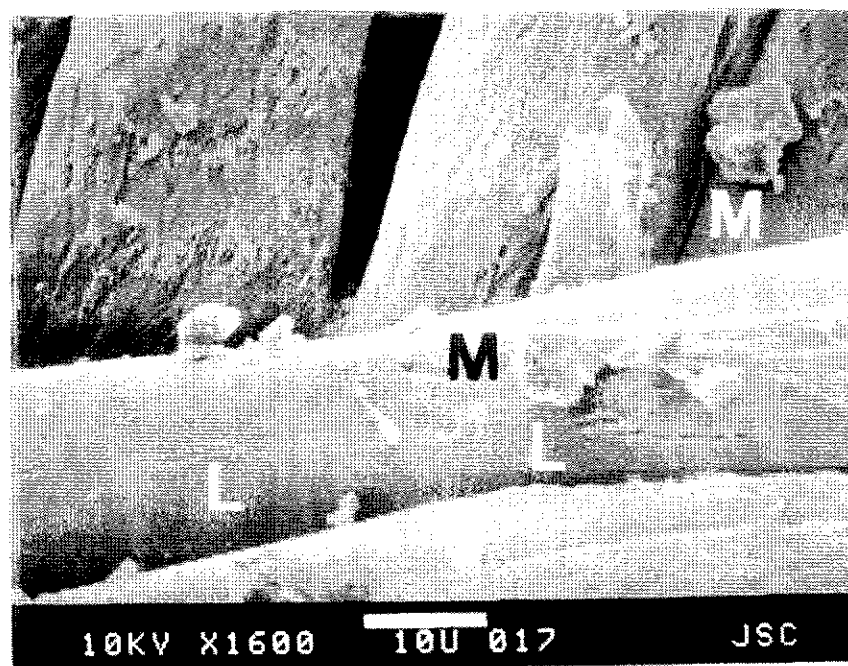
Figure 101

Sample: 6  
View: Back  
Condition:  
Lunar EVA use  
Ref: 10 microns  
Mag: 1600x
