The Evolution of Failure Analysis at NASA's Kennedy Space Center and the Lessons Learned

Failure in LEO: the Solar Alpha Rotary Joint (SARJ):

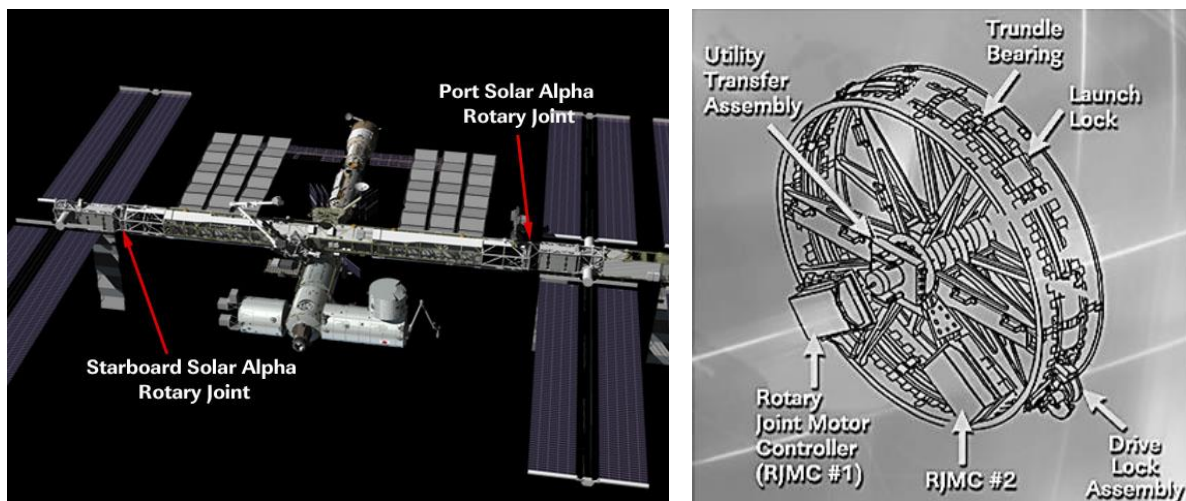
Figure 3. Location of port and starboard SARJ on the truss of the ISS (left) and details of the SARJ mechanism (right). Credit: NASA

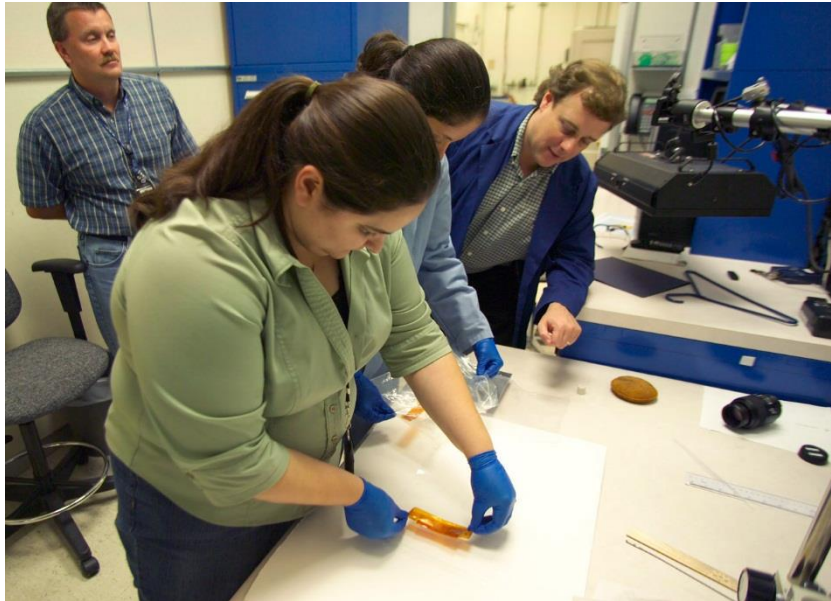
Figure 5. Meticulous handling of the starboard SARJ samples was carried out by the team during the investigation. Credit: P. Marciniak/NASA KSC

The three pieces of polyimide tape collected by astronaut Tani and returned to Earth were photodocumented and initially observed in a stereomicroscope. The particles sizes for the debris ranged from very fine particulate less than 100 μm up to approximately 1 mm. The first significant observation was apparent machine markings still present on the surface of some of the larger fragments and fracture features visible on other fragments (Figure 6). Additionally, the debris was classified as fine particulates, flattened agglomerations, and large chips. The debris had a slight magnetic response [13].
