Advanced Space Suit PLSS 2.0 Cooling Loop Evaluation and PLSS 2.5 Recommendations

John Steele¹, Greg Quinn²
UTC Aerospace Systems, Windsor Locks, CT 06096-1010

Colin Campbell³, Janice Makinen⁴, Carly Watts⁵, and David Westheimer⁶
NASA Johnson Space Center, Houston, TX, 77058

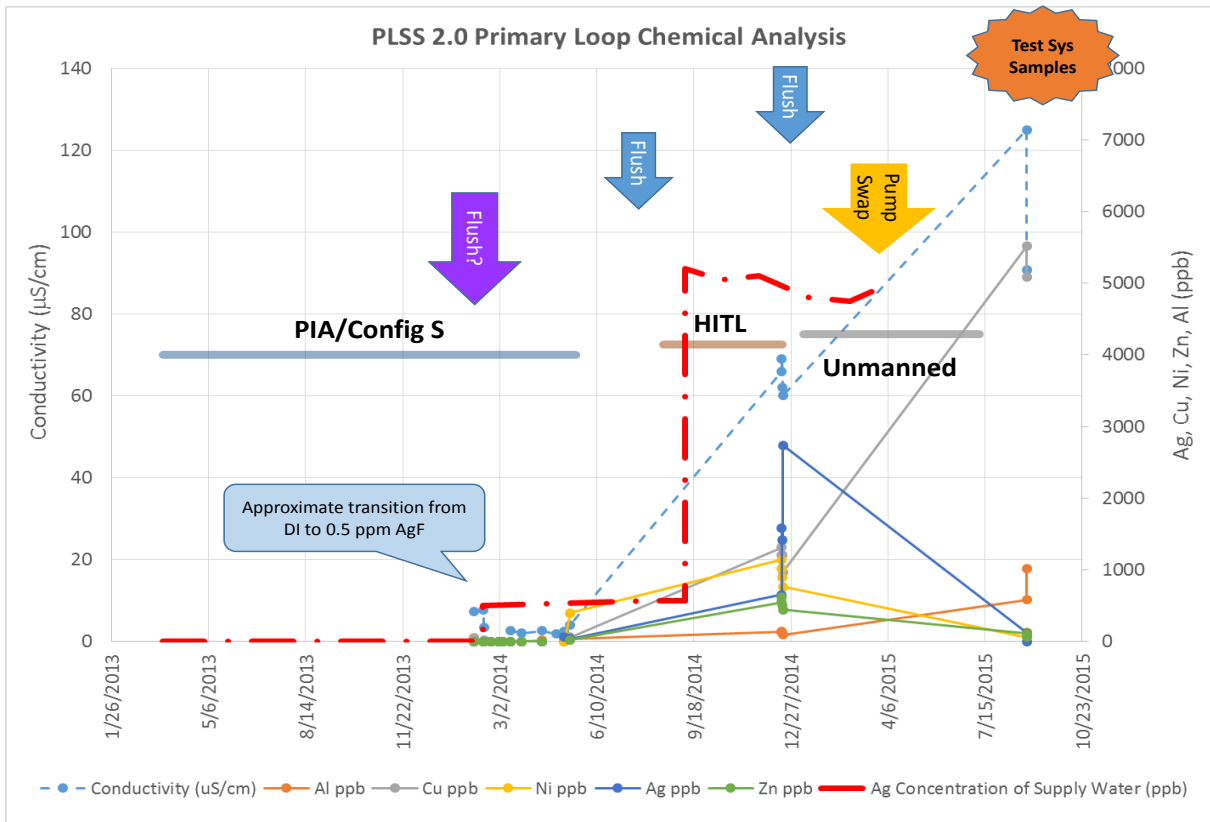
Figure 5. Water Sample Analysis Results from TCL

Figure 5 captures the fact that the system was drained, broken into, reconfigured, and refilled several times during PIA. These are captured by the downward arrows. It is believed that the flush and subsequent water recharge in February 2014 (purple arrow) was performed after the system was into Config S, although the test log does not explicitly capture that information. Supply water chemistry changes are also indicated in this graph as a red dashed line labeled “Ag Concentration of Supply Water.” Early tests were performed using deionized (DI) water. At some point, possibly when Config S tests began (the test logs are not specific enough), water with 0.5 ppm of silver, added as AgF (silver fluoride), was used. Ag is a common biocide used in aerospace water loops. The silver concentration of the water was further increased to 5 ppm as AgF after the system was reconfigured to support HITL testing.

Figure 5 shows the results of conductivity measurements and concentrations of metals of interest: aluminum (Al), copper (Cu), nickel (Ni), silver (Ag), and zinc (Zn). Again, it should be emphasized that due to the intermittent frequency of samples, caution should be used when interpreting these measurements. However, some very clear trends are apparent. The obvious trend is that the conductivity of the water in the TCL and the concentration of these metals are clearly increasing throughout the duration of testing. It is inferred that these increases occur at the end of HITL testing, the system is flushed, decreasing the metals back down towards the detection limits, and then another increase occurred during unmanned testing. The conductivity of the water is significantly elevated by the end of HITL testing and appears to rise again, after the system was flushed during the change in configuration, at the end of the unmanned testing. The trend during this unmanned test cannot be verified because the only sample taken was at the completion of testing, but if it is assumed that everything was flushed as part of the configuration change, and these end measurements that were high had returned to elevated levels, that similar processes were occurring during unmanned tests. Elevated silver concentrations were expected since new silver, in the form of AgF, was added to the system every time it was recharged with feed-water. The fluoride levels taken in the last sample from the stagnant test system components after testing had been completed were also elevated. Unfortunately, there were not intermediate samples taken to actually track these trends. Increases in aluminum, copper, nickel and zinc are considered likely corrosion by-products. Wetted metallic corrosion will be discussed further in subsequent sections.

High levels of fluoride (31 – 50-ppm) and sodium (30 – 45 ppm) are also observed. The likely source of these constituents is the silver fluoride biocide that was continuously added to the PLSS 2.0 feed-water loop throughout testing as shown in Figure 5. The silver was added as silver fluoride, but sodium fluoride was added as well to enhance silver fluoride solubility. Though the TCL of PLSS 2.0 and the test system were periodically flushed, extended periods of testing in between these flushes provided an opportunity for SWME operation to concentrate non-volatile constituents in the water while water evaporated through the SWME fibrous bundle for cooling. The water contained in the SWME at the time these samples had been taken was the result of six months of testing (25 simulated 8-hour EVAs), and several component-specific tests without a system flush and refill. The fact that fluoride and sodium rose to such high levels, and the silver did not (observed at 0.08 – 0.57-ppm total silver levels in

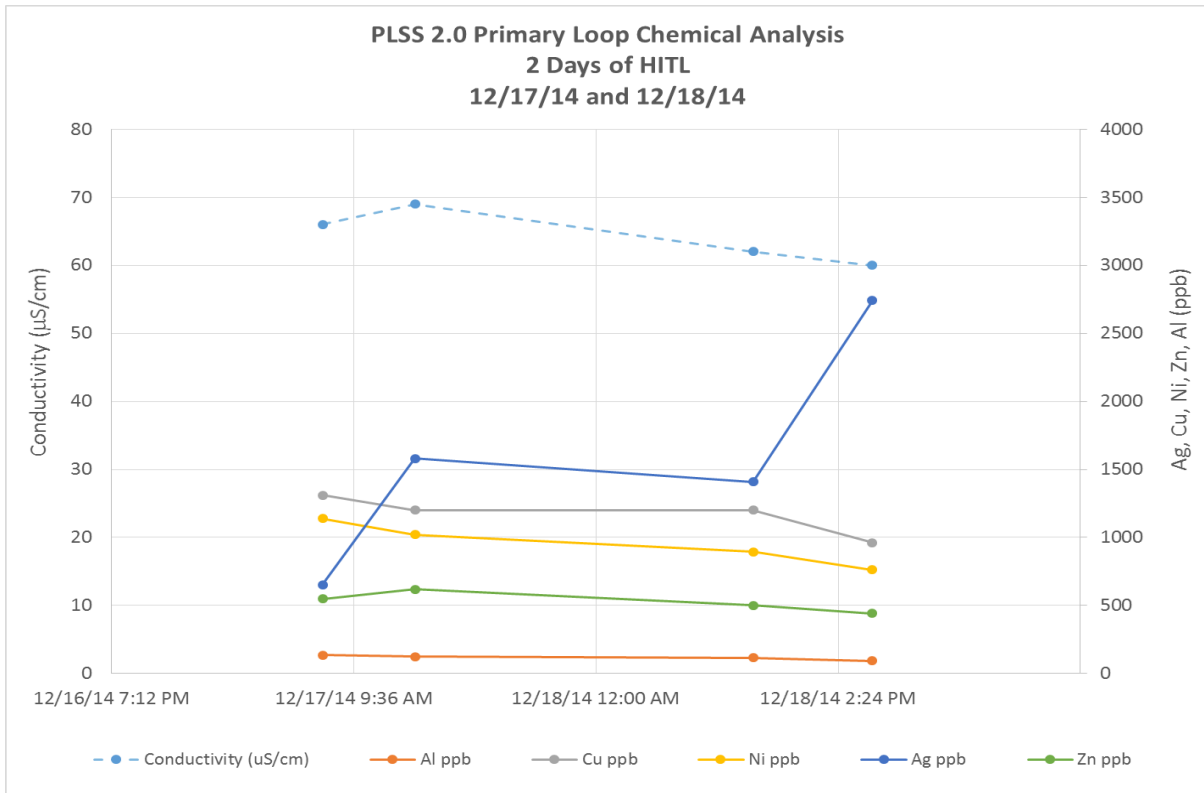
Figure 6. Water Analysis From Two HITL Days

Figure 6 shows a series of samples that were taken before and after two HITL test days. Figure 5 provides an indication of how the water chemistry was changing based on the recharge and evaporation of water after each simulated EVA. HITL test points only lasted for approximately 2 hours, so not as much water was used as compared to a nominal 8-hour simulated EVA. The primary phenomena that this figure shows is the step function increase in silver concentration that occurs during each recharge as new silver is added to the system for every EVA. The other metals, which are thought to be corrosion by-products, did not change significantly, nor did the conductivity of the water, suggesting the possibility of precipitate formation (assuming a constant generation of metal ions due to steady-state corrosion activity). As expected, there were clear increases in the silver concentration that corresponds to the recharges performed. Throughout testing, silver concentrations peaked around 3 ppm, again suggesting precipitate formation due to reaching equilibrium of ionic silver, since solid silver particles were subsequently found throughout the loop and the influent charge of silver was 5-ppm.. Silver laden precipitates were observed in several places throughout the integrated system after testing was completed and the test set-up was disassembled.

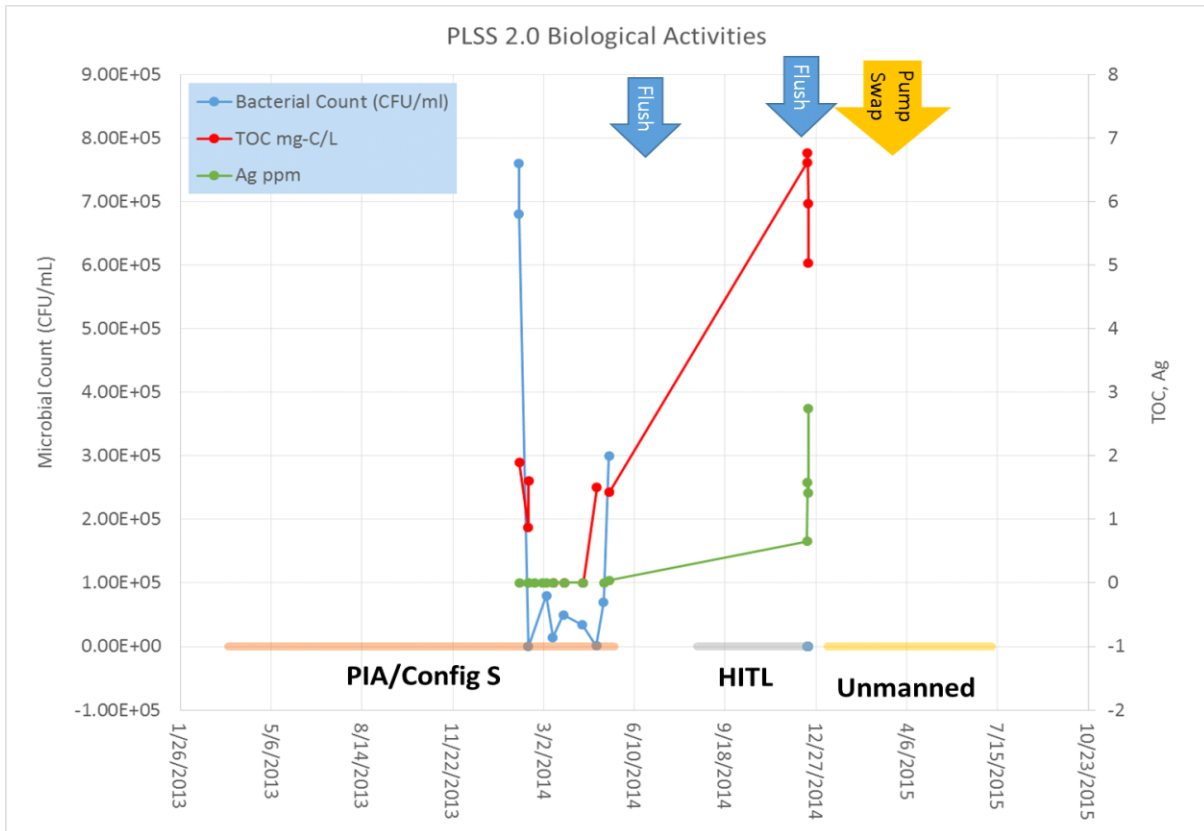
Figure 7. Results of Microbial Sample Analyses.

The silver concentration of the supply water was increased prior to performing the HITL tests based on an increasing amount of observed microbial activity as indicated in Figure 7 (levels up to 7.5×10^5 CFU/ml). Silver concentrations were increased from 0.5 ppm to 5.0 ppm as silver fluoride and the measured microbial counts subsequently declined. While adding 5-ppm silver as silver fluoride proved to be an effective way to decrease microbial activity, the long-range implications to water chemistry and the system as a whole were not thoroughly considered at that time.
