Vehicle Integrated Propulsion Research (VIPR) III Volcanic Ash Environment (VAE) Preliminary Visual and Teardown Observations

Michael Venti, NASA Armstrong Flight Research Center
John Lekki NASA Glenn Research Center
Grizelda Loykraft Air Force Research Laboratory (AFRL)

VIPR III Volcanic Ash Environment

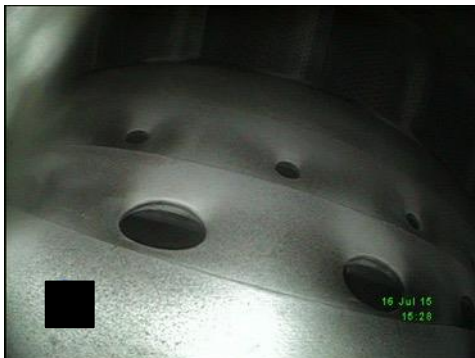
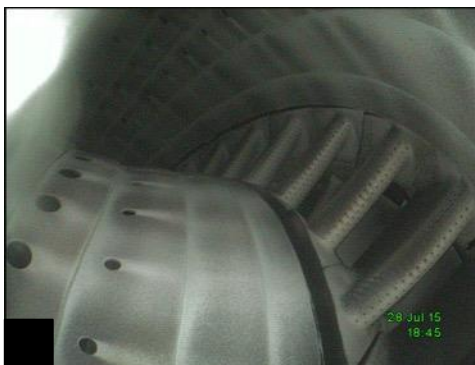
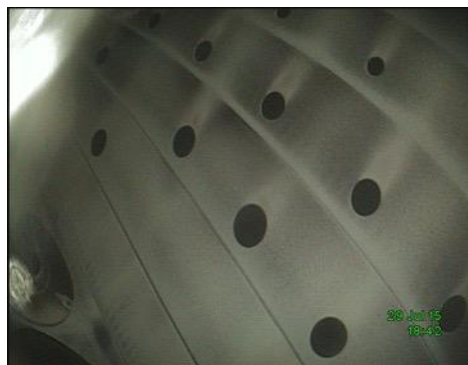
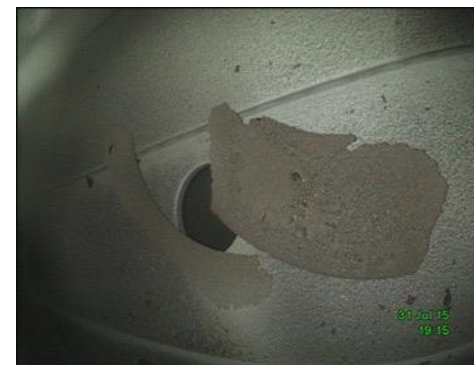
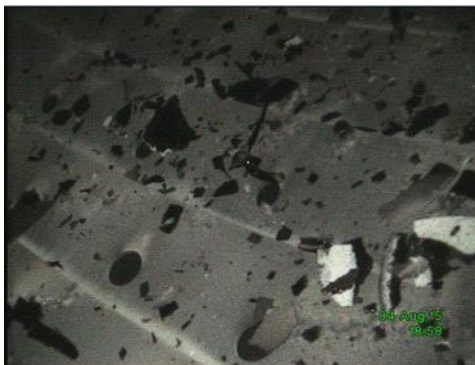
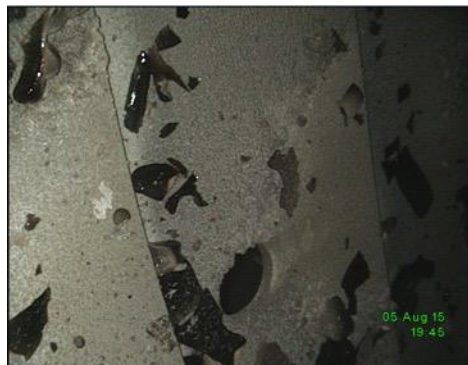
Summary – Combustor Degradation

- Inner and outer combustor liner intact with no evidence of distress
 - Ash accumulation on inner and outer liner surfaces with additional build up in the outer cavity between the burner and diffuser case
 - Inner liner had a light tan ash deposits aft of the cooling holes
- *Green tint on outside wall of outer basket, increasing further aft
- Combustor was more difficult to remove than typical
- Glass-like deposits found at 6 o'clock position when engine held horizontal

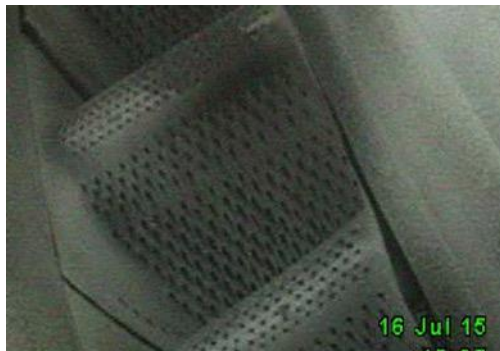
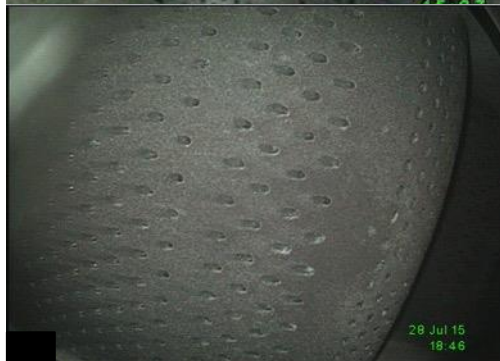
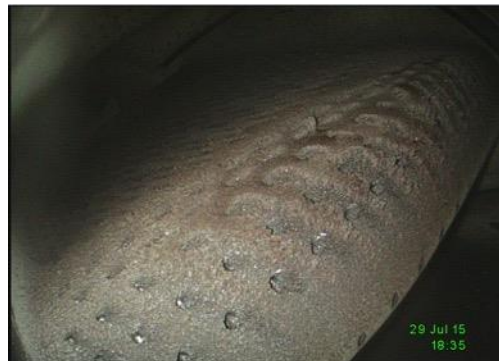
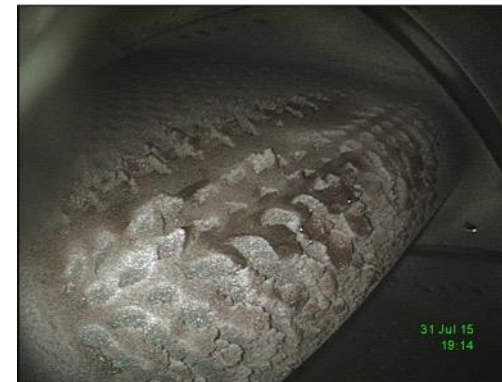
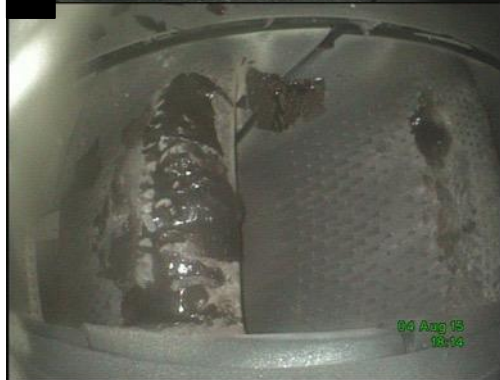
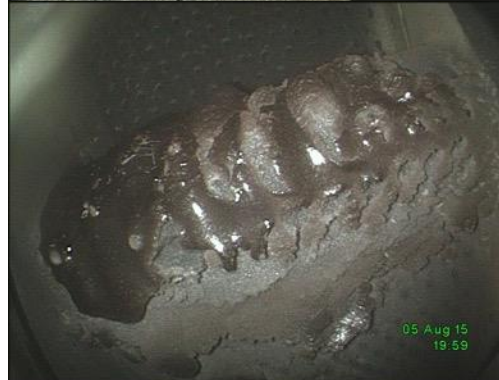
Summary – First Stage Turbine Vane Degradation

- **1st stage turbine vanes**
 - Build up appears to be glassified ash as expected
 - Gauge point region -still not significantly closed down
- **Combustor and turbine**
 - Show large thin flakes of ash shedding
- **1st blades still are relatively clean**
 - No concerns
- **Recommend**
 - Continue running at this point

- Few vanes had TBC missing

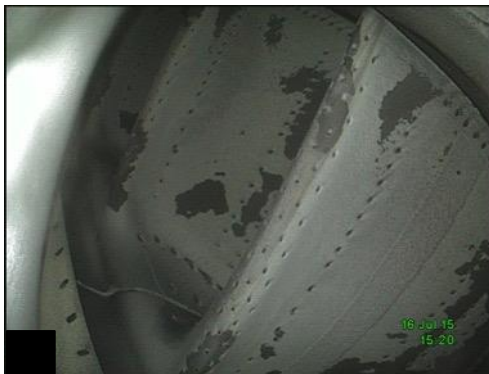
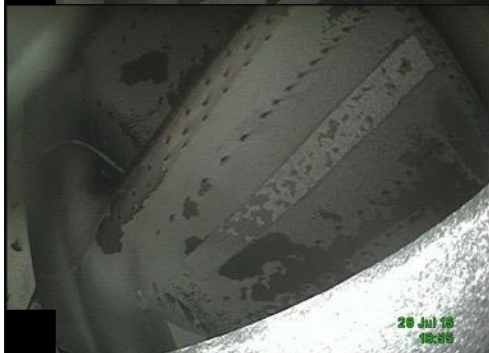
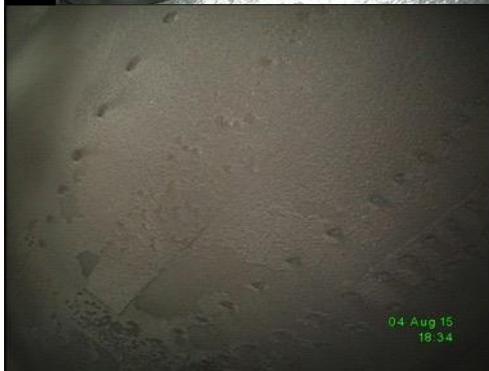
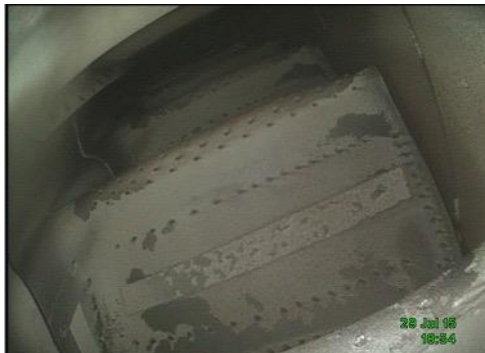
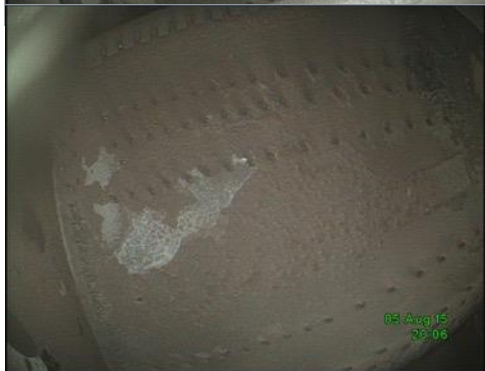
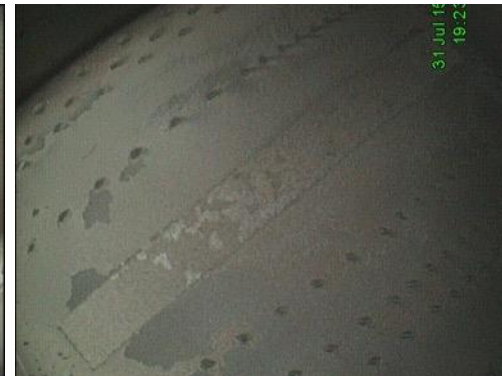
Summary – 1st Stage Turbine Rotor Degradation

- Various levels TBC spallation and removal observed throughout blades
 - Ash accumulation found in cooling passage at root but did not show plugging
 - Platform cooling holes were not plugged
 - Typical wear on outer edge BOAS

- Blades were normal, unremarkable
 - Loose ash found on blades and blade roots
 - Heavy ash content found below the platform
 - Coating material on BOAS missing in blade path
