Failure Analysis and Recovery of a 50-mm Highly Elastic Intermetallic NiTi Ball Bearing for an ISS Application

Christopher DellaCorte*, S. Adam Howard* and Lewis E. Moore III†

Abstract

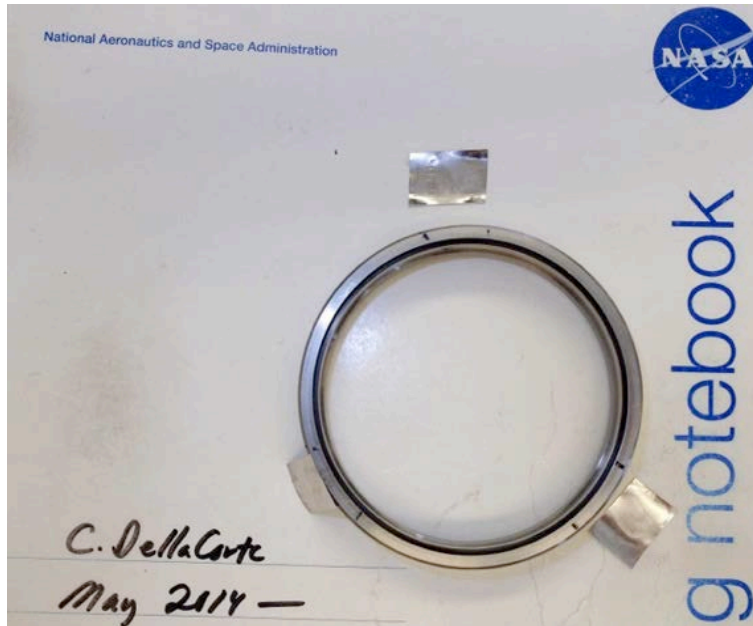
Figure 9. Shims used to deform the bearing outer race to match operating conditions in the DA that lead to the premature failure

The first test undertaken was to duplicate the hub-side bearing fit conditions that are believed to have caused the premature bearing failure. This could be achieved by manufacturing a new test rig bearing housing with the same three spoke structure and fit as the DA. Instead, a simplified approach was used that did not require extensive fabrication. The existing cylindrical housing was retained and three small pieces of stainless steel shim stock were placed between the bearing outer race and the housing. These three shims were approximately the same circumferential length and depth as the DA spokes. The shim thickness was selected to deform the bearing outer race approximately the same magnitude as the DA hub side housing. The use of shims is not an exact simulation of the physical race deformations in the DA but it is a fair approximation of the clearance reduction and tri-lobe shape variation. Figure 9 shows a photograph of the bearing outer race and the three shims used for the deformation experiment.
