Swift BAT Thermal Recovery After Loop Heat Pipe #0 Secondary Heater Controller Failure in October 2015

Michael K. Choi*

NASA Goddard Space Flight Center, Greenbelt, MD 20771

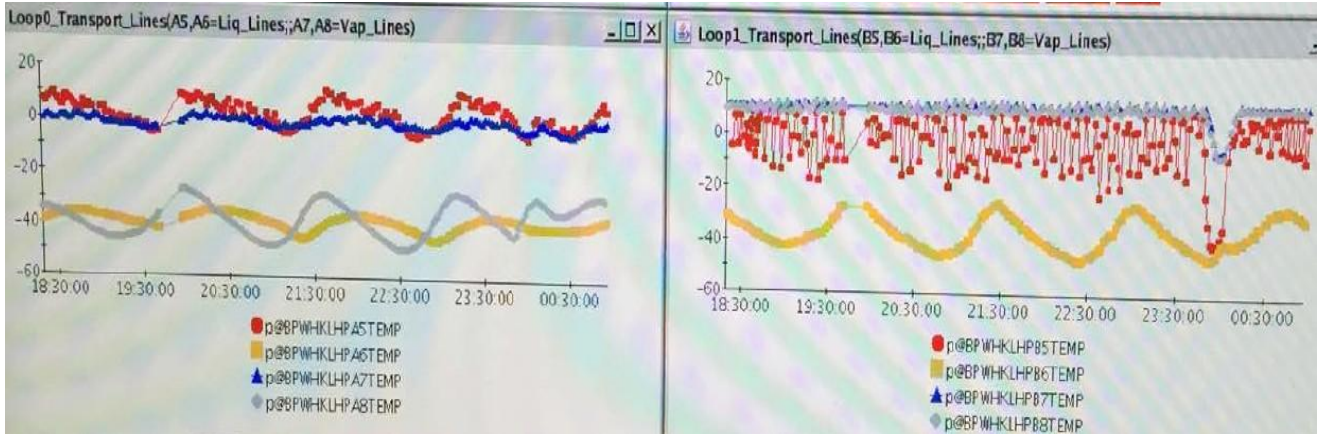
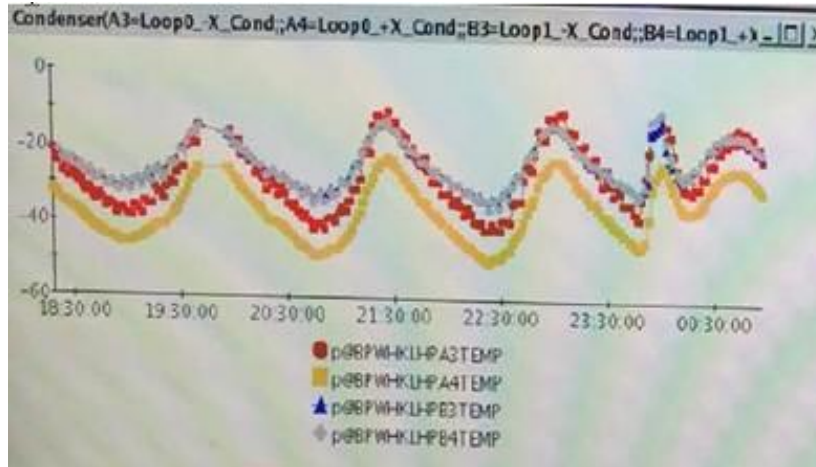
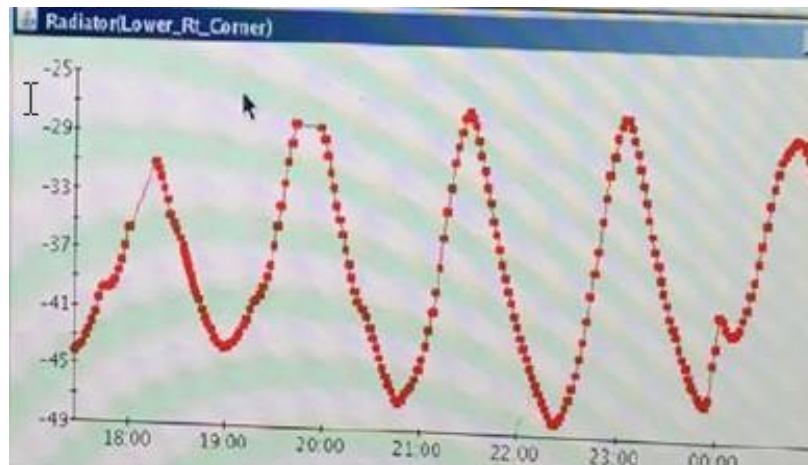
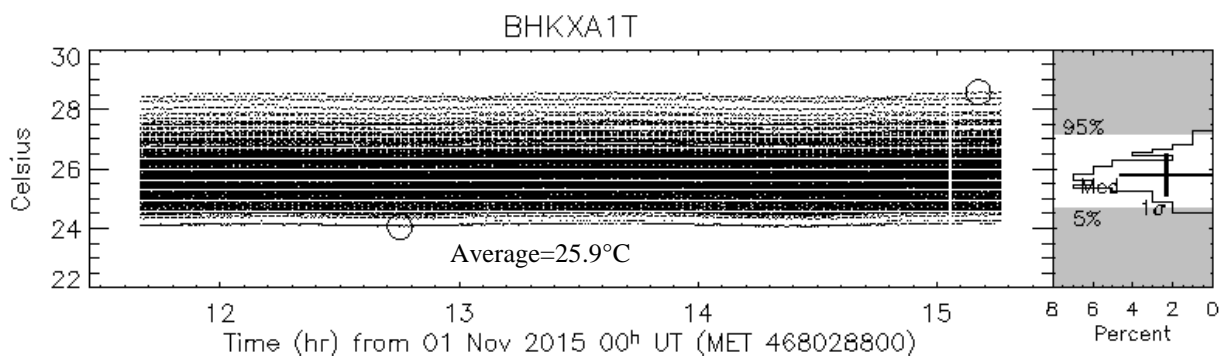
On October 31, 2015, the secondary heater controller of LHP #0 failed. Fig. 10 shows the LHP #0 CC flight temperature telemetry during the failure. From October 30-31, the LHP #0 CC temperature became unstable and oscillated between 8°C and 22°C for about 24 hours. Note that prior to the failure, the heater controller maintained the LHP #0 CC temperature at the 8.8°C set point. At 14:00 Universal Time (UT) on October 31, the LHP #0 CC temperature had a temperature droop. It decreased to 1°C first and settled at approximately 18°C. Fig. 11 through 13 show the flight temperature telemetry of the LHP #0 evaporator, liquid line/vapor line, and condenser respectively. At 20:00 UT on October 31, the Detector Module (DM) Block temperature increased to 21°C (Fig. 14), which led to an increase in the average DM XA1 temperature to 25.9°C. It also led to noisy detectors and high triggering rates. Therefore the detector high voltage was reduced from 200 V to 100 V.

Figure 11. Transport Line Temperatures of LHP #0 and LHP #1 on November 1, 2015.

Figure 12. Condenser Temperatures of LHP #0 and LHP #1 on November 1, 2015.

Figure 13. Radiator Temperature on November 1, 2015.

Figure 14. DM XA1 Temperature on November 1, 2015.

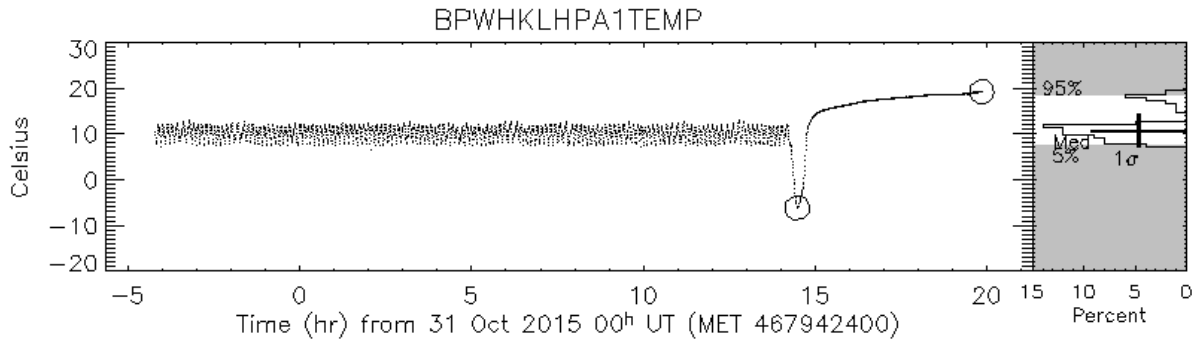
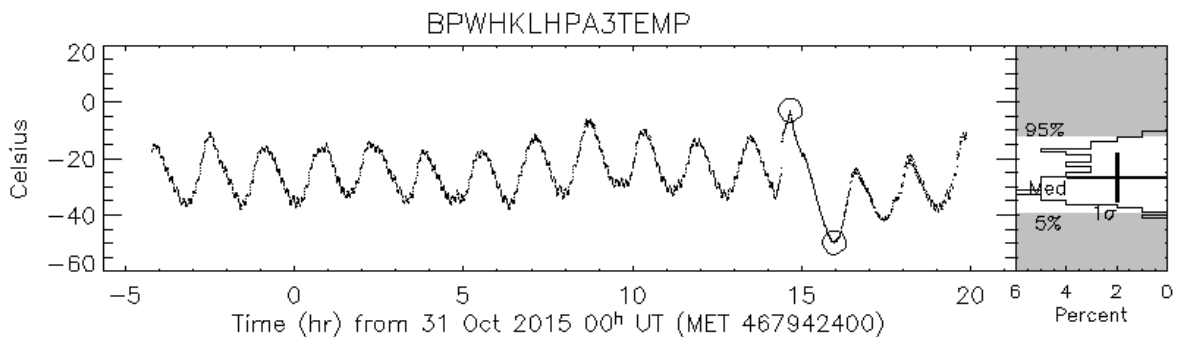
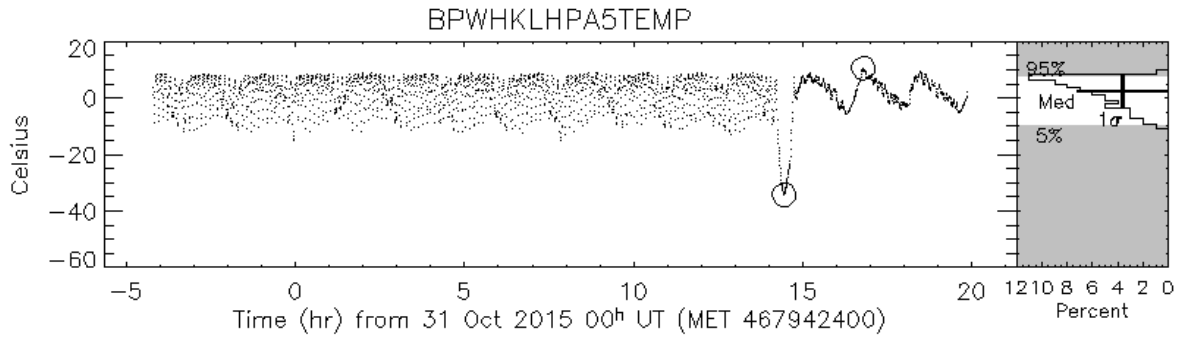
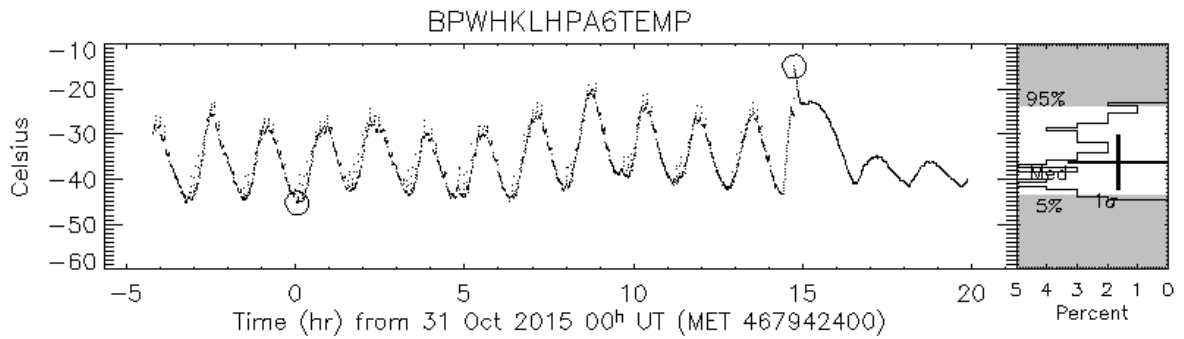
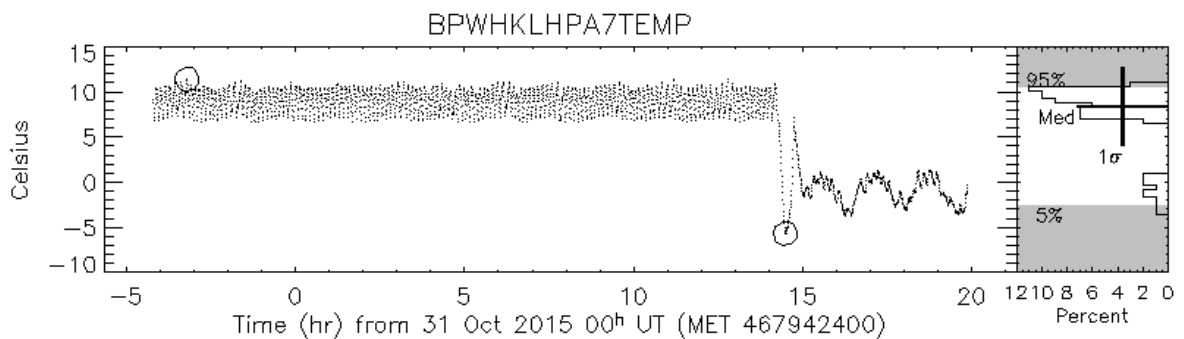
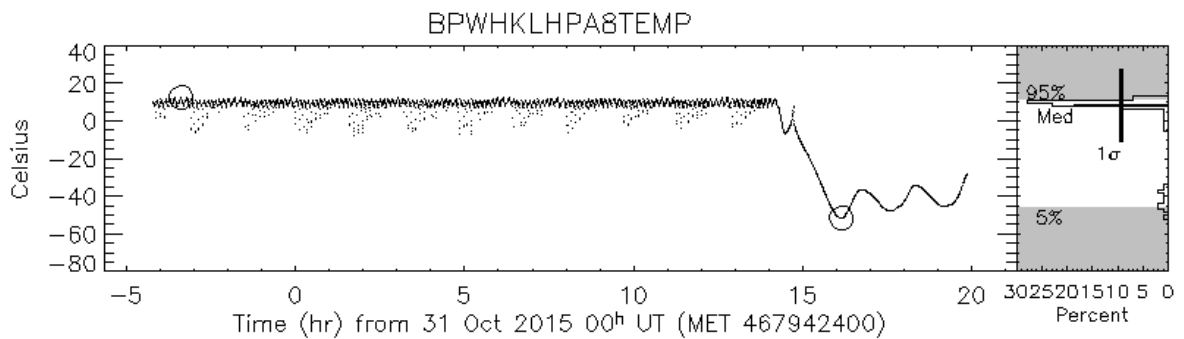
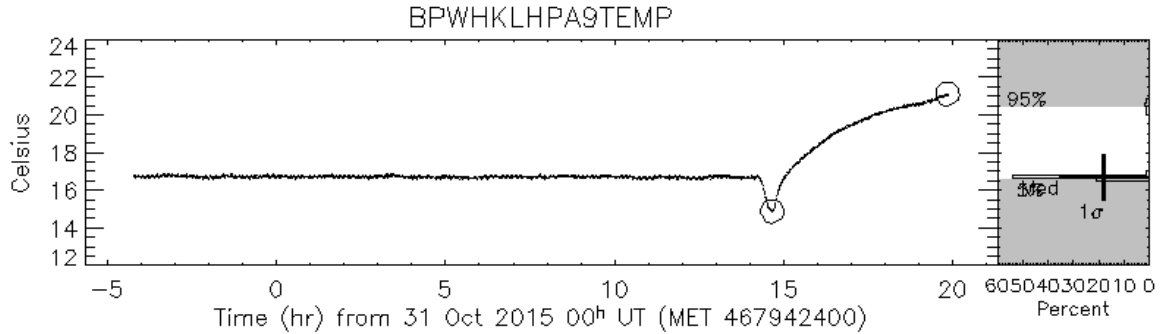
Fig. 15 through Fig. 21 show the flight temperature telemetry of LHP #0 on October 31, 2015. The LHP #0 CC temperature (about 18.6°C) is much higher than the LHP #0 secondary heater controller set point (8.8°C). After the LHP #0 secondary heater controller failed, it was unable to control the LHP #0 CC temperature. It possibly failed on (i.e., operating at 100% duty cycle). As a result, the LHP #0 evaporator temperature increased to 20°C. To verify this hypothesis, the set point of this heater controller was decreased in 0.5°C decrements by sending commands

The LHP #1 CC and evaporator temperatures were not affected by the LHP #0 secondary heater controller failure. Therefore the LHP #1 secondary heater controller was nominal. With LHP #0 operating at temperatures nearly 10°C warmer than nominal, and LHP #1 operating at nominal temperatures, the conductive heat sink temperature for the DM XA1 was basically the average of the two LHP evaporator temperatures. As a result, the average DM XA1 temperatures was nearly 5°C warmer than nominal. Fig. 22 presents the DM Block flight temperature telemetry on October 31, 2015. The DM Block temperature increased from 16.7 at 20:00 UT on October 30, 2015 to 21.2°C at 20:00 UT on October 31, 2015.

Figure 16. LHP #0 Evaporator Temperature on October 31, 2015.

Figure 17. LHP #0 Condenser Temperature on October 31, 2015.

Figure 18. LHP #0 Liquid Line at CC Temperature on October 31, 2015.

Figure 19. LHP #0 Liquid Line at Condenser Outlet Temperature on October 31, 2015.

Figure 20. LHP #0 Vapor Line at Evaporator Outlet Temperature on October 31, 2015.

Figure 21. LHP #0 Vapor Line at Condenser Outlet Temperature on October 31, 2015.

Figure 22. DM Block Temperature on October 31, 2015.

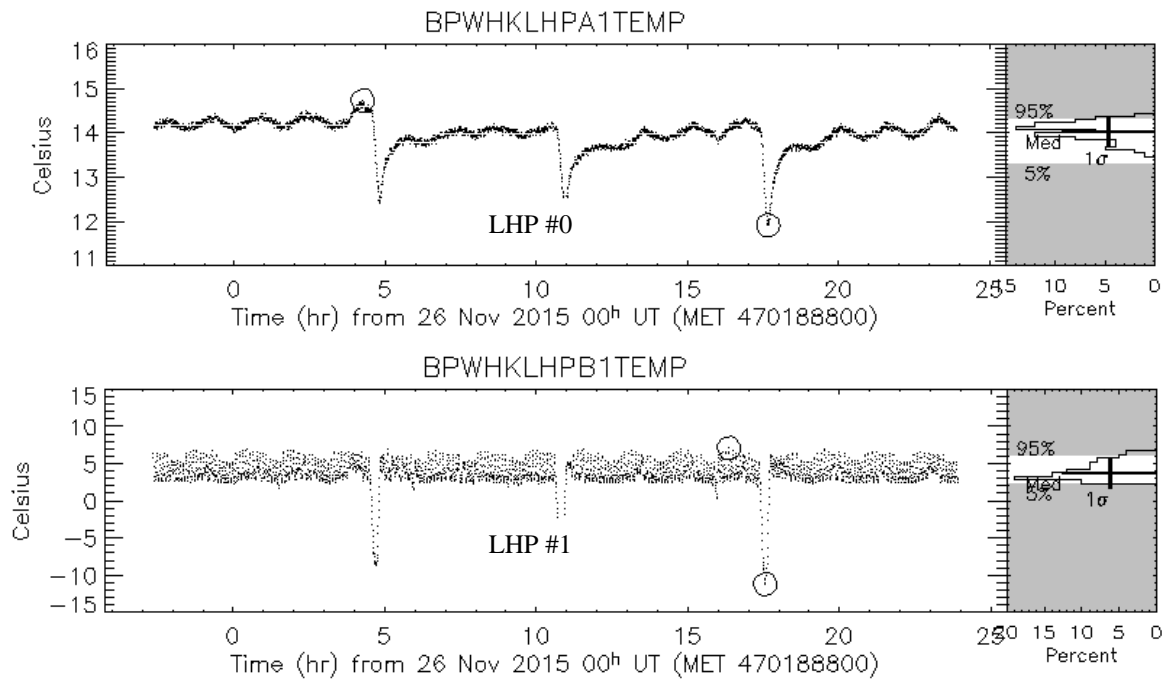
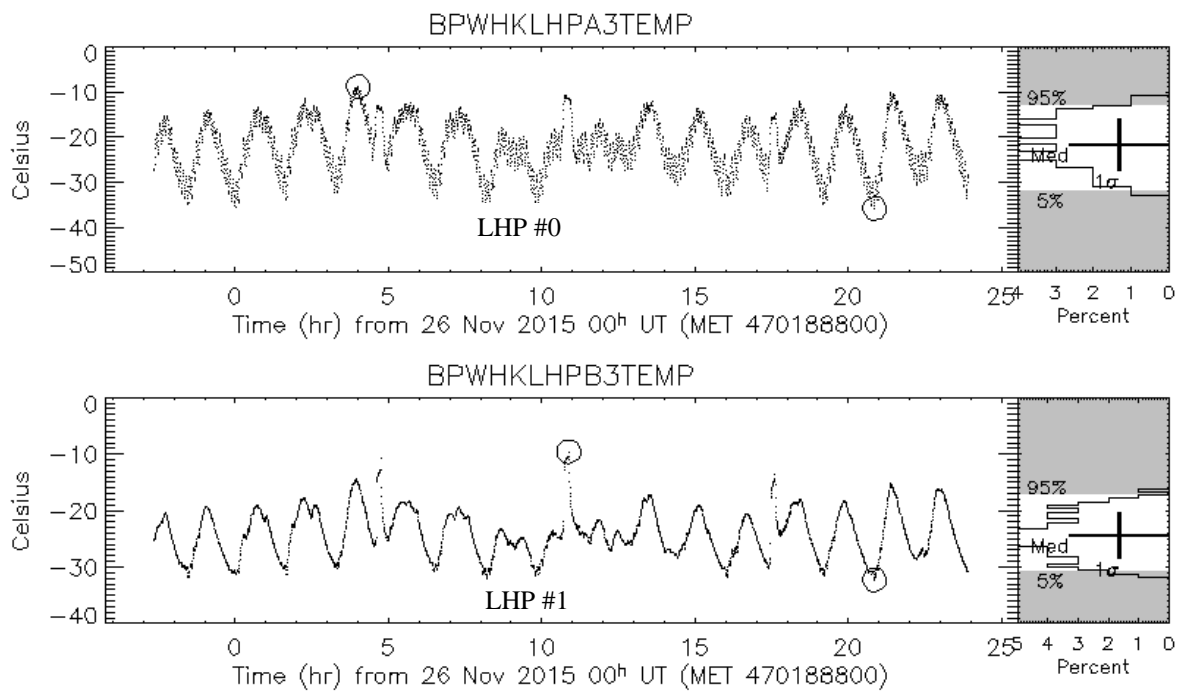
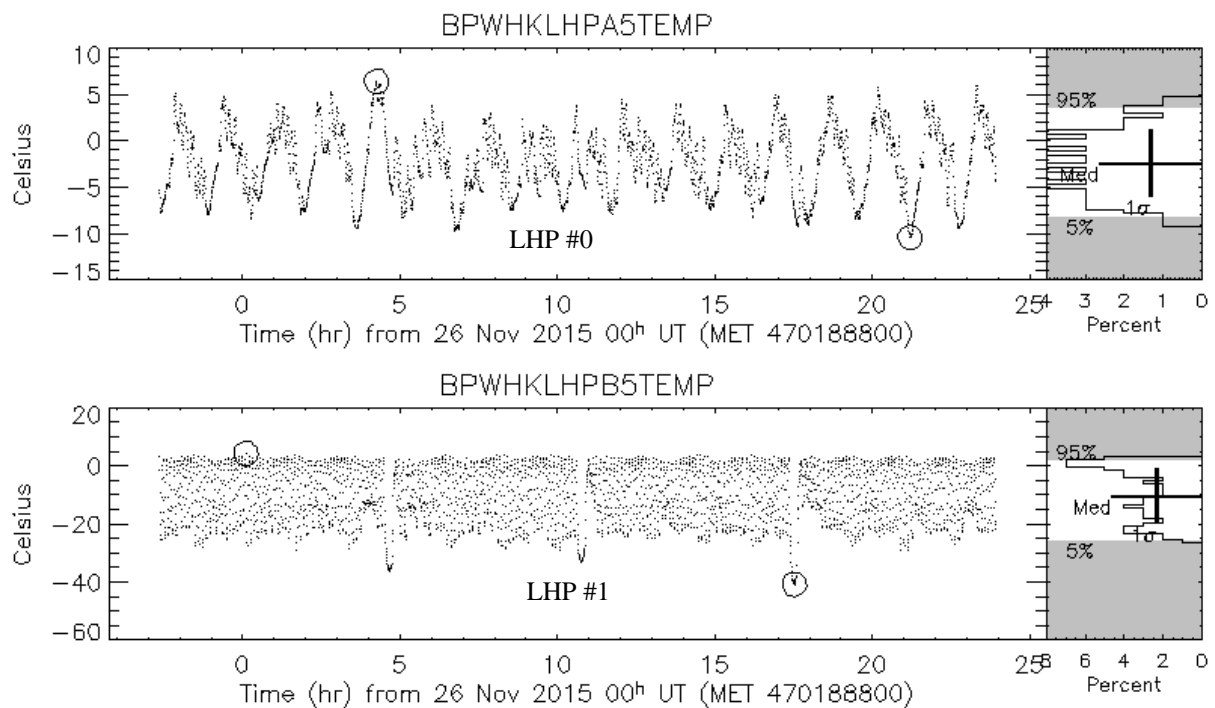
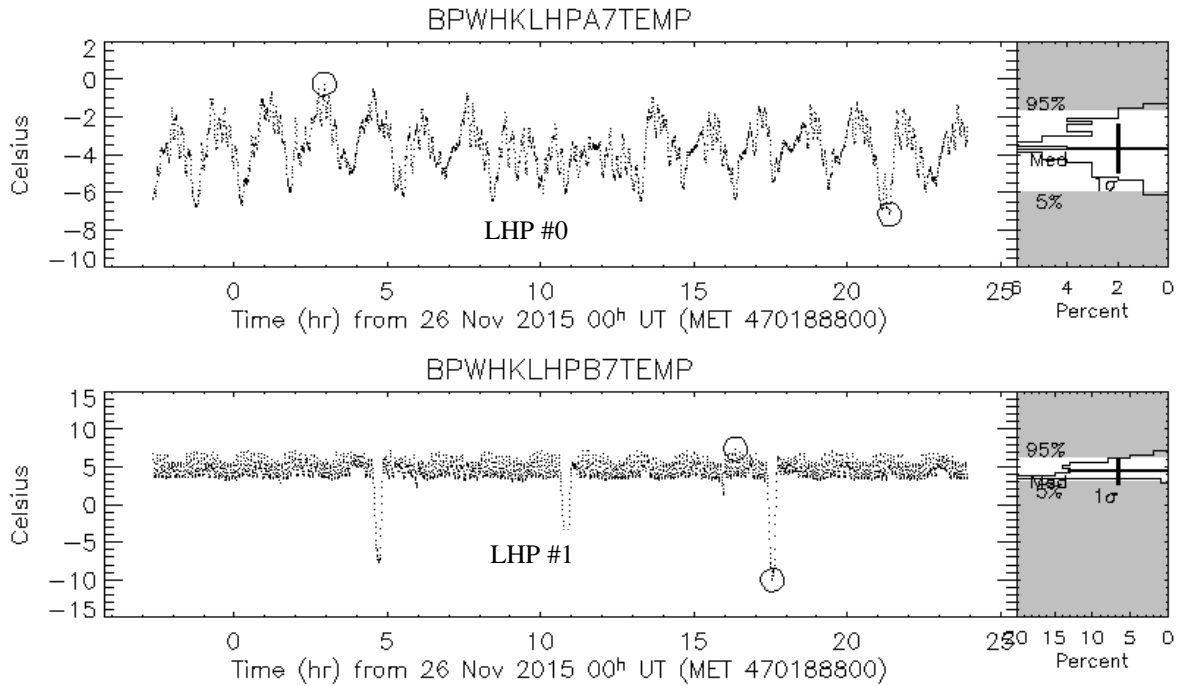
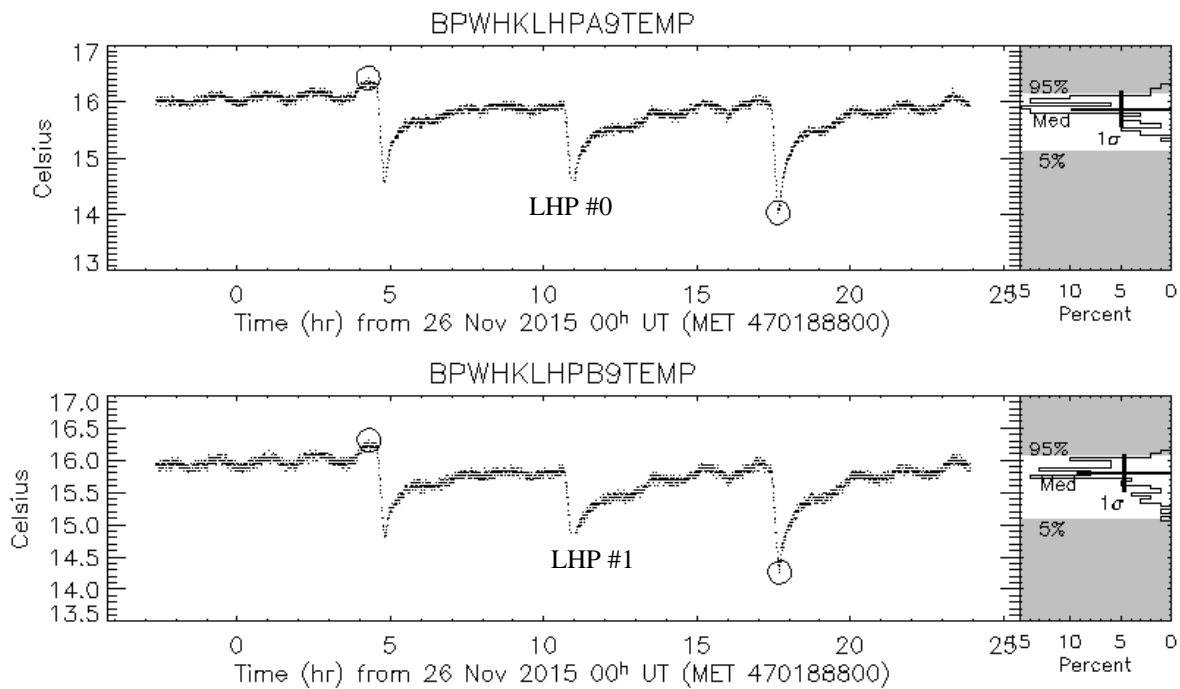
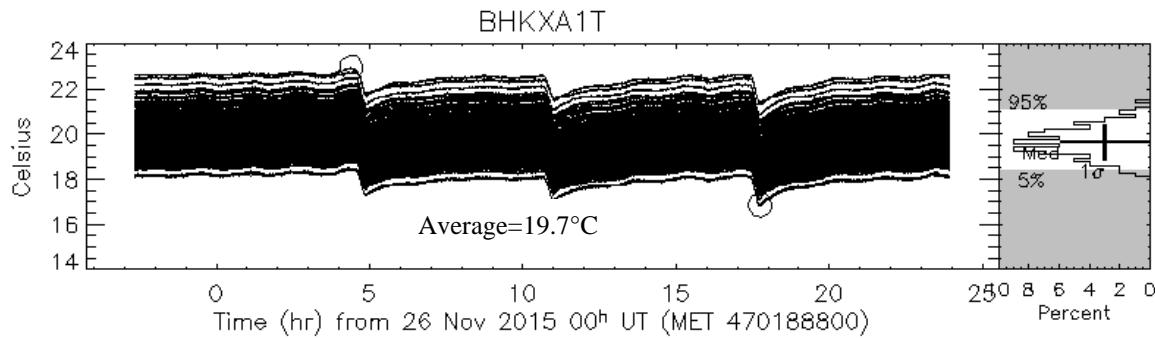
Fig. 23 shows the LHP CC and evaporator flight temperature telemetry from November 14-16, 2015. The LHP #0 CC temperature was between 12°C and 17°C. The LHP #1 CC temperature was between -1°C and 5°C, except during the droops. It decreased to -11°C minimum during the eight droops over 72 hours. Fig. 24 through Fig. 28 present the LHP flight temperature telemetry on November 26, 2015. Fig. 29 and Fig. 30 present the DM Block and DM XA1 flight temperature telemetry respectively on November 26, 2015. They represent the BAT flight temperatures after its thermal control system recovery. Presently the average DM XA1 temperatures remains at 19.7°C. The BAT is operating nominally.

Figure 25. LHP Evaporator Temperature on 26 November, 2015.

Figure 26. LHP Condenser Temperature on 26 November, 2015.

Figure 27. LHP Liquid Line at CC Inlet Temperature on 26 November, 2015.

Figure 28. LHP Vapor Line at Evaporator Outlet Temperature on 26 November, 2015.

Figure 29. DM Block Temperature on 26 November, 2015.

Figure 30. DM XA1 Temperature on 26 November, 2015.

With the DM XA1 temperatures nearly 5°C warmer than nominal, the detectors became noisy and had high triggering rates. It was necessary to decrease these temperatures to the nominal value. Since the average temperature of the two LHP evaporators determines the DM XA1 temperatures and the LHP #0 failed on, it was necessary to decrease the LHP #1 evaporator temperature significantly. Therefore, the LHP #1 secondary heater controller set-point was decreased gradually by 0.5°C at a time until the LHP temperatures became nearly stabilized. Decreasing the heater controller set point removes thermal energy from the LHP. A large set point change could cause large temperature instabilities and shut down the LHP. Therefore the set point (8.6°C) was decreased gradually during command passes, such as TDRSS, beginning on November 6. On November 16, the average DM XA1 temperatures was restored to the nominal temperature of 19.7°C. The LHP #1 secondary heater controller set-point decrease was completed with a 2.2°C set-point.

Also the primary DM Block heater controller set points were reduced to 15.5°C, which is about 1°C below the DM Block temperature telemetry, on November 17. It is to assure not to add heat to the DM Blocks or XA1s when there were no droops. During the droops, if the Block temperatures reach 15.5°C, the DM Block heaters will be activated. After activation, they will be deactivated when they reach 16°C. The secondary Block heater controller set points were reduced to 13.5°C, so that only the primary DM Block heaters will be activated when the Block temperatures reach 15.5°C.
