# Large Area Nondestructive Evaluation of a Fatigue Loaded Composite Structure

<sup>1</sup>NASA Langley Research Center, MS231 Hampton, VA 23681

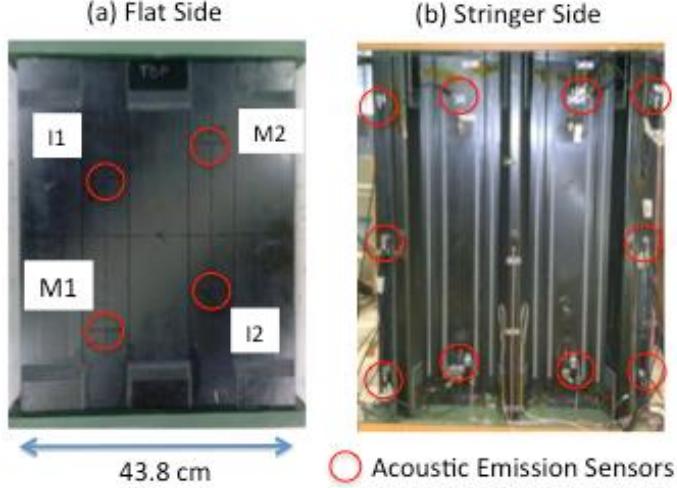
The hat stiffened composite panel flat side and stringer side with acoustic emission locations (stringer side) are shown in Figures 1a and 1b respectively. The panel skin is 17 plies with a thickness of 0.32 cm. The hat flange is 11 plies with a thickness of 0.21 cm. Barely visible impact damage (BVID) were induced at 4 locations (I1, M1, I2, M2) on the panel skin on the hat stiffeners flange or right next to the flange. The BVID was used to simulate existing delamination damage and to serve as potential damage growth sites. Cyclic compressive loads were applied from -20,000 pounds up to -150,000 pounds at 2 Hz using the setup shown in Figure 2. The sample was painted with a speckle pattern for high speed digital image correlation imaging. The high speed digital image correlation cameras required illumination using red light emitting diode (LED) lights. The LED lights were not a problem for the IR cameras operated in the mid IR waveband. The load was

applied from the bottom while the top was held stationary. Passive thermography was used to track the damage on both the flat and stringer sides during loading using two IR cameras. Shown in Figure 1b are the locations of the acoustic emission sensors in relation to the BVID. The acoustic emission sensors were used for real time detection of acoustic events indicating damage growth.

Figure 1: Three stringer composite panel tested with impact and acoustic emission sensor locations.

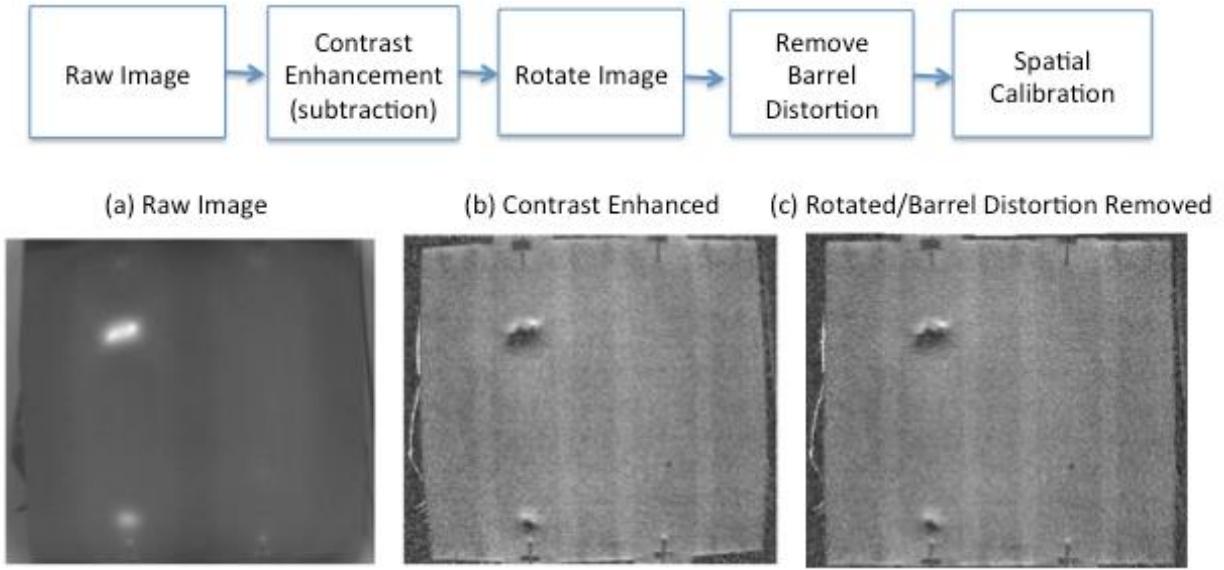
Where  $r_{undistorted}$  is the corrected Cartesian coordinate vector distance from the center of the image and  $r_{distorted}$  is the distorted Cartesian vector distance from the center of the image. The parameter  $d$  was set to 0.2 to remove the distortion. The pixel resolution was calculated to be 8.2 pixels per cm. A comparison of the contrast enhanced, rotation corrected and barrel distortion thermal images are shown in Figures 7b and 7c. The image in Figure 7c is used to map the acoustic emission data.

Figure 7. Procedure to process thermal imagery for mapping of acoustic emission data.
